**Interim Project Effectiveness Report
Moose Creek Steelhead Improvement Project
OWEB #208-3057-6820
South Santiam Watershed Council
January, 2010**

Moose Creek Steelhead Habitat Improvement Project

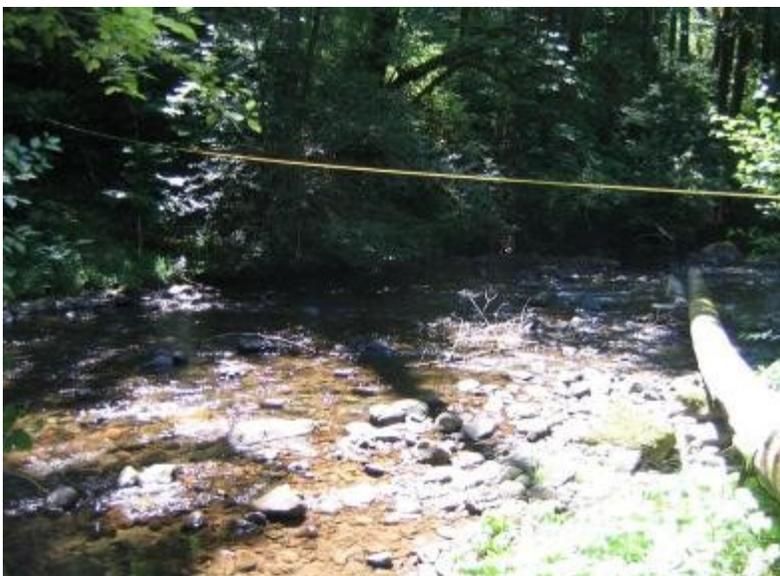
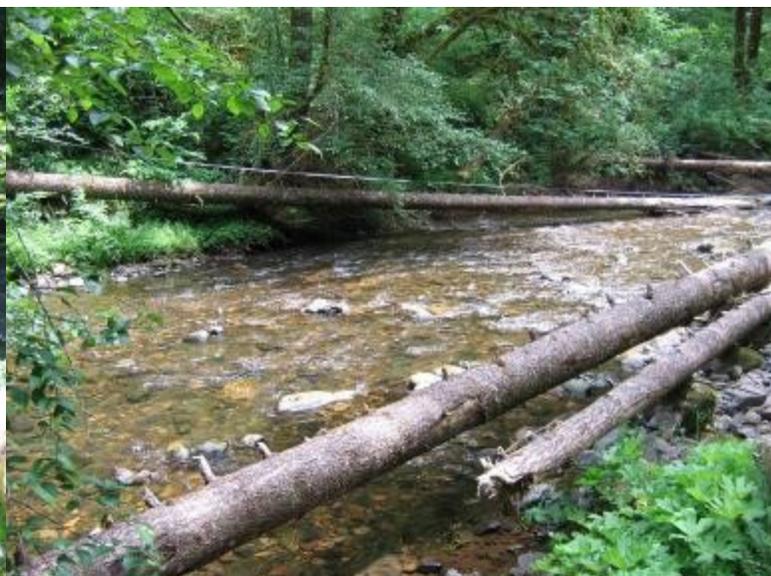
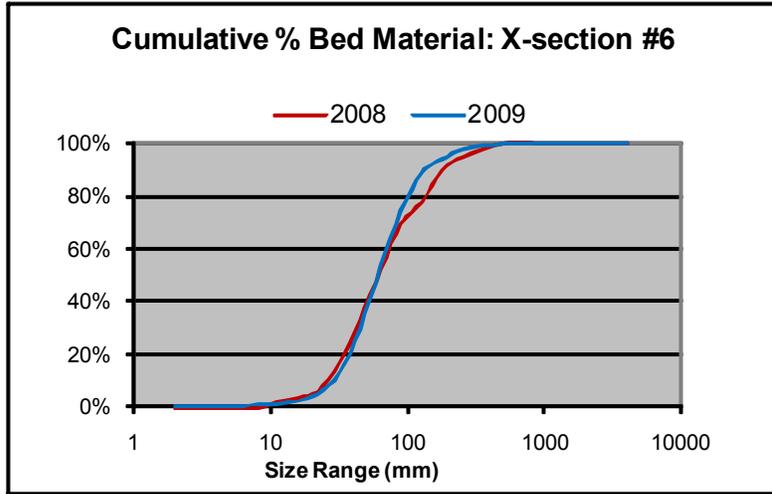
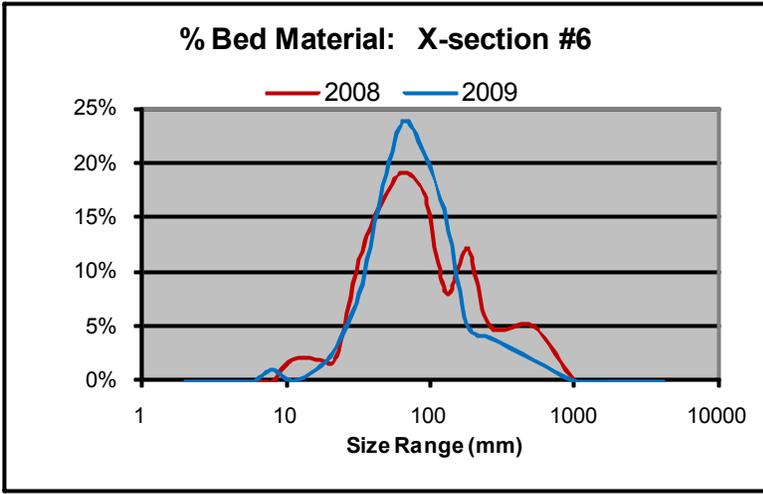
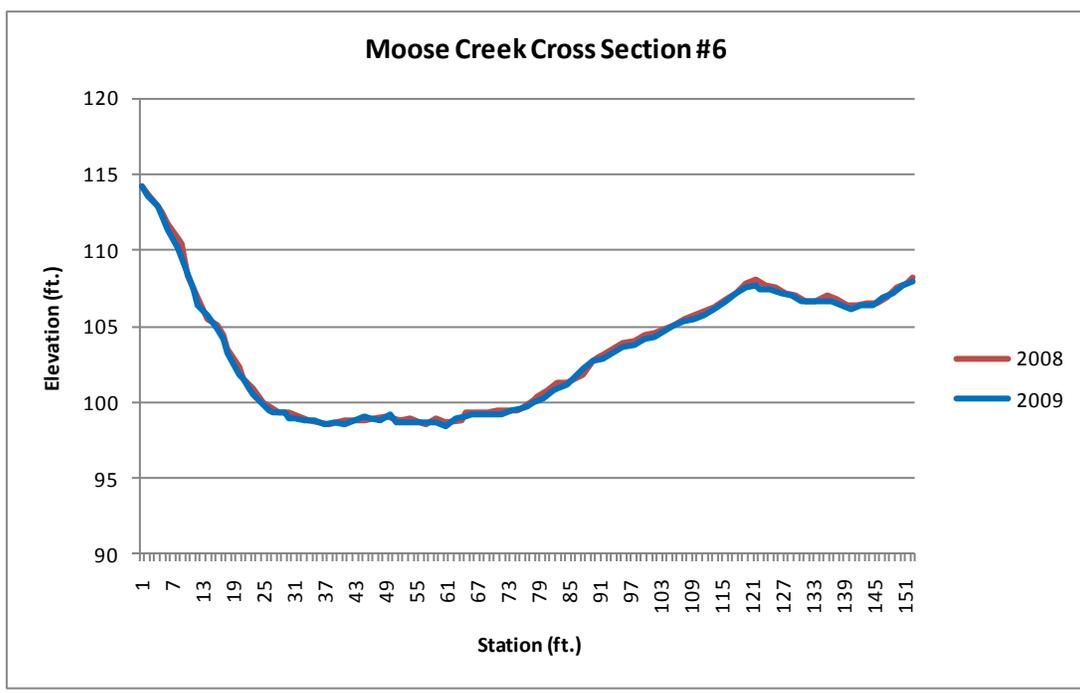
Moose Creek Cross-Section #6

Pre-project 7/31/2008

Post-project 6/16/2009

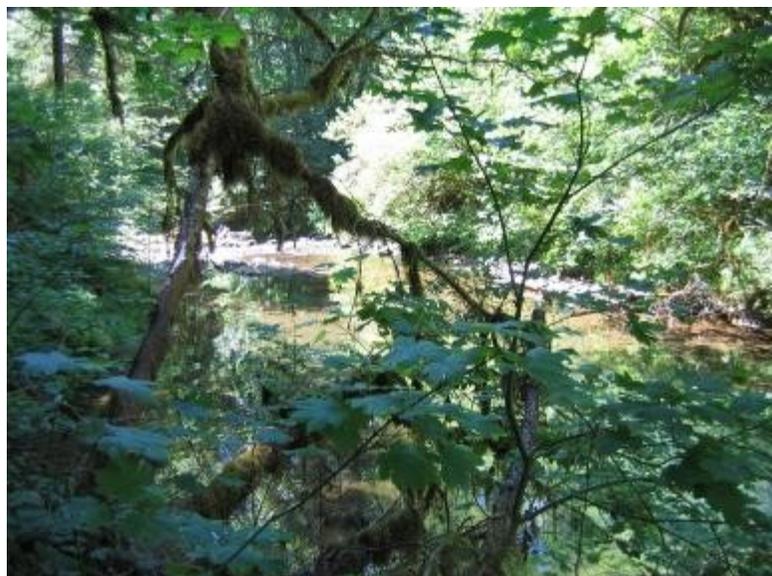
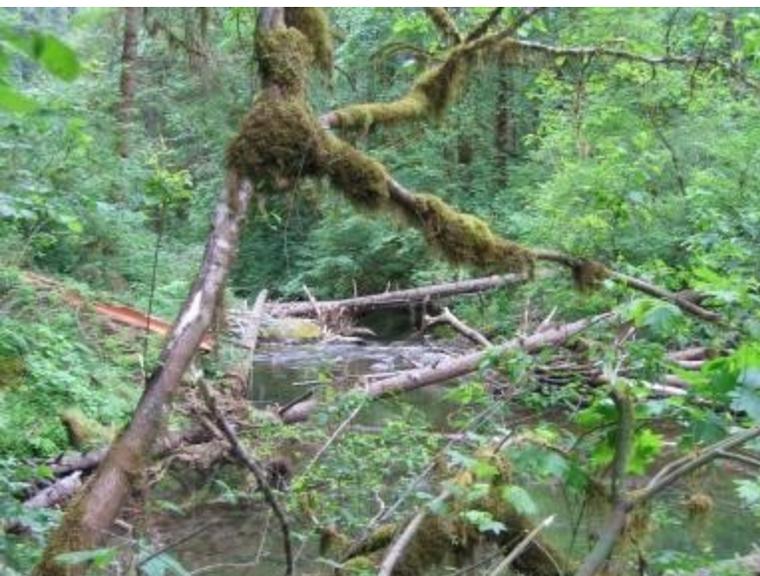
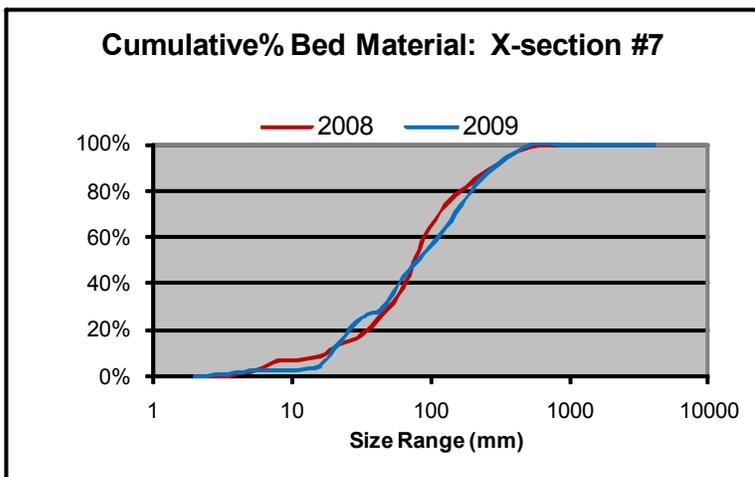
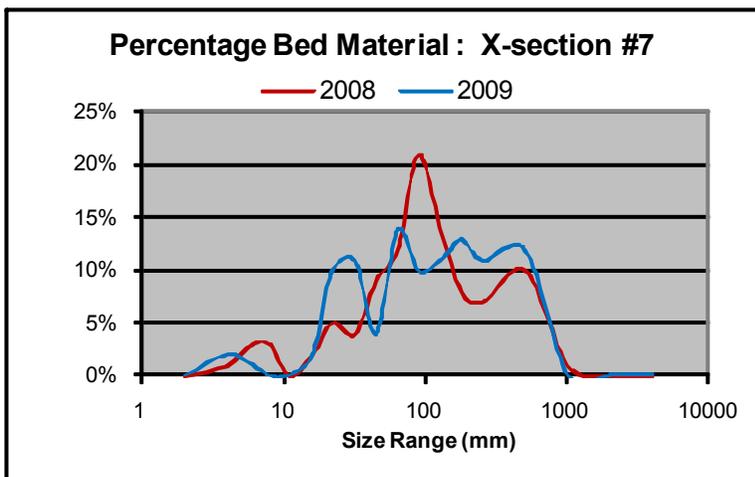
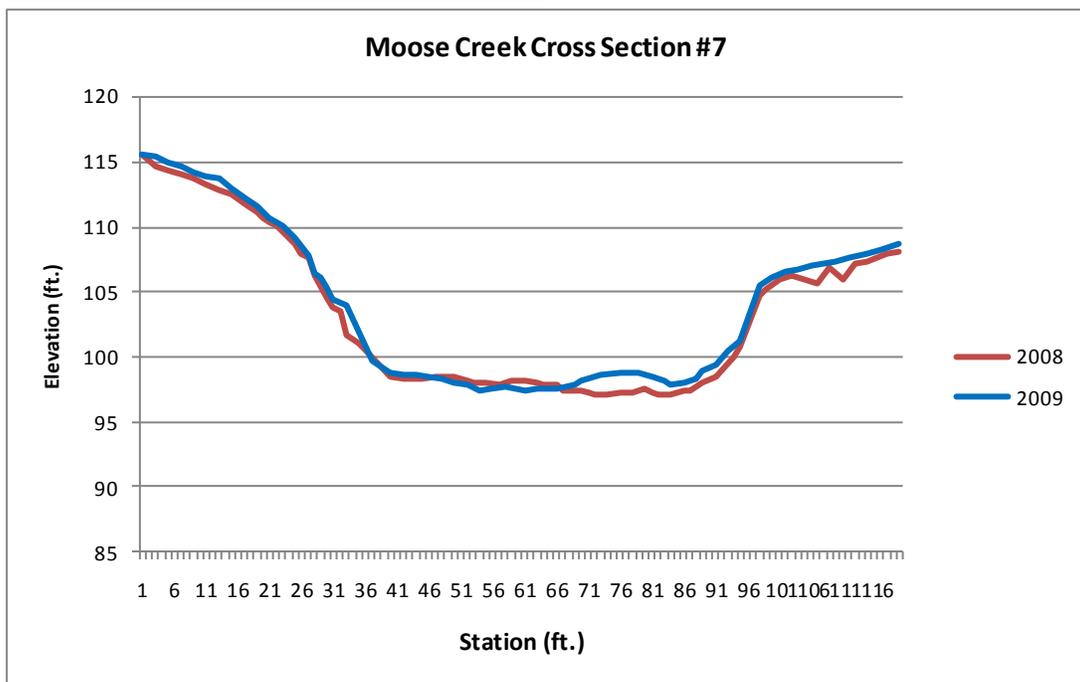
Moose Creek Cross-Section #7

Pre-project 7/31/2008

Post-project 6/16/2009

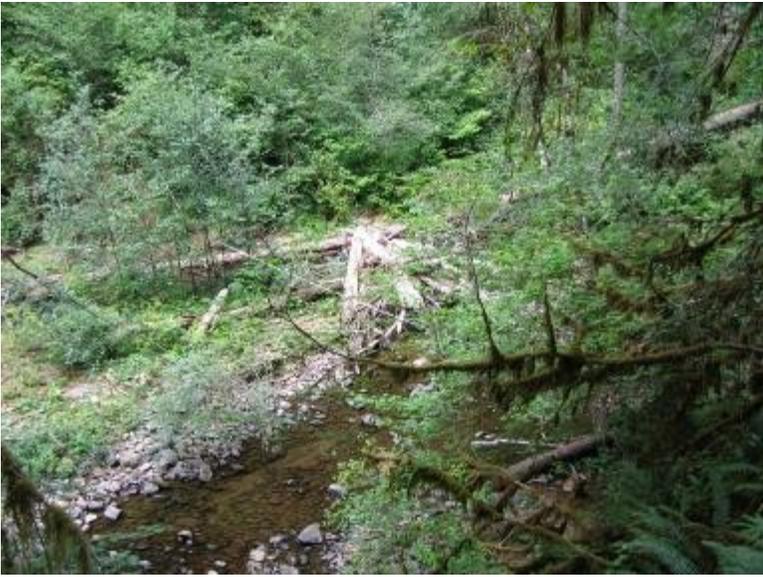
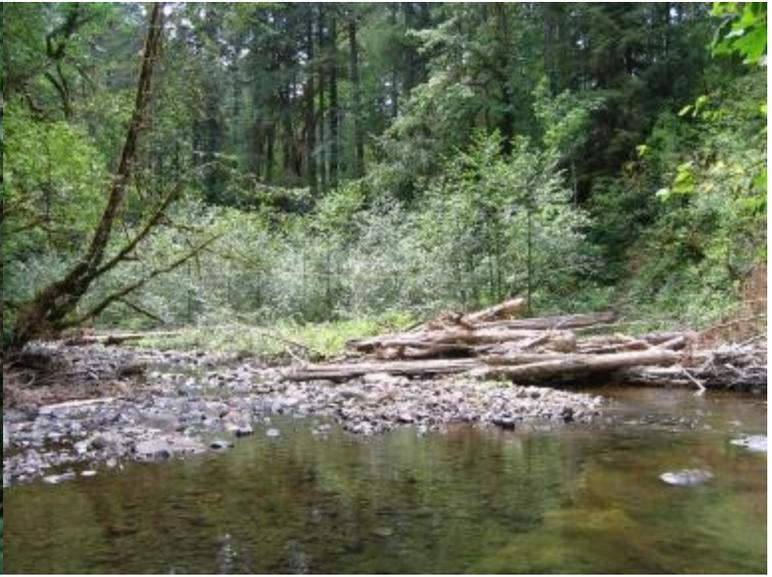
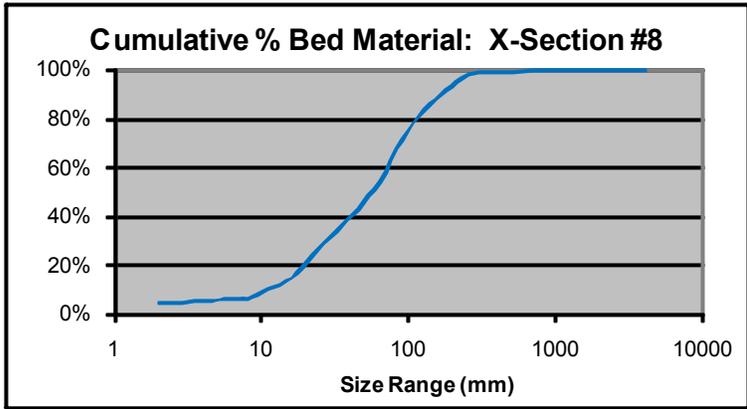
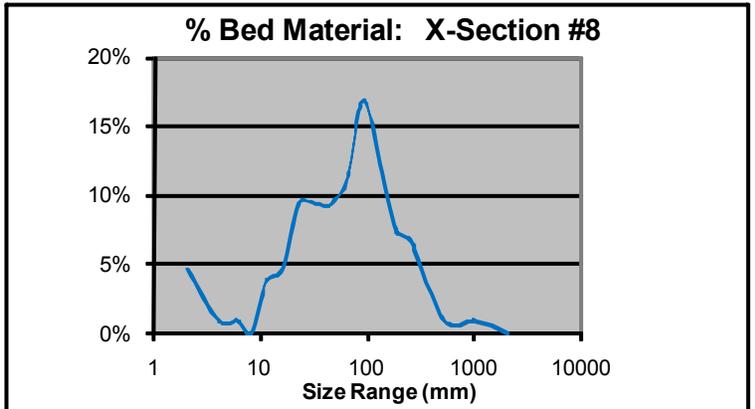
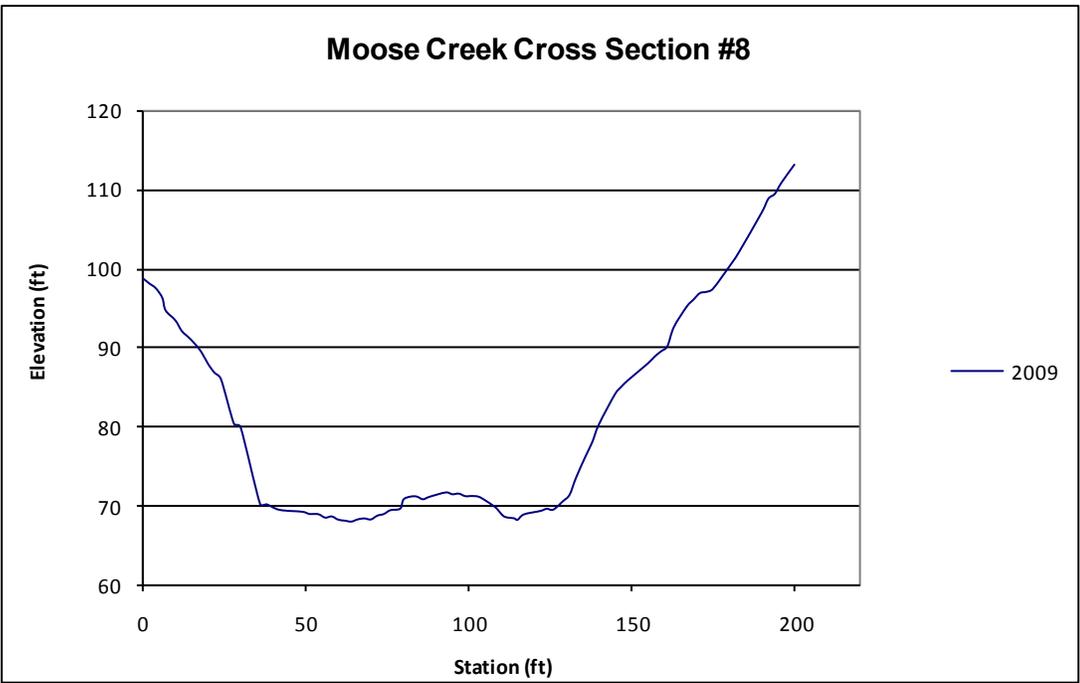
Moose Creek Cross-Section #8: Data from 2009 Only

Cross Section #8, Post-project 9/1/2009

Cross Section #8, Looking Downstream, Post-project 9/1/2009

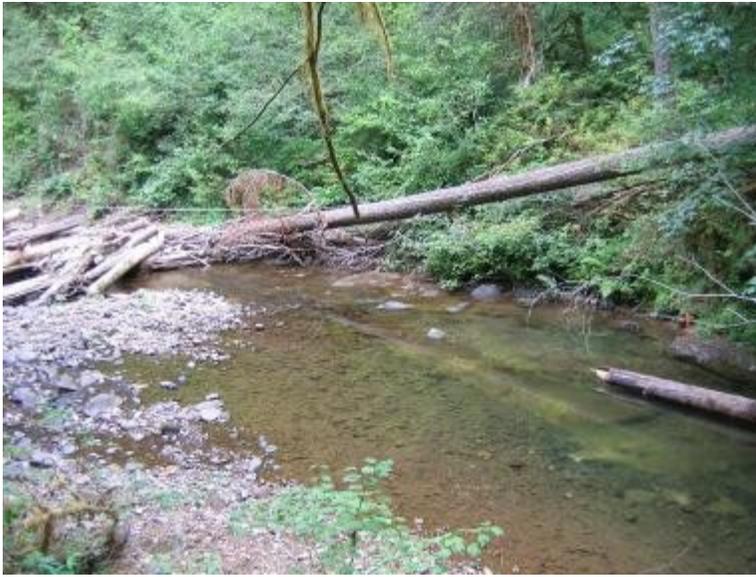
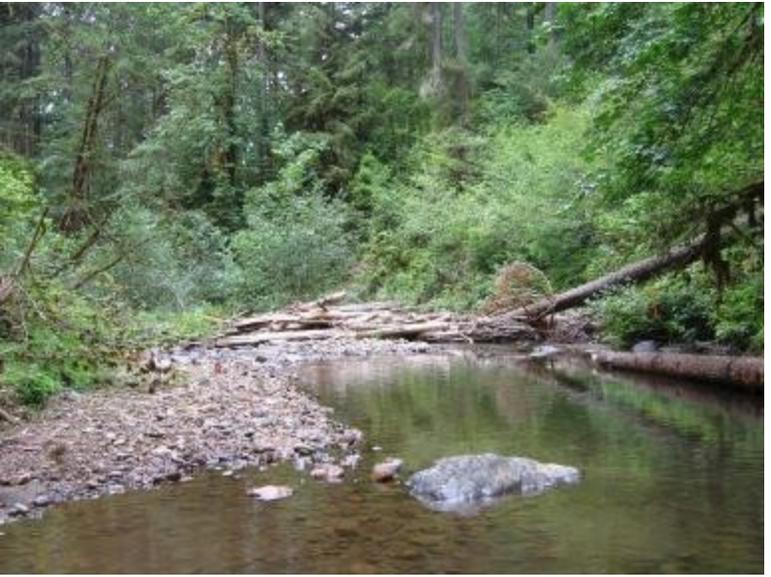
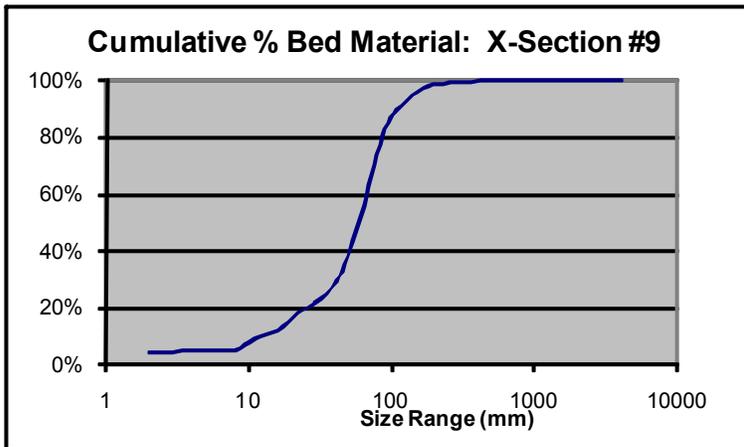
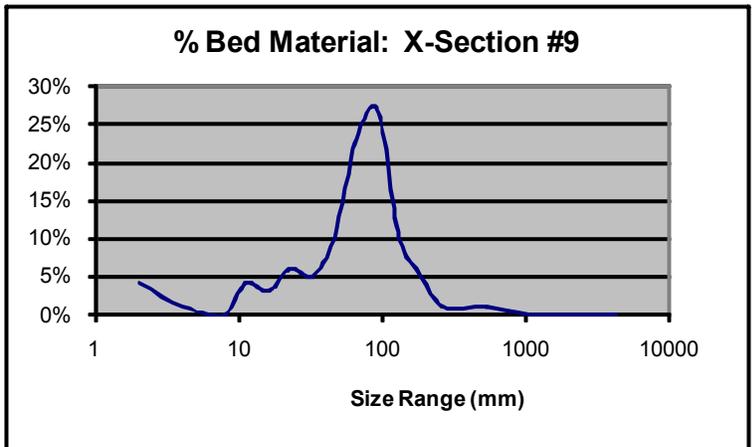
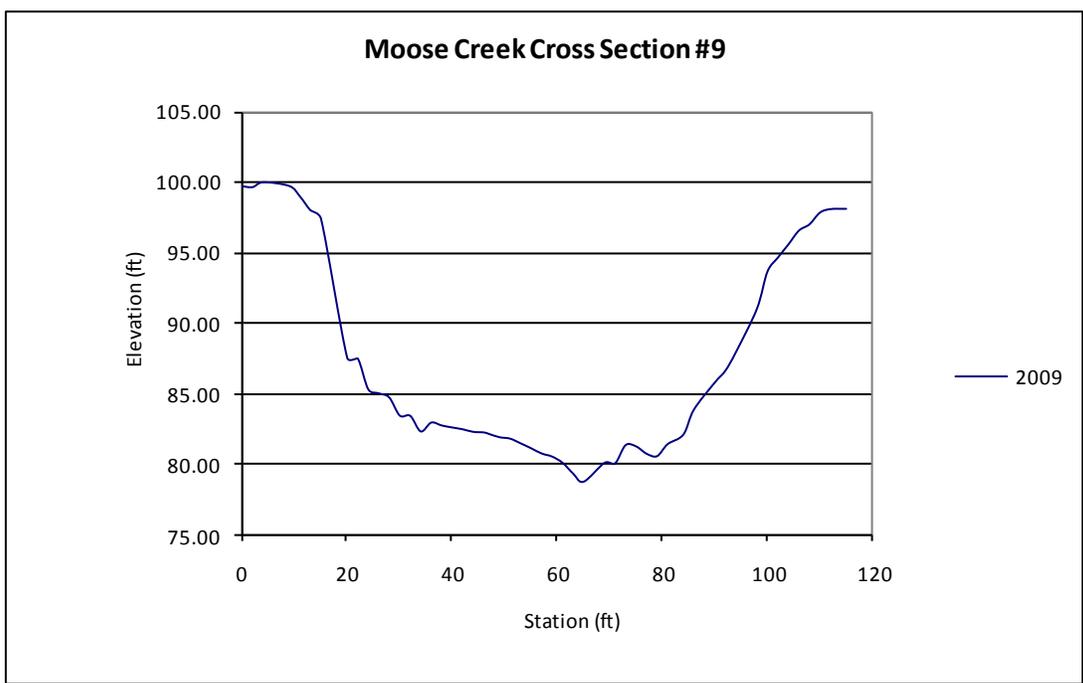
Moose Creek Cross-Section #9: Data from 2009 Only

Cross Section #9, Post-project 9/1/2009

Cross Section #9, Looking Downstream, Post-project 9/1/2009
