Project Monitoring Report
OWEB Grant 204-372C – Coos Watershed Association Projects 2004 Riparian
Coos Watershed Association
October 23, 2008

Projects completed under this grant addressed limiting factors for salmon production by restoring riparian areas with native vegetation (see Table 1). Located at nine project sites (see Map 1), spanning 6 landowners, the Coos Watershed Association has incorporated all but one of the projects completed under this grant into our restoration program effectiveness monitoring effort. Riparian monitoring data is collected using protocols outlined in the *Coastal Oregon Riparian Silviculture Guide* (Massingill 2003). Monitoring data has been collected yearly, for 4-6 years at each of the four project sites, and managed through our Riparian Silviculture Database. Results have shown consistent tree growth, notwithstanding some variation for species and site, and overall generally good plant survival.

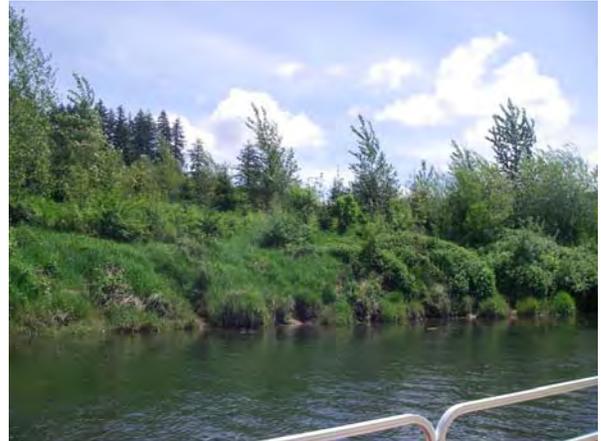
Photo 1. Winter Springs Ranch Riparian Planting, June, 2008.

The Winter Springs Ranch is the Coos Watershed Association's oldest CREP project and is one of our best examples of incorporating diverse species in riparian restoration projects (Photo 1). The landowner remains committed to the success of this project through maintaining the live-stock exclusion fencing. Japanese knotweed patches at the site were treated during the summer, 2008 and the control appears effective.

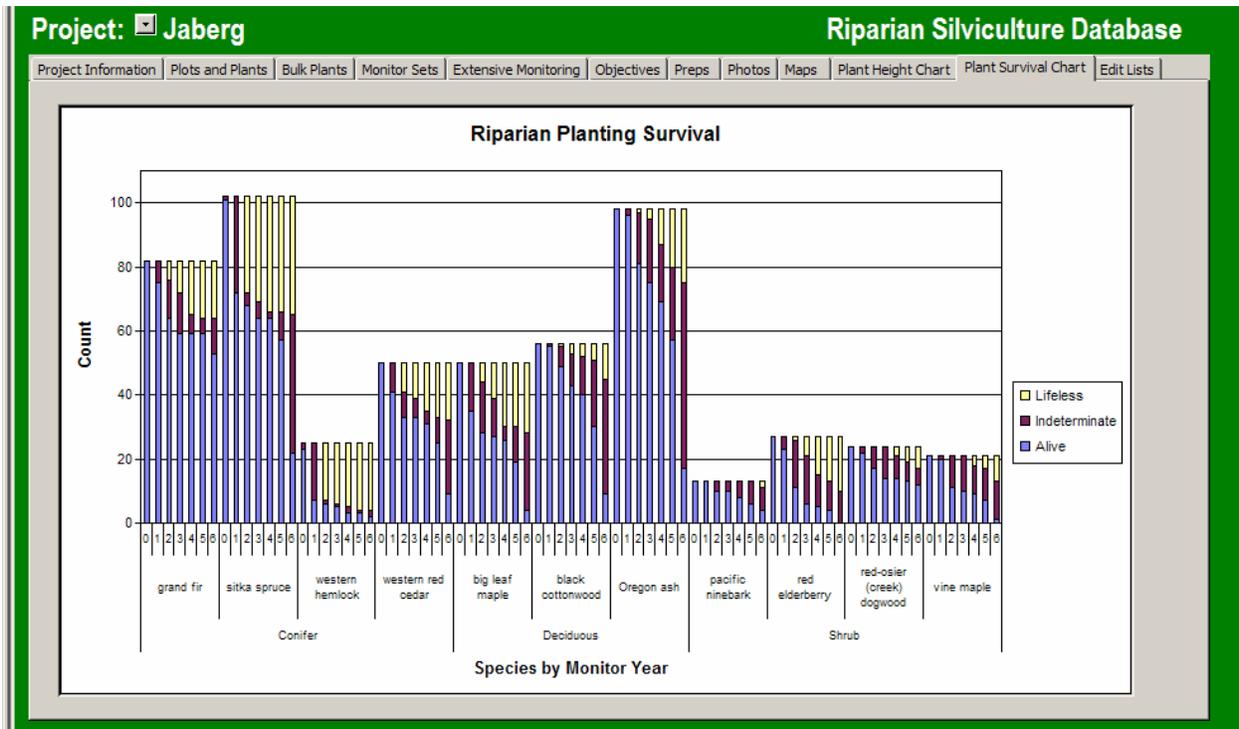
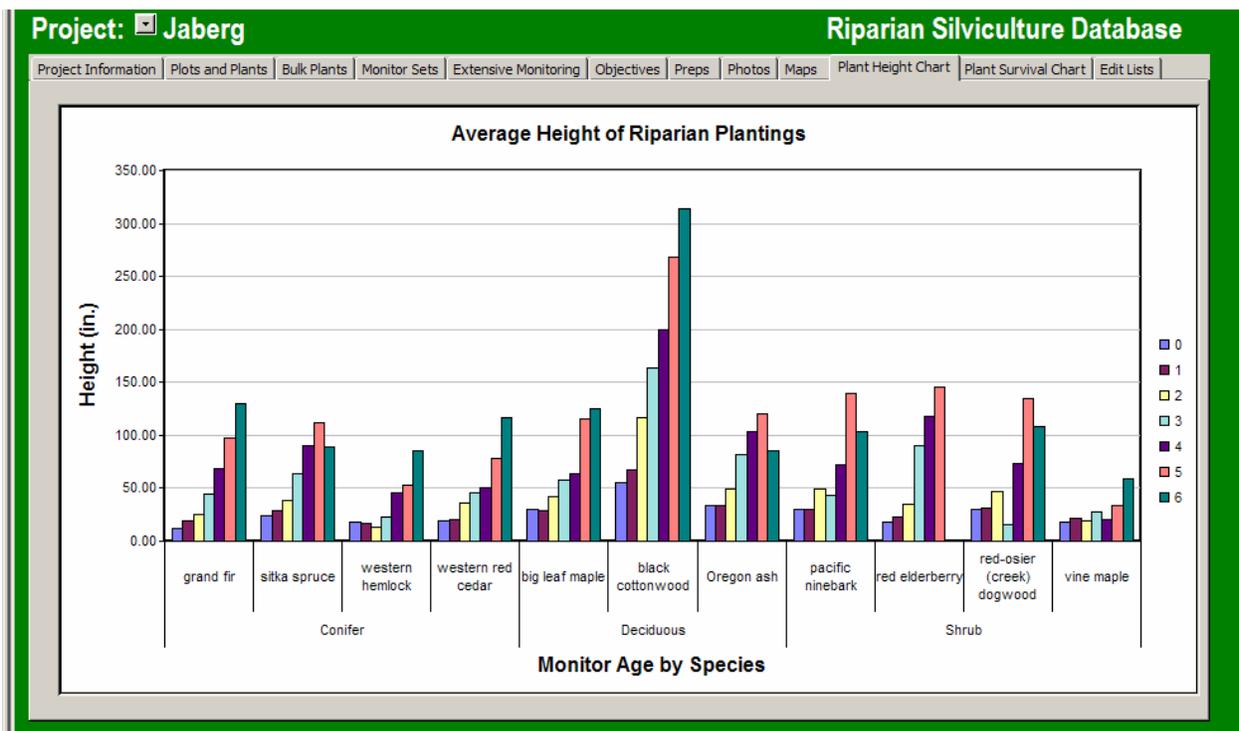
**Jaberg Winter Springs Ranch, Planted 2002 & 2003
Last Monitored November 2007**

The Winter Springs Ranch riparian planting was one of the first projects to be monitored under the *Coastal Oregon Riparian Silviculture Guide* intensive monitoring protocol to gauge growth and survival of the plantings. Survival data and height growth from monitoring plots is summarized in the figures on the next page. The average survival rate alive was 22%, but this data is suspicious given the large number of "indeterminate" ratings. Species-specific survival ranges from potentially 0% (red elderberry and vine maple, which were not found in the late 2007 monitoring) to 68% (grand fir). Trees that are recorded as indeterminate are either unable to be found (i.e., the identification tag and stake were lost) or surveyors could not tell whether the tree was living during survey.

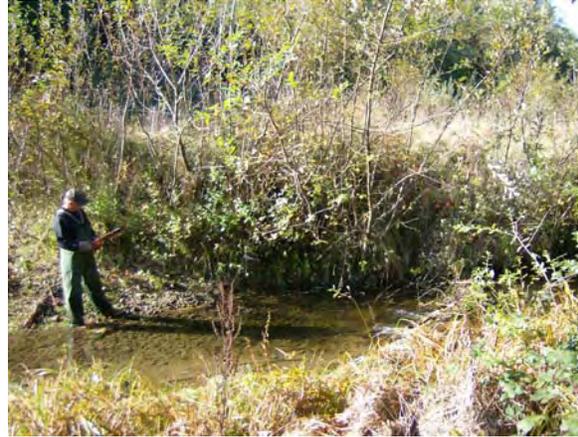
Photo 2. Packard Riparian Restoration, November, 2007 showing stabilized banks.

The riparian plantings and willow walls at Packard Creek were implemented in 2003 due to a high level of streambank erosion, solar loading, and livestock accessing the creek. The site was fenced from livestock, although fence maintenance continues to be a concern. Willow walls were used to treat vertical streambanks at several places along the stream and have been highly successful at stabilizing banks, shading the stream and providing beaver forage. The willow walls and dense plantings have served to stabilize eroding banks (see Photo 2). Riparian plantings continue to be monitored for survival and growth. Figure on the next page show survival and height growth data for all species (excluding willow) at the site. Survival rates for individual species ranged from 0% (grand fir and black cottonwood) to 79% (Sitka spruce), with an average overall survival of 38%.

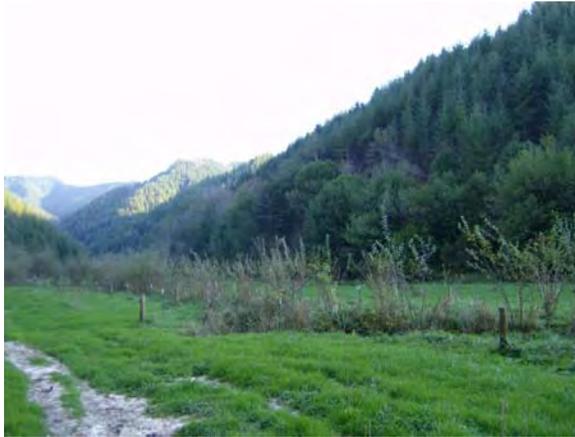
Photo 3. Hendrickson Creek, lower pasture, November, 2007.

Hendrickson Creek was fenced and planted in 2003 primarily with shrubs and low-growing trees to reduce shade cast on the adjacent pasture (see Photo 3). Figures on the next page depict survival and plant heights five years after establishment. The average survival rate at this site is 67%, with a range of 33% (red-osier dogwood) to 100% (grand fir). Maintenance and monitoring costs for Hendrickson Creek since the final report (September, 2007 to September, 2008) have been \$4,926.87.

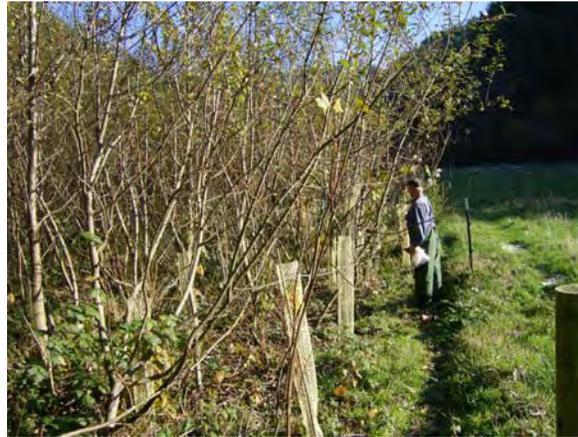
Photo 4. Hendrickson Creek, height of plantings November, 2007.

This project is meeting its objectives (see Photo 4). There have been no formal educational or outreach activities associated with this project in the last year, although there have been a couple of site visits by potential landowners interested in riparian restoration projects.

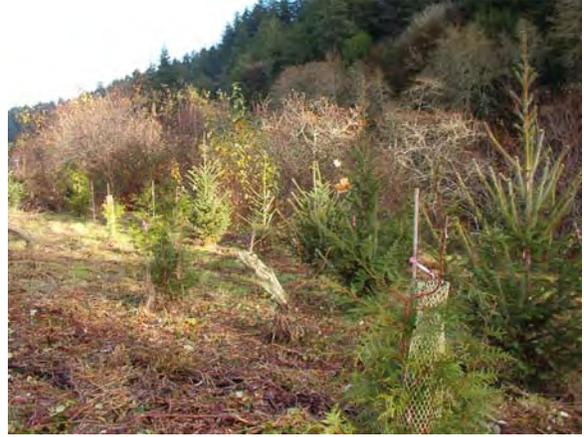
Photo 5. Phase 1 planting (2003) in the Wilson Ranch Riparian Restoration project, June, 2008.

The Wilson Ranch planting project on Rogers Creek and South Fork Coos River has been successful in regards to the establishment of trees and shrubs in the riparian area. We have observed steady growth in willows, conifers and deciduous species. The Wilson Ranch was sold in late 2006 and the new landowner has not been interested in enrolling in the CREP program. We have developed a relationship with the new landowners to the point where we have recently been allowed access for maintenance and monitoring. The landowners have stated they are committed to keeping most of the trees, although they have been removing cottonwoods from the riparian to increase the size of the pasture for agricultural use. More recent communications in October, 2008 indicate a willingness to work with CoosWA on continued maintenance of the plantings and possibly re-enrolling the project in the CREP.

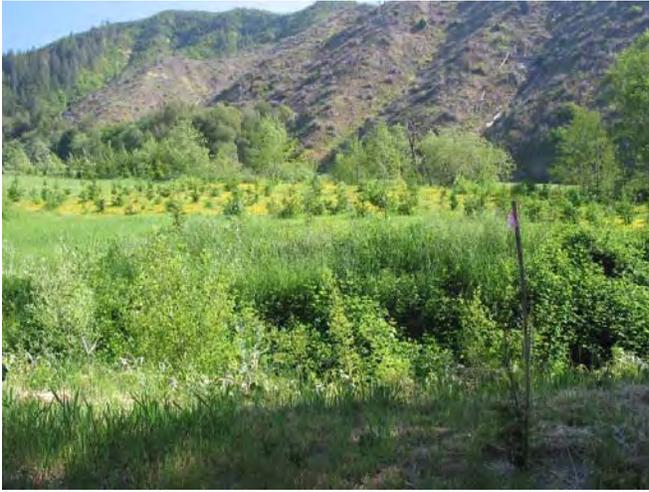
Photo 6. Taylor CREP showing willows along tributary stream and conifers in background, December, 2006.

The establishment of plantings at this site has been very successful (see Photo 6). The former landowner completed the majority of the maintenance at this site, and while the Association has not undertaken rigorous silvicultural monitoring on

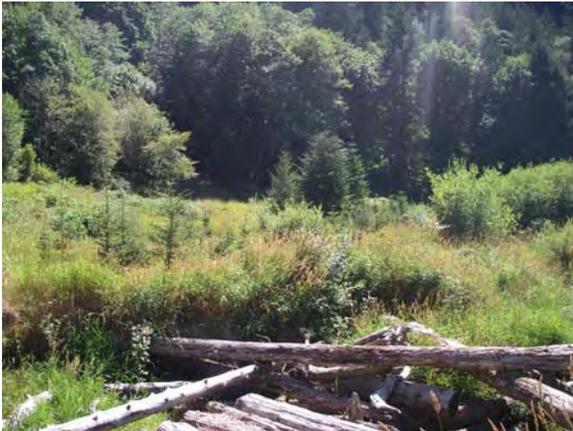
Photo 7. ODF Ranch riparian planting downstream from the washed out log stringer bridge, August, 2008.

This project occurred on Oregon Department of Forestry owned lands (formerly 3 homesteads) in the upper reaches of Palouse Creek. This project included planting 2,486 trees and shrubs and 4,000 willow on 4.4 acres of riparian in February, 2004 and January, 2005 (see Photo 7). Eight species were planted during two project phases, and include Sitka spruce, western red cedar, western hemlock (Phase 2), bigleaf maple, grand fir (Phase 1), red-osier dogwood, vine maple (Phase 2), and willow cuttings. The total project was 3,810 feet long by 50 feet wide and included several fenced in areas to exclude elk herds (see Photo 8) that were considered to be a significant risk to plantings.

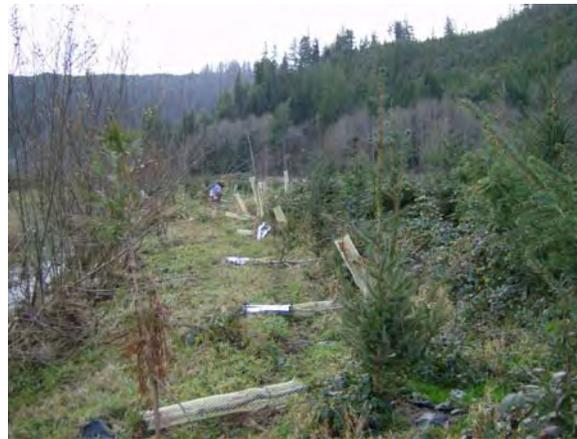
Photo 10. Cattle damage to tubed trees along Rogers Creek.

Riparian plantings in the Roger Creek area of the project have a similar outlook. Plant survival is high (almost 100%) for Sitka spruce and western red cedar. Again, red elderberry has largely failed, and the dogwood may also have been unsuccessful, although the large number of “indeterminate” status for this species may be due to late-in-the-year monitoring. Black cottonwood are noticeably shorter at Rogers Creek compared to similarly aged planting on the South Fork. This is largely due to beaver falling many of the trees, which then resprout from their stumps but are shorter as a result. Sitka spruce, bigleaf maple, Oregon ash and crabapple have all done nicely. There is a continued problem at this site with cattle breaking through the fence and dam-

aging the plants. Because it is a CREP project, NRCS has contacted the landowner about correcting this situation.

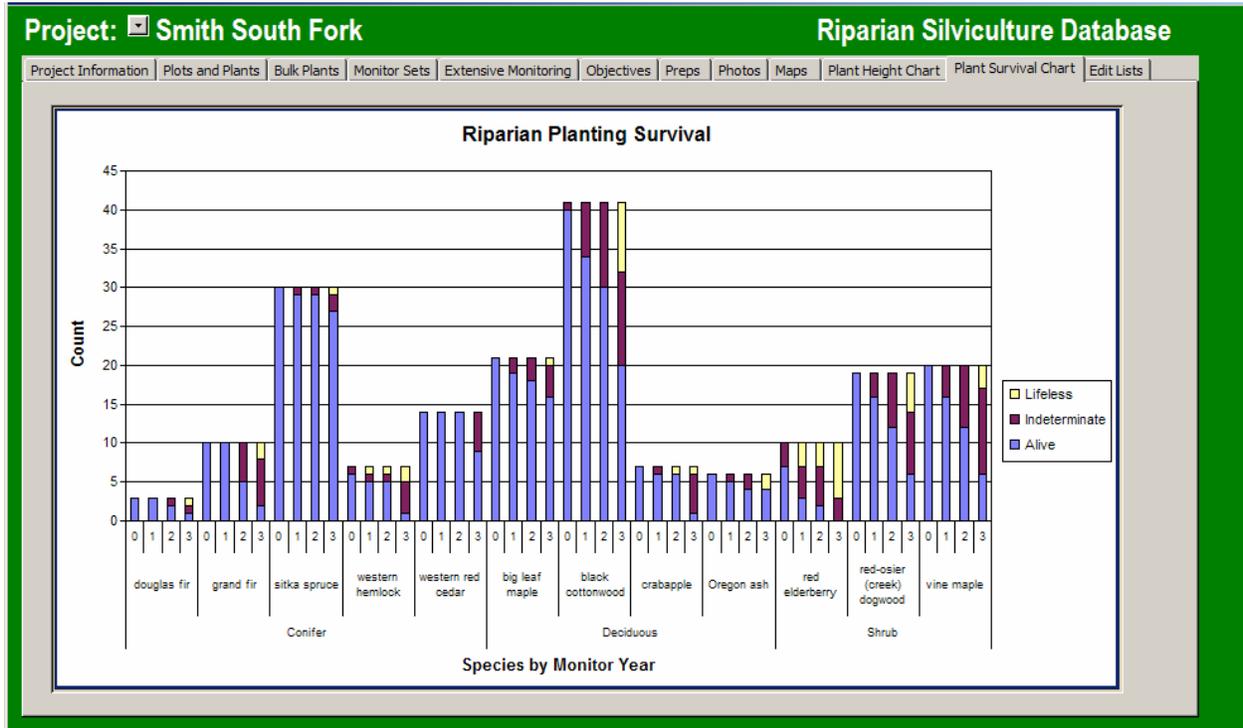
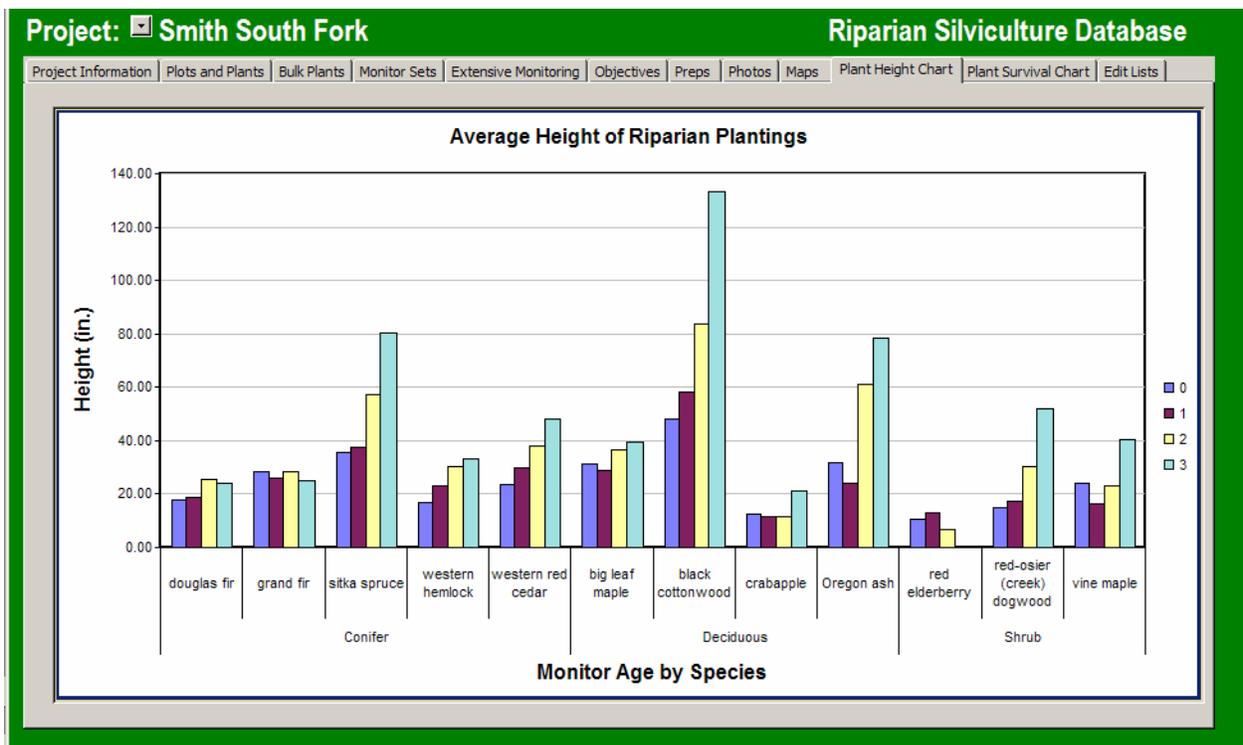
**Smith Ranch Fern Hollow South Fork Coos River, Planted 2005
Last Monitored December 2007**

Plant survival in the South Fork Coos River project area varies from virtually zero for red elderberry to almost 100% for Sitka spruce. In general, the conifers survived better than the deciduous plants, although many hardwoods and shrubs were classified as “indeterminate” because their leaves had fallen prior to the monitoring in December, 2007. Our expectation is that most of these plants have survived. Height growth in the South Fork project area is consistent with the plants nearing or achieving “free-to-grow” above competing vegetation. The black cottonwoods averaged 132 inches in height, or 11 feet after three years. Sitka spruce and Oregon ash were the two other species that grew rapidly, both averaging about 80 inches (almost 7 feet) after three years. These three species are clearly “free to grow”. With the exception of red elderberry, which has almost completely failed, the other plants are averaging between 20 inches and 50 inches in height, indicating that they will require continued maintenance if they are to thrive. Japanese knotweed is a problem in this planting. Treatment in the summer, 2008 appears successful but will require periodic followup to insure that the infestation is controlled.
