Pavement
Evaluation/
Maintenance
Management Program
2015

Warrenton-Astoria
Regional Airport

**2015 Pavement Evaluation / Maintenance
Management Program**

**Final Report – Individual Airports
Functional Category 2, Coastal Climatic Zone**

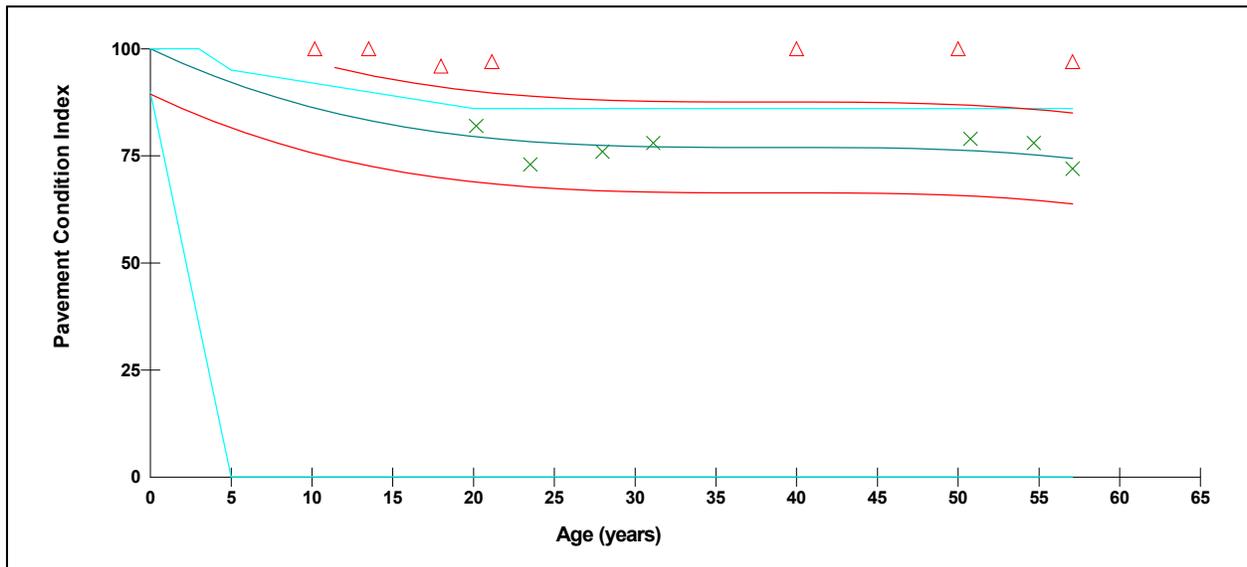
Figure 2. Performance Curve for Category 2 AAC Aprons – Coastal Oregon.

To allow future pavement condition to be predicted, data collected throughout the State were used to generate "performance curves". The curves were developed based on surface type, use, airport functional category and climatic region. These curves (models) are used to predict future pavement condition by assuming the behavior of an individual pavement section is similar to the behavior of the pavement sections used to generate the "performance curve". Figures 2 through 9 show the "performance curves" used to model pavements in your airport's functional category and climatic region.

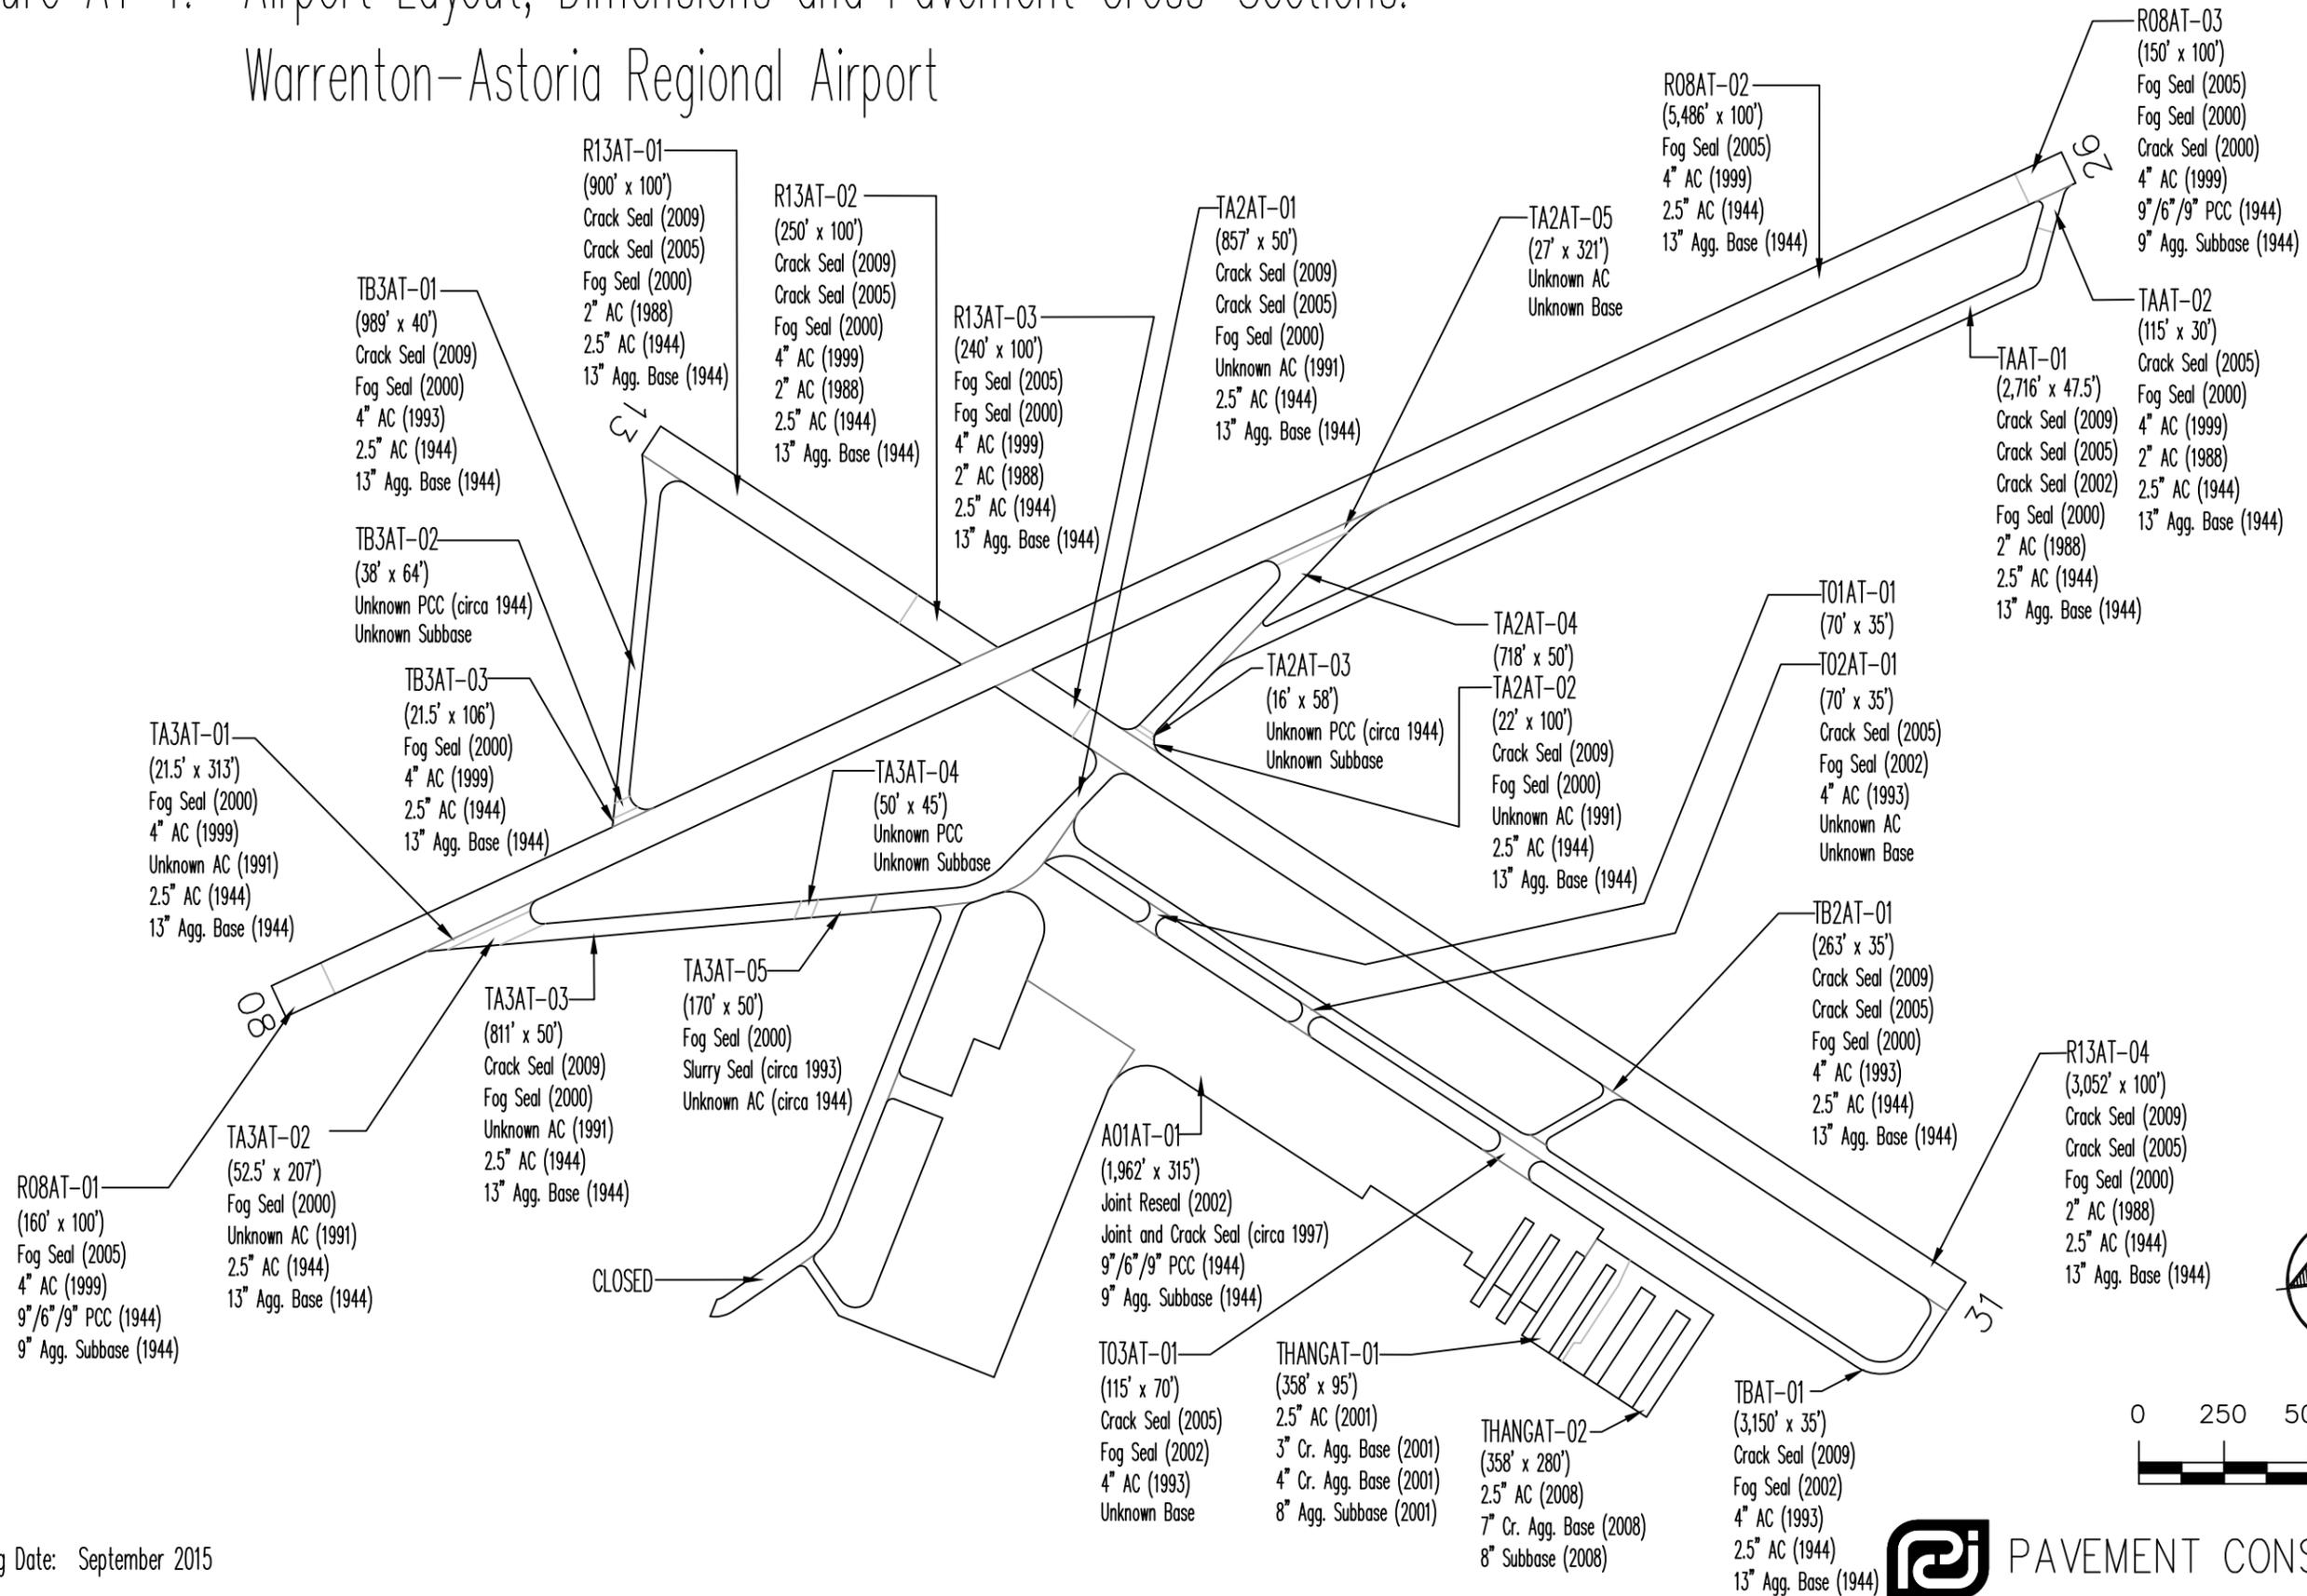
Figure AT-1. Airport Layout, Dimensions and Pavement Cross-Sections.
Warrenton-Astoria Regional Airport

To determine how your pavements were constructed and their age, a records review was conducted. Figure AT-1 shows the records review results. This figure identifies pavement boundaries, dimensions, pavement layer types, thicknesses and dates of construction. The most recent construction date for each pavement can also be found in the Section Condition Report in Appendix 2. Figure AT-1 and the information contained in Appendices 1, 2 and 4 ensure that your airport complies with the “pavement inventory” requirement of FAA’s PMMP guidelines.

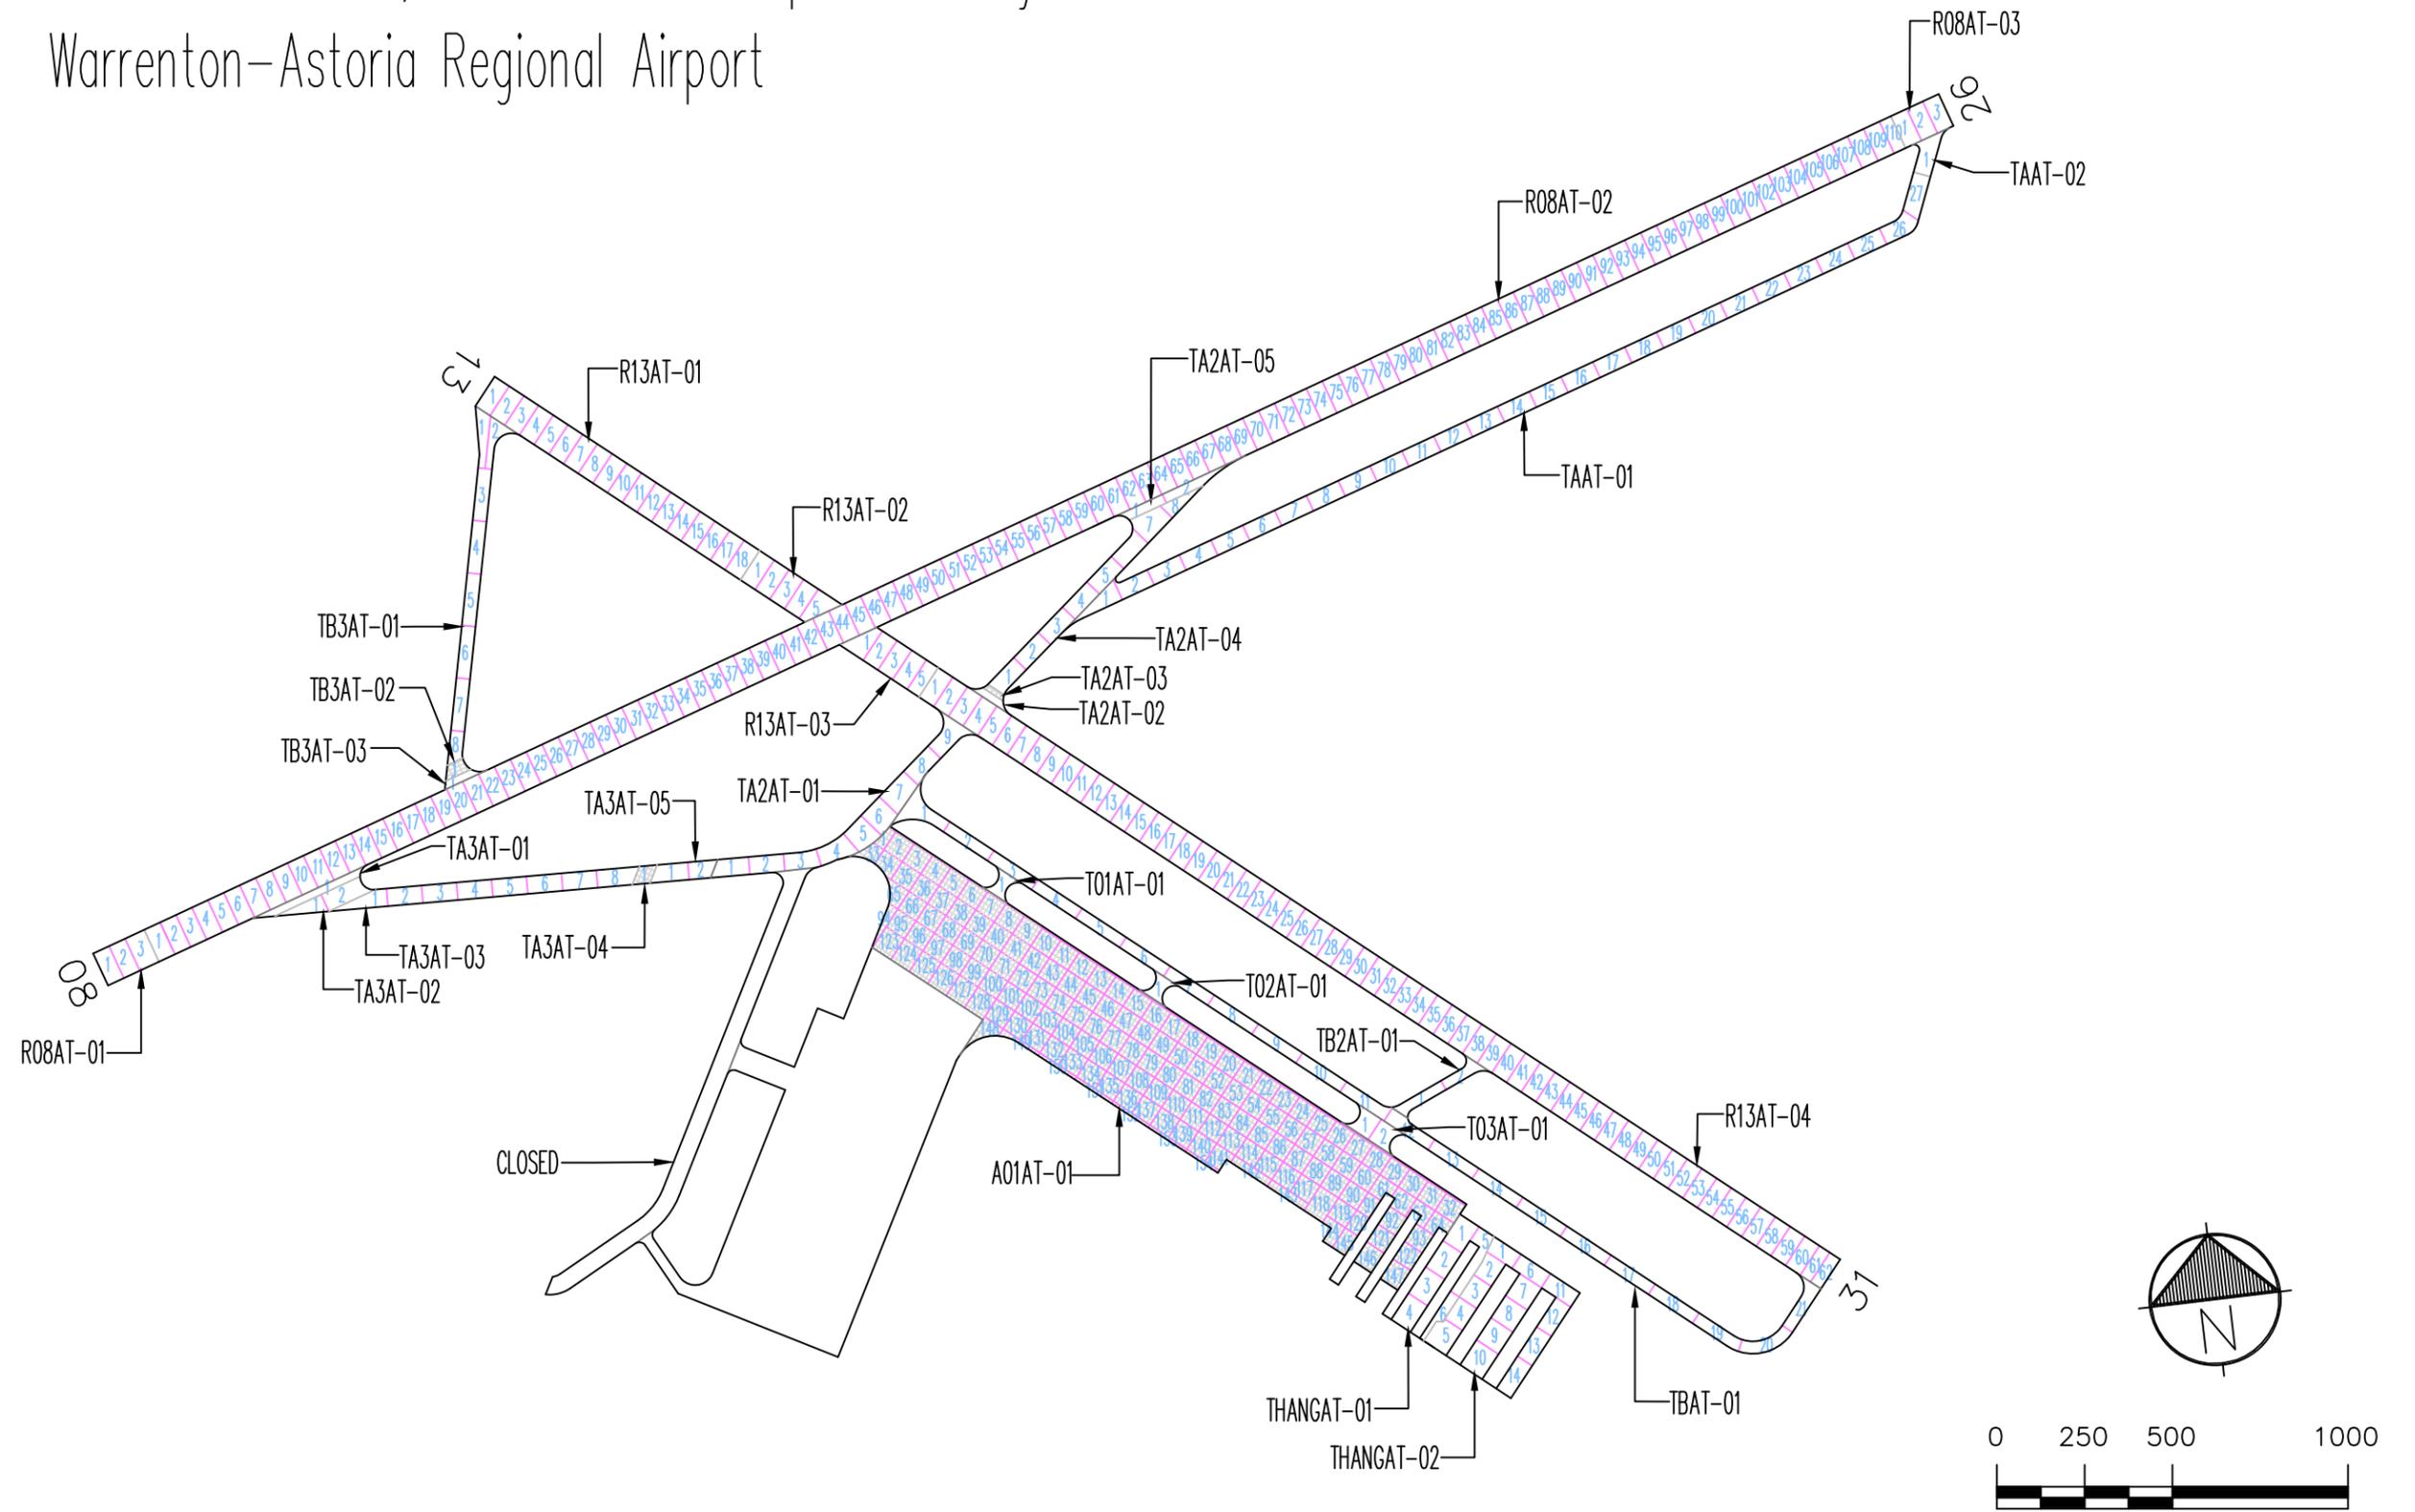
Figure AT-2. Pavement Branch, Section and Sample Unit Layout.
Warrenton-Astoria Regional Airport

The pavements at your airport were divided into branches, sections and sample units in accordance with the methodology outlined in the current edition of ASTM D5430, *Standard Test Method for Airport Condition Index Surveys*. The branches, sections and sample units established at your airport are shown in Figure AT-2. A Branch Condition Report showing all branches, their associated areas, and their area-weighted average condition is provided in Appendix 1. Additionally, the Appendix 2 Section Condition Report provides information used to define each branch and section in the Micro PAVER database.

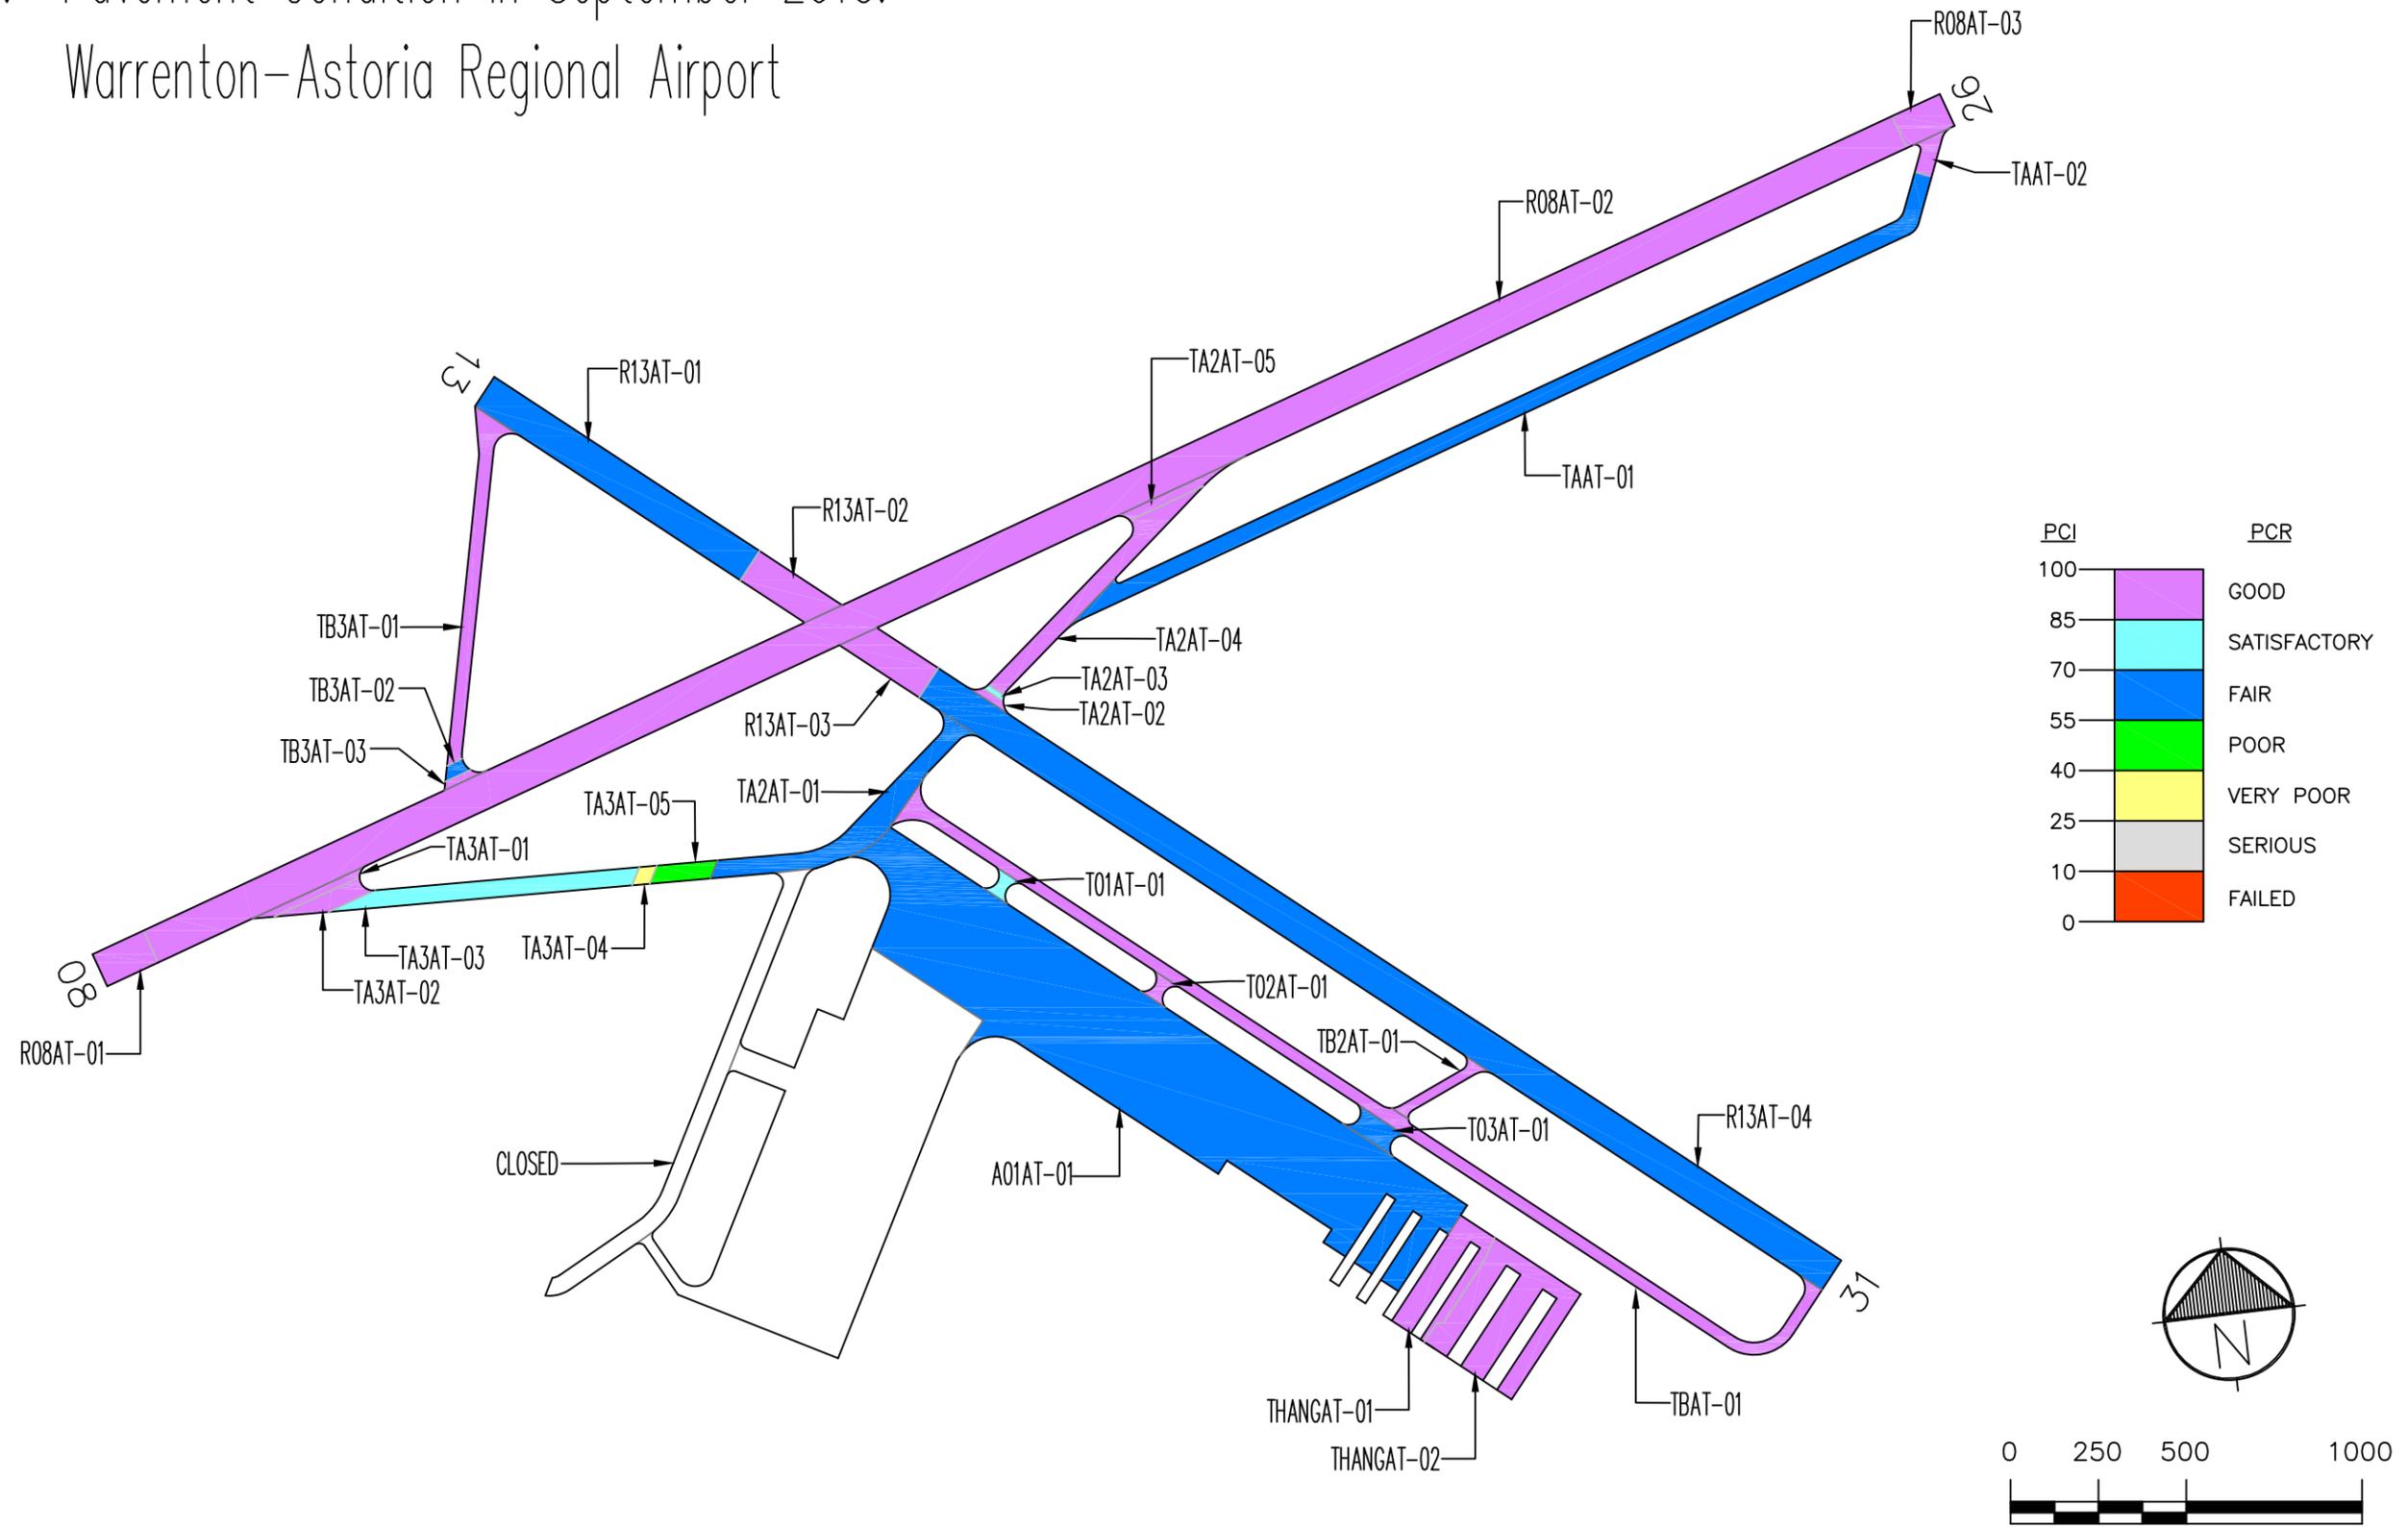
Figure AT-3. Pavement Condition in September 2015.
Warrenton-Astoria Regional Airport

The Branch Condition Report in Appendix 1 summarizes current pavement condition by branch while the Section Condition Report in Appendix 2 lists pavement condition by section. The current PCR is shown graphically in Figure AT-3.

Section PCIs at Astoria Regional Airport range from a low of 36 (a PCR of “Very Poor”) to a high of 100 (a PCR of “Good”). The area-weighted average PCI for all airport pavements is 79, corresponding to an overall PCR of “Satisfactory”. Figure AT-4 shows how much pavement area is associated with each Pavement Condition Rating category and also shows pavement condition distribution from the inspections conducted in 2008 and 2012.

The primary distresses observed during the inspection in the asphalt pavements were: longitudinal and transverse cracking, block cracking, and patching, with isolated occurrences of raveling, depressions, weathering and alligator cracking. The primary distresses observed in the concrete pavements were: linear cracking, joint seal damage, and shattered slabs, with isolated occurrences of corner spalls, joint spalls, large patches, small patches, and shrinkage cracks.

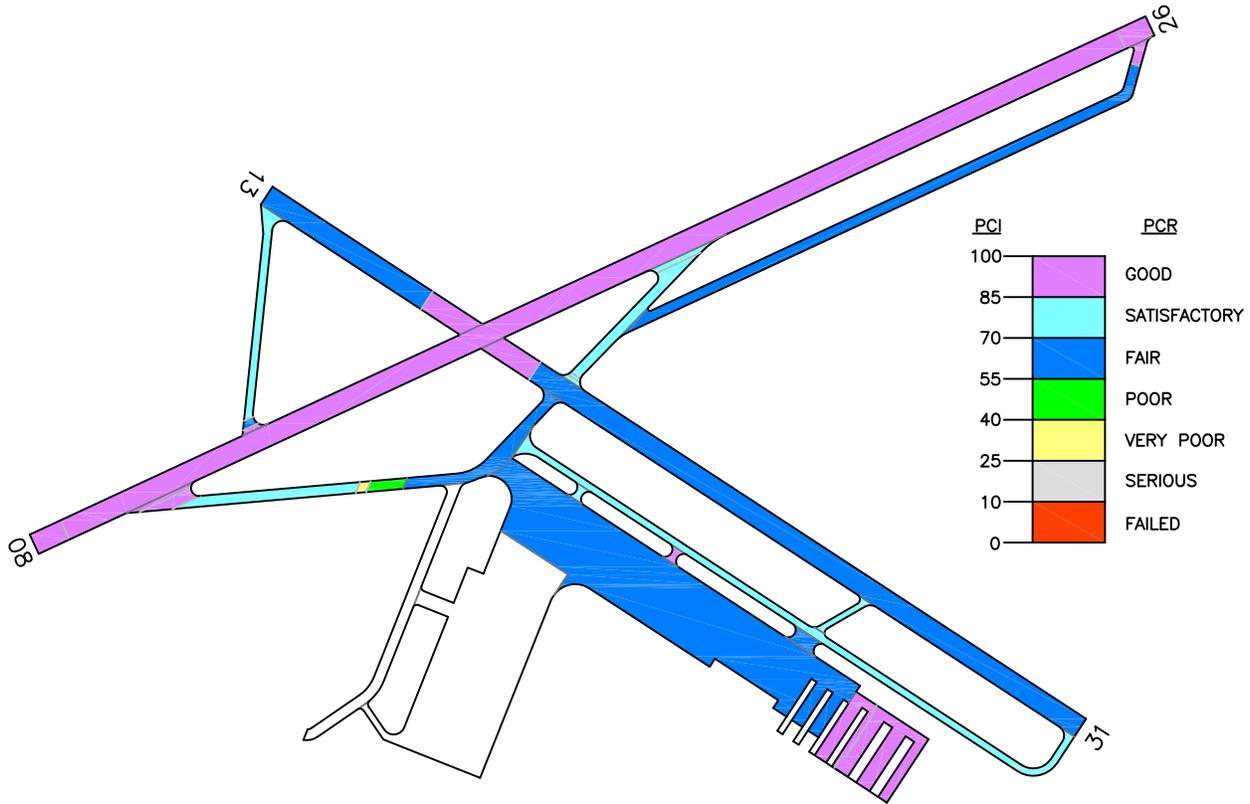
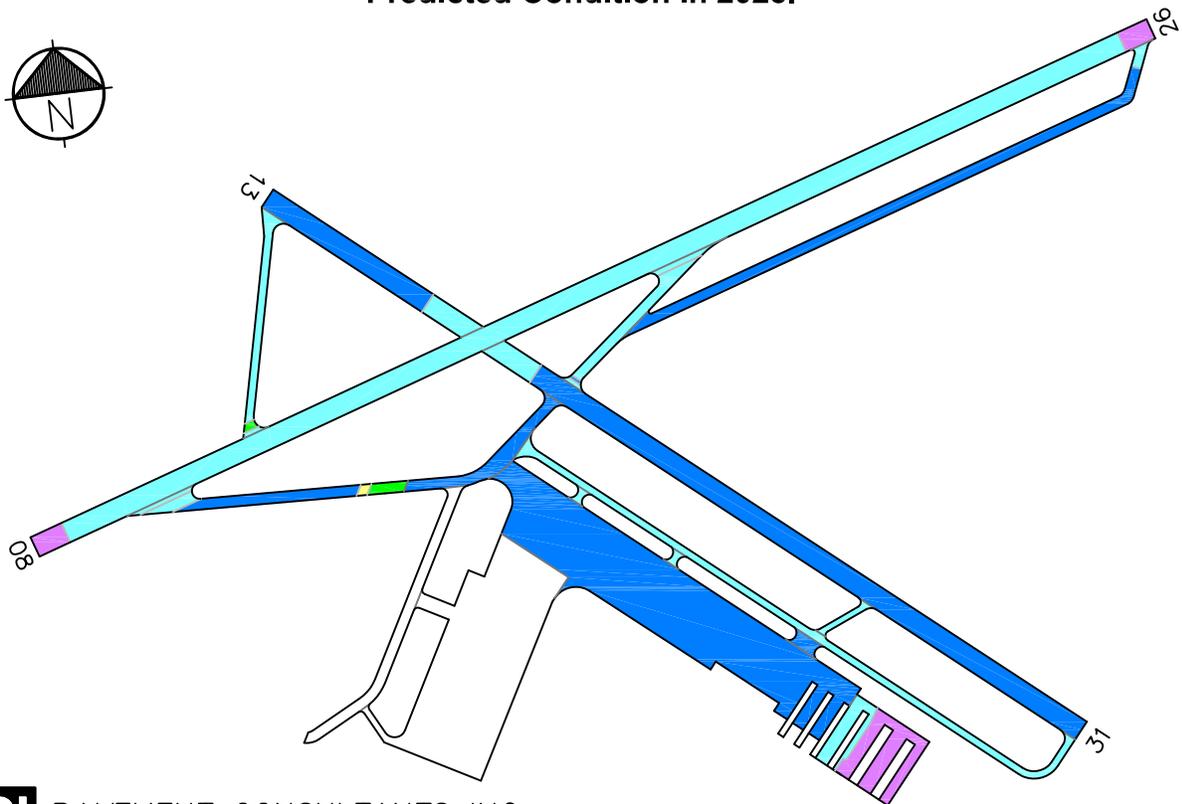
Figure AT-5. Future Pavement Condition.

Predicted Condition in 2020.

Predicted Condition in 2025.

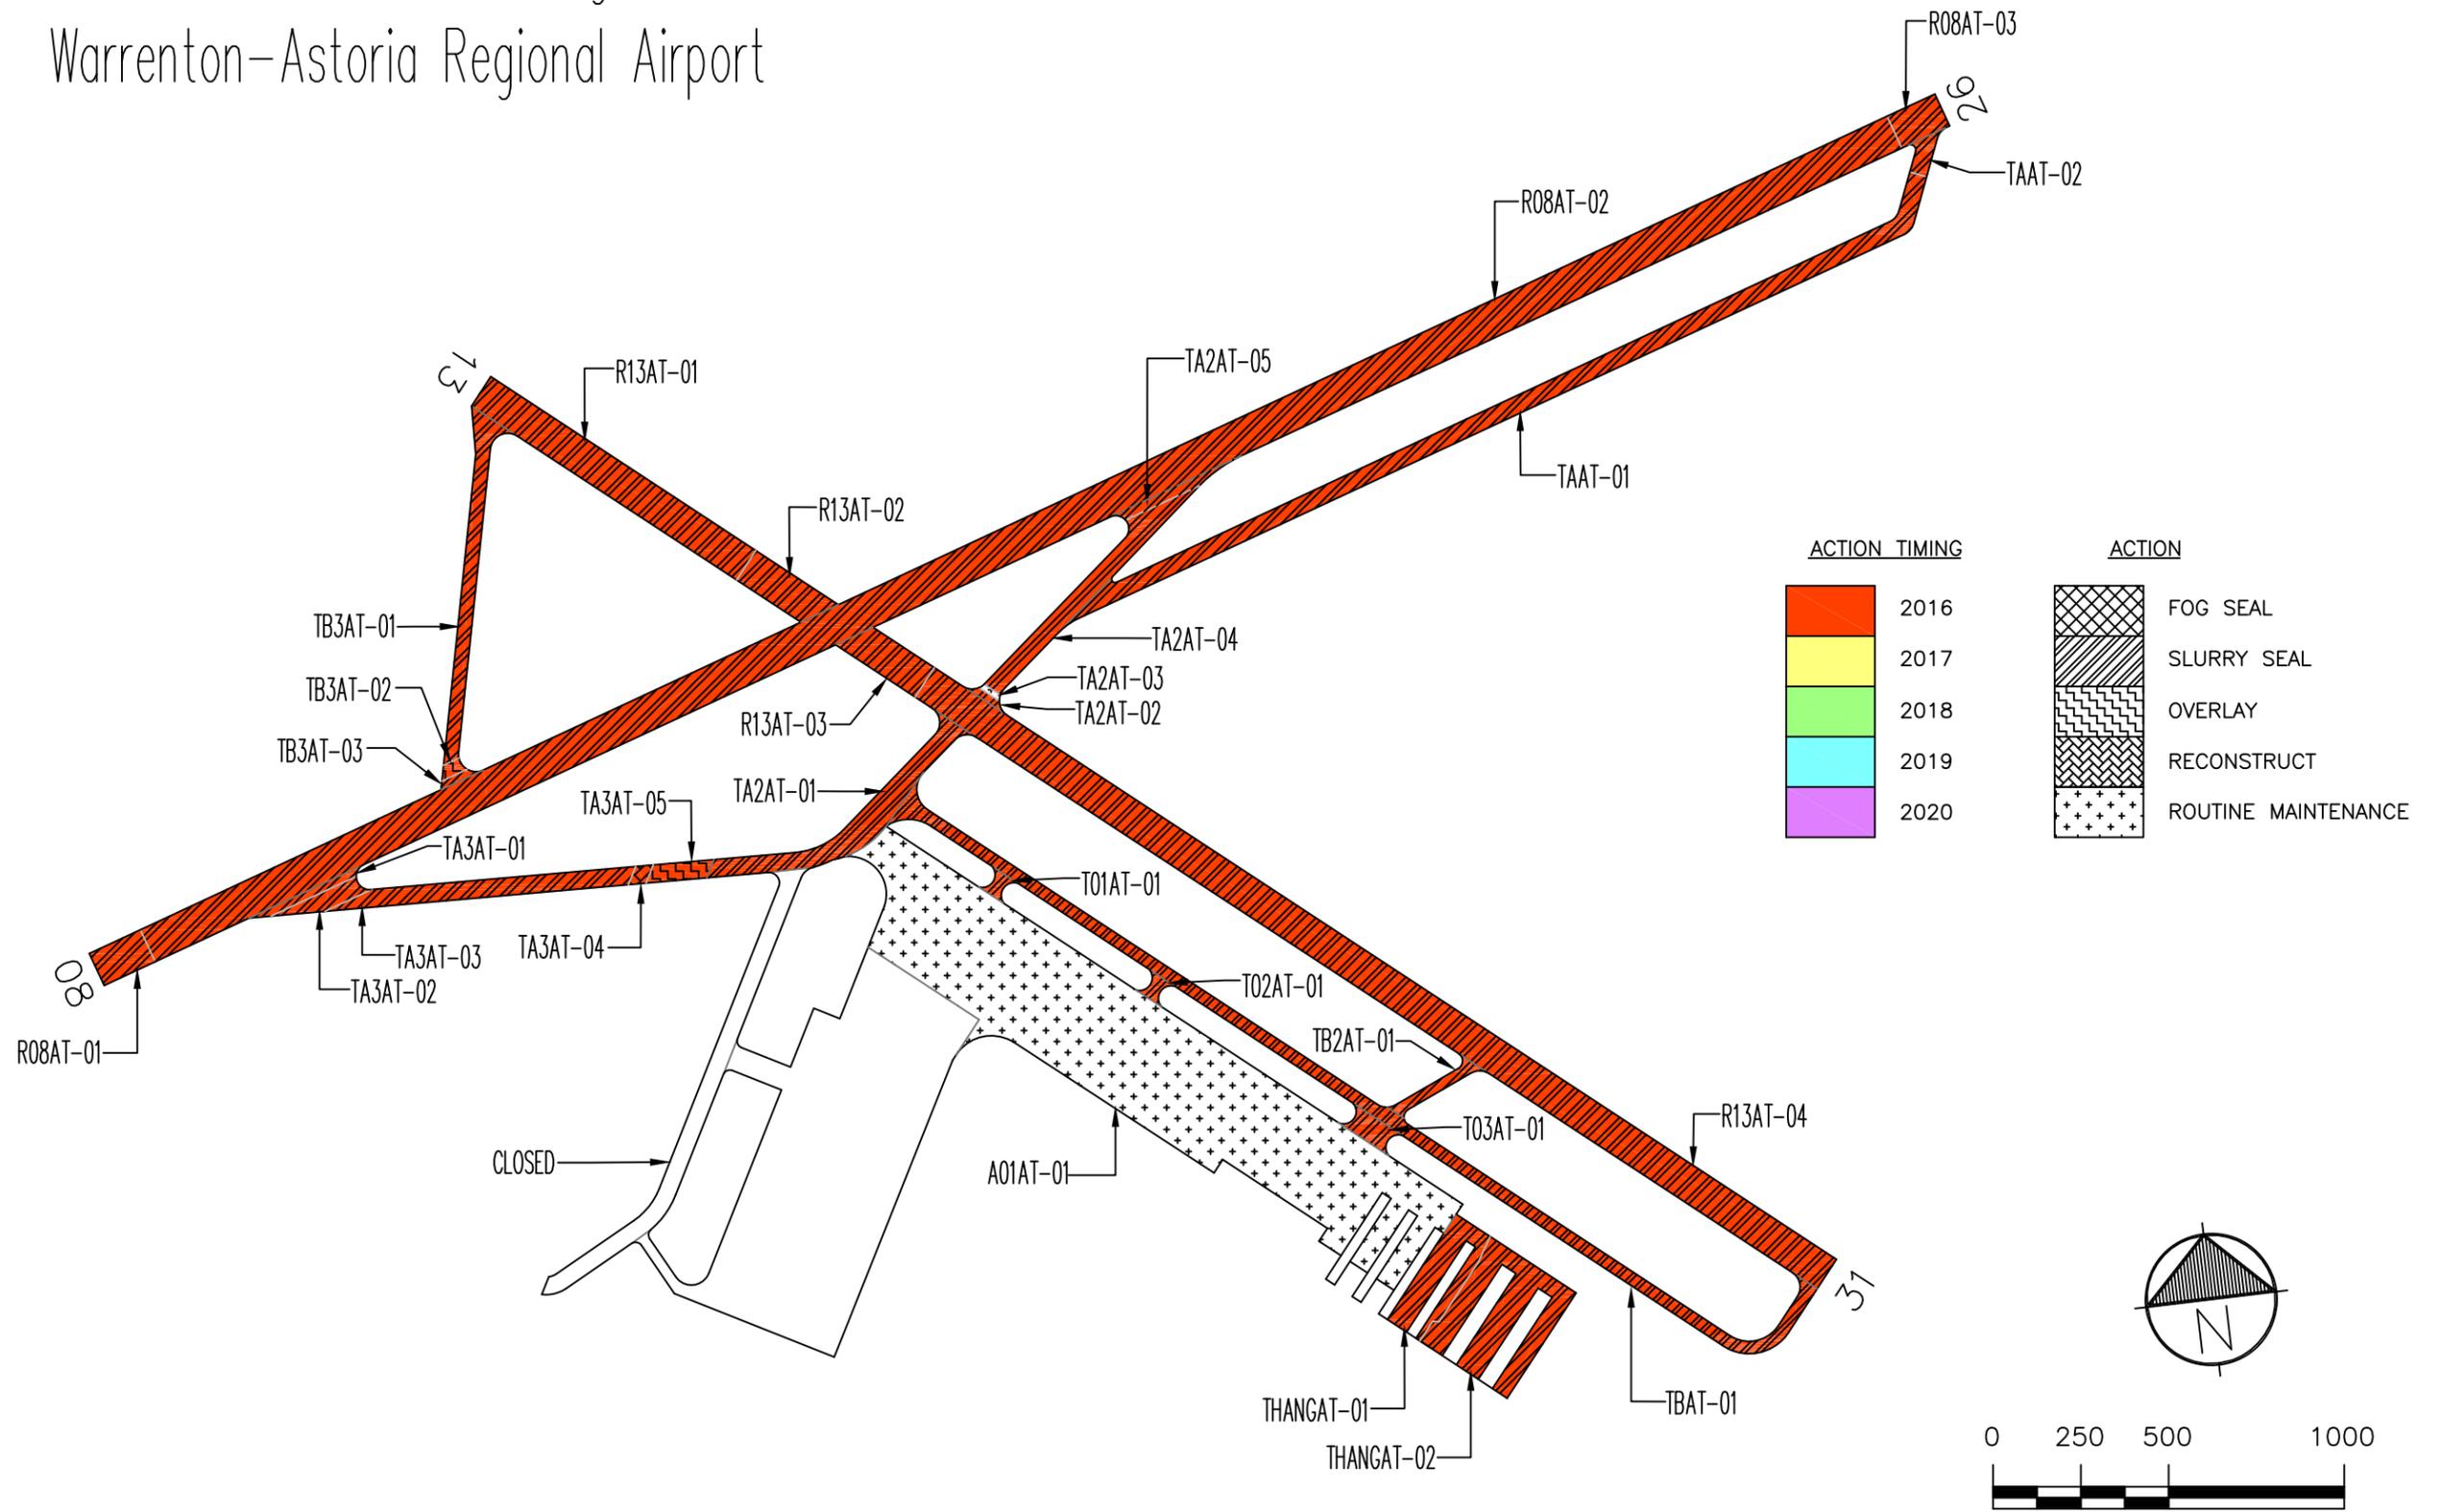
Figure AT-6. Five-Year Pavement Management Plan.
Warrenton-Astoria Regional Airport

During this project a 5-year program outlining recommended global maintenance and rehabilitation was developed. The program begins in the year 2016 to allow time for project development. These recommendations are presented in Table 2, which identifies the pavement section requiring rehabilitation, the year the action should be completed, the type of action, and an associated cost. This information is also presented graphically in Figure AT-6.
