Hermiston
Municipal
Airport

**2014 Pavement Evaluation / Maintenance
Management Program**

**Final Report – Individual Airports
Functional Category 3, Eastern Climatic Zone**

November 2014

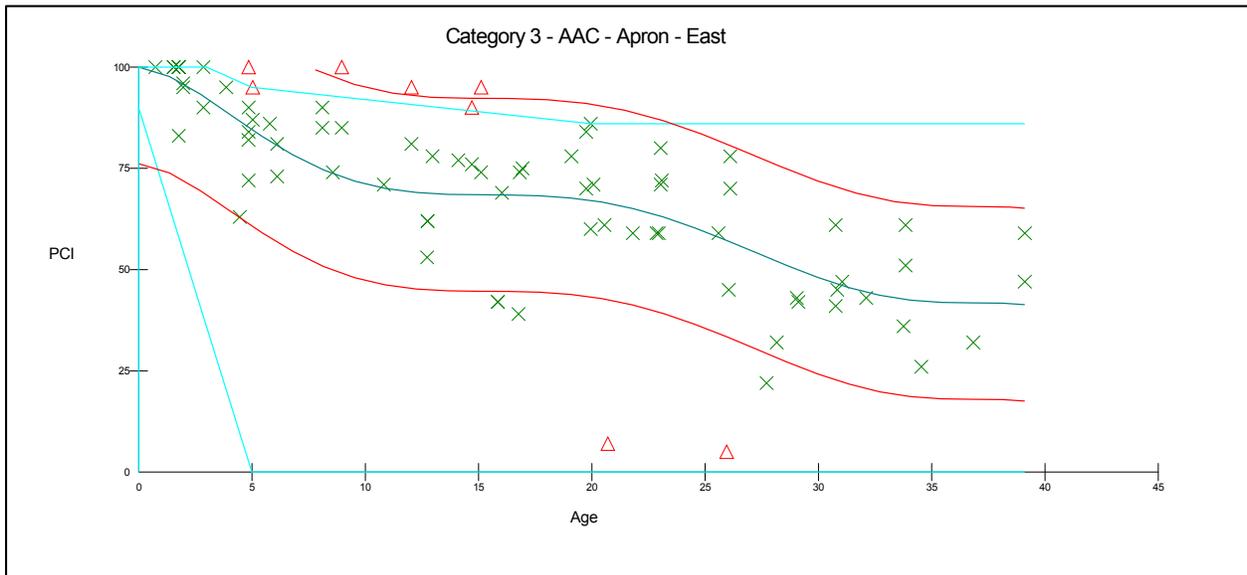
Figure 2. Performance Curve for Category 3 AAC Aprons – Eastern Oregon.

To allow future pavement condition to be predicted, data collected throughout the State were used to generate "performance curves". The curves were developed based on surface type, use, airport functional category and climatic region. These curves (models) are used to predict future pavement condition by assuming the behavior of an individual pavement section is similar to the behavior of the pavement sections used to generate the "performance curve". Figures 2 through 9 show the "performance curves" used to model pavements in your airport's functional category and climatic region.

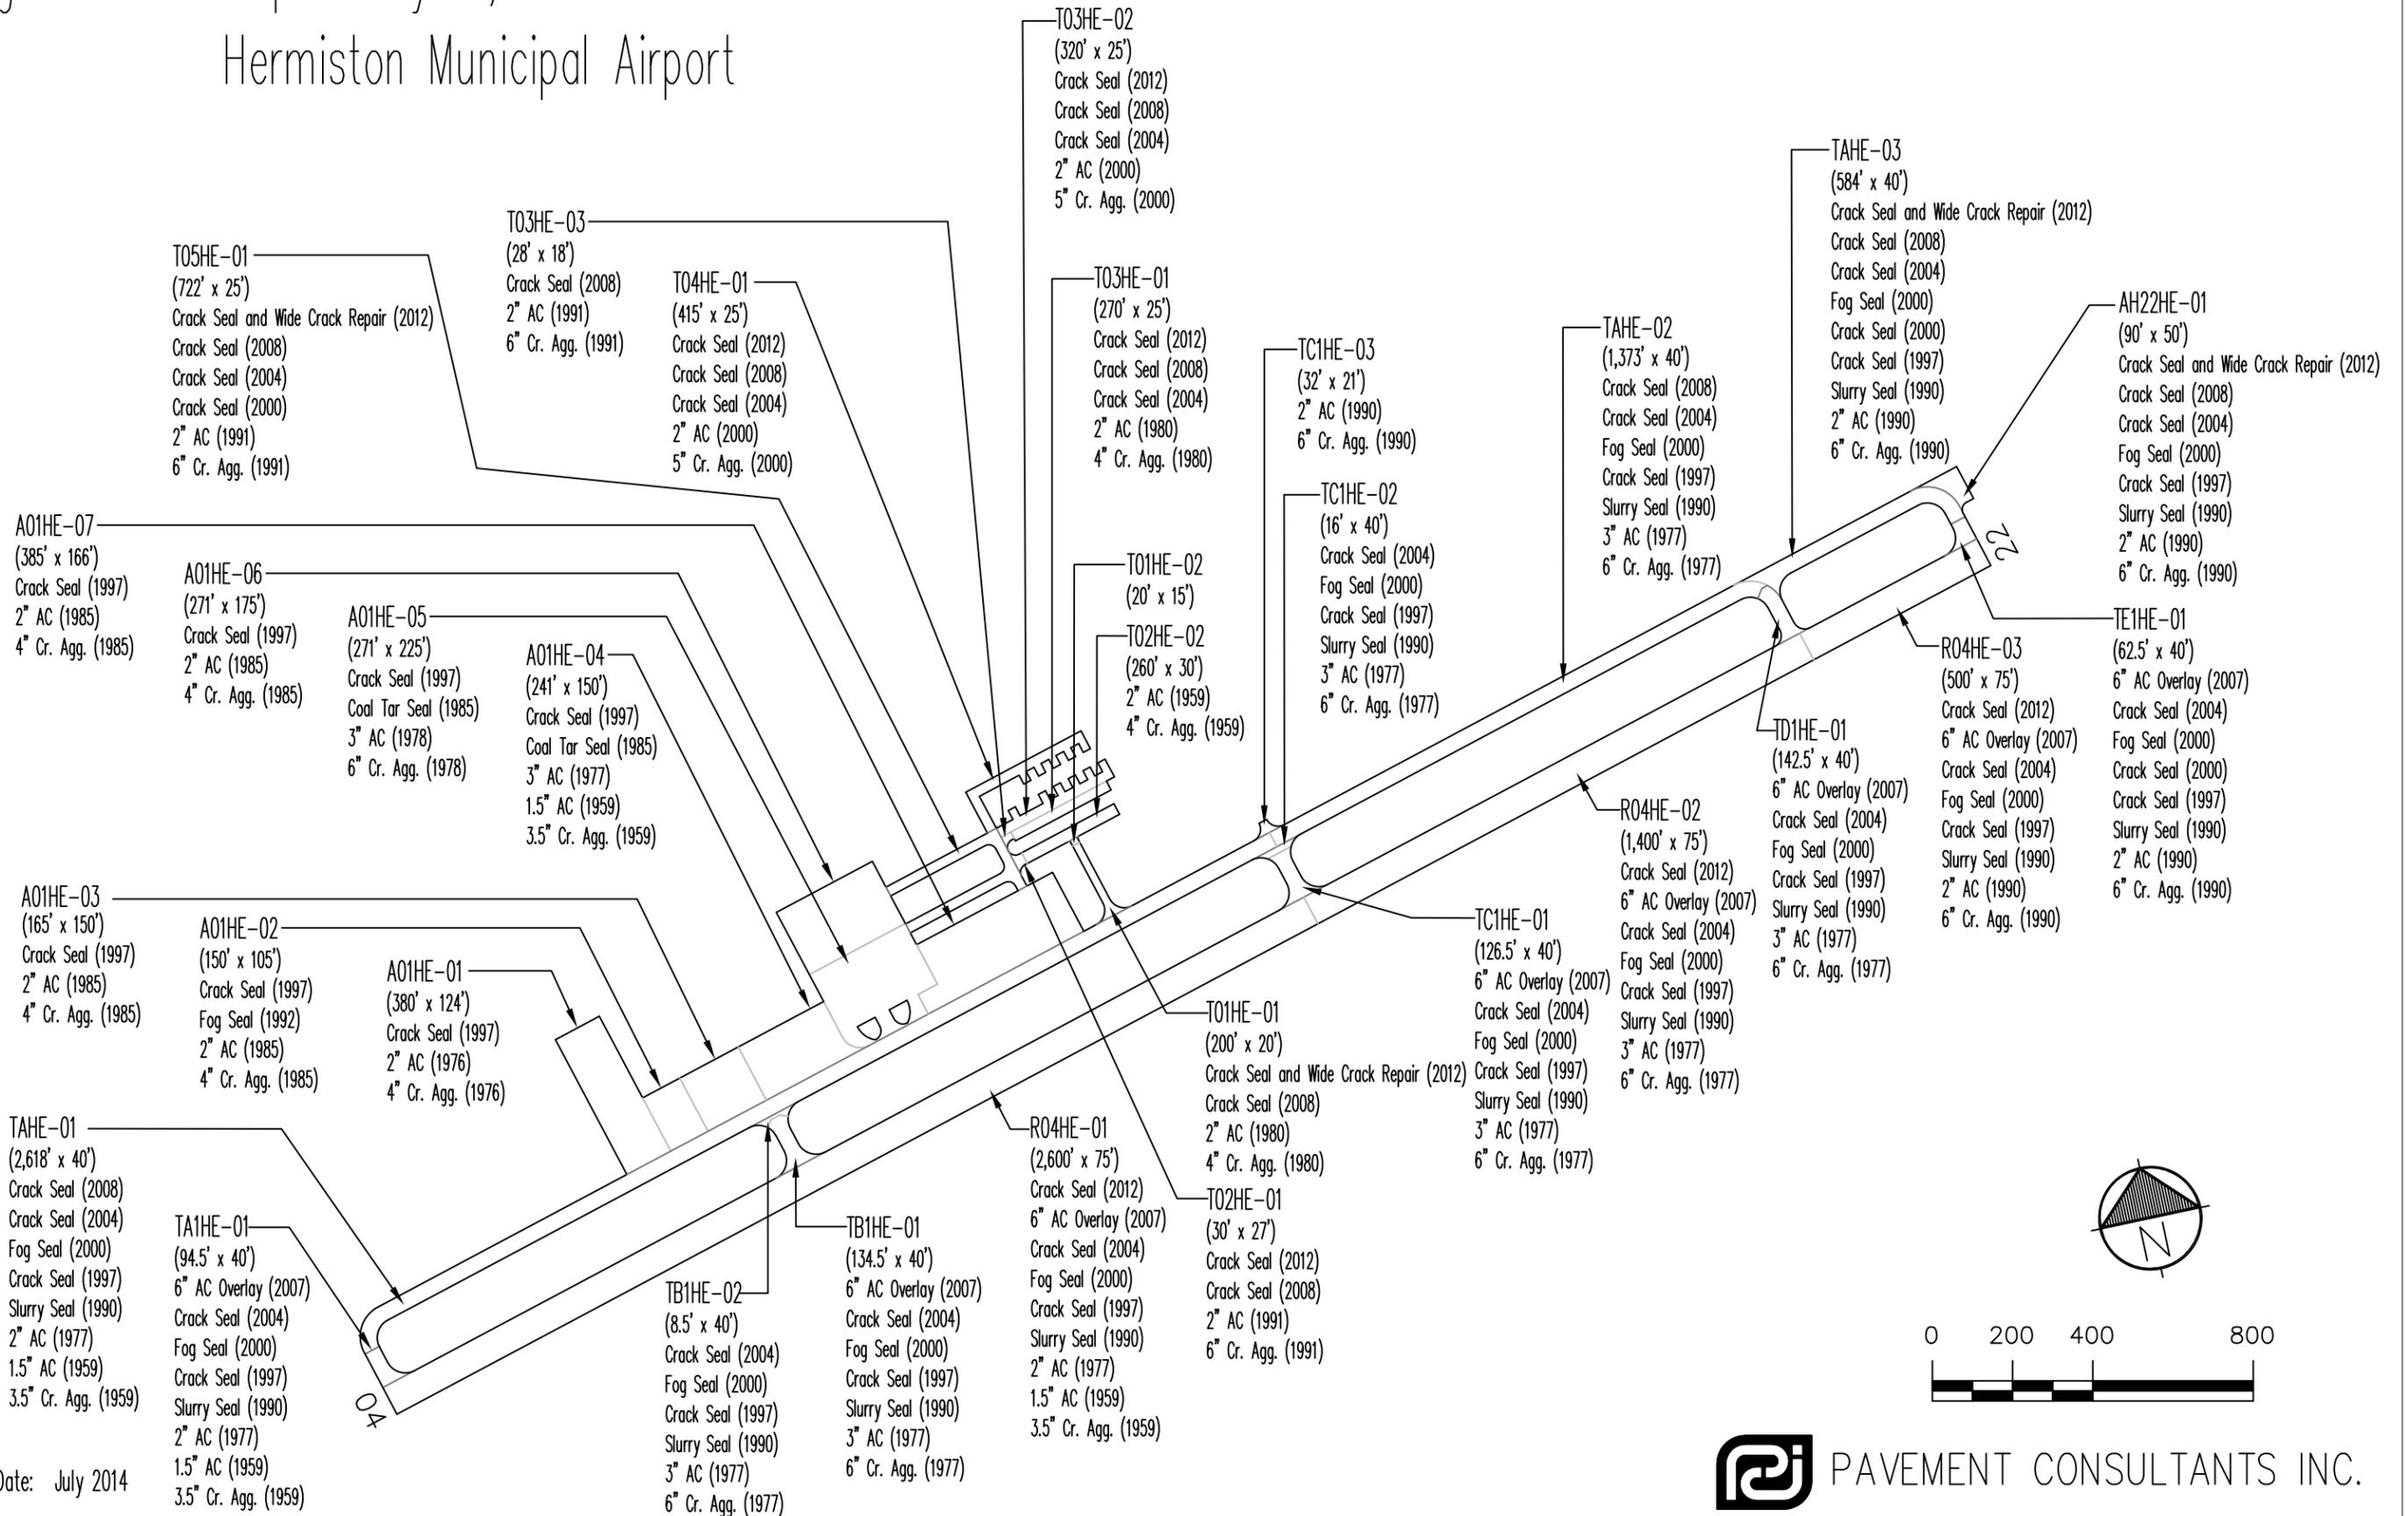
Figure HE-1. Airport Layout, Dimensions and Pavement Cross-Sections.
Hermiston Municipal Airport

To determine how your pavements were constructed and their age, a records review was conducted. Figure HE-1 shows the records review results. This figure identifies pavement boundaries, dimensions, pavement layer types, thicknesses and dates of construction. The most recent construction date for each pavement can also be found in the Section Condition Report in Appendix 2. Figure HE-1 and the information contained in Appendices 1, 2 and 4 ensure that your airport complies with the “pavement inventory” requirement of FAA’s PMMP guidelines.

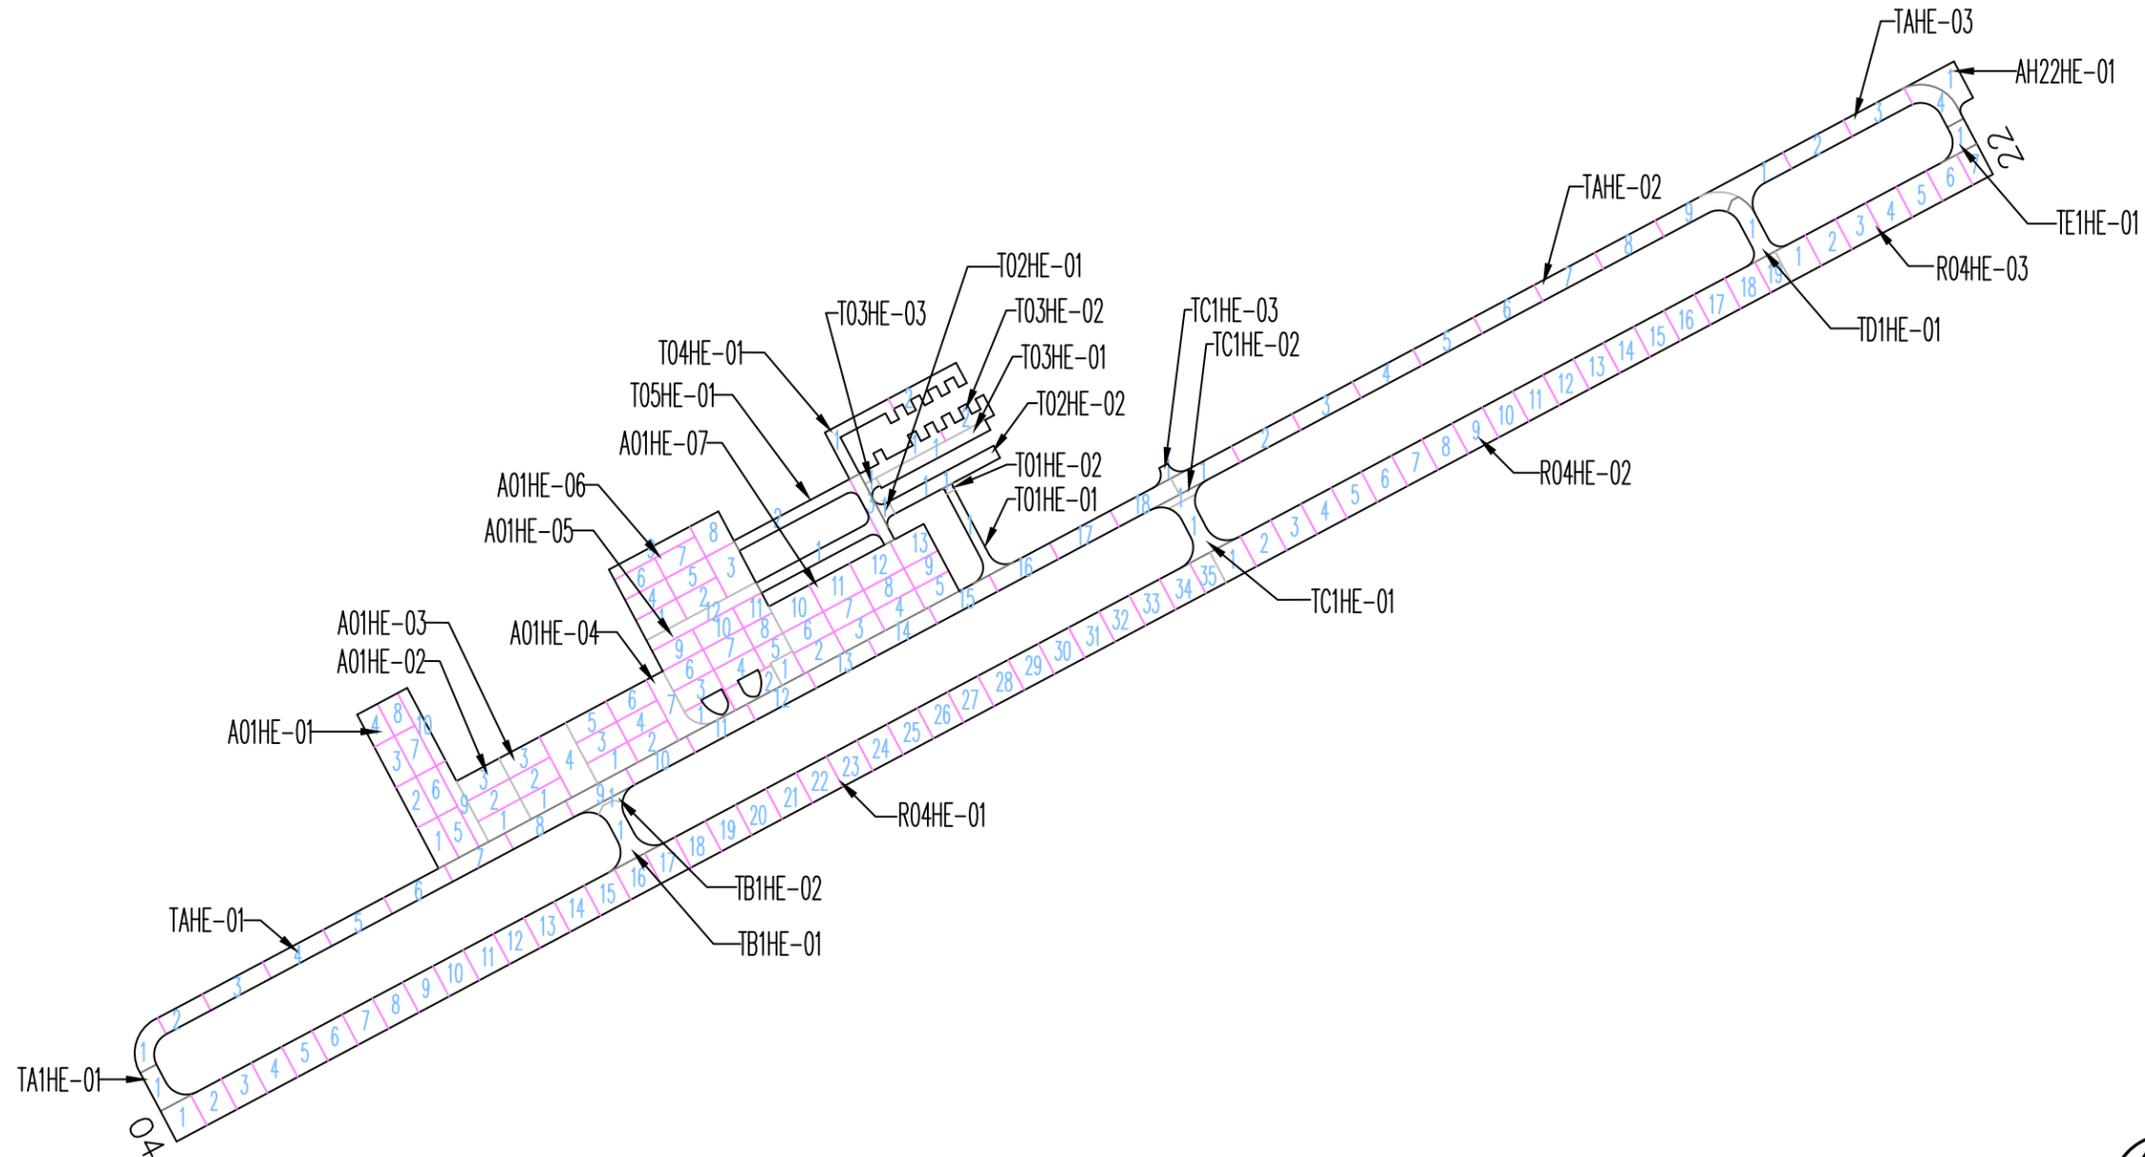
Figure HE-2. Pavement Branch, Section and Sample Unit Layout.
Hermiston Municipal Airport

The pavements at your airport were divided into branches, sections and sample units in accordance with the methodology outlined in the current edition of ASTM D5430, *Standard Test Method for Airport Condition Index Surveys*. The branches, sections and sample units established at your airport are shown in Figure HE-2. A Branch Condition Report showing all branches, their associated areas, and their area-weighted average condition is provided in Appendix 1. Additionally, the Appendix 2 Section Condition Report provides information used to define each branch and section in the Micro PAVER database.

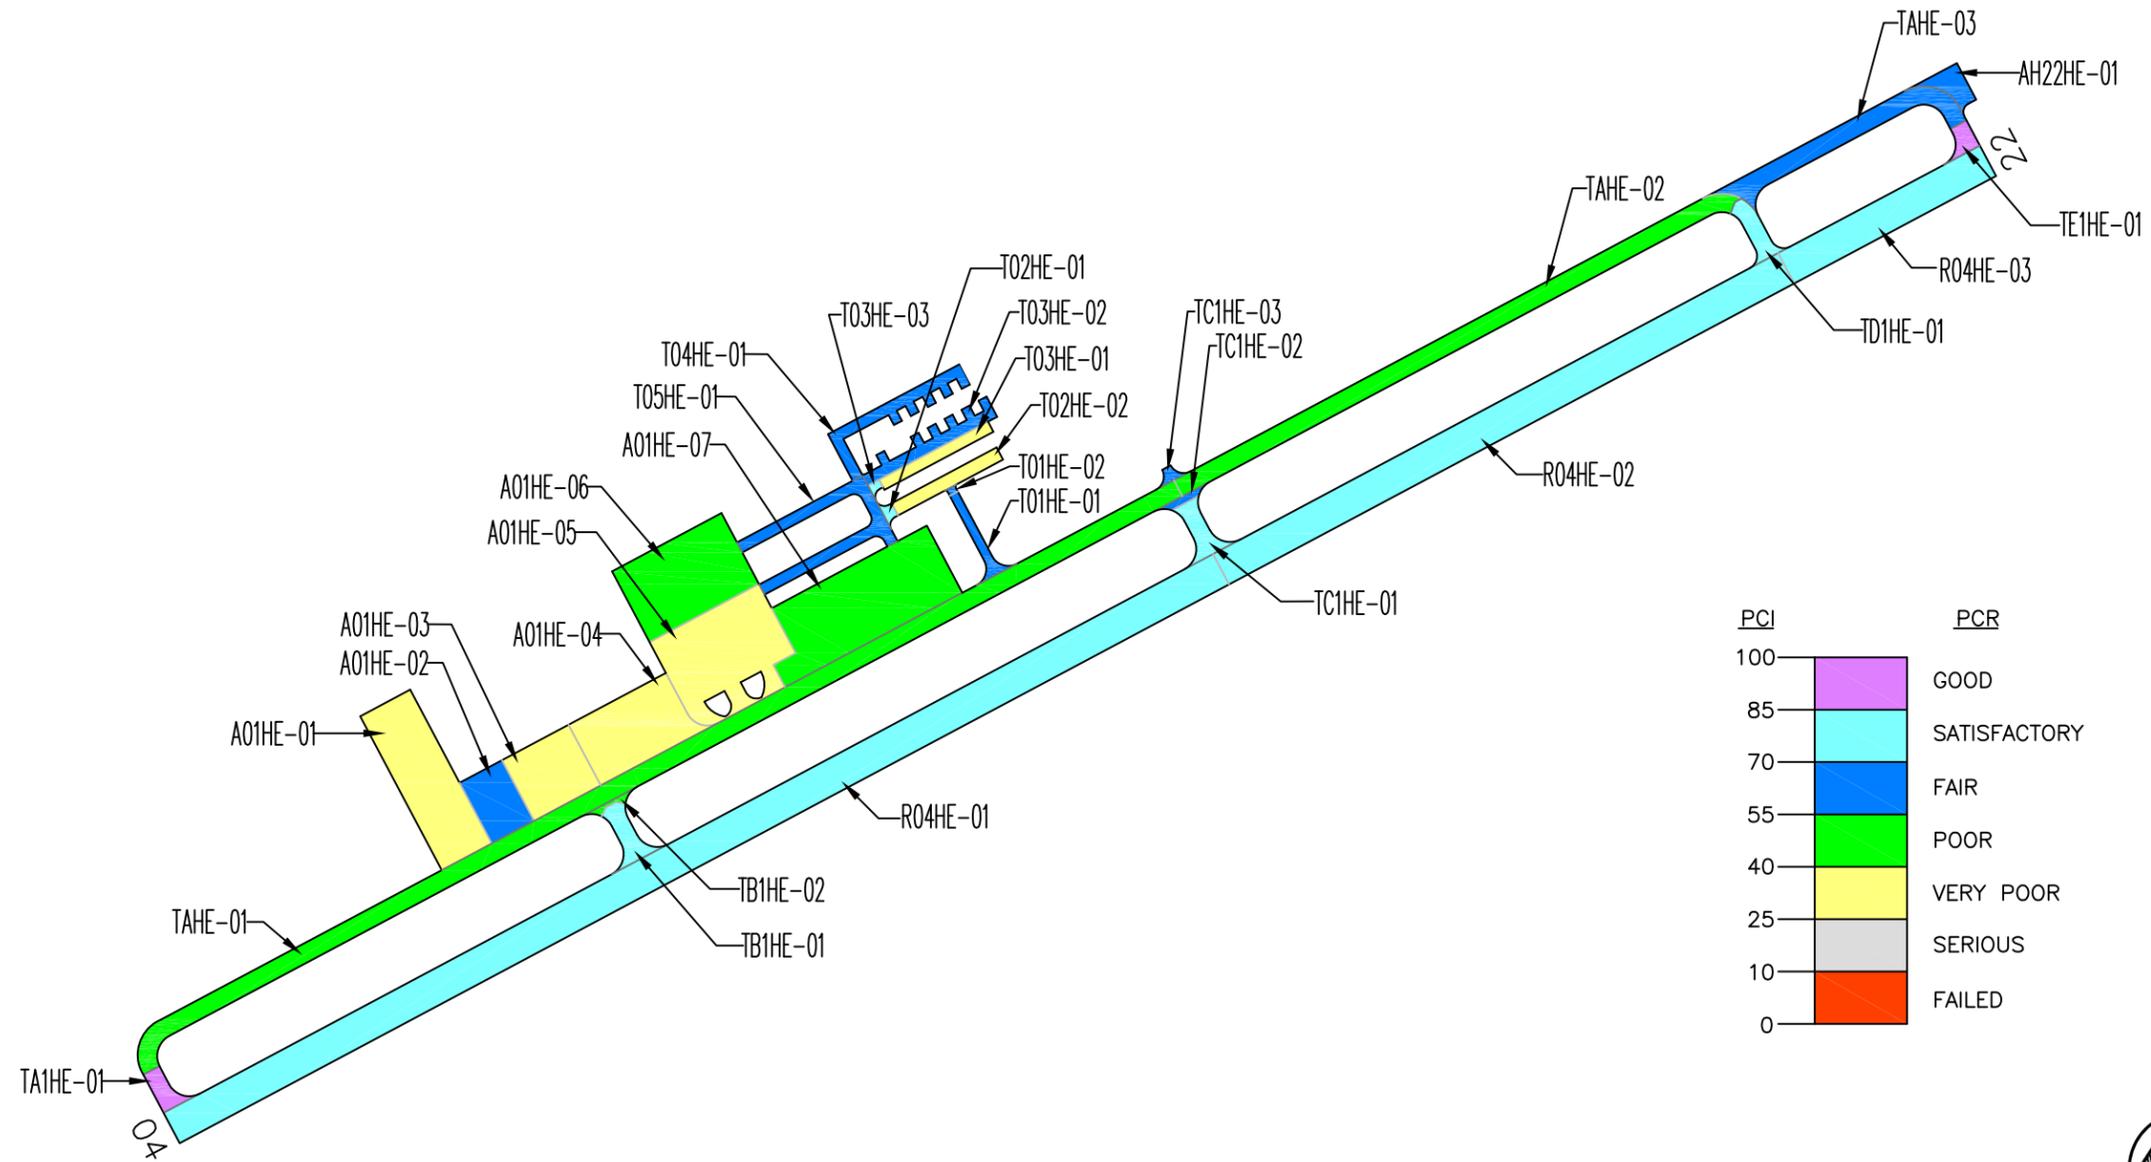
Figure HE-3. Pavement Condition in July 2014.
Hermiston Municipal Airport

The Branch Condition Report in Appendix 1 summarizes current pavement condition by branch while the Section Condition Report in Appendix 2 lists pavement condition by section. The current PCR is shown graphically in Figure HE-3.

Section PCIs at Hermiston Municipal Airport range from a low of 26 (a PCR of “Very Poor”) to a high of 95 (a PCR of “Good”). The area-weighted average PCI for all airport pavements is 59, corresponding to an overall PCR of “Fair”. Figure HE-4 shows how much pavement area is associated with each Pavement Condition Rating category and also shows pavement condition distribution from the inspections conducted in 2006 and 2011.

The primary distresses observed during the inspection were: weathering, longitudinal and transverse cracking, block cracking, alligator cracking, bleeding, patching and depressions, with isolated occurrences of raveling.

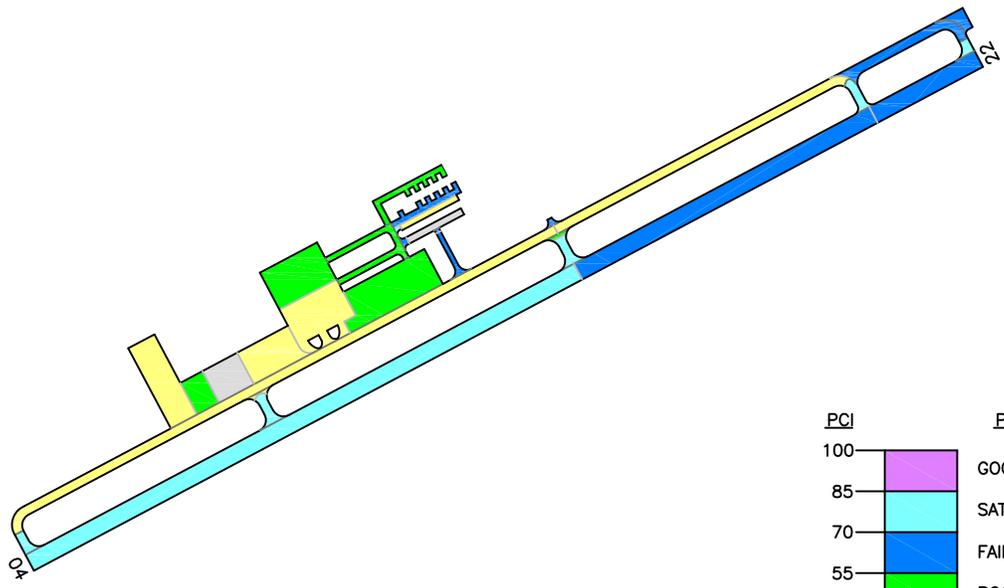
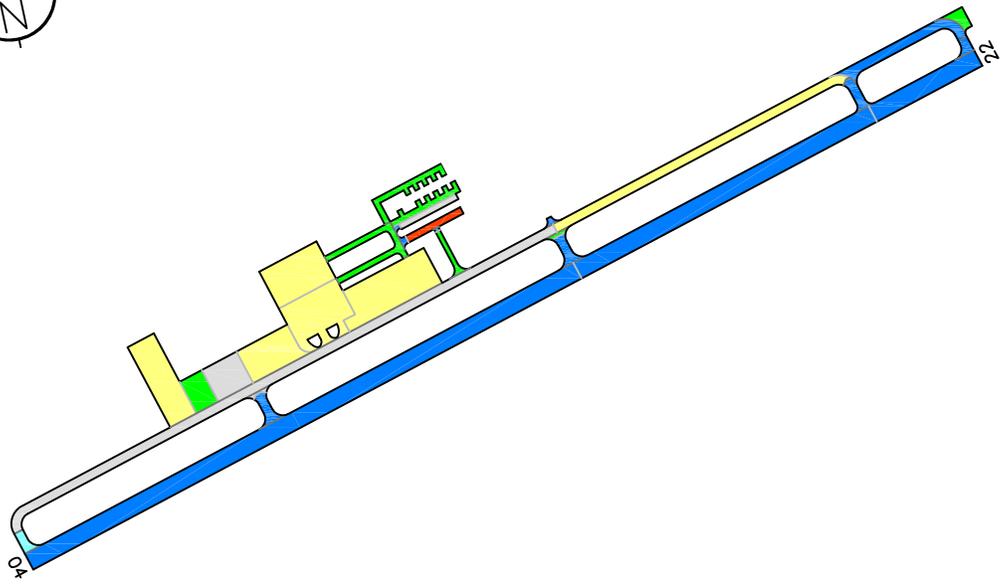
Figure HE-5. Future Pavement Condition.

Predicted Condition in 2019.

Predicted Condition in 2024.

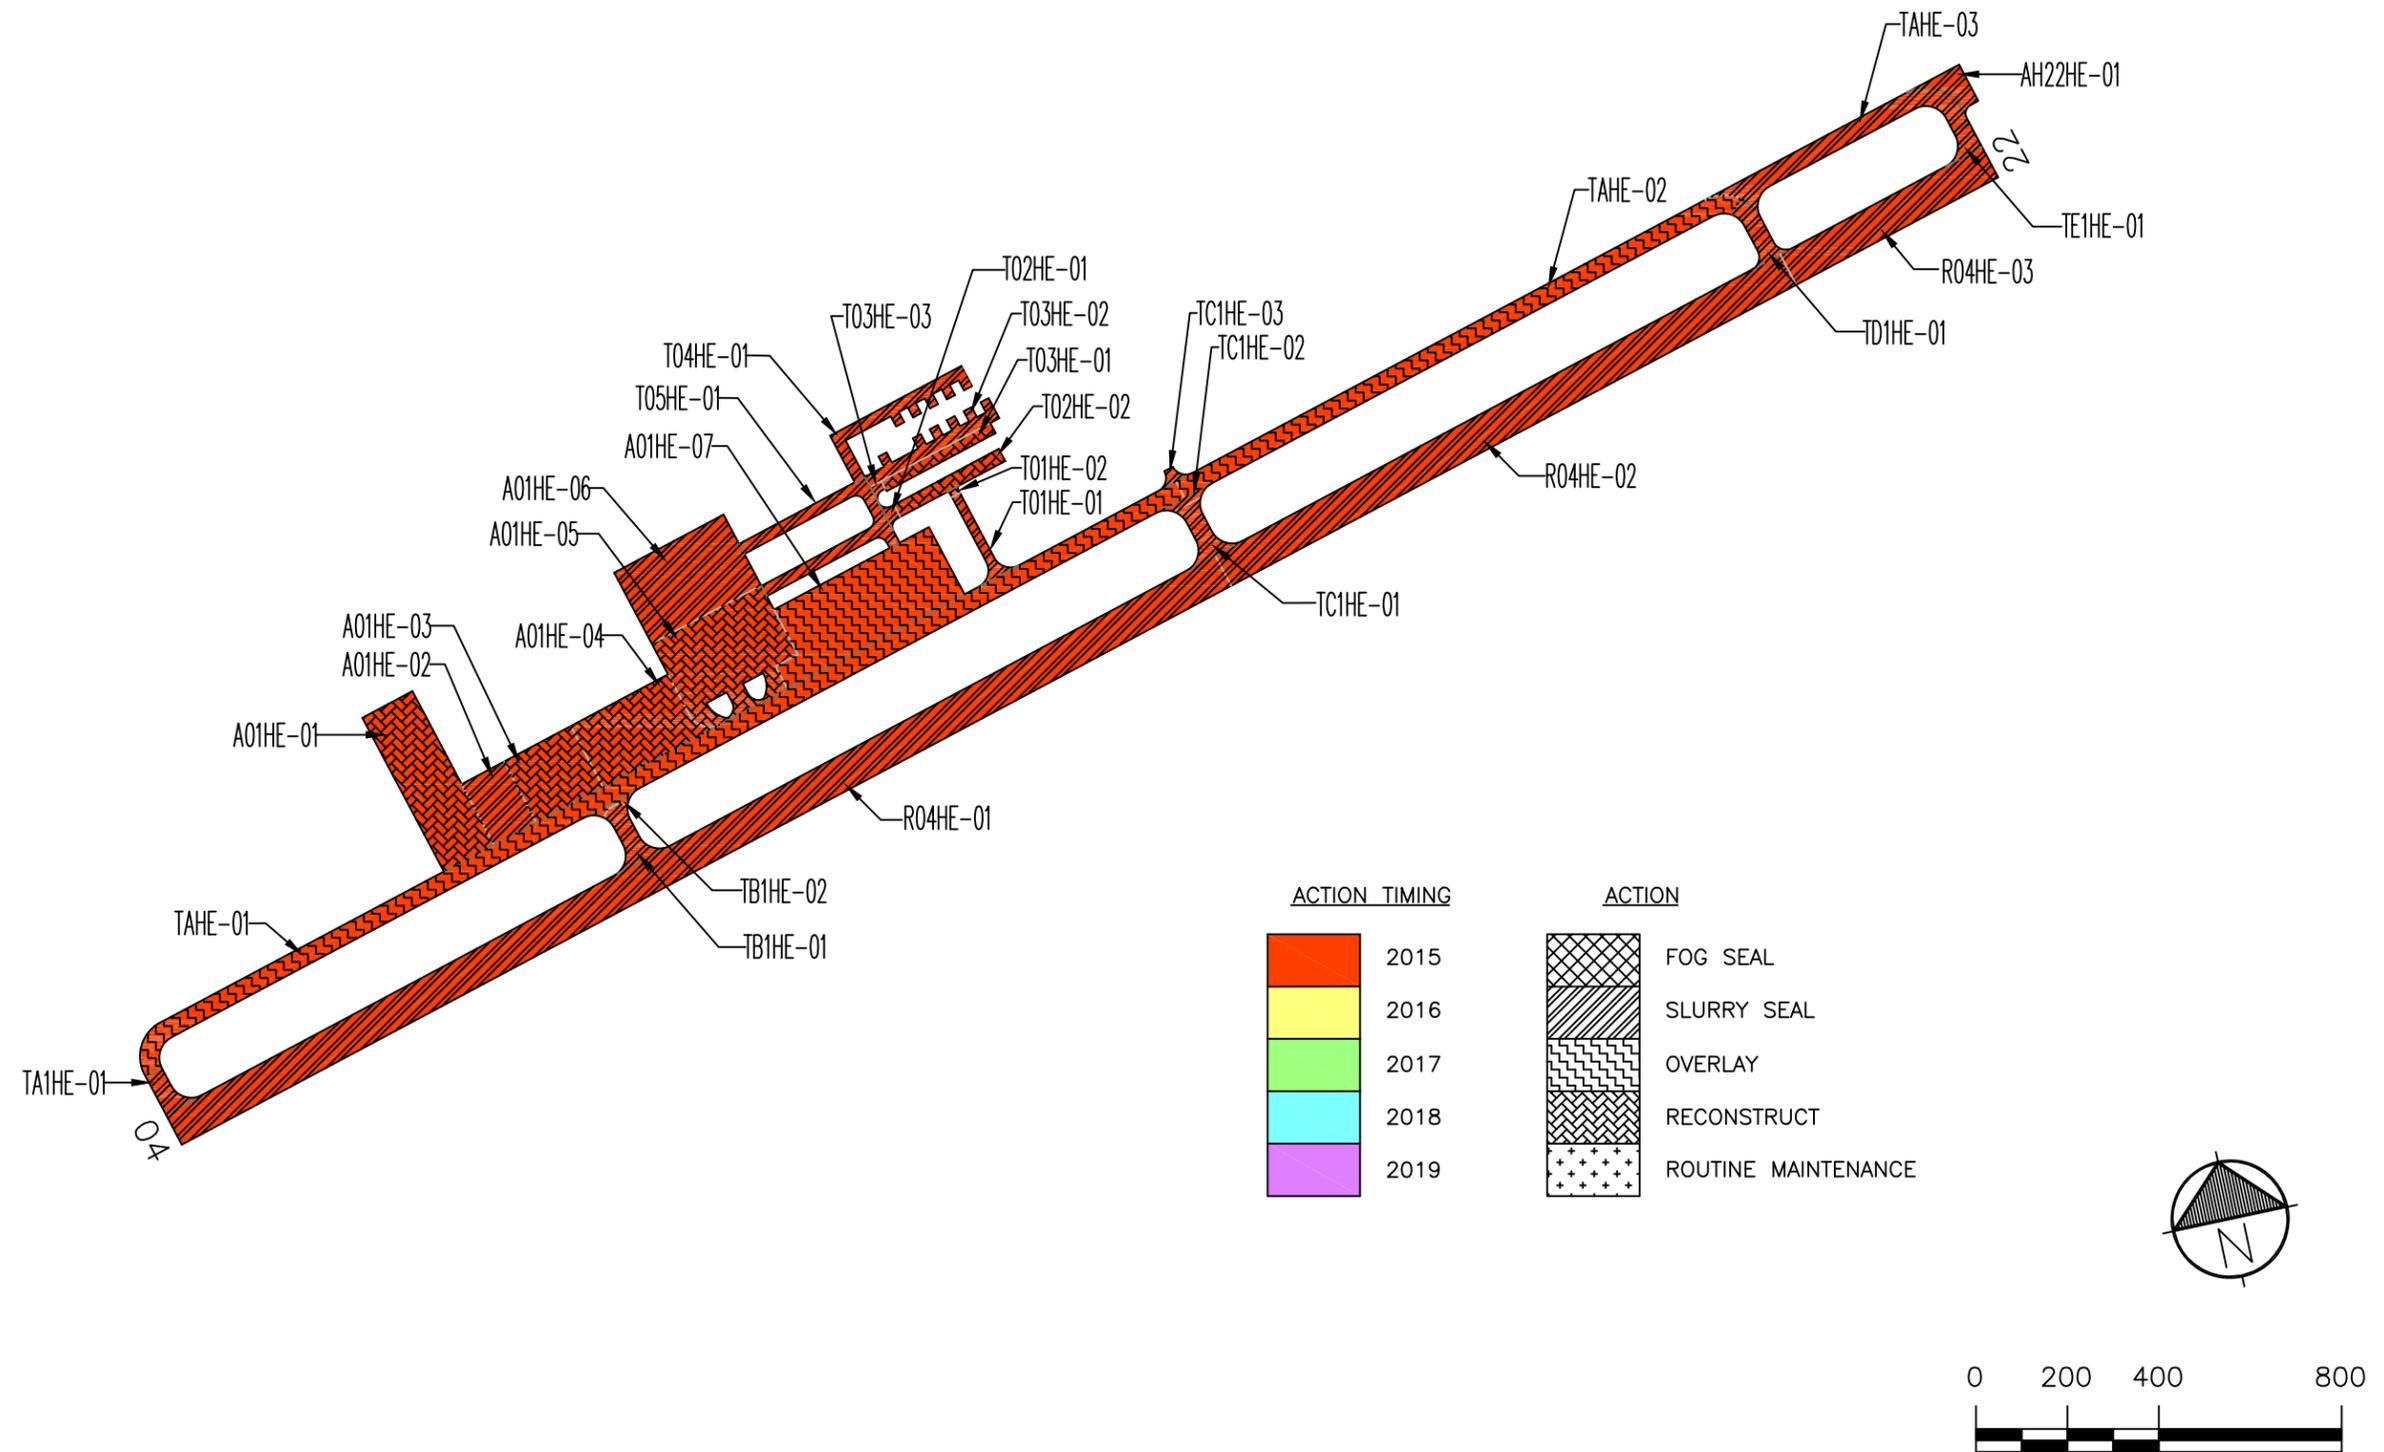
Figure HE-6. Five-Year Pavement Management Plan.
Hermiston Municipal Airport

During this project a 5-year program outlining recommended global maintenance and rehabilitation was developed. The program begins in the year 2015 to allow time for project development. These recommendations are presented in Table 2, which identifies the pavement section requiring rehabilitation, the year the action should be completed, the type of action, and an associated cost. This information is also presented graphically in Figure HE-6.
