Pavement
Evaluation/
Maintenance
Management Program
2012

McMinnville Municipal
Airport

**2012 Pavement Evaluation / Maintenance
Management Program**

**Final Report – Individual Airports
Functional Category 2, Central Climatic Zone**

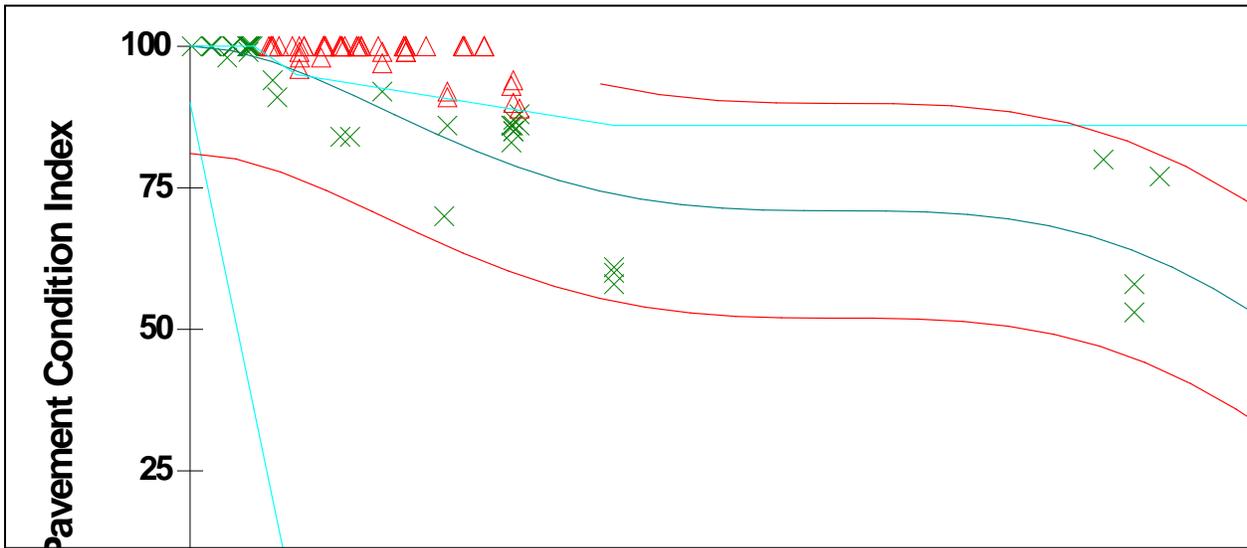
Figure 2. Performance Curve for Category 2 AC Runways – Central Oregon.

To allow future pavement condition to be predicted, data collected throughout the State were used to generate "performance curves". The curves were developed based on surface type, use, airport functional category and climatic region. These curves (models) are used to predict future pavement condition by assuming the behavior of an individual pavement section is similar to the behavior of the pavement sections used to generate the "performance curve". Figures 2 through 10 show the "performance curves" used to model pavements in your airport's functional category and climatic region.

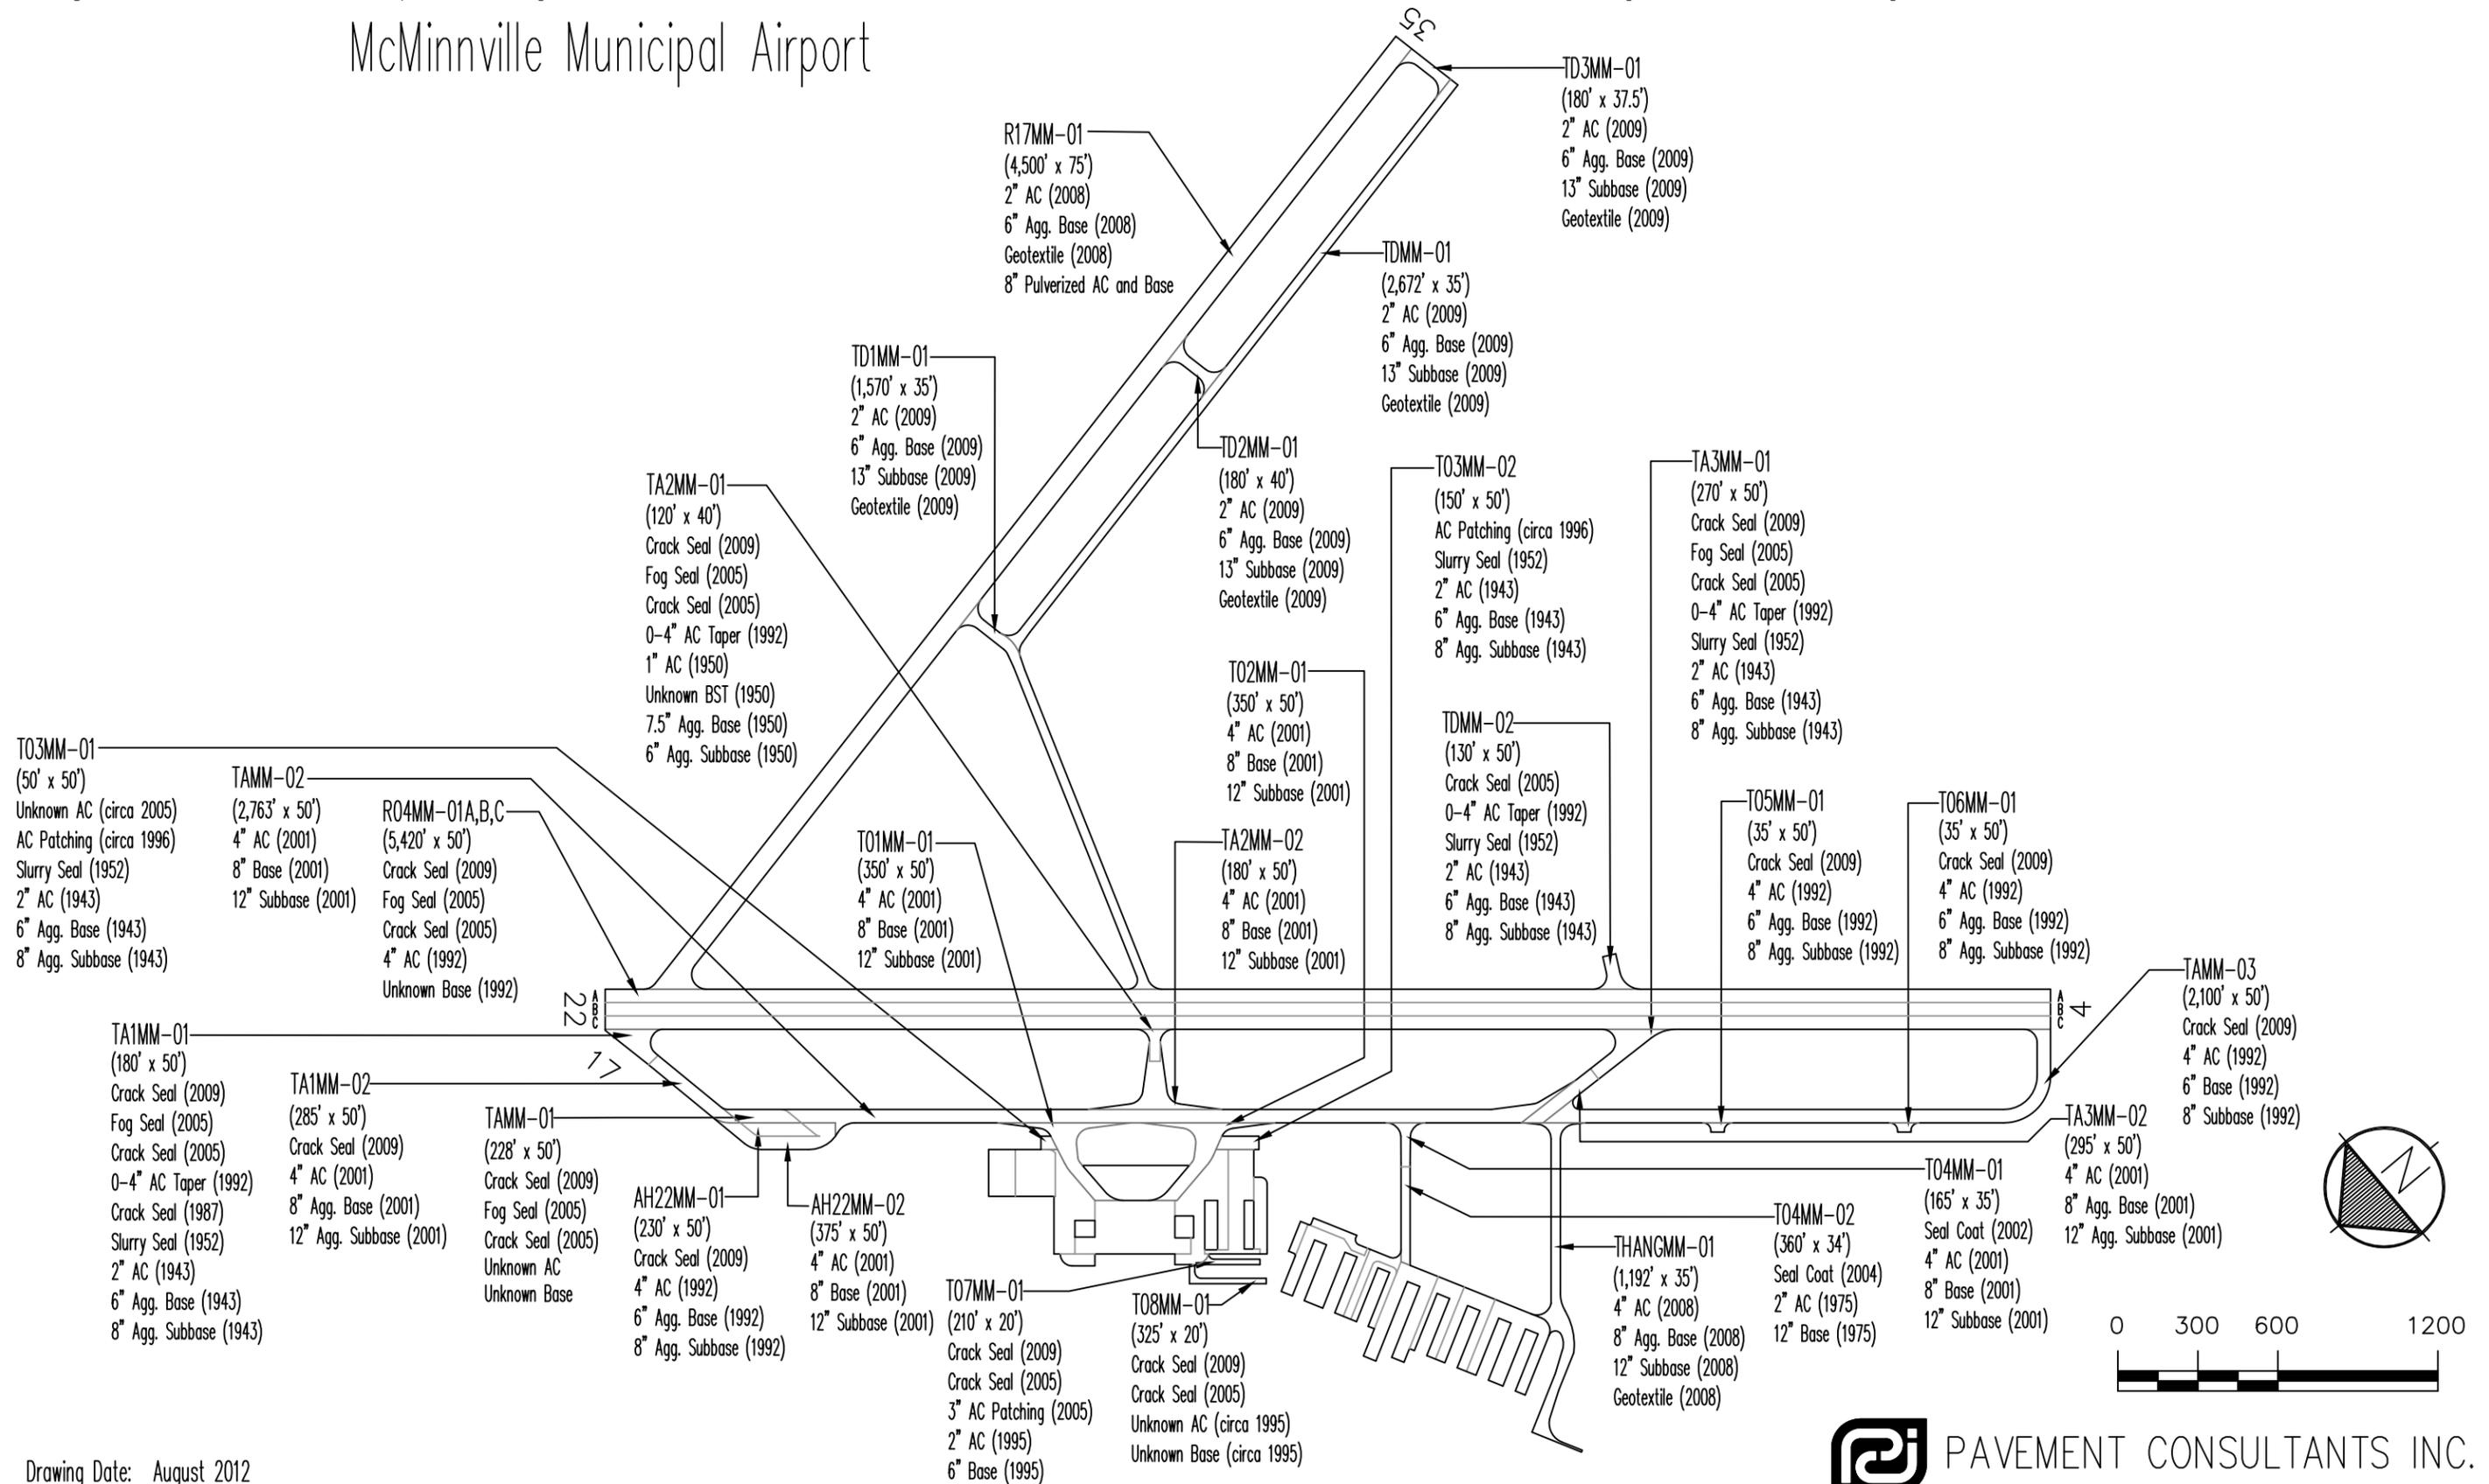
Figure MM-1A. Airport Layout, Dimensions and Pavement Cross-Sections – Runways and Taxiways.
McMinnville Municipal Airport

To determine how your pavements were constructed and their age, a records review was conducted. Figure MM-1 shows the records review results. This figure identifies pavement boundaries, dimensions, pavement layer types, thicknesses and dates of construction. The most recent construction date for each pavement can also be found in the Section Condition Report in Appendix 2. Figure MM-1 and the information contained in Appendices 1, 2 and 4 ensure that your airport complies with the “pavement inventory” requirement of FAA’s PMMP guidelines.

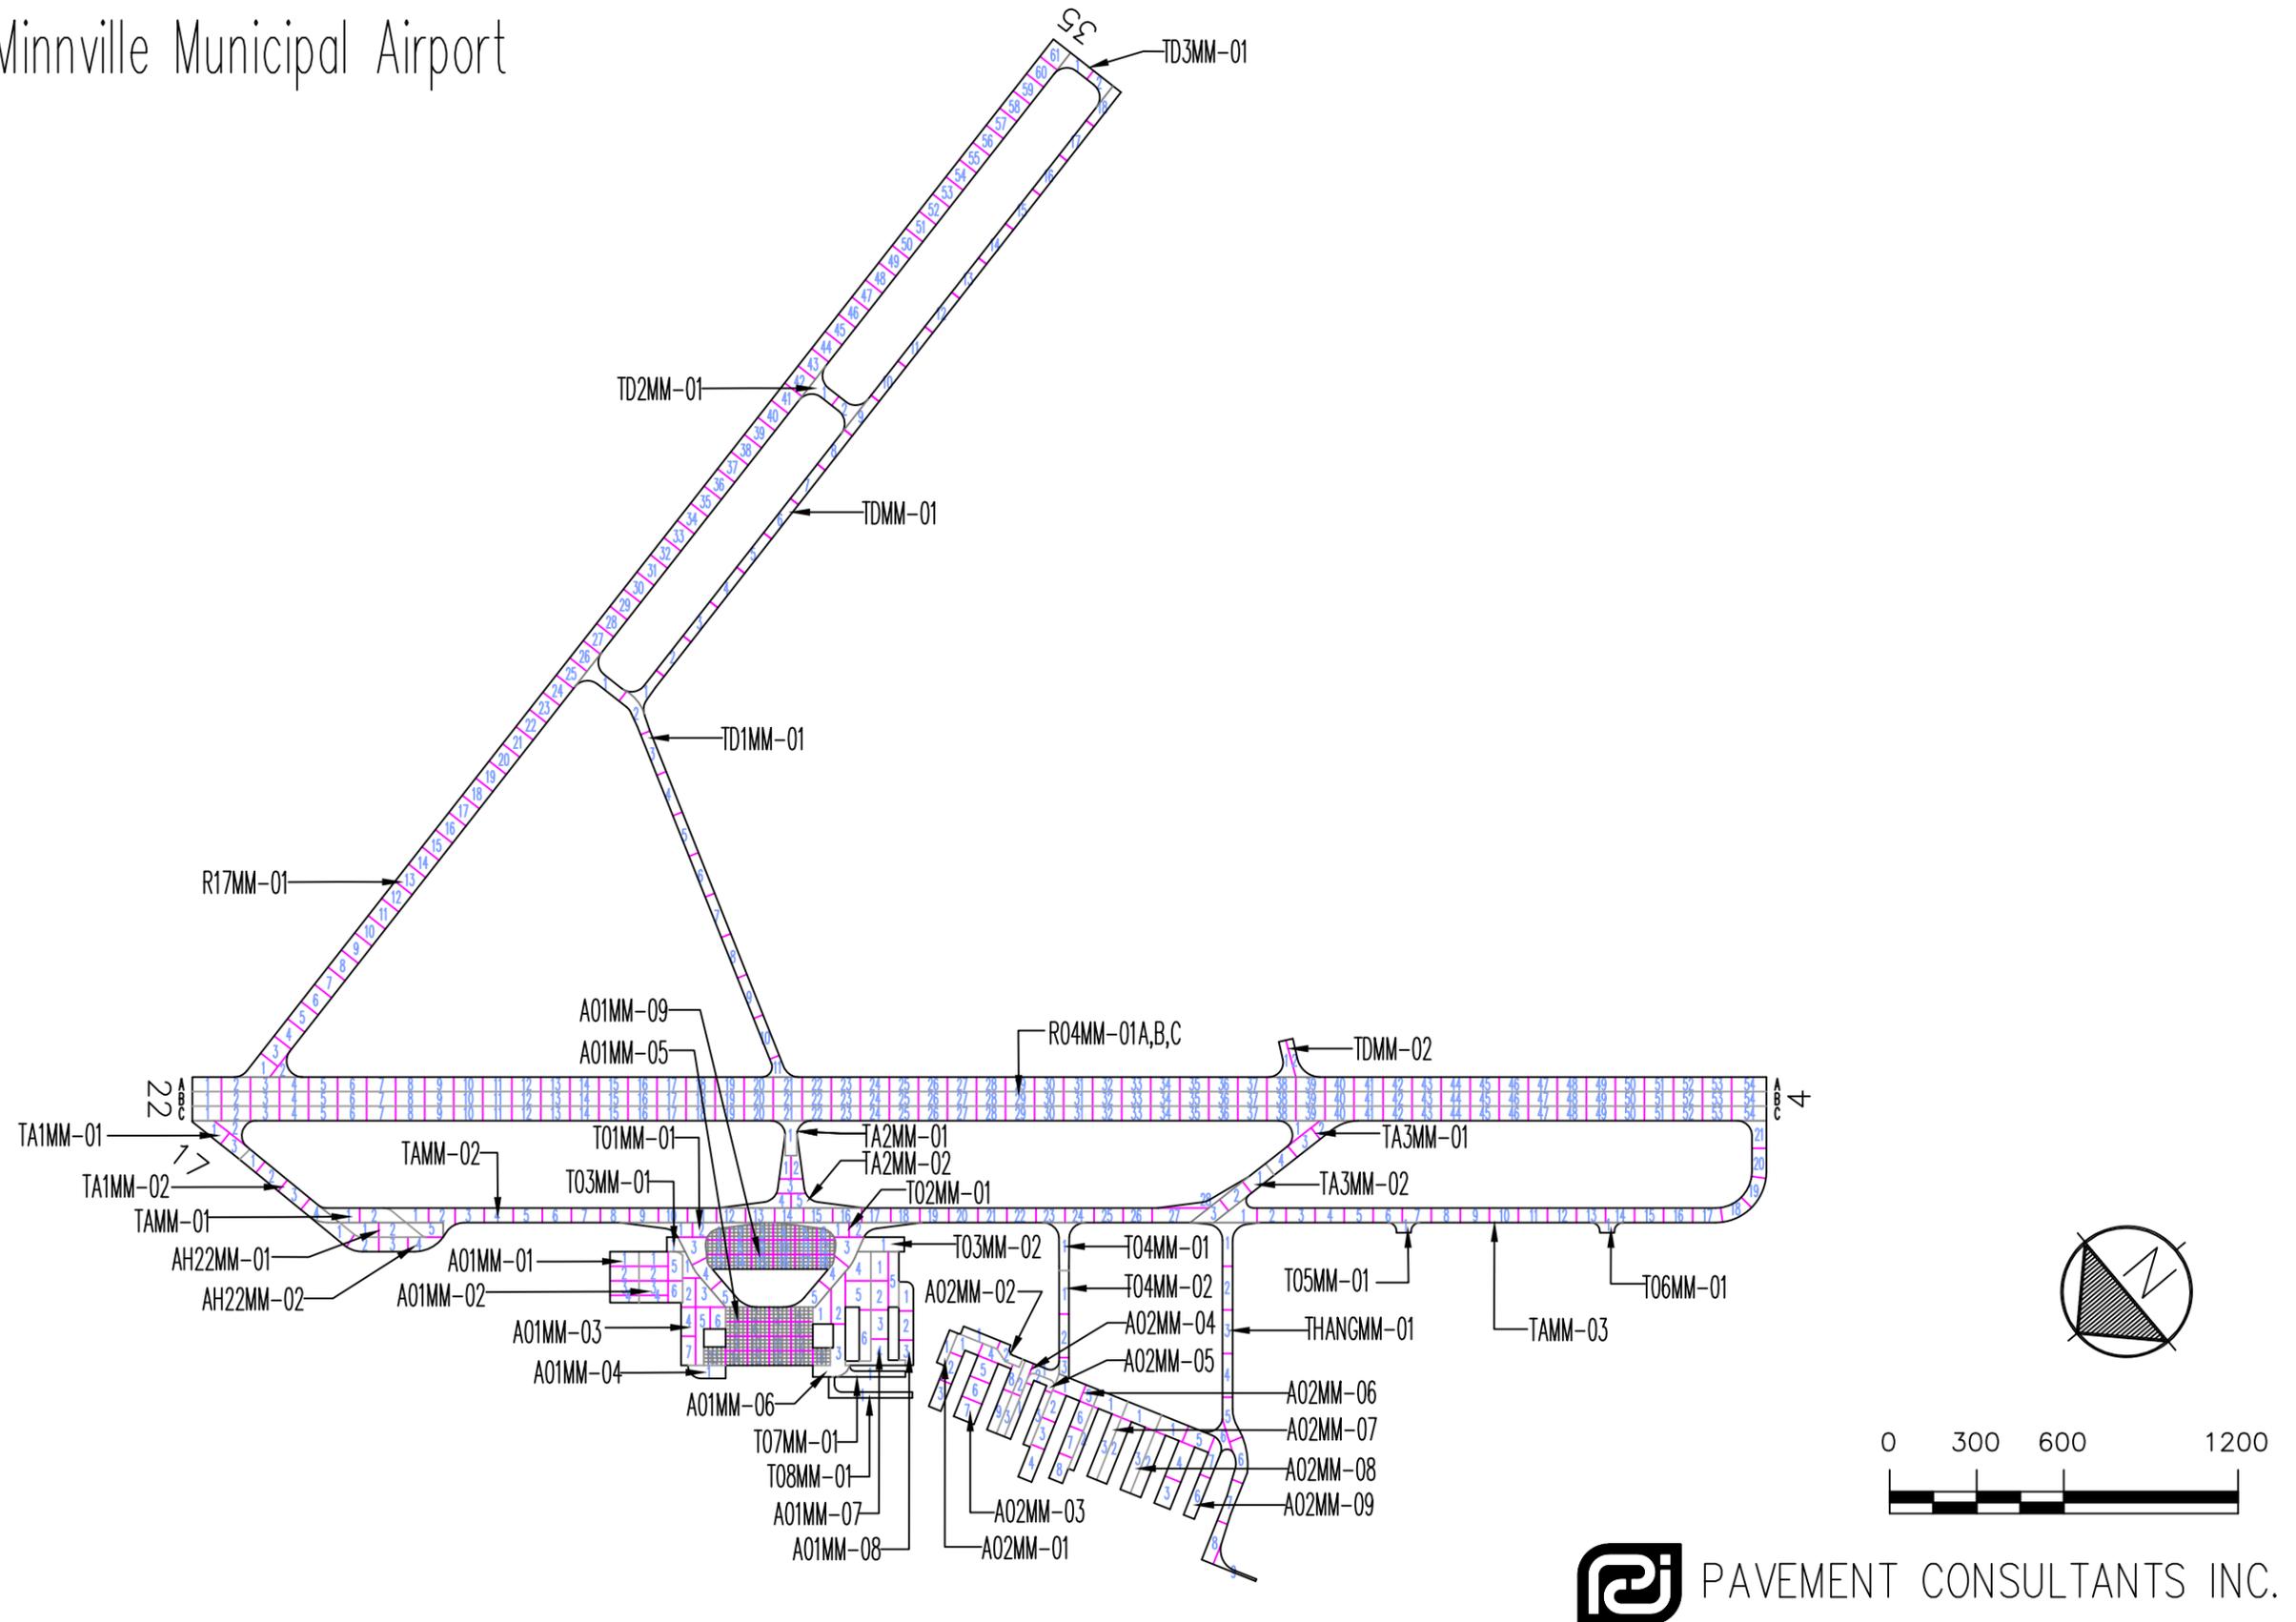
Figure MM-2. Pavement Branch, Section and Sample Unit Layout.
McMinnville Municipal Airport

The pavements at your airport were divided into branches, sections and sample units in accordance with the methodology outlined in the current edition of ASTM D5430, *Standard Test Method for Airport Condition Index Surveys*. The branches, sections and sample units established at your airport are shown in Figure MM-2. A Branch Condition Report showing all branches, their associated areas, and their area-weighted average condition is provided in Appendix 1. Additionally, the Appendix 2 Section Condition Report provides information used to define each branch and section in the Micro PAVER database.

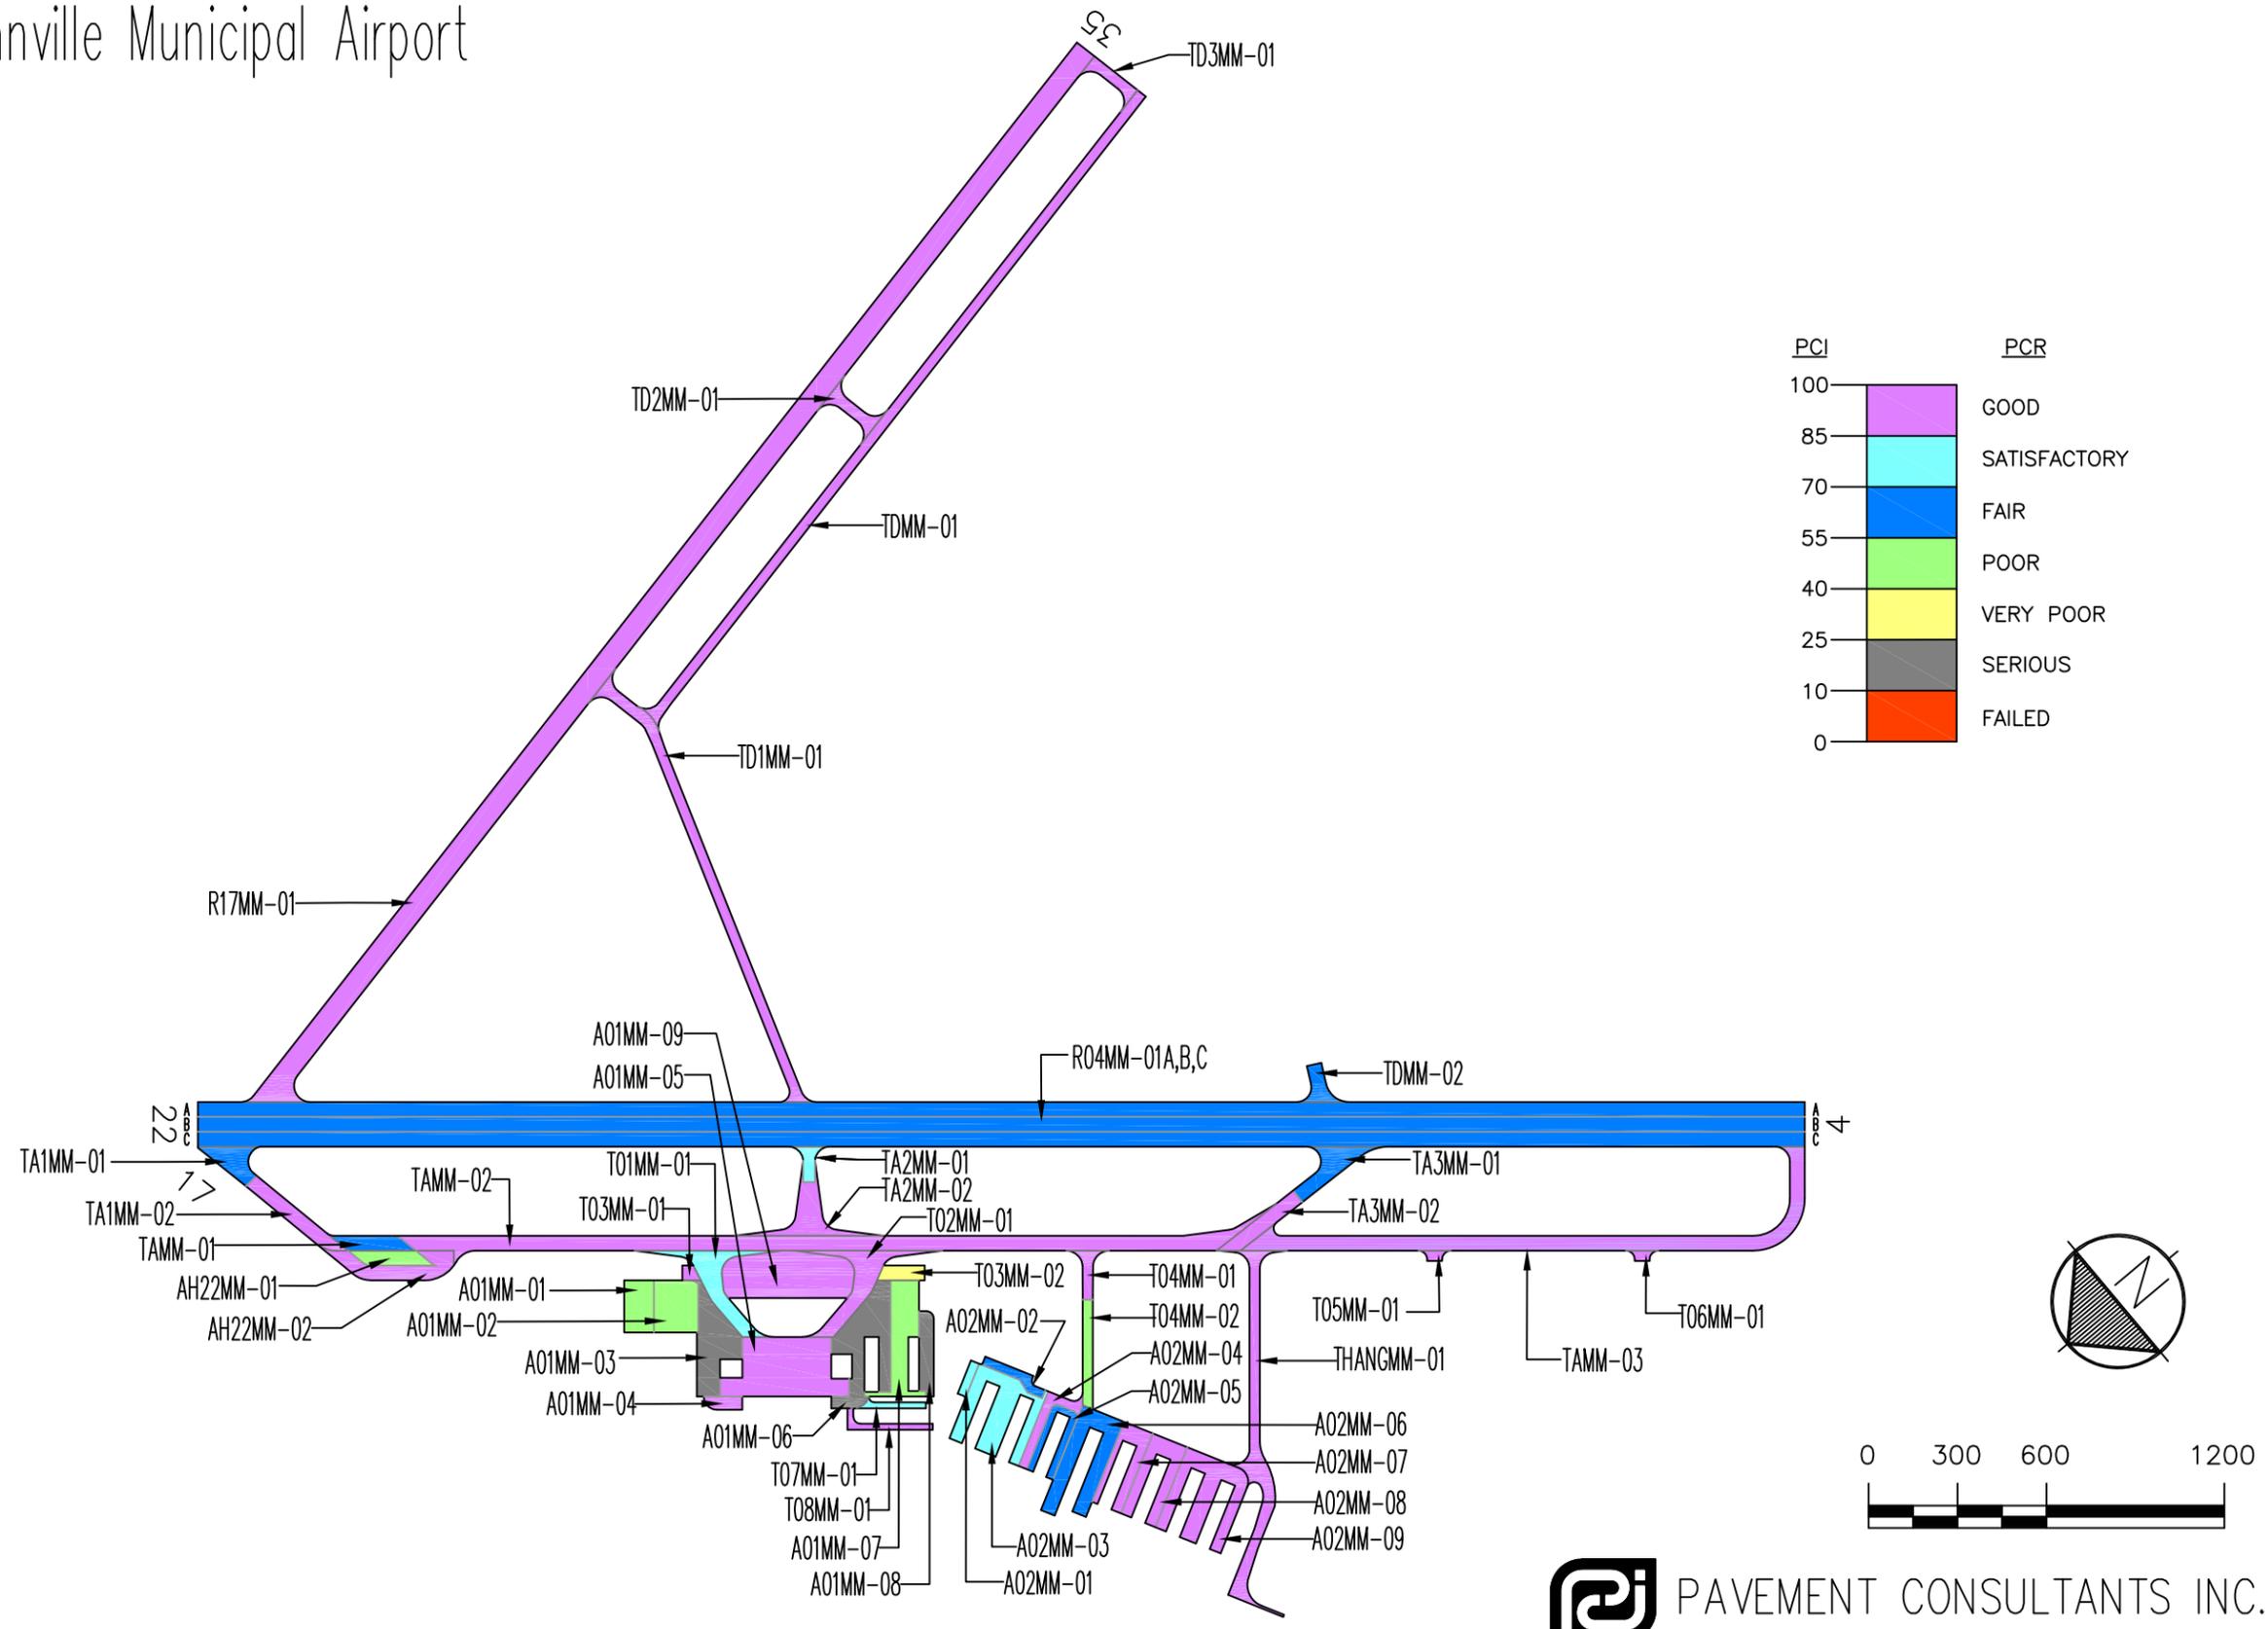
Figure MM-3. Pavement Condition in July 2012.
McMinnville Municipal Airport

The Branch Condition Report in Appendix 1 summarizes current pavement condition by branch while the Section Condition Report in Appendix 2 lists pavement condition by section. The current PCR is shown graphically in Figure MM-3.

Section PCIs at McMinnville Municipal Airport range from a low of 24 (a PCR of “Serious”) to a high of 100 (a PCR of “Good”). The area-weighted average PCI for all airport pavements is 75, corresponding to an overall PCR of “Satisfactory”. Figure MM-4 shows how much pavement area is associated with each Pavement Condition Rating category and also shows pavement condition distribution from the inspections conducted in 2004 and 2008.

The primary distresses observed in the asphalt pavements during the inspection were: longitudinal and transverse cracking, block cracking, raveling, depressions, patching, alligator cracking and an isolated occurrence of rutting. The distresses observed in the concrete

pavement were: linear cracking, joint seal damage, small patch, corner spall, shattered slab and corner break.

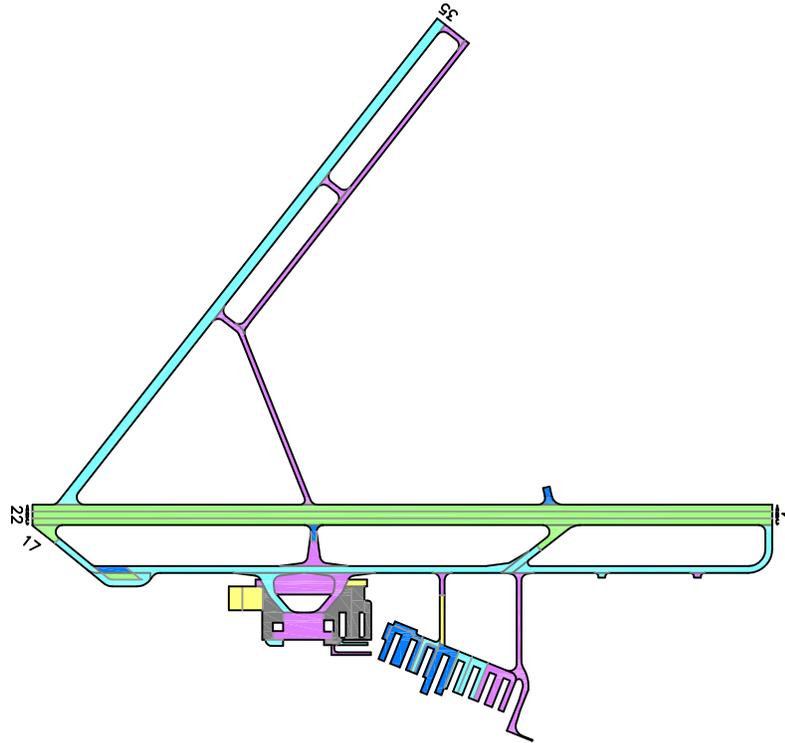
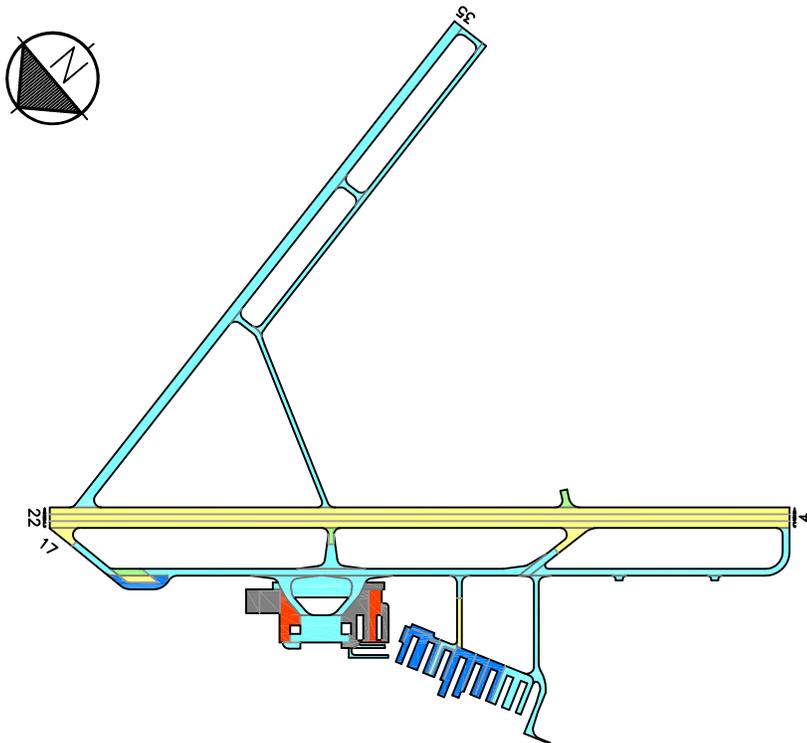
Figure MM-5. Future Pavement Condition.

A graphical representation of the projected PCIs listed in Table 1 is shown in Figure MM-5.

Predicted Condition in 2017.

Predicted Condition in 2022.

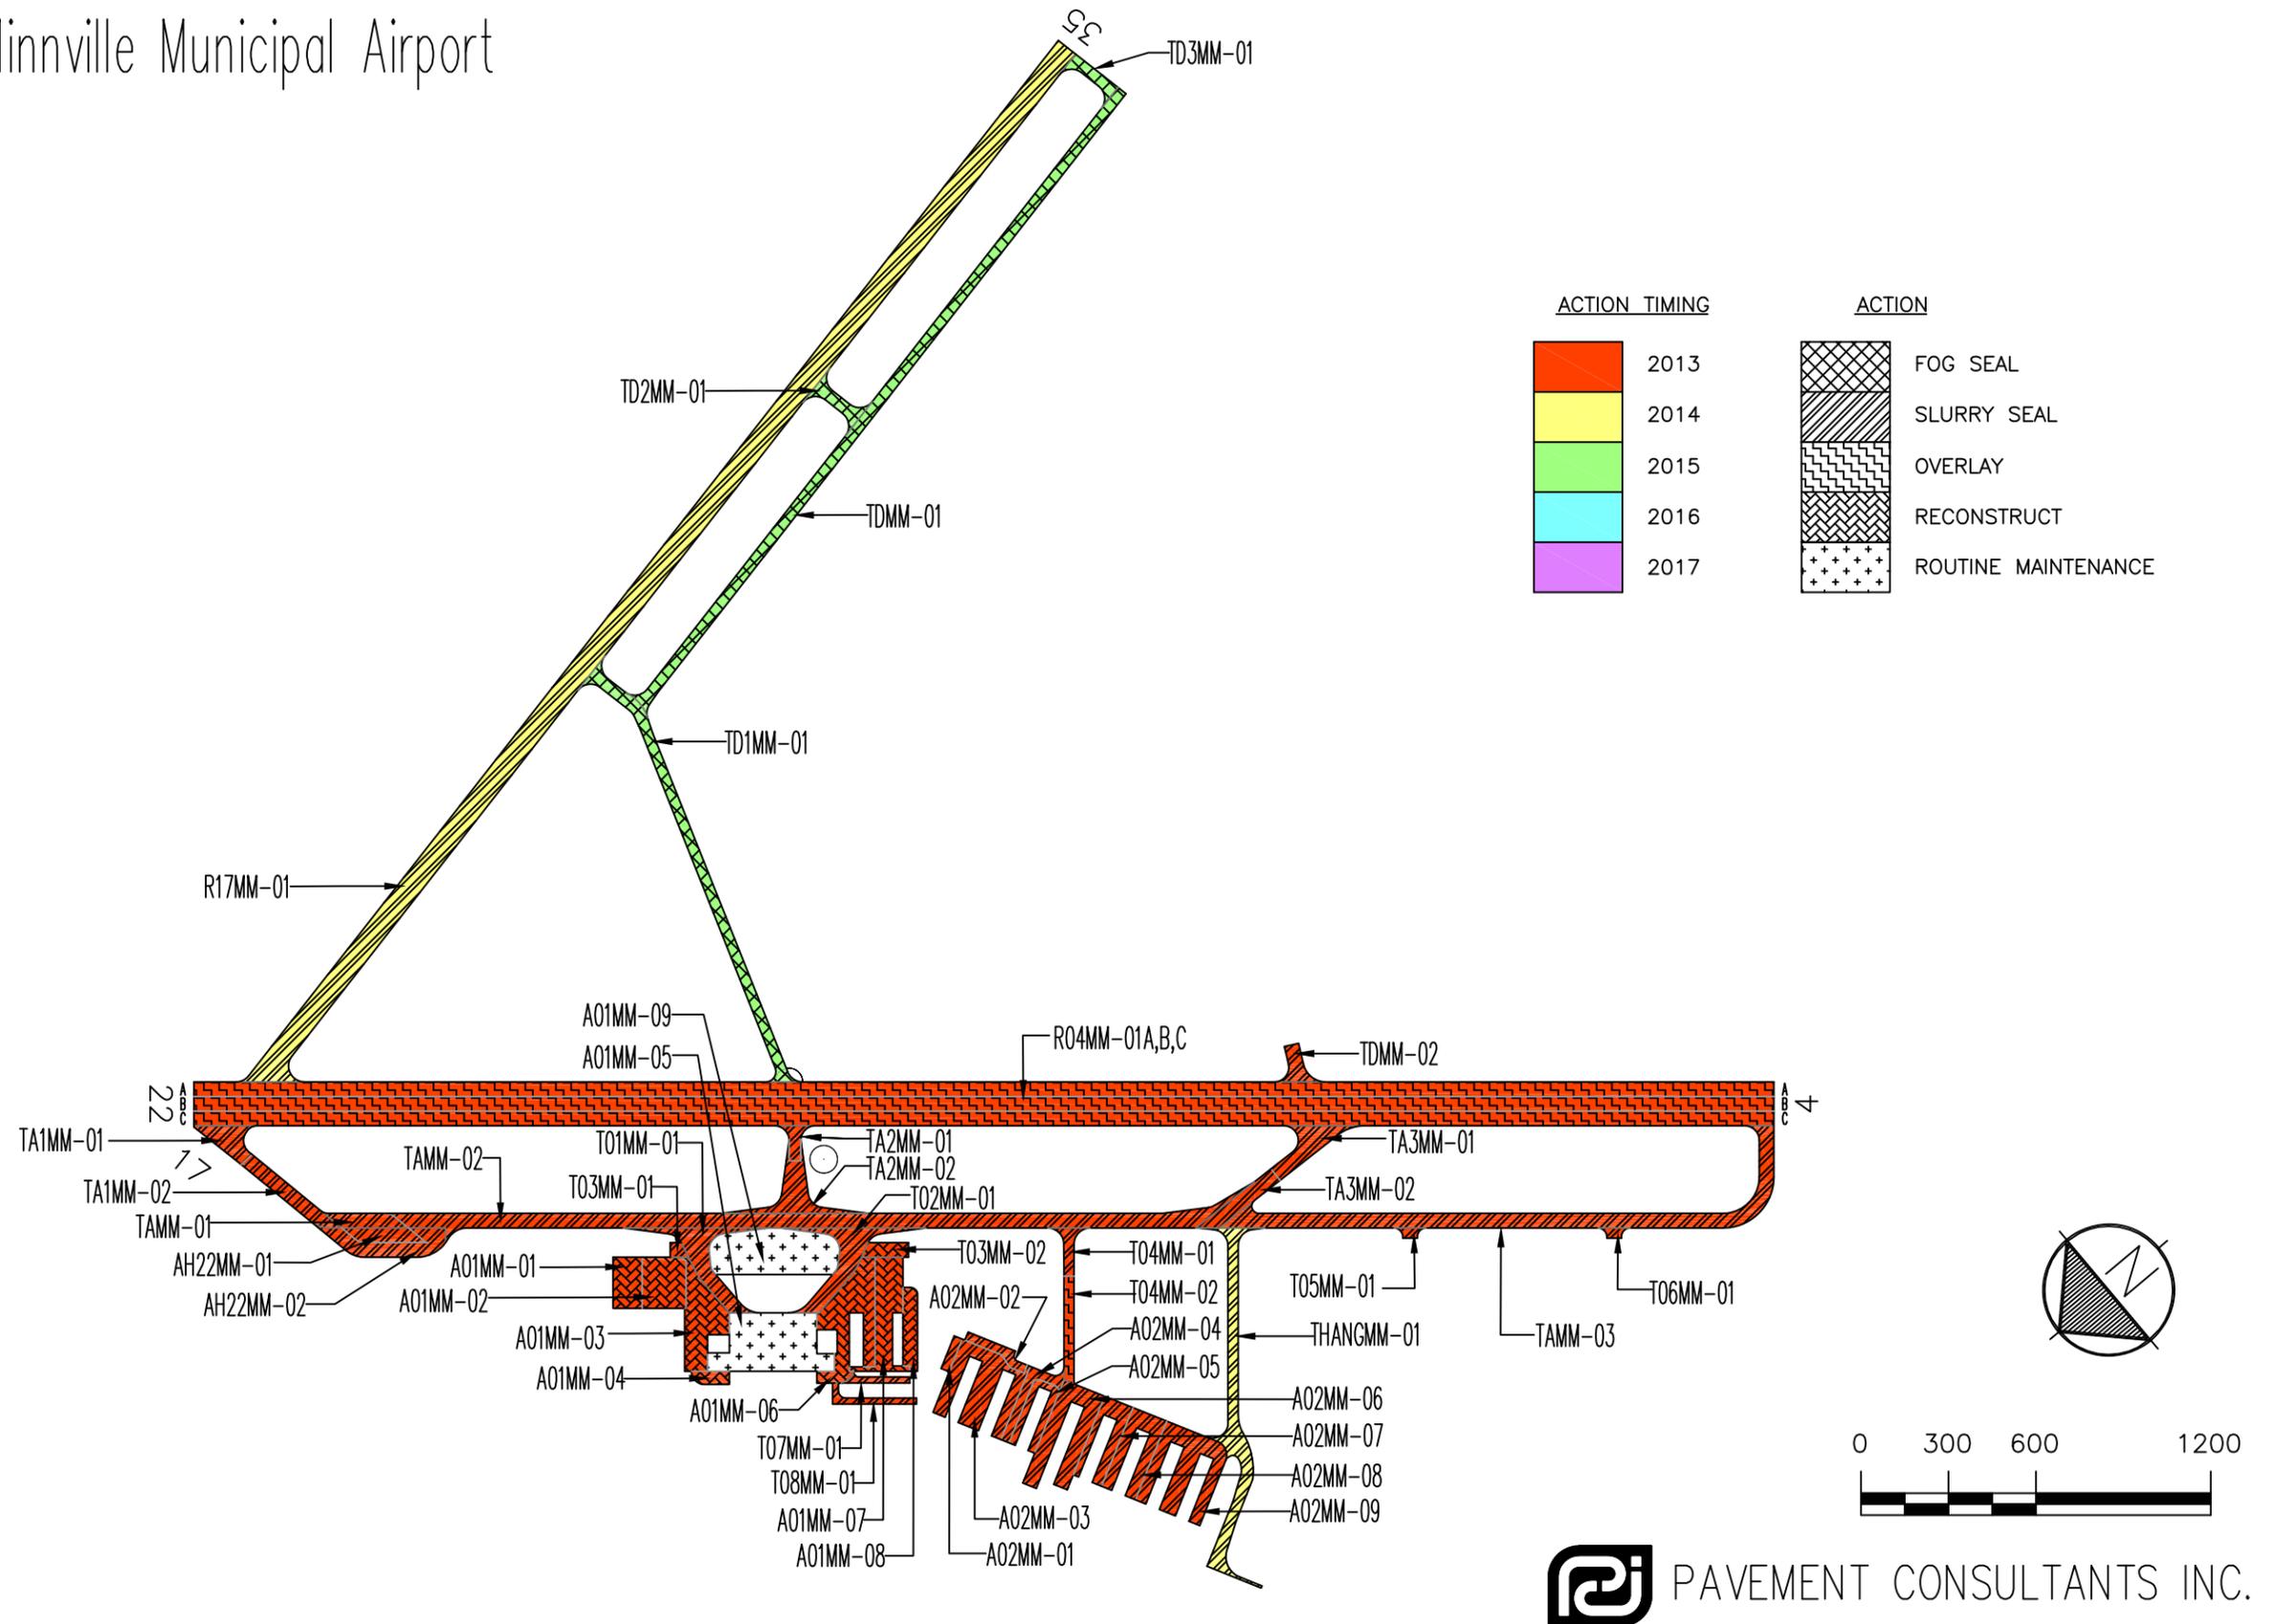
Figure MM-6. Five-Year Pavement Management Plan.
McMinnville Municipal Airport

During this project a 5-year program outlining recommended global maintenance and rehabilitation was developed. The program begins in the year 2013 to allow time for project development. These recommendations are presented in Table 2, which identifies the pavement section requiring rehabilitation, the year the action should be completed, the type of action, and an associated cost. This information is also presented graphically in Figure MM-6.

If the global maintenance and/or rehabilitation activities recommended in Table 2 are not completed, the localized maintenance activities identified in the Network Maintenance Report (Appendix 3) for that section should be done. Additionally, for those sections not listed in Table 2 as requiring global maintenance or rehabilitation, the localized maintenance activities outlined in the Network Maintenance Report should be completed. By completing the localized maintenance activities, pavement condition is improved, life is extended, deterioration is slowed and the length of time until major repair or rehabilitation is required is increased.
