# RESTORING ANDERSON CREEK

A case history addressing methods for constructing a complex, non-tidal stream channel

One in a series of three case histories about the South Slough NERR's Winchester Tidelands Restoration Project

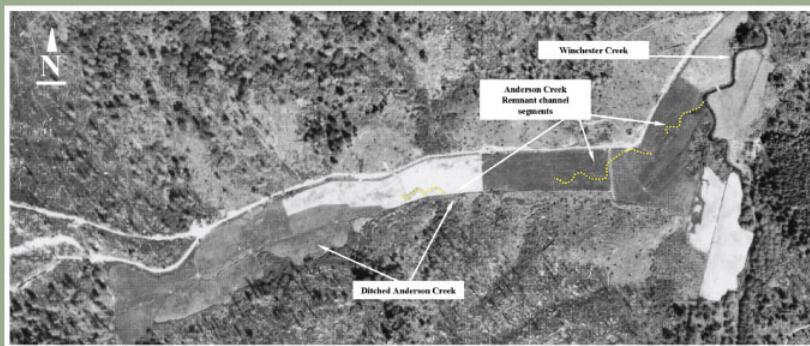
**Figure 2.** Anderson Creek floodplain in 1939 when the site was actively maintained for farming.

**Figure 3.** Anderson Creek floodplain in 1991 prior to restoration.

Anderson Creek is a small stream located at the head of tide in the upper reaches of the South Slough estuary (see Figure 1). Draining an approximately 100-hectare watershed, the stream is formed by two main tributaries that flow from surrounding hills and join together at the head of a long, narrow floodplain. From there, Anderson Creek once meandered through freshwater wetlands for nearly a kilometer to its confluence with Winchester Creek. In the early 1900s, the floodplain wetlands were converted to farmland, and Anderson Creek was diverted into a straight ditch built along the south edge of the floodplain (see Figures 2 and 3). In addition, a road and

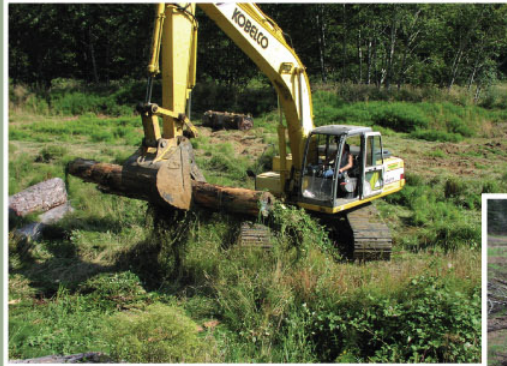
**Figure 8.** Placing large wood in the Anderson Creek channel and floodplain.

To provide additional structure for the developing stream channel, Reserve staff obtained 35 large (0.5 m to 1.0 m in diameter) conifer cull logs from a nearby mill and strategically placed them in and around the pilot channel (see Figure 8). The contractor buried some of the logs just below the stream bottom to prevent the new channel from head-cutting. Others were placed across and along the edges of the channel to encourage the development of scour pools and other structural elements that would increase habitat complexity.

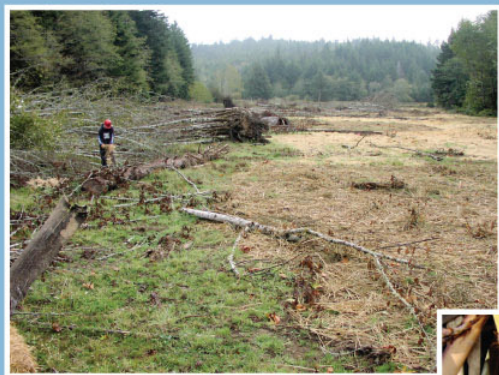
**Figure 9.** Anderson Creek floodplain mulched with seedless straw and native slough-sedge hay with ripe seed-heads (inset).

In fall 2002, with construction completed, youth crews placed mulch along the pilot channel and floodplain area to reduce erosion and to prepare the area for planting. Two kinds of mulch were used. Commercial straw (seedless) was spread where small-fruited bulrush (*Scirpus microcarpus*) was to be planted, and slough-sedge hay with ripe seed heads was spread where slough sedge (*Carex obnupta*) was to be planted (see Figure 9). The hay was harvested from slough sedge growing in a meadow next to the project area. In winter 2002, with the ditch filled, the water table under the floodplain rose, effectively restoring wetland hydrology to the site (see cover photo).

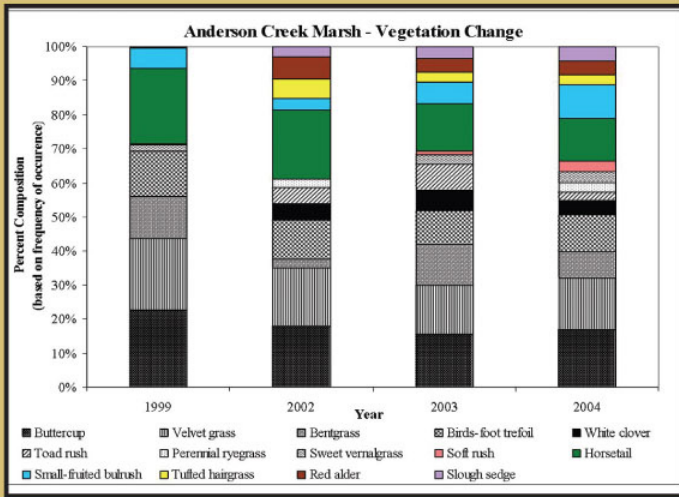
**Figure 12.** Vegetation change in the Anderson Creek floodplain, 1999 to 2004. Solid colors represent native species. Black-and-white patterns represent non-native species.

In the first growing season (2003), residual pasture grasses and exotic forbs dominated the floodplain. However, there was vigorous growth of the planted slough sedge, small-fruited bulrush, and of soft rush (*Juncus effusus*), a native volunteer (see Figure 12).

By summer 2004, native wetland grasses and forbs had significantly increased in abundance. Small-fruited bulrush had overgrown the banks of the creek. However, grasses such as velvet grass (*Holcus lanatus*), an introduced pasture grass, persisted in the drier parts of the floodplain.

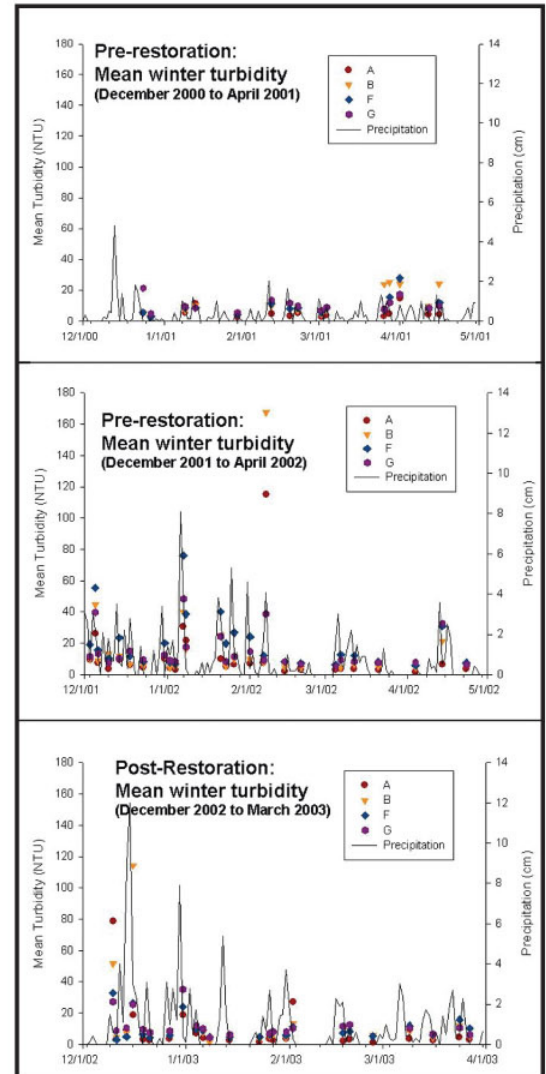
**Figure 14. Pre- and post-restoration turbidity values at Anderson Creek. Sample sites A and B are above the project site. Site F is in the lower part of Anderson Creek and site G is in Winchester Creek above its confluence with Anderson Creek.**

Turbidity was measured with a turbidometer (Hach 2100P) during precipitation events ( $\geq 0.15$  cm per day) at five locations: one upstream of the project site, three within the project area, and one downstream from the project. Measurements were taken before project construction which began in 2001, and then again in winter 2002, after the creek was re-routed into the

pilot channel and flowed again to Winchester Creek. Turbidity at Anderson Creek sites did not increase even after high-precipitation events (see sidebar and Figure 14).
