# **PUBLIC HEALTH CONSULTATION**

**Willamette Cove  
Portland Harbor  
Multnomah County, Oregon**

Oregon Department of Human Services  
Superfund Health Investigation and Education

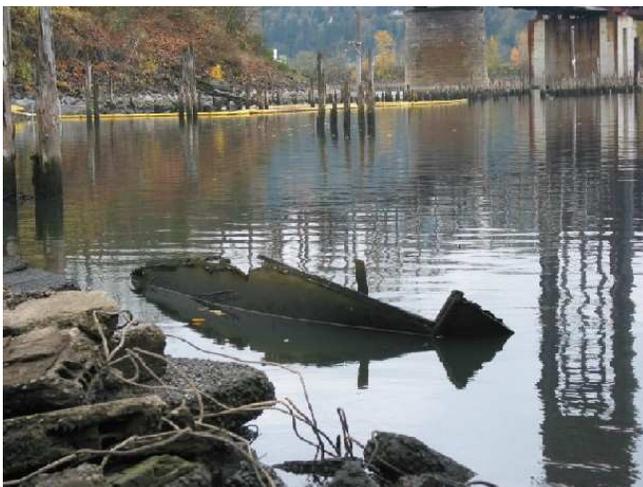
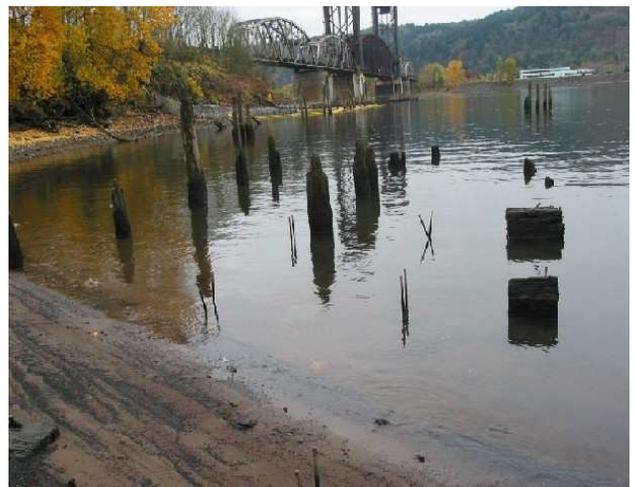
**Figure 1. Examples of in water hazards at Willamette Cove.**

In-water hazards, which are the responsibility of the Oregon Division of State Lands, are shown in Figure 1. These hazards were most obvious during the November 2002 site visit, since the water in the Willamette River was lower compared with the March 2003 visit. Evident features along the riverbank include numerous reinforcing steel bars (rebar) and broken treated pilings embedded in the sediment. The rebar and pilings project out of the water and present a risk to potential waders, swimmers and boaters at the site. Jagged posts and pilings are found at various distances from the beach area of the Cove as well. At one location, a large piece of scrap metal can be found within a few feet of the beach. The entire Cove area would be extremely dangerous for any water-based activity, especially at night and during high water when the hazards may not be visible.

4. Rebar, posts and pilings should be pulled from the sediment, especially near shore, when permitted by appropriate regulatory agencies.
5. Concrete blocks, wire and other debris should continue to be removed from the site.

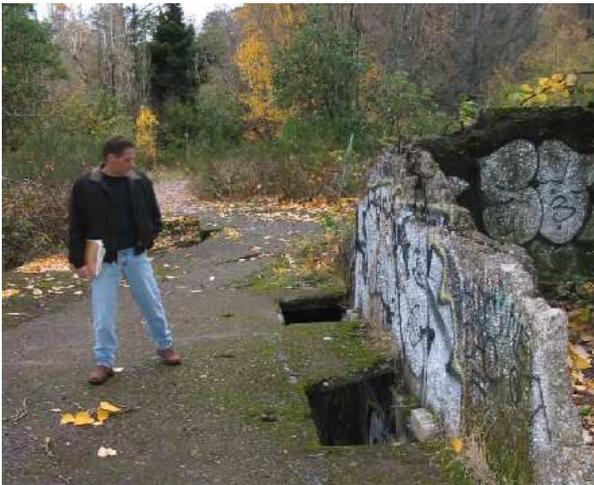
Bank and non-water hazards are shown in Figure 2. During the first site visit, two large, gaping holes were evident in an abandoned cement structure, shown in Figure 2a. The holes were level with the bank and along a pathway, posing a severe falling and entrapment hazard. Metro demolished the structure (and several others), as noted in the second site visit (Fig. 2b). Concrete beams that overhang the banks of the Cove continue to present a falling hazard (Fig. 2c).

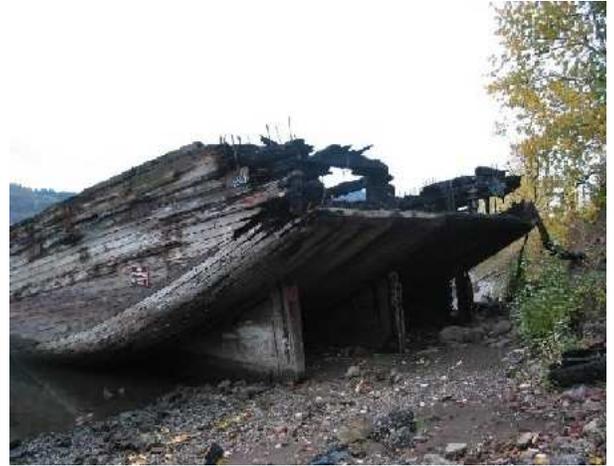
Along the beach, numerous piles of broken cement blocks, sharp slag-like material, rebar, wire and other industrial debris are strewn about. Metro has removed much of the debris using volunteer programs and hired prison labor on many occasions. At the northern end of the Cove is an abandoned barge, as shown in figure 2d. The stern end of the barge is beached on the Cove and the bow faces the Willamette River. Evidence of makeshift

camps can be observed between the rudders of the barge. A large branch has been secured to the barge from the nearby bank, permitting access to the vessel. The floor and sides of the barge consist of numerous protruding spikes and jagged, fire-damaged planks. Unfortunately, the barge may be an enticing attraction for visitors. Children have been observed sitting at the far (riverward) end of the barge [4]. During the March 2003 site visit, a fisherman walked across the barge to the far end. The holes in the barge deck and abundance of broken planks and spikes pose a hazard to site trespassers. Metro has erected a chain-link fence around the barge to limit access. The fence was destroyed within two weeks [1].

1. Until the site can be remediated as planned by Metro, areas that are frequently accessed should be posted with visible “Public Health Hazard-No Trespassing” warnings.
2. All concrete overhangs should be demolished or made inaccessible.
3. Access to the barge should continue to be discouraged or restricted until it can be dismantled or removed.
