**FIRE LOOKOUTS AND ASSOCIATED STRUCTURES
ON THE
UMATILLA NATIONAL FOREST**

**A DETERMINATION OF ELIGIBILITY
TO THE
NATIONAL REGISTER
OF
HISTORIC PLACES**

**USDA FOREST SERVICE
PACIFIC NORTHWEST REGION
UMATILLA NATIONAL FOREST**

**Jan M. Tomlinson
Archaeologist/Historic Preservationist**

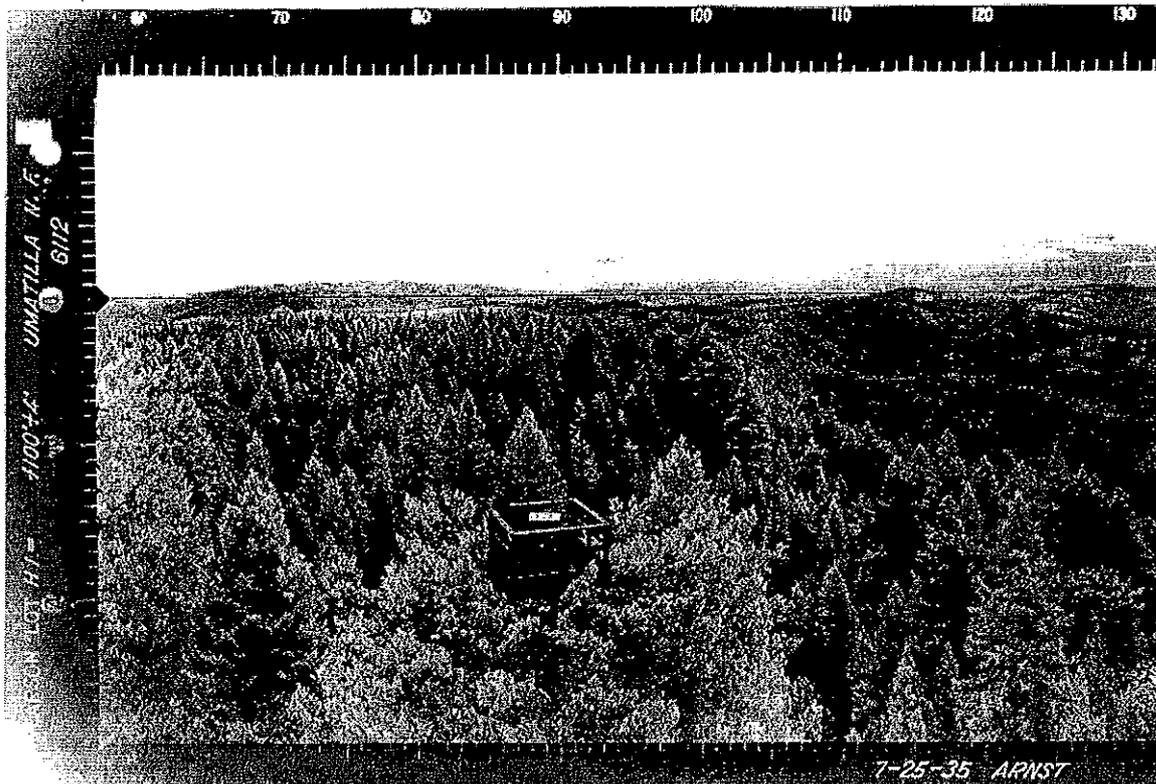
Figure 2. Pearson Ridge crow's nest lookout viewed from the newer lookout. Source: National Archives, Pacific Northwest Region, USFS Records, portion of panoramic photo taken at Pearson Ridge Lookout, ESE view, 7/25/35; copy from *Osborne Panoramic Images of Eastern Oregon*, CD-ROM (Portland, OR: IamWho Panoramic Imaging, 1999).

One of the values of the panoramic photos today is the information about the lookout structure and associated cultural features such as buildings that sometimes appear in the photos (as shown in Figure 2). Each photo also has the name of the lookout station, date of photo, photographer’s name, height photo was taken from (i.e. the height of the lookout structure plus height of transit, though errors have been noted), and whether the lookout was a tower or a ground house. A great deal of new information about the Umatilla lookouts was found from these photos. The table in Appendix A, which lists all known lookouts on what is now the Umatilla NF, includes information on which lookout stations had panoramic photos taken from them.

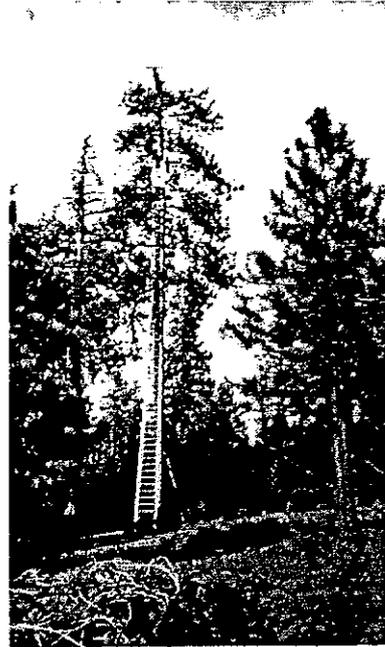
Hoodoo Tower

Figure 3. Hoodoo Ridge crow’s nest lookout, date unknown. Source: USFS Umatilla National Forest archives.

As mentioned earlier, the first lookout stations were just high points that had good views of the surrounding area. As early fire detection became more crucial to suppressing fires, these lookout points became more permanent stations with accommodations that made the observer more comfortable and the viewing area more expansive. For locations that did not have full viewing areas because of trees, the lookout would climb a tree for a better view. When climbing up and hanging on to the tree trunk became a nuisance, the resourceful lookouts started building steps or ladders up the trunk. Some trees even had all the branches removed to avoid rubbing against them. Trees that were topped and had a platform built on top, usually with a safety railing, were called “crow’s nests.” The Umatilla had its share of crow’s nests including the one at Pearson Ridge captured in the panoramic photo taken in 1935 (Figure 2), the one at Hoodoo Ridge (Figure 3) and another at Summit Ranger Station (Figure 4).

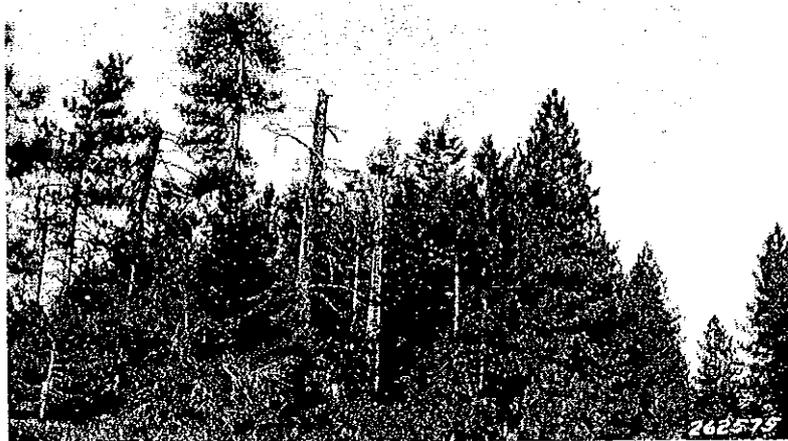
Figure 4. “Summit Tree Tower,” 30 December 1931. J. F. Irwin, photographer, USFS Photo #262575. Source: USFS, Umatilla National Forest archives.

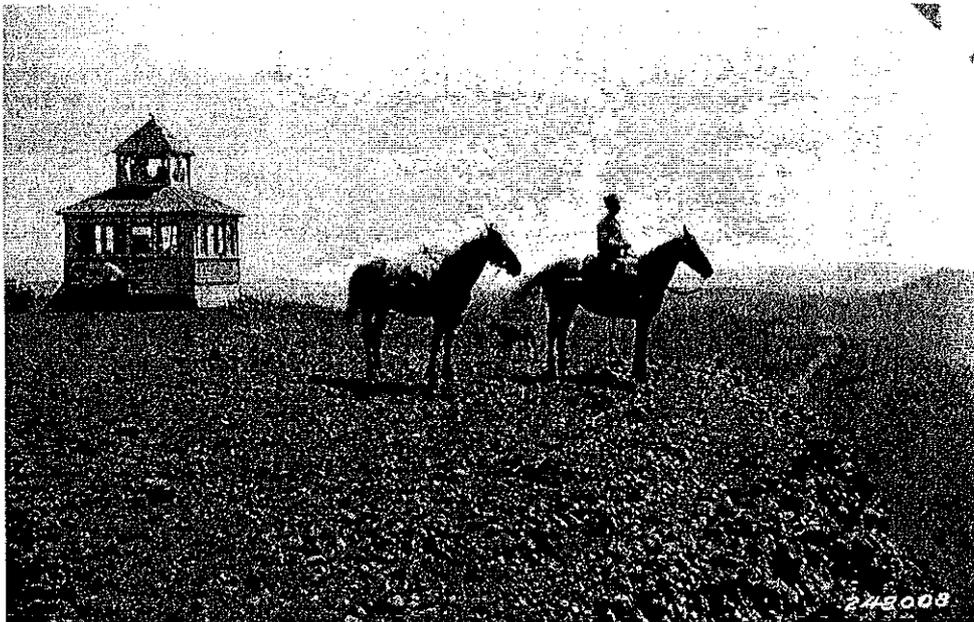
Figure 5. Table Rock D-6 Cupola Lookout, July 1930. F. W. Cleator, photographer, USFS Photo #248008. Photo of copy located at Table Rock Lookout taken by author, 30 August 2001.

Soon the lookouts were building structures that protected them from the variable weather conditions that high elevations in the mountains could present even during the summer. In the Northwest, the first standardized lookout structure with living quarters was what later would be called the D-6 Cupola (because it was designed in District 6). The prototype was designed by Elijah "Lige" Coalman for use on top of Mt. Hood. In 1915, Coalman, known as the "Man of the Mountain" because he eventually climbed Mt. Hood 586 times, applied for a position as "fire watch" on Mt. Hood, if such a position was ever created. The forest supervisor took him up on his offer on an experimental basis. After five weeks of living in a tent at the top of the 11,239-foot mountain, he designed plans for the cupola and submitted them to the supervisor. Four days later, pack mules were headed up the mountain carrying 4,000 pounds of materials. The loads had to be carried by men up the last stretch to the summit. The D-6 cupola was a 12' x 12' framed building with a 6' x 6' glassed-in, pyramidal-hipped roof cupola centered on top of the truncated pyramidal-hipped roof first story. The first floor was the living quarters; the cupola, set up with a firefinder, was the observatory. All the windows had shutters for when the lookout house was not in use. Both roofs were covered with cedar shingles. Coalman's cupola was staffed until 1935, and survived until 1941 when it toppled over and fell into a deep crevasse (Kressek 1998:11, 25-6; Sinclair 1991:18).

These lookout houses were designed to rest on the ground rather than on towers like later models. At least four "cupola" lookouts were built on the Umatilla, reportedly as late as 1936, including at Table Rock, which was built in 1929 (Figure 5). Unfortunately, none of these cupolas survive on the Umatilla.

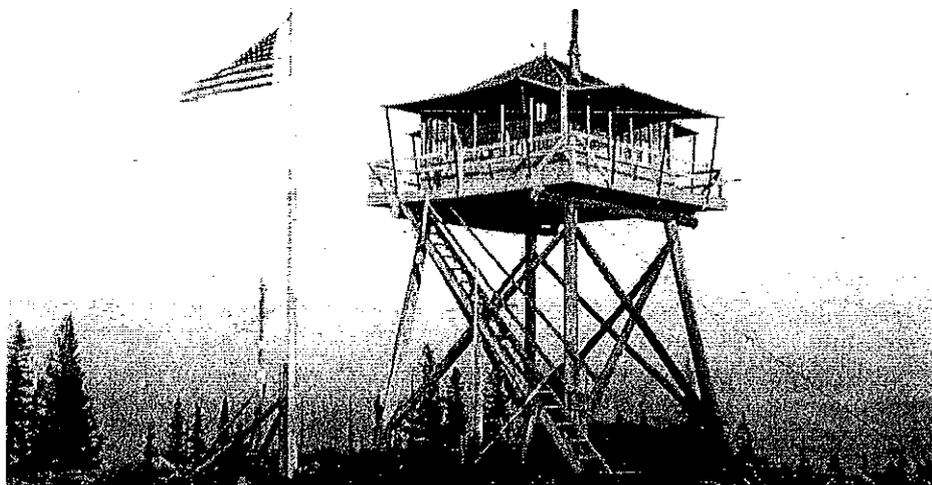
Figure 7. Saddle Butte Lookout, L-4 1932 version, unknown date.
Source: USFS, Umatilla National Forest archives.

1932 Version. By 1932 the plans were revised to a hipped roof version that provided greater structural stability under snow loads. Struts were still used to hold up the shutters. The windows may have also been changed at this time to have only four-light sashes, which provided better visibility and easier cleaning. By 1935, specifications referred to the window design as “four light barn sash, 1 3/8” thick.” According to Kresek, this popular version of the L-4 was built until 1953 (1998:11). Only four lookouts on the Umatilla NF were documented as 1932 versions – Griffin Peak (1933), High Ridge (1932), McIntyre Point (1932), and Saddle Butte (1932, Figure 7). Another may have been at Ant Hill (1935). None of these lookouts remain on the Umatilla National Forest.

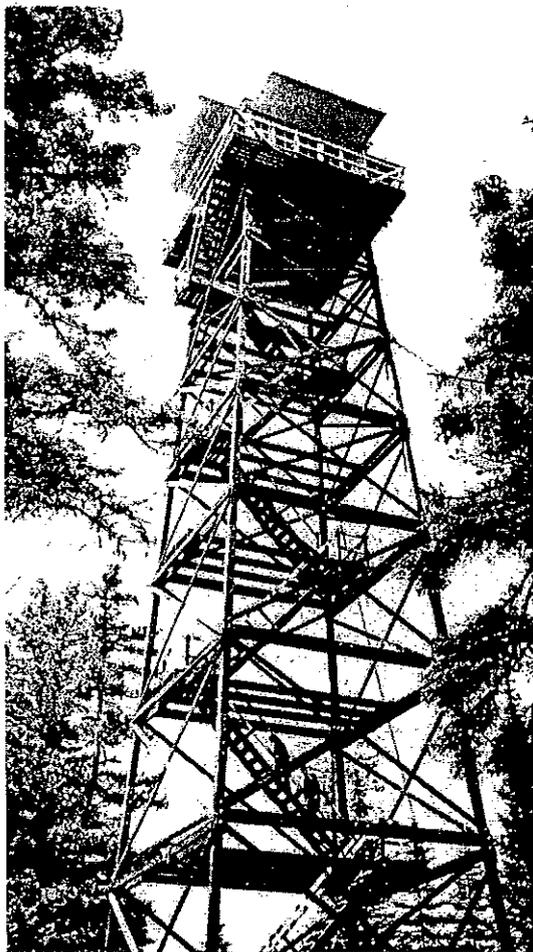
Figure 8. Big Butte “R-6 Standard 1936 L-4 Lookout,” 1959. Source: USFS Umatilla National Forest archives.

This very common style of lookout house was also built until about 1953 (Kresek 1998:11). On the Umatilla NF as many as thirteen Standard 1936 L-4s may have been built. Three lookout cabs of this style survive – Lookout Mountain (1949), Table Rock (1949), and Big Butte (1950). Lookout Mountain and Big Butte (Figure 8) are on towers; Table Rock, which has been heavily modified, sets on a 1-story concrete foundation that serves as a storage room.

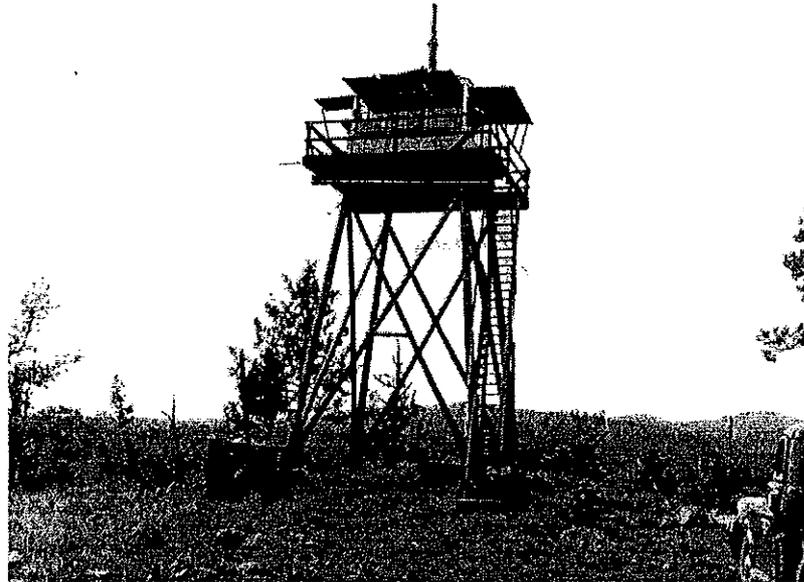
Figure 9. Red Hill Lookout, a possible L-5 cab, 24 June 1953, by C. M. Rector. Source: USFS, Umatilla National Forest, South Zone archives.

(by 1932), both on the Heppner RD, are believed to have been built on the Umatilla NF (from photo identification). Based on Red Hill's photo (Figure 9), the 10' x 10' can be assumed as it has only three window sashes of four lights each on each façade (assuming all sides are the same, except the door). Each sash had its own shutter, propped up by struts mounted on the catwalk railing. The roof appears to have been a hip roof. If not an L-5, Red Hill L.O. may have also been a variation of an L-6 or an individualized plan. This lookout structure was abandoned in 1957.

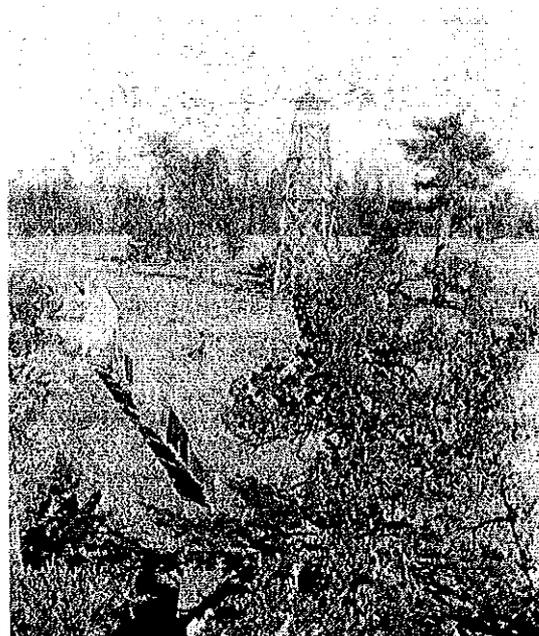
Figure 10. Wheeler Point Lookout with house and outhouse (foreground), 1932. Source: USFS, Umatilla National Forest archives.

Wheeler Point Lookout (Figure 10) may be another variation of an L-5 or L-6 cab, or its own unique design. Its cab style varies from Red Hill's in that it does not have a catwalk or shutters; the windows appear to be smaller in height; and the roof may have a steeper pitch. It also does not exactly match either the L-5 or L-6 plans (both dated 1932) that are owned by Ray Kresek. This Wheeler Point lookout tower was replaced in 1959 by an R-6 Flat cab on a 67-foot treated-timber (TT) tower (see Figure 13), which was torn down ca. 1983.

No historic records could be found for the outhouses at the lookout sites, yet they do appear to have been at some of the lookouts as early as 1932, such as at Wheeler Point (Figure 10), and another captured in 1935 in a panoramic photo at Silver Butte (Figure 19). Without documentation, construction dates could not be determined for certain. The outhouses were probably contemporary with the houses, but were just not mentioned because of their private function. The outhouses at Big Butte and Hoodoo Ridge may be historic (> 50 years old) but without documentation of their construction dates, this cannot be confirmed. Saddle Butte and Bone Point's outhouses are also likely to be over 50 years old, because of their level of deterioration and unique styles. The designs of the outhouses are square or slightly rectangular with various roof forms. Hoodoo Ridge and Big Butte's outhouses both have a front-gabled roof. Bone Point has a shed roof and Saddle Butte has a side gable roof. These four outhouses each have different siding. Big Butte has 7" wide horizontal shiplap siding, Hoodoo has 1-foot high split cedar siding (which may cover earlier shiplap siding), Bone Point has drop siding and Saddle Butte has a board and batten siding. The variation in styles of these four lookouts indicates that these outhouses were built before any standardized plans were developed. They were most likely constructed by whoever built the lookouts or houses and they may have just used leftover materials.

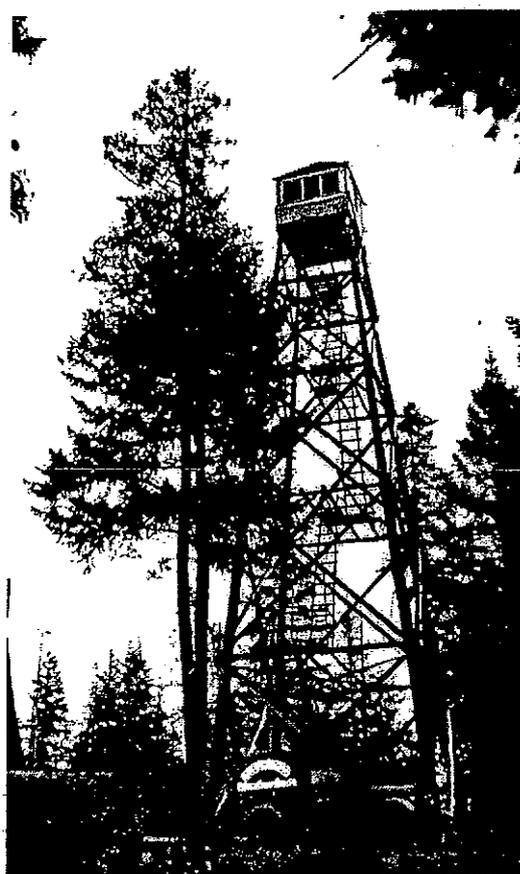
Figure 12. Ukiah RS 7' x 7' Lookout, 1962. At some earlier point in time, a large water tank was placed just under the cab that apparently supplied water to the ranger station compound. Source: USFS, Umatilla National Forest archives.

The Umatilla NF had at least three of these rare 7' x 7' types, at Pearson Ridge (1935), Ukiah Ranger Station (Figure 12, 1939), and Goodman Ridge (1936). Goodman Ridge is the only extant 7' x 7' still standing on the Forest, and it is in very poor condition.

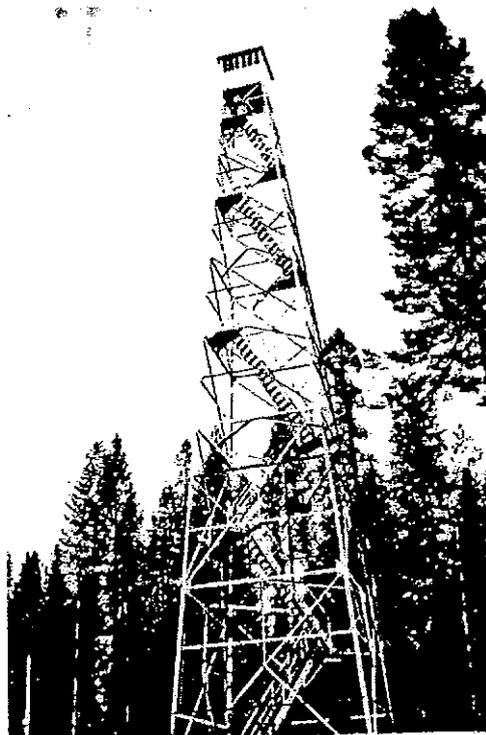
Figure 13. Hoodoo Ridge MC-39 or -40 Aermotor Lookout Tower, date unknown. Source: USFS, Umatilla National Forest, North Zone archives.

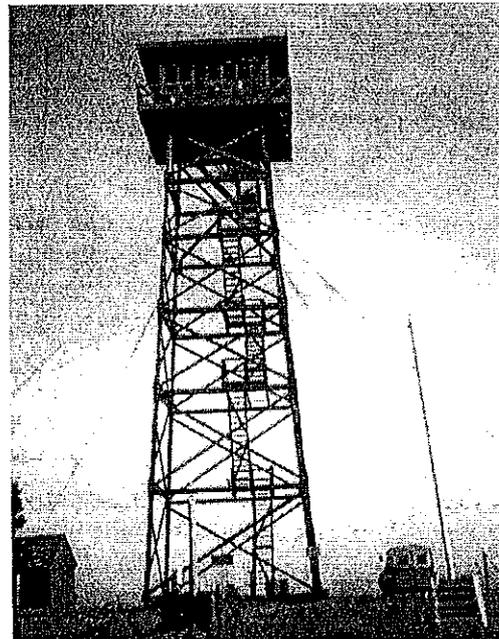
Figure 14. Wheeler Point R-6 Flat Lookout, date unknown (pre-1983). Source: USFS, Umatilla National Forest, South Zone Archives.

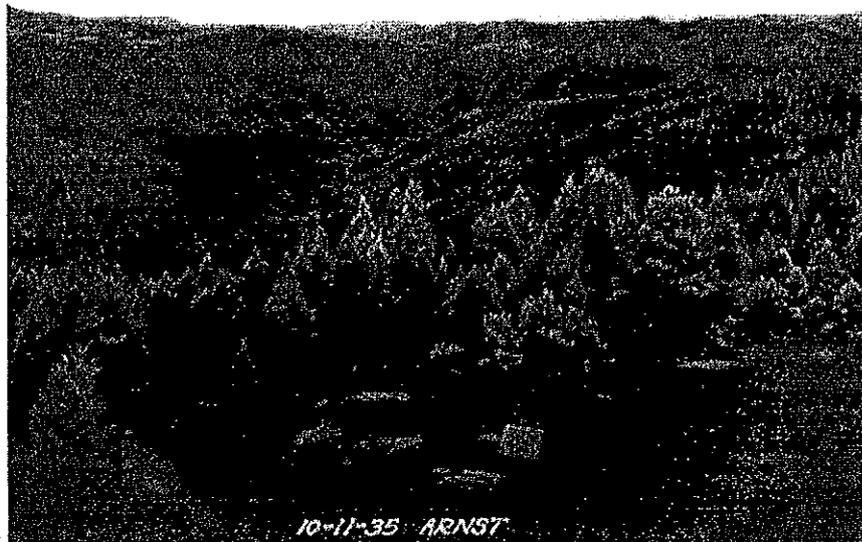
Figure 19. View ESE from Silver Butte Lookout showing outhouse in foreground, 1935. Source: Portion of panoramic photo, *Osborne Panoramic Images of Eastern Oregon*, CD-ROM.

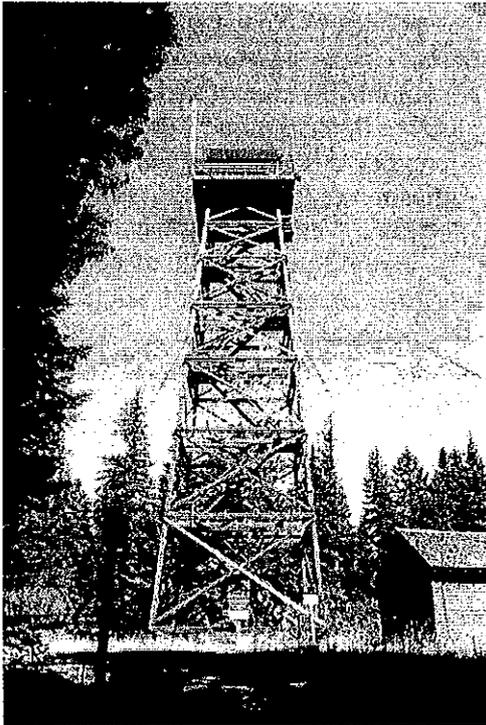
Figure 20. Big Butte Lookout Tower, looking east, 8 August 2001. Photo by author.

Integrity: Very good. The only noticeable alteration, other than possible paint colors, is the shutters. The original full window length shutters have either been modified to fold up in half, or replaced with hinged shutters that fold up in half. A 1959 photo shows full-length shutters, but perhaps the shutters can be hung either full-length or folded. Standard plans up to 1945 only show the full length shutters. Additionally, safety wire has been attached to the inside of the catwalk railing. The lookout falls within the historic period of significance and retains its integrity of location, design, setting, materials, workmanship, feeling, and association with the primary context.

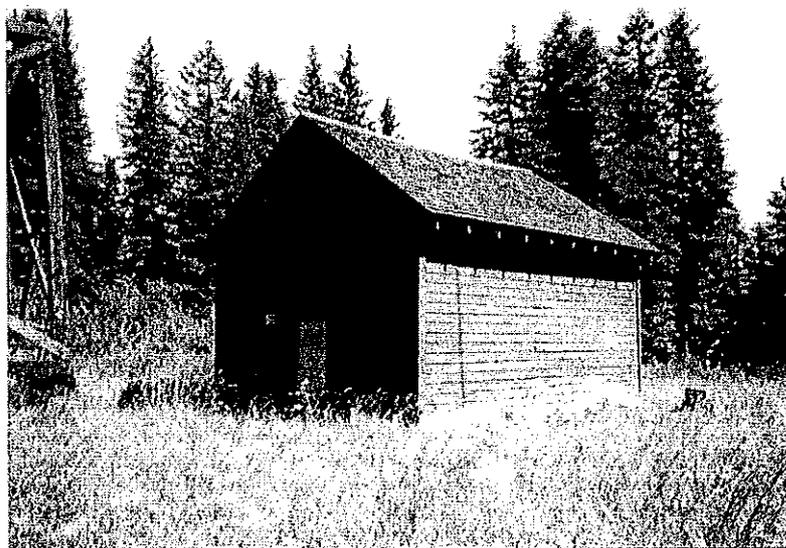
Figure 22. Big Butte Garage, front (north) and west facades, 20 July 2001. Photo by author.

Description: An 18' x 16' gable roof, single garage with additional room for storage. The exterior siding is horizontal 1"x6" single "V" rustic siding. Wood shingles cover the roof. At an unknown date, the garage was converted to a storage building by filling in the large door opening and changing to a standard door opening with a sliding door on the interior. The new siding filling in where the garage door was is the same style and width as the other siding, but can be differentiated because of its newer appearance and because the exterior garage door trim is still present around the original opening.

The construction date is estimated as a ground house was built in 1930 to provide housing for a lookout tower with an L-6 or 7x7' cab built in 1929. The garage is shown in an undated photo of the earlier tower so it had to have been built before 1950 when the newer tower was built. The 1" x 6" single "V" rustic siding was available on the district at least as early as 1931, as the L-4 Oregon Butte L.O. used that type of siding that year.

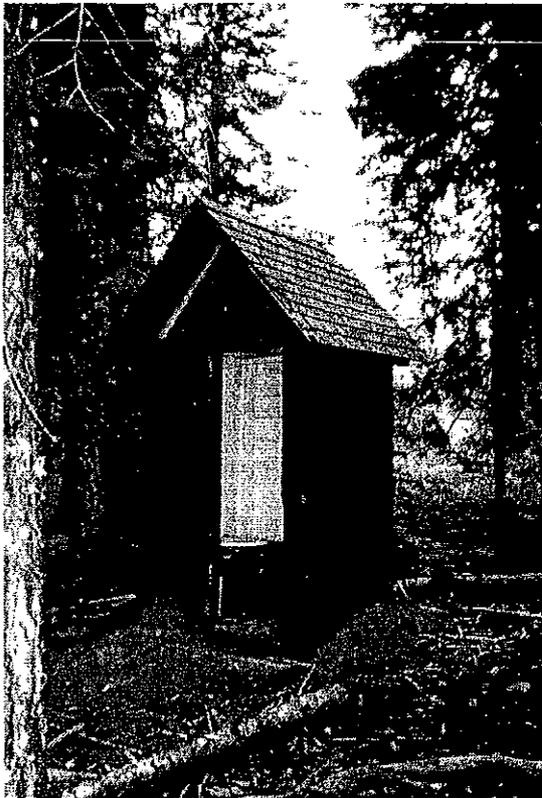
Figure 23. Big Butte Outhouse, north and west facades, 20 July 2001. Photo by author.

Integrity: Good. No significant alterations are apparent.

NRHP Eligibility: Potentially eligible under Criterion A.

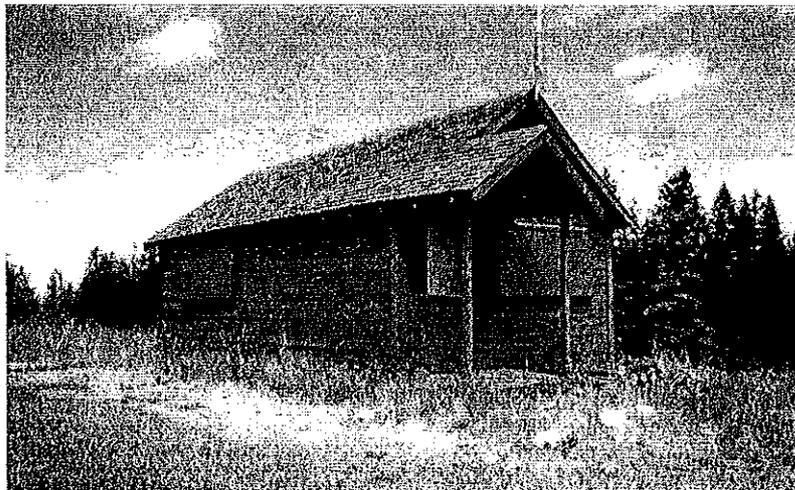
Figure 26. Clearwater House, south and east (front) facades, 20 July 2001. Photo by author.

Integrity: Without a historic photo, the original condition cannot be determined with certainty. However, the aluminum frame windows with plywood shutters, the front hollow core door and possibly the two porch posts appear to be modern. The house was most likely built during the historic period of significance and despite some modifications to the design and materials it still retains its integrity of location, setting, workmanship, feeling, and association with the primary context.

NRHP Eligibility: **Eligible under Criterion A.**

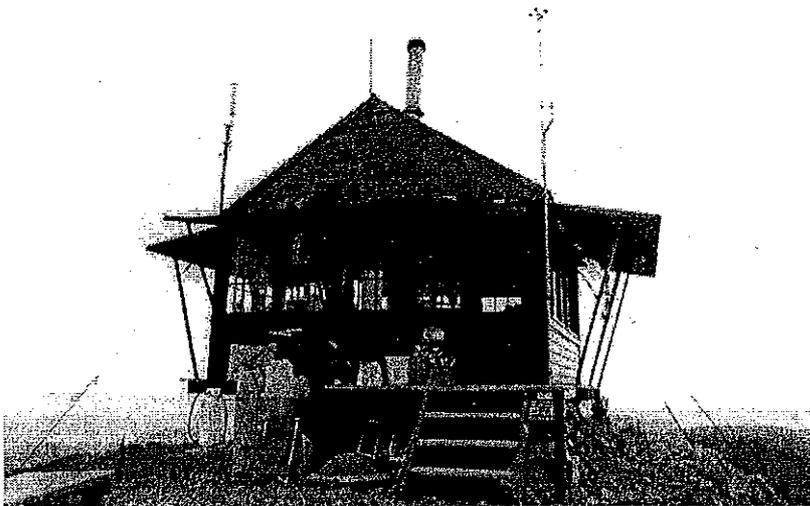
Figure 29. Oregon Butte Lookout, north façade, 13 September 2001. Photo by author.

Integrity: Good. It is the only surviving gable roofed L-4 lookout on the Umatilla National Forest and only one east of the Cascade Mountains in Washington or Oregon. It is also the oldest surviving lookout on the Umatilla NF.

NRHP Eligible: The Oregon Butte Lookout was previously determined eligible in 1994.

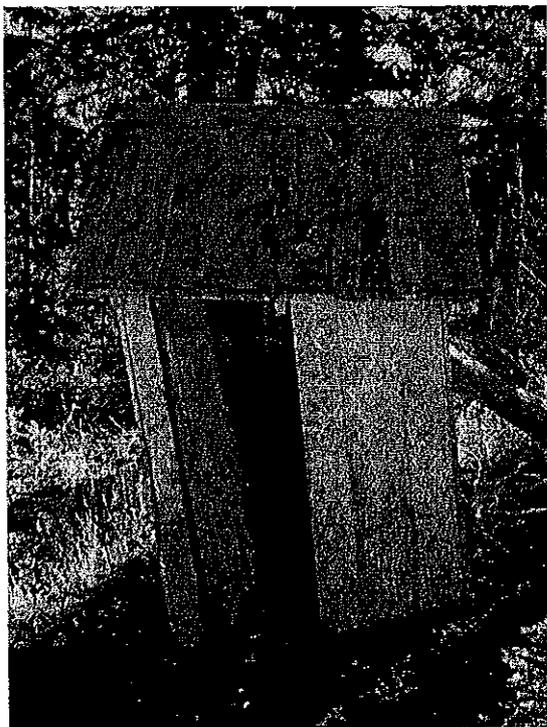
Figure 31. Saddle Butte Outhouse, north-northeast (front) façade, 8 October 2002. Photo by Jill Bassett.

Integrity: Good. No alterations are apparent.

NRHP Eligibility: **Not eligible due to loss of integrity of the setting.**

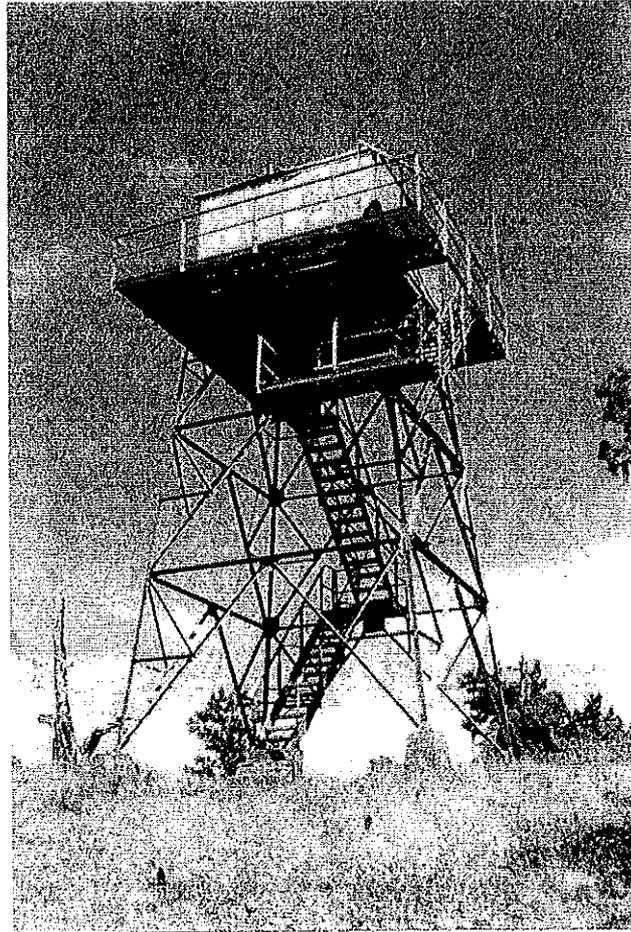
Description: A 14' x 14' hip roofed, steel-clad, live-in house on top of a 40' steel tower. The lookout, which had been staffed by the Oregon Dept. of Forestry, is no longer used.

Figure 33. Bone Point Lookout,
looking east-northeast, 5 July 2001.
Photo by author.

NRHP Eligibility: Not eligible.

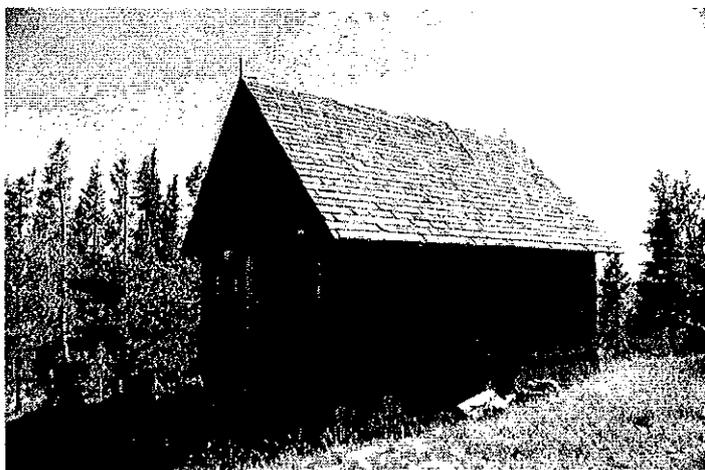
Figure 36 (above). Desolation Butte Garage, front (east) and north facades, 5 August 2001. Photo by author.

The building is in poor condition and evidently has not been used for quite some time.

Description: The garage/storage building is 18' 3" x 14' 4". Wooden shakes cover the gabled roof. The siding is split cedar, 16 1/2" exposed to the weather. This cedar siding, of which some is missing, covers the original single V rustic siding. In the gabled ends, the siding is flat vertical boards with dog-eared clipped corners. On the west façade, are two symmetrically placed, six-light fixed windows measuring 40" high x 22 1/2" wide (most glass is missing). Both the garage door and the exterior door to the storage room are covered with single V rustic siding laid vertically. The foundation is poured concrete. On the south side the concrete was poured on top of a few layers of flat rocks. Inside the storage room is divided from the garage area by a single wall running east-west with the gable. A door near the front (east side) of the garage is again covered with vertically-laid single V rustic siding. The garage interior walls are unfinished with 2"x4" studs. The storage room walls, floor and ceiling are covered with a mix of finishes. The ceiling and west and east walls are covered with 3 1/4" wide double grooved boards; the north wall is covered with 7" wide boards; and the south wall is covered with single 3 1/4" boards. The floor is finished with 4" tongue and groove boards. A small bench extends across the west wall of the storage room.

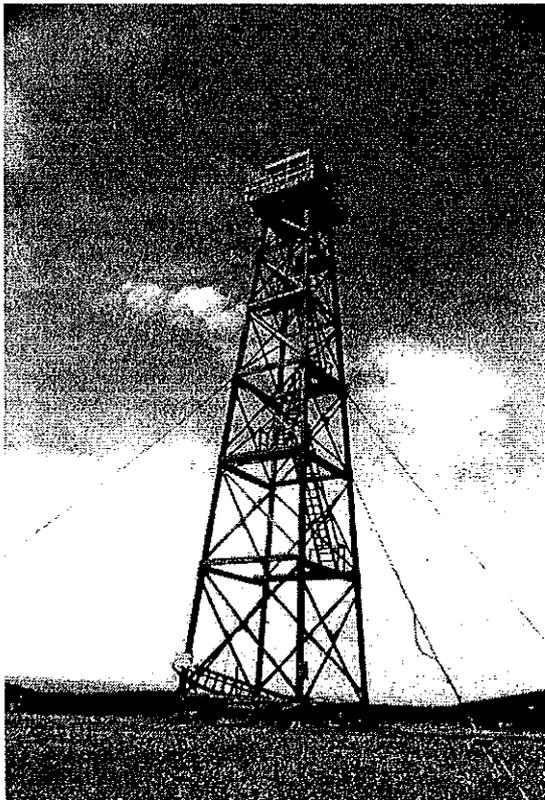
Figure 40 (left). Goodman Ridge Lookout Tower, looking southwest, 1 August 2001. Photo by author.

Integrity: Good. Despite the poor condition, enough of the original design and materials are present. If funding was available, although unlikely, it could be restored to its original condition. The Goodman Ridge Lookout Tower falls within the historic period of significance and retains its integrity of location, design, setting, materials, workmanship, feeling, and association with both historic contexts.

NRHP Eligibility: **Eligible under Criteria A and C.**

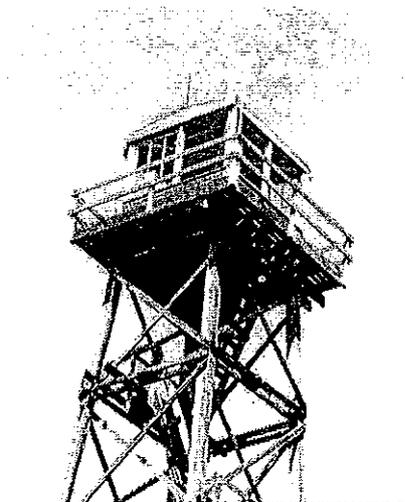
Figure 41 (below). Close-up of Goodman Ridge Lookout cab, south and east facades, 1 August 2001. Photo by author.

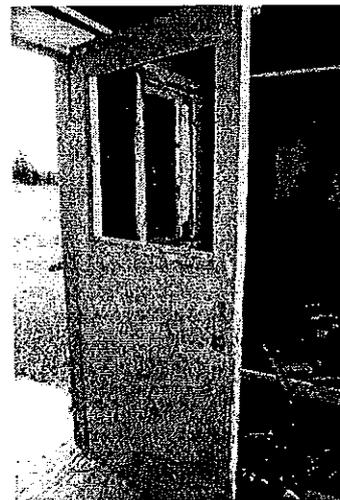
Figure 43 (right). Goodman Ridge House Door, 1 August 2001. Photo by author.

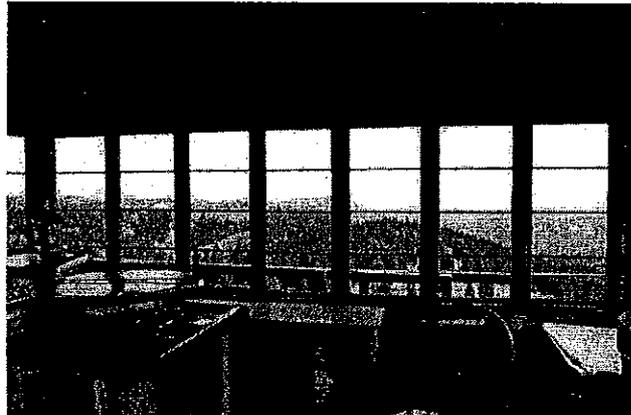
Figure 45. High Ridge Lookout, interior south wall, 1 August 2001. Photo by author.

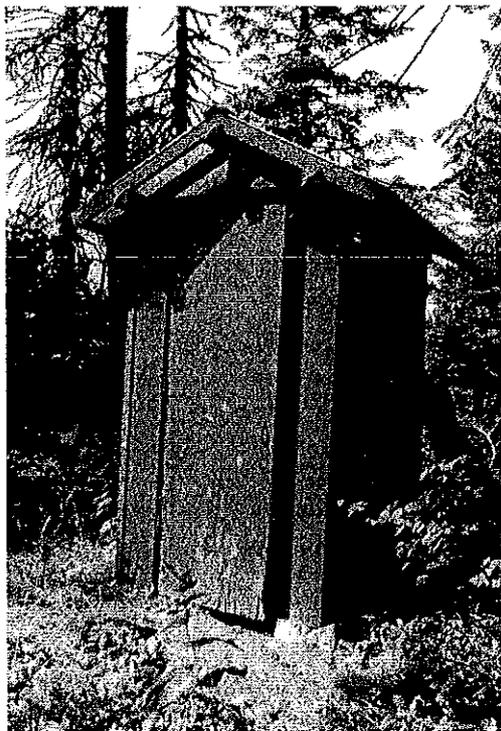
Figure 46. High Ridge Outhouse, front (south) and east facades, 1 August 2001. Photo by author.

Construction Date: Modern

NRHP Eligibility: Not eligible.

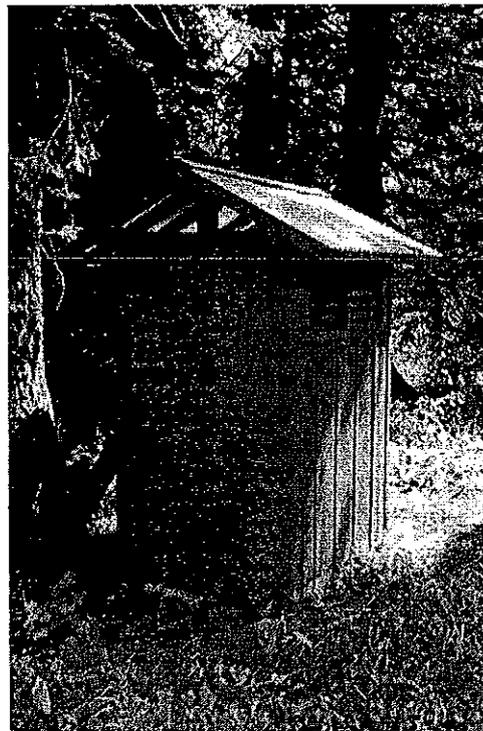
Figure 47. High Ridge Outhouse, north and west facades, 1 August 2001. Photo by author.

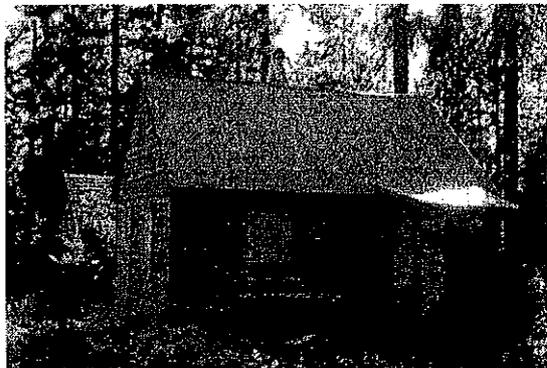
Figure 49. Hoodoo Ridge Cabin, east and north (front) facades, 8 October 2000. Photo by author.

Integrity: Good. Other than the metal roof, no other major alterations were noted. The Hoodoo Ridge Cabin falls within the historic period of significance and retains its integrity of location, design, setting, materials, workmanship, feeling, and association with both contexts.

NRHP Eligibility: **Eligible under Criteria A and C.**

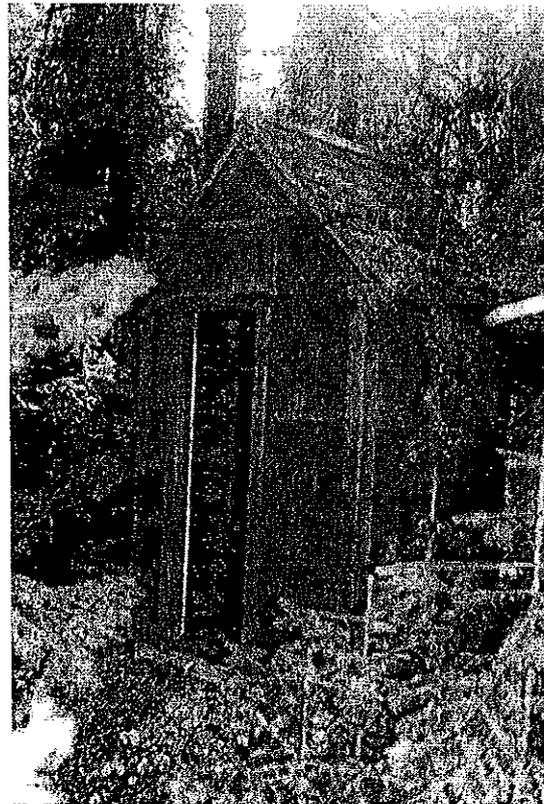
Figure 52. Hoodoo Ridge Outhouse, east (front) and north facades, 8 October 2000. Photo by author.

Integrity: Very good. All materials are present. The split cedar siding may be historic which would not compromise the building's integrity. The outhouse may have been constructed by the CCC with the other structures which, if this is confirmed, would make the building associated with both contexts.

NRHP Eligible: Potentially eligible under Criterion A and C.

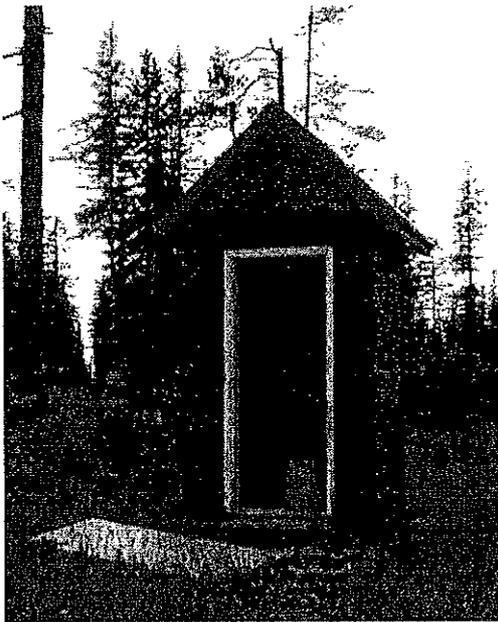
Figure 54. Lookout Mountain Outhouse. Photo courtesy Jane Stuessy.

Construction Date: Modern

NRHP Eligibility: Not eligible.

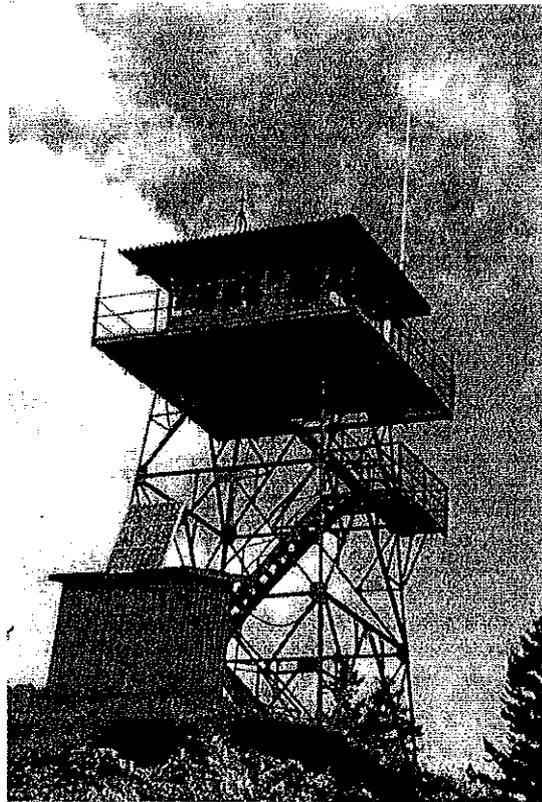
Figure 56. Madison Butte Lookout Tower and Radio Building, looking NNW, 22 July 2001. Photo by author.

Construction Date: Modern

NRHP Eligibility: **Not eligible.**

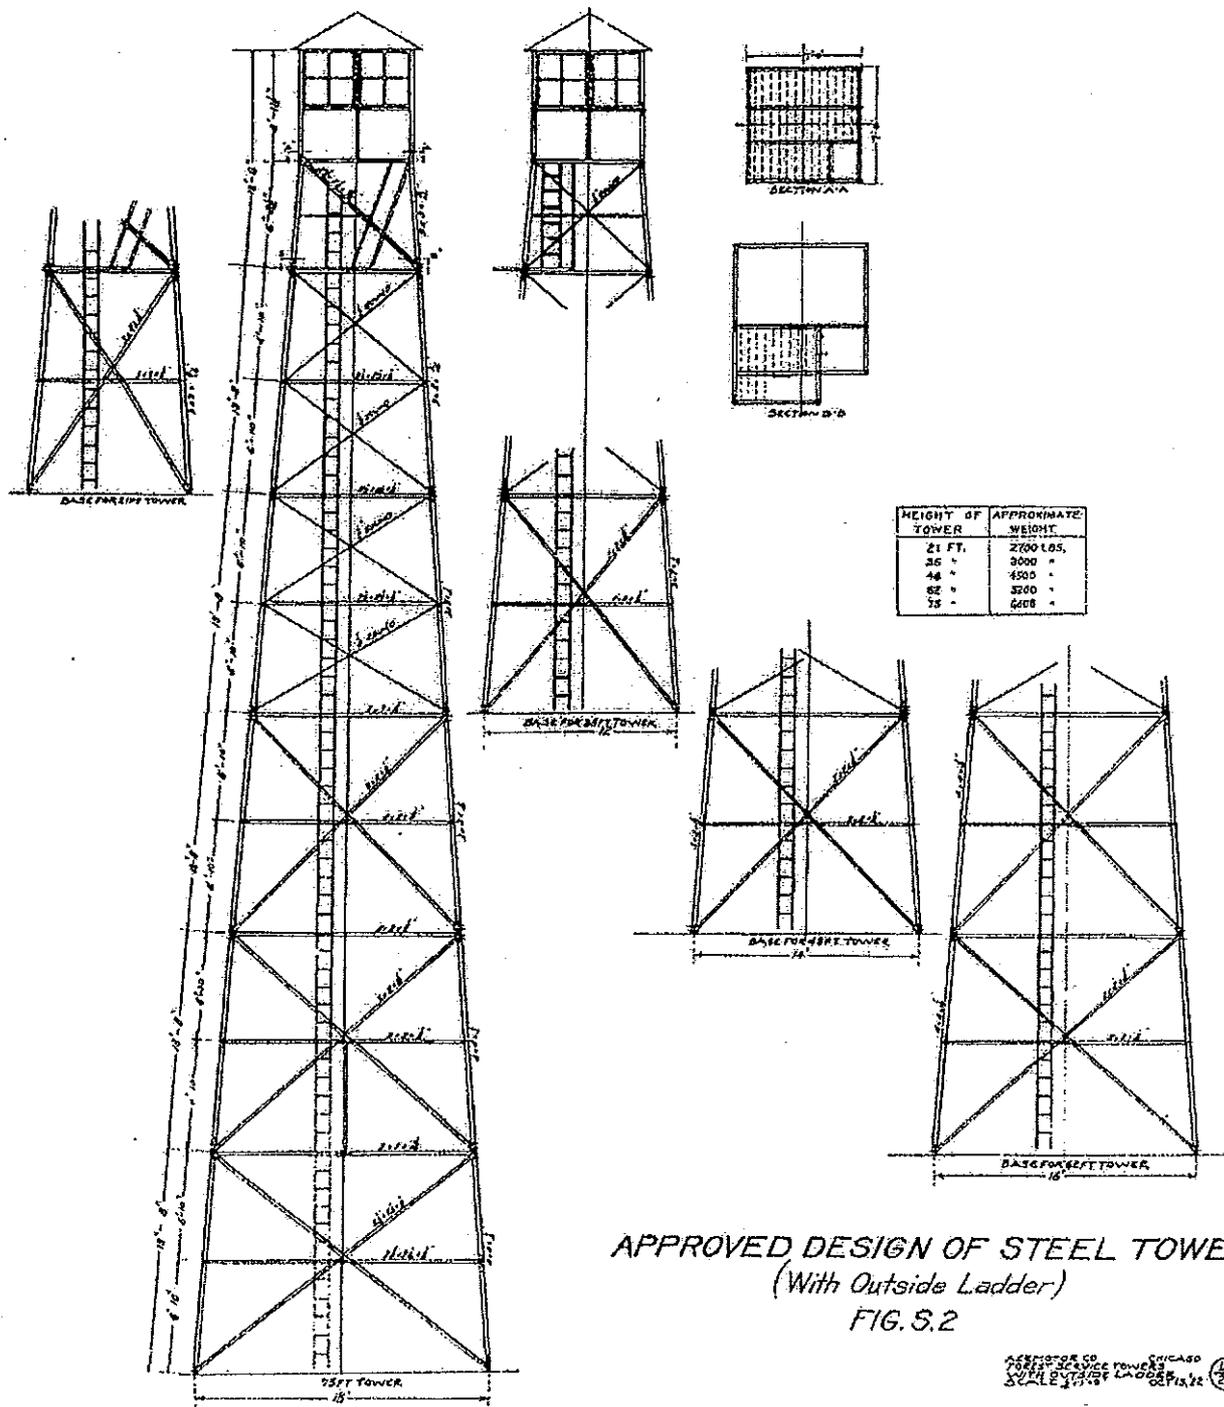
APPROVED DESIGN OF STEEL TOWER
 (With Outside Ladder)
 FIG. S.2

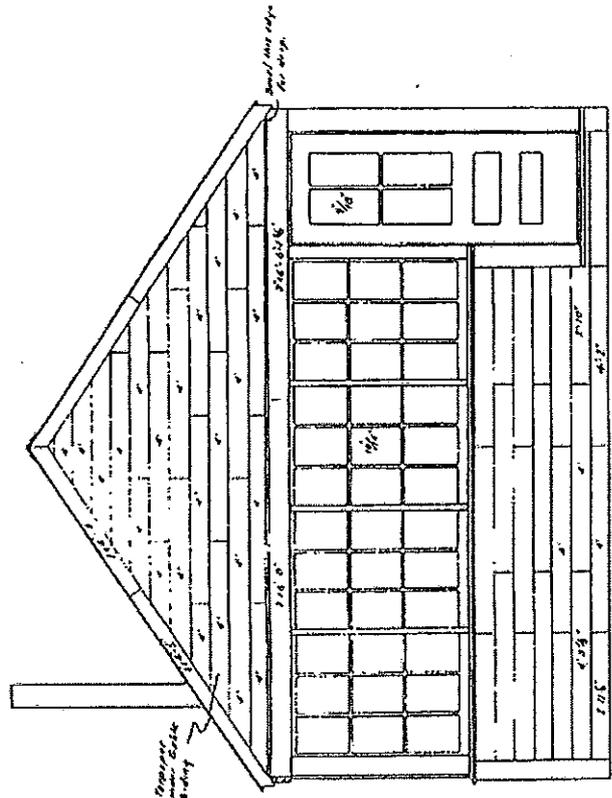
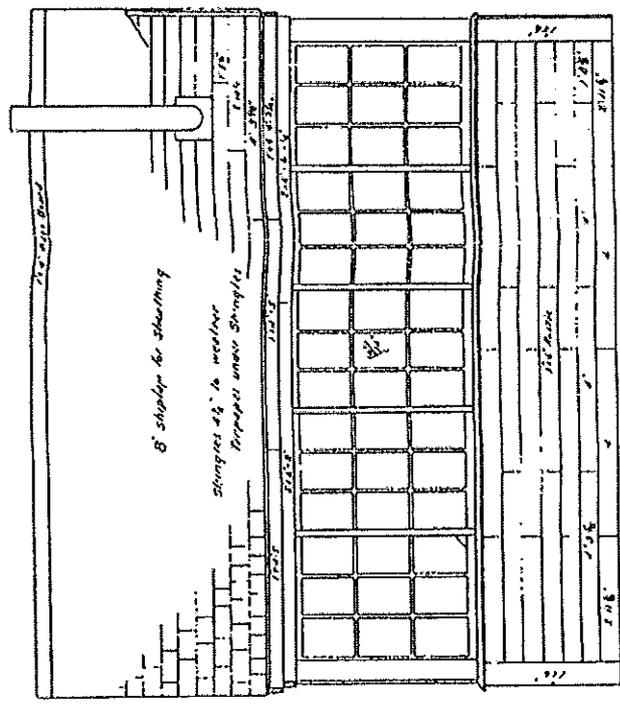
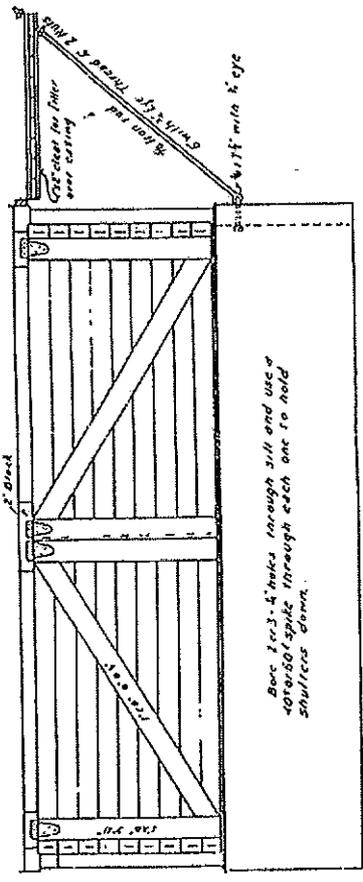
Portion of "Lookout House Plan L-4,"
 1931 Revision, Sheet 2 of 5. Source:
 Courtesy of Charles and Beverly Heebner.

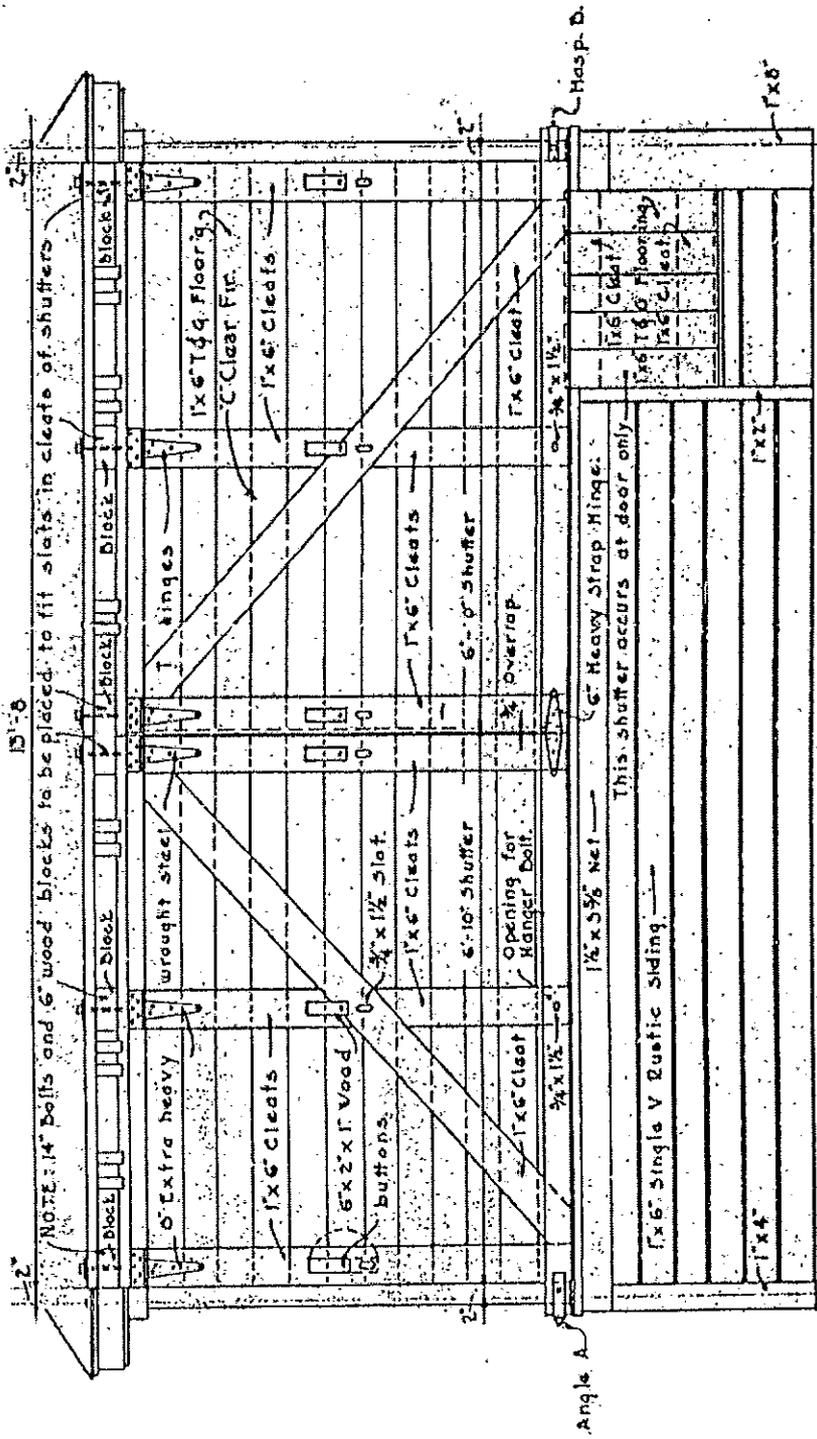
ELEVATION OF TYPICAL SHUTTER
