# Repair of Embankment Dams with Seepage Problems

Oregon Dam Safety Conference, 2013

E. George Robison, Ph.D, PE, D.WRE

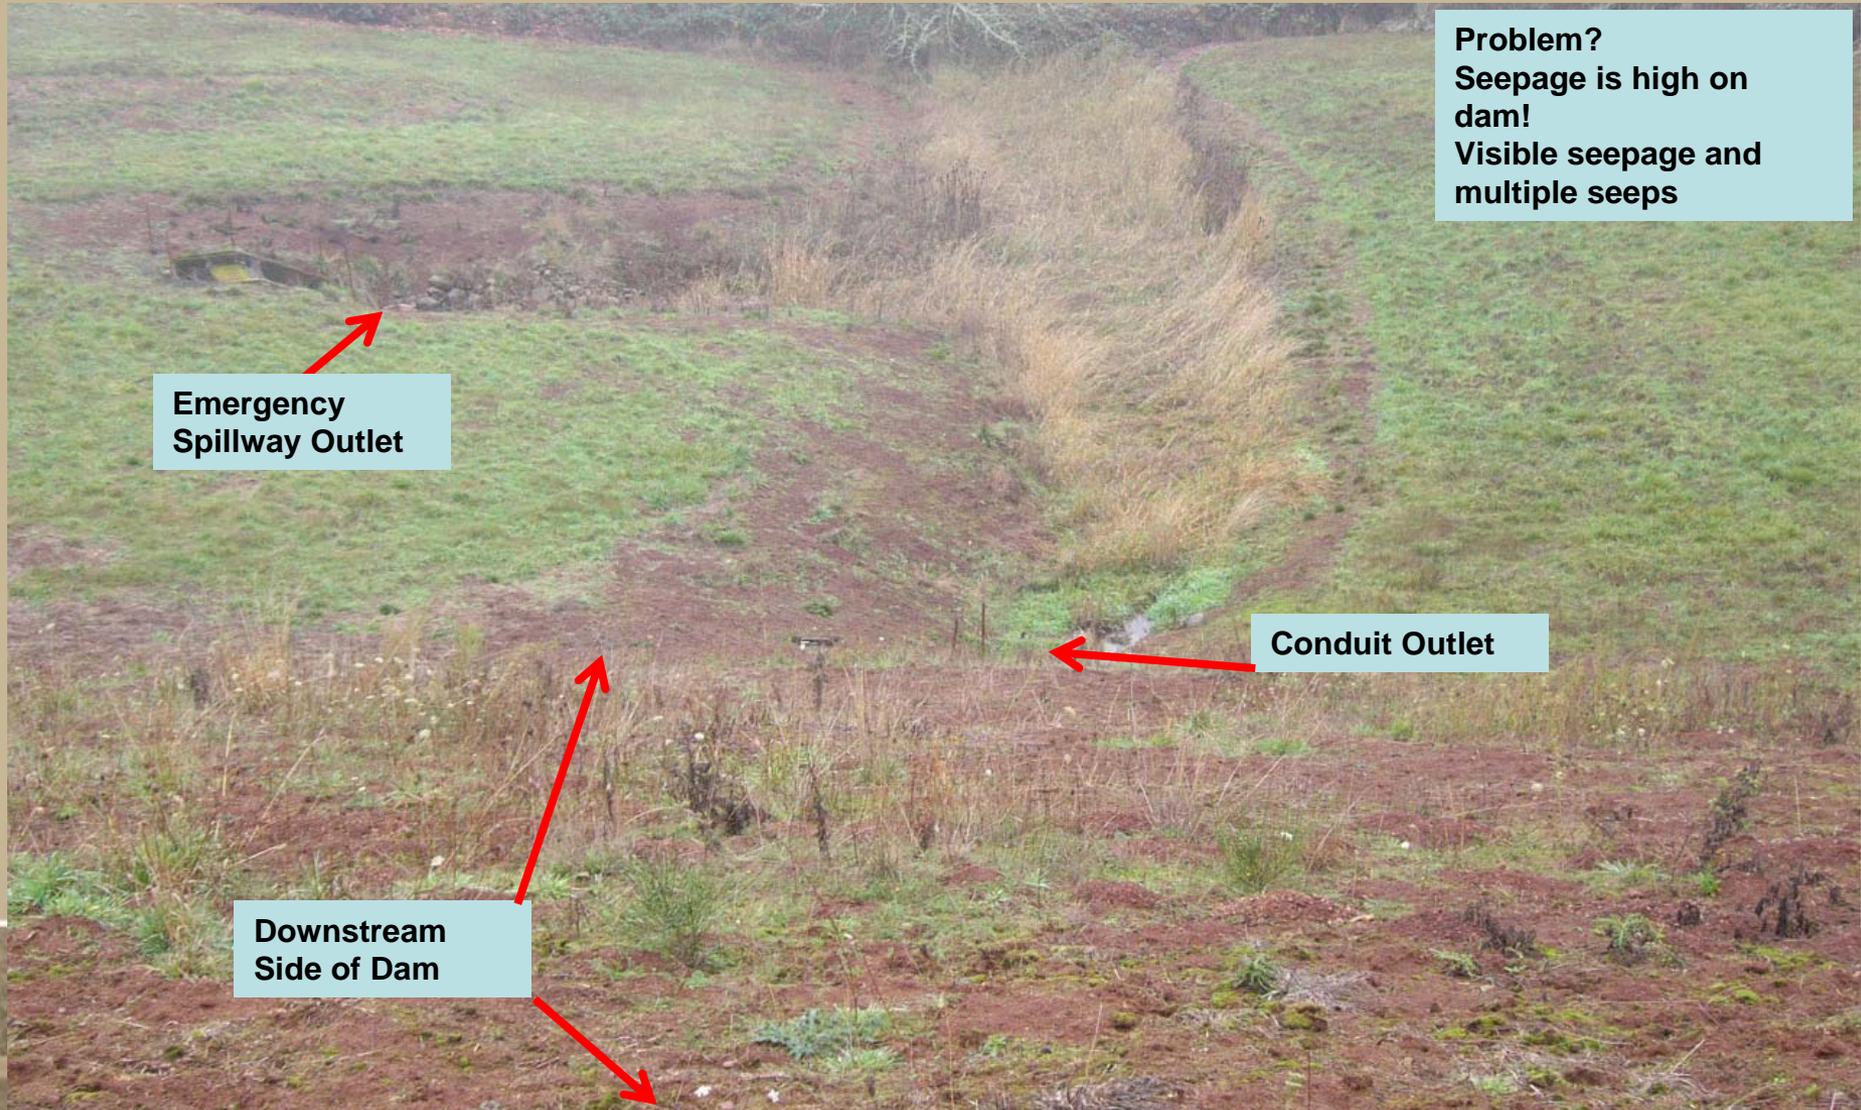
# Croft Reservoir – Problem Detection

**Line of water seepage about 2/3 up the dam**

- Center Dam Solutions are best for high on the dam seepage issues (Croft Dam) or very small dams (Akutan) and less effective or feasible for deep seepage at base or in foundation of taller dams.

- Seepage Detection and Discernment
  - Visual detection of flowing or seeping water or vegetation changes on dam or near toe or even downstream (for foundation seepage) (Can be missed – Croft Dam?)

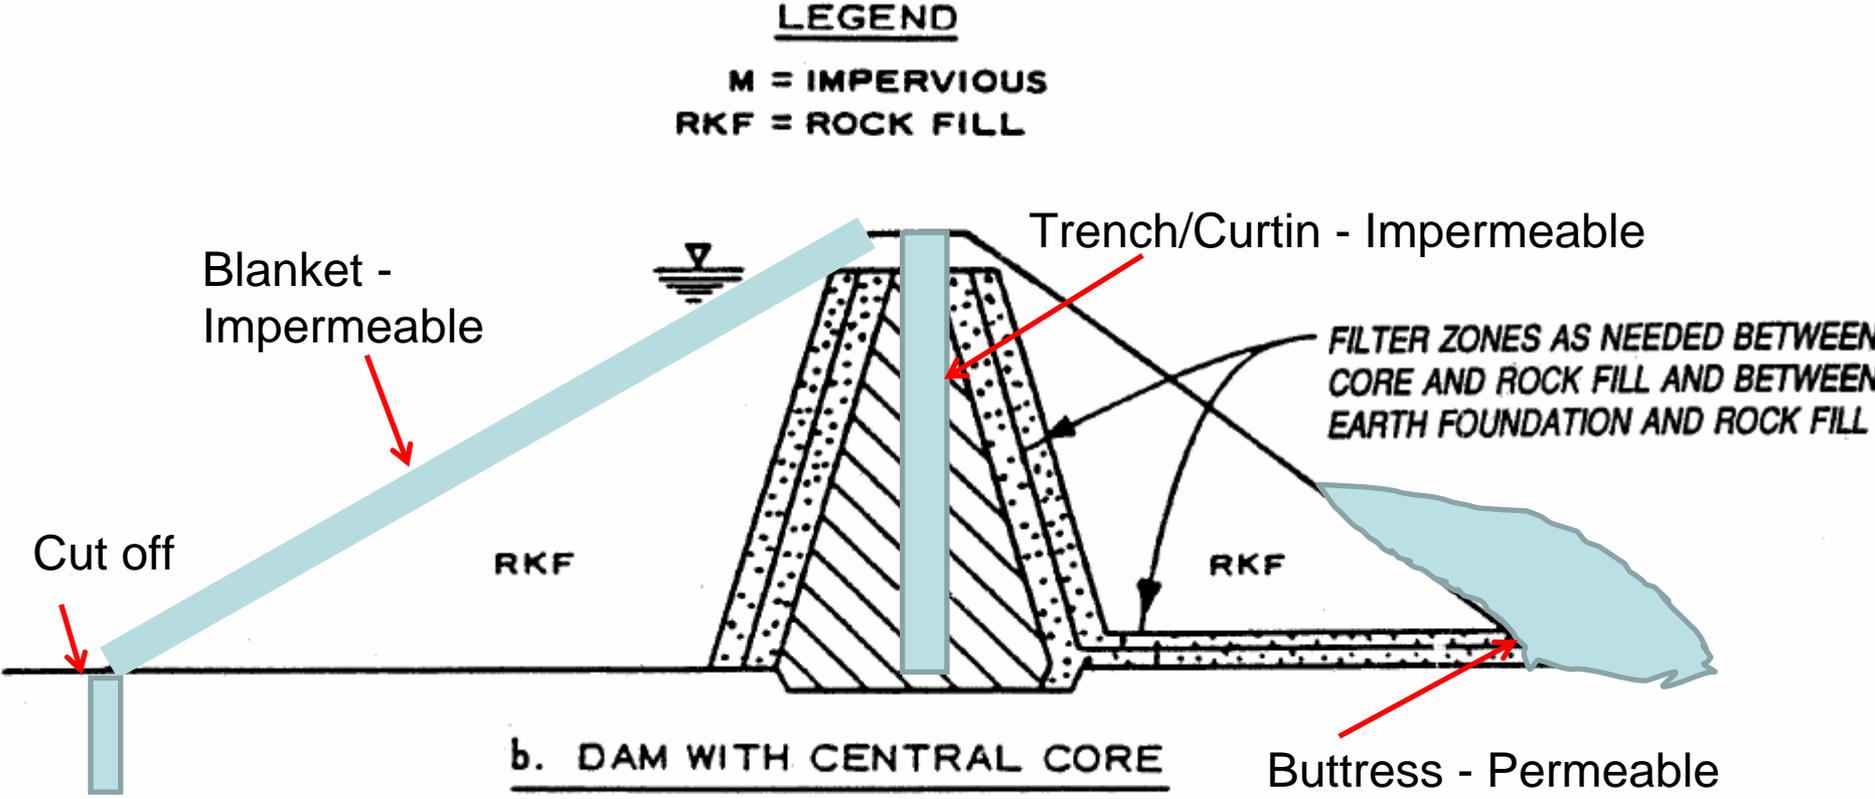
# Possible Fixes

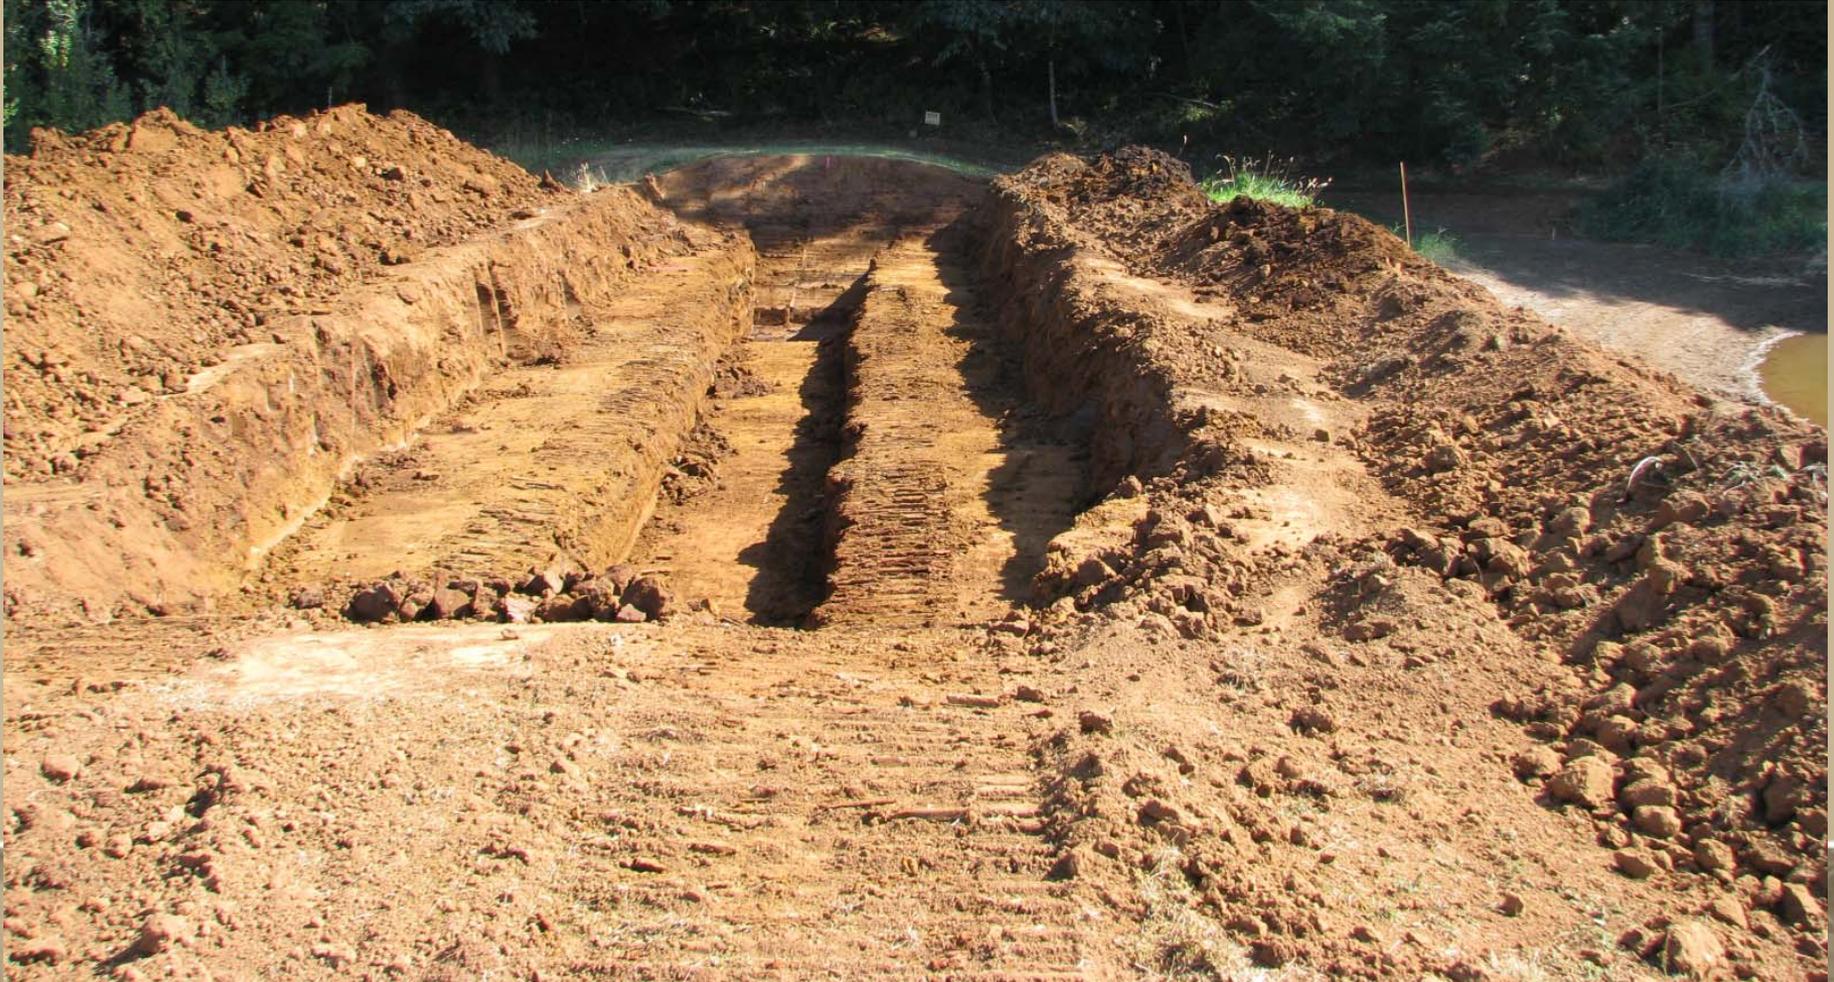
# Center Trench and fill

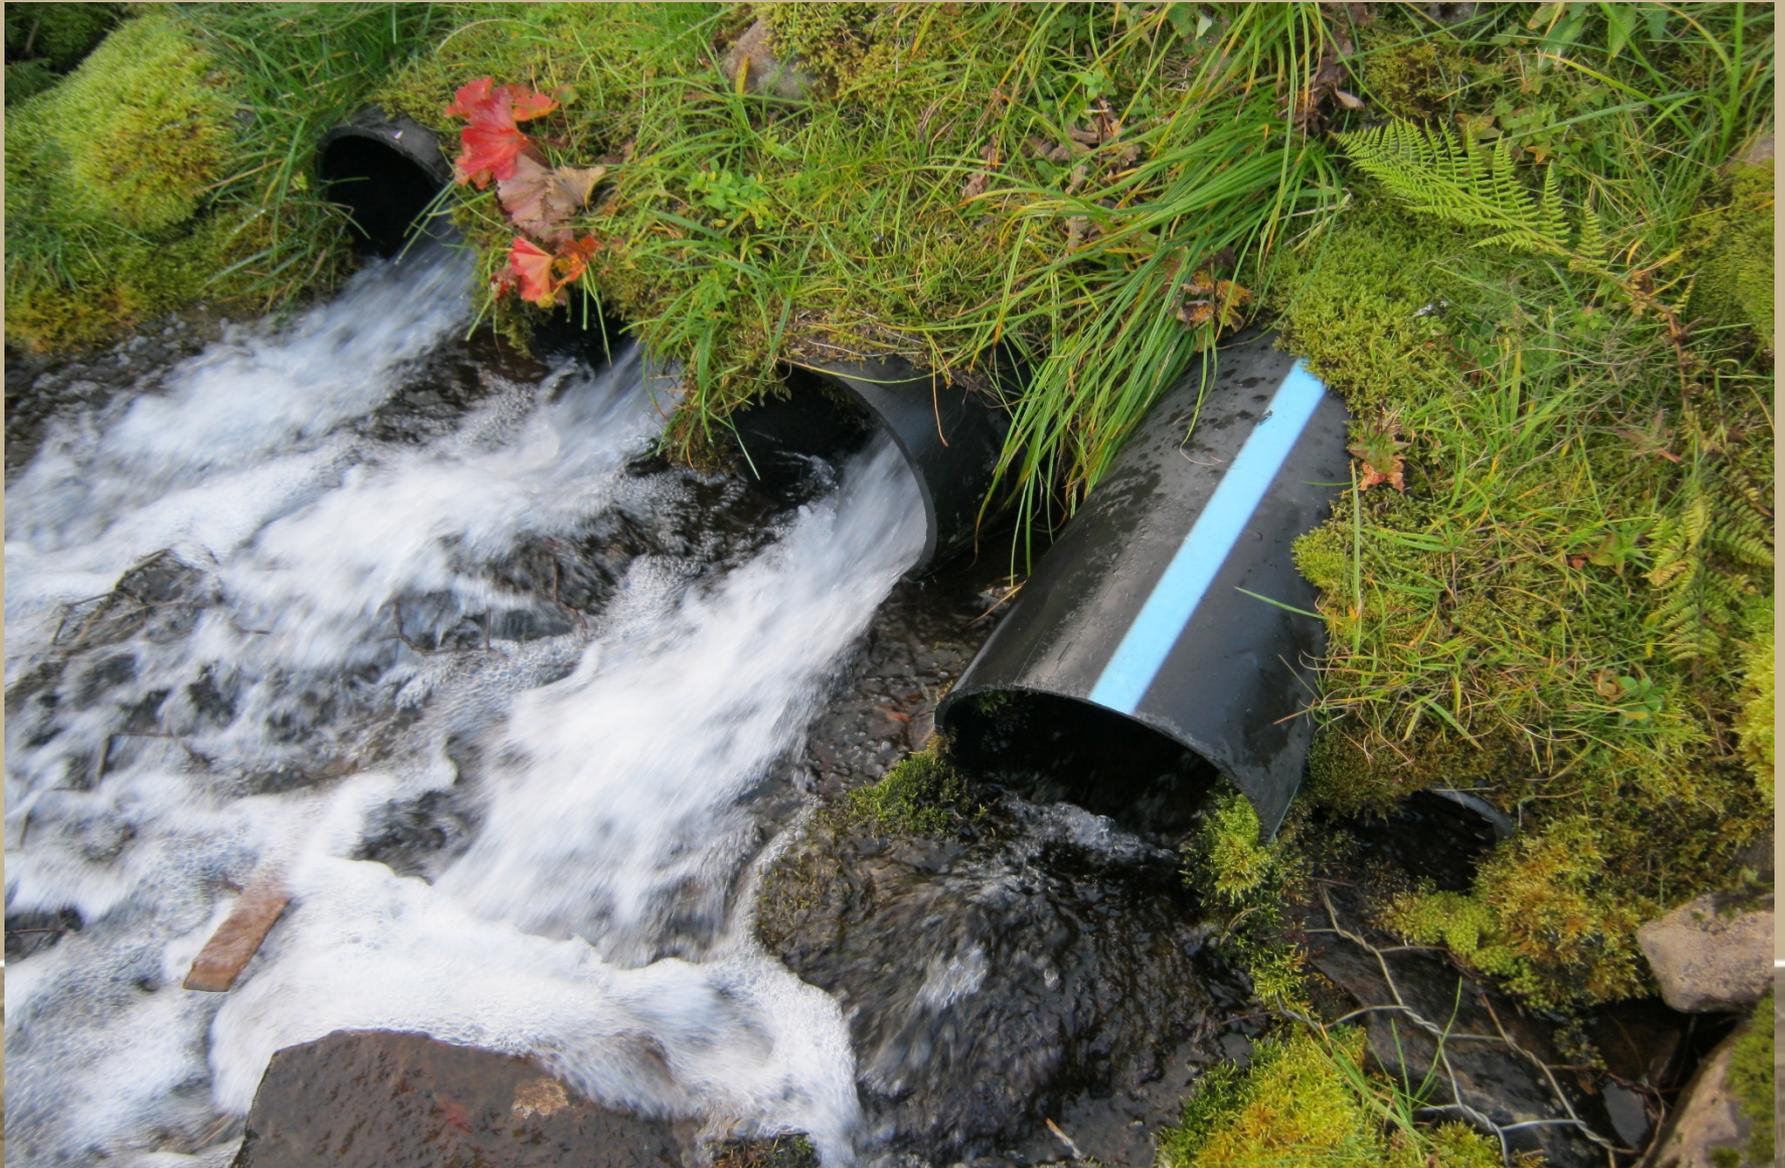
## Controlled vs. Uncontrolled Seepage

- Detection of other ancillary indicators such as sink holes (Lambs Lake), sand boils.
  - How to determine if seepage is really a problem versus something that is stable and unlikely to cause problems with a dam (Akutan).

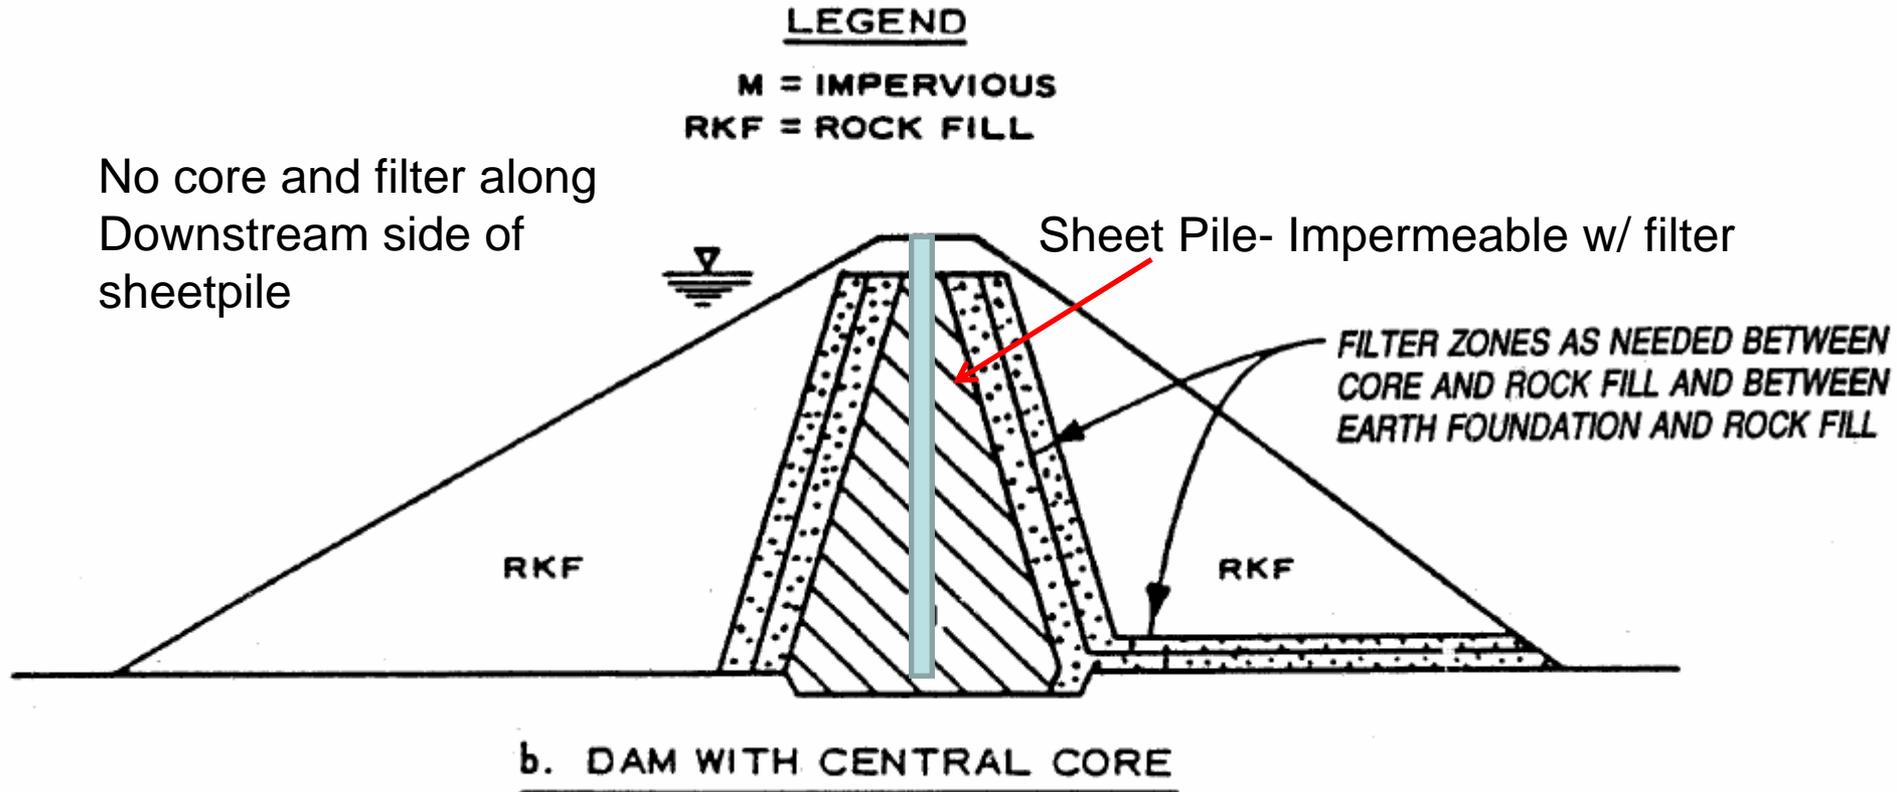
# Dam Configuration

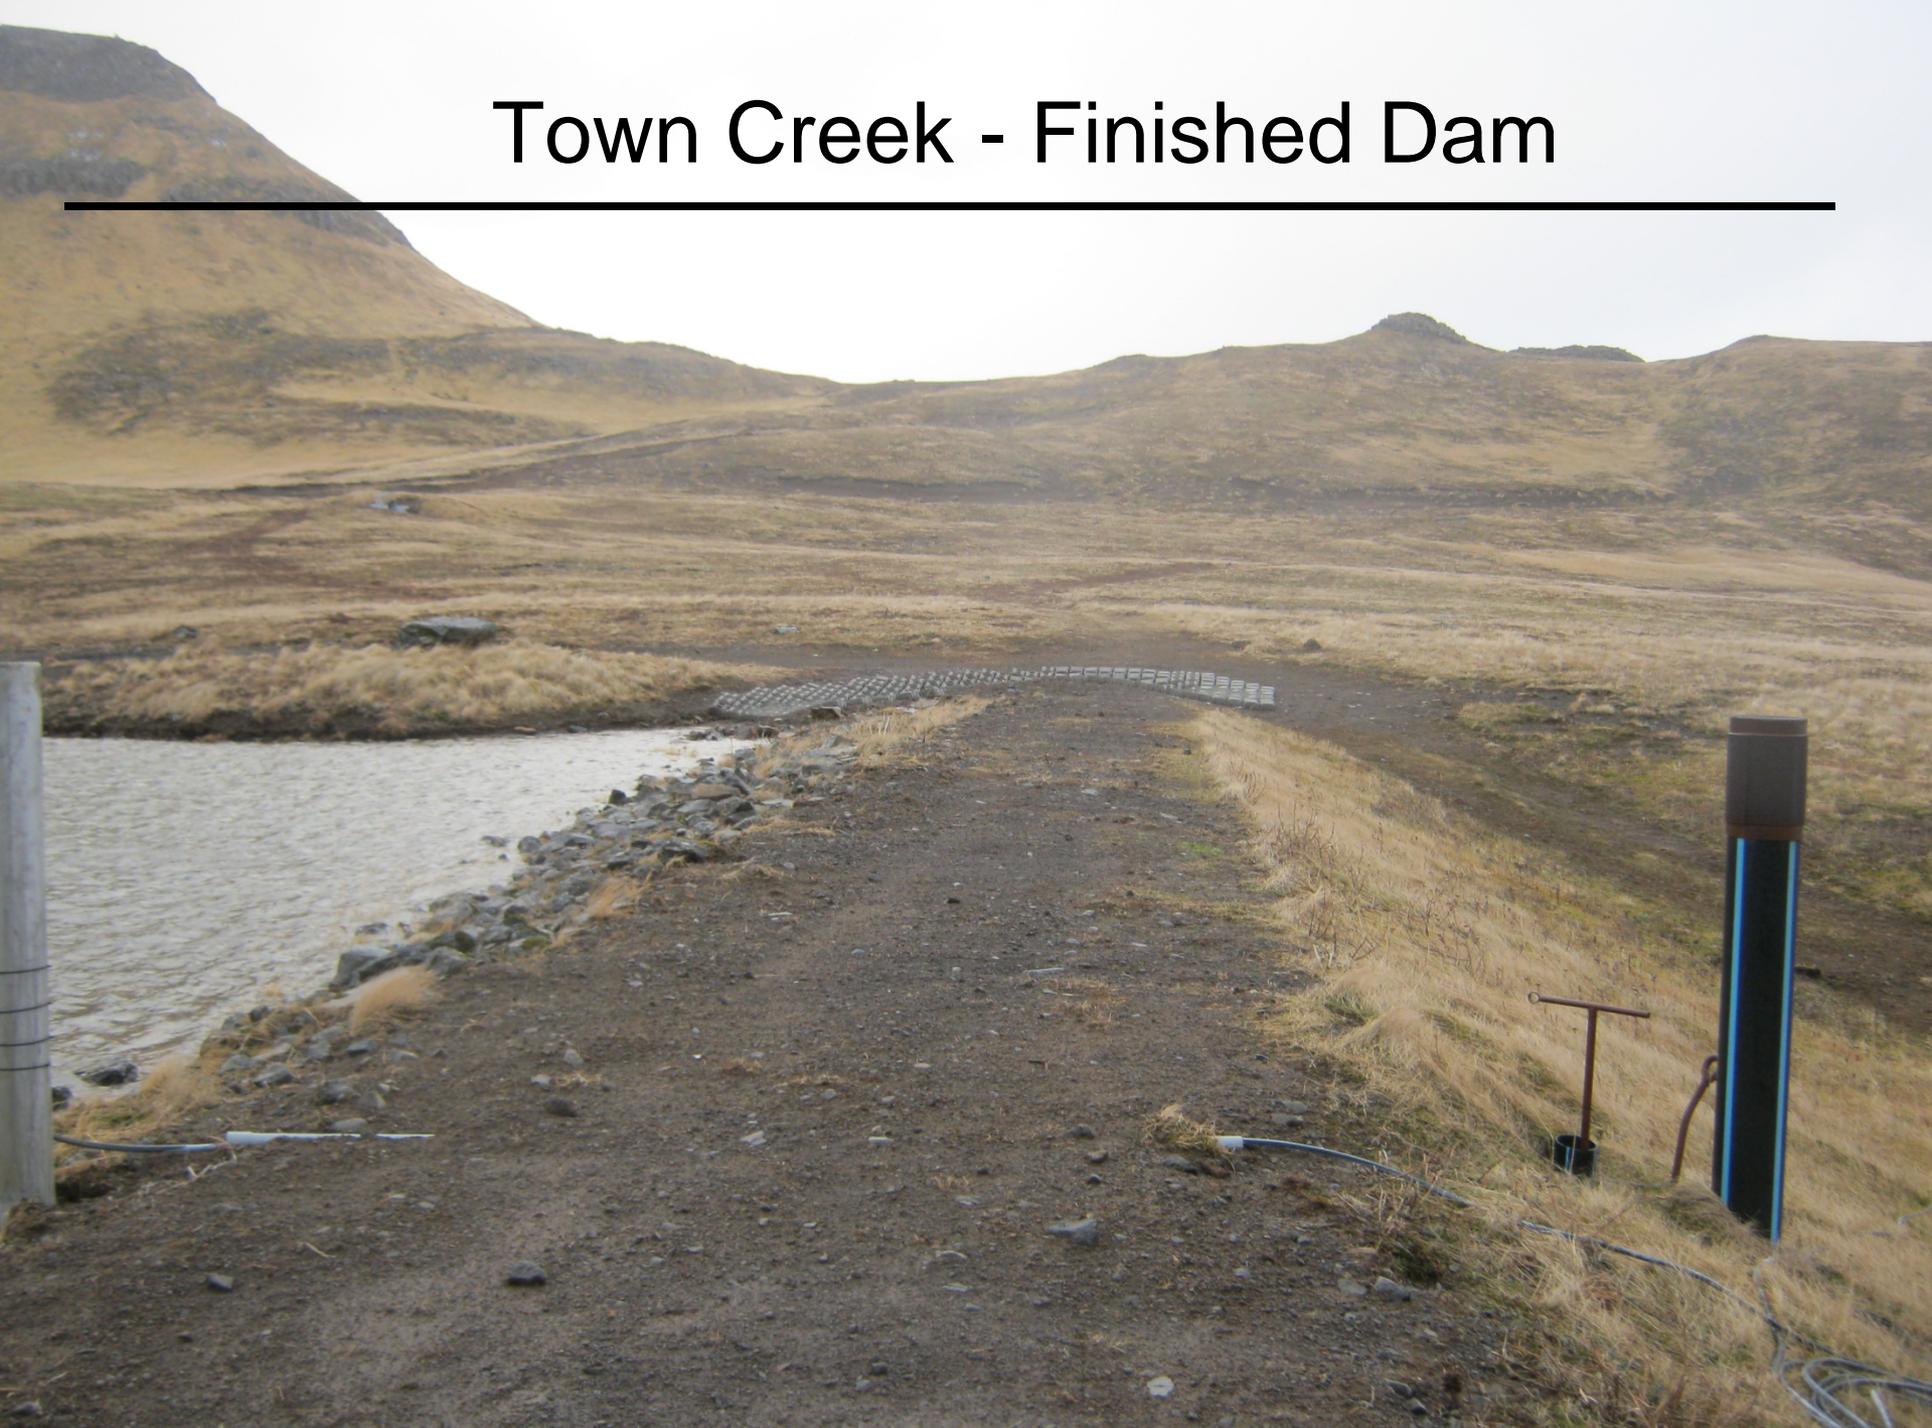
# Town Creek - Finished Dam

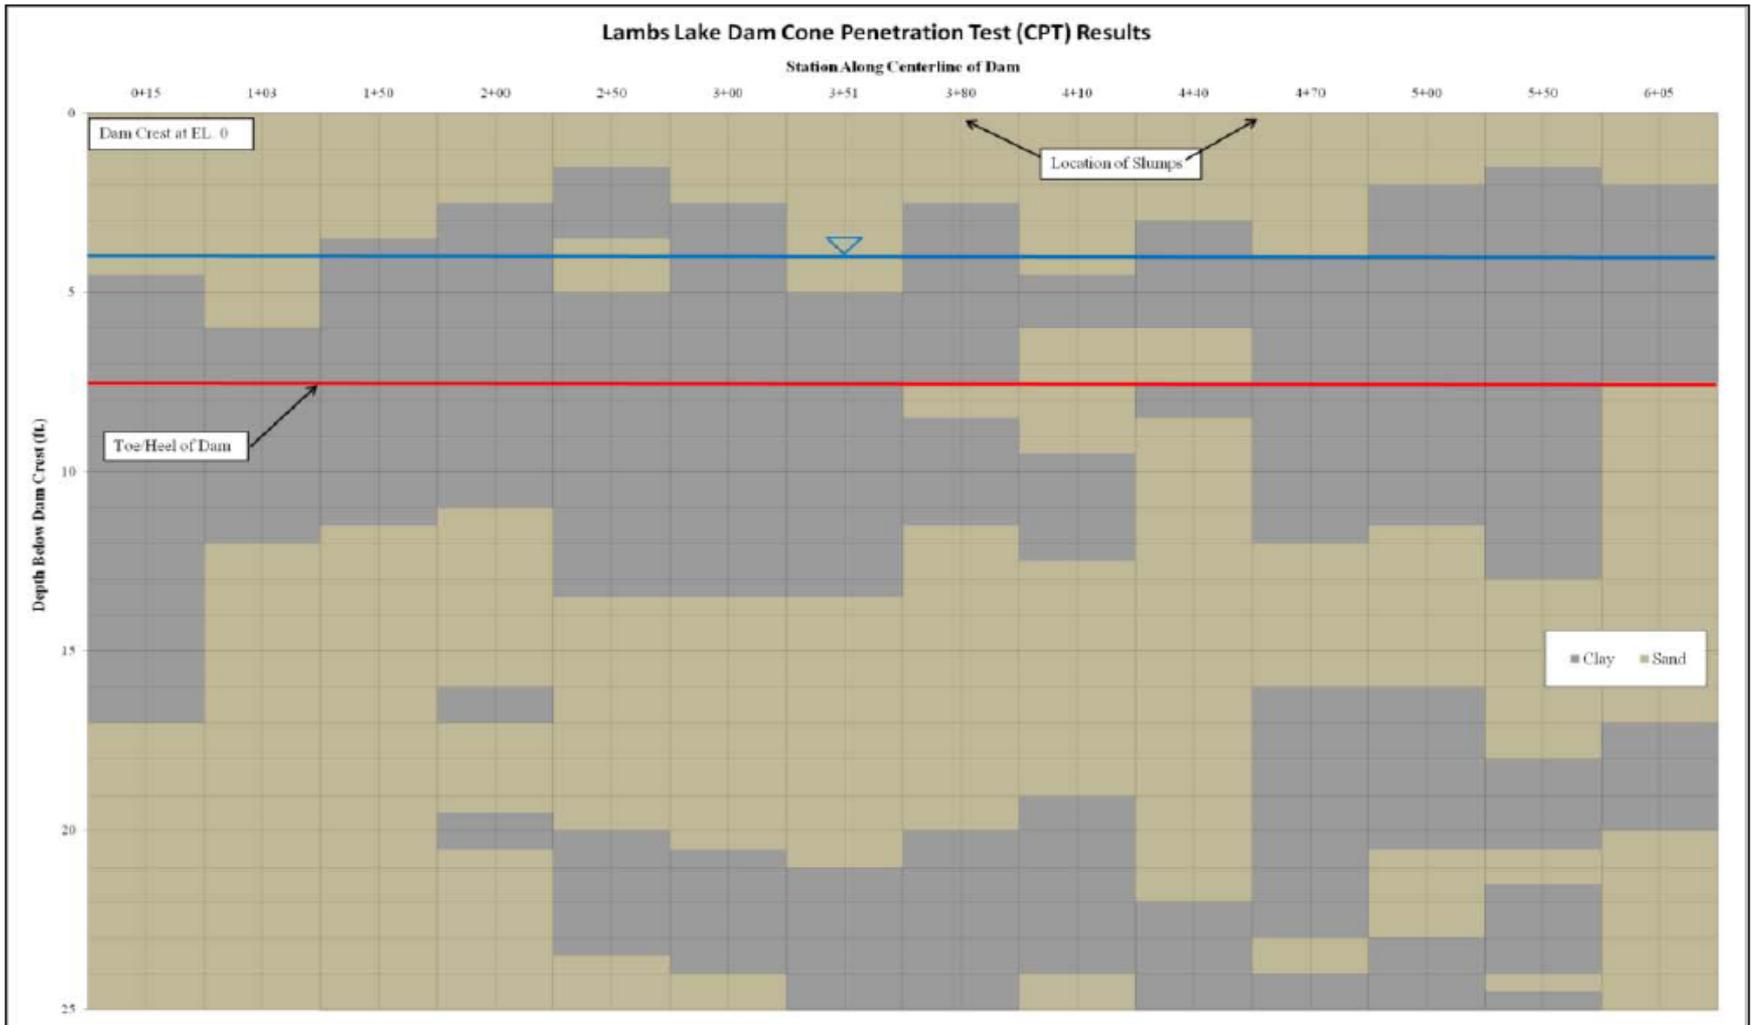
# Lambs Lake, ND

## Appendix A - Visual Representation of CPT Results

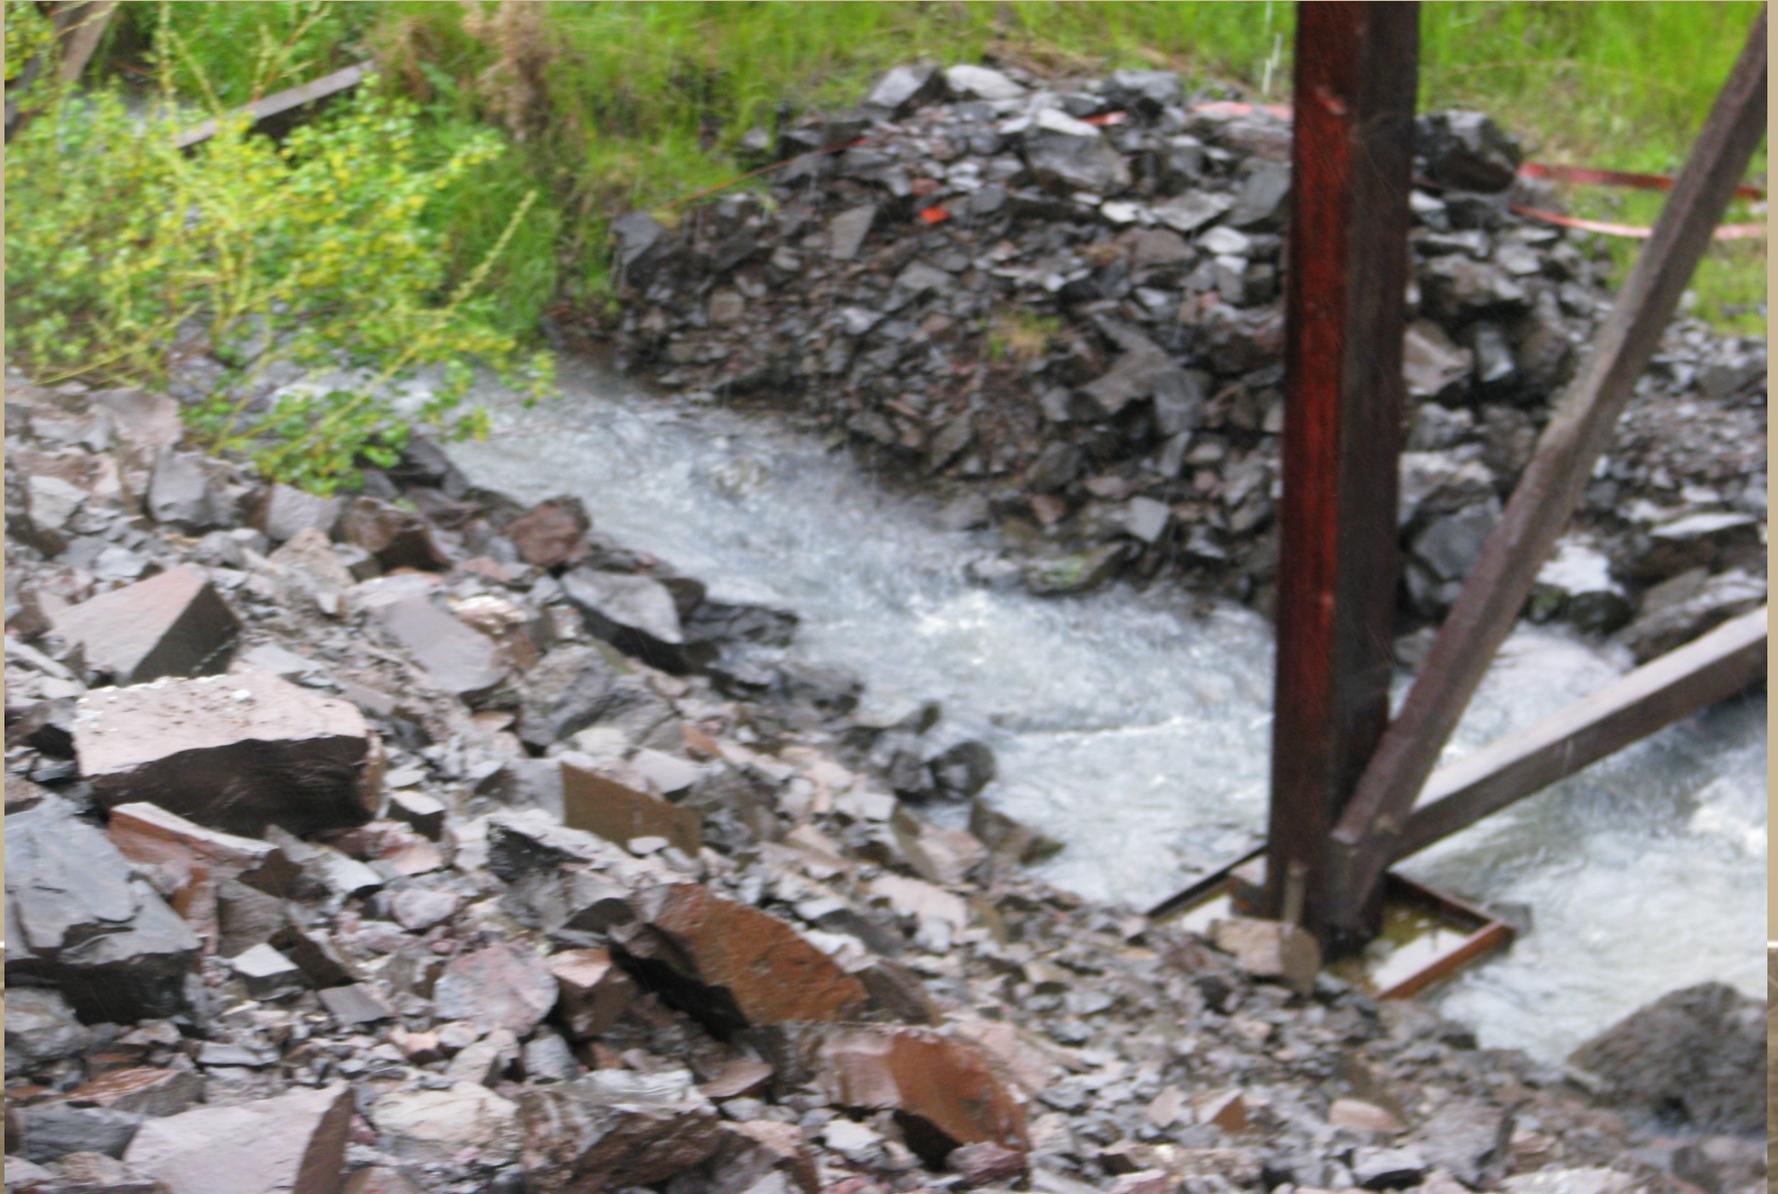
# Seepage from Dregs

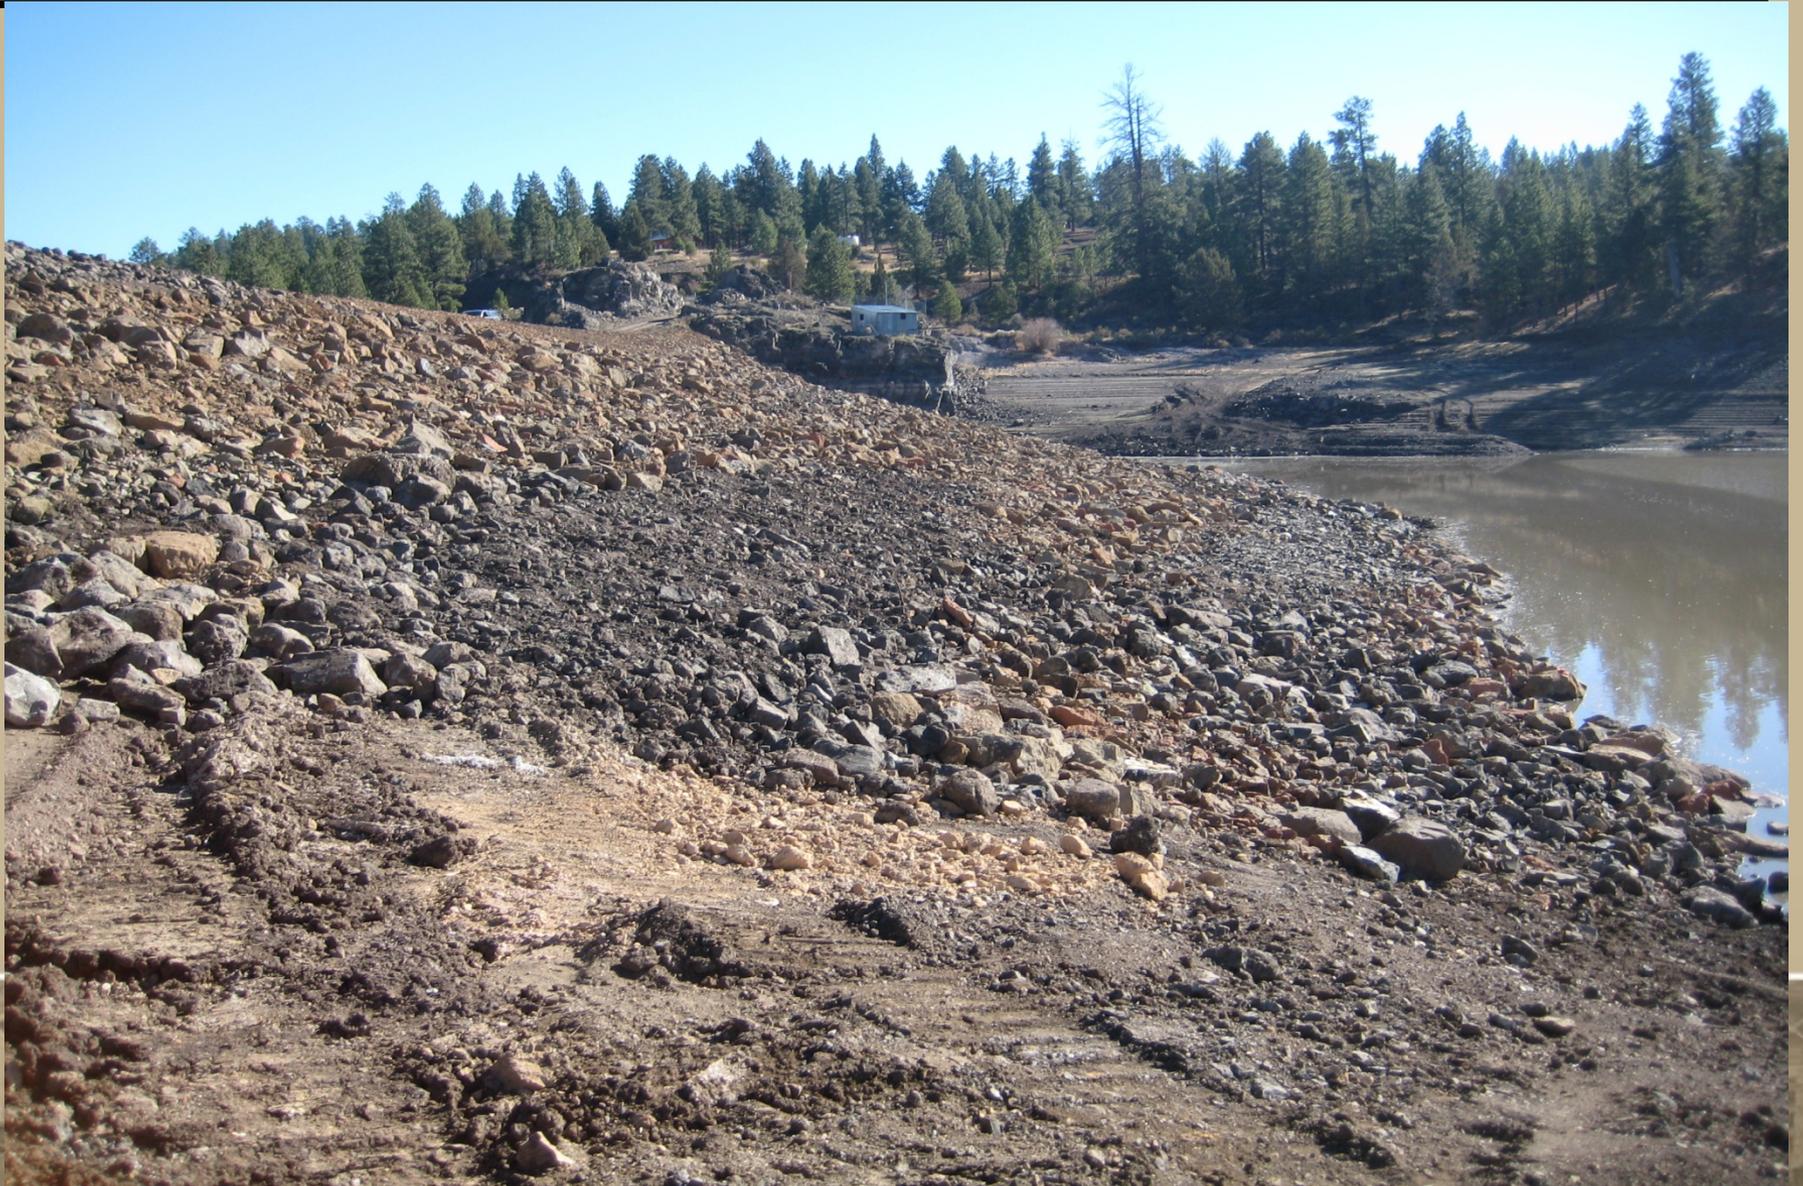
# Drews after construction
