Attachment 20

Type of Project: Proposed irrigation reservoir

**Title: CULTURAL RESOURCES OF THE PROPOSED DRIFT
CREEK RESERVOIR, MARION COUNTY, OREGON**

Date: December 11, 2006

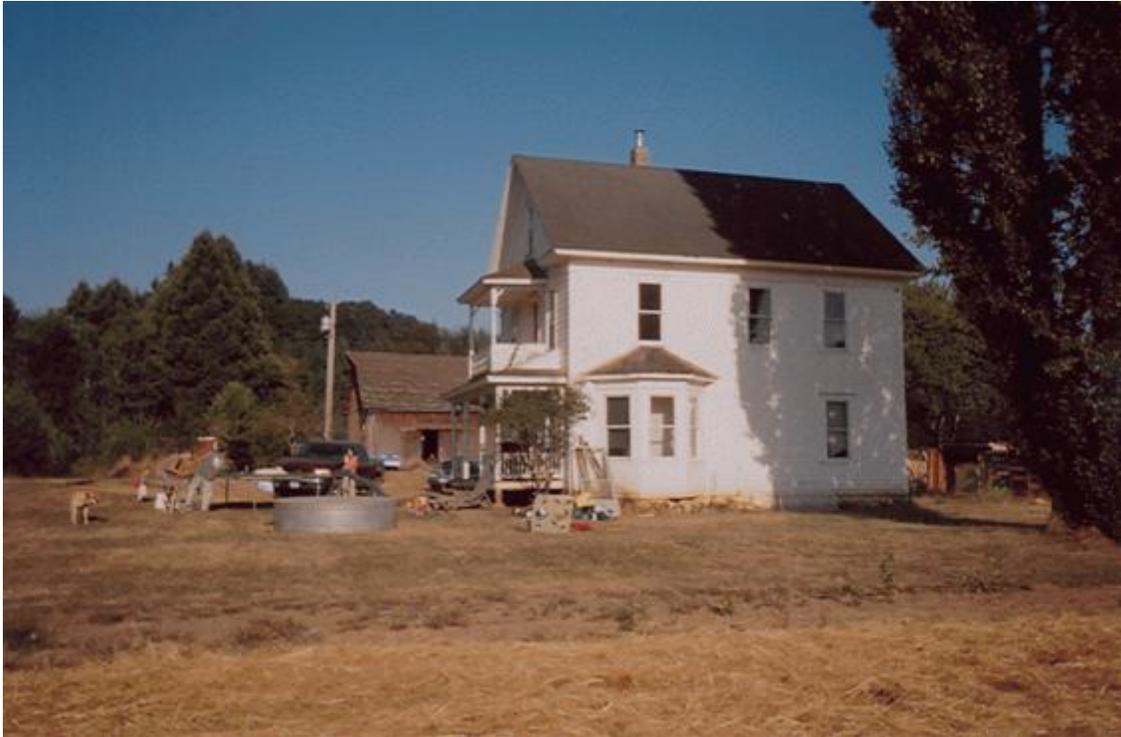
Photo 1

1. Early 20th Century Farmhouse, view east
2. Early 20th Century Farmhouse, view southeast
3. Early 20th Century Farmhouse, view south
4. Early 20th Century Farmhouse, view southwest

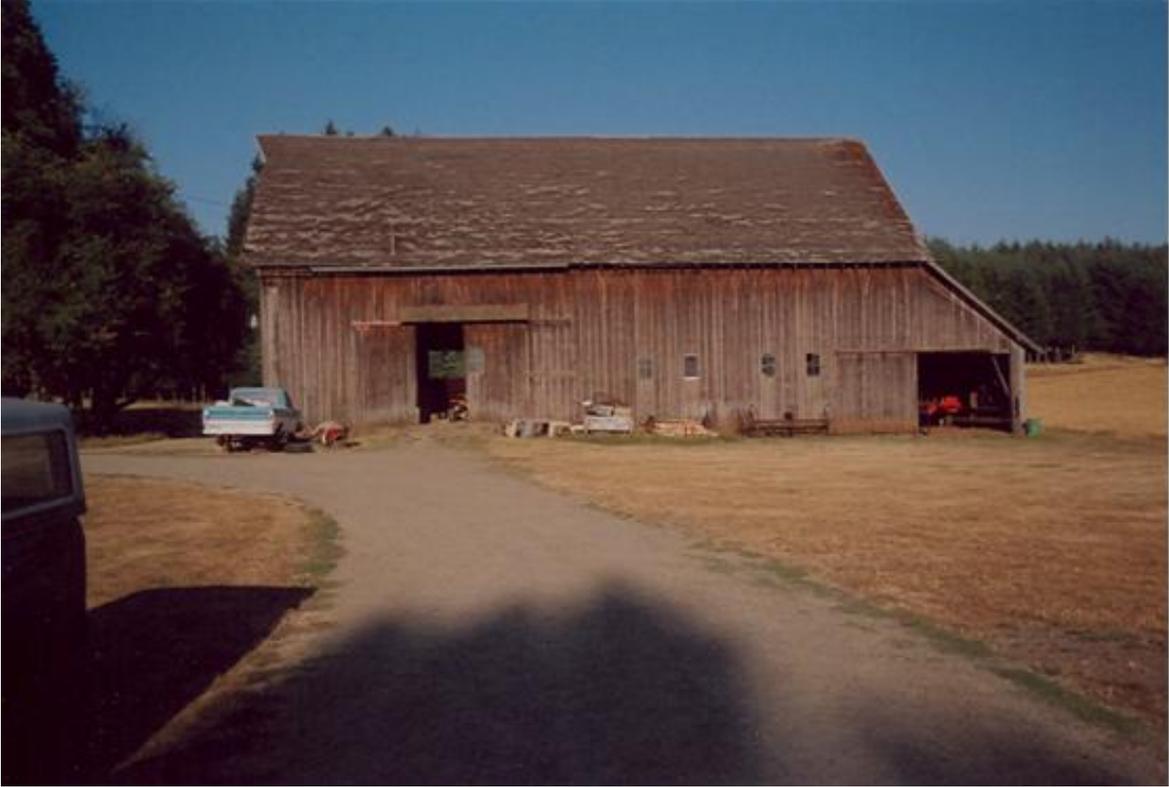
Photo 5

5. 1916 barn, view east
6. View southeast from early 20th Century Farmhouse. Irrigation ditch along treeline in middle distance. Toe of hillside visible at edge of floodplain just to right of barn.

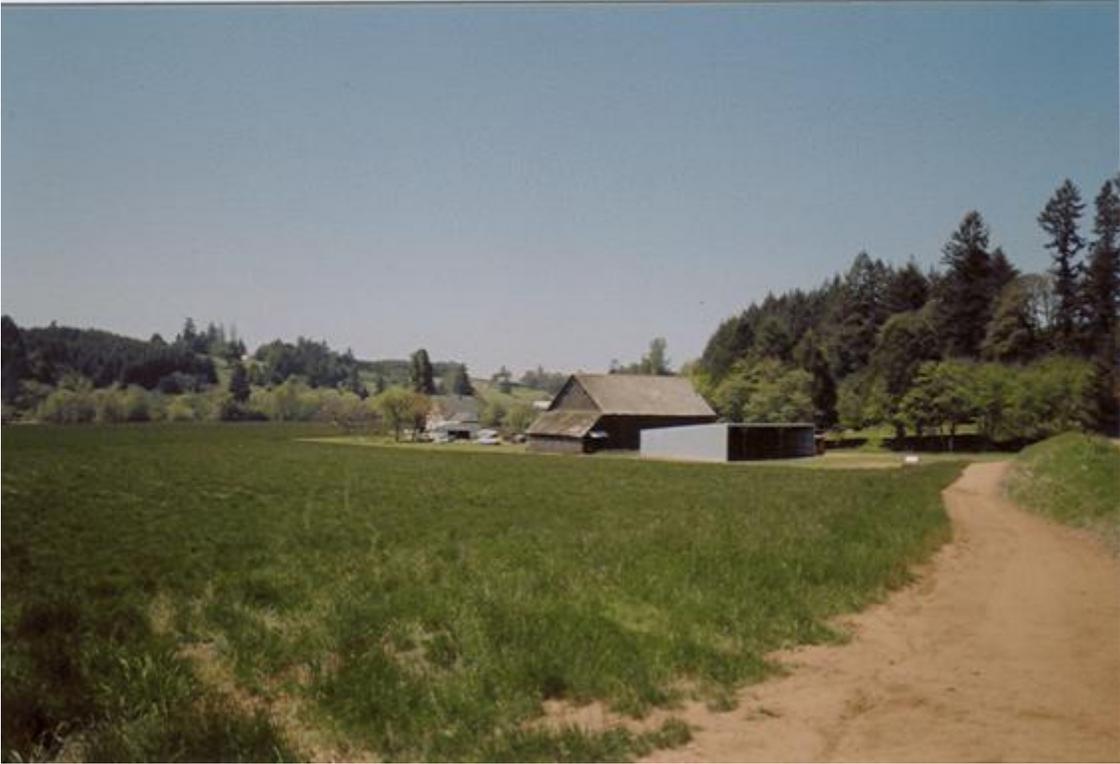
Photo 7

7. View northwest from toe of hillside toward early 20th Century Farmstead
8. View of Drift Creek floodplain from fire lane at east edge of flood-pool. View Southwest

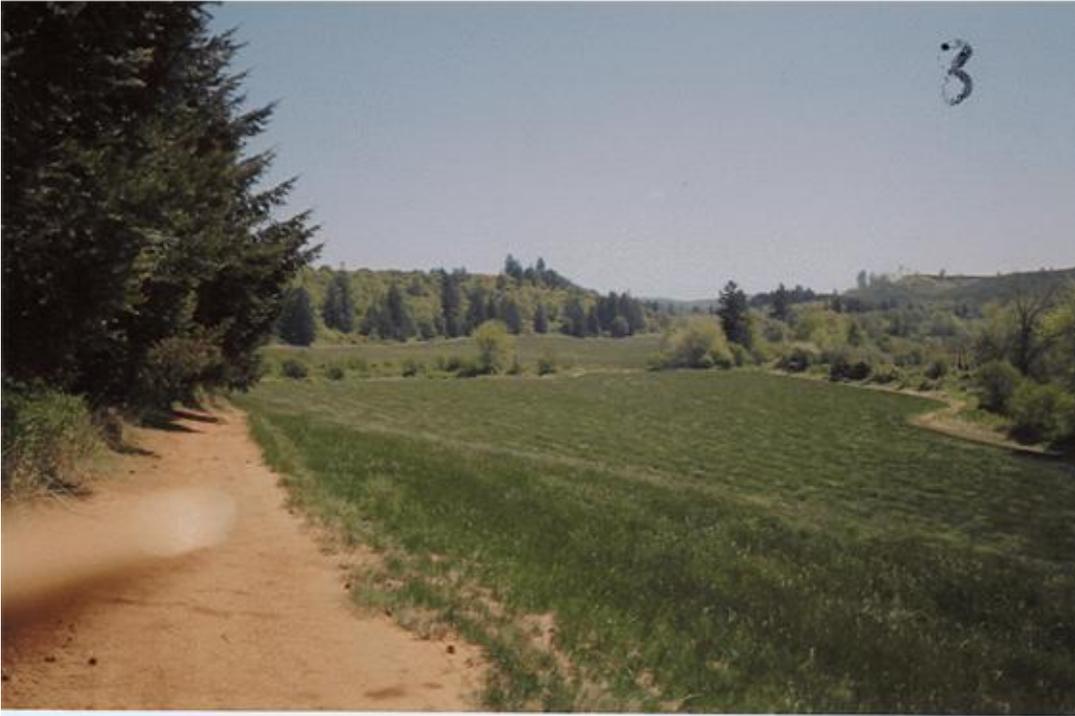
Photo 9

9. View of Drift Creek floodplain from fire lane at east edge of flood-pool. View south southeast
10. View from Drift Creek floodplain to north northwest

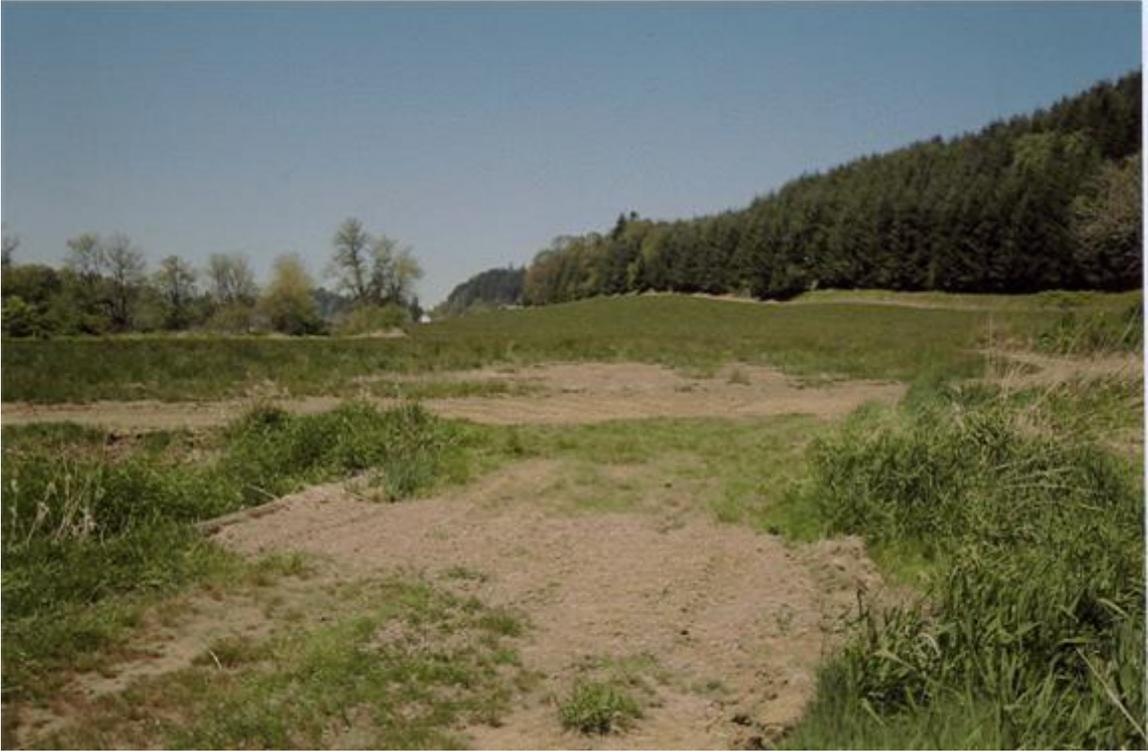
Photo 11

11. View from small bridge over tributary of Drift Creek toward northwest
12. View from Drift Creek floodplain south toward Christmas tree farm visible in middle distance. Fairly good ground exposure

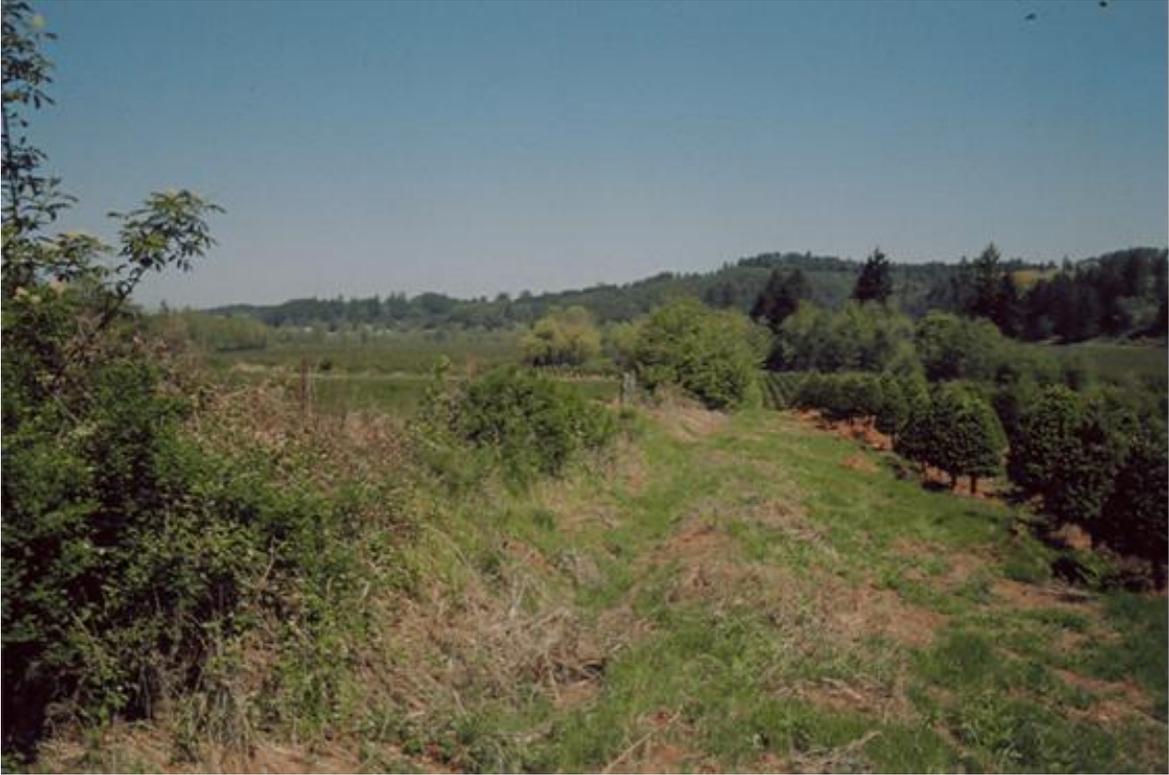
Photo 13

13. View south from fire lane adjacent to Christmas tree farm. Drift Creek to left. Dense underbrush .
14. Christmas tree farm, view to southwest. Heavy mulch on ground under trees.

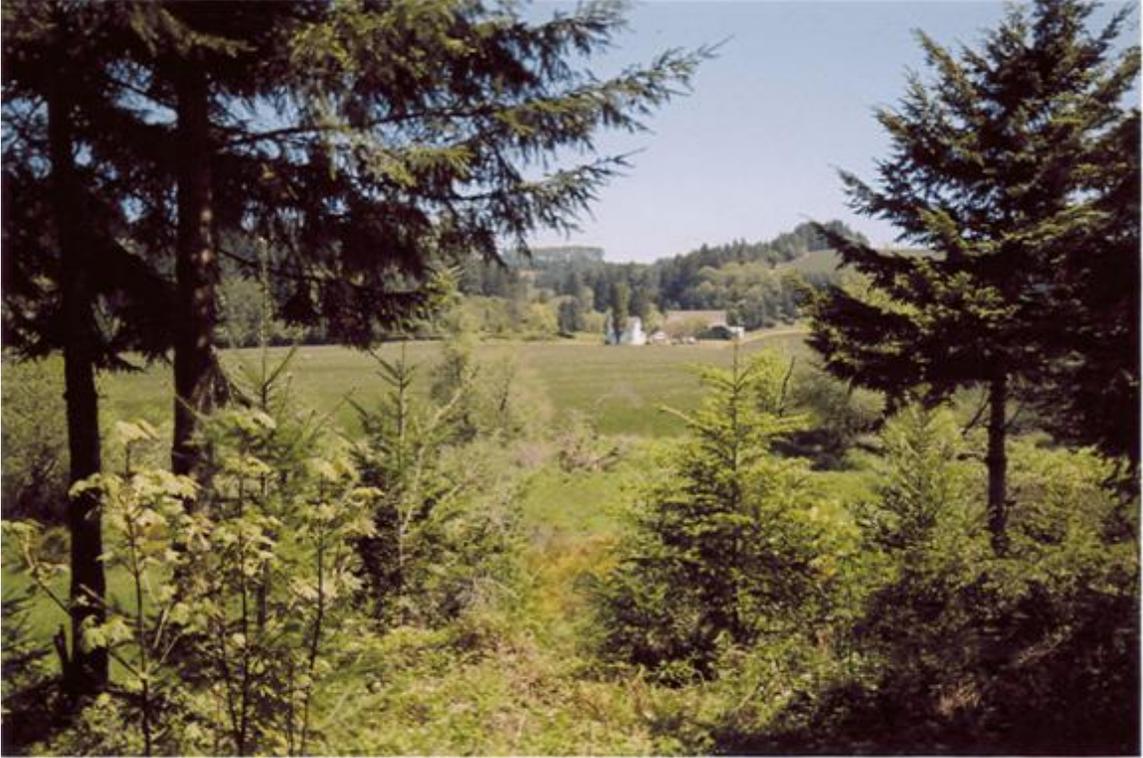
Photo 15

15. View from roadway along west edge of project area looking east toward 20th Century Farmstead. Heavy underbrush in foreground and cultivated fields in middle ground.
