Oregon DEQ Harmful Algae Bloom (HAB) Strategy

Appendix C

June 2011

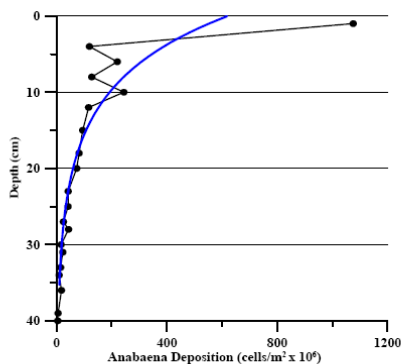
Figure 12. Deposition rate of *Anabaena* akinetes in the sediment of Devils Lake. The blue curve is a logarithmic fit to the observed data.

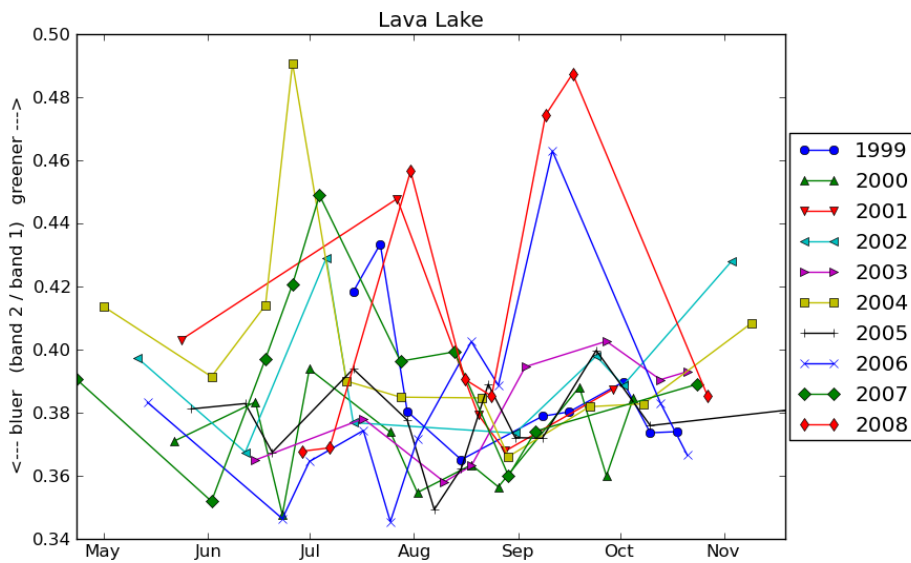
Remote sensing of chlorophyll *a* concentrations using Landsat data suggests that algal blooms commonly occur in Lava Lake. A band 2/band 1 ratio (the ration of the visible green band to the visible blue band) of 0.4 is approximately equivalent to a chlorophyll *a* of 15 ug/l, which equates to a visible bloom based on regression estimates (Turner, 2010). Values typically exceeded 0.4 from mid-June to mid-August in most years with some years, such as 2006 and 2008, having later blooms starting in September.

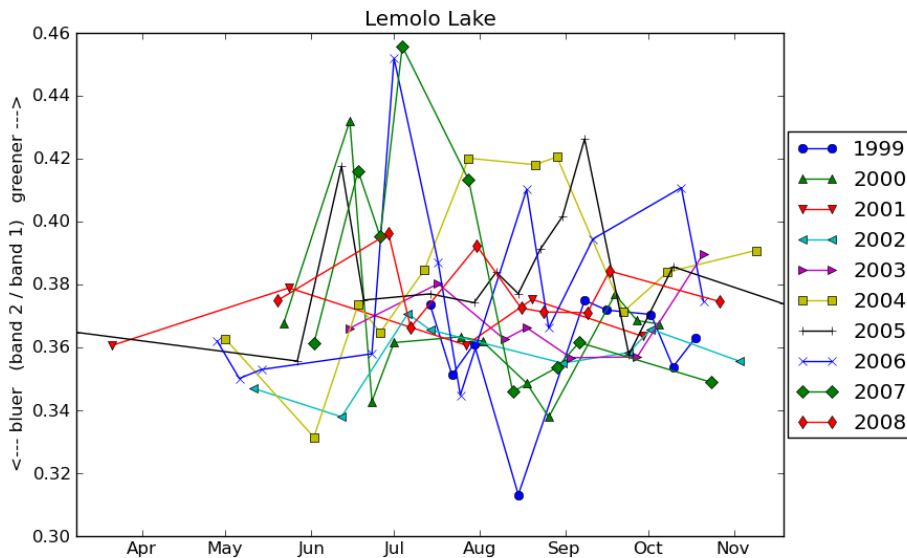
Remote sensing of chlorophyll *a* concentrations using Landsat data suggests a trend in increasing algal blooms in Lemolo Reservoir over the 10 year period when data was analyzed, beginning around 2004. A band 2/band 1 ratio (the ration of the visible green band to the visible blue band) of 0.4 is approximately equivalent to a chlorophyll *a* of 15 ug/l, which equates to a visible bloom based on regression estimates (Turner, 2010). As shown, values often exceed 0.4 from early to mid June until mid September in 2000 and then from 2004 on; although it appears like the late bloom period in 2008 (from 9/18 – 10/15/2008) did not have useable satellite coverage.

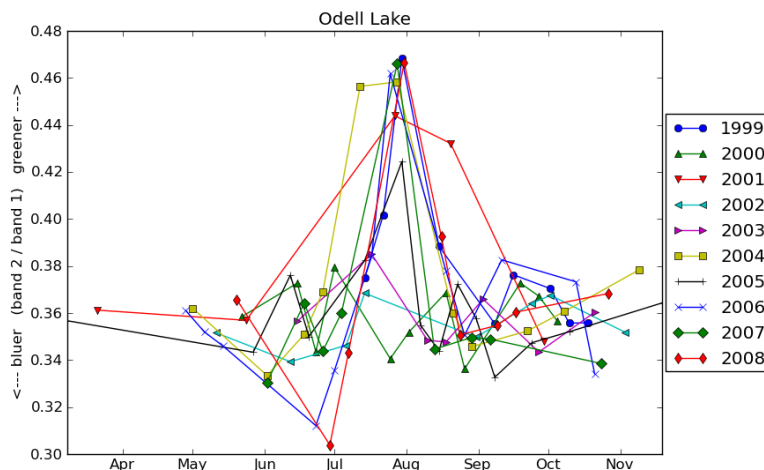
Remote sensing of chlorophyll *a* concentrations using Landsat data suggests a strong pattern in the algal blooms in Odell Lake. A band 2/band 1 ratio (the ration of the visible green band to the visible blue band) of 0.4 is approximately equivalent to a chlorophyll *a* of 15 ug/l, which equates to a visible bloom based on regression estimates (Turner, 2010). As shown, values typically exceed 0.4 from early to mid July until mid August in most years.

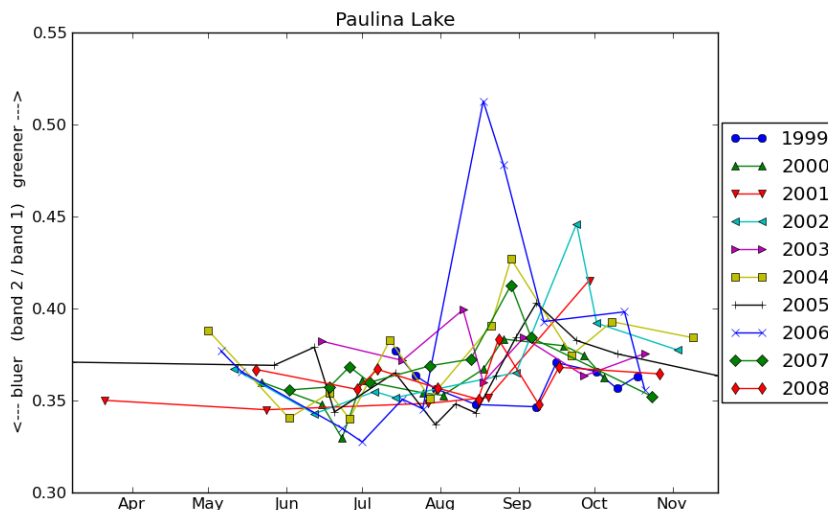
Remote sensing of chlorophyll *a* concentrations using Landsat data suggests a pattern of algal blooms in Paulina Lake. A band 2/band 1 ratio (the ration of the visible green band to the visible blue band) of 0.4 is approximately equivalent to a chlorophyll *a* of 15 ug/l, which equates to a visible bloom based on regression estimates (Turner, 2010). Values above 0.4 indicate blooms starting from mid-August until early September, although they may occur later in September as in 2001 and 2002.

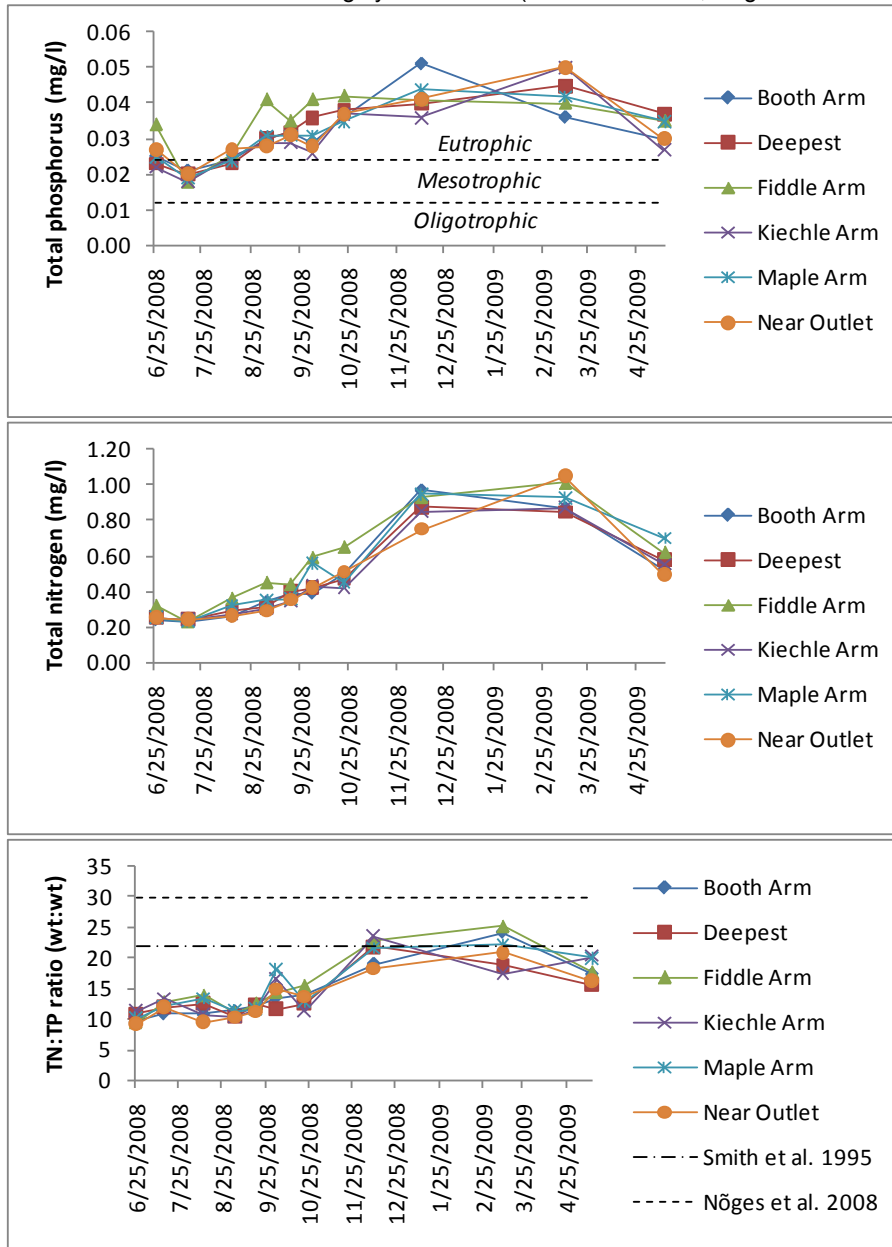
Figure 1. TP and TN concentrations and TN:TP ratios in Siltcoos Lake. TP trophic status categories are according from Carlson (1977). Dashed lines on the TN:TP plot are critical values below which conditions are considered favorable for N₂-fixing cyanobacteria (Smith et al 1995; Nöges et al. 2008).

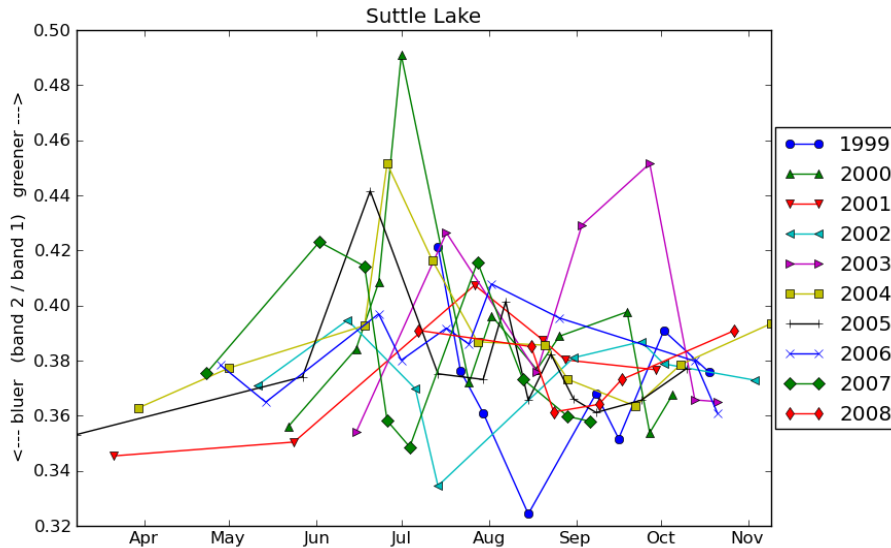
Remote sensing of chlorophyll *a* concentrations using Landsat data suggests a pattern in the algal blooms of Suttle Lake. A band 2/band 1 ratio (the ration of the visible green band to the visible blue band) of 0.4 is approximately equivalent to a chlorophyll *a* of 15 ug/l, which equates to a visible bloom based on regression estimates (Turner, 2010). Values are generally above 0.4 from mid-June until late July in most of the years assessed, with the exception of 2002.

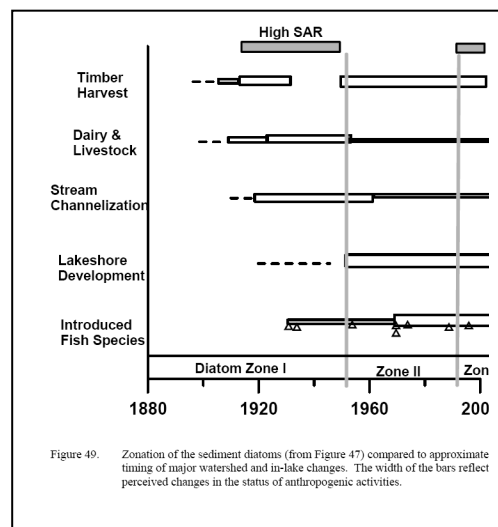
Figure 49. Zonation of the sediment diatoms (from Figure 47) compared to approximate timing of major watershed and in-lake changes. The width of the bars reflect perceived changes in the status of anthropogenic activities.
