Miami River Watershed Assessment and Analysis of ODF Lands

August 15, 2005

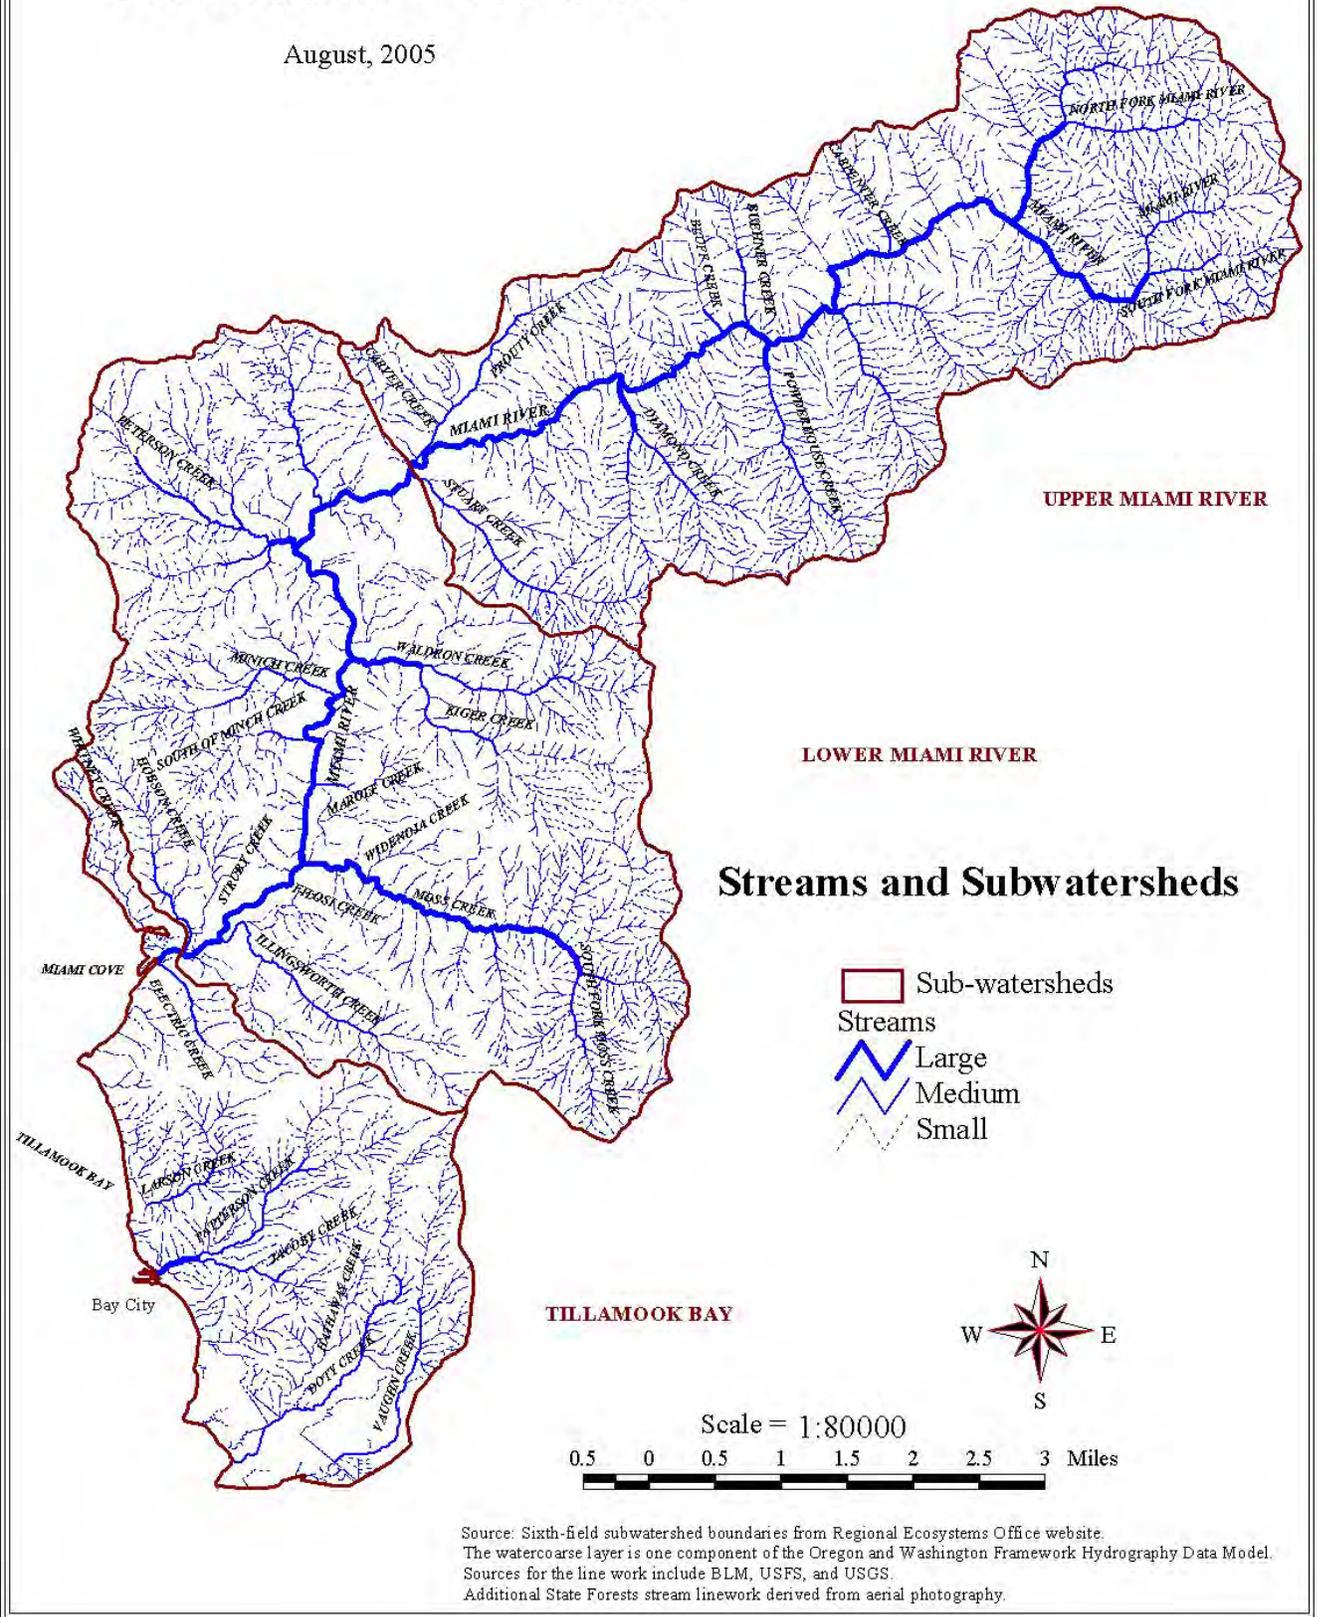
Figure 3. Streams and subwatershed boundaries for the Miami River Watershed Project Area.

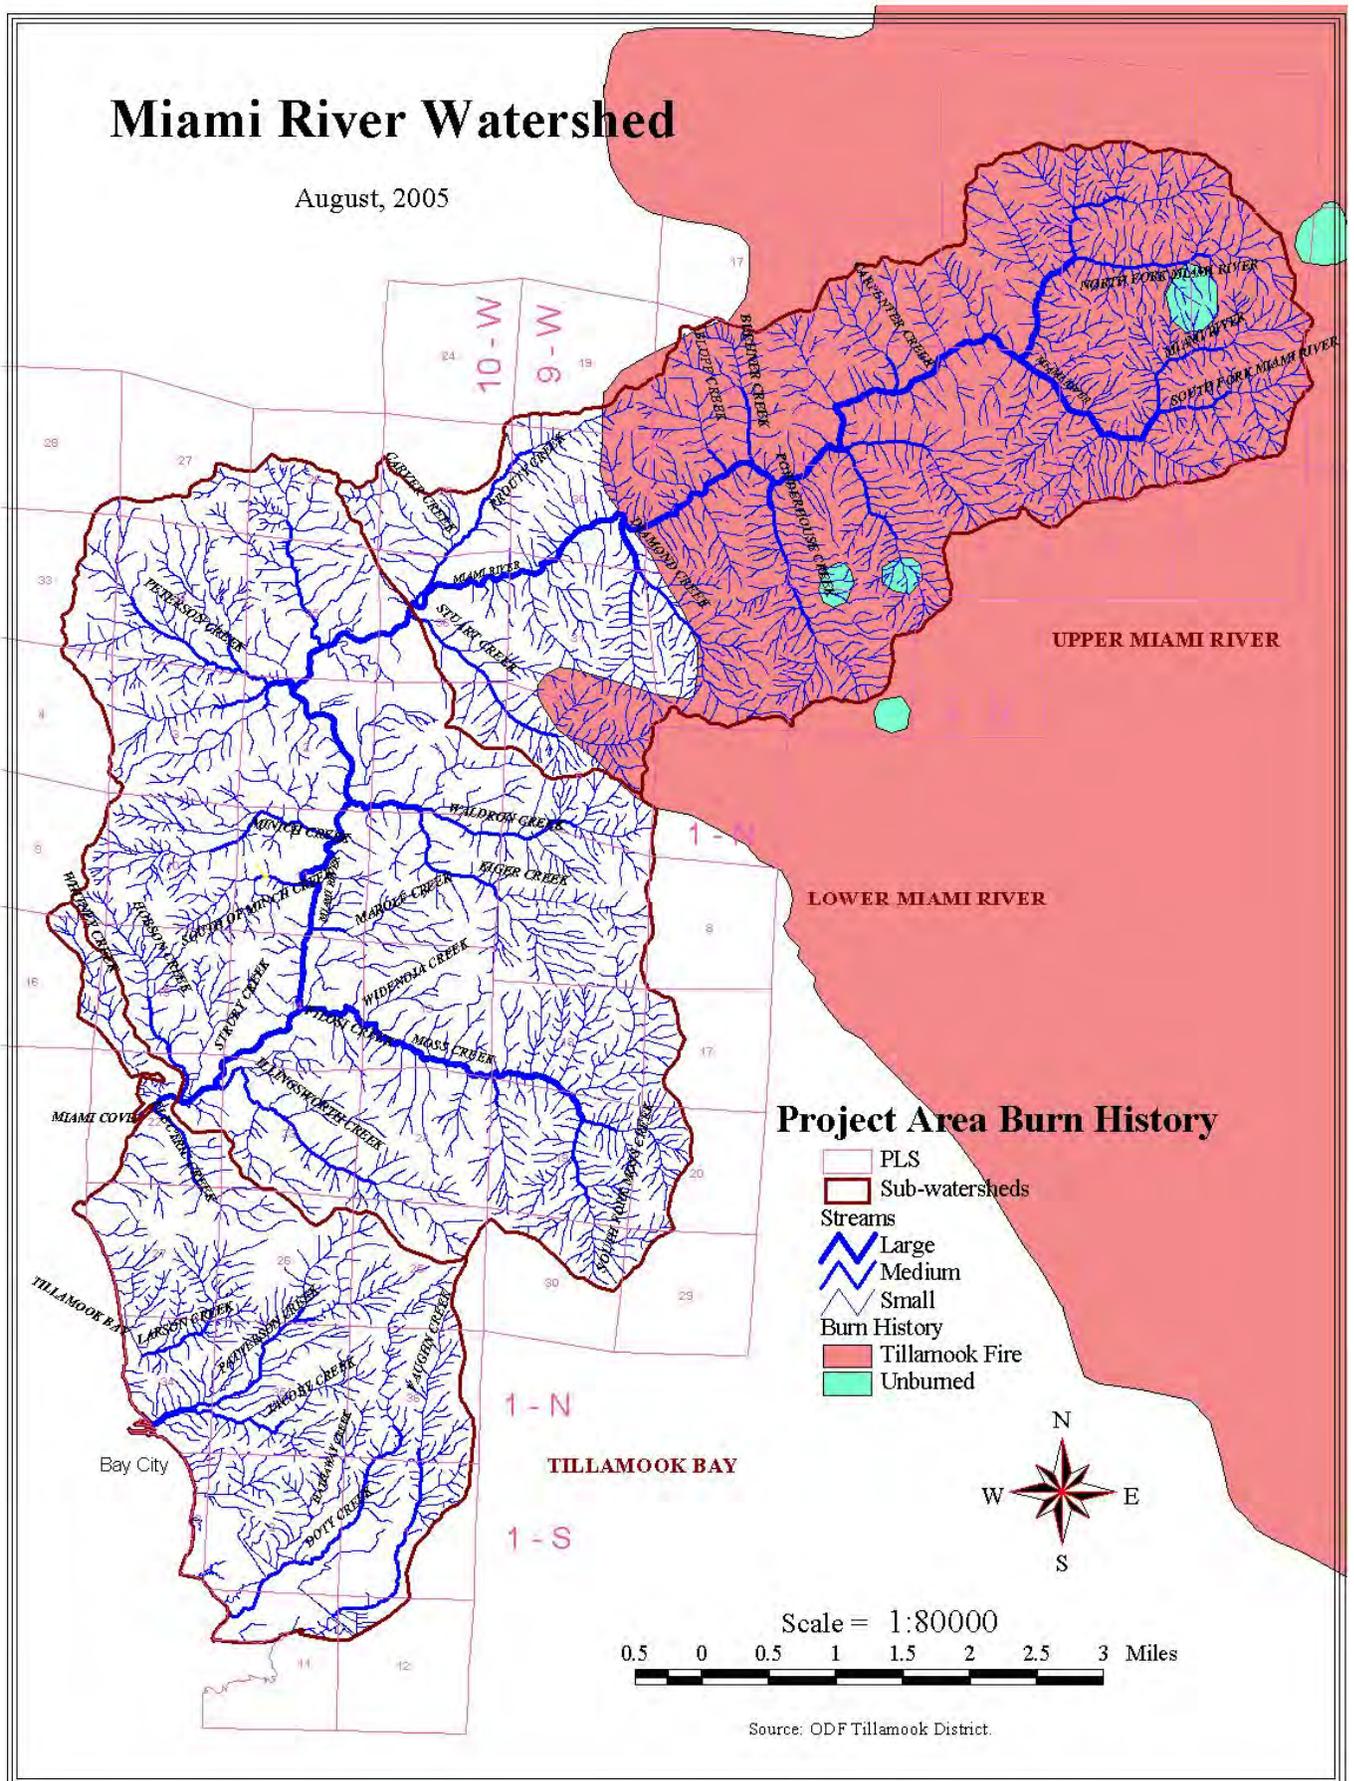
Figure 4. Burn history of the Miami River Watershed Project Area.

- An estimated 75% of the Miami watershed burned in the 1933 Tillamook Burn (ODF 2004a). Portions burned again in the 1939 fires (Fick and Martin 1992, TBNEP 1996). The upper half of the Miami from the eastern divide to Diamond Creek was affected (Figure 4).

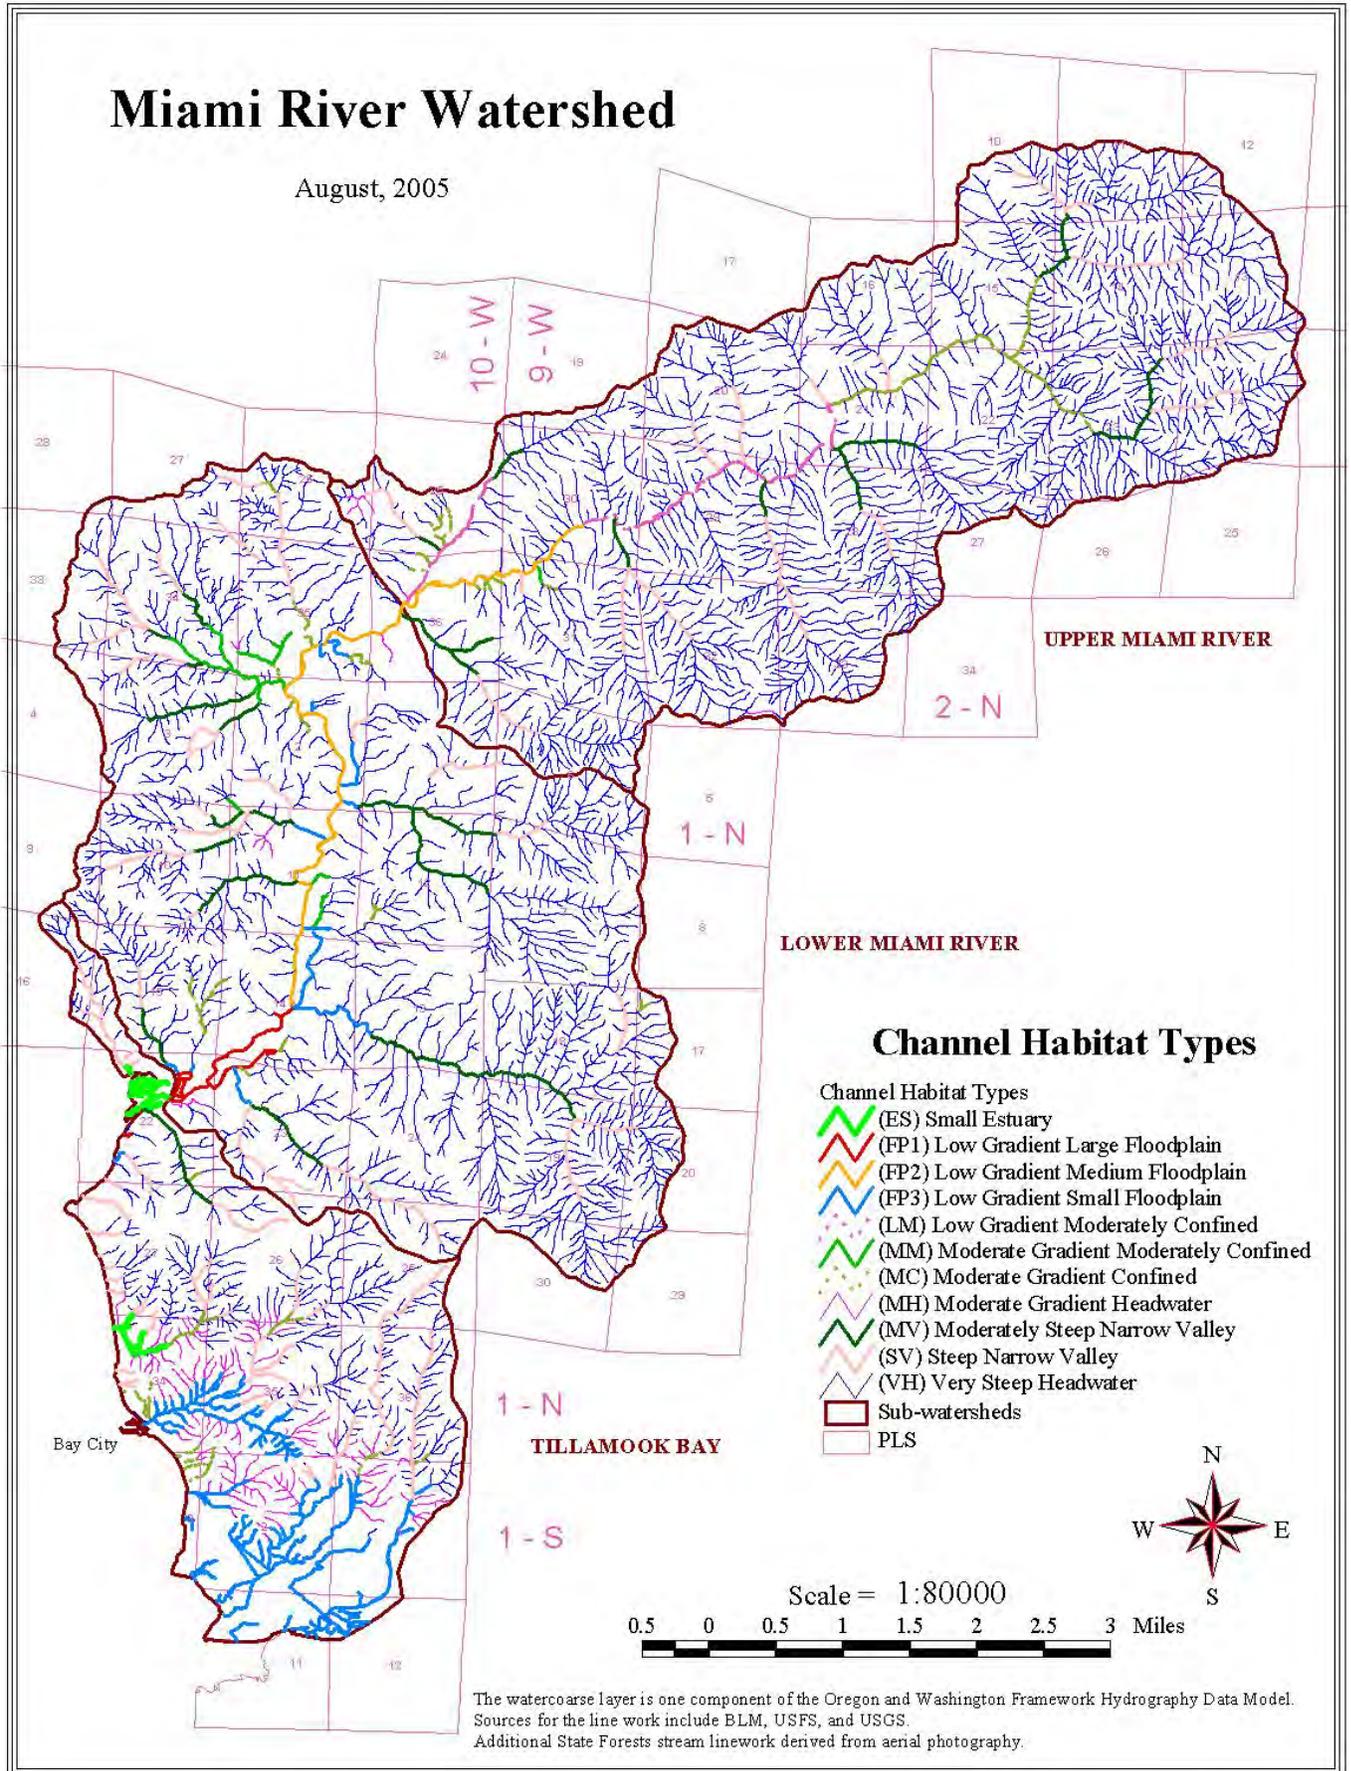
Figure 1. Channel habitat types for the Miami River Watershed Project Area.

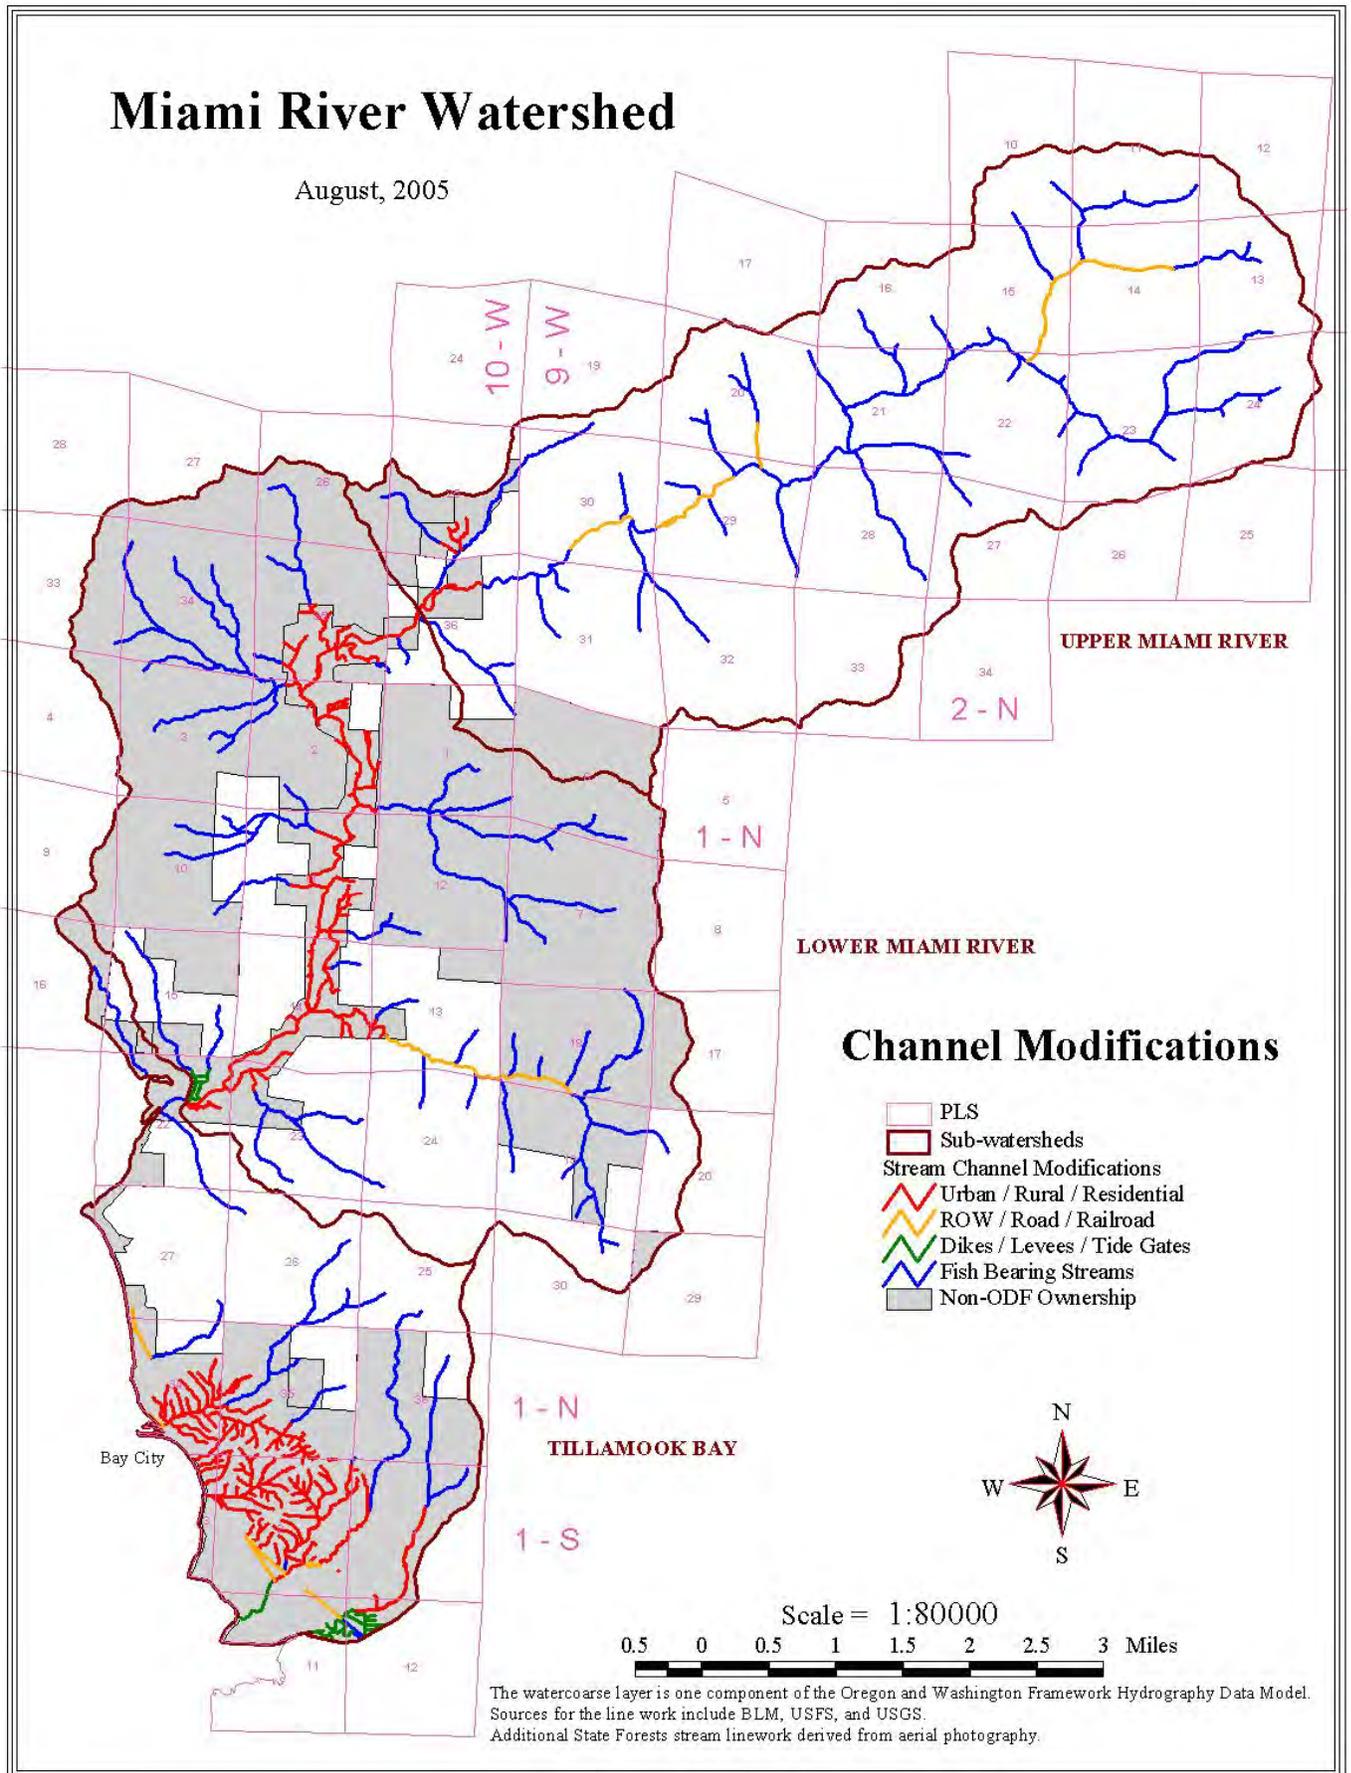
Figure 2. Map of modified channels for the Miami River Watershed Project Area.

Currently, there are certain road segments of the Miami River road on ODF land that encroach upon the floodplain and channel of the river between Prouty and Buehner Creeks. Segments also impinge upon the lower and middle reach of the North Fork upstream from its confluence with the South Fork. Other notable road segments on ODF land have resulted in modified channel conditions in the narrow drainage bottoms of Moss and Buehner Creeks (ODF 2005a).

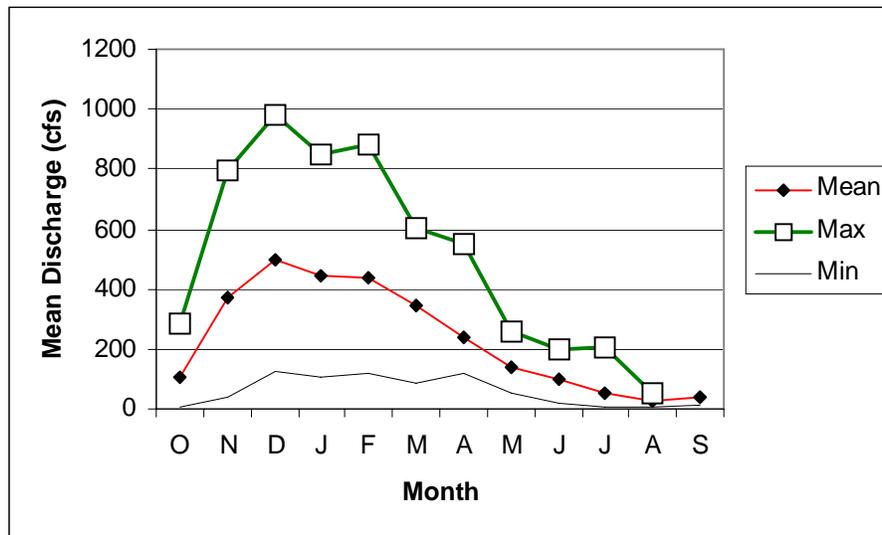
Figure 3. Hydrograph of mean daily flow for the period of record 1973-1995 for the Miami River (ODWR Gage No. 14301300) (Source: ODWR 2005).

Stream flow data specific to the project area is only known to be available for two former gauging sites no longer in service. One was located near the mouth of the Miami River (ODWR gage no. 14301300), and another was located on a lower reach of Patterson Creek (ODWR gage no. 14301400). The Miami River site was in use from 1973 to 1995, and the Patterson Creek site was in use from 1952 to 1968. Using data from the Miami River site, Figure 7 displays the representative hydrograph based upon the daily mean for the 22-year period of record. The hydrologic regime for the project area is a rain dominated system typical of the Coast Range. Stream flow increases sharply in the fall with the onset of the rainy season and peaks during the winter before steadily decreasing to a low in late summer.

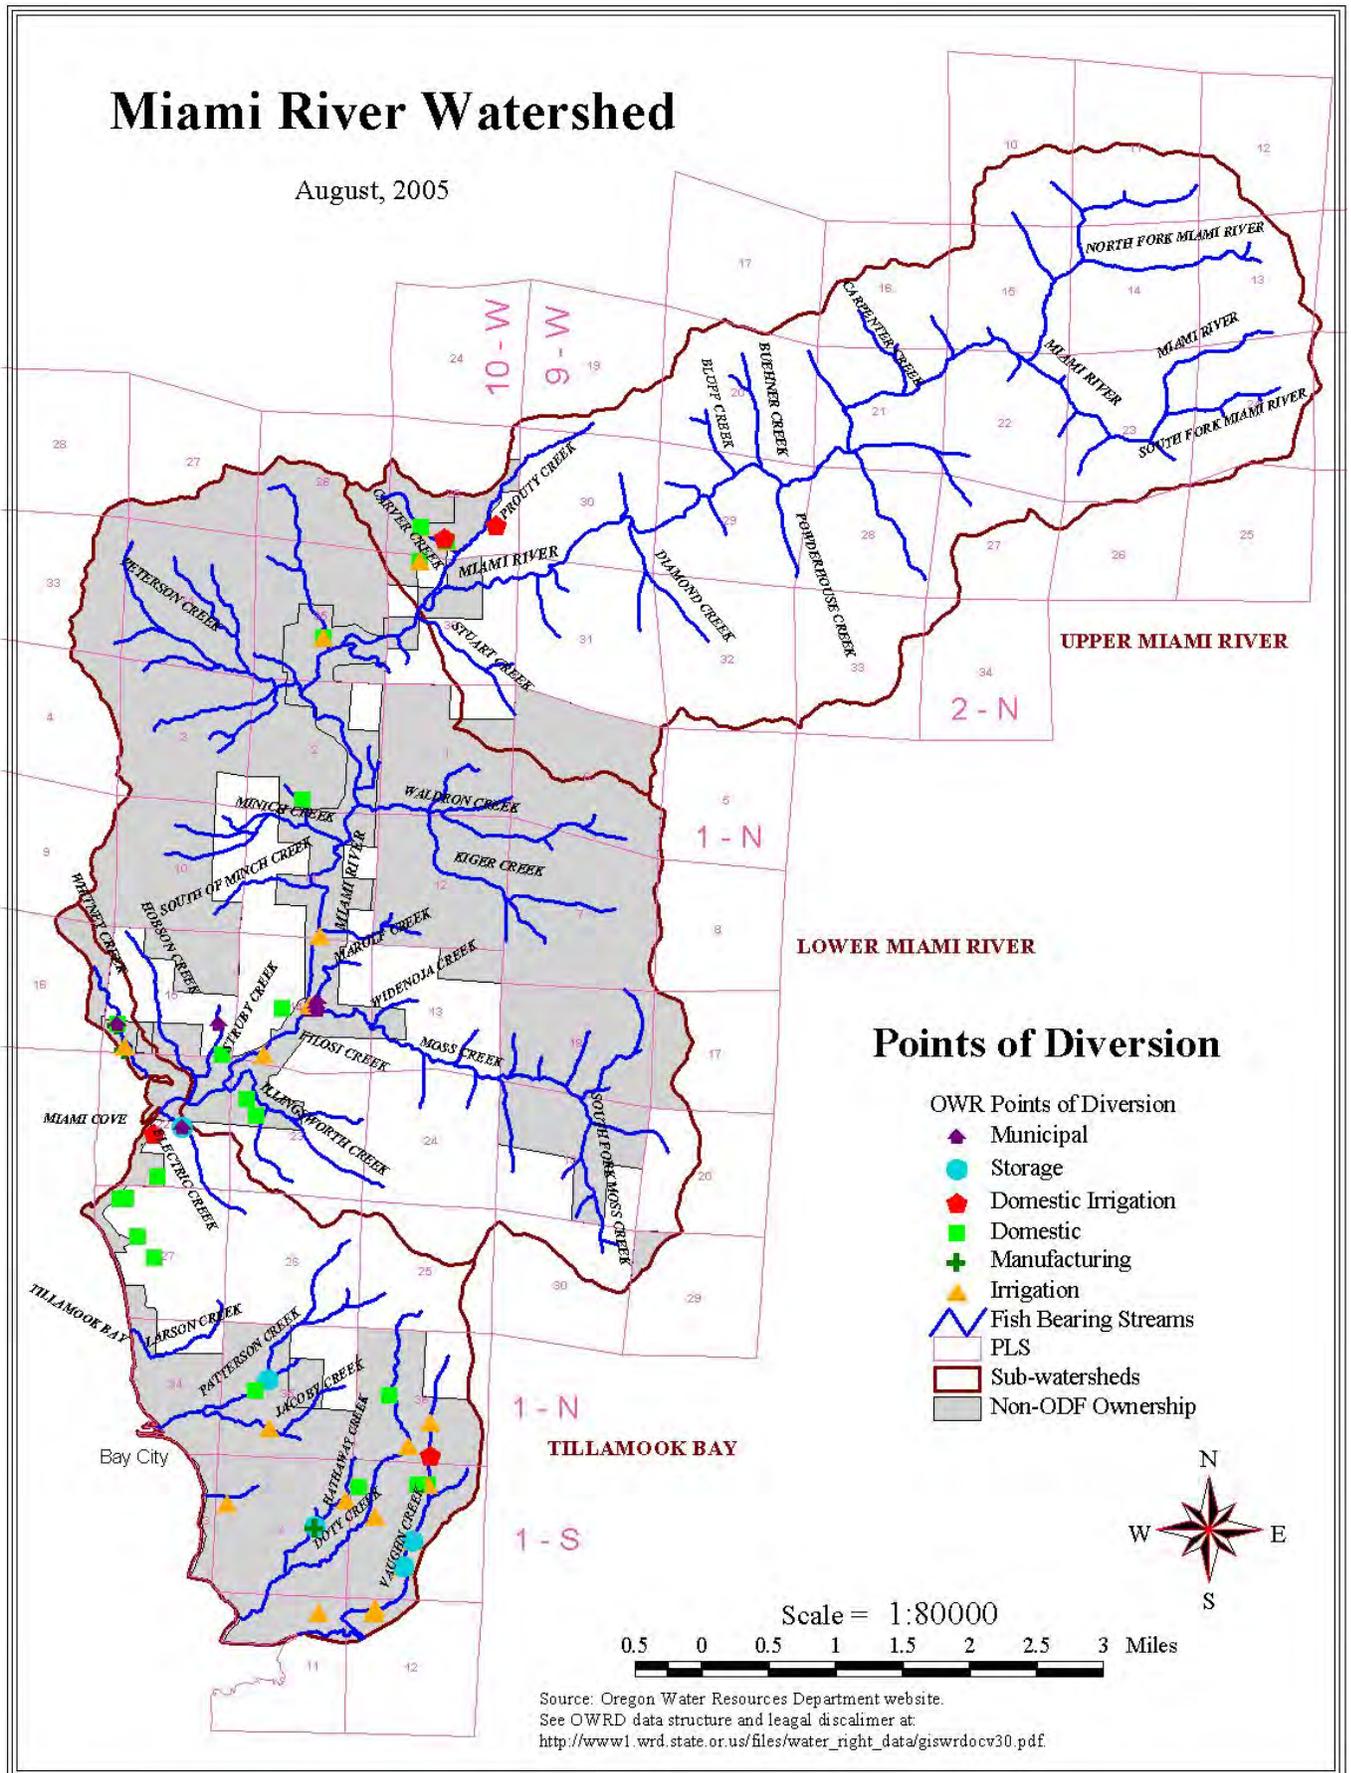
Figure 1. Points of diversion in the Miami River Watershed Project Area.

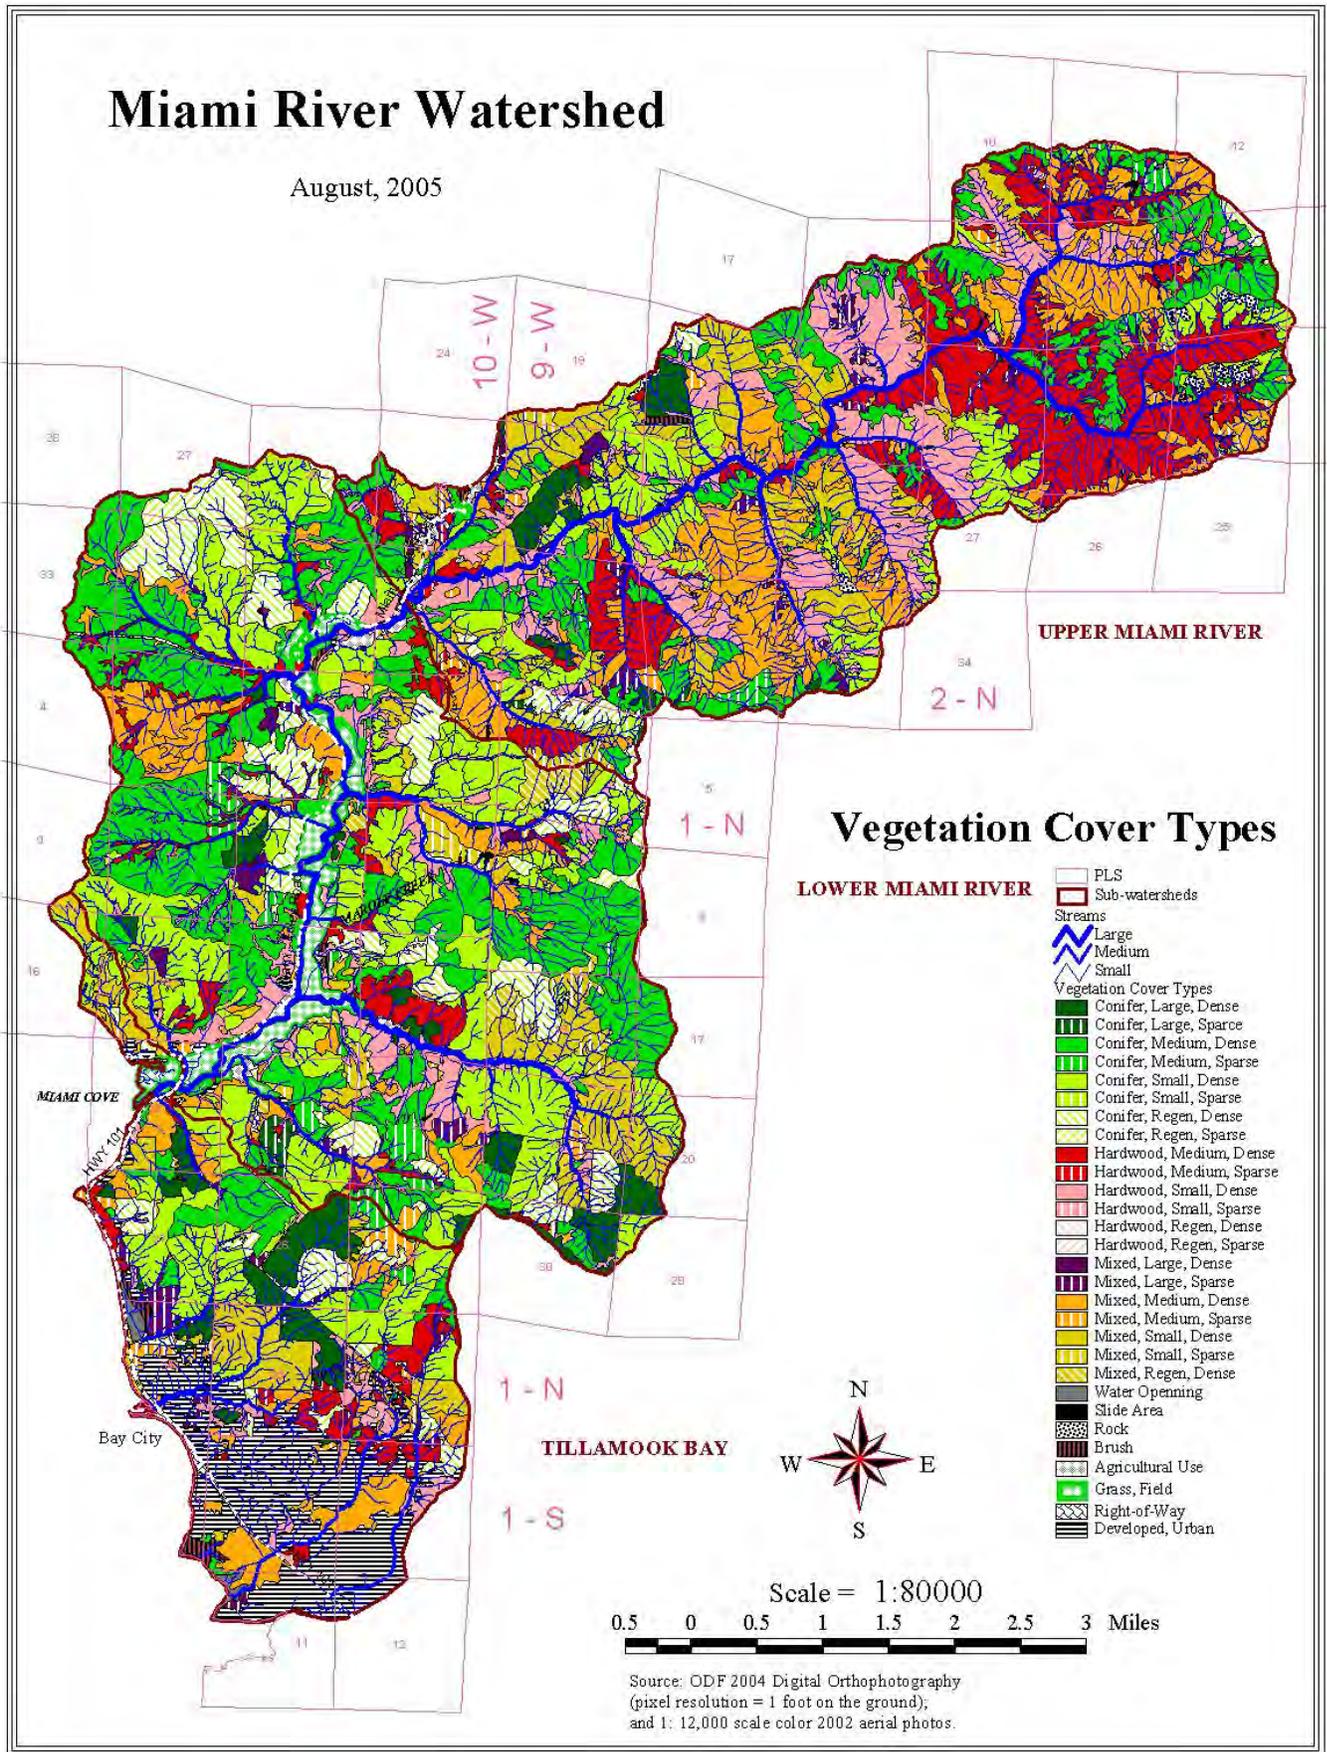
Figure 2. Vegetation cover types and streams in the Miami River Watershed Project Area.

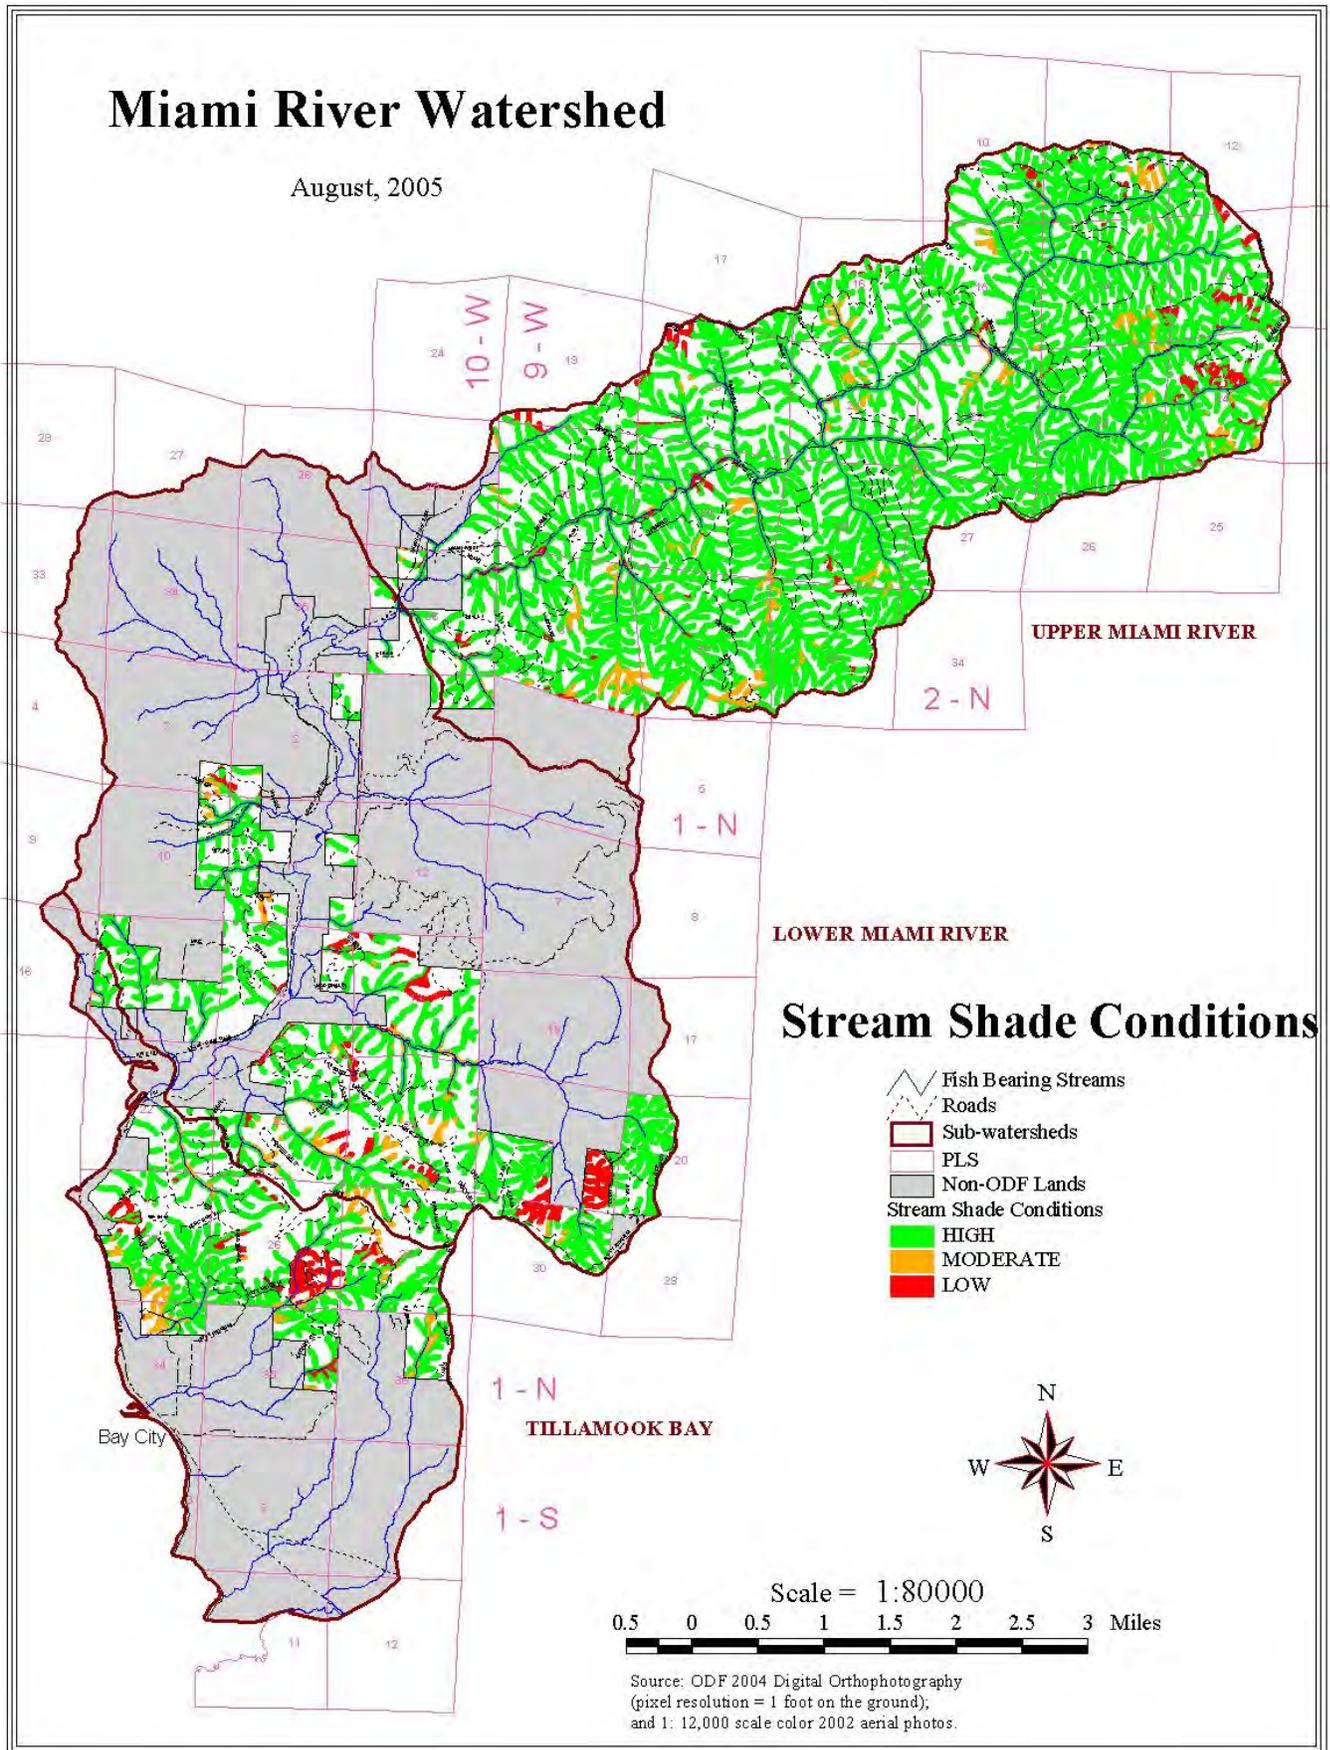
Figure 1. Current estimate of stream shade conditions on ODF Lands in the Miami River Watershed Project Area.

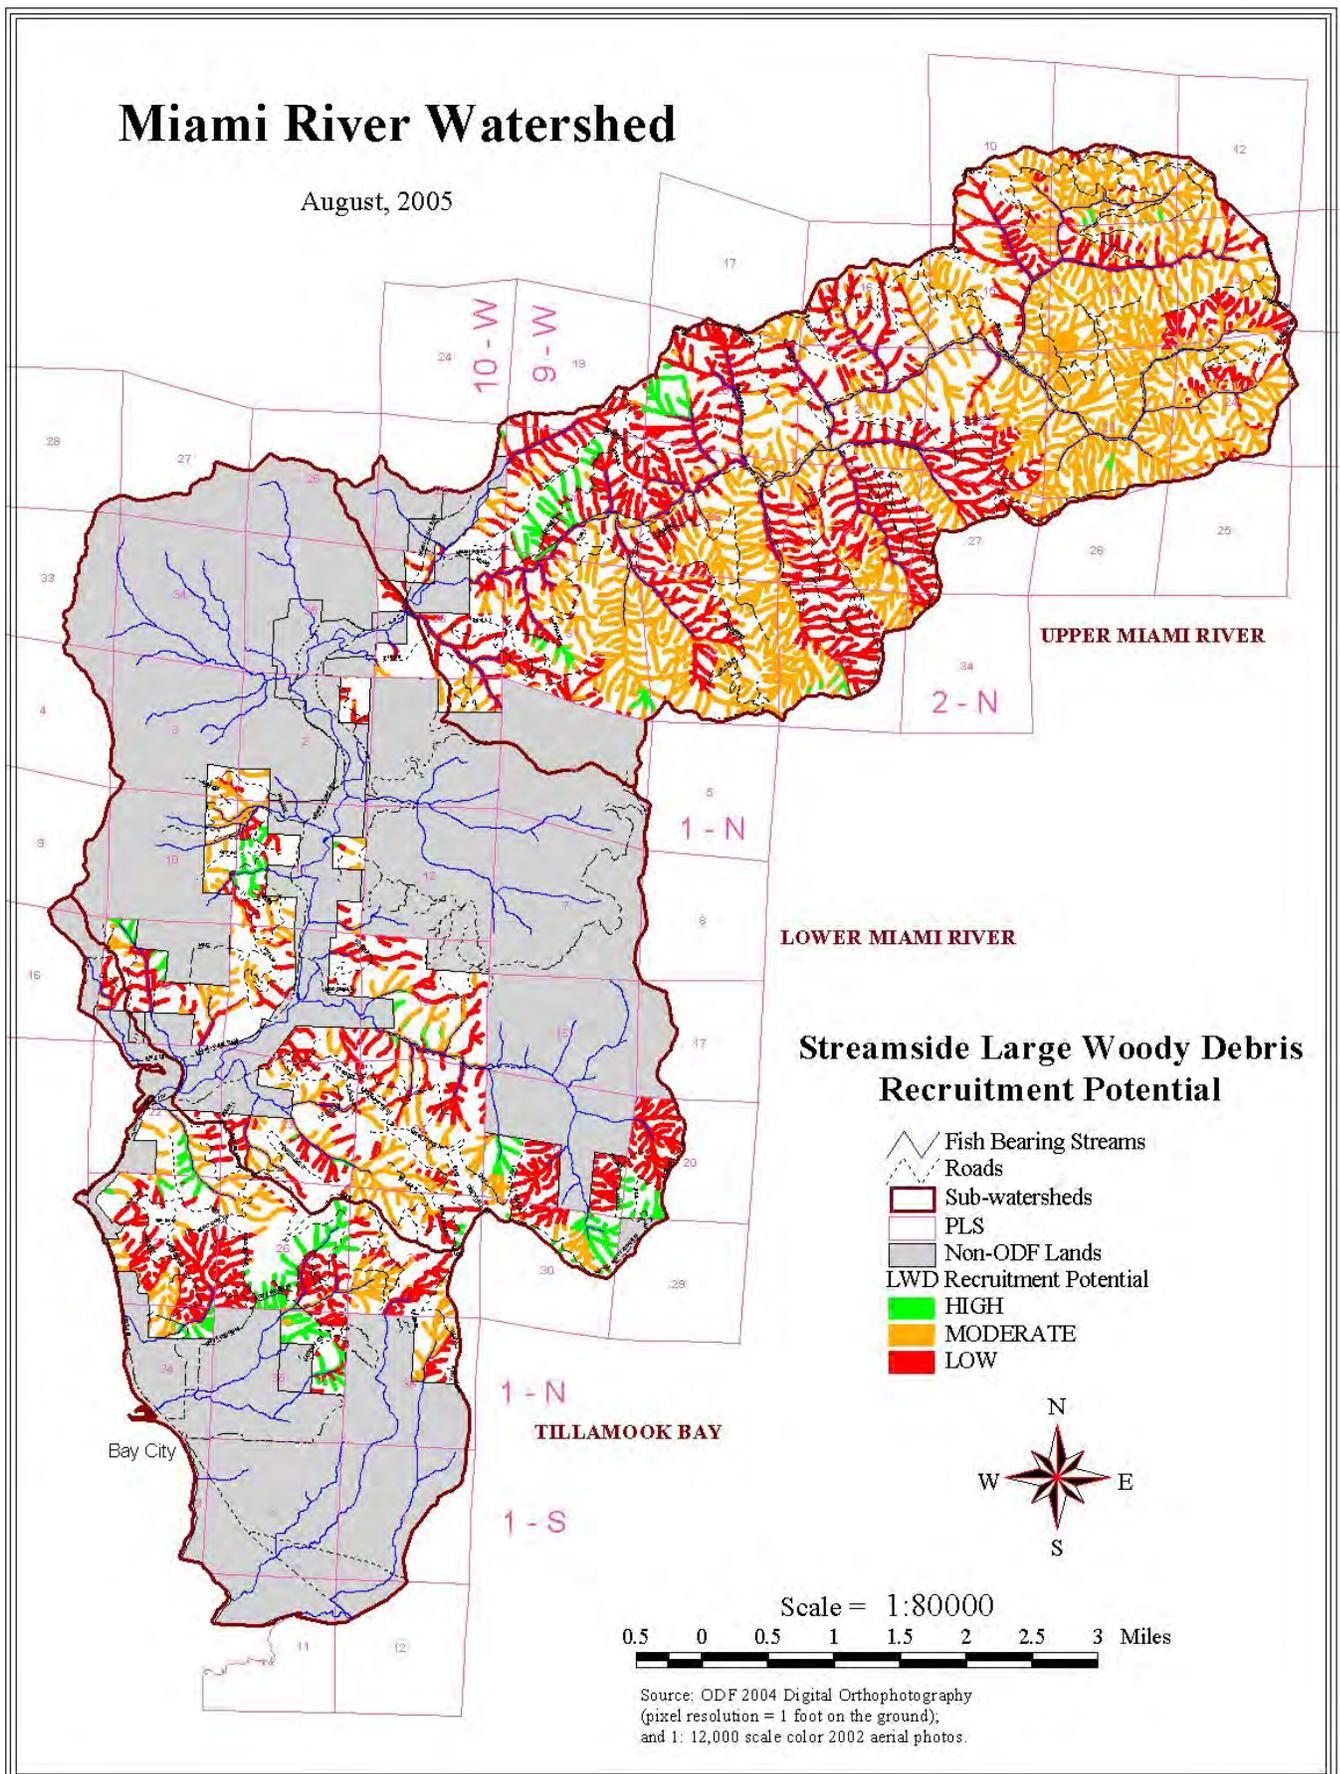
Figure 2. Current estimate of large woody debris recruitment potential on ODF lands in the Miami River Watershed Project Area.

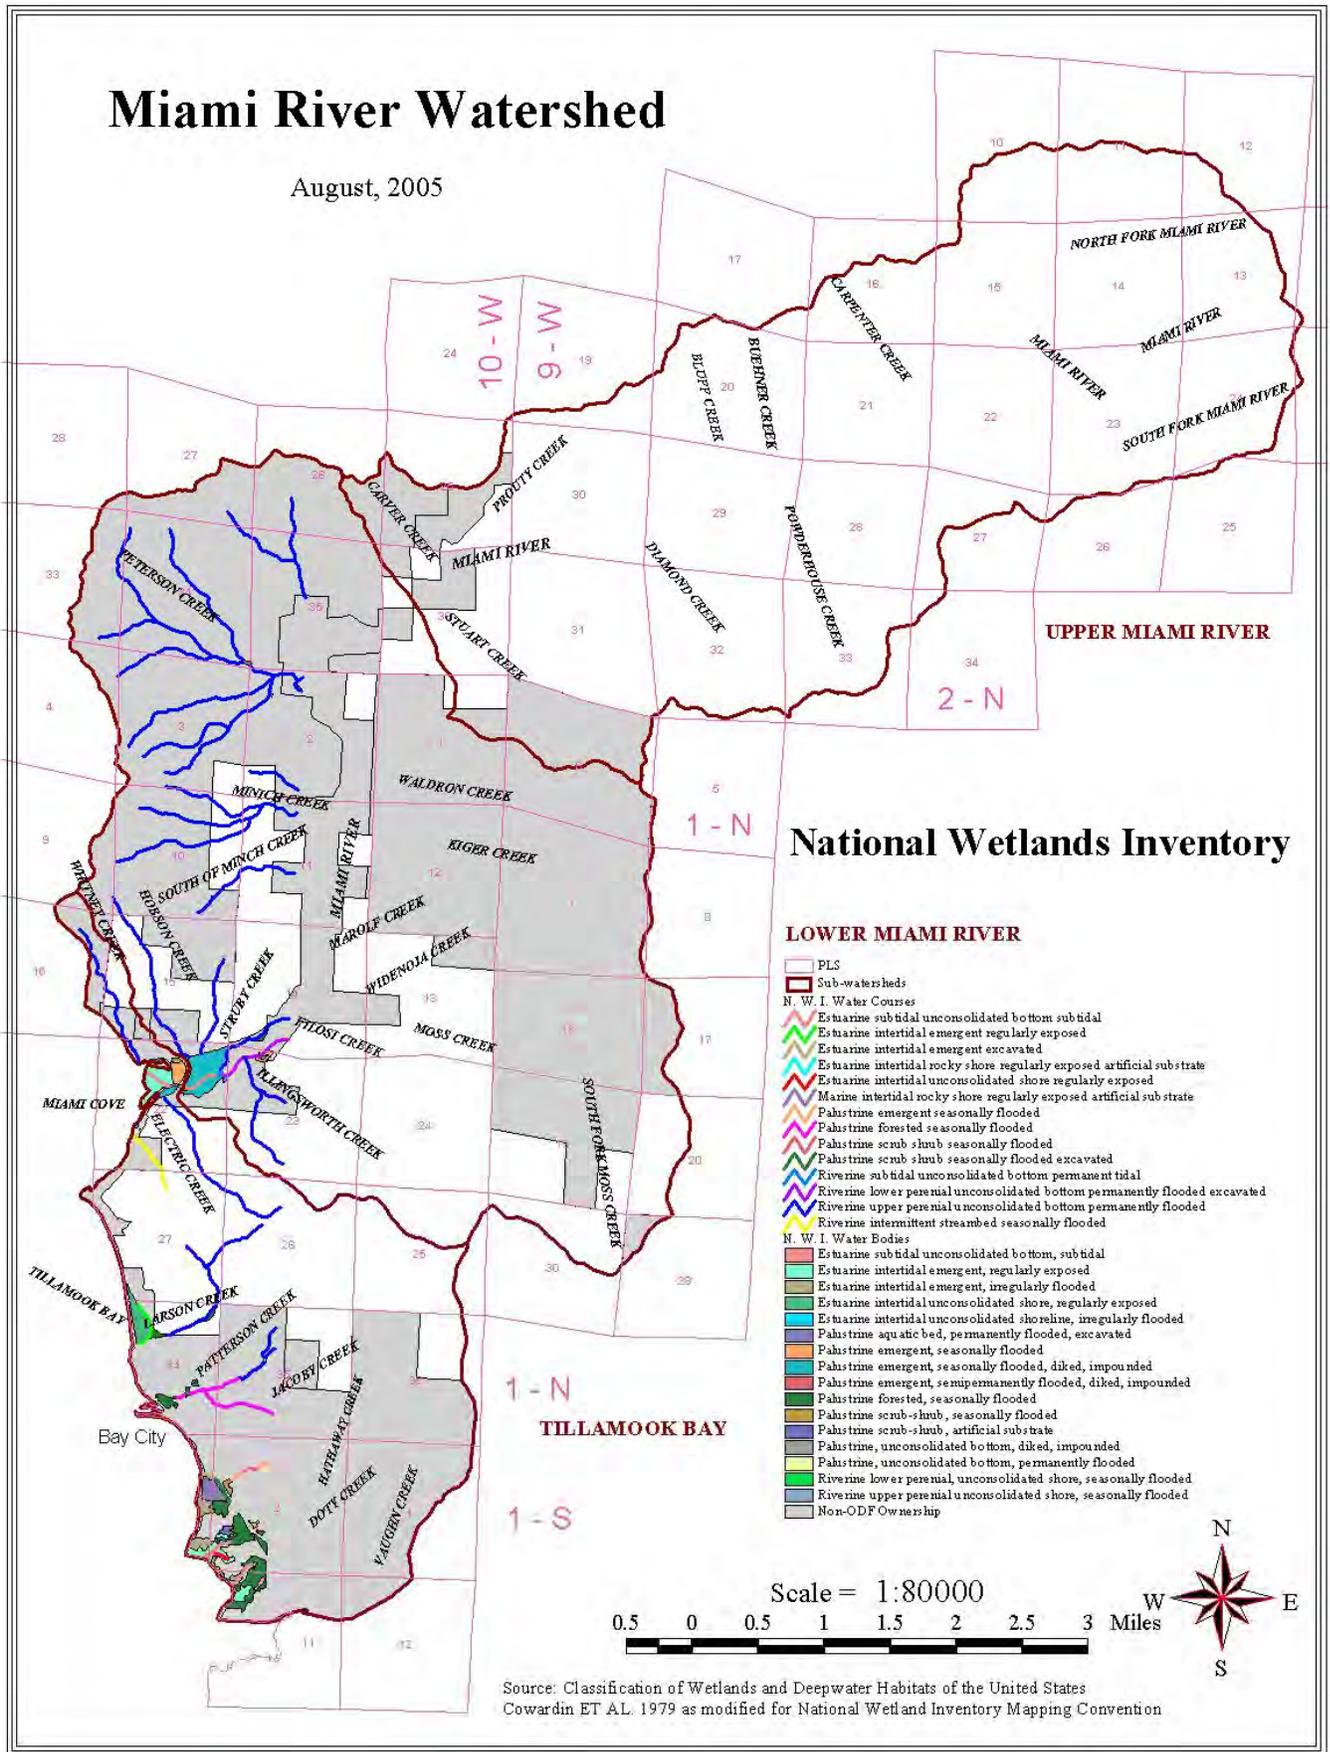
Figure 3. Mapped wetlands in the Miami River Watershed Project Area (Source: NWI).
