Miami River Watershed Assessment and Analysis of ODF Lands

August 15, 2005

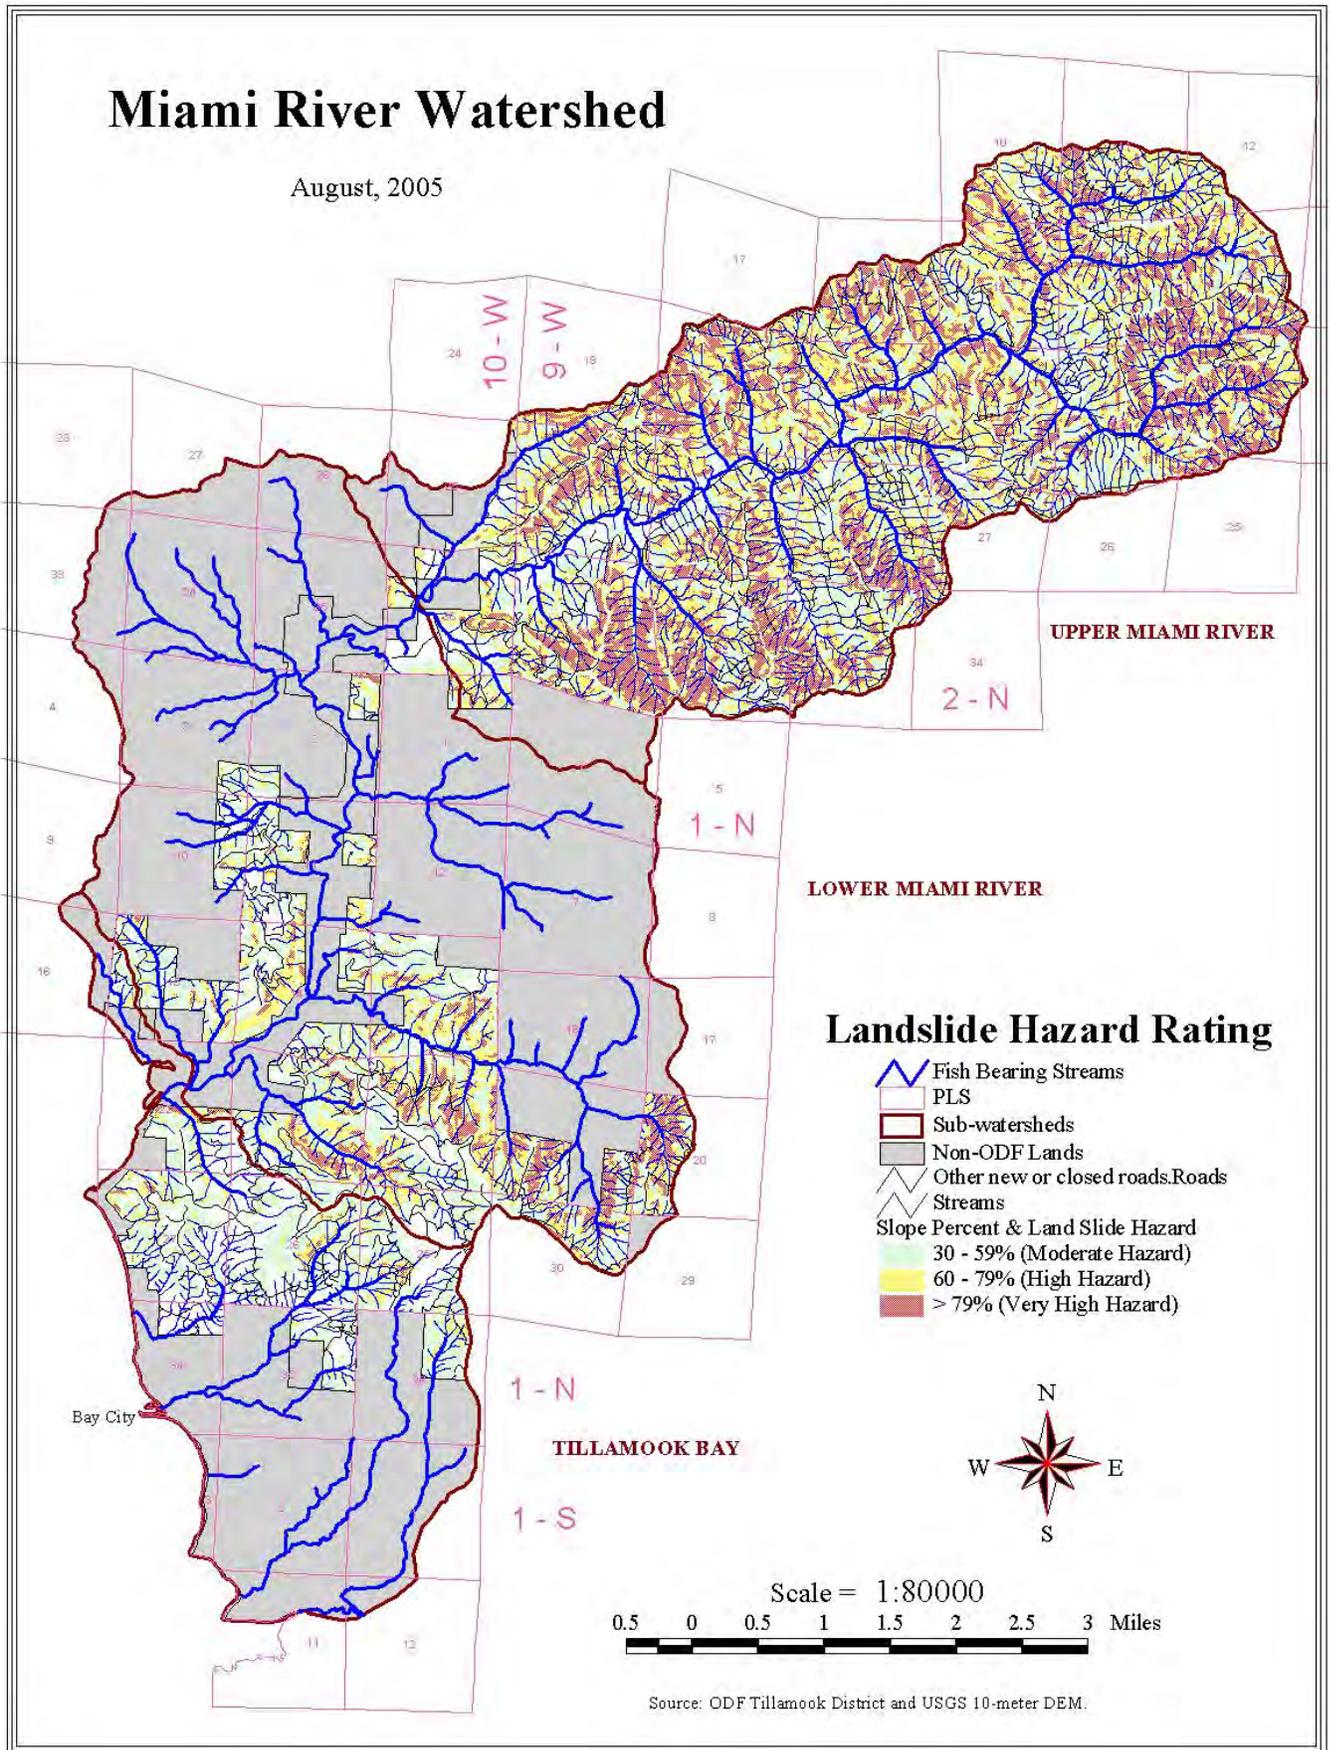
Figure 1. Map of shallow rapid landslide risk on ODF lands in the Miami River Watershed Project Area.

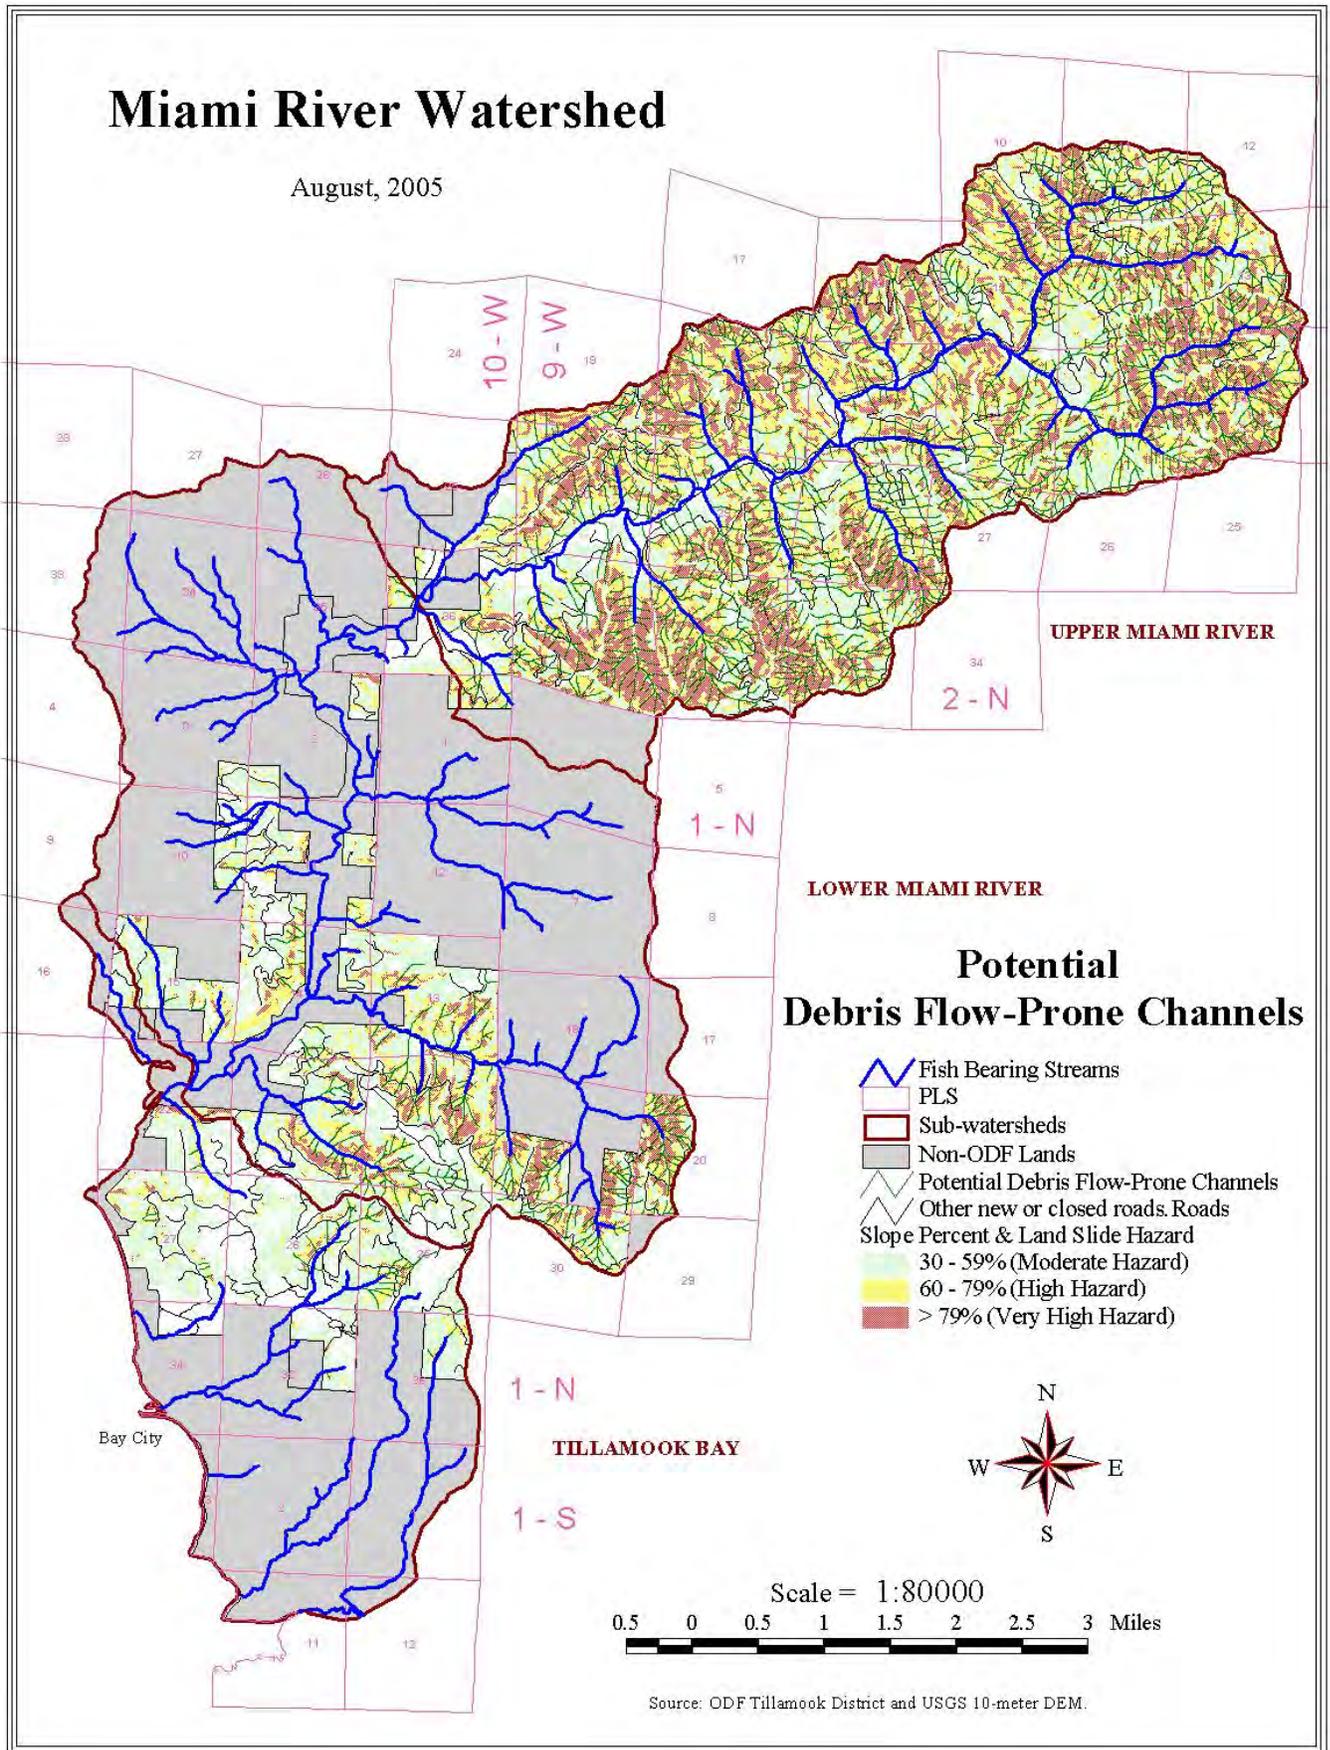
Figure 2. Potential debris flow-prone channels identified on ODF lands in the Miami River Watershed Project Area.

To evaluate the accuracy of Figure 14, the mapped distribution of debris flow-prone channels was compared to conditions observed in the field. Seventy-one different locations were sampled. Five sites (7% of samples) that were designated on the map did not exhibit features consistent with debris flow-prone channels. Two (3% of samples) sites that were *not* designated on the map, exhibited characteristics resembling debris flow-prone channels. Additionally, an aerial photo reconnaissance of ODF lands that was conducted revealed eighteen readily identifiable landslide features. Of these, twelve were observed in the field. All were debris slides that corresponded to a debris flow-prone feature on the map. These validations suggest that the automated (GIS) method that was used to predict debris flow-prone channels is reasonably accurate at the watershed scale, and the map is judged to be useful for planning purposes.

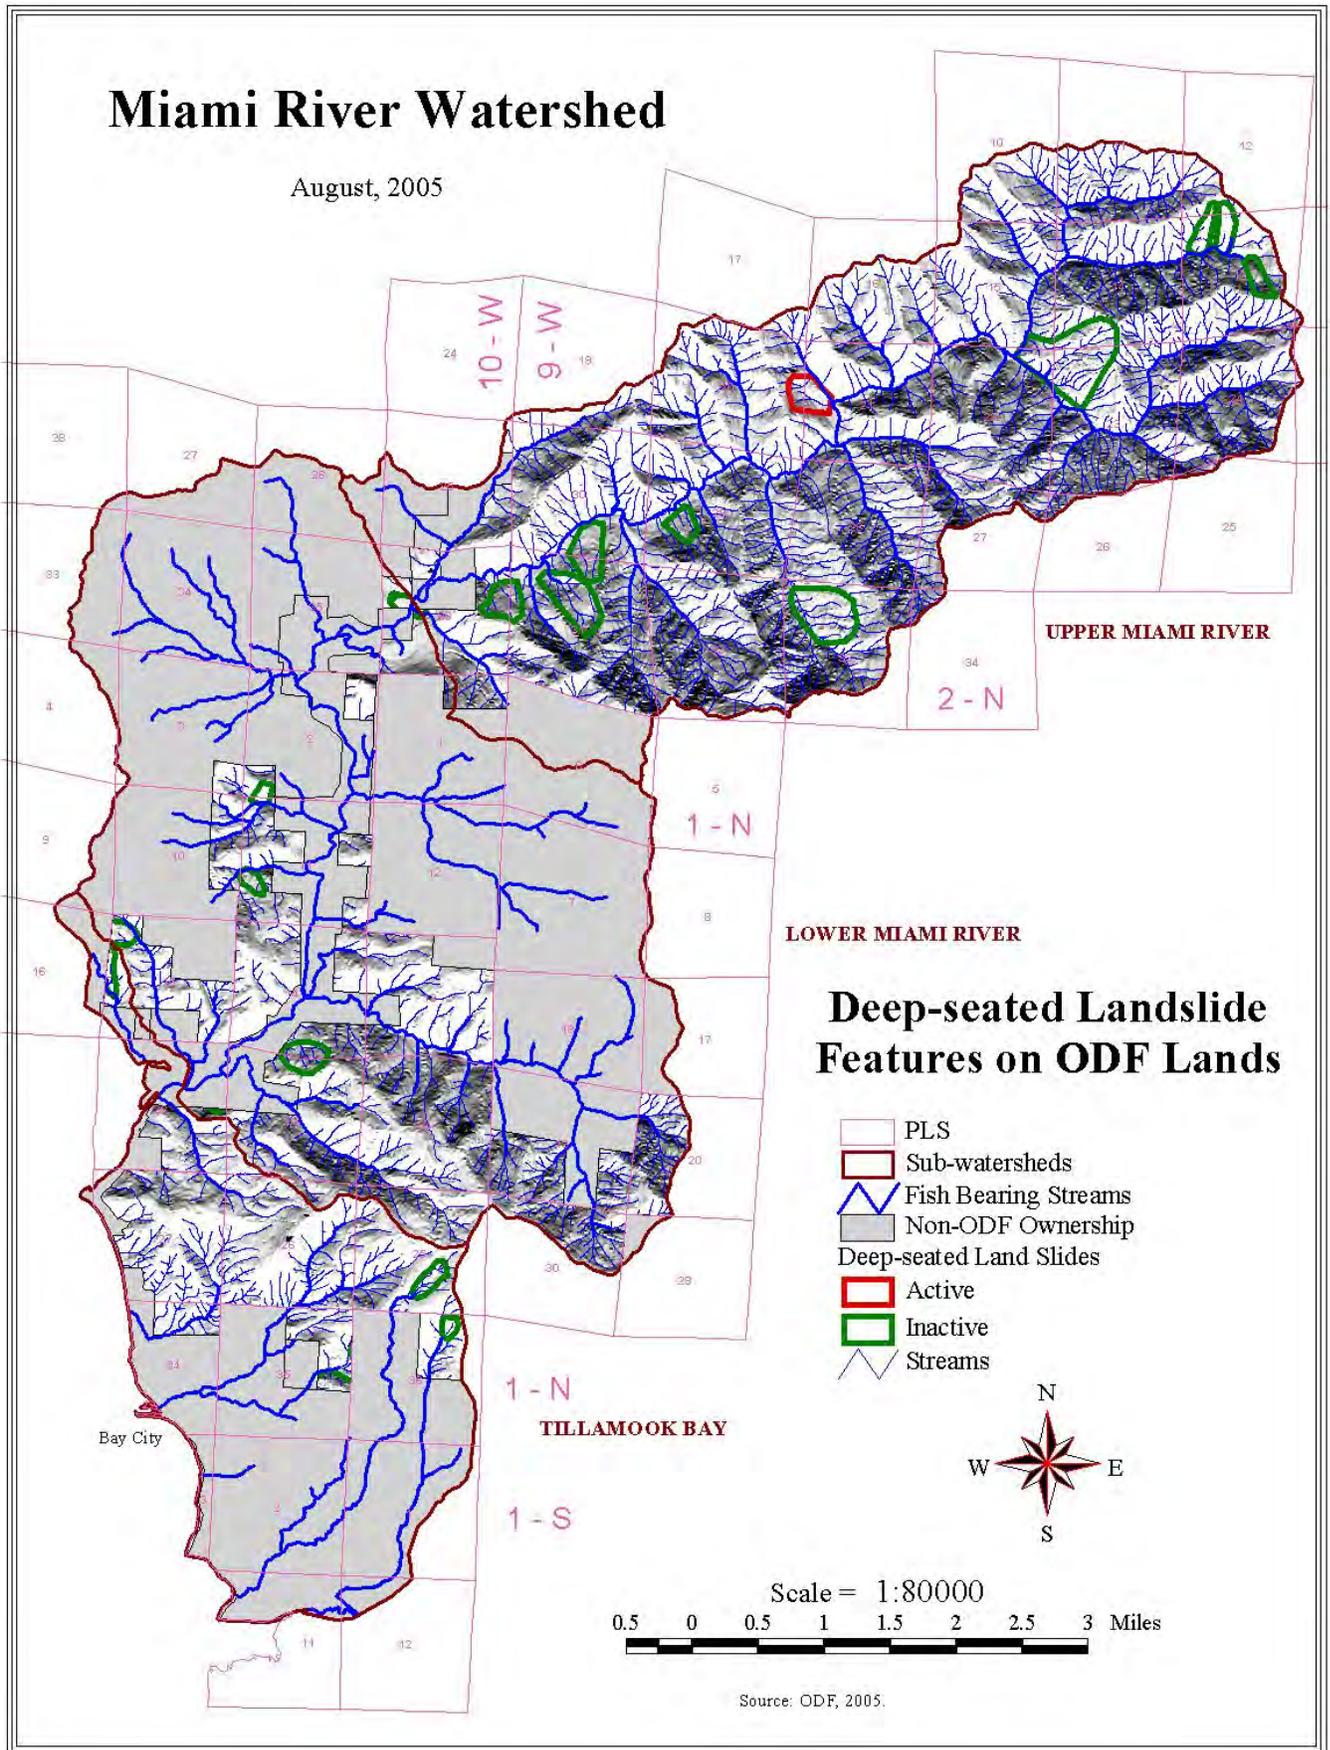
Figure 3. Active and inactive deep-seated landslides in the Miami River Watershed Project Area.

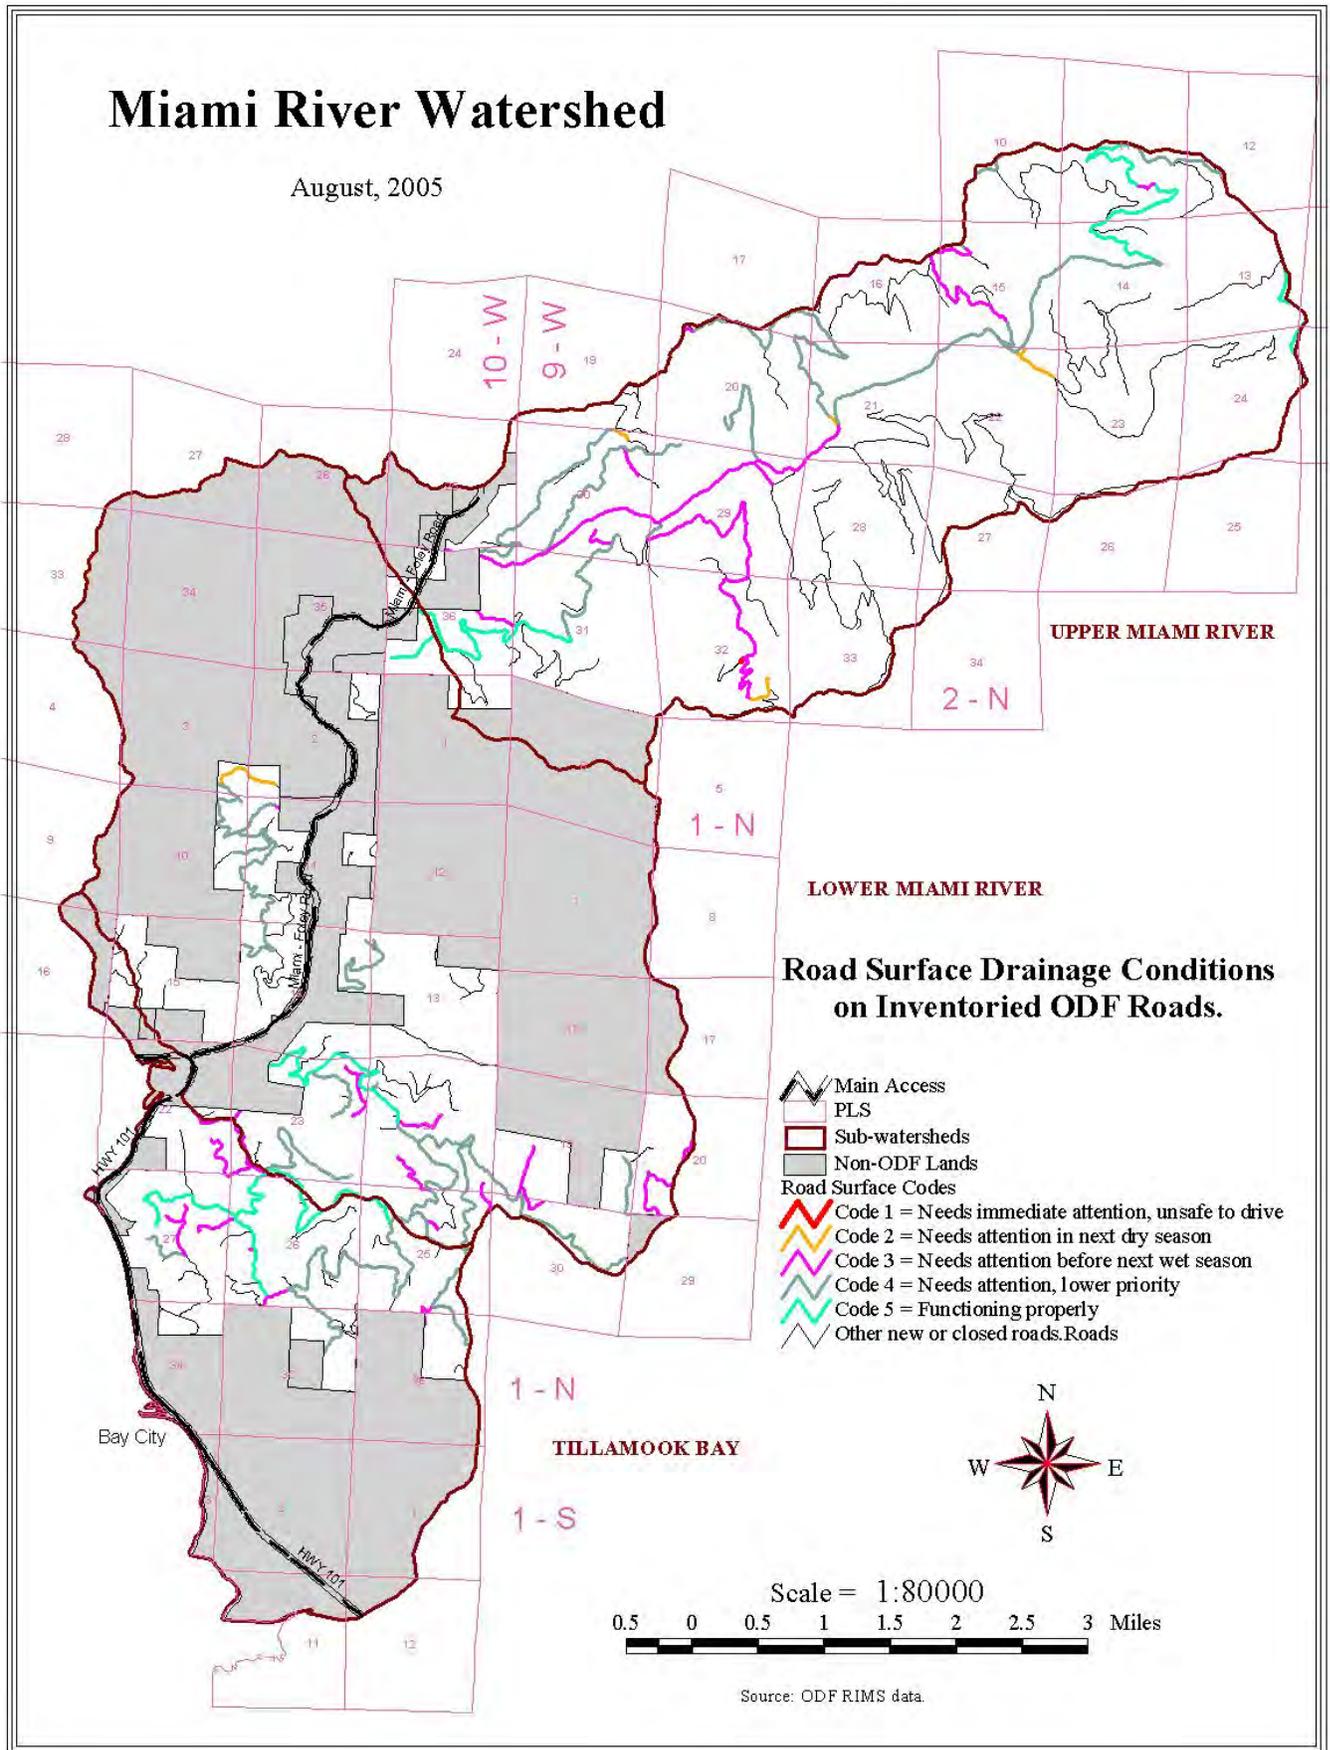
Figure 1. Road surface drainage conditions on inventoried ODF roads within the Miami River Watershed Project Area.

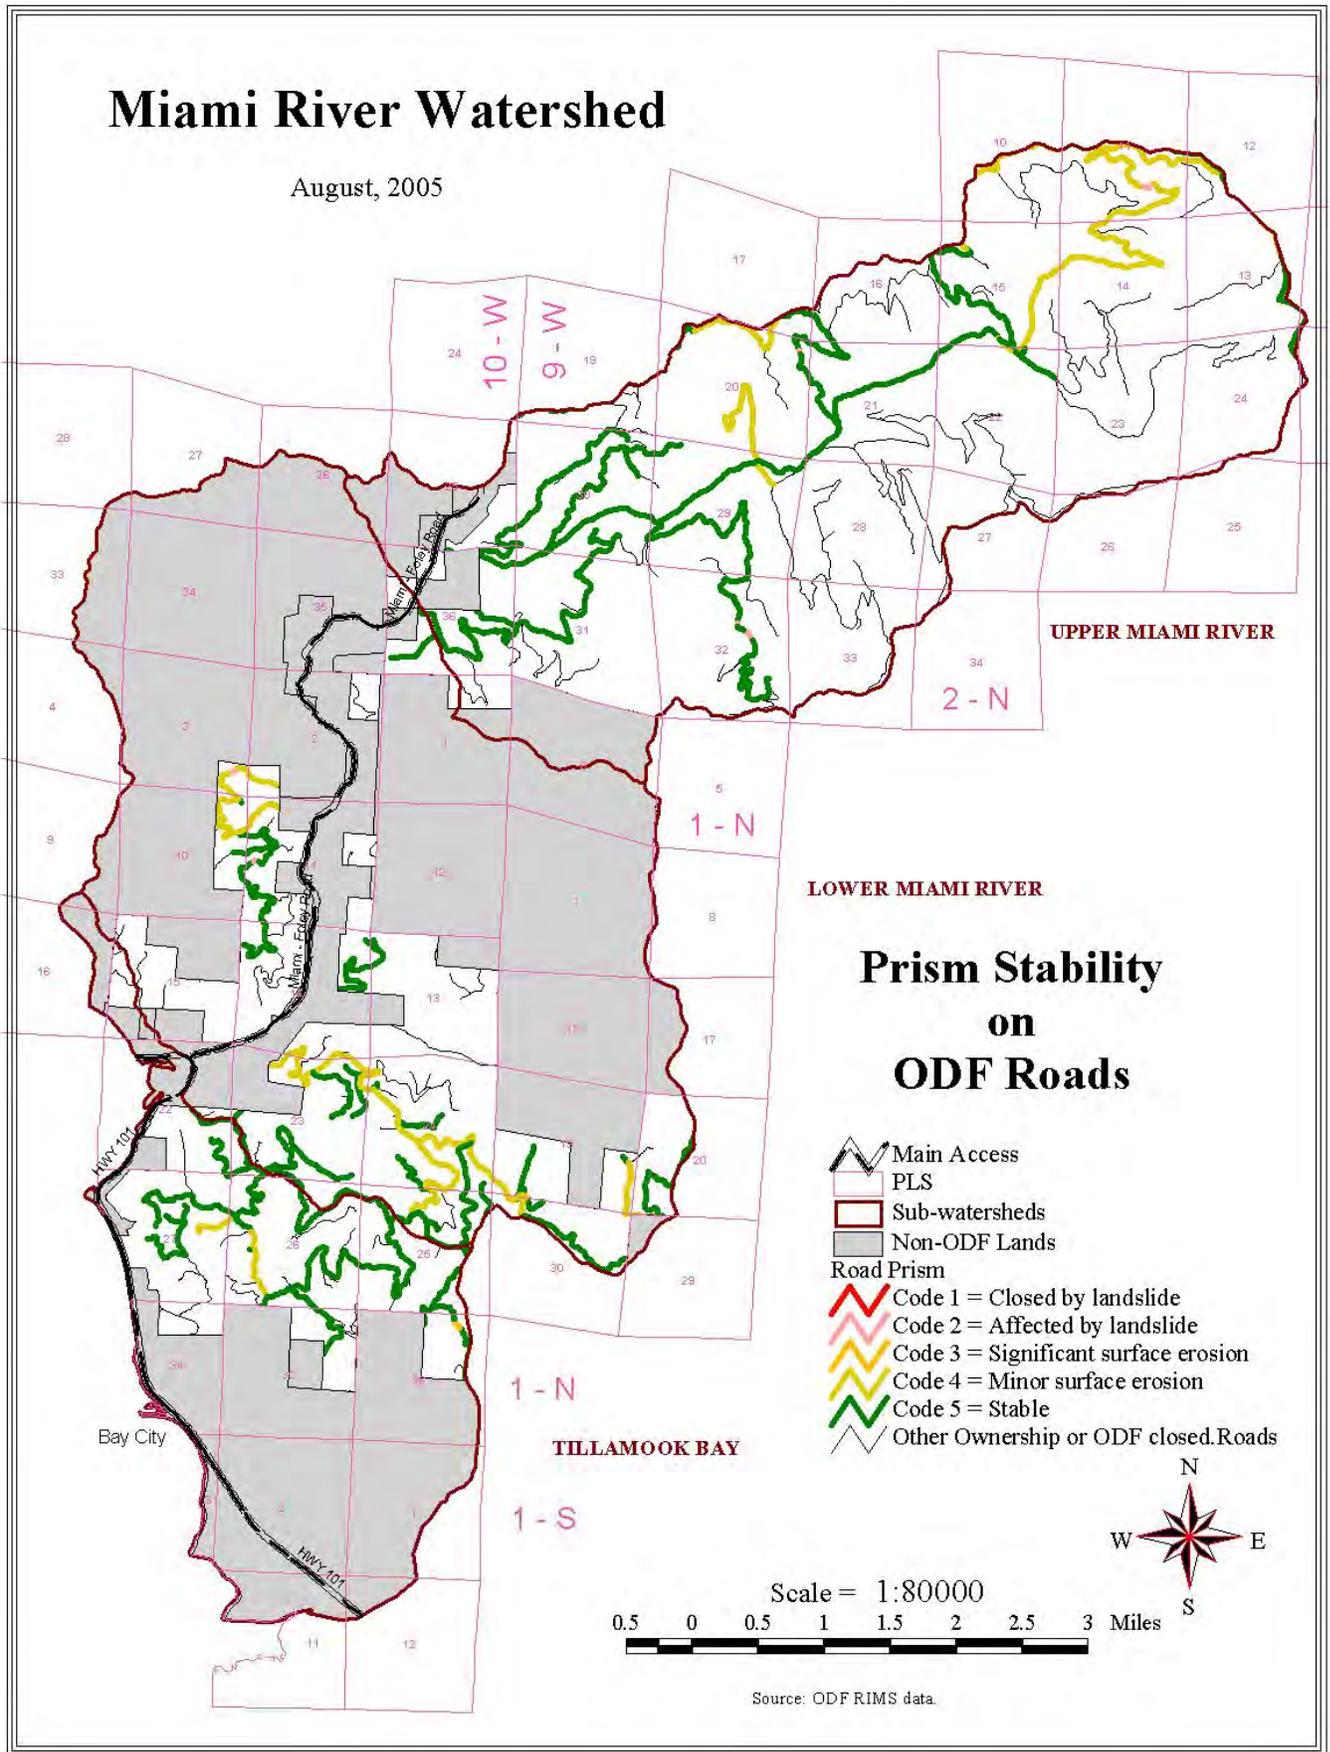
Figure 2. Road prism stability on inventoried ODF roads within the Miami River Watershed Project Area.

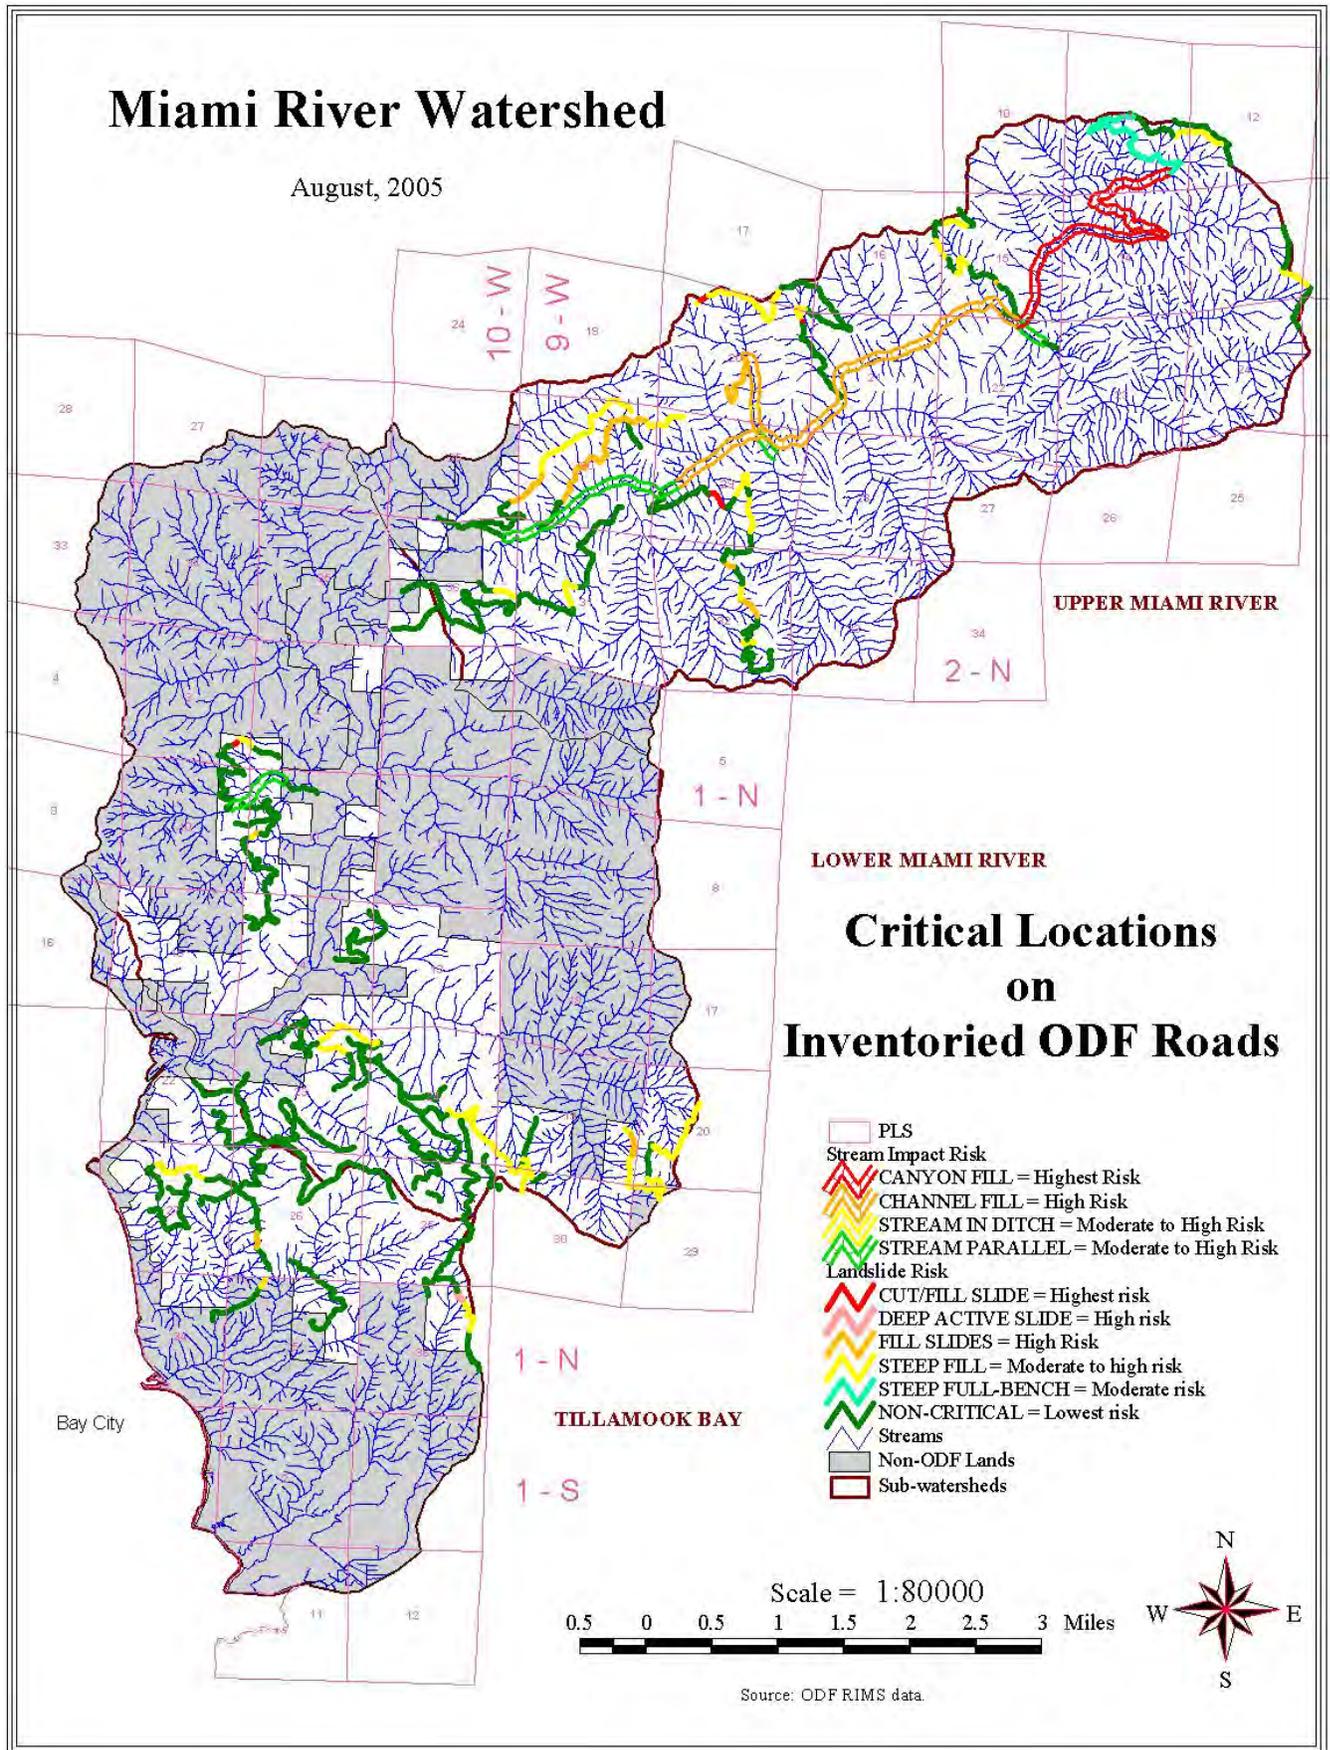
Figure 3. Road segments rated as critical locations for risk to aquatic and riparian resources on ODF lands in the Miami River Watershed Project Area.

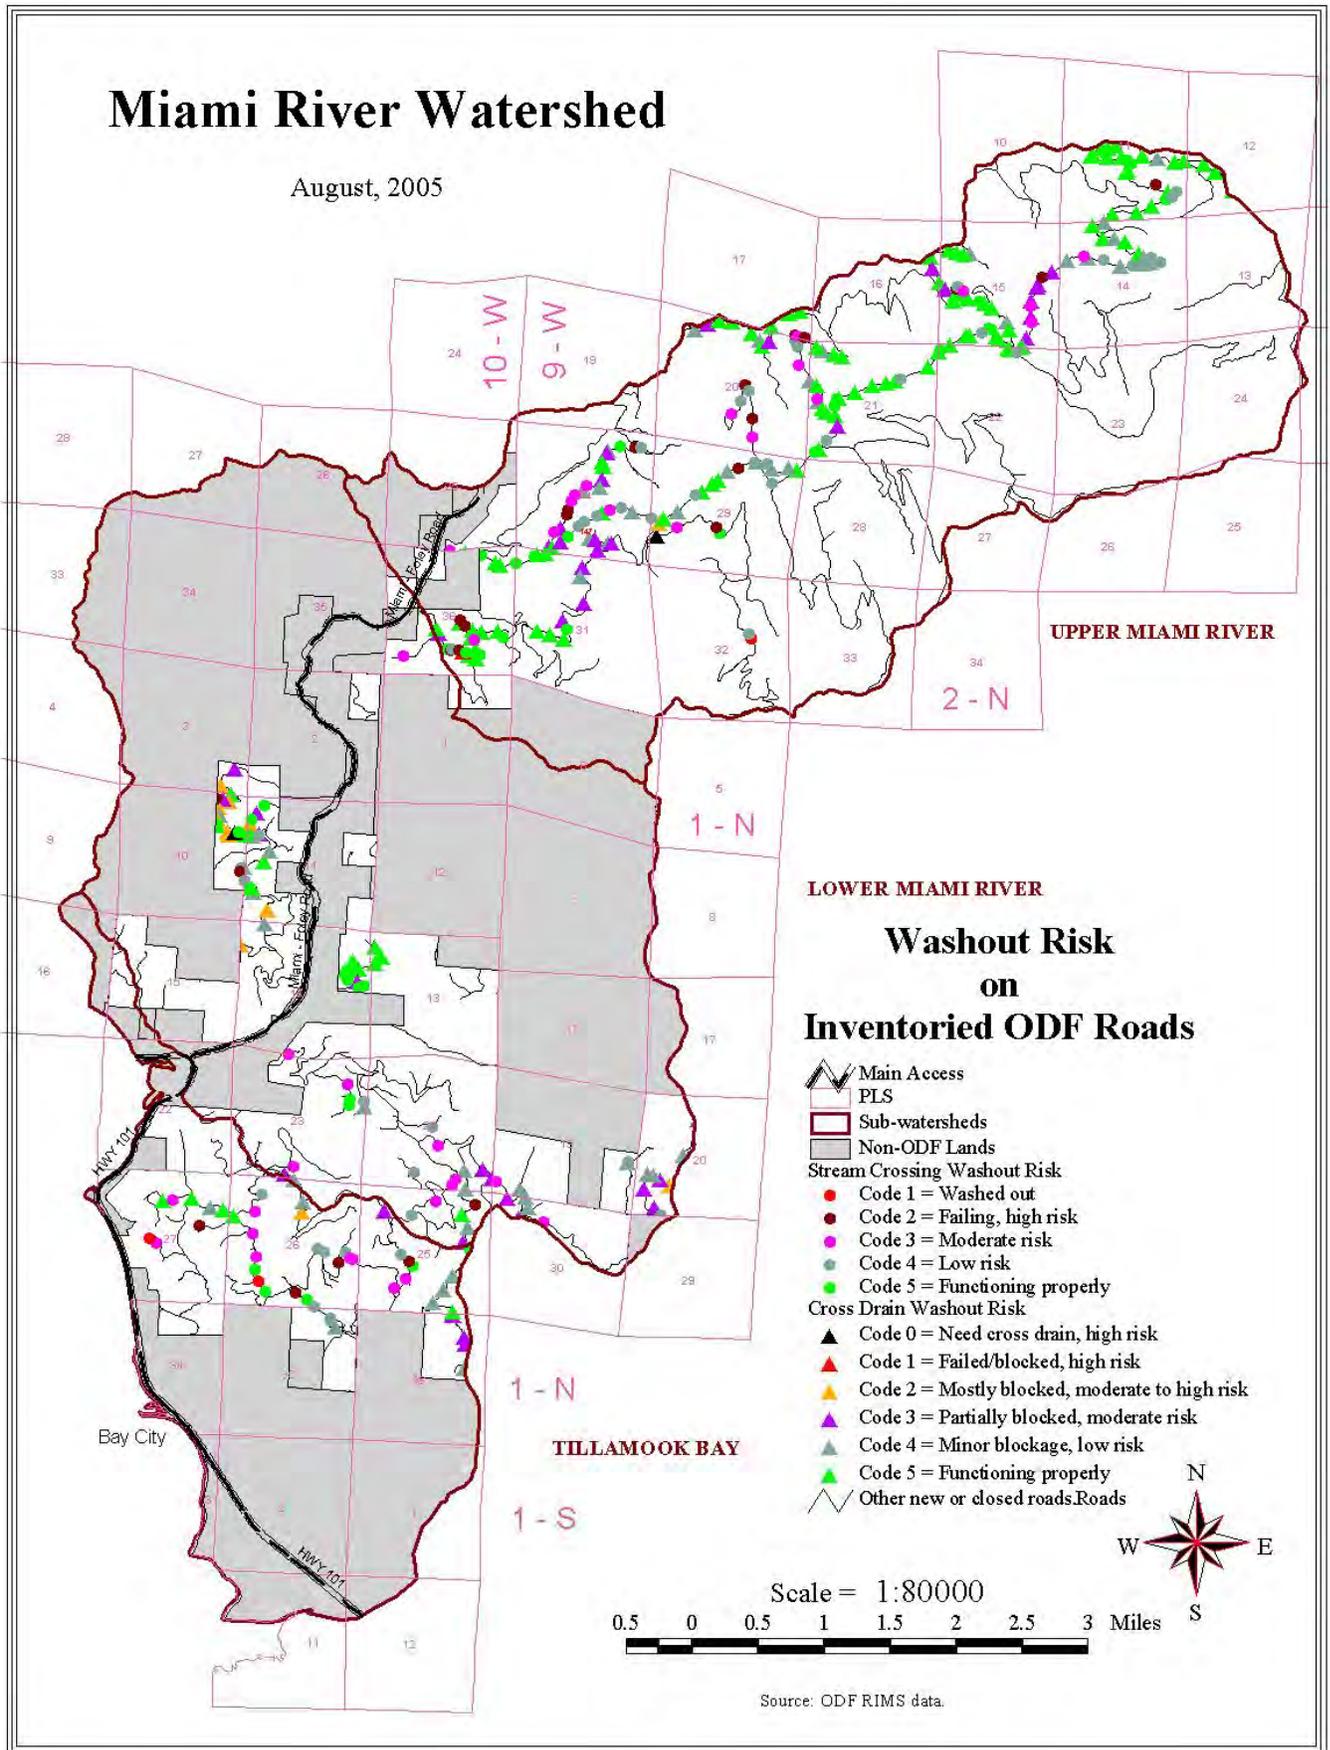
Figure 1. Stream crossings with a high risk of washout on ODF lands in the Miami River Watershed Project Area.

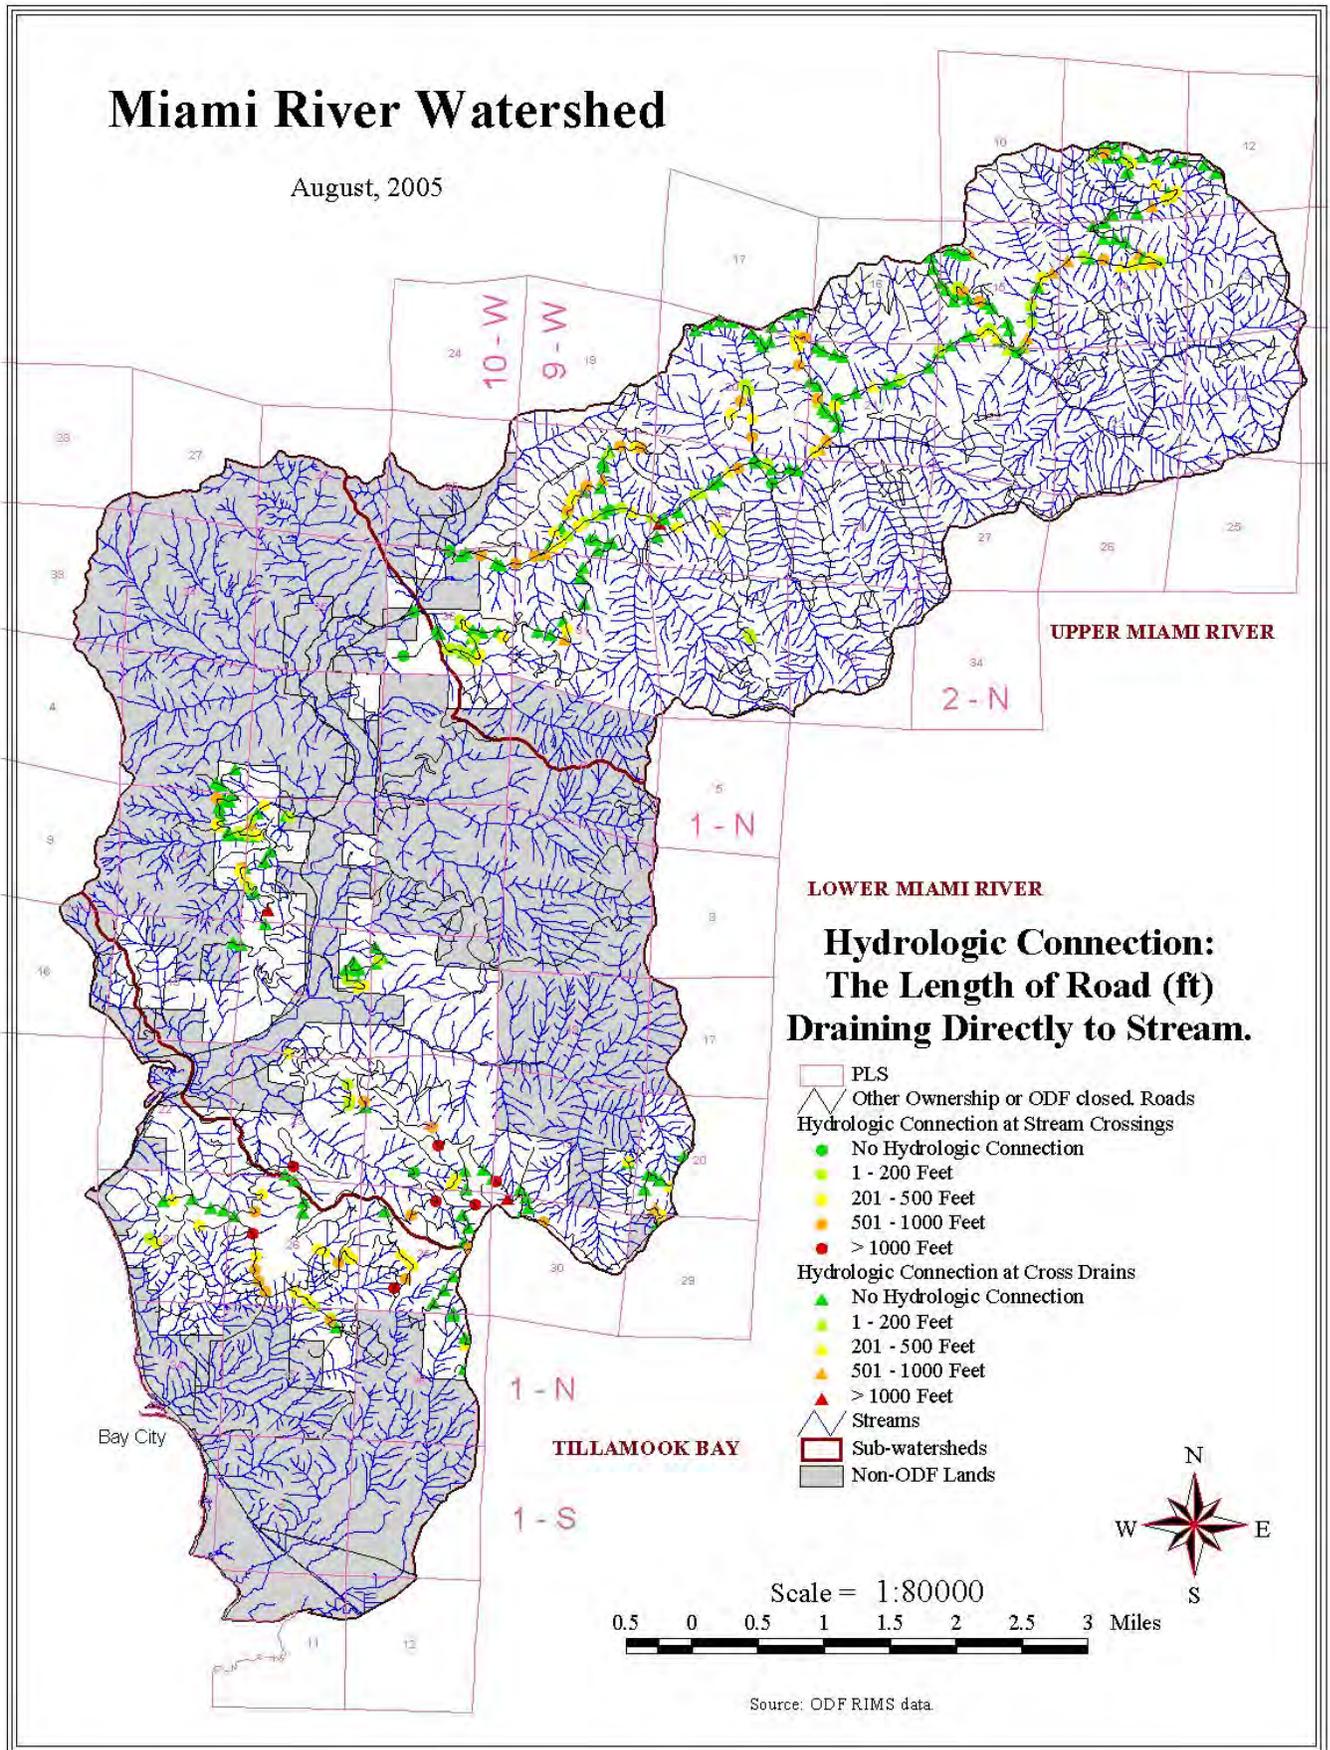
Figure 2. Road segments on ODF lands draining directly to streams in the Miami River Watershed Project Area.

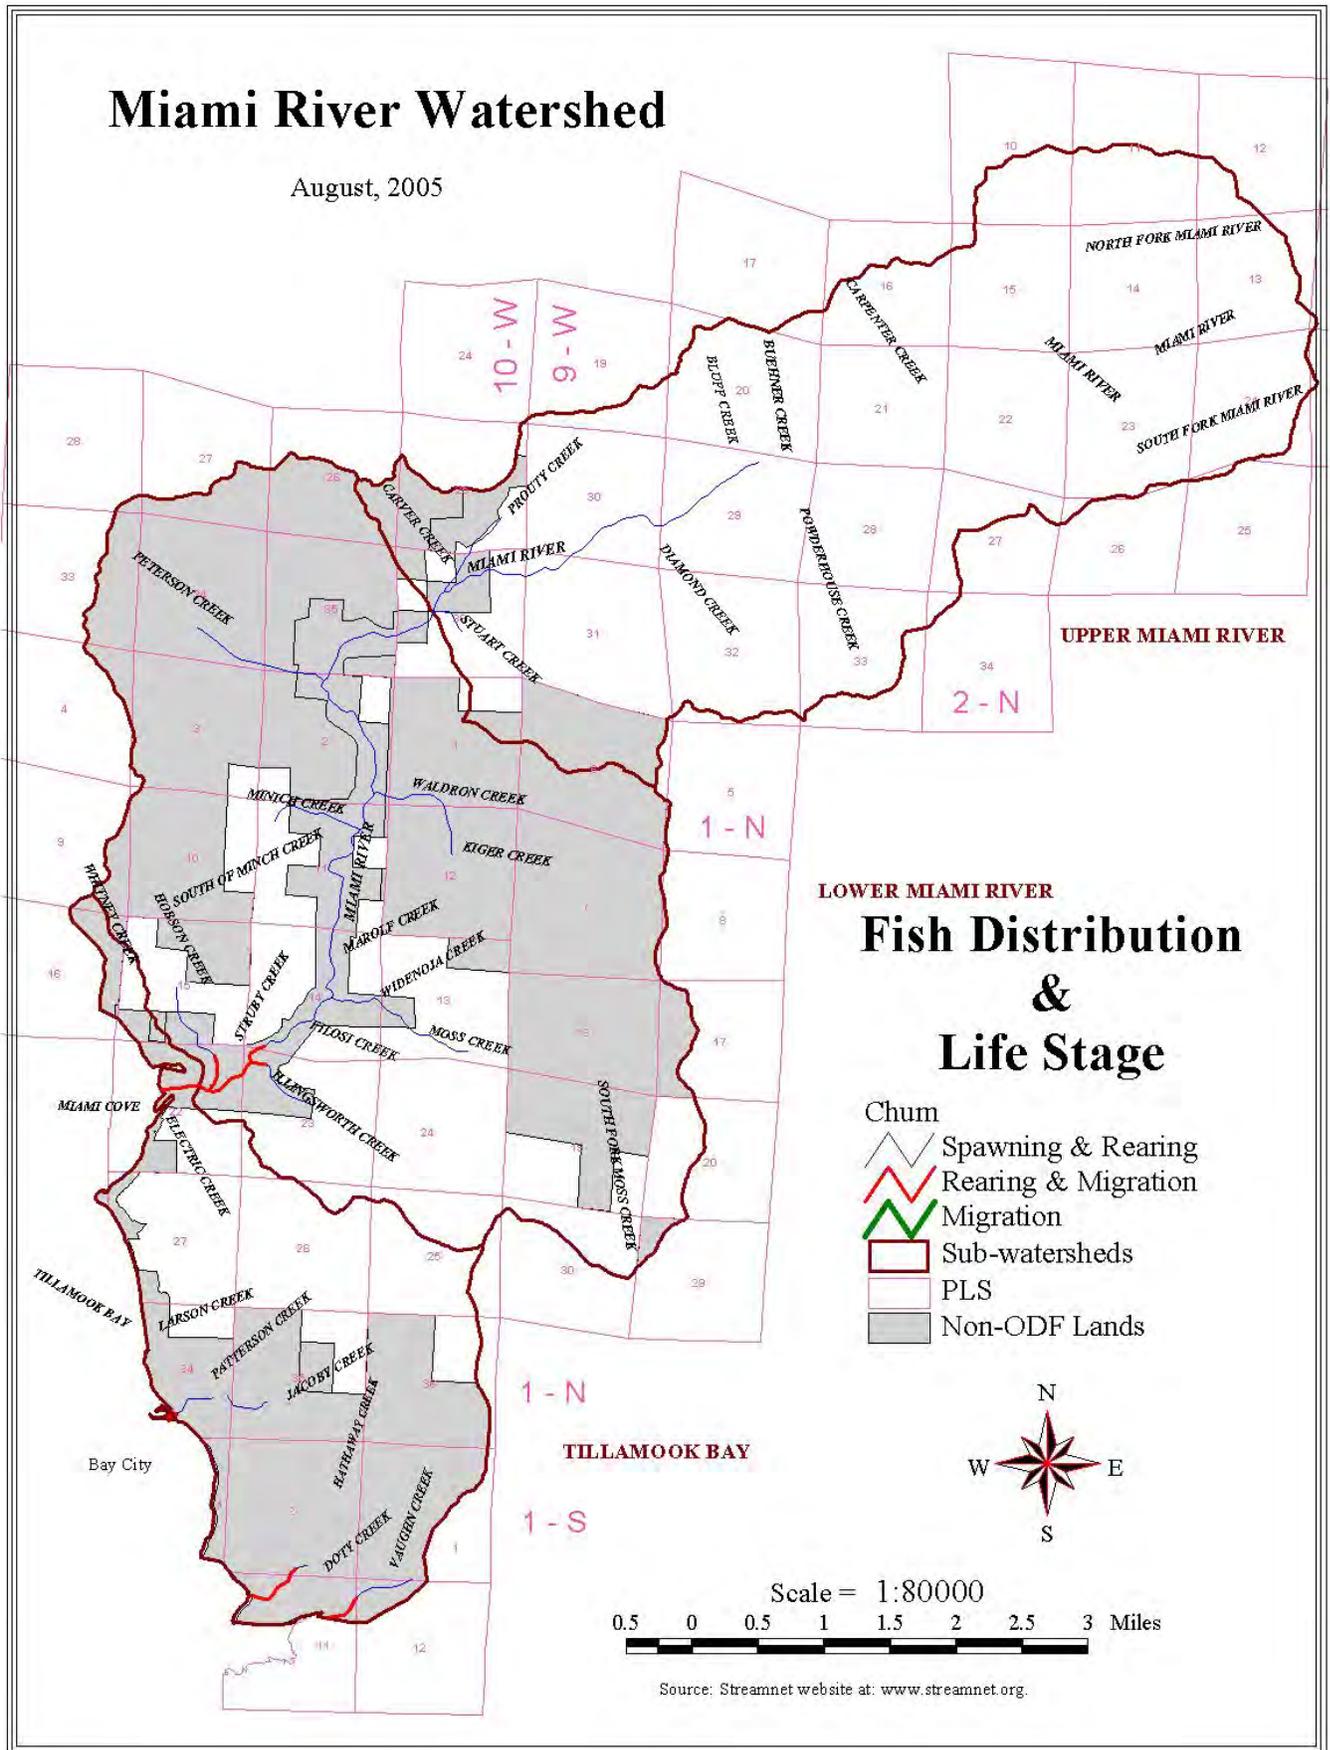
Figure 1. Estimated chum salmon distribution in the Miami River Watershed Project Area.
