Miami River Watershed Assessment and Analysis of ODF Lands

August 15, 2005

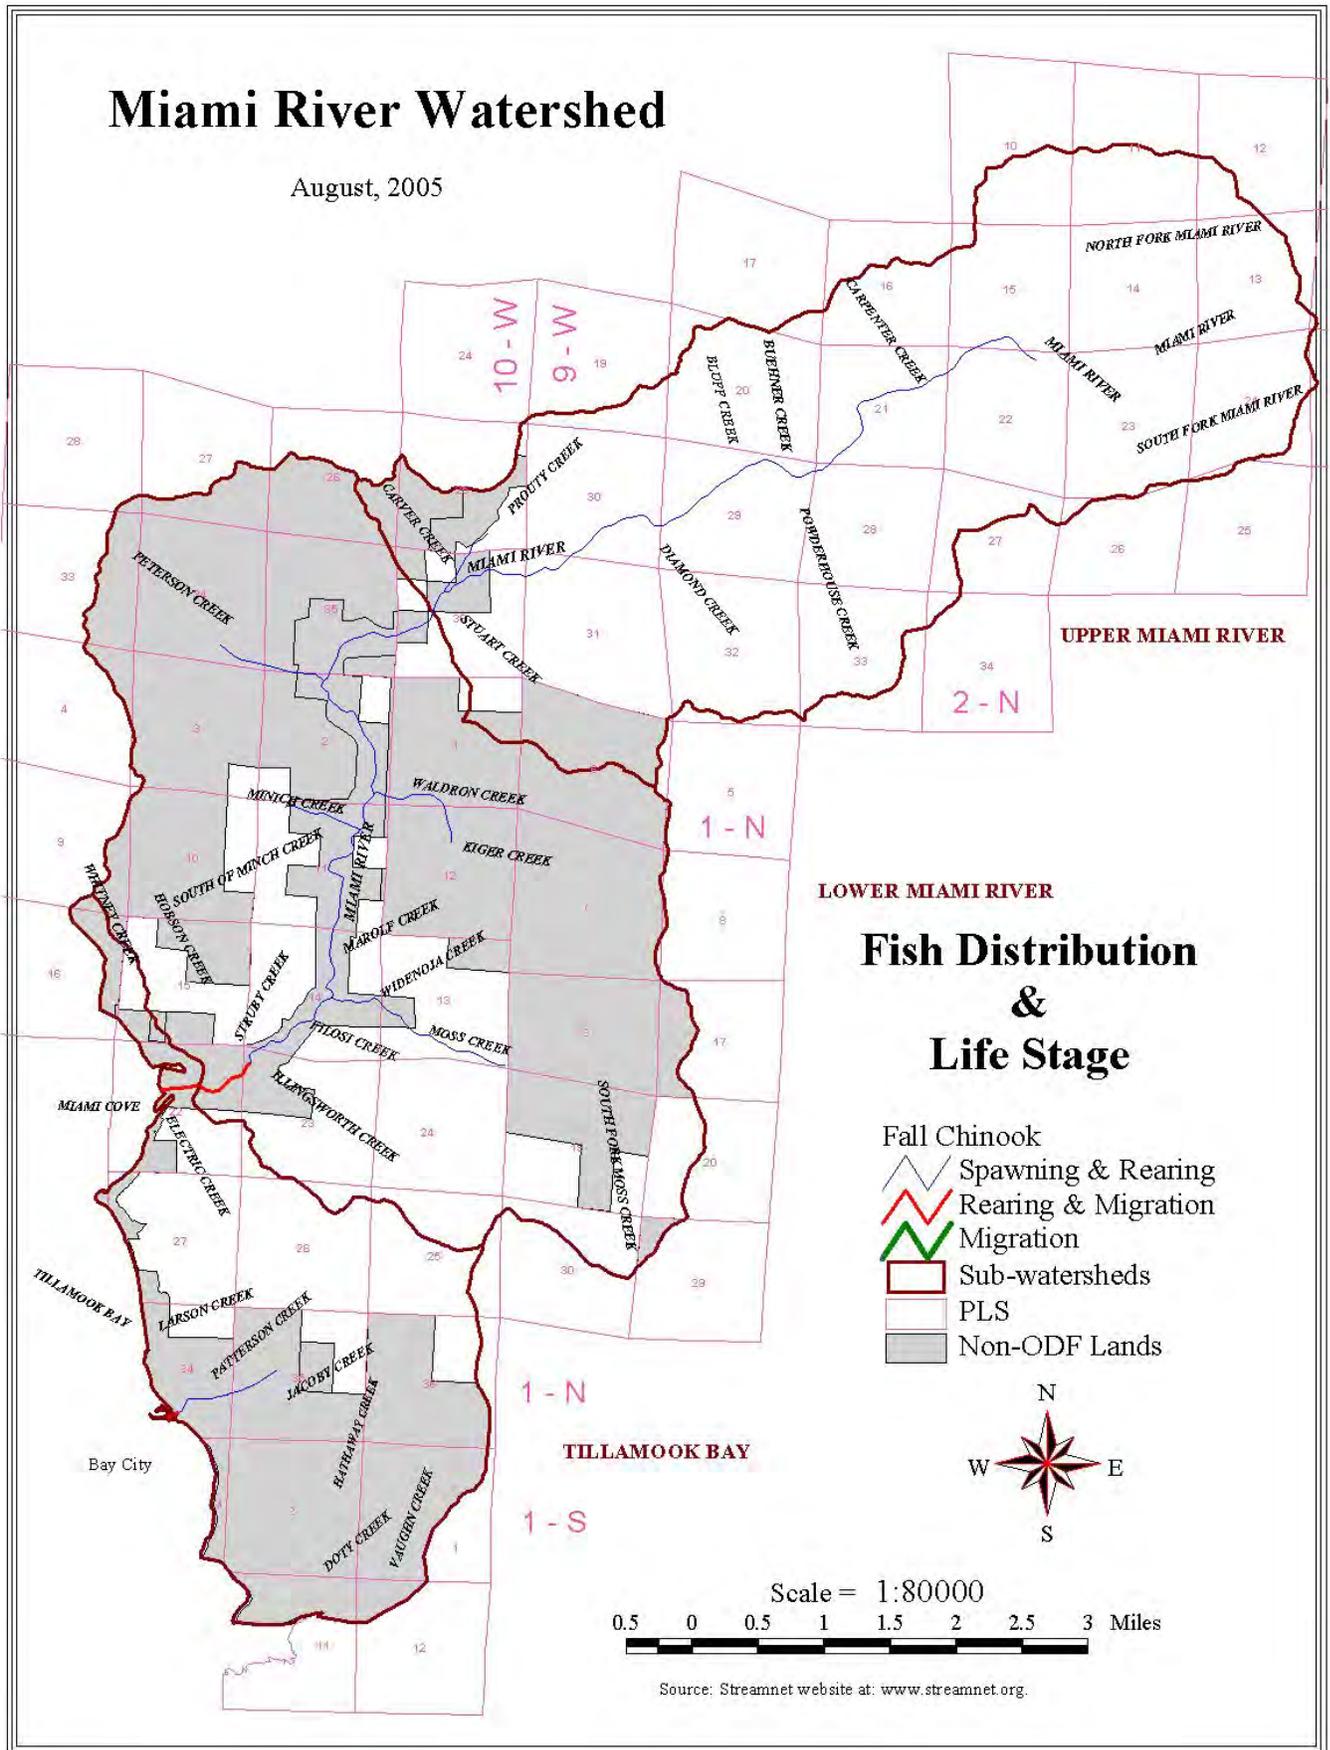
Figure 2. Estimated fall Chinook salmon distribution in the Miami River Watershed Project Area.

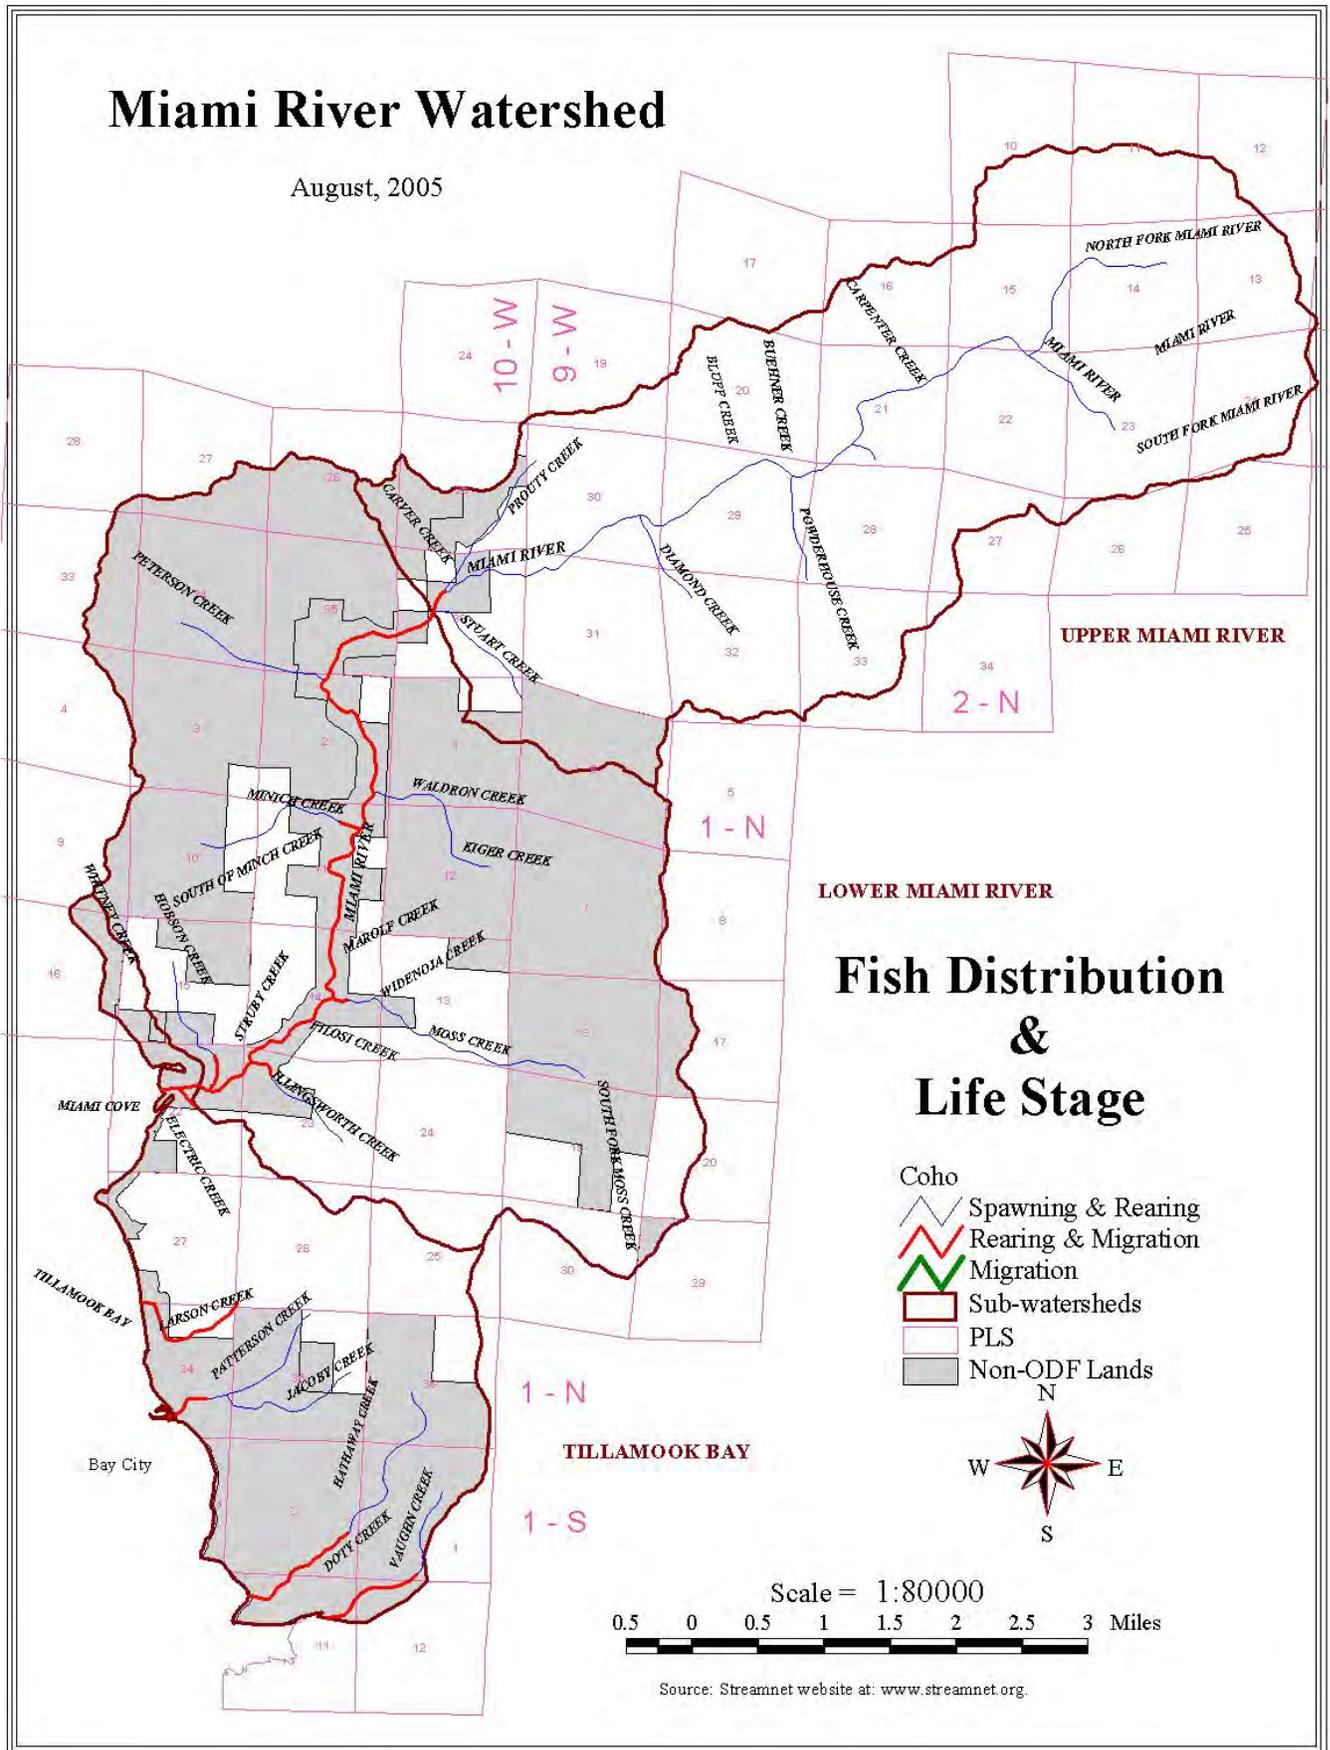
Figure 3. Estimated coho salmon distribution in the Miami River Watershed Project Area.

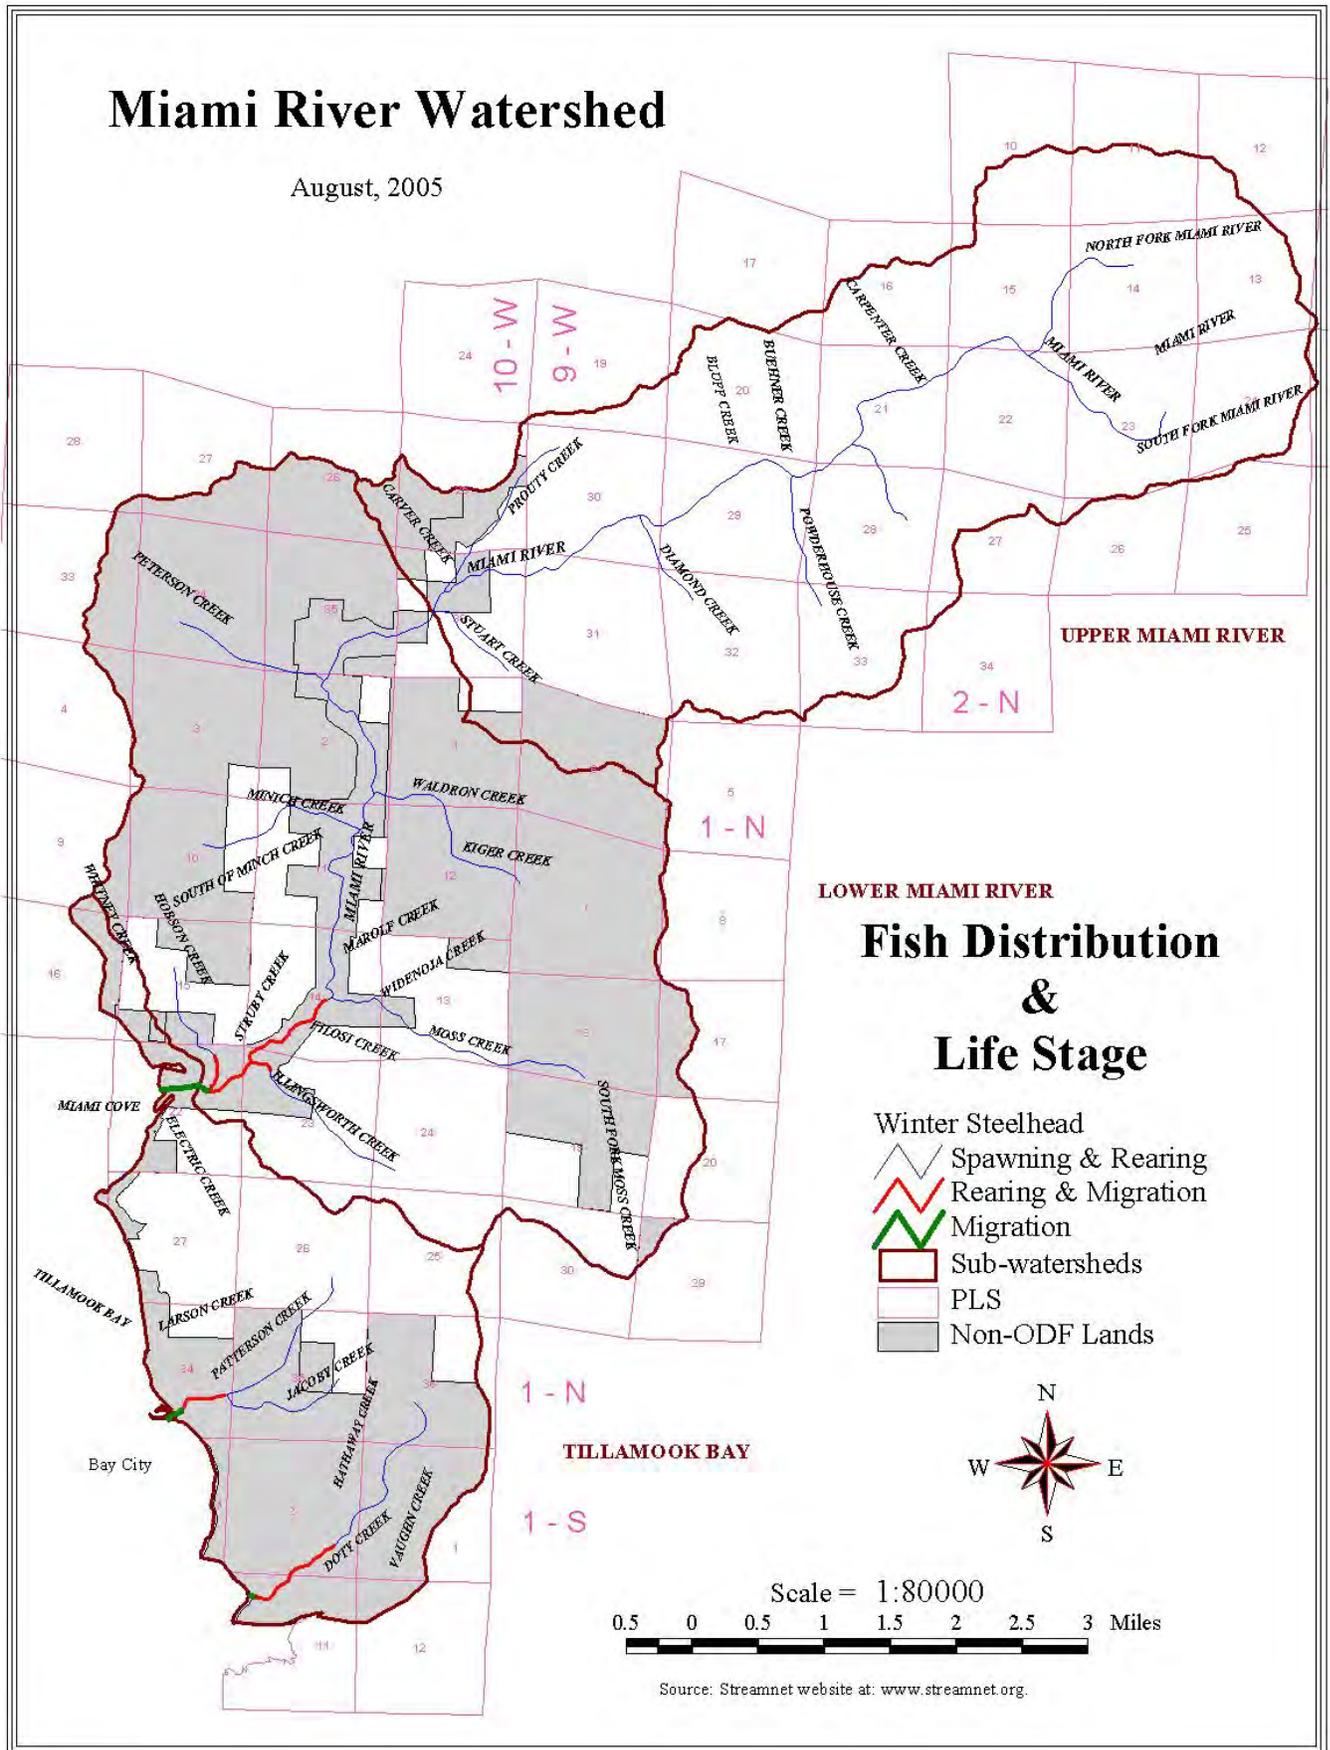
Figure 4. Estimated winter steelhead distribution in the Miami River Watershed Project Area.

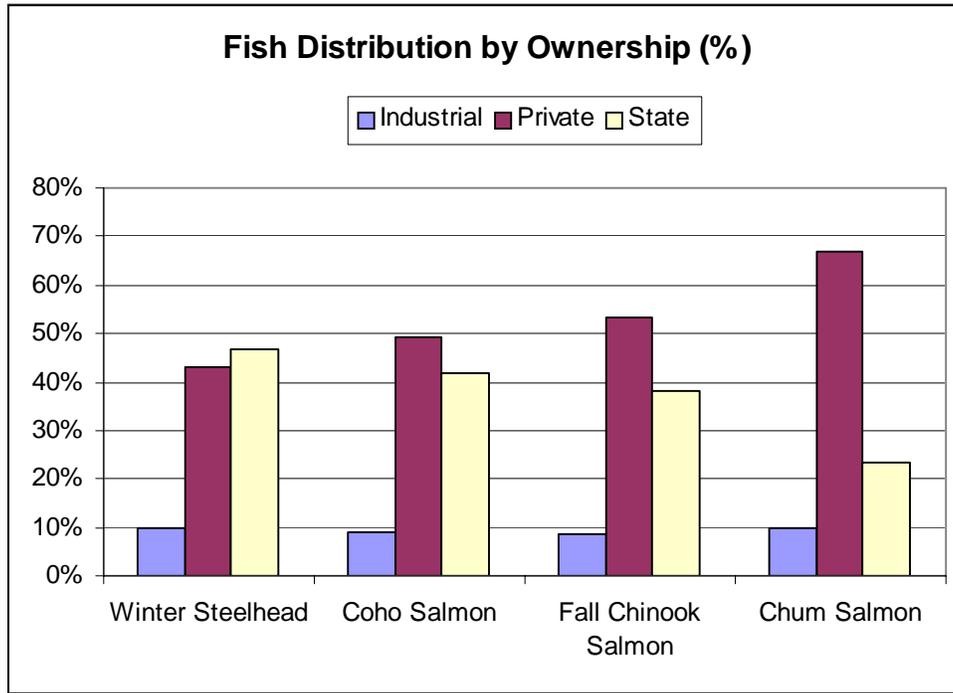
Figure 5. Fish distribution as a function of ownership (in percent) for the Miami River Watershed Project Area.

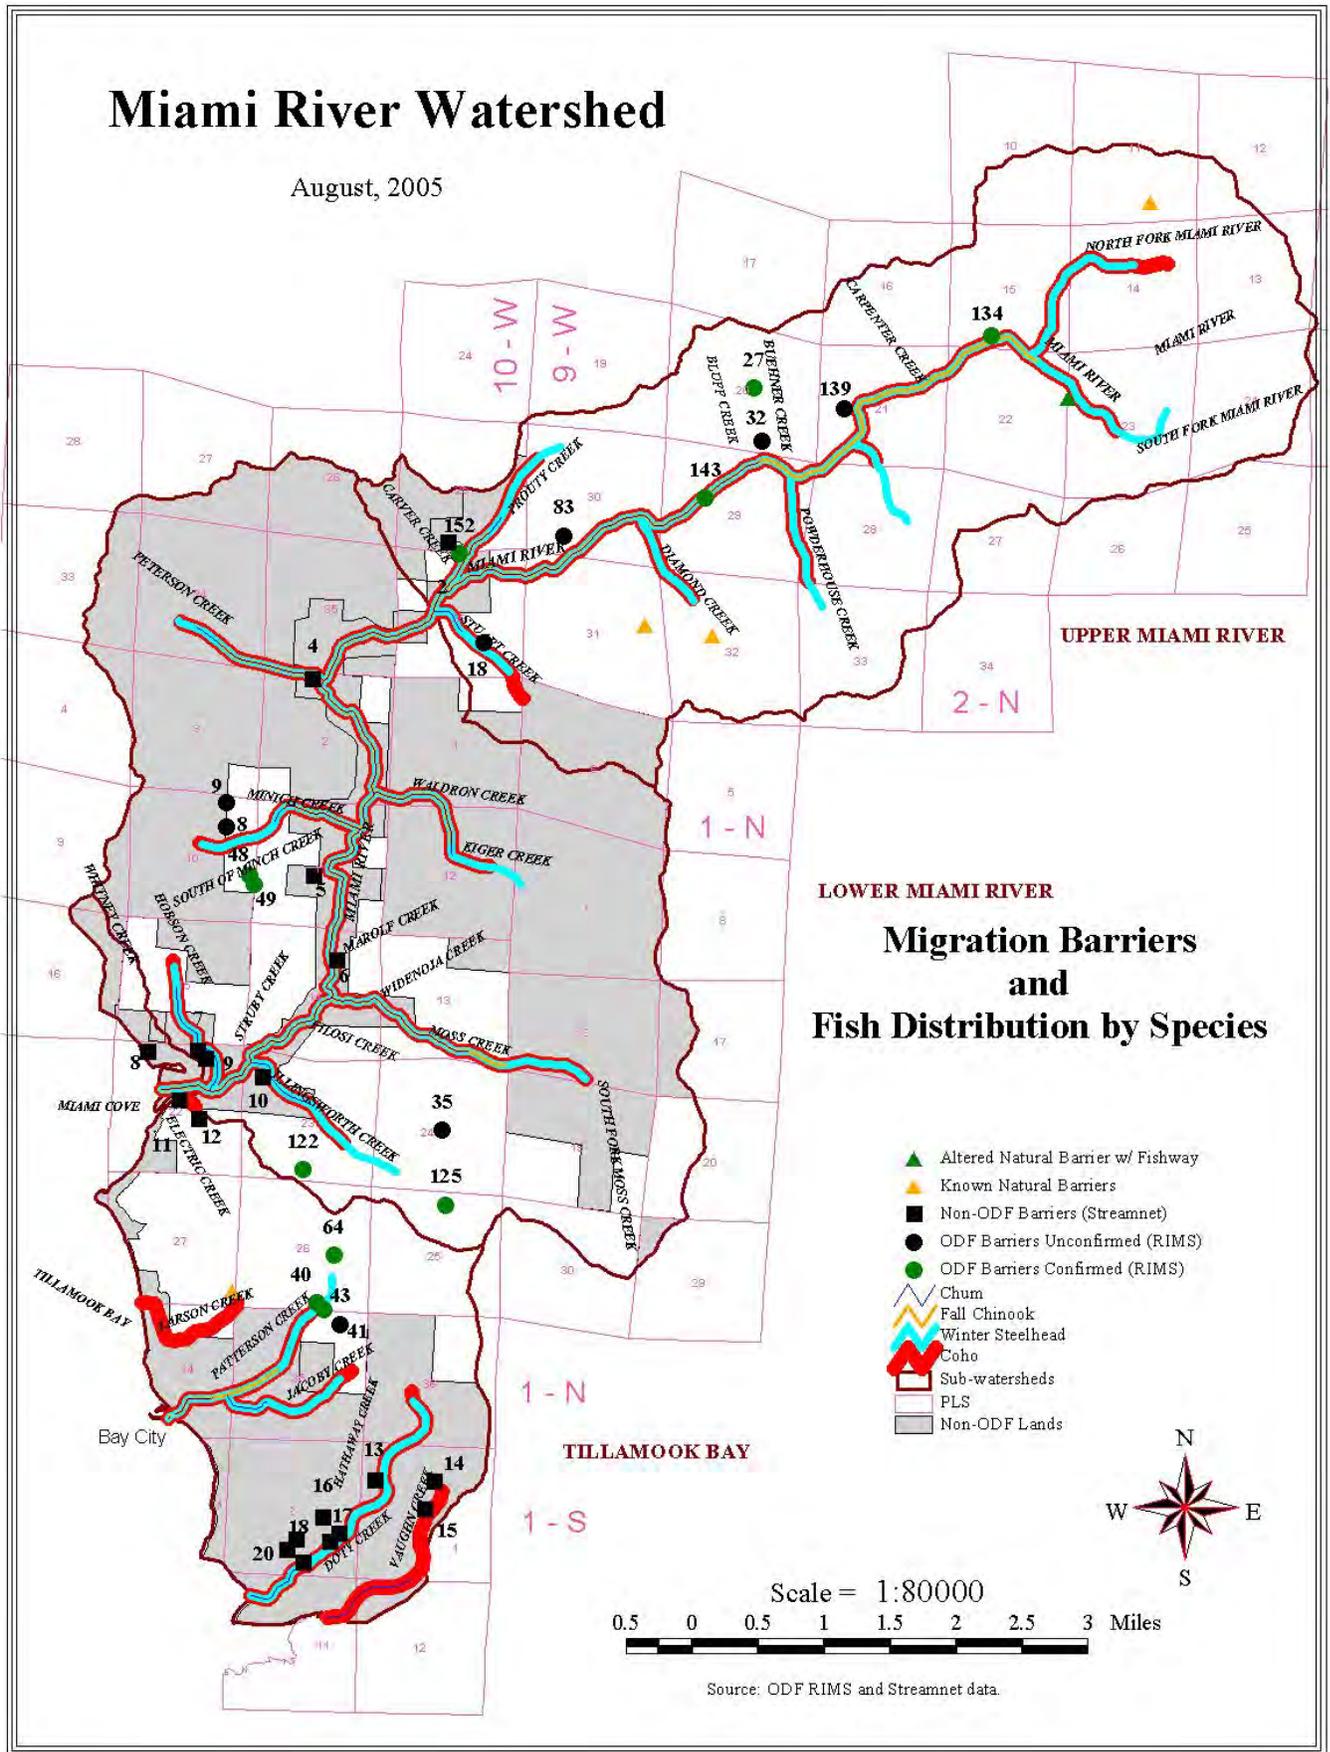
Figure 6. Map of fish passage barriers from RIMS and Streamnet and fish distribution by species for the Miami River Watershed Project Area.

RIMS barrier data was further refined based on limited field reconnaissance. Potential barriers were grouped into four categories: known natural barriers, Streamnet non-ODF barriers, ODF barriers unconfirmed, and ODF barriers confirmed (Figure 26). Barriers depicted in Figure 26 that are outside of the mapped fish distribution may be barriers to cutthroat trout.

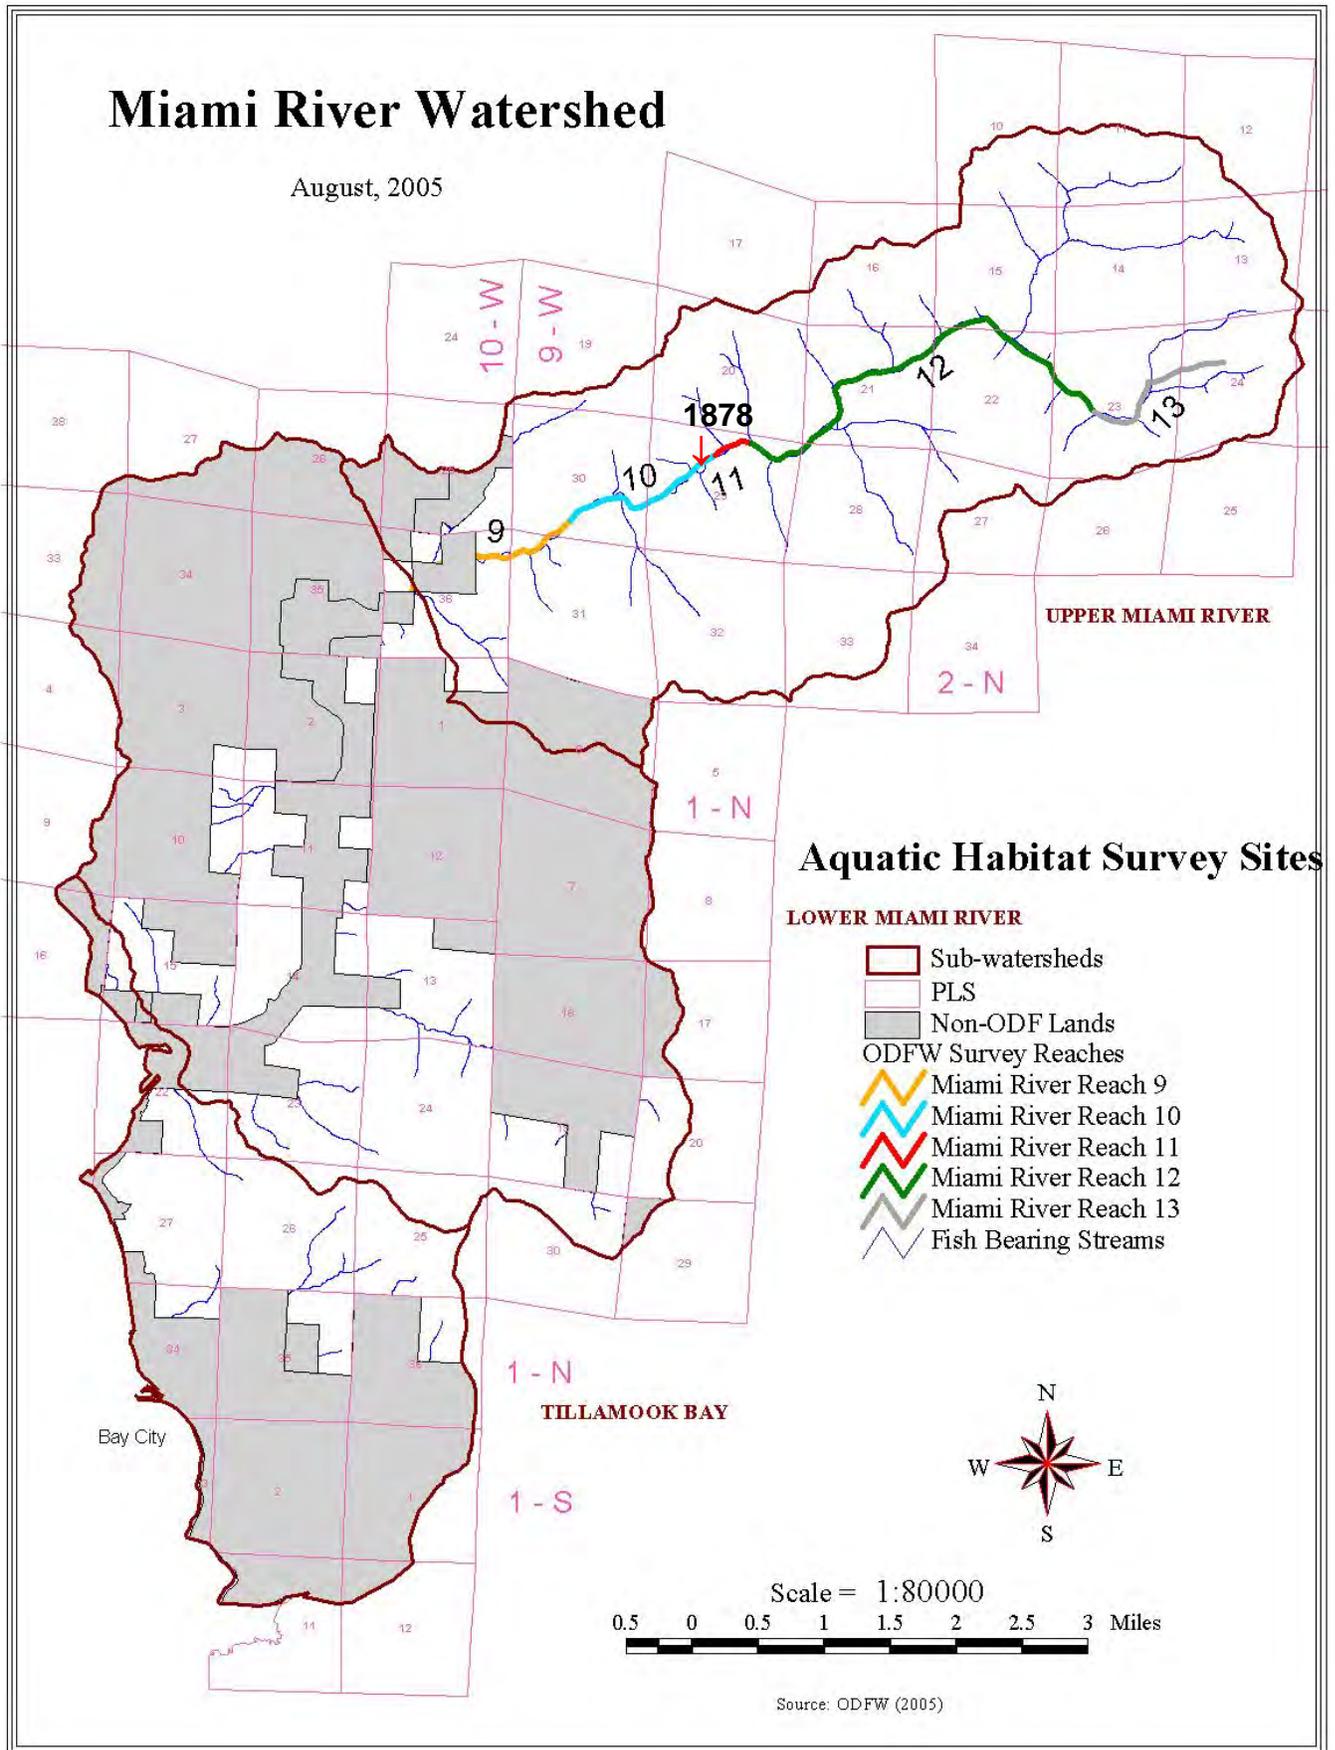
Figure 1. ODFW aquatic habitat survey sites on ODF lands within the Miami River Watershed Project Area (from ODFW 2005).

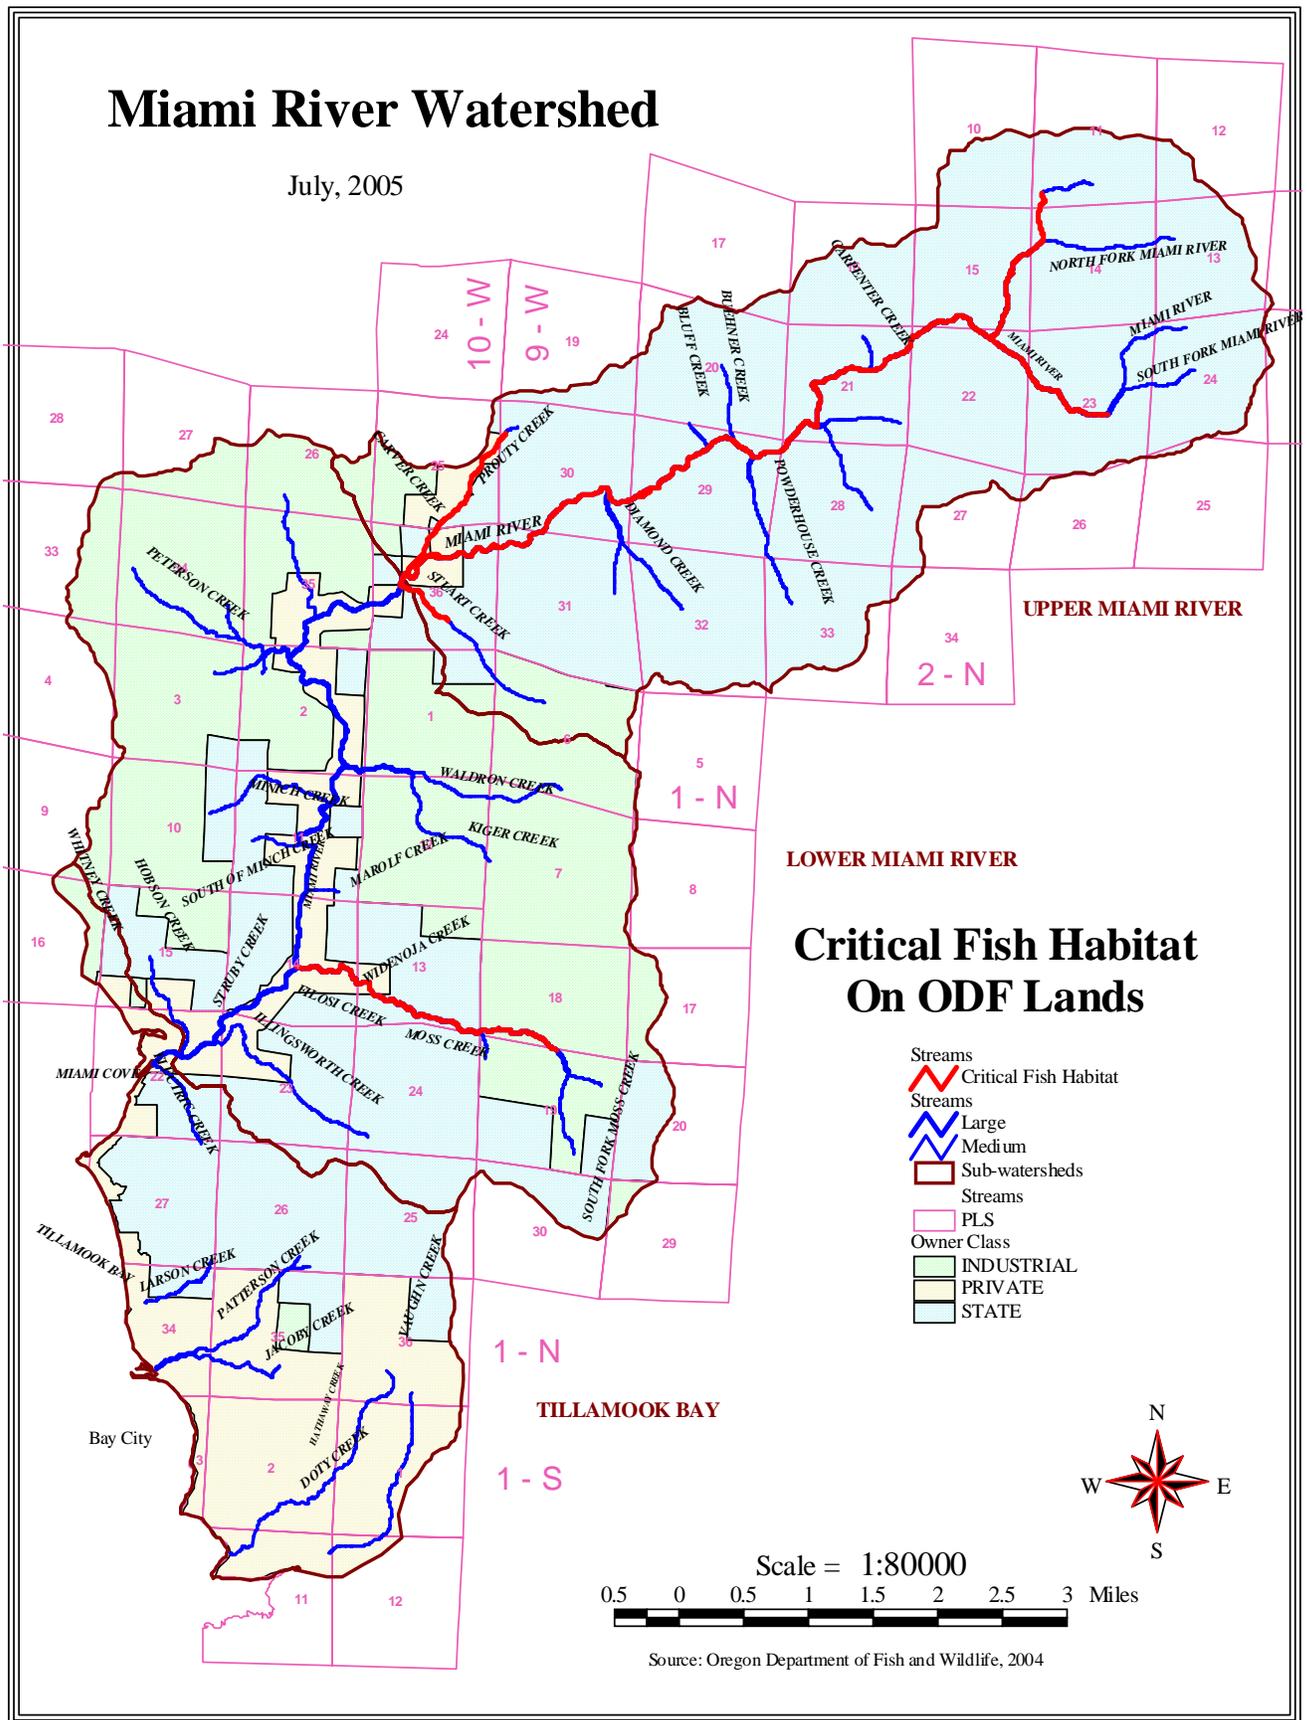
Figure 2. Potential critical fish habitat on ODF lands within the Miami River Watershed Project Area.

Figure 28 identifies approximately 10 miles of critical habitat on state lands (9.1 miles in the upper Miami River and on 1.1 miles in the lower Miami River subwatersheds).

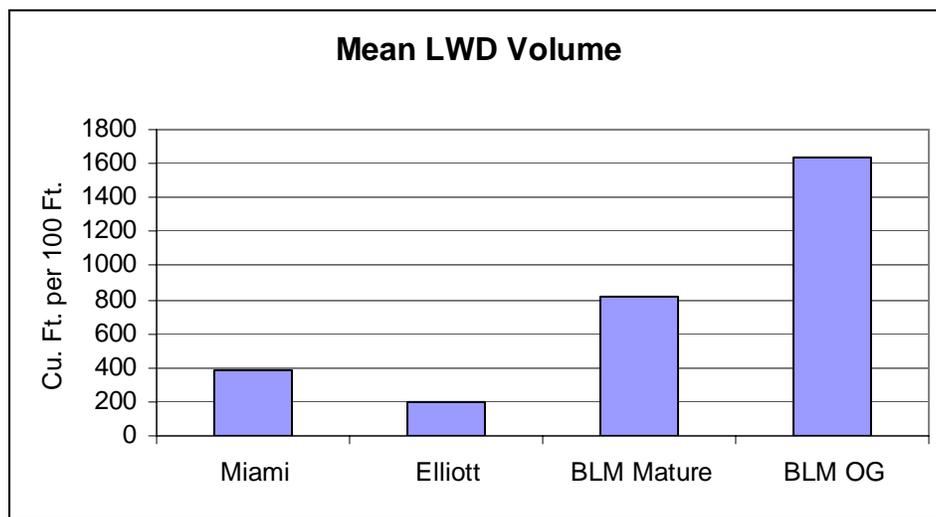
Figure 1. A comparison of large wood volumes in the Miami River Watershed to the Elliott State Forest and BLM mature and old-growth stands.

As a comparison, consider how levels of in-stream wood on ODF lands in the Miami compare to the findings documented in the Elliott State Forest Watershed Analysis. In the Elliott analysis, the overall mean wood volume on ODF lands was 193 cu. ft³ per 100 ft., and the mean number of key pieces was 0.33 per 100 feet of stream (97 reaches represented (ODF 2003A, page 7-18). The mean wood volume on ODF lands in the Miami was 385 ft³ per 100 ft., and the mean number of key pieces was 0.7 per 100 feet of stream (7 reaches represented, ODFW 2005). If you remove the one reach with high volume and key pieces (reach NC1878) from the calculation, the mean wood volume is 225 ft³ per 100 ft., and the mean number of key pieces is 0.1 per 100 feet of stream. This simply illustrates the weight and importance this one reach has on the overall in-stream wood levels. It further illustrates the importance of this reach as critical habitat for salmonids since habitat quality far exceeds that of other mainstem reaches. As previously noted, the 1996 flood may have accomplished significant changes in other reaches resulting in increased habitat quality.

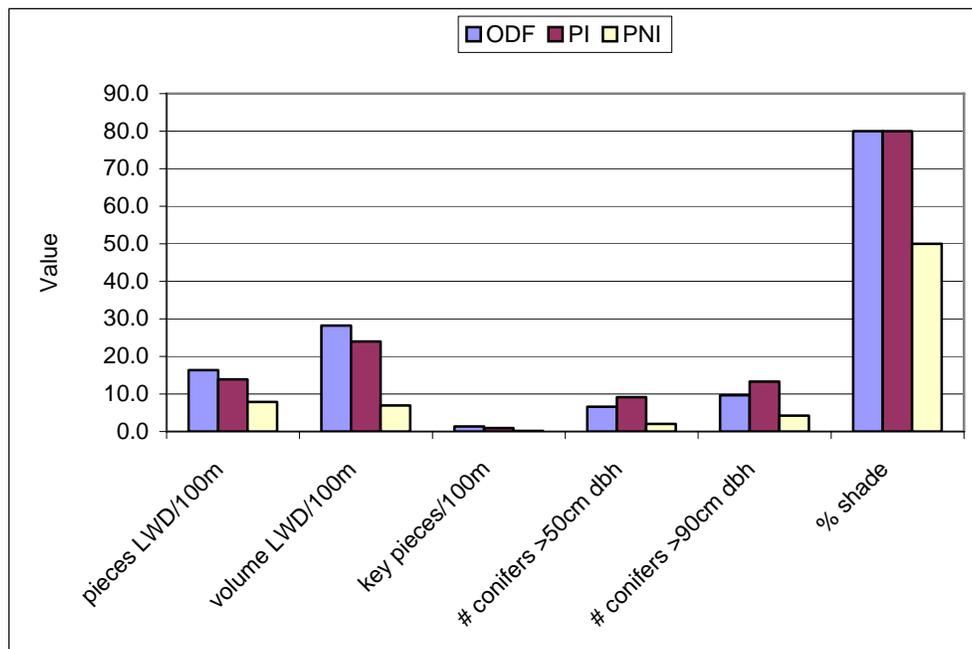
Figure 2. A comparison of large wood and shade variables (from ODFW 2005) between surveys conducted on ODF, private industrial and non-industrial lands

Since, no habitat surveys have been conducted on ODF lands in the Lower Miami or Tillamook Bay Frontal Subwatersheds, the level of in-stream wood is not known. However, habitat surveys have been conducted on approximately 5 miles (8000 meters) of private industrial lands and 5.6 miles (9000 meters) of private non-industrial lands (ODFW 2005). A comparison of the large wood and shade survey variables on ODF lands versus private industrial and non-industrial lands is presented in Figure 34. Data represent the length-weighted value for all surveyed reaches. From this, we can infer that variables related to large wood and riparian condition on ODF lands and private industrial lands are essentially in the same overall condition.

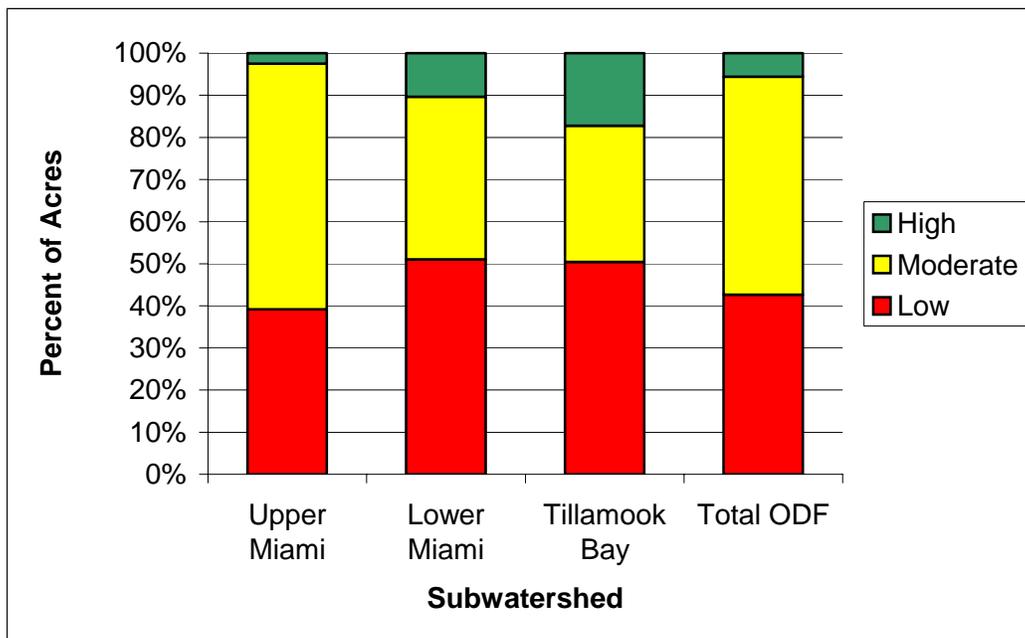
Figure 3. Estimated levels of LWD recruitment potential as a percent of total ODF lands in mapped riparian buffers (RA1+RA2).

As described earlier in the assessment, only 6% (424 acres) of the mapped riparian (RA1 and RA2) acres administered by ODF currently exhibit a high likelihood of producing large wood to the adjacent stream (Figure 35)(see Figure 11 for mapped spatial distribution of riparian corridors). The majority of acres exhibit a moderate or low recruitment potential (52% and 43%, respectively). Obviously, the lack of large conifer pieces entering stream channels will continue until conifer riparian forest stands are established and mature or other sources are introduced (i.e. manual placement).

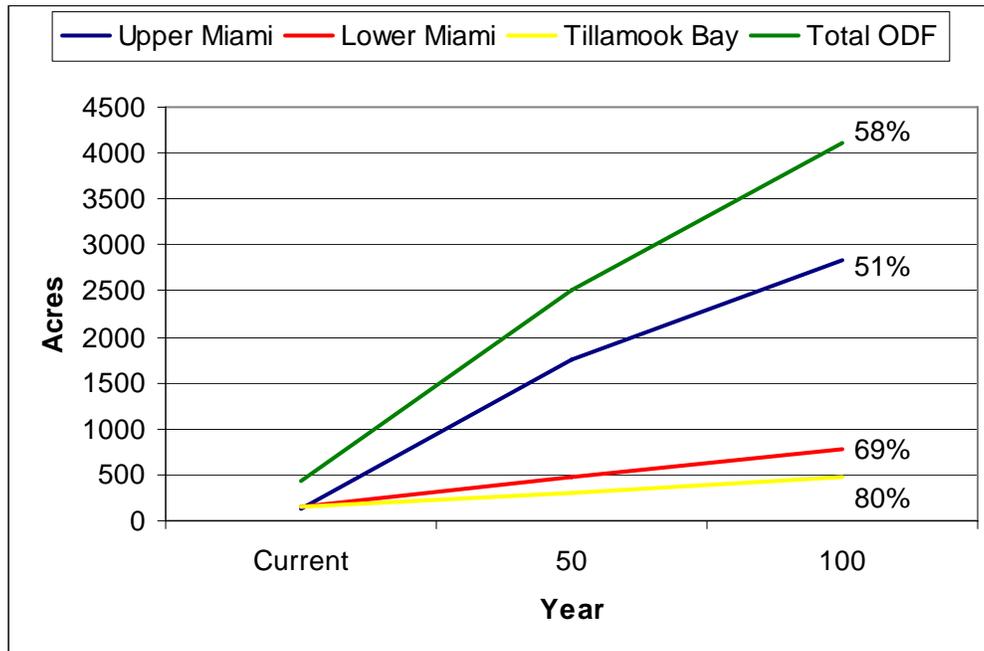
Figure 4. The amount of "High" LWD recruitment potential for ODF lands (RA1+RA2) in the current, 50-, and 100-year timeframes. Percentages indicate amount of ODF land (compared to total ODF ownership) in the subwatershed.

The overall amount of “High” LWD recruitment potential on ODF lands (RA1 and RA2) increased from 6% to 33% (424 acres to 2516 acres) in 50 years, and from 6% to 58% (424 acres to 4385 acres) in 100 years. The largest gain, in terms of acres, was in the Upper Miami Subwatershed where the amount of “High” recruitment potential increased from 132 acres (2%) to 2733 acres (51%) in 100 years. The Lower Miami and Tillamook Bay Subwatersheds showed significant increases in the percent of area in the “High” recruitment potential category, from 10% to 69% and from 17% to 80%, respectively. However, due to the low amount of ODF ownership in these subwatersheds, the amount of acres was relatively small (Table 26, Figure 36, 37, and 38).

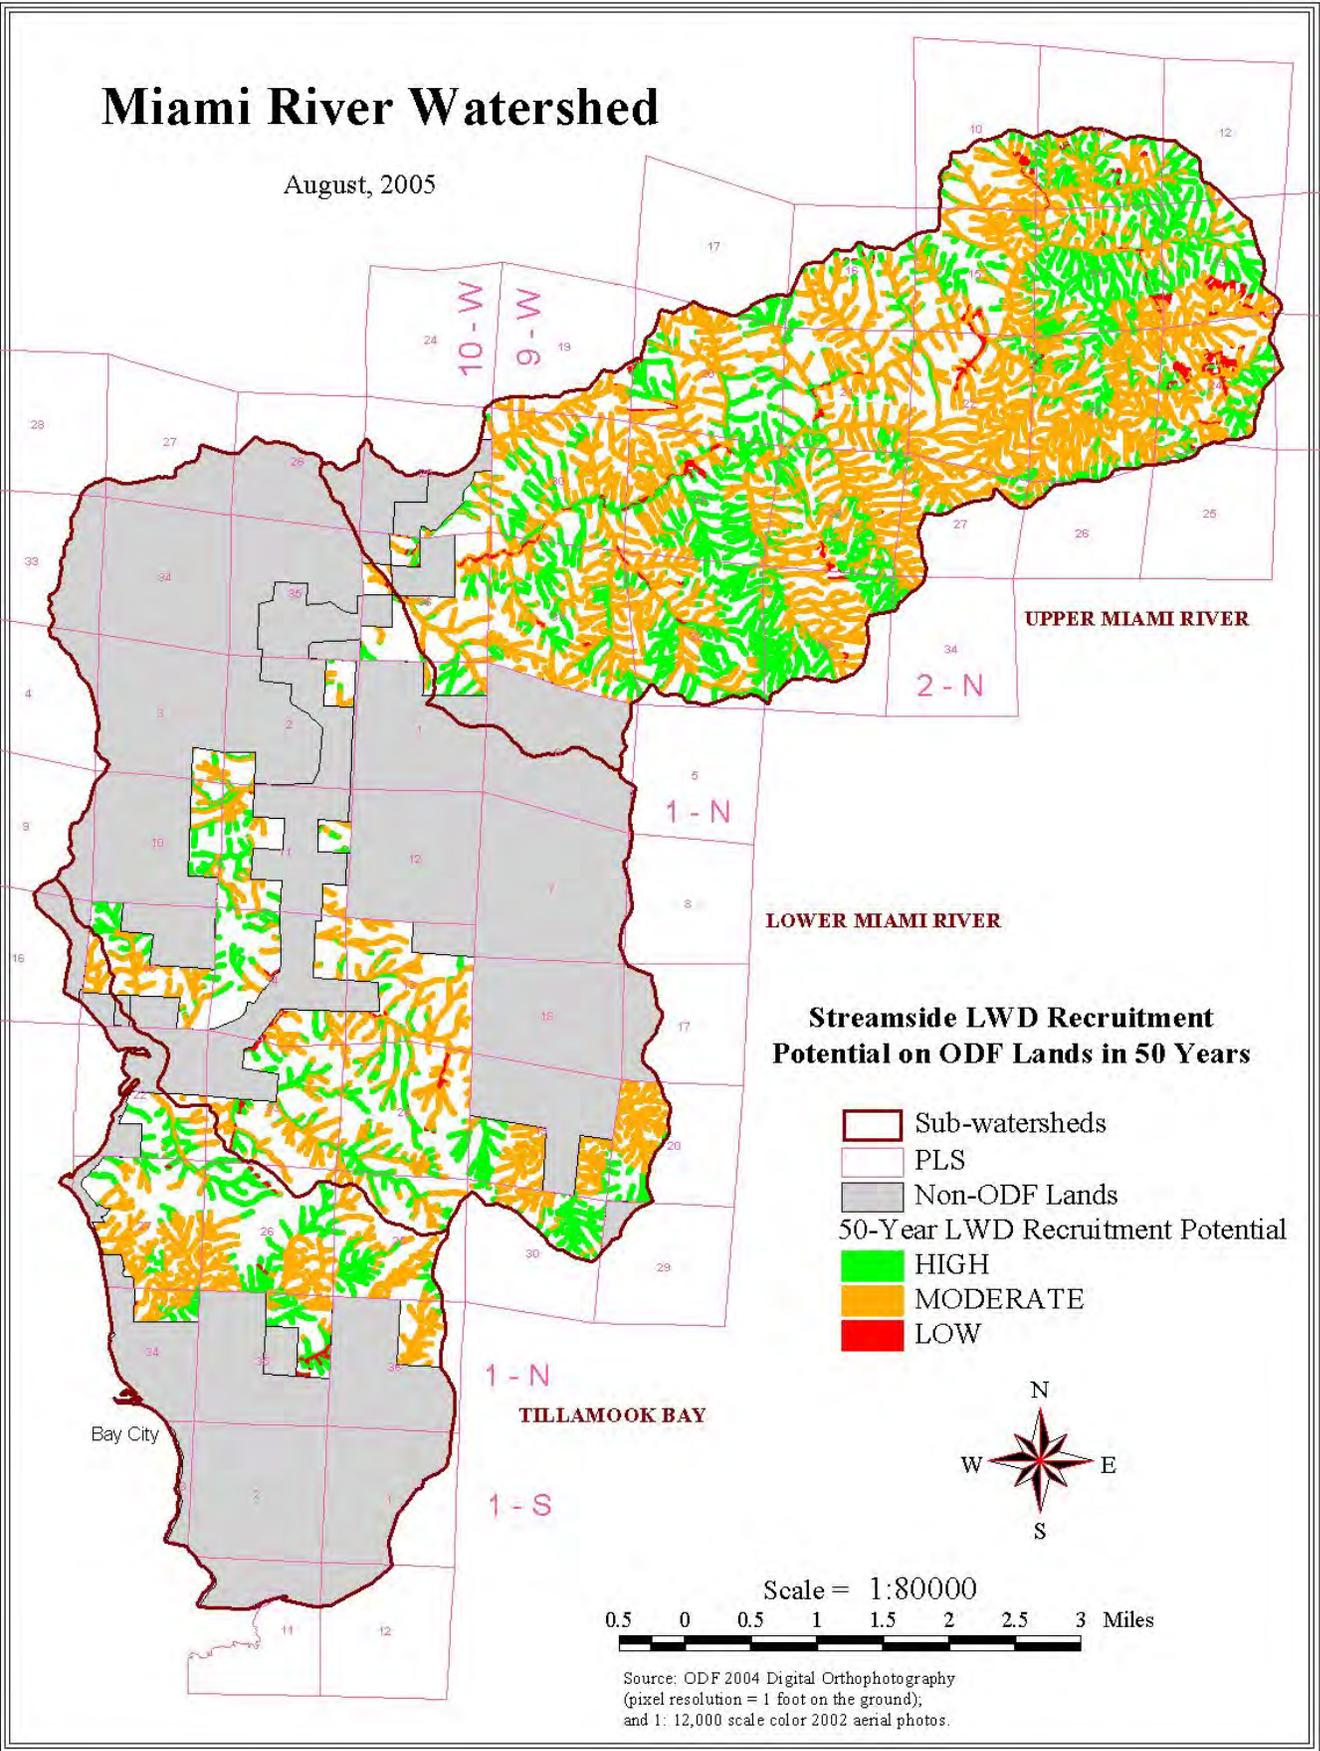
Figure 5. Estimated large woody debris recruitment potential in 50 years for the Miami River Watershed Project Area.

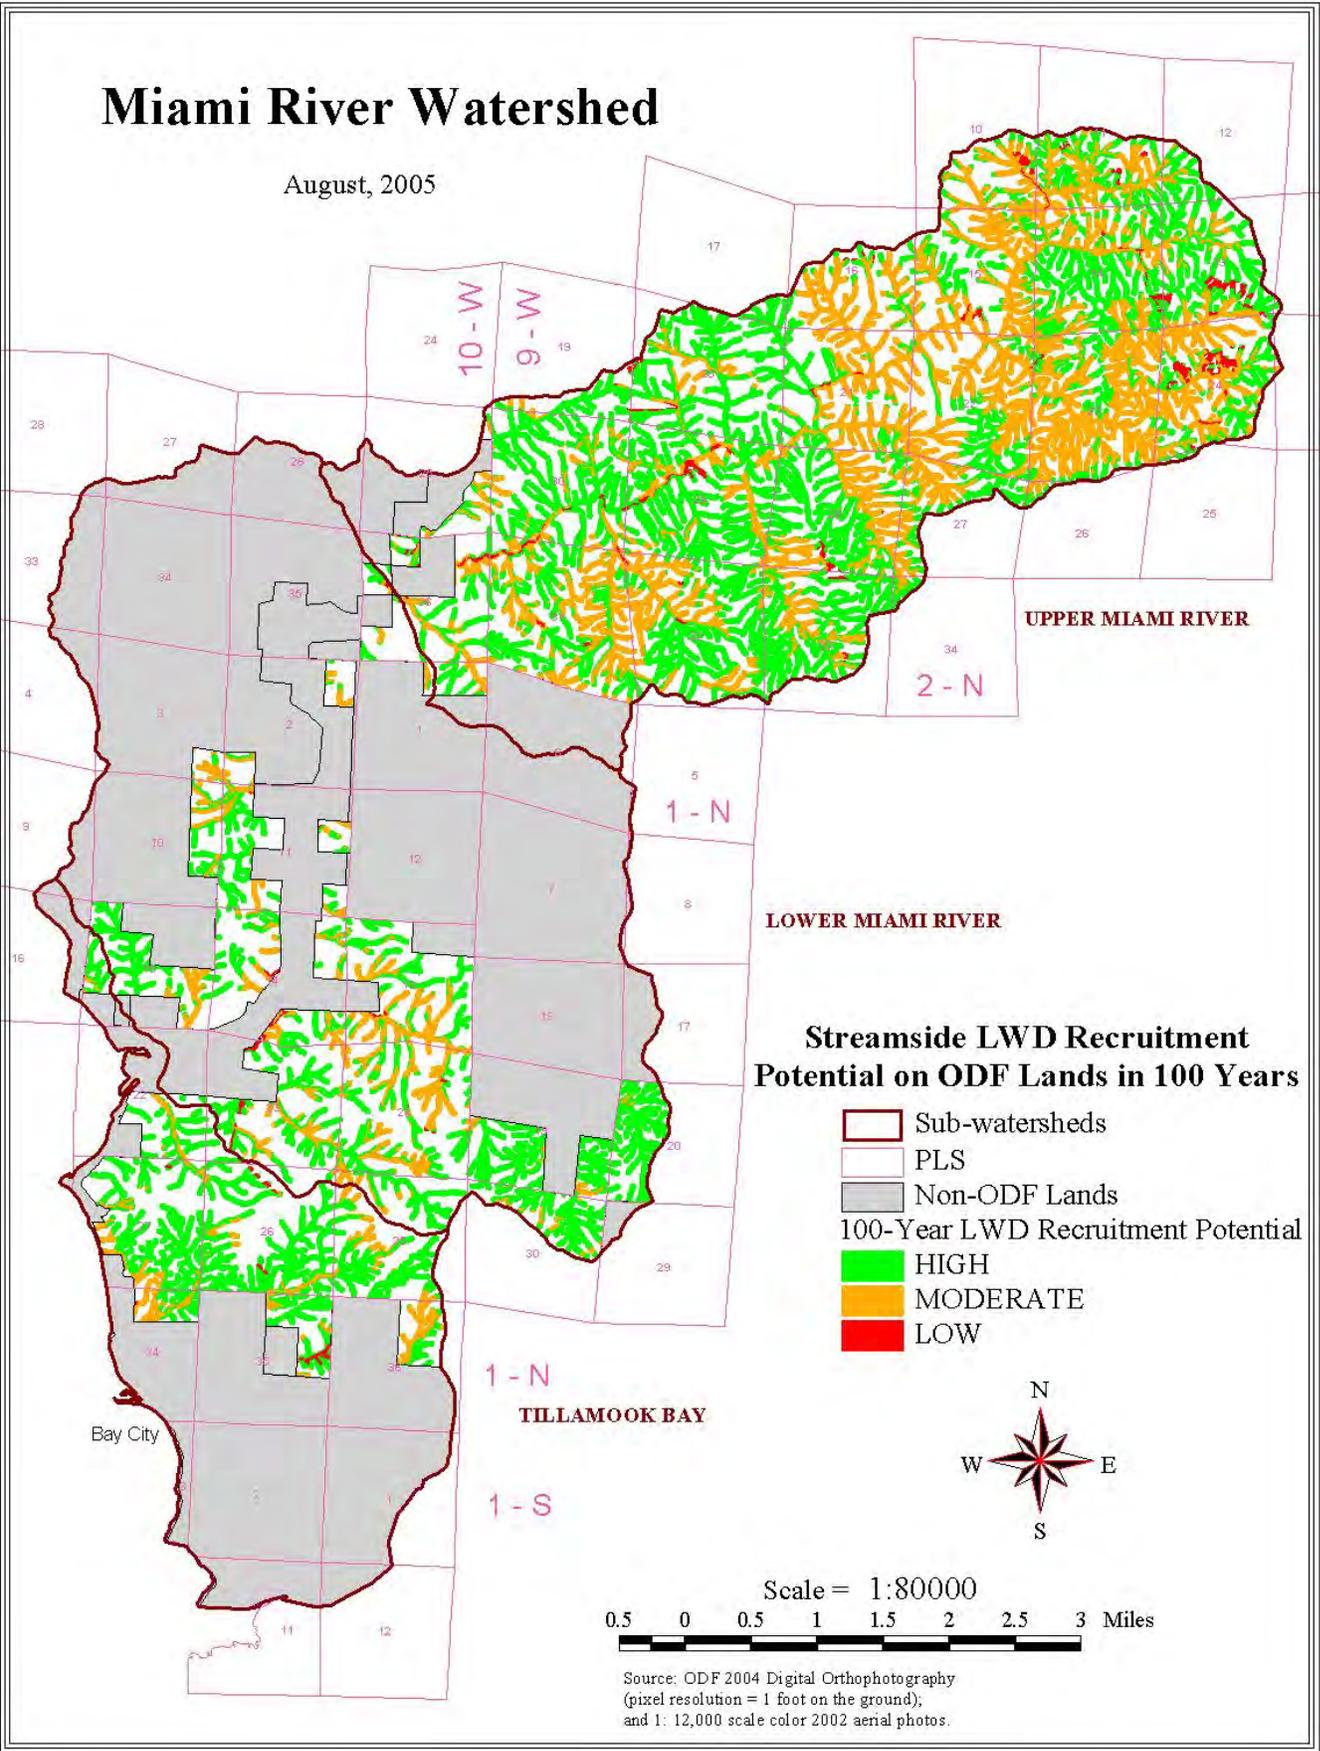
Figure 6. Estimated large woody debris recruitment potential in 100 years for the Miami River Watershed Project Area.
