Miami River Watershed Assessment and Analysis of ODF Lands

August 15, 2005

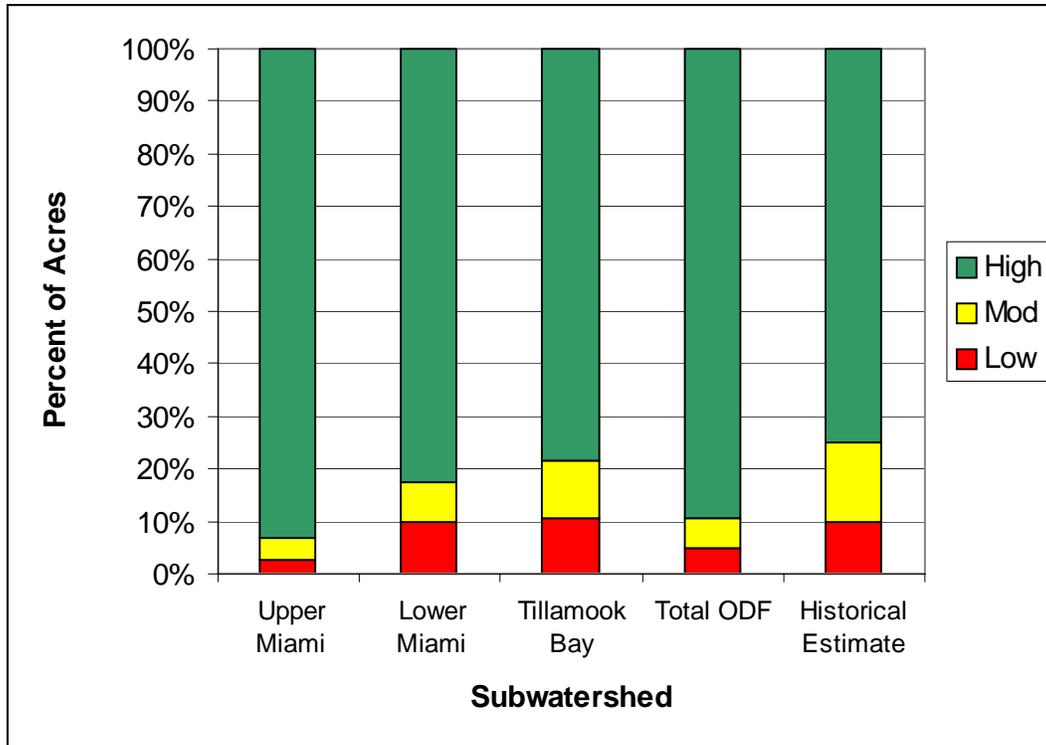
Figure 1. Estimated levels of shade as a percent of total ODF lands in mapped riparian buffers.

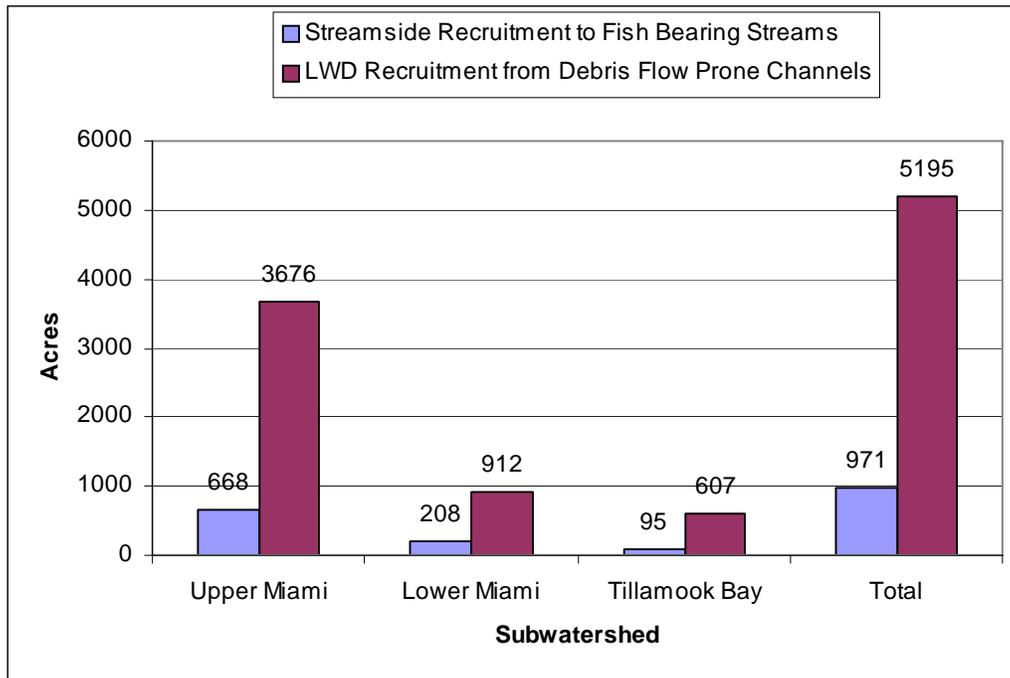
Figure 2. Acres of riparian management area along fish bearing streams and debris flow prone channels potentially limiting the achievement of properly functioning condition.

Forest stands along fish bearing streams that currently have low to moderate large wood recruitment potentials are limiting the achievement of properly functioning condition. Likewise, debris flow prone channels that could be expected to deliver large wood to downstream fish bearing streams in the event of failure but do not contain large conifers in which to transport, are limiting the achievement of properly functioning condition. In addition, channel modifications due to roads adjacent to the mainstem Miami River and Moss Creek could be affecting channel functions. These locations are summarized in Figure 40 and identified on Figure 41.

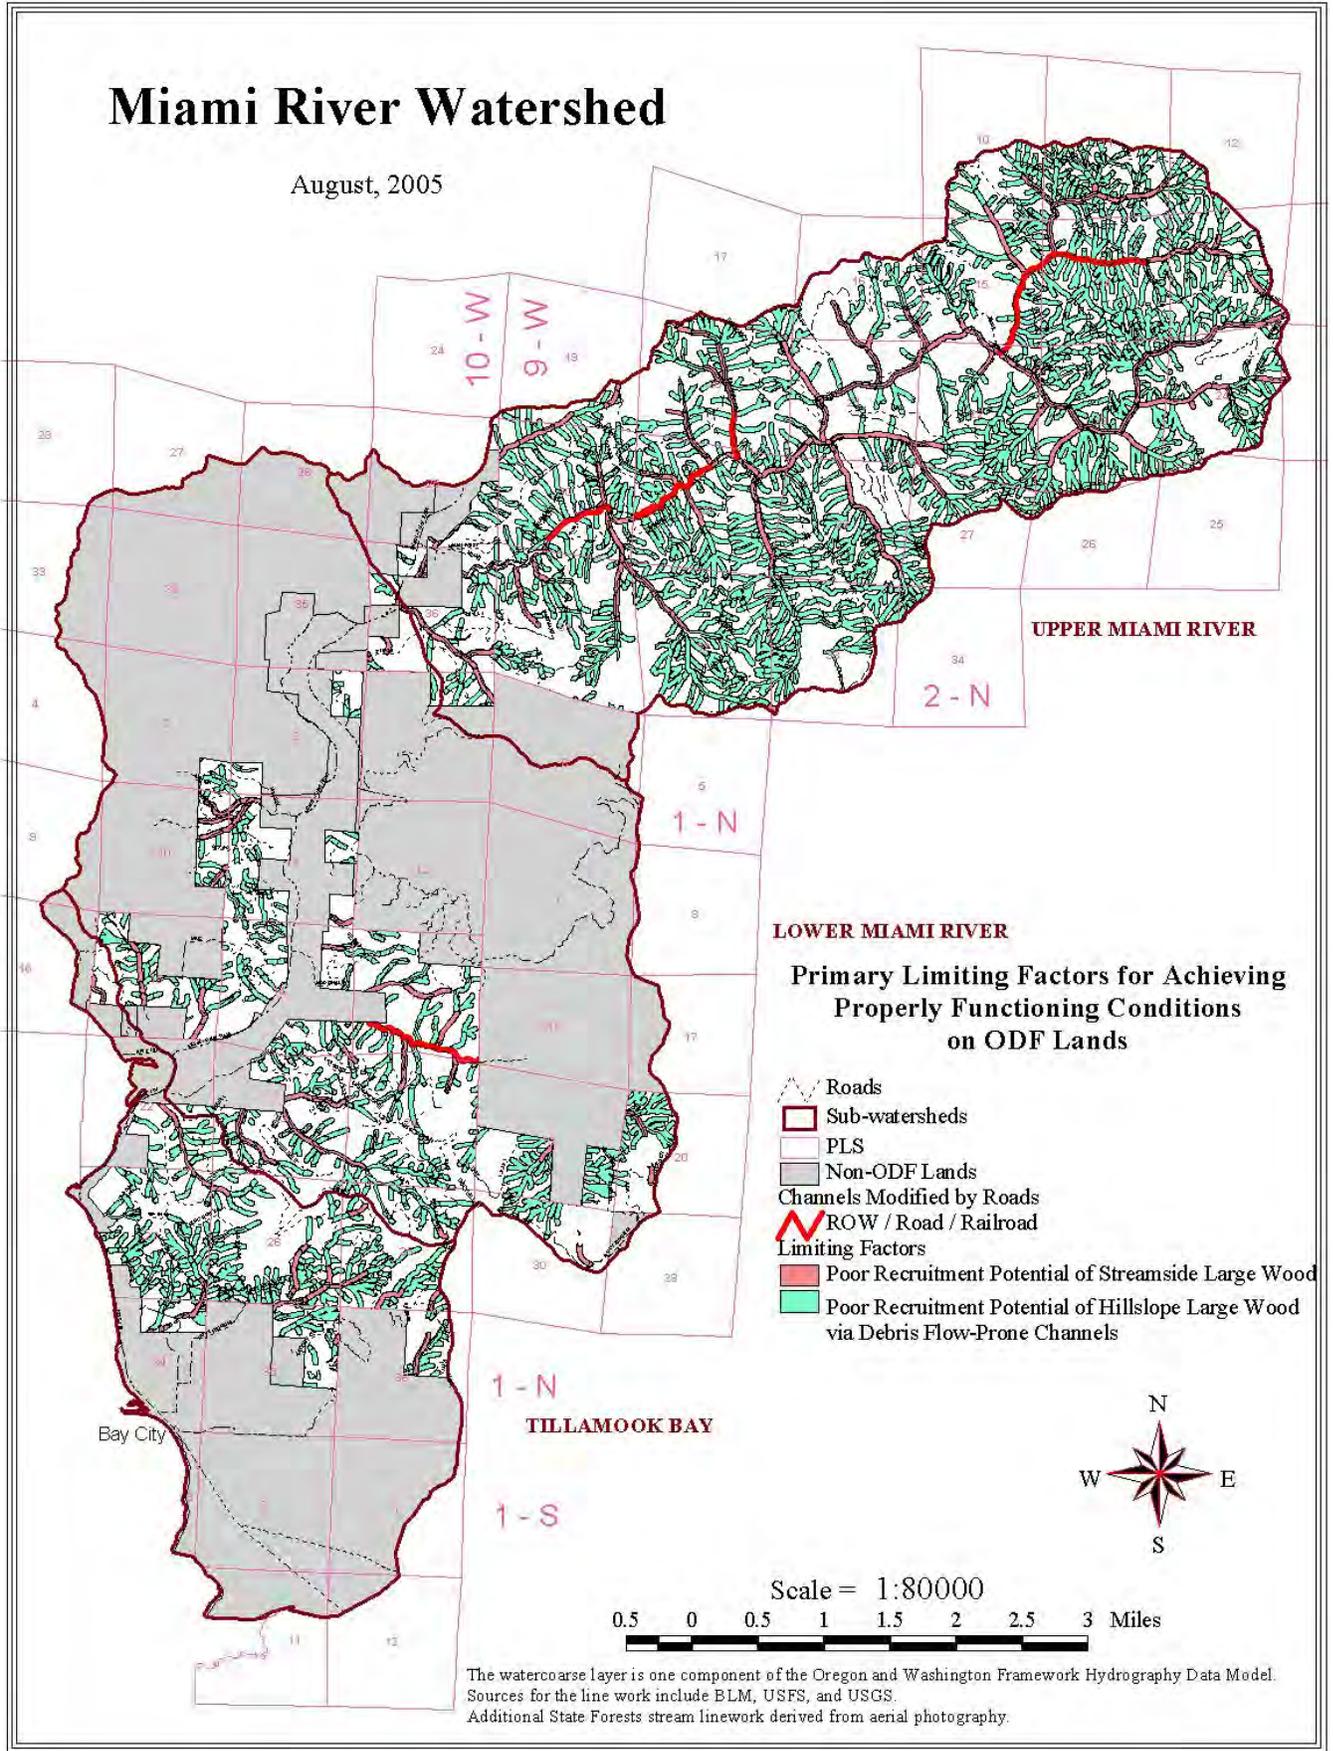
Figure 3. Limiting factors affecting the achievement of properly functioning condition for aquatic and riparian conditions.

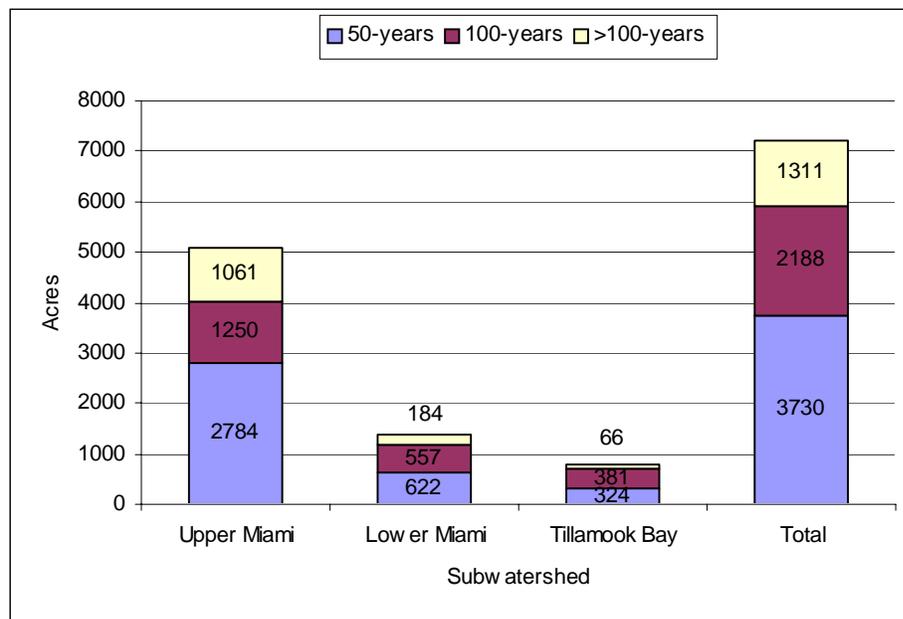
Figure 4. Mapped riparian acres of ODF lands projected to achieve PFC over the 50-, 100- and >100-year timeframes.

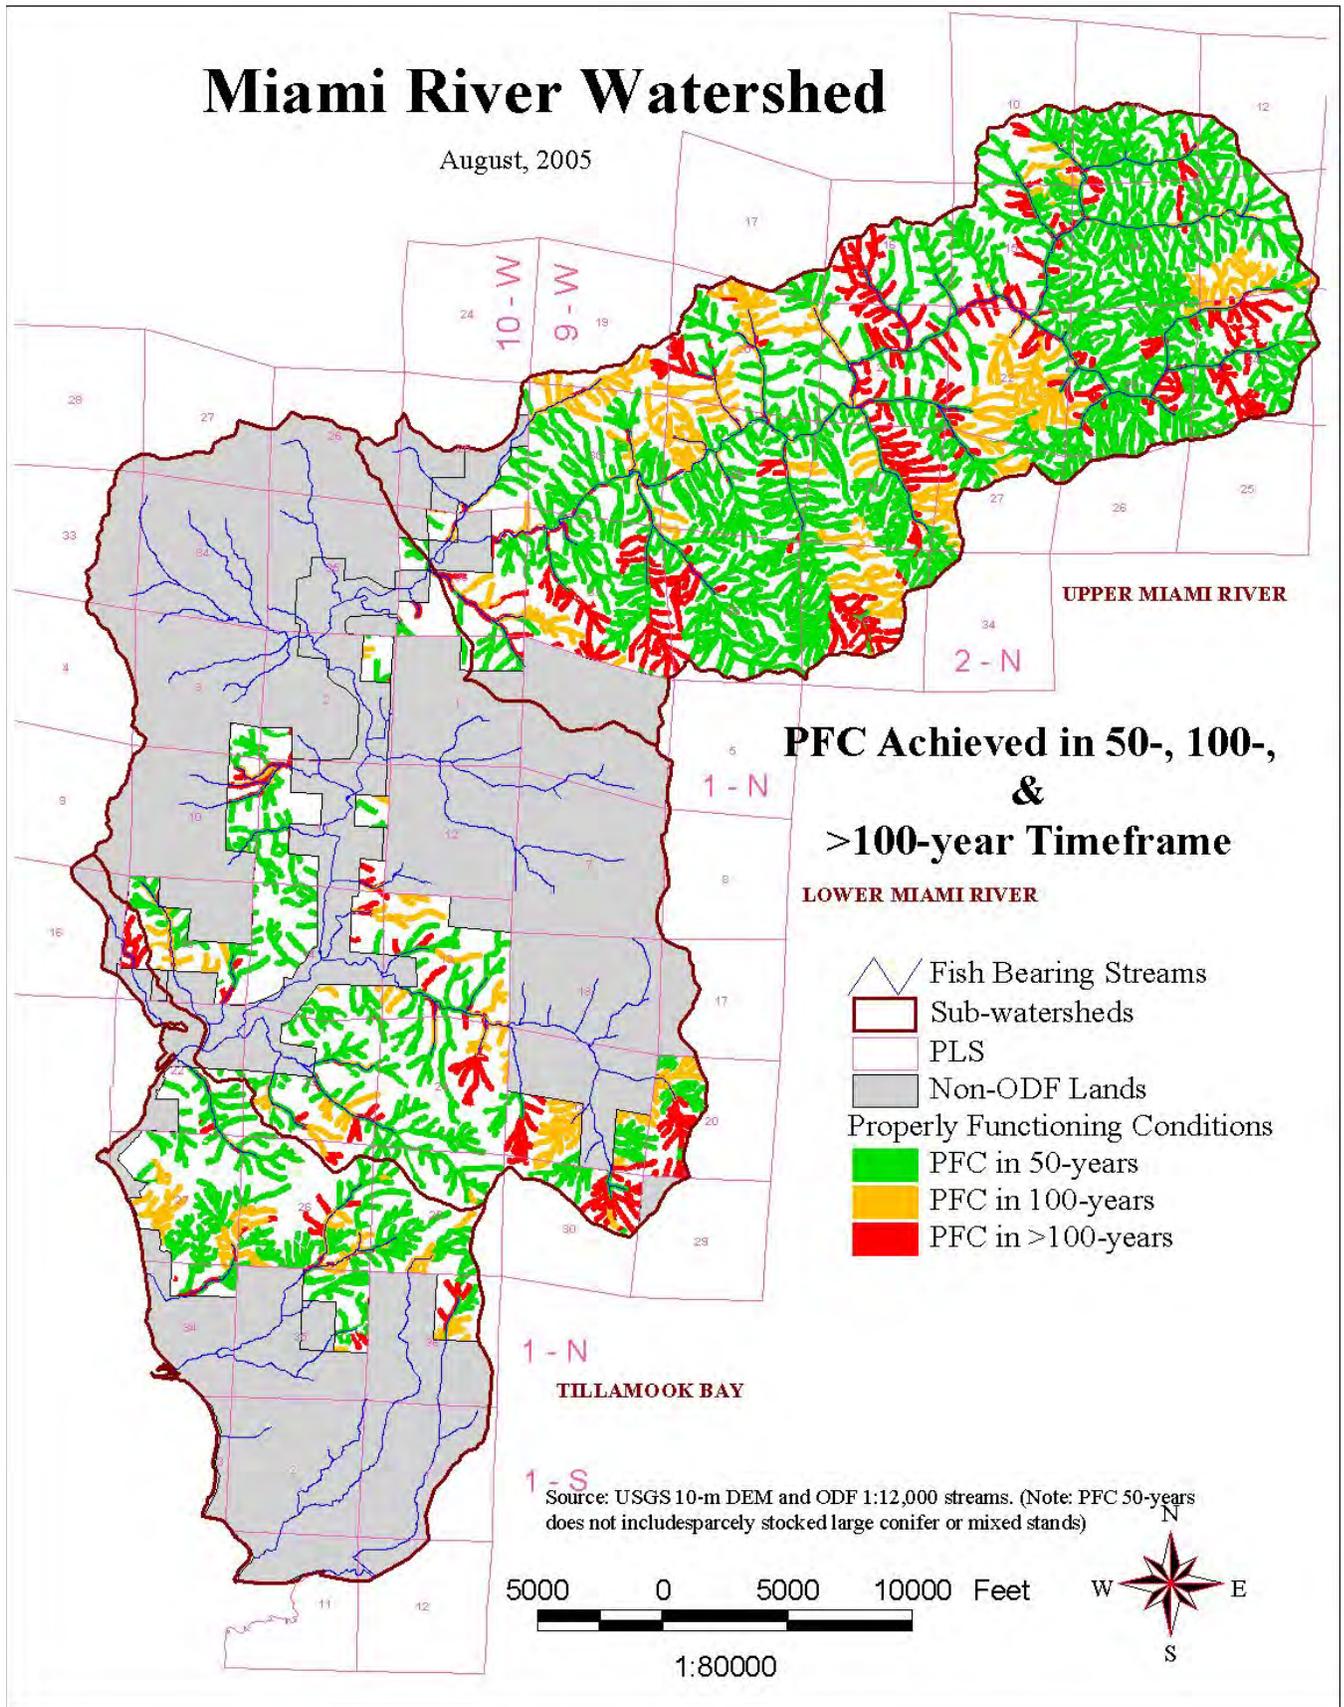
Figure 5. Projected achievement of PFC on ODF lands over the 50-, 100- and >100-year timeframes.

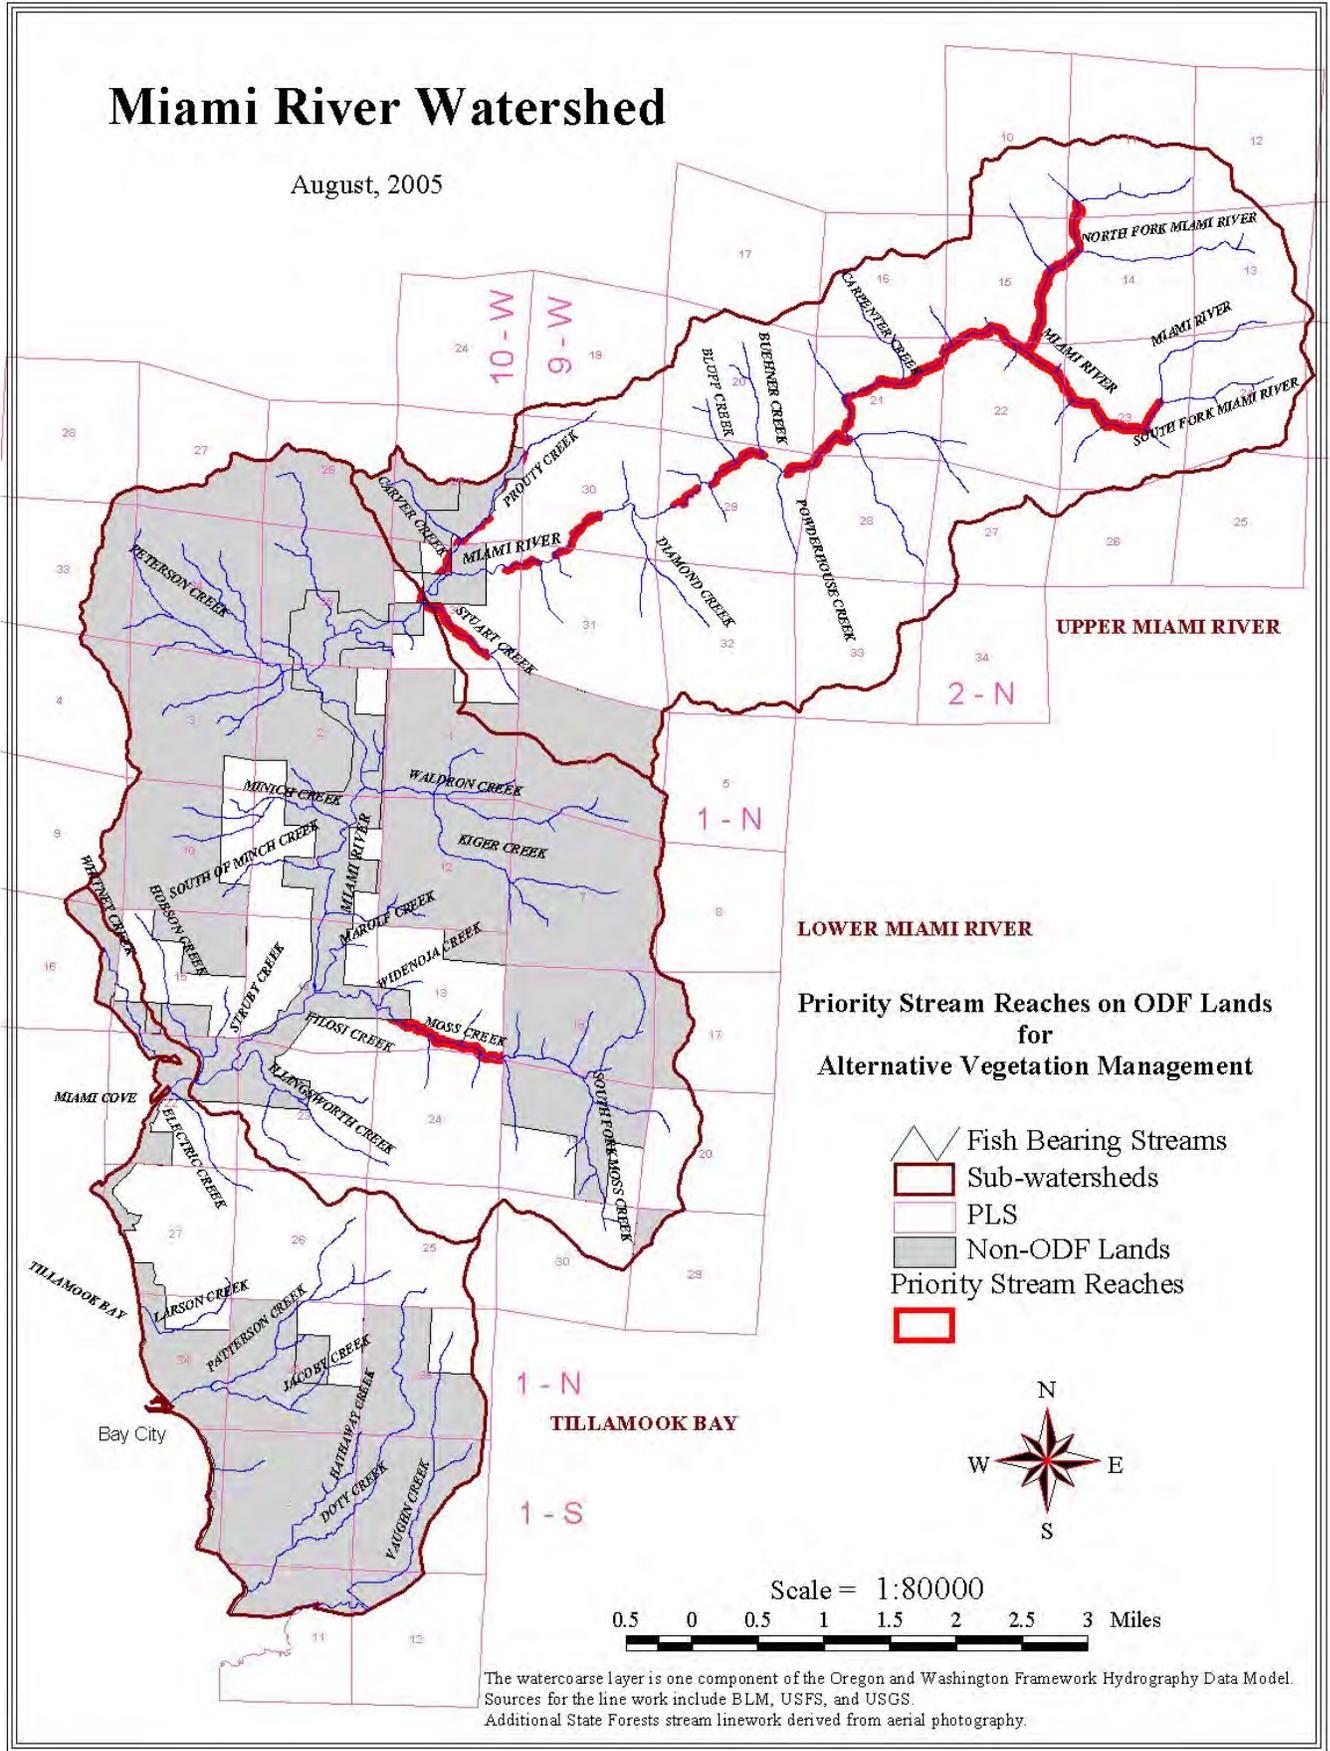
Figure 6. Areas with a high priority for further study and likely vegetation management opportunities.

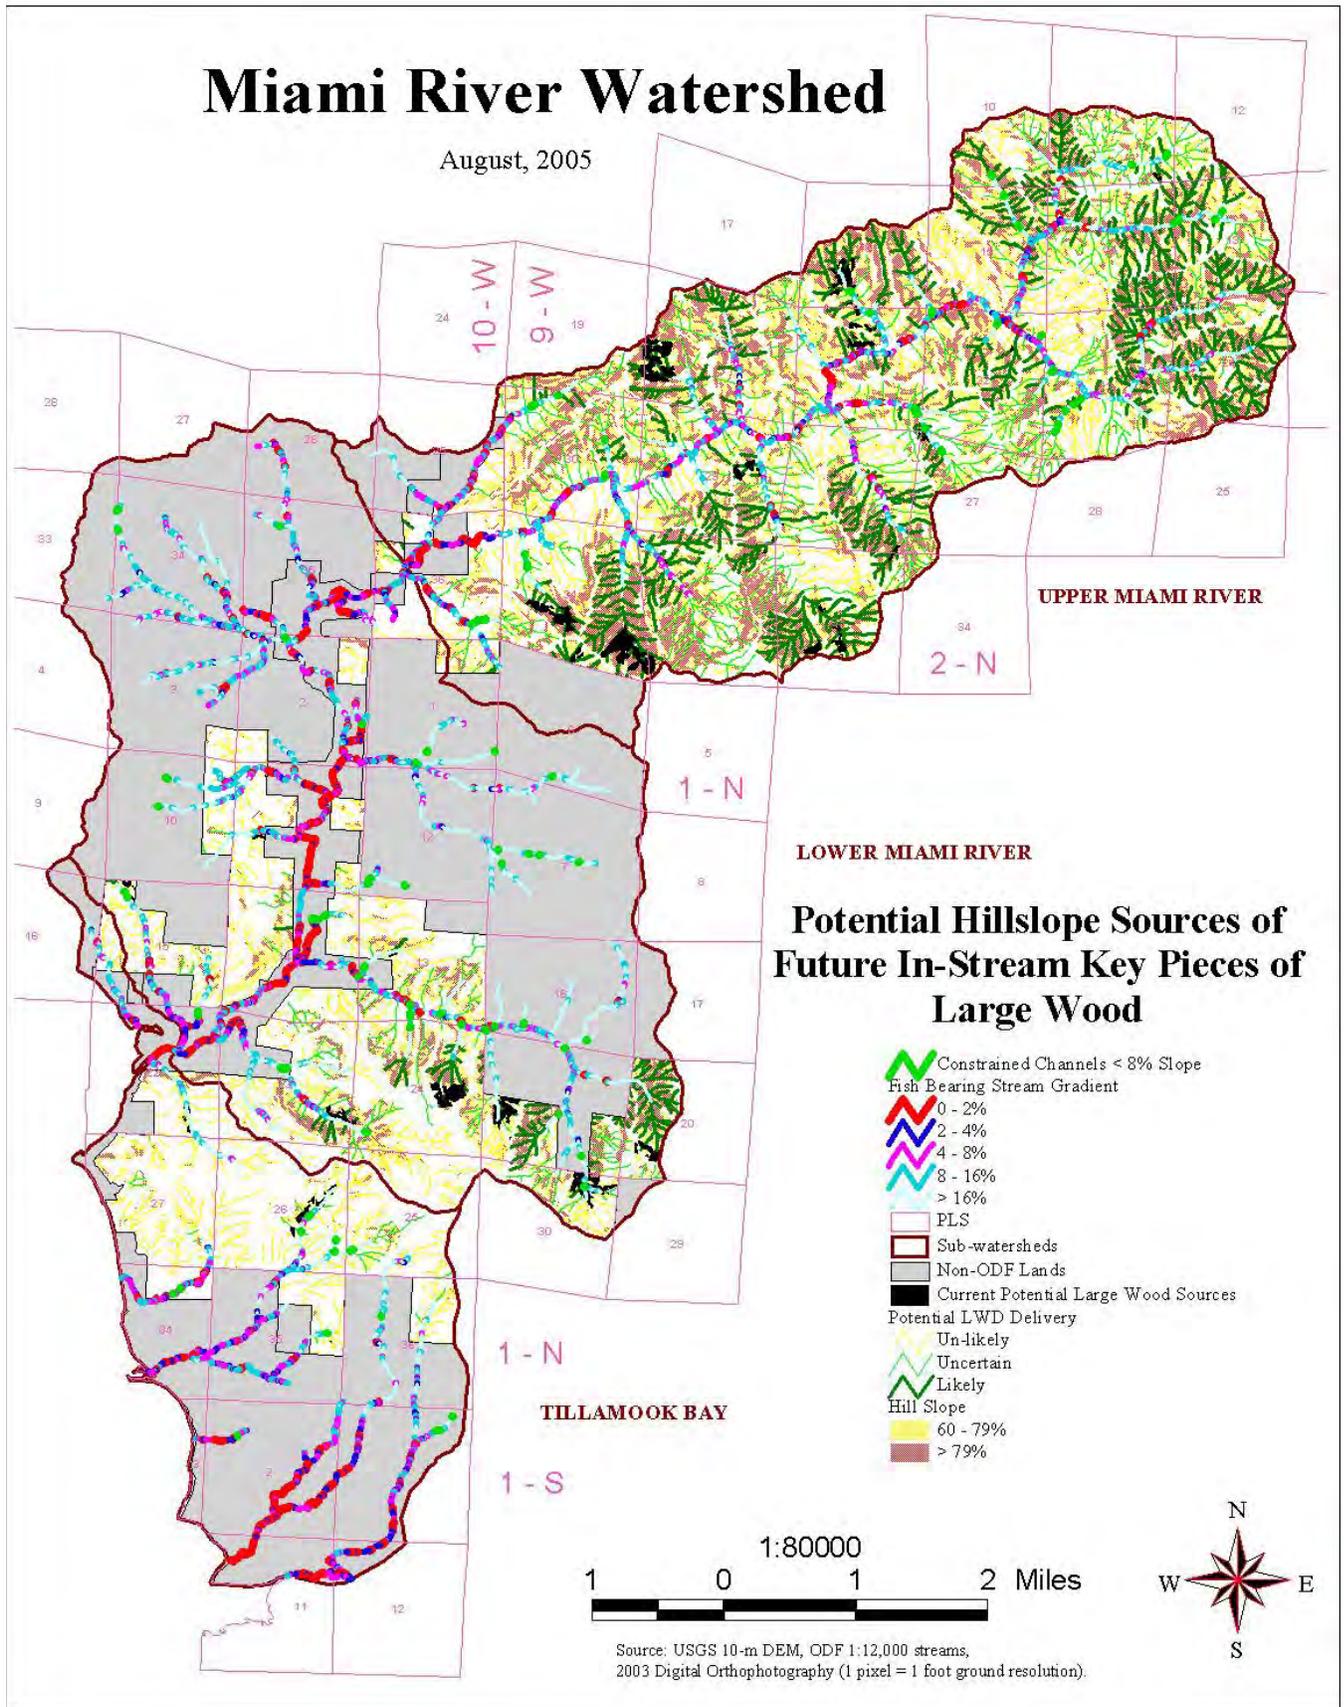
Figure 7. Potential hillslope sources of future in-stream key pieces of large wood debris.

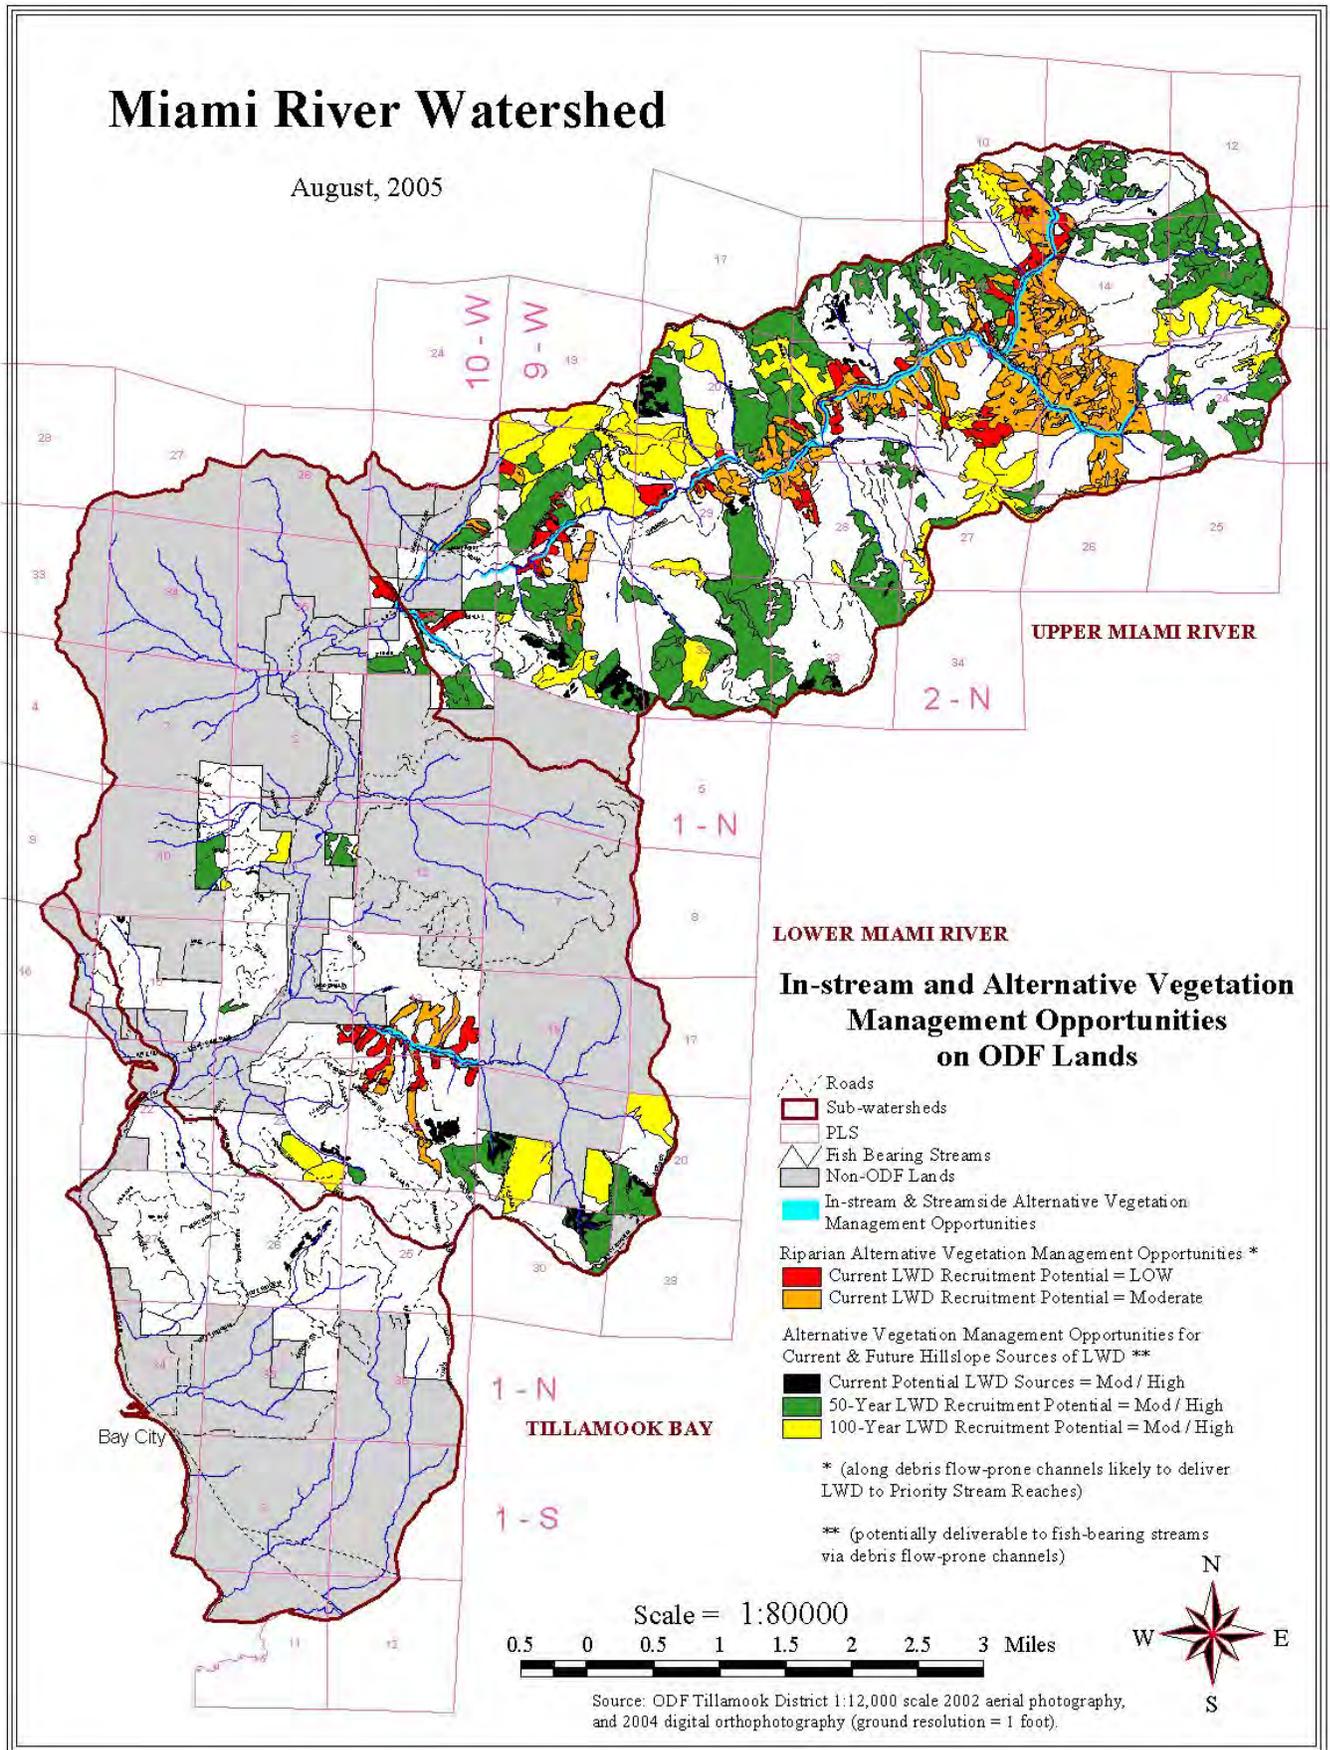
Figure 1. Stream segments and forest stands with a high priority for further study and management opportunities.

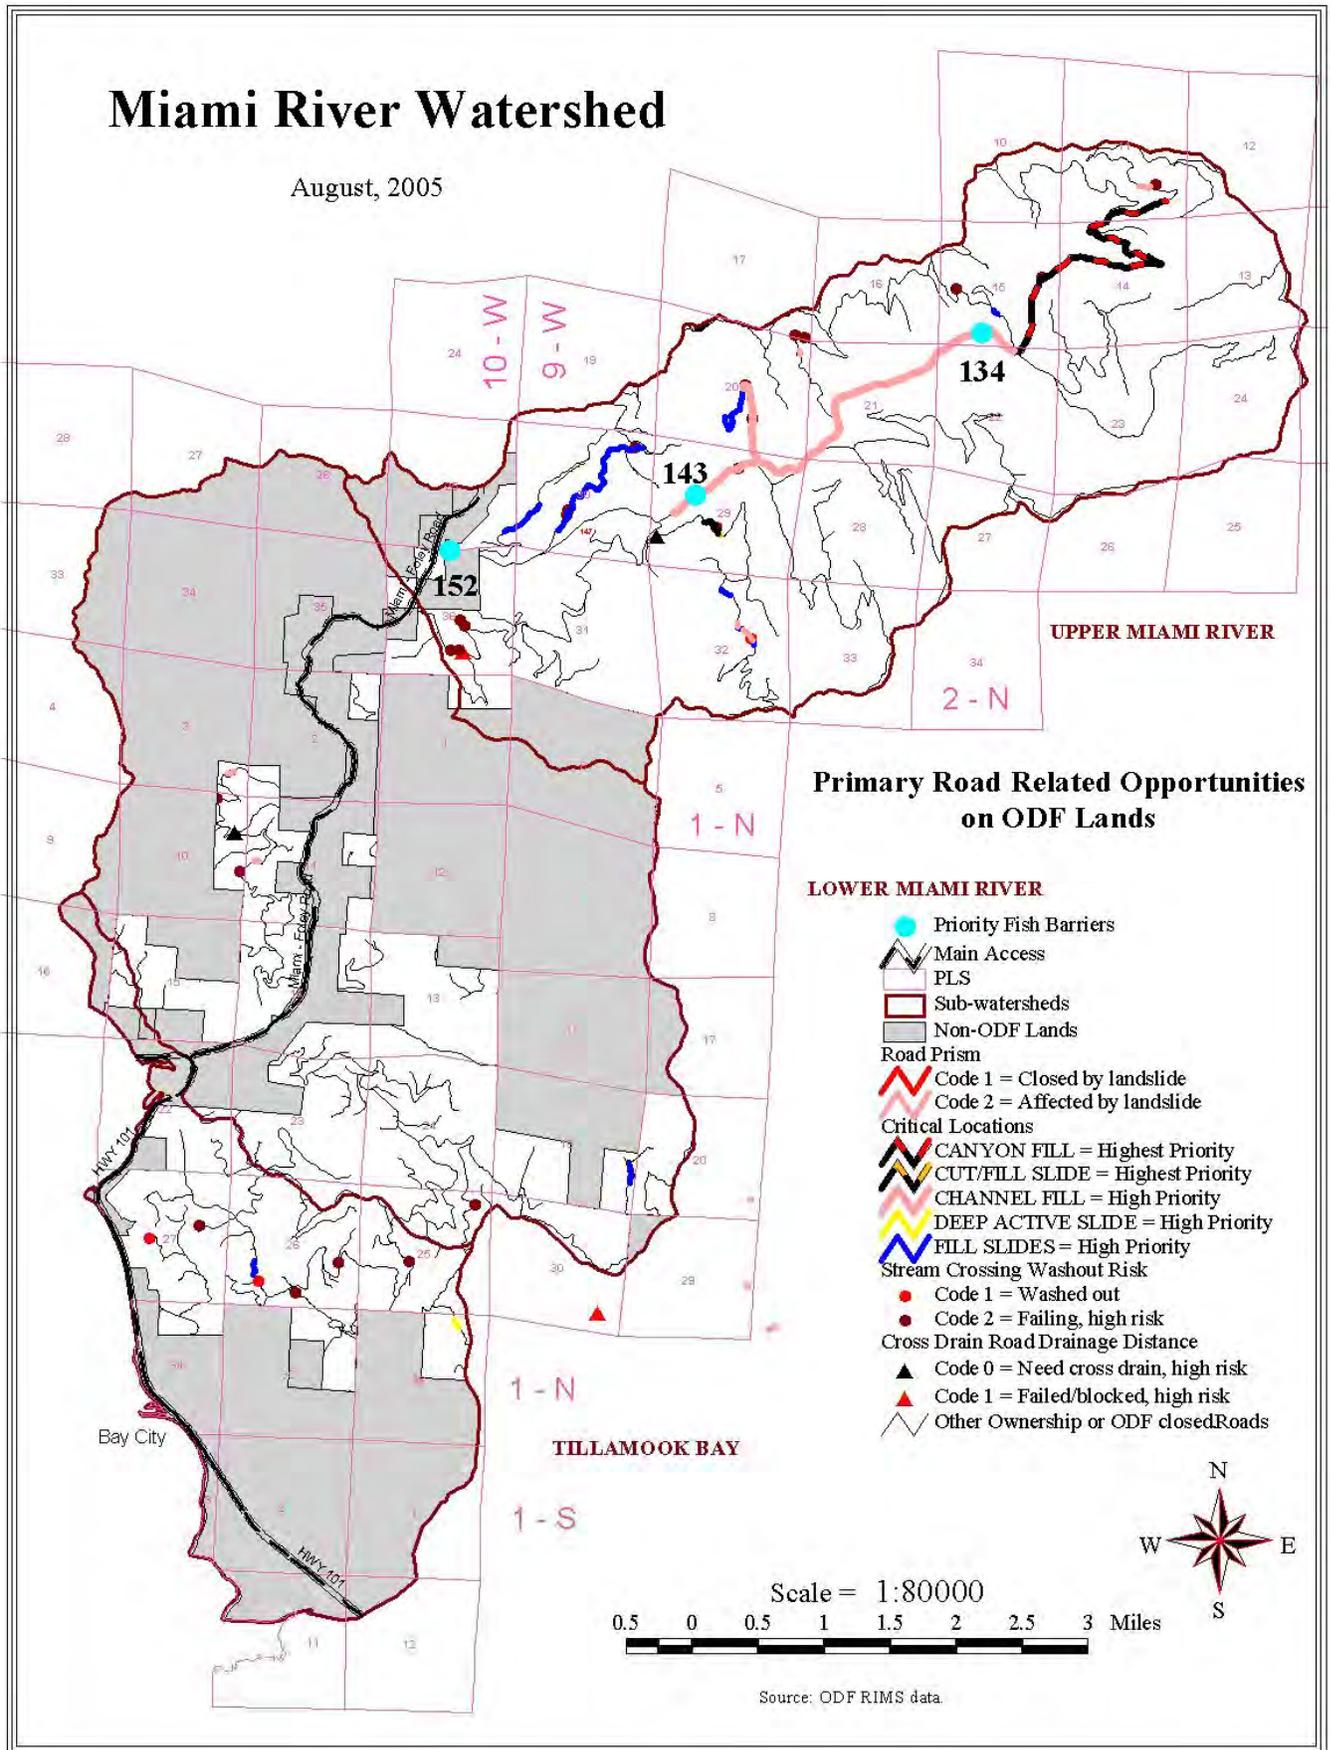
Figure 2. Road segments with a high priority for further study and management opportunities.
