Historic Columbia River Highway

Rockfall Hazard Study

January 2013

Oregon Department of Transportation
Region 1 Geo/Hydro/HazMat Unit
Portland, Oregon

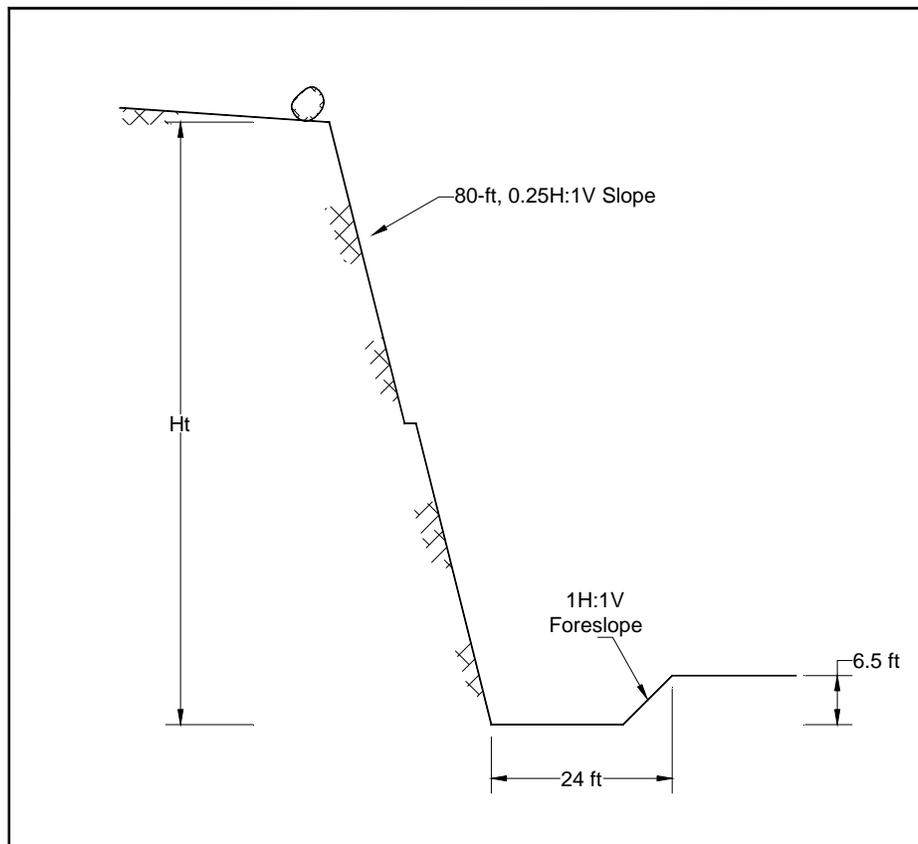
Figure 3-1. Typical Ritchie catchment area geometry

The Rockfall Catchment Area Design (RCAD) Guide was developed by ODOT in collaboration with the Federal Highway Administration (FHWA) to update previous Ritchie ditch design guidelines (1963). A typical Ritchie Ditch catchment area geometry is shown in figure 3-1.

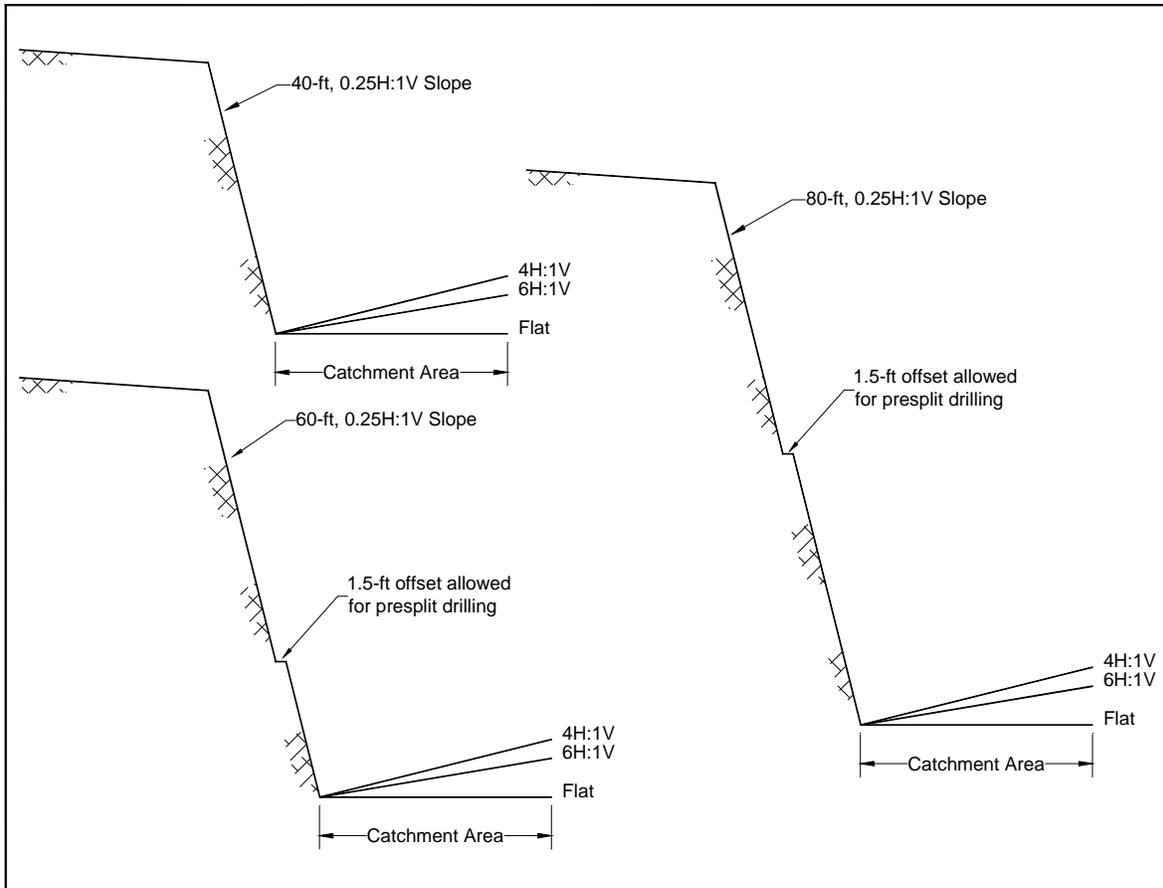
Figure 3-2. Typical RCAD catchment geometries

This paper summarizes a research project that investigated how slope, catchment area geometry and rockfall properties affected rockfall retention at the toe of varying slopes and developed updated guidelines for catchment design. Typical RCAD catchment area geometries are shown in Figure 3-2. The RCAD study showed that the most effective and economical catchment area was a single-slope configuration with an angle of 4H:1V. This slope is considered recoverable (an errant vehicle can return to the roadway). Steeper slopes or Ritchie configurations can provide better rockfall containment, but would require guardrail or barrier to separate traffic from the unrecoverable slope.

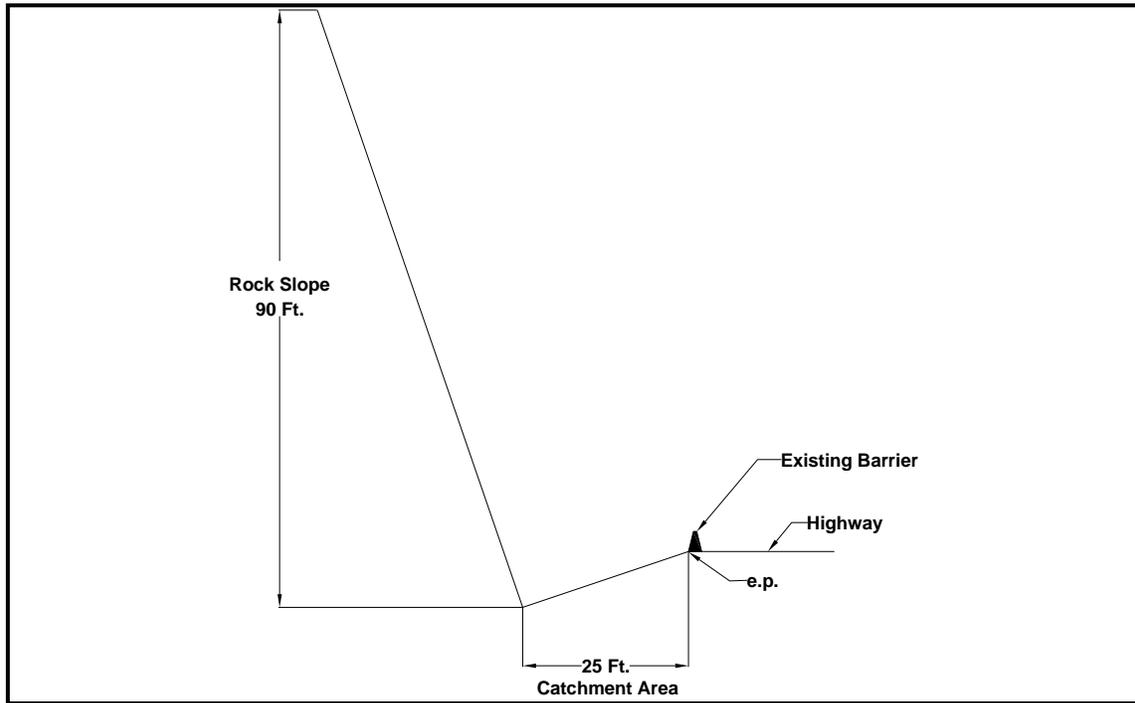
Figure 8-1. Existing Slope Geometry

Initially, two slope geometries were modeled for each rockfall site. The first model represents the existing slope and catchment geometry (Figure 8-1). This was done to calibrate the input parameters to the observed rockfall conditions. The calibrated input parameters were then used in all subsequent simulations. Each simulation was run repeatedly using 500 rocks. A final run of 10,000 rocks was used as a check.

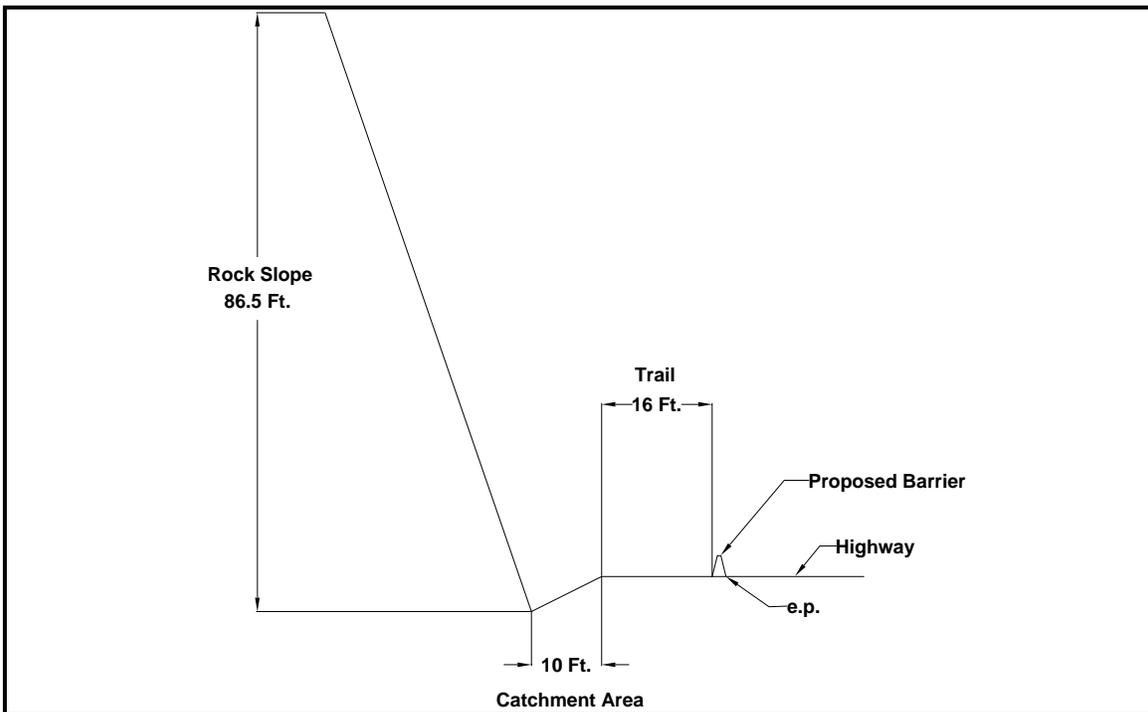
Figure 8-2. Proposed Slope Geometry

The second geometry modeled modified slope and catchment area geometry, adding a trail prism and concrete barrier (Figure 8-2). The trail prism represents the width and depth of the trail foundation and pavement. We used a 16-ft-wide trail prism, which is consistent with the HCRH Trail Guidelines for a preferred 12-ft-wide paved trail with 2-ft-wide shoulders. We modified the trail prism width to a total of 12-ft-wide in some locations where the existing and available width between the highway and rock slope is less than 16-ft-wide. In all cases, concrete barrier was positioned at the existing edge of pavement, assuming no reduction of the highway paved shoulder width.

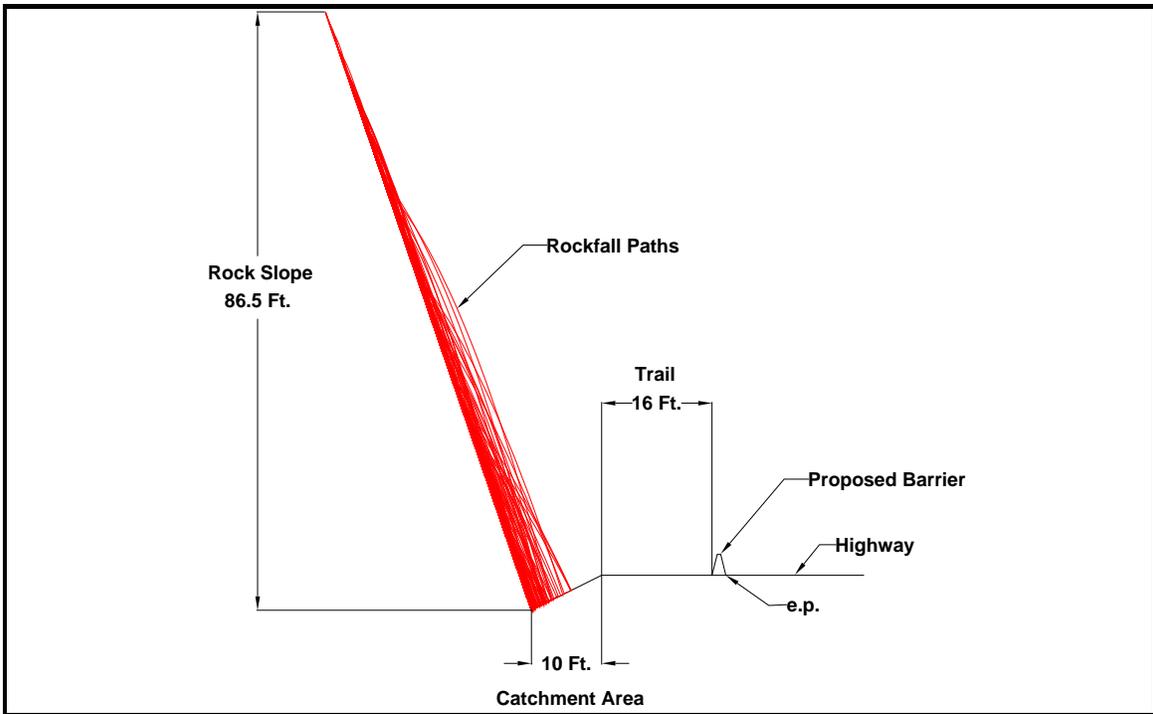
Figure 8-3. Rockfall Analysis: No Impact to Trail

The modified models were used to determine if rockfall mitigation was necessary. If the model showed less than 1% of rocks impacting the trail and less than 10% of rolling rocks reached the trail, the rockfall hazard was considered acceptable and no further modeling or analysis was needed (Figure 8-3). At sites 2, 4 and 5, less than 1% of rocks impacted the trail prism and less than 10% of rocks rolled to the trail. At these locations no rock slope mitigation is required for trail construction. At sites 8 and 9, the trail requires narrowing to 12-ft-wide to fit existing geometry (width between highway shoulder and rock slope), but less than 1% of rocks impacted the narrowed trail prism and less than 10% of rocks rolled to the trail. For the remaining rockfall sites (Sites 1, 3, 6, and 7) additional models, with mitigation options added, were evaluated to

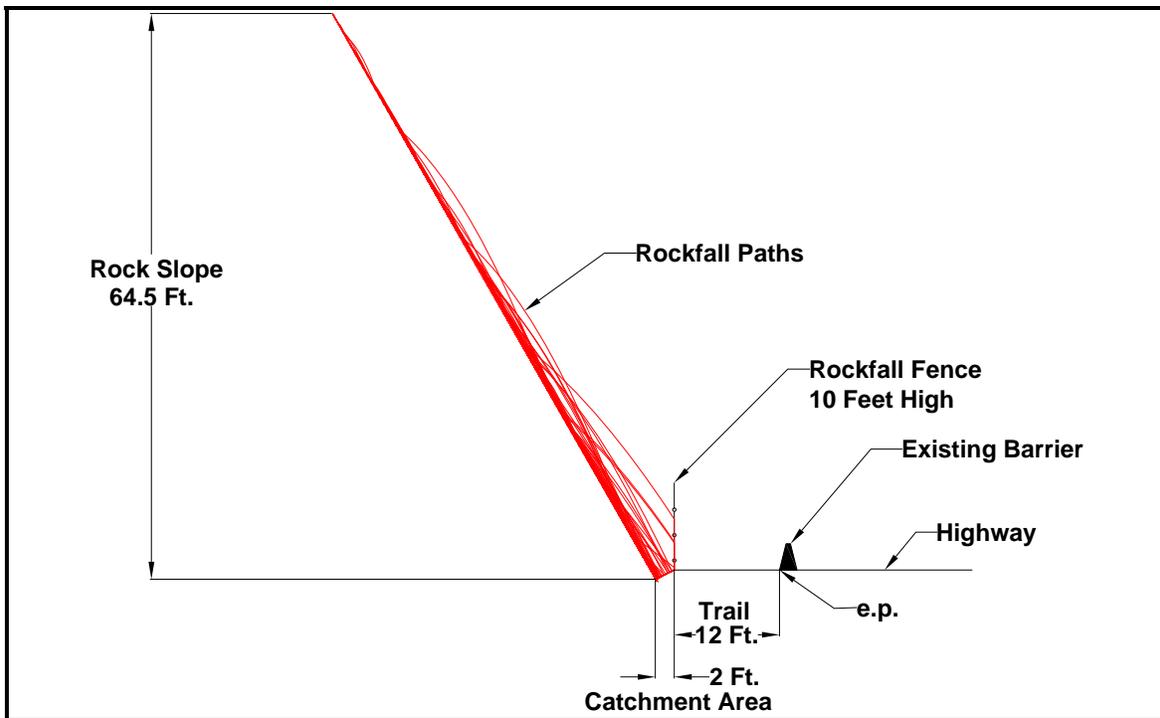
Figure 8-4. Rockfall Analysis: Rockfall Fence and Narrow Trail

determine the most appropriate mitigation type for each specific site (Figure 8-4). This was an iterative process, testing both the type and geometry of mitigation measures.

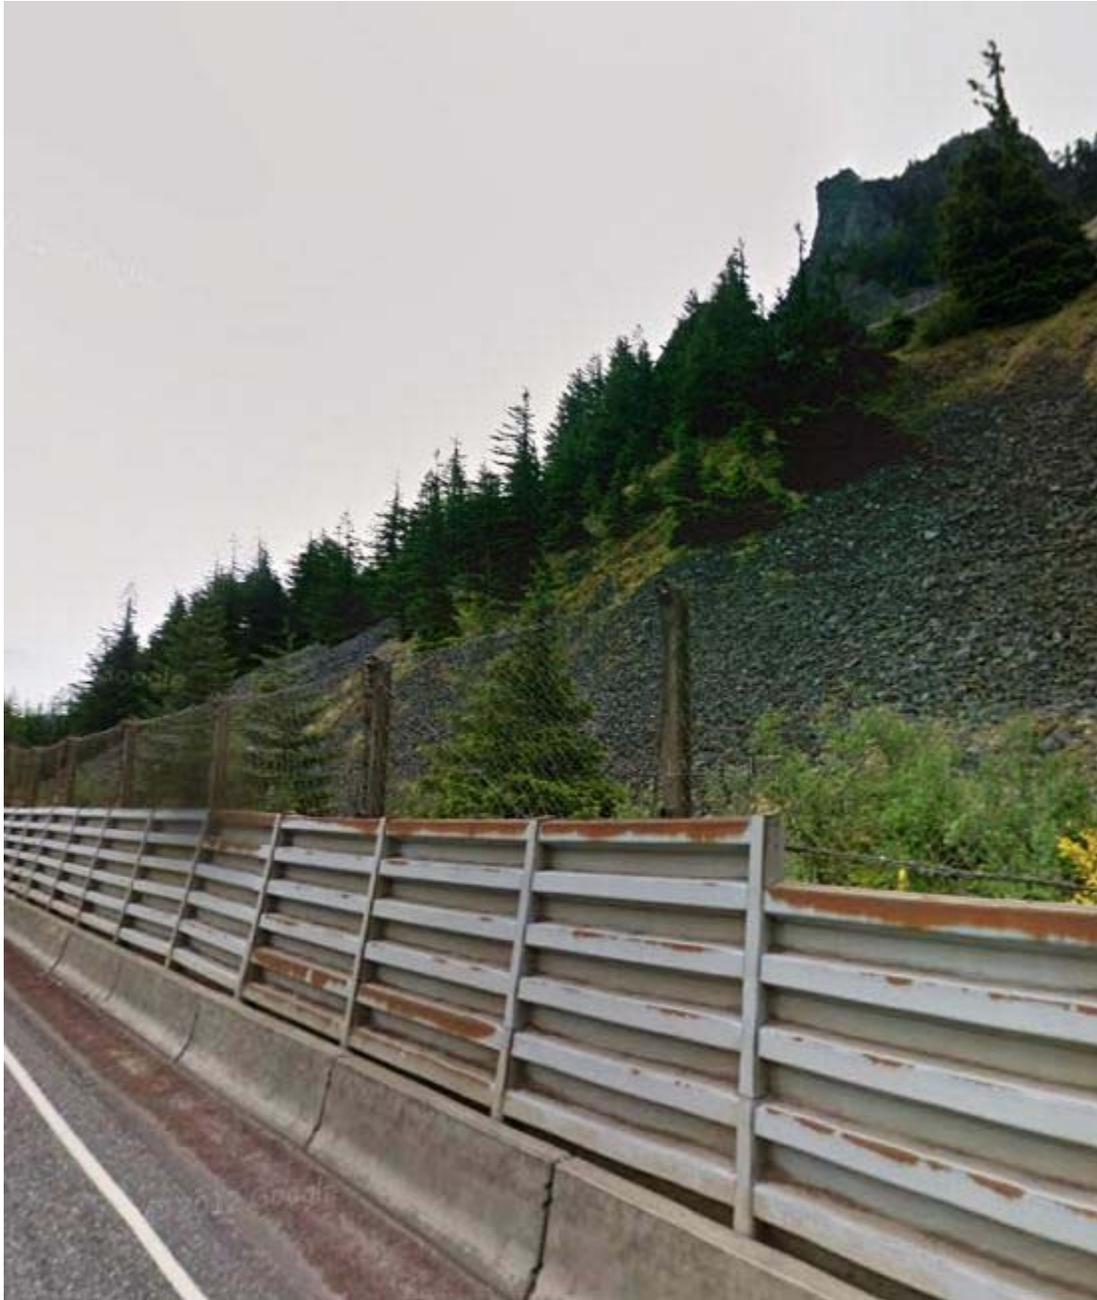
Figure 9-1. Site 1: Existing catchment area, bin wall, and cable-mesh fence

Shellrock Mountain is an igneous intrusion (Tolan and Beeson, 1984), younger than surrounding Columbia River Basalt. The surface slopes of Shellrock Mountain are active talus composed of loose, angular basalt. Existing rockfall protection for I-84 is composed of a metal bin wall topped with a cable-mesh rock protection fence. The proposed trail alignment crosses the active talus about 10 ft above I-84. In this area the proposed trail alignment lies behind the existing cable-mesh rock protection fence, within the active rockfall catchment area for the existing talus slope.

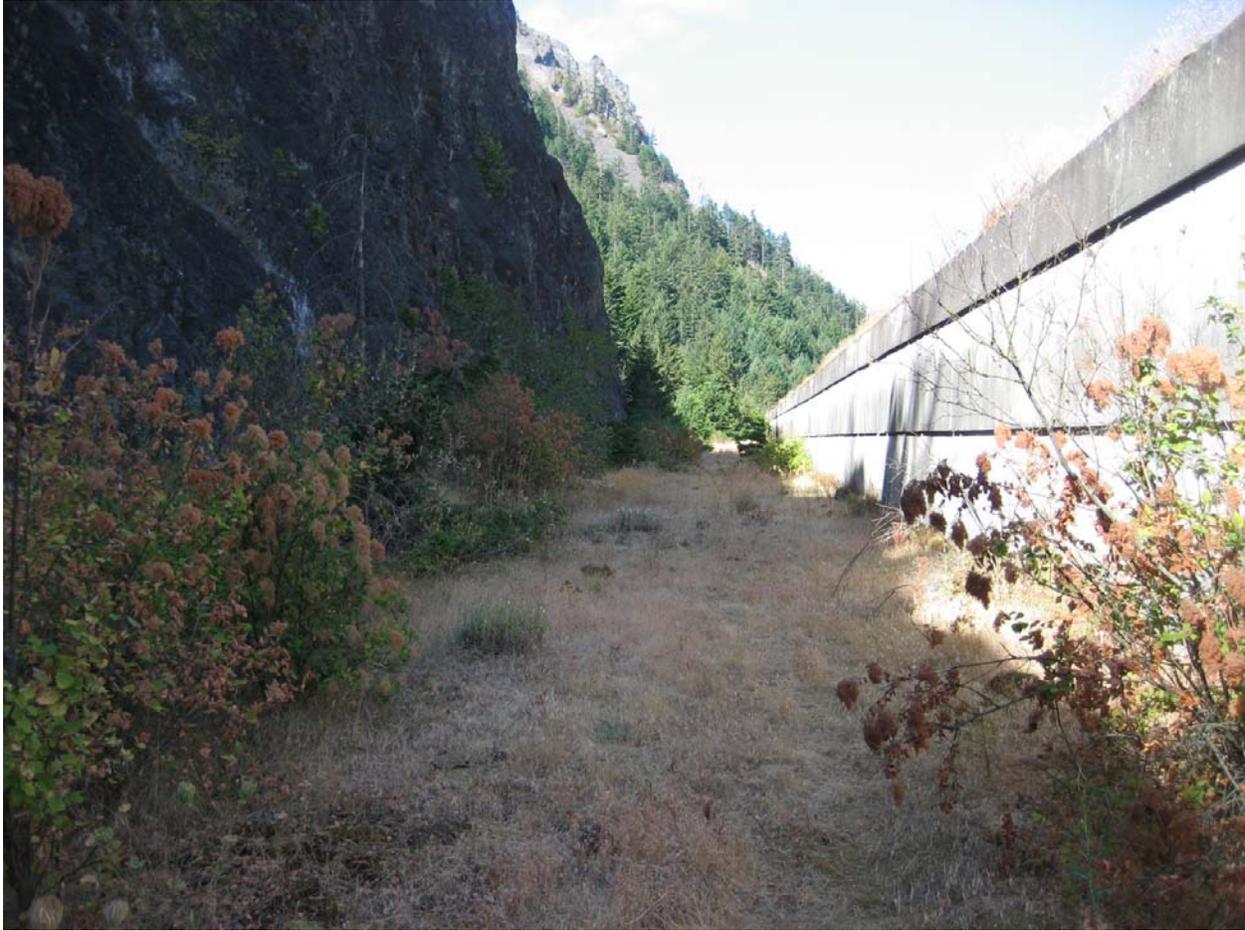
Figure 9-3. Site 2: Existing catchment area behind bin wall.

East of Summit Creek the proposed trail alignment passes between an existing concrete bin wall and a near vertical basalt cliff that more than 200 feet tall. The rock slope is benched at a height of about 70 ft. The cliff benching and bin wall construction were completed in the mid-1980s following a multiple fatality accident caused by a rockfall originating from this location. Gabion baskets were constructed on the lower bench to provide additional catchment and protection for the upper slope. The concrete bin wall is about 10-ft-tall and about 600-ft-long. Between Stations 106+00 to 109+00, the rock slope is about 70 feet high, 4V:1H, with a catchment width of 30 feet. From Station 109+00 to 112+00, the slope height reduces to 45 feet; the slope angle is about 3V:1H, and the catchment width narrows to 17 feet.

Rock debris was observed in the catchment area behind the bin wall and the bin wall shows damage that may be from rock impacts, especially at the east end of the wall.

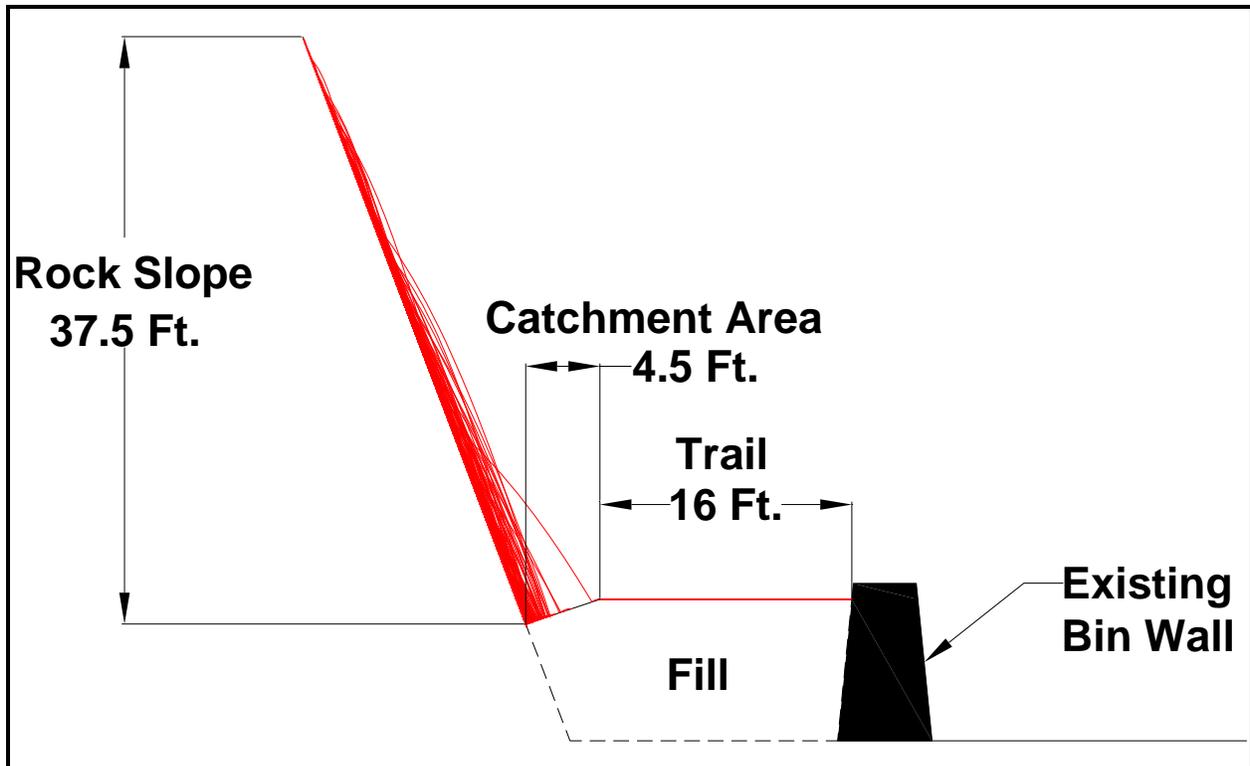
Figure 9-3. Site 2: Rockfall Analysis and Proposed Mitigation

An analysis of the existing and proposed geometry and field observations between Stations 106+00 and 109+00 indicates less than 1% impact and 10% roll-out occurs within the proposed trail footprint. No mitigation is necessary in that section. From field observation between Station 109+00 to 112+00 and computer analysis of the existing and proposed geometry, more than 1% rock impact is observed within the proposed trail footprint.

At this location we considered the following mitigation options: narrowing trail, draped mesh, rockfall protection fence, and raising the grade of the trail. To protect the trail from impact, we recommend elevating the trail about 9 ft above the existing surface. This proposed design is shown in Figure 9-3. The catchment area includes an impact dampening blanket of loose soil or gravel. Note that one of the 500 simulated rocks (0.2%) impacted high up in the catchment area and rolled across the trail. The stability of the proposed embankment or existing bin wall has not been investigated.

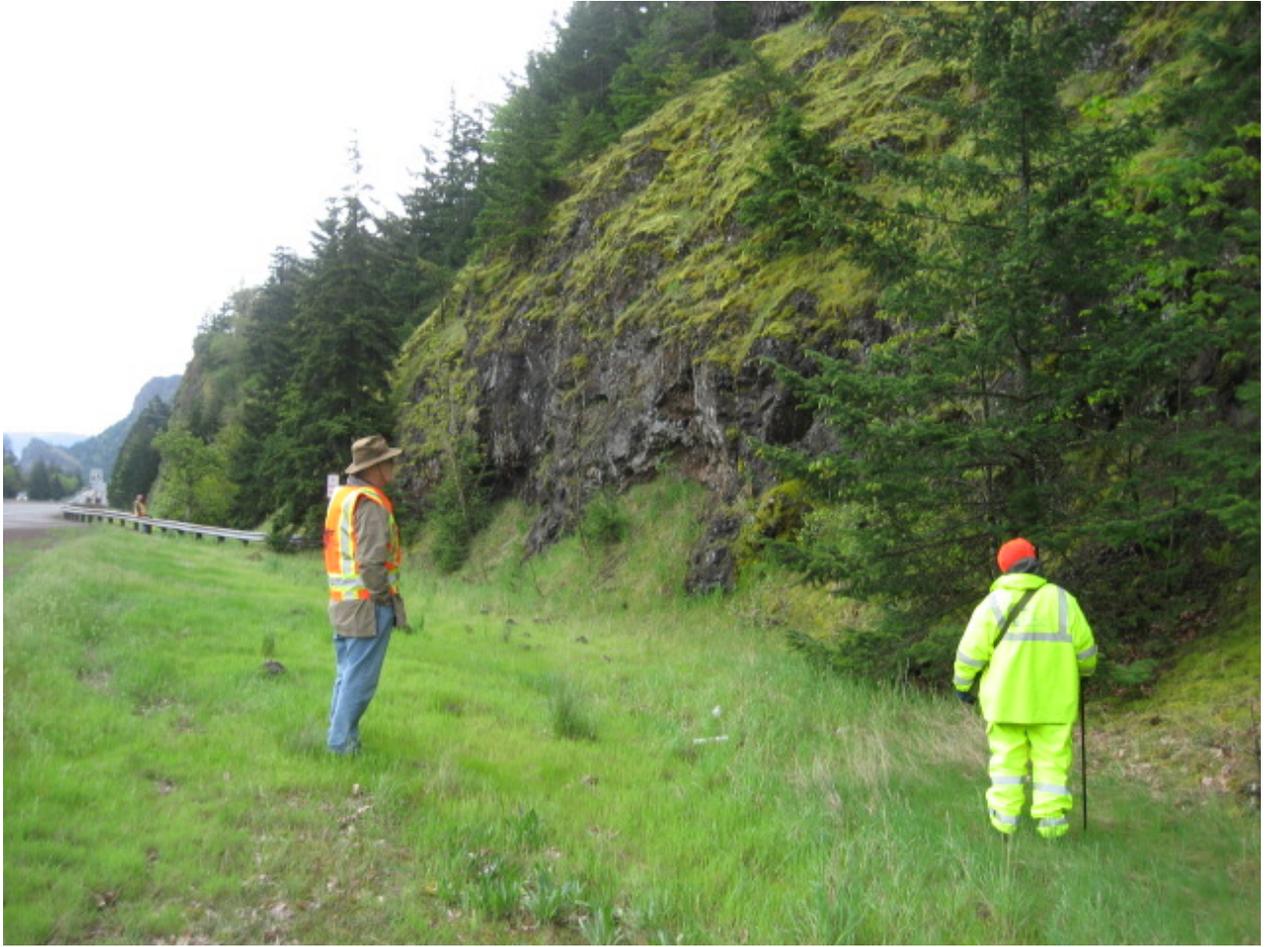
Figure 9-4. Site 3: Existing catchment area and lower rock slope

At this location the trail alignment is located off the highway shoulder at the toe of an existing 60 degree rock slope. The rock slope is up to about 230-ft-tall and has two benches, at heights of about 40- and 90-ft-tall. The existing catchment area is 37-ft-wide (from behind the existing barrier to the toe of the slope) with a 7-ft-deep, 15-ft-wide ditch at the toe.

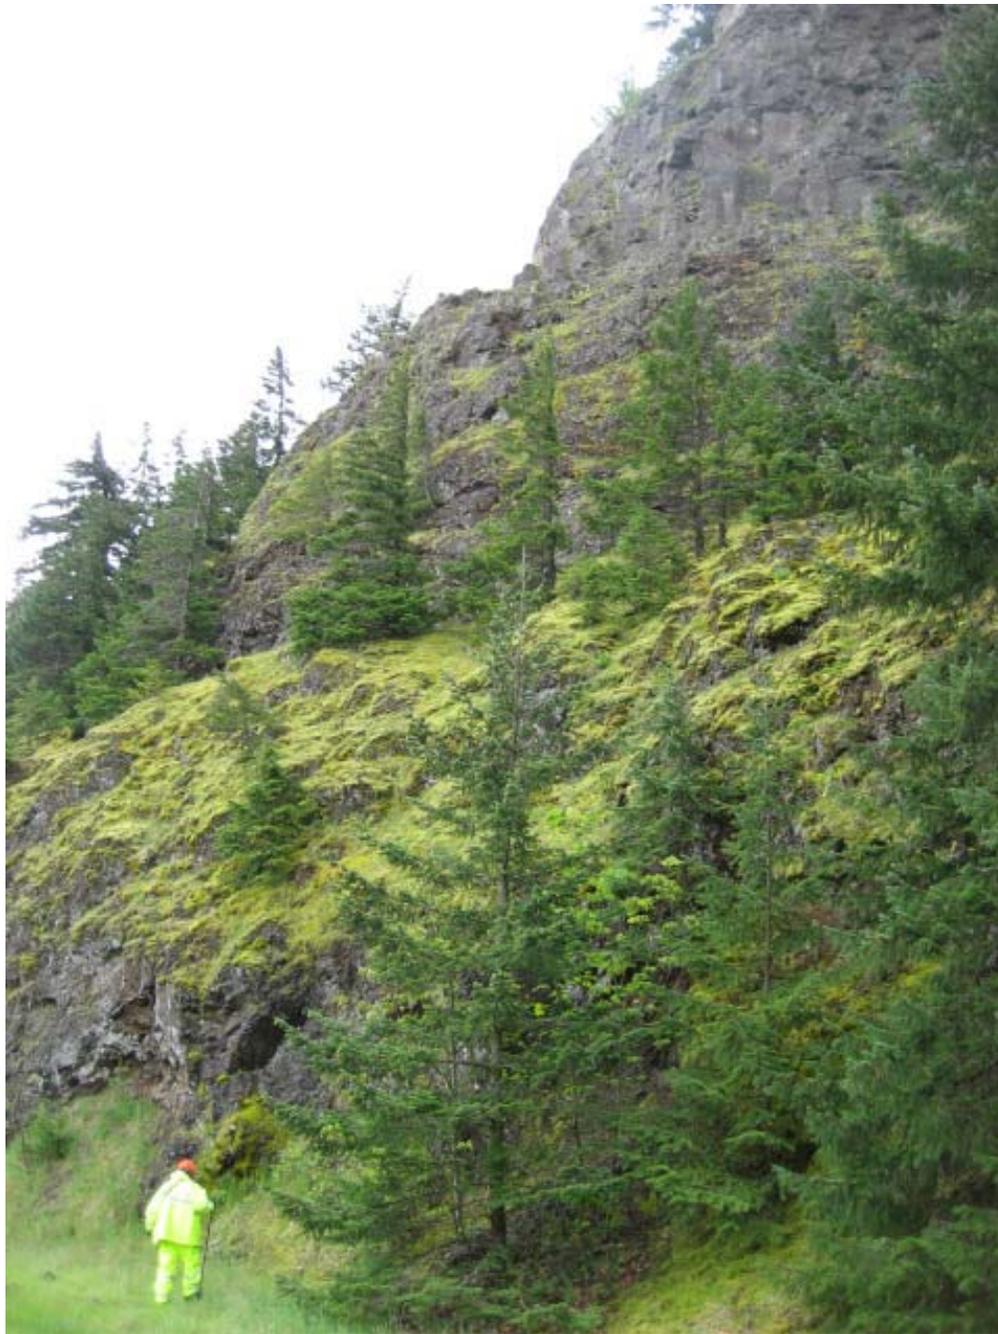
Figure 9-5. Site 3: Rock slope benches

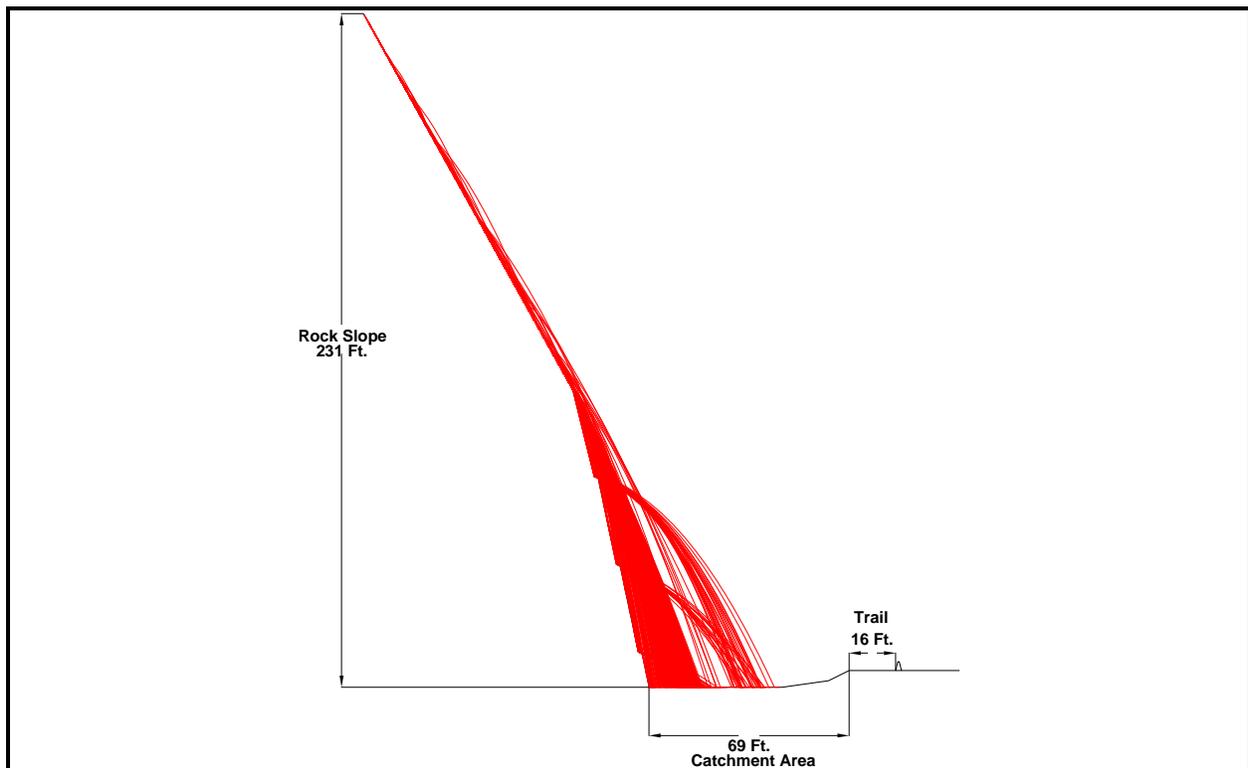
Figure 9-6. Site 3: Rockfall Analysis and Proposed Mitigation

To protect the trail from impact, we recommend that the lower half of the slope be excavated. The proposed design, shown in Figure 9-5, shows a catchment area width of 69 feet, a 100-foot high excavated slope with an angle of 4V:1H. This recommendation assumes some removal of blast-hole traces (half-casts) and rock staining.

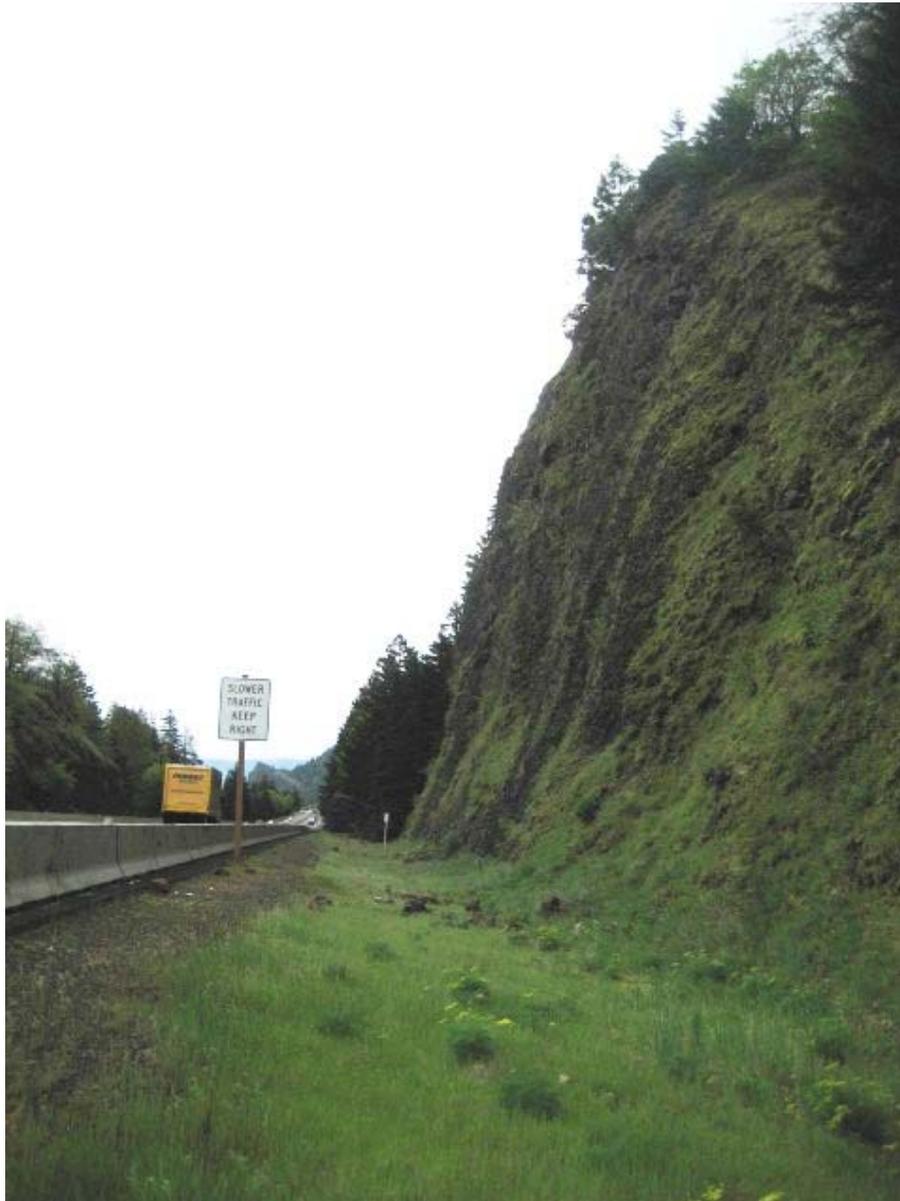
Figure 9-7. Site 4. Existing Catchment Area.

At the time of reconnaissance, we observed freshly impacted, 8- to 12-in-diameter cobbles scattered in the existing catchment area, that appear to originate from the middle to top of the slope at the soil-rock contact where the rock slope is over steepened. Rockfall debris is scattered across the catchment area, and has impacted the back of the existing concrete barrier. The existing catchment area is 27-ft-wide (from behind the existing barrier to the toe of the slope) with a 5-ft-deep, 10-ft-wide ditch at the toe.

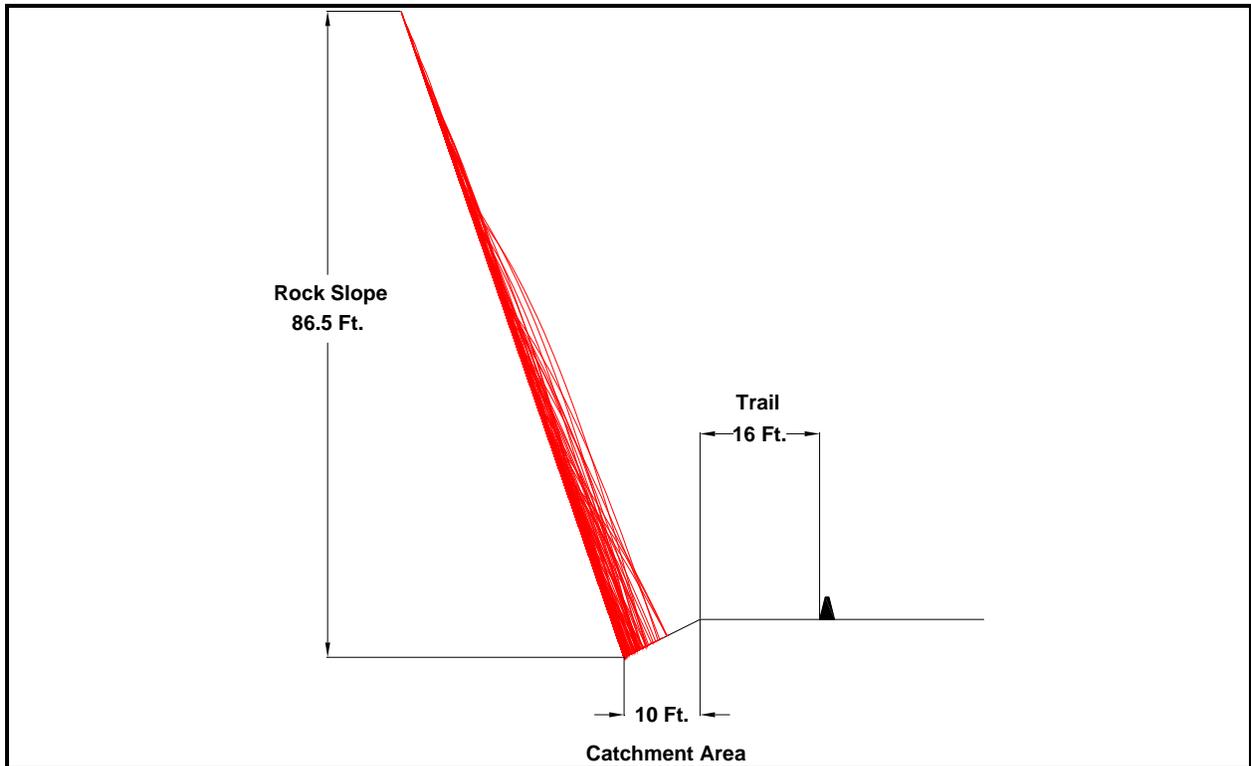
Figure 9-8. Site 4: Rockfall Analysis: No Mitigation

No mitigation is necessary. Construct catchment area with a dampening blanket of loose soil or gravel.

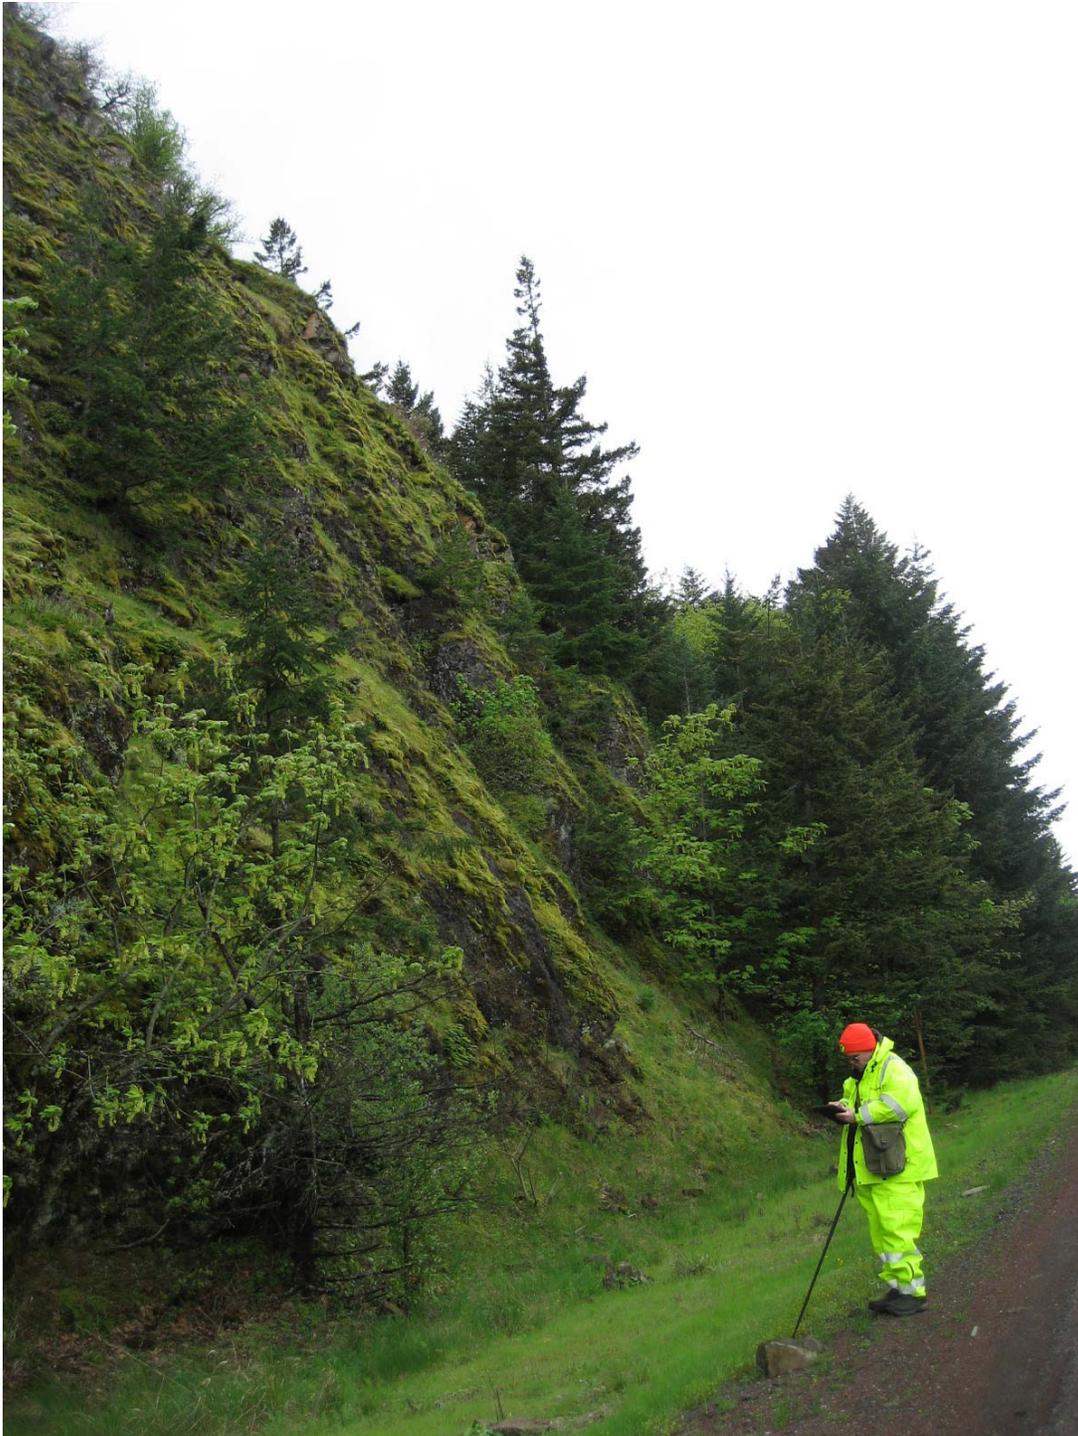
Figure 9-9. Site 5: Existing Catchment area

This basalt slope is partially vegetated with small fir trees and shrubs. The existing catchment area is 25-ft-wide (from behind the existing barrier to the toe of the slope) with a 5-ft-deep, 10-ft-wide ditch at the toe. There is no indication of recent rockfall in the catchment area.

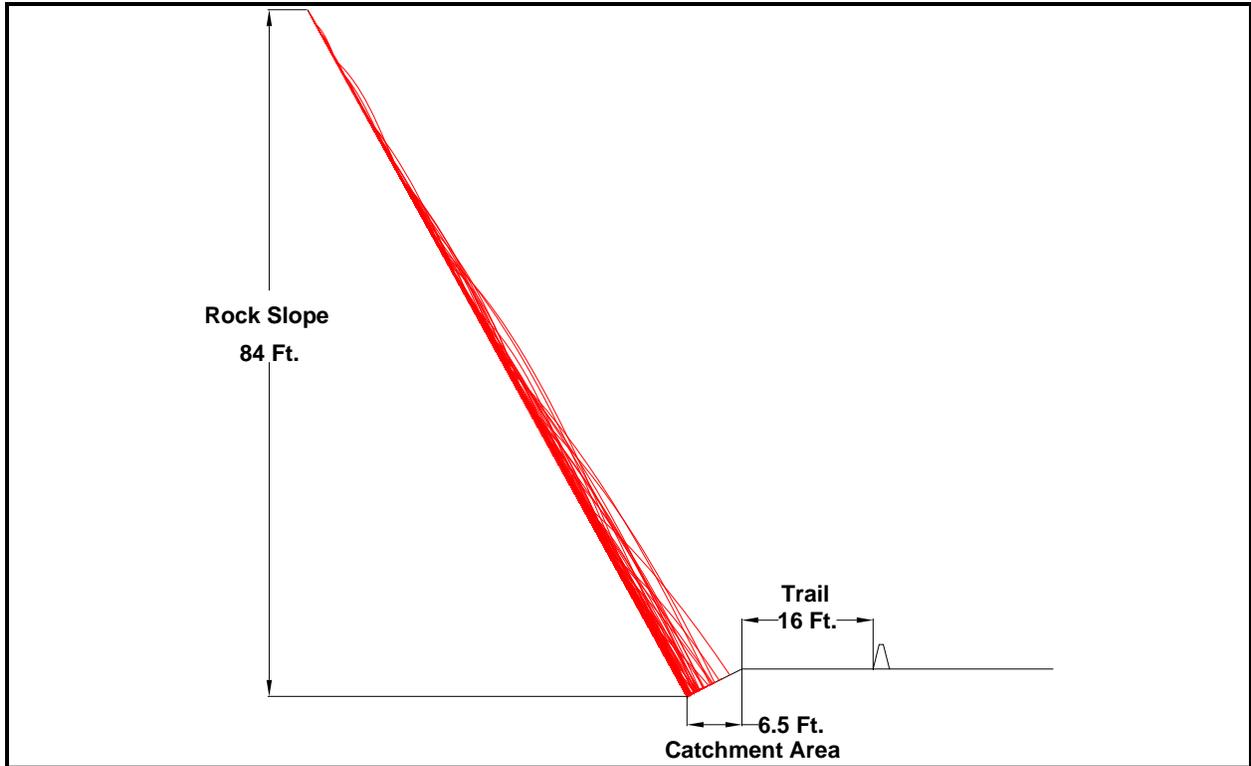
Figure 9-10. Site 5: Rockfall Analysis: No Mitigation

No mitigation is necessary. Construct catchment area with a dampening blanket of loose soil or gravel.

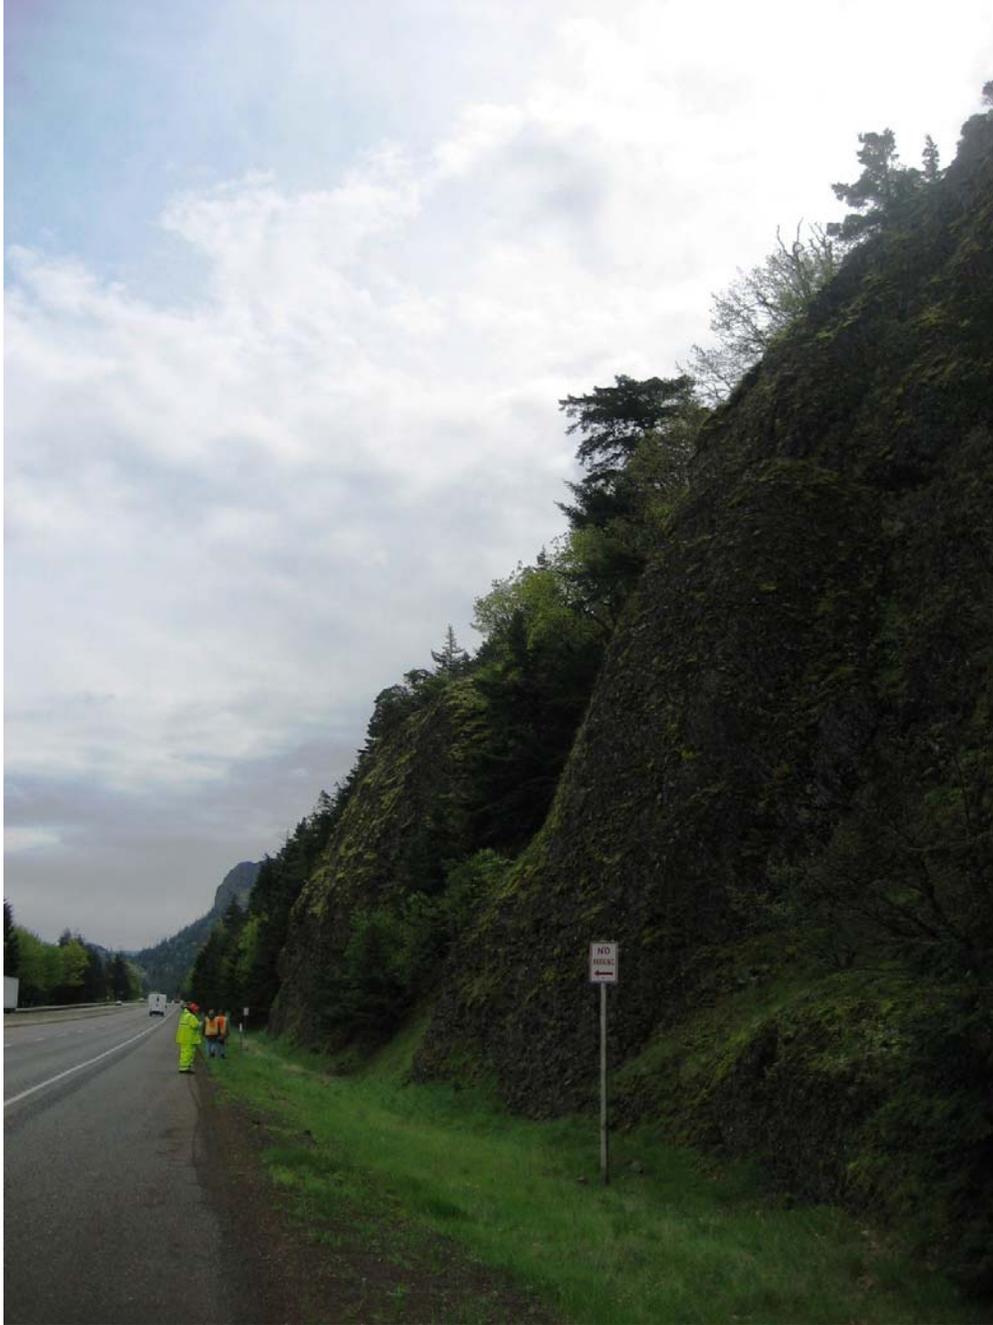
Figure 9-11. Site 6: Existing Catchment area

At this location the trail alignment is located off the highway shoulder at the toe of an existing 60 to 70 degree, 50- to 70-ft-tall rock slope. The east end of the rock slope is active, with fresh rockfall debris observed in the catchment area. The existing catchment area is 14-ft-wide (from behind the existing barrier to the toe of the slope) with a 2-ft-deep, 2-ft-wide ditch at the toe.

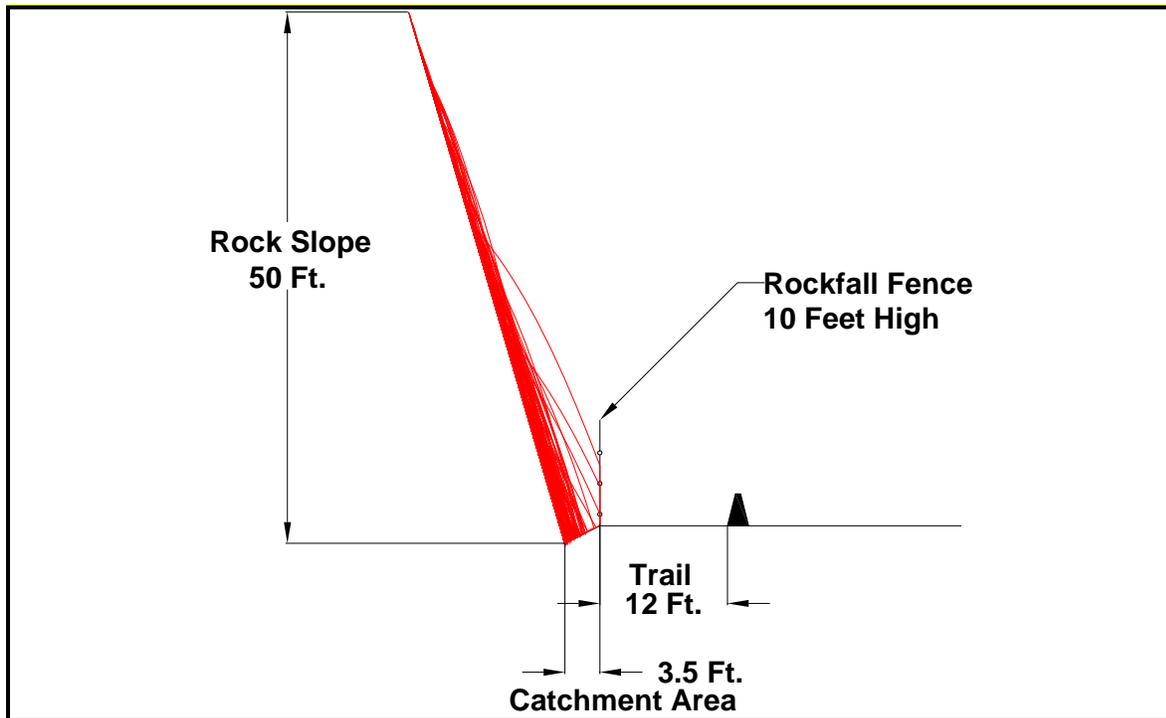
Figure 9-12. Site 6: Rockfall Analysis: Rockfall Protection Fence

An analysis of the existing and proposed geometry and field observations indicate that mitigation is necessary to protect the trail from rock impacts. Slope excavation, pinned mesh, draped mesh and a rockfall protection fence were the mitigation options considered. All the options except slope excavation include a 12-foot wide trail. Slope excavation and the mesh options are not recommended based on cost and visual impacts.

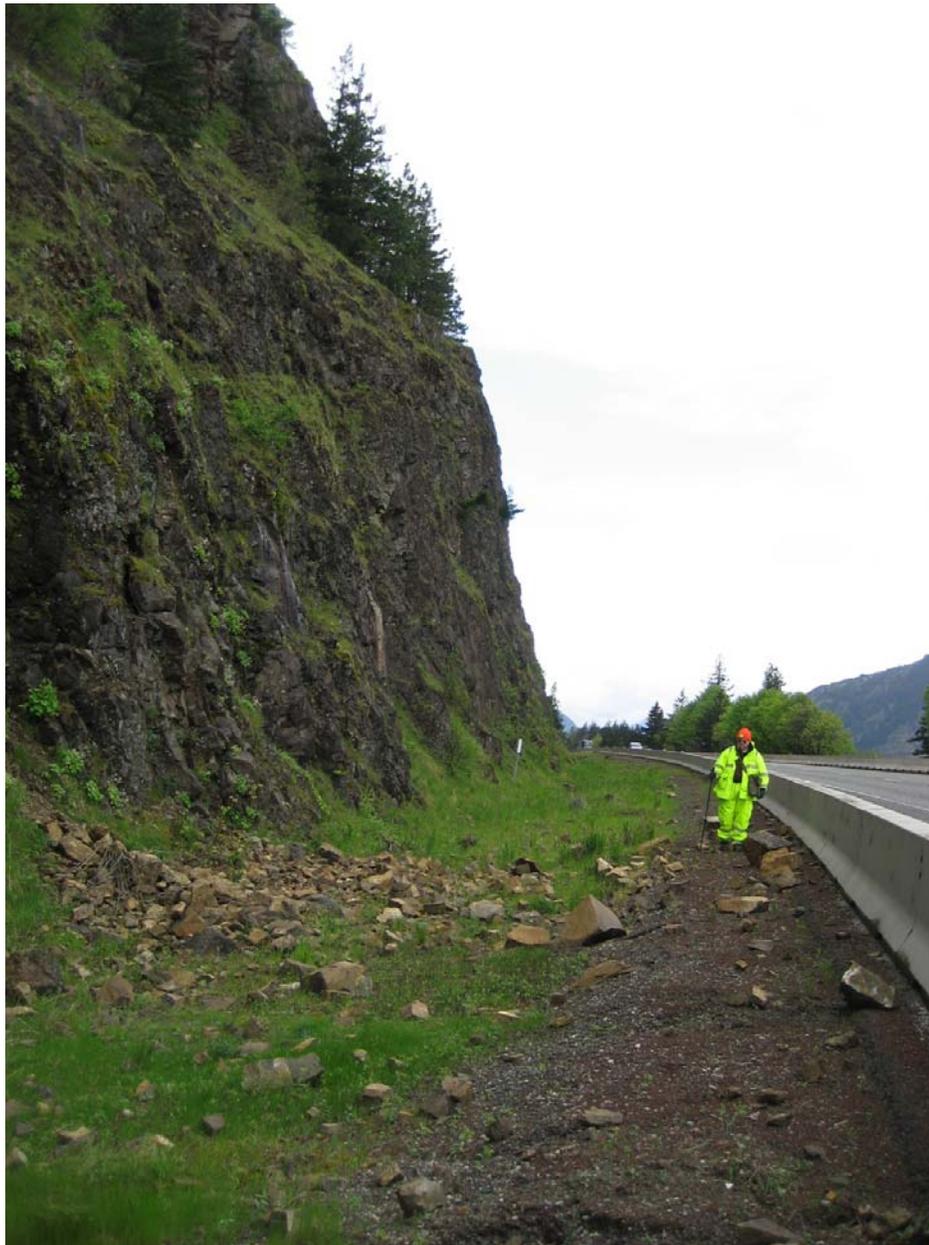
Figure 9-13. Site 7. Existing catchment area

catchment area is up to 25-ft-wide (from behind the existing concrete barrier to the toe of the slope, with a 5-ft-deep, 5-ft-wide ditch at the toe of slope.
