Historic Columbia River Highway

Rockfall Hazard Study

January 2013

Oregon Department of Transportation
Region 1 Geo/Hydro/HazMat Unit
Portland, Oregon

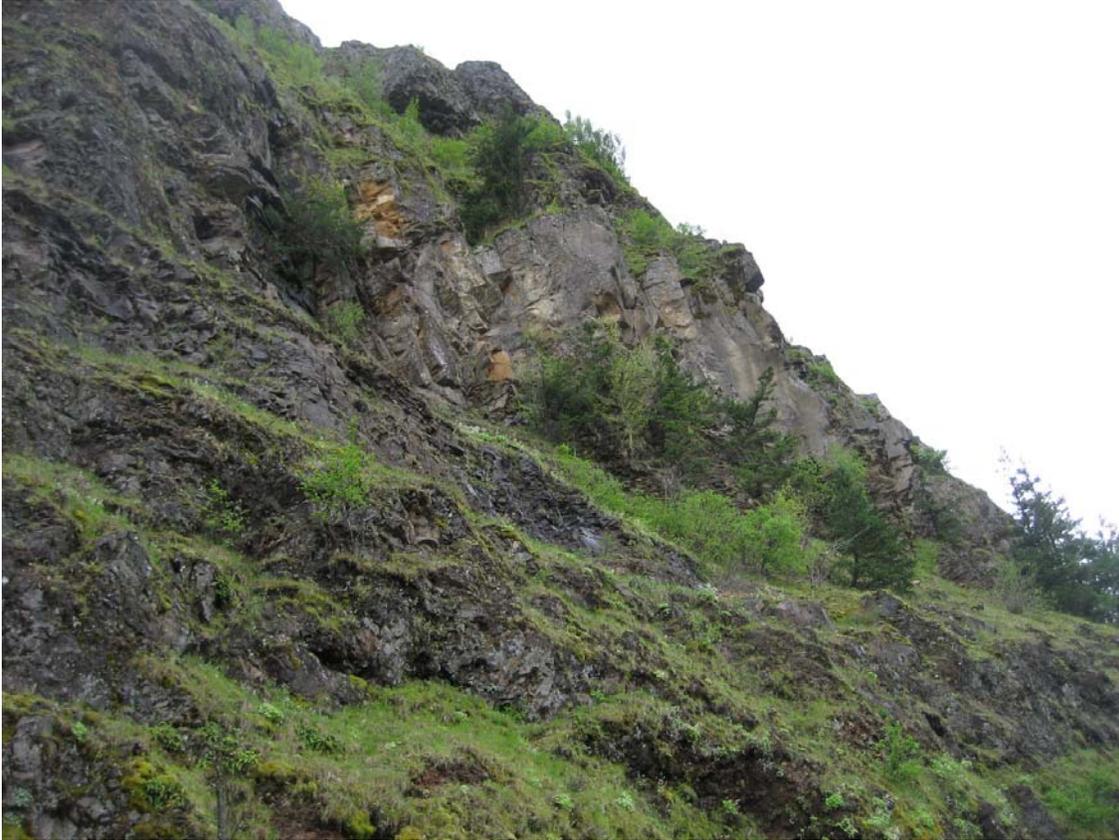
Figure 9-14. Site 7: Upper rock slope

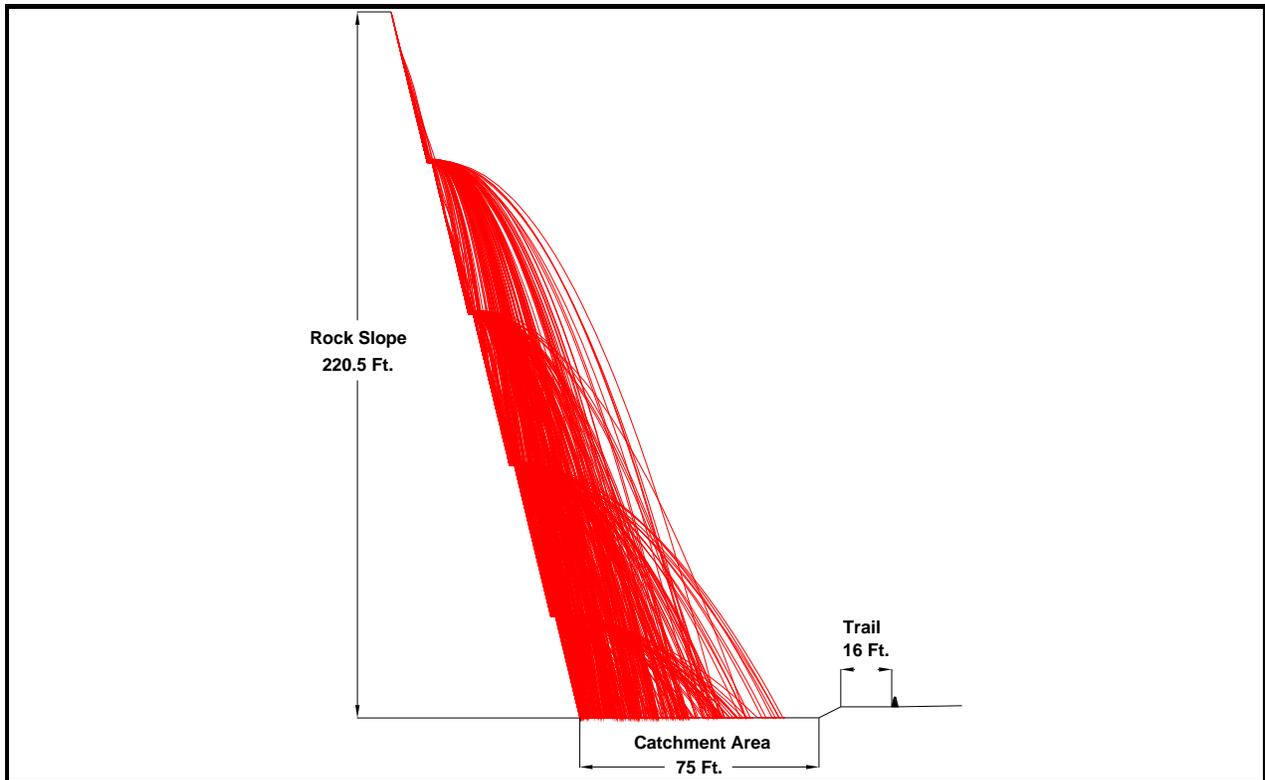
Figure 9-15. Site 7: Rockfall Analysis: Slope Excavation

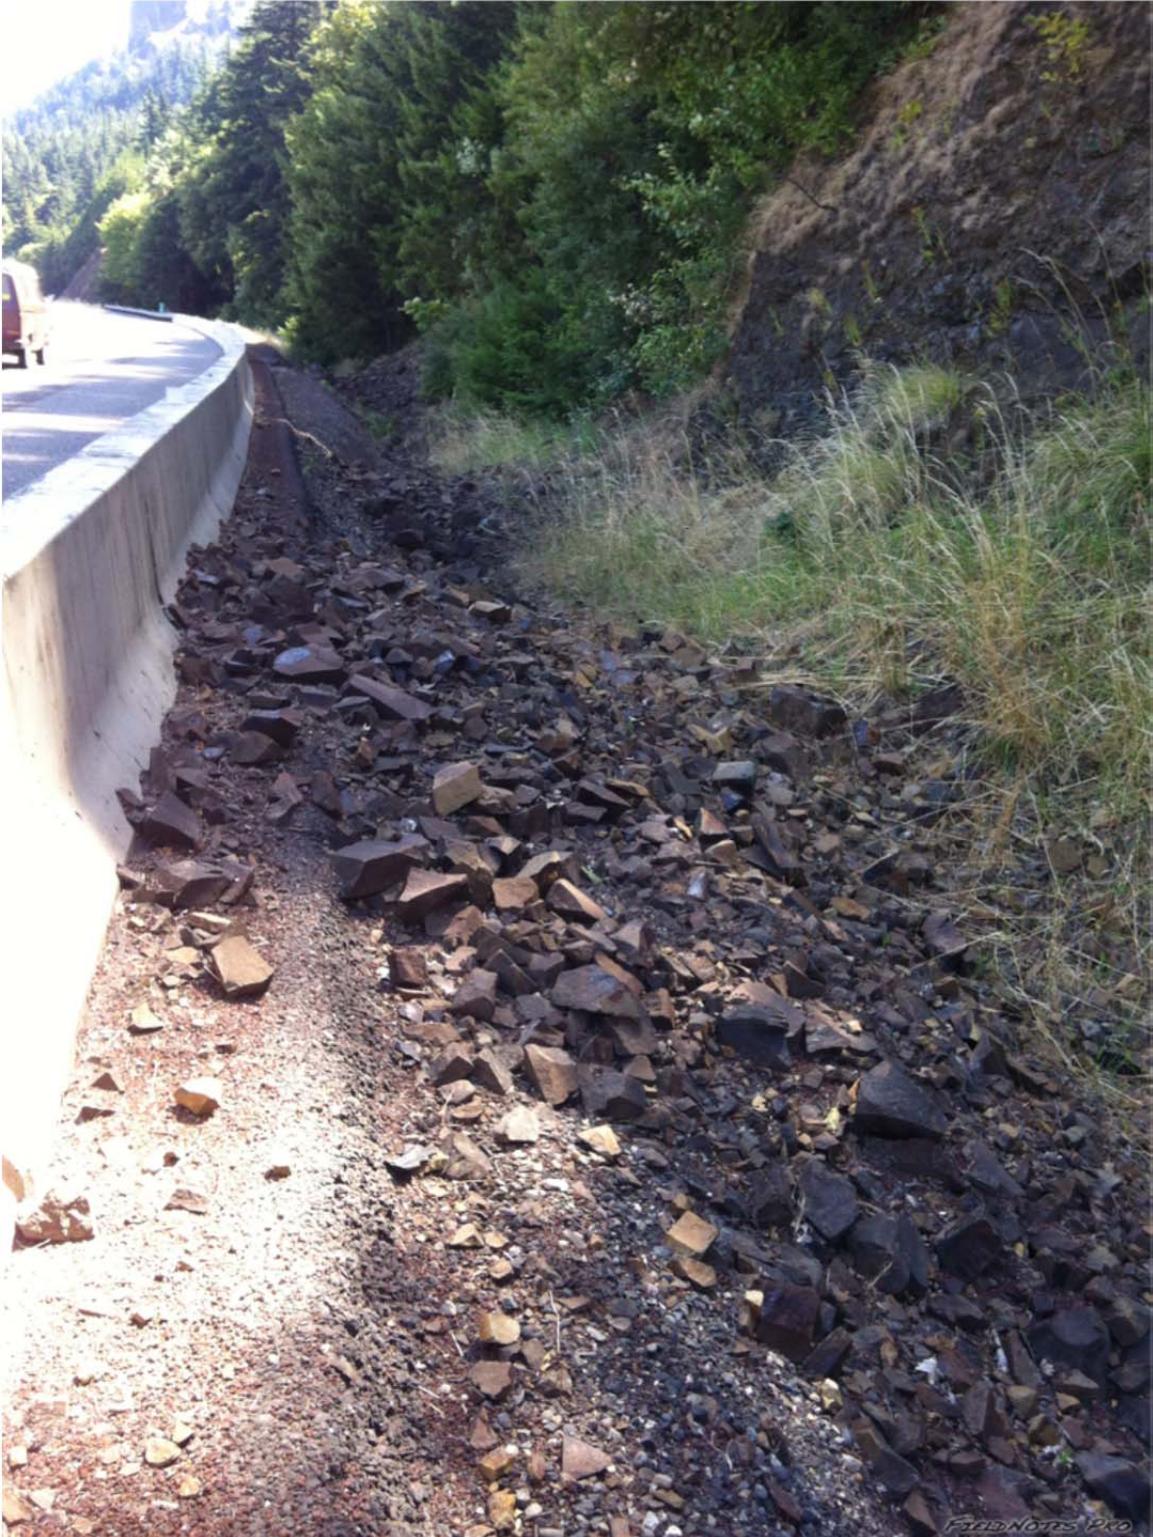
Figure 9-16. Site 8: Existing catchment area

At this location the trail alignment is located off the highway shoulder at the toe of an existing 70 degree, 70-ft-tall rock slope. The catchment area is 15 feet wide and 5 feet deep, separated from the highway by concrete barrier. The existing rock slope has a weathered basalt horizon at the top of slope. The material is undermined and raveling to toe. The rock slope is densely vegetated in some areas and is highly active in other areas with rockfall debris partially to fully filling the catchment area, allowing rocks to bounce or roll out and impact the back of the barrier.

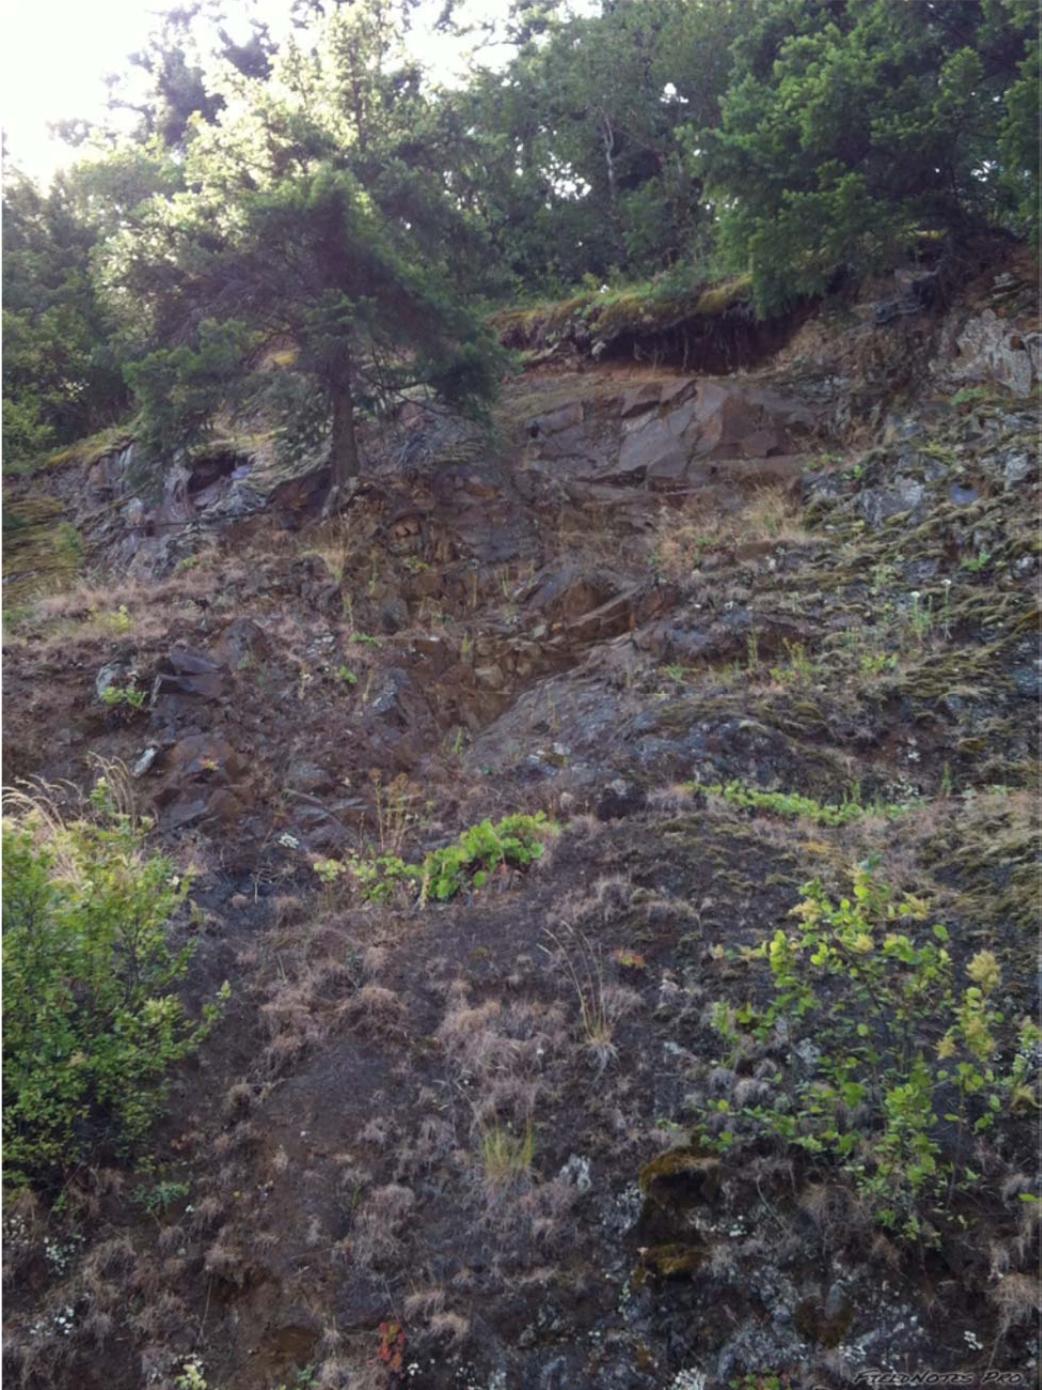
Figure 9-17. Site 8: Rock slope

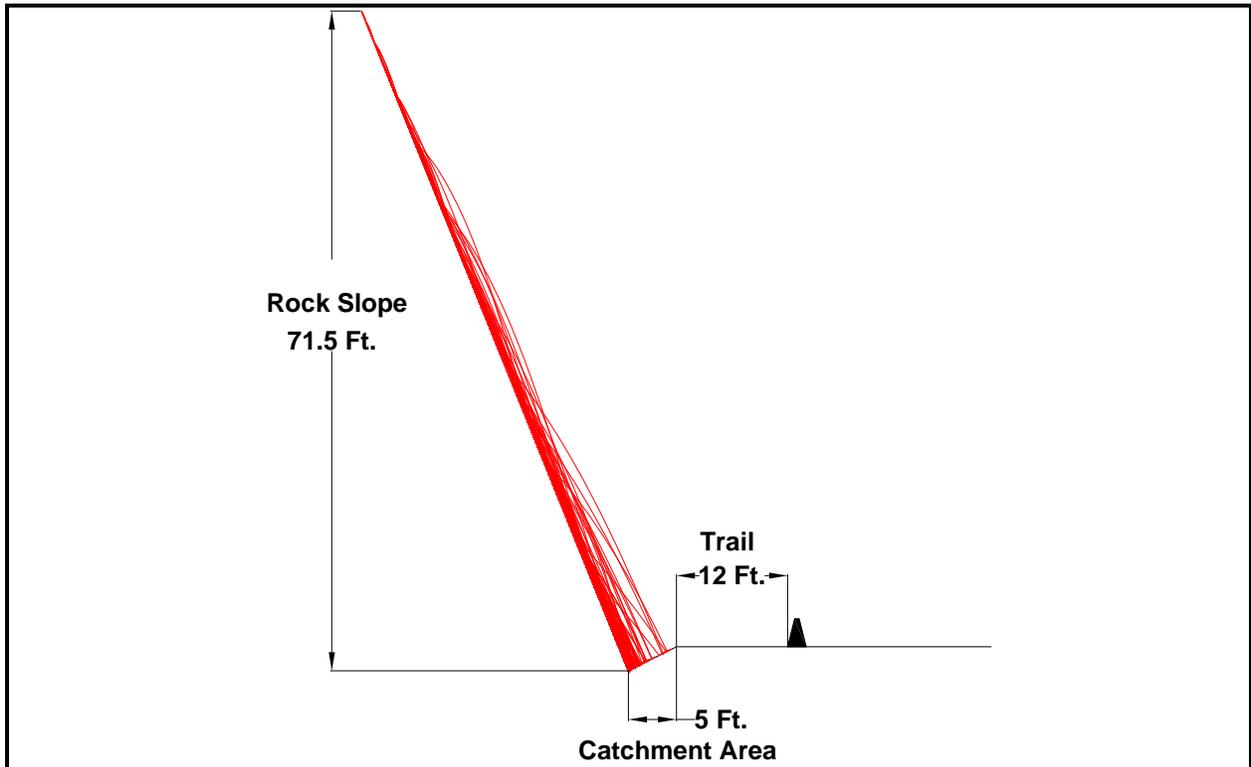
Figure 9-18. Site 8: Rockfall Analysis: Narrow Trail

The existing catchment geometry requires that the trail at this location be constructed 12-ft-wide to fit in the existing space between the highway shoulder and rock slope. Analysis of this proposed geometry (Figure 9-18) indicates that rockfall will not impact the trail, so no further analysis or mitigation is needed.

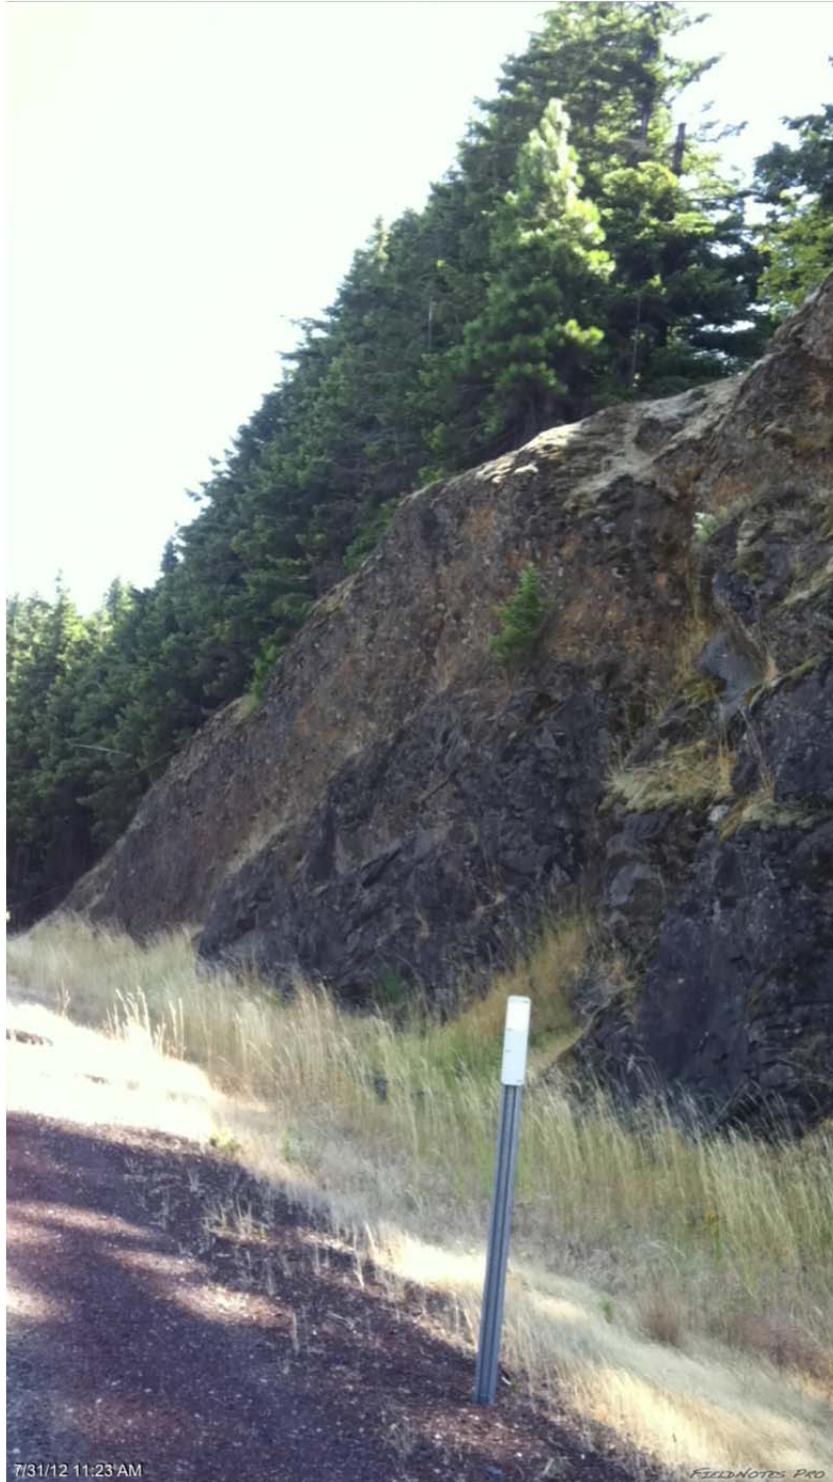
Figure 9-19. Site 9: Existing catchment area

At this location the trail alignment is located off the highway shoulder at the toe of a 30-foot high, 75 degree slope. The existing catchment area is 22 feet wide. The slope is massive basalt overlain by cobble conglomerate. There is very little rockfall debris in the catchment area.

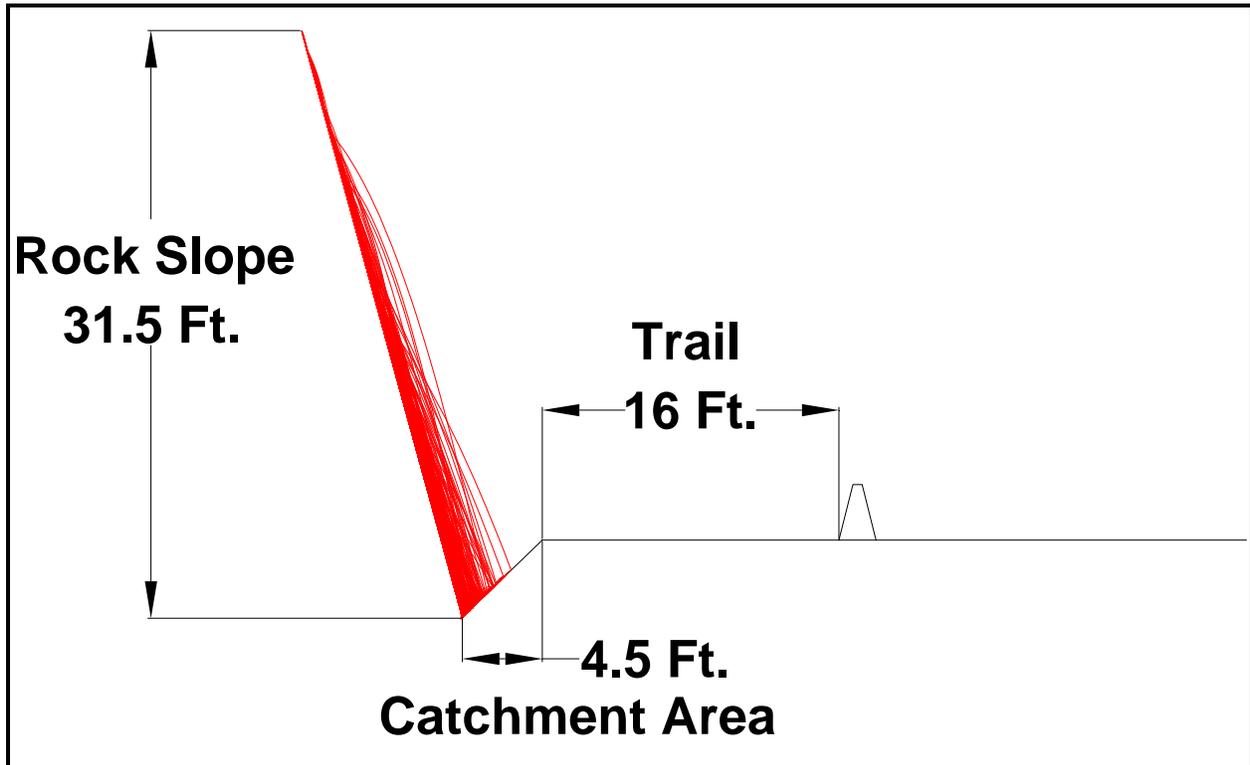
Figure 9-20. Site 9: Rockfall Analysis: No Mitigation

The existing catchment geometry (Figure 9-20) indicated that no rockfall will impact the trail and no further analysis is needed. The catchment area should be constructed with a dampening blanket of loose soil or gravel.
