**SHEAR REPAIR METHODS FOR  
CONVENTIONALLY REINFORCED  
CONCRETE GIRDERS AND BENT CAPS**

**Final Report**

**SPR 636**

Christopher Higgins, Professor  
Daniel A. Howell, Former Graduate Research Assistant  
Matthew T. Smith, Former Graduate Research Assistant  
A. Ekin Senturk, Post-doctoral Faculty Research Associate

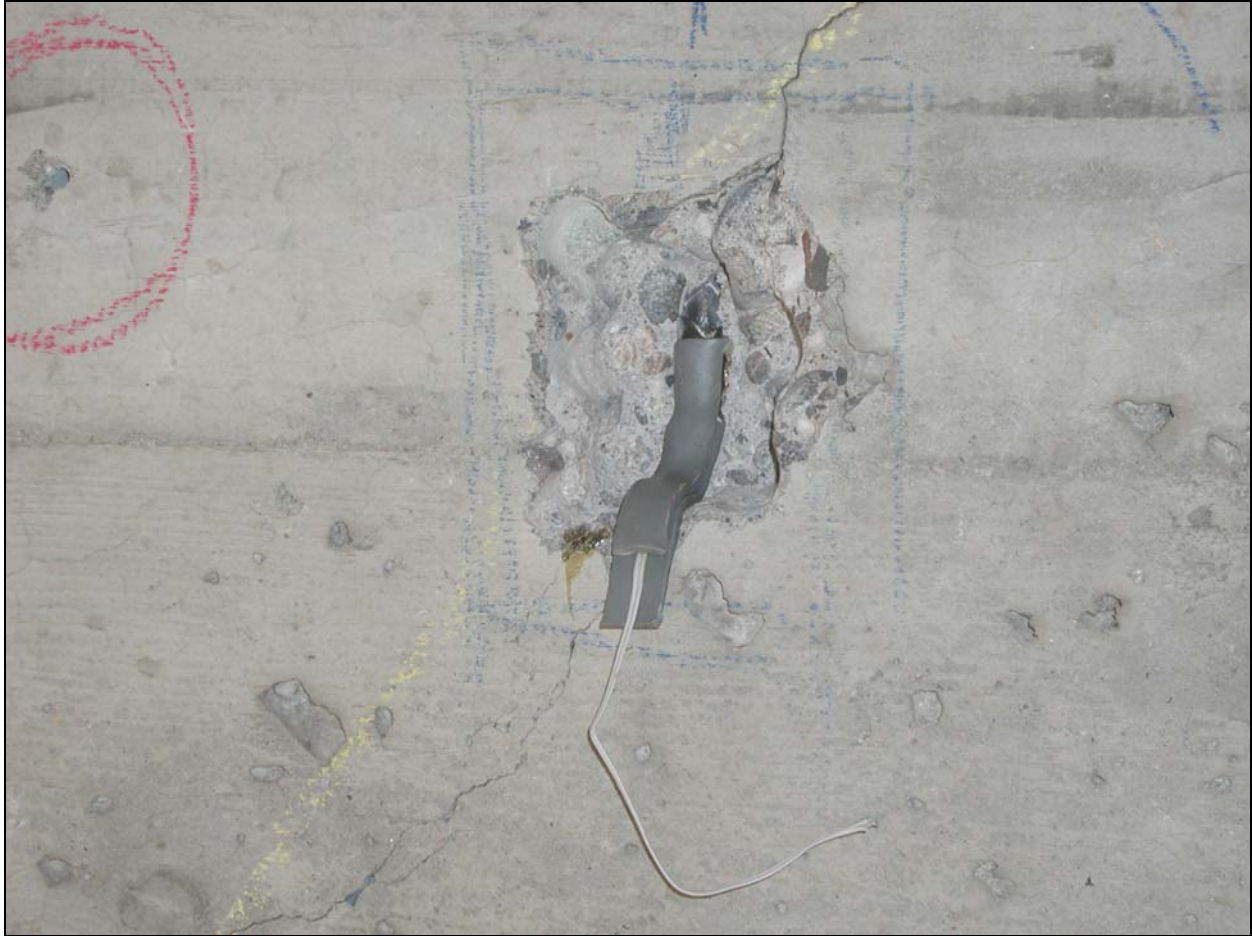
Figure 3.4: Example installation of strain gage on stirrup at diagonal crack location

After inspection, locations were selected for instrumentation. At selected diagonal crack locations, strain gages were installed on stirrups at the crack locations. Diagonal crack locations were selected based on the width and orientation of the cracks and to coincide as well as possible with locations that were of similar distance from the face of the supports. Strain gages were installed to measure stirrup stress at the diagonal cracks during ambient traffic and controlled truck loading. Strain gages were installed by chipping into the concrete and exposing the embedded stirrup at the diagonal crack locations. The actual amount of concrete removed varied, based on the concrete cover, but typical concrete removal provided an exposed stirrup length of approximately 75-100 mm (3-4 in) overall, centered about the crack as seen in Figure 3.4. The width of the excavation was approximately 50-75 mm (2-3 in), permitting preparation of the rebar surface for bonding strain gages on the stirrup leg. The deformation pattern on the stirrup was not removed to install the strain gages, as the strain gage size (Measurements Group strain gage EA-06-062AQ-350, with a gage length of 1.5 mm (1/16 in) and gage factor of 2.105) permitted installation within the deformation pattern. This strain gage was a bondable type gage with a 350-Ohm resistance.

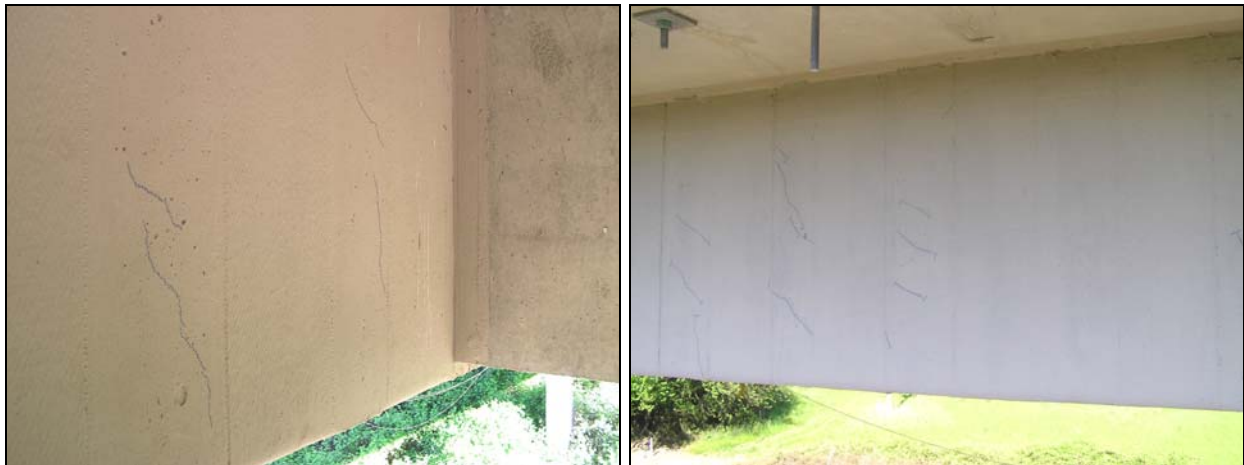
Figure 3.15: Example diagonal cracks observed

The bridge was re-inspected in 2008, and the original sensors were checked to determine if they were still operational. They were observed to be in good condition without a change in resistance; thus they were wired into the same data logger system described previously, and CFRP strains were collected during field testing using the same sensors at the same locations used in 2004. During this re-inspection, diagonal cracking was observed in the concrete between CFRP strips at a number of locations, with most being located on the exterior girders as seen in Figure 3.15. These cracks appeared to be previous diagonal cracks that had reopened. No stress induced CFRP debonding was observed at strip terminations or at locations adjacent to the newly observed diagonal cracks. Additionally, there were locations that exhibited loss or flaking of the protective coating that covers the CFRP matrix as seen in Figure 3.16.

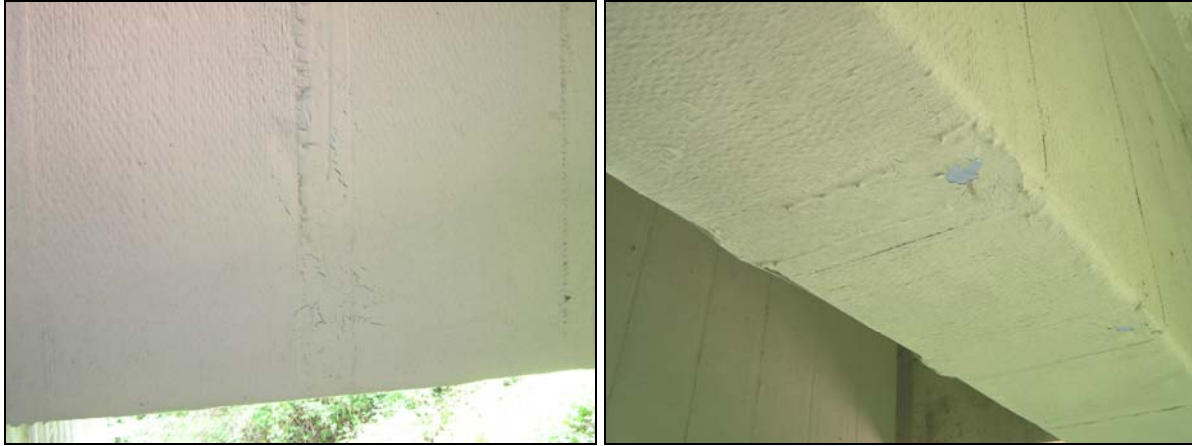
Figure 3.16: Example loss of surface protective coating

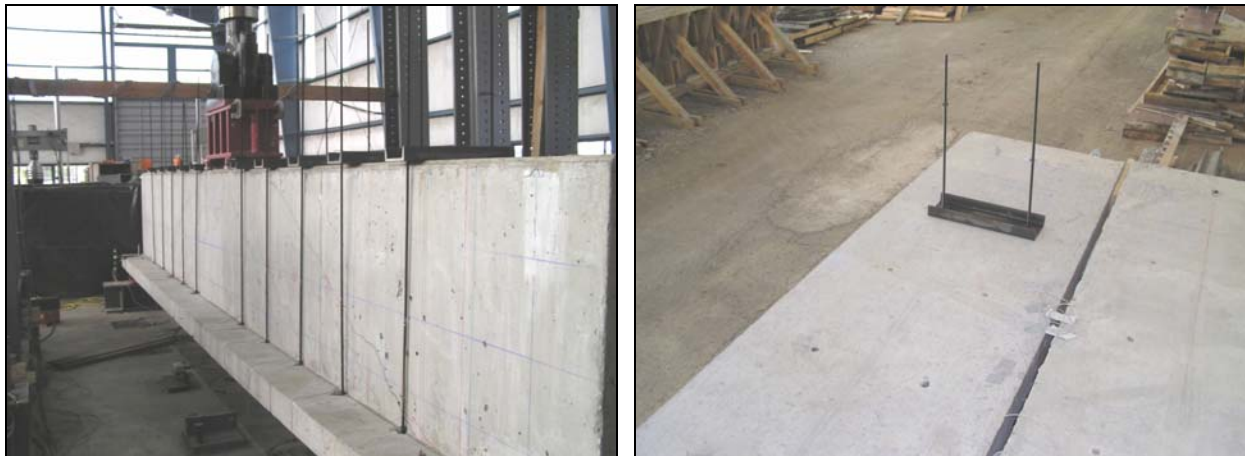
Figure 5.17: External stirrup installation

- Identify external stirrup spacing along shear span.
- Locate flexural and deck steel locations on specimen with a rebar locator.
- Mark hole locations such that they fall outside the width of the web.
- Drill holes with a rotary hammer drill with caution if steel is encountered.
- Place threaded rod through holes in the flange.
- Connect reaction sections to the threaded rod and tighten to predetermined force.

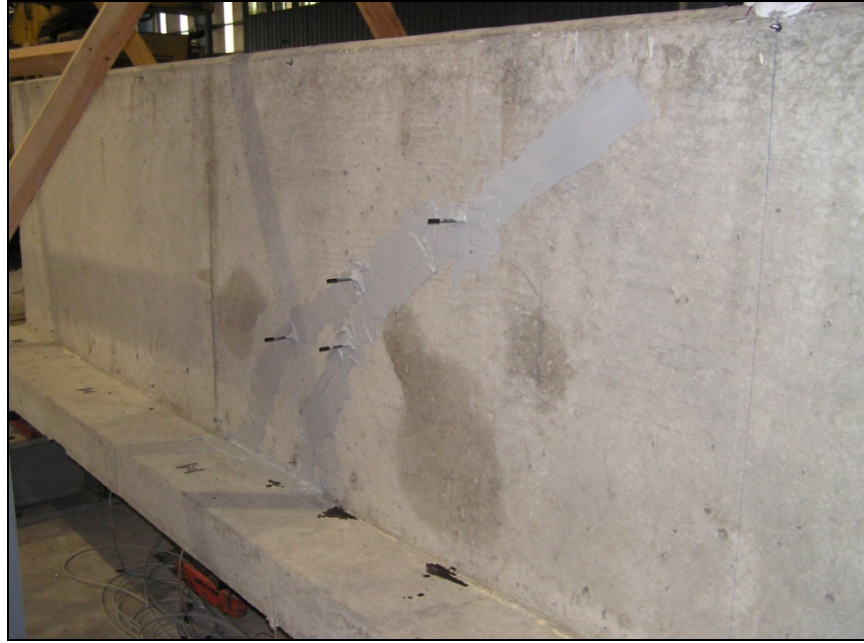
Figure 5.74: CFRP beam installation: epoxy injection
