**FIELD EVALUATION OF THE
MYRTLE CREEK ADVANCED
CURVE WARNING SYSTEM**

Final Report

SPR 352

June 2006

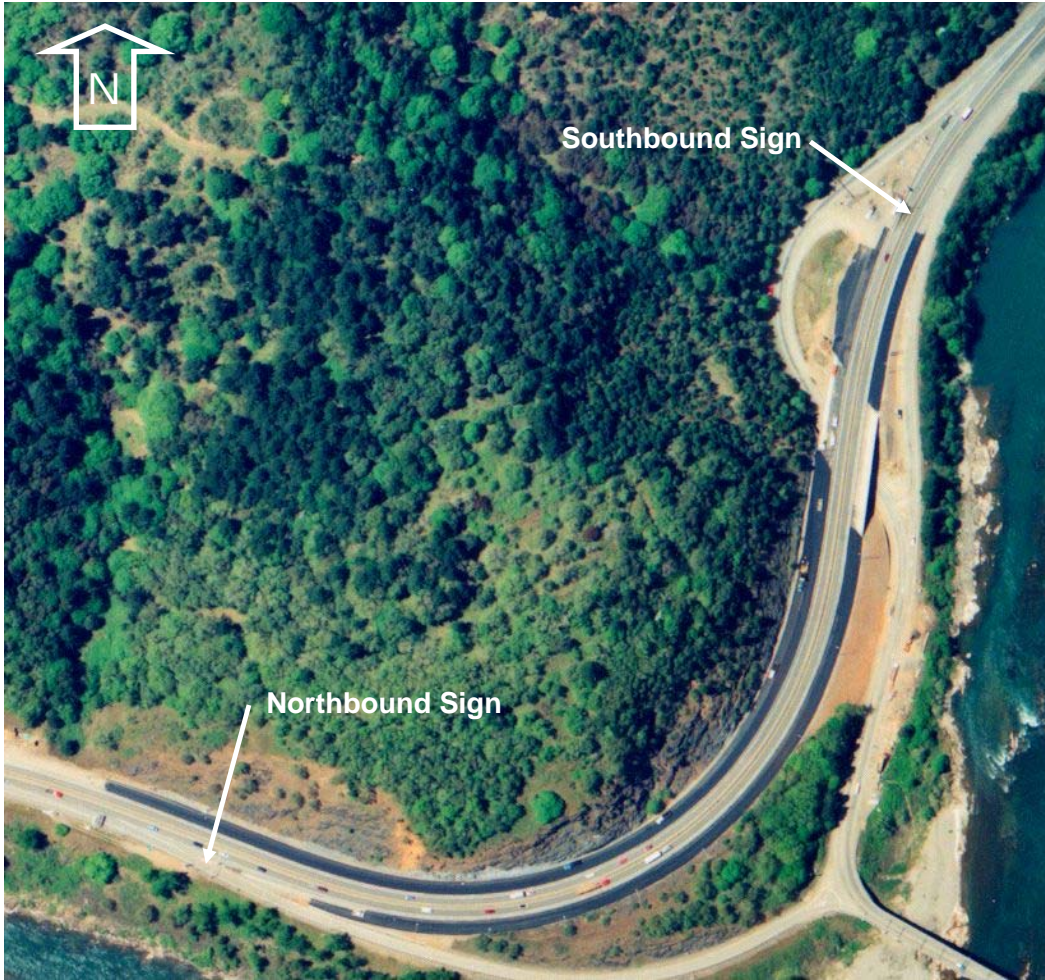
Figure 3.2: Aerial photograph of Myrtle Creek curves

As shown in Figure 3.2, the curved section of Interstate 5 is tightly constrained by an embankment on one side and the South Umpqua River on the other. The curves are located in a 50 mile per hour (mph) speed zone and are posted with an advisory speed of 45 mph for all vehicles in both directions. Approximately 0.5 mile upstream and downstream of the signs the posted speed is 65 mph for passenger cars and 55 mph for trucks.

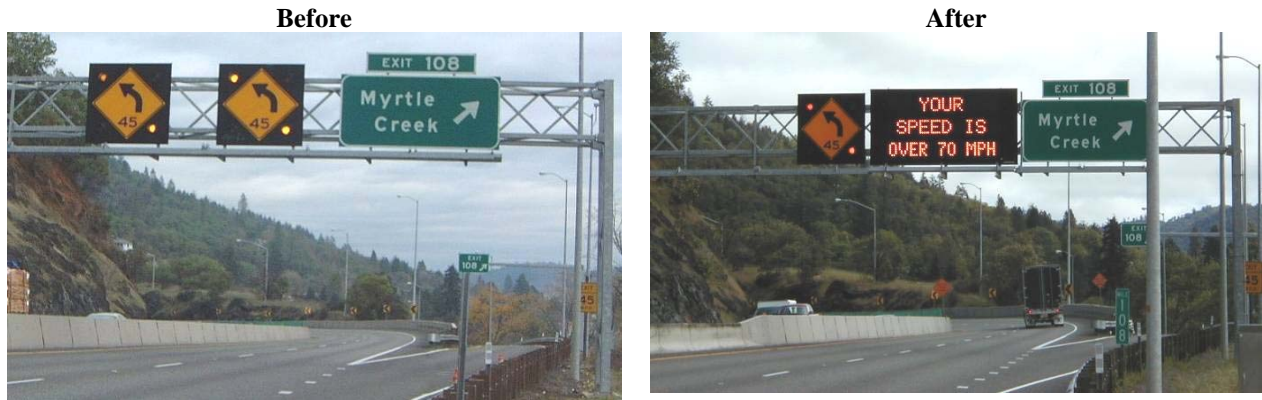
Figure 3.3: Northbound sign bridge, I-5 Milepost 108.00, before and after ACWS installation

The static warning signing in place prior to the installation of the ACWS consisted of dual overhead horizontal alignment/advisory speed combination sign assemblies (MUTCD W1-2a) with 4 flashing beacons. A ground mounted truck rollover warning sign was also present (Oregon OW8-12) slightly upstream of the sign bridge in the northbound direction and on the sign bridge support pole in the southbound direction. There are chevrons (MUTCD W1-8) installed through the curves in the northbound direction but there are no chevrons in the southbound direction. The “before” sign conditions are visible in Figure 3.3 and 3.4.

The Myrtle Creek ACWS consists of the following key elements at each sign location: a dynamic message sign (DMS), a radar unit for speed measurement, a controller unit and computer software to manage the speed inputs and (locally) modify the sign message. Fortunately, the existing sign bridges were of sufficient structural capacity to accommodate the DMS without modifications. For the northbound sign bridge one of the W1-2a assemblies was removed to provide sufficient space for the DMS. The DMS were installed overhead on existing sign bridges as shown in Figures 3.3 and 3.4.

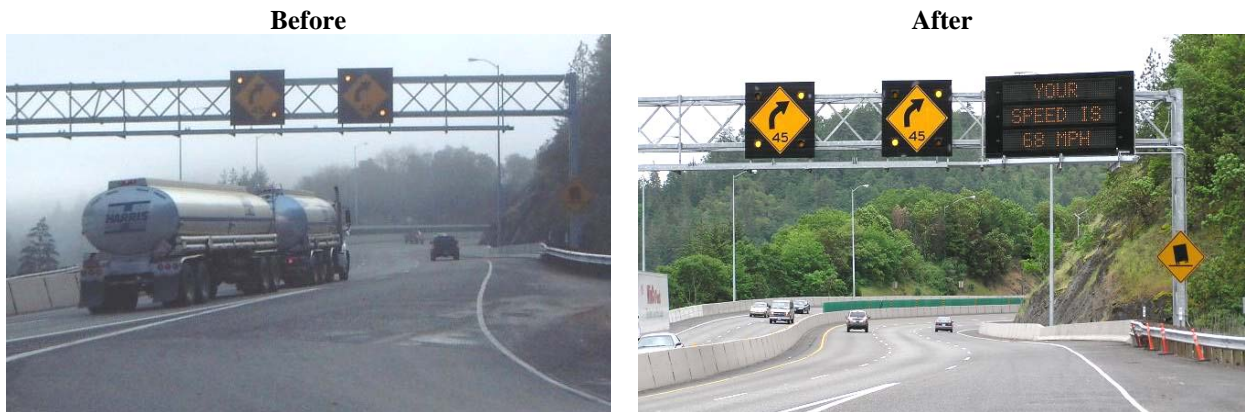
Figure 3.4: Southbound sign bridge, I-5 Milepost 108.35, before and after ACWS installation

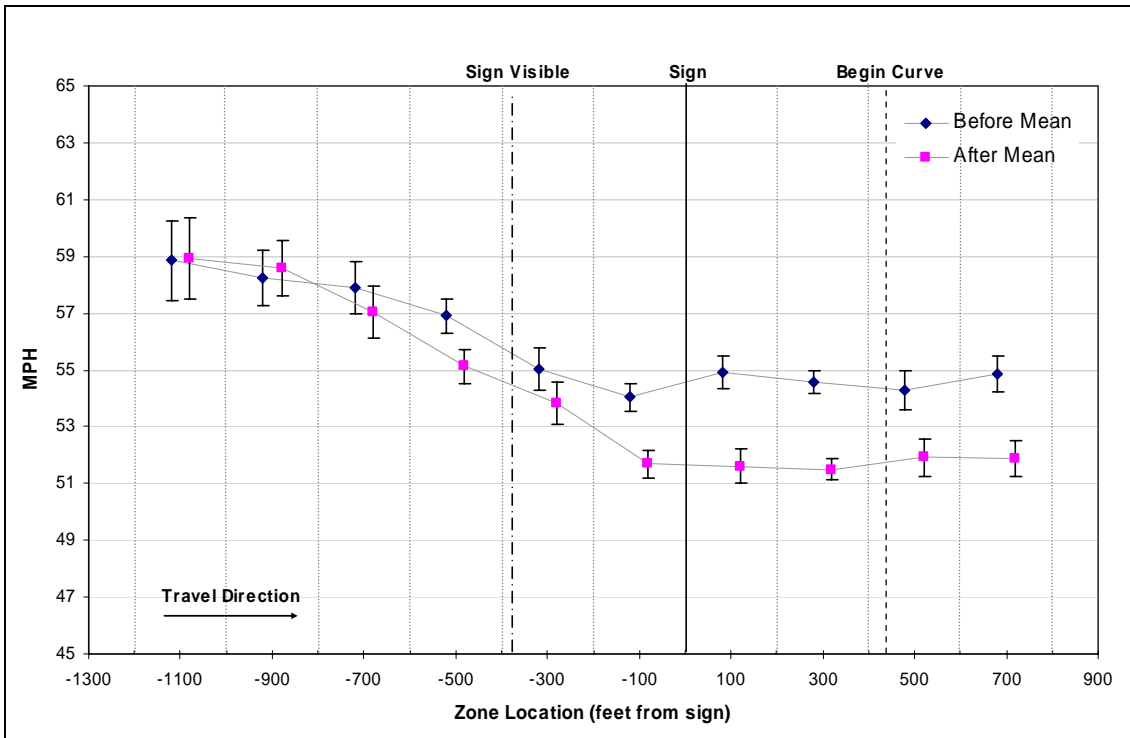
(a) Passenger Vehicles

(b) Commercial Vehicles

Figure 6.1: Before and after comparison of mean speeds, southbound

Subsequent to data cleaning, all speed measurements were aggregated into 200-foot zones for commercial vehicles and passenger cars by direction. The number of samples obtained for each vehicle was not necessarily consistent, since each time a target was acquired a data record for that particular location and vehicle speed was recorded. Other data treatments were tested, but given the data collection technique, 200-foot zones kept the number of multiple vehicle records in each zone to a minimum (desirable to avoid biasing a zone with multiple samples from slower speed vehicles) while providing sufficient sample resolution for the analysis. In addition, the 200-foot zone provided sufficient fidelity to observe driver speed choice after the sign installation. For each zone, the mean speed, the standard deviation, and the 95th percentile confidence intervals were calculated. These data are plotted for commercial and passenger vehicles for both directions in Figures 6.1 and 6.2.

As shown in the figures, distances upstream of the sign are displayed as negative numbers. For purposes of display, the mean speed for each speed zone is plotted at the midpoint of that zone. For example, the mean speed for the zone that includes all speed samples with distances from the sign to 200 feet downstream is plotted at +100 feet. The before and after speed midpoints are slightly offset for plotting purposes.

The equality of means for the speeds of each vehicle class for each zone was tested using the t -test for significance. Results of the test are displayed in Table 6.1. For both directions, shown in Figure 6.1 and 6.2, the critical location for speed reduction is the location between the “sign visible” line and the “begin curve” line. It should be noted that all mean observed speeds lie above the posted advisory speed of 45 mph for the curve.

The plots in Figure 6.1 for the sharper southbound curve clearly show a change in vehicle speed for both passenger cars and commercial trucks. For the farthest upstream zones, the before and after mean speeds are not statistically significantly different, as indicated by t -tests in zone -1100, -900, and -700 in Table 6.1 for passenger cars. As drivers approached the sign, however, there was a statistically significant reduction in the mean speeds that appears to be associated with the presence of the ACWS (because the before speeds are similar when the sign is not visible).

For commercial vehicles, the same speed trend is evident; however, the results are not as conclusive statistically. Only in the -1100 and -300 zone are the differences in speeds not significant. After the sign, starting in zone -100, all of the differences are statistically different. The maximum mean speed reduction occurred in the zone immediately following the sign location and is 3.3 mph for passenger cars and 3.0 mph for commercial vehicles.

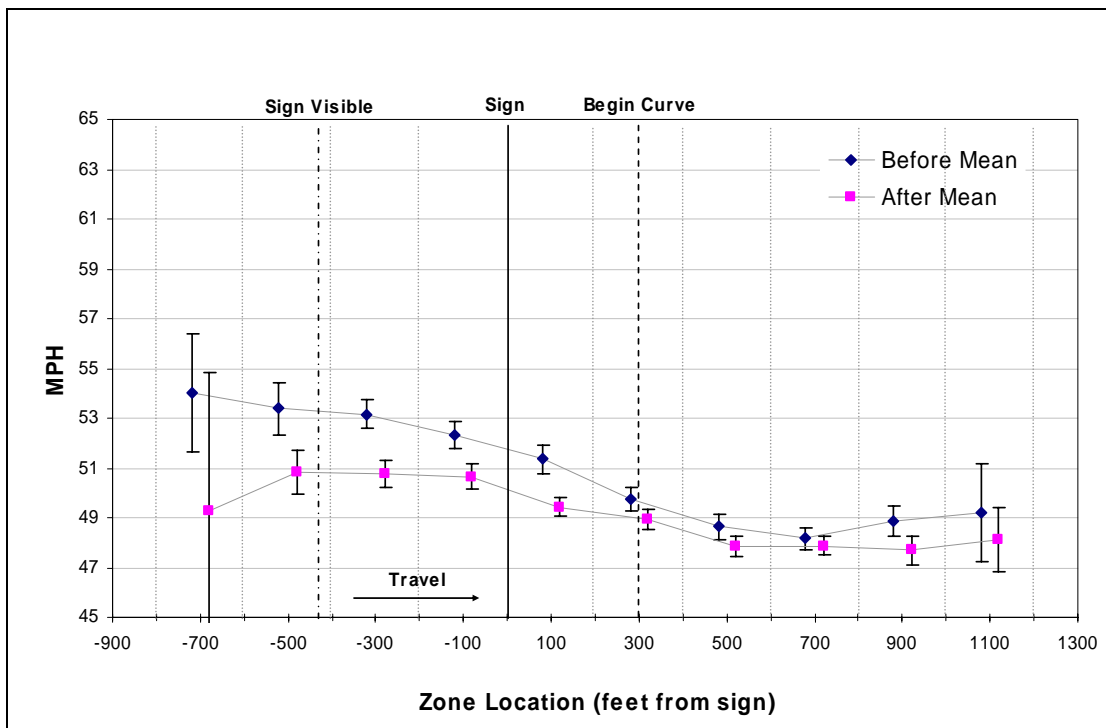
(a) Passenger Vehicles

(b) Commercial Vehicles

Figure 6.2: Before and after comparison of mean speeds, northbound

The plots in Figure 6.2 for the northbound curve also display reductions in the mean speeds after ACWS implementation, but the clear driver reaction to the sign observed in the southbound direction is not evident. The after speeds are statistically significantly lower in all zones except two (-700 commercial vehicles, and 700 commercial vehicles) making it difficult to conclude that speed reductions are attributable only to the ACWS.

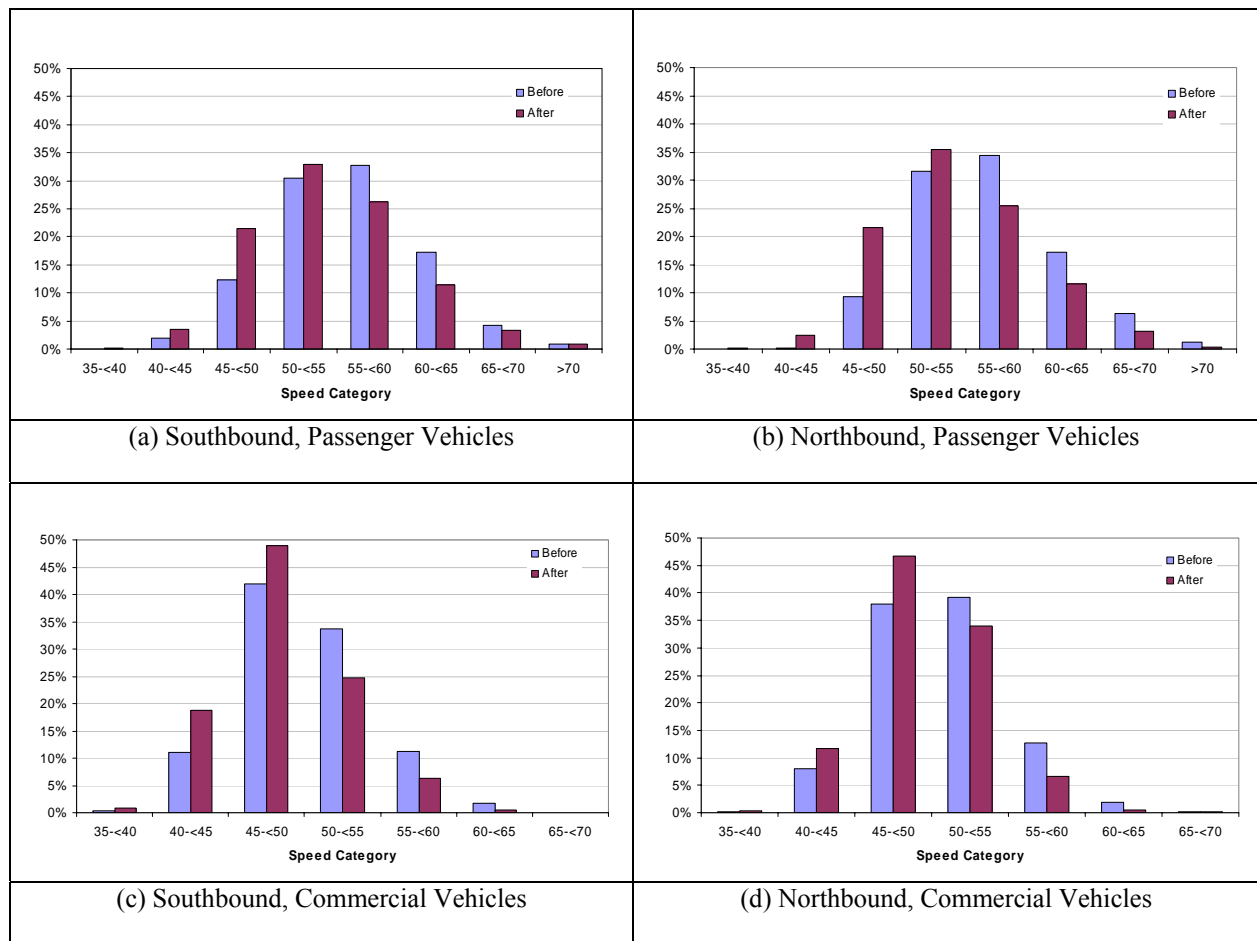
Figure 6.3: Before and after comparison of speed distributions

The speed distributions were tabulated as a percentage of vehicles in each five-mile-per-hour speed bin and are shown as histograms in Figure 6.3. The frequency distributions were compared with the chi-square test for goodness of fit. Examination of the speed distributions shown in Figure 6.3 indicates that there was a shift to the left in the after distributions relative to before distributions for all four graphs. This shift represents a lower number of vehicles in the higher speed bins and at least for commercial vehicles, a higher concentration of vehicles near the mean speed. The chi-square test indicated that all of these distribution shifts were statistically significant at a 95th percent confidence level.

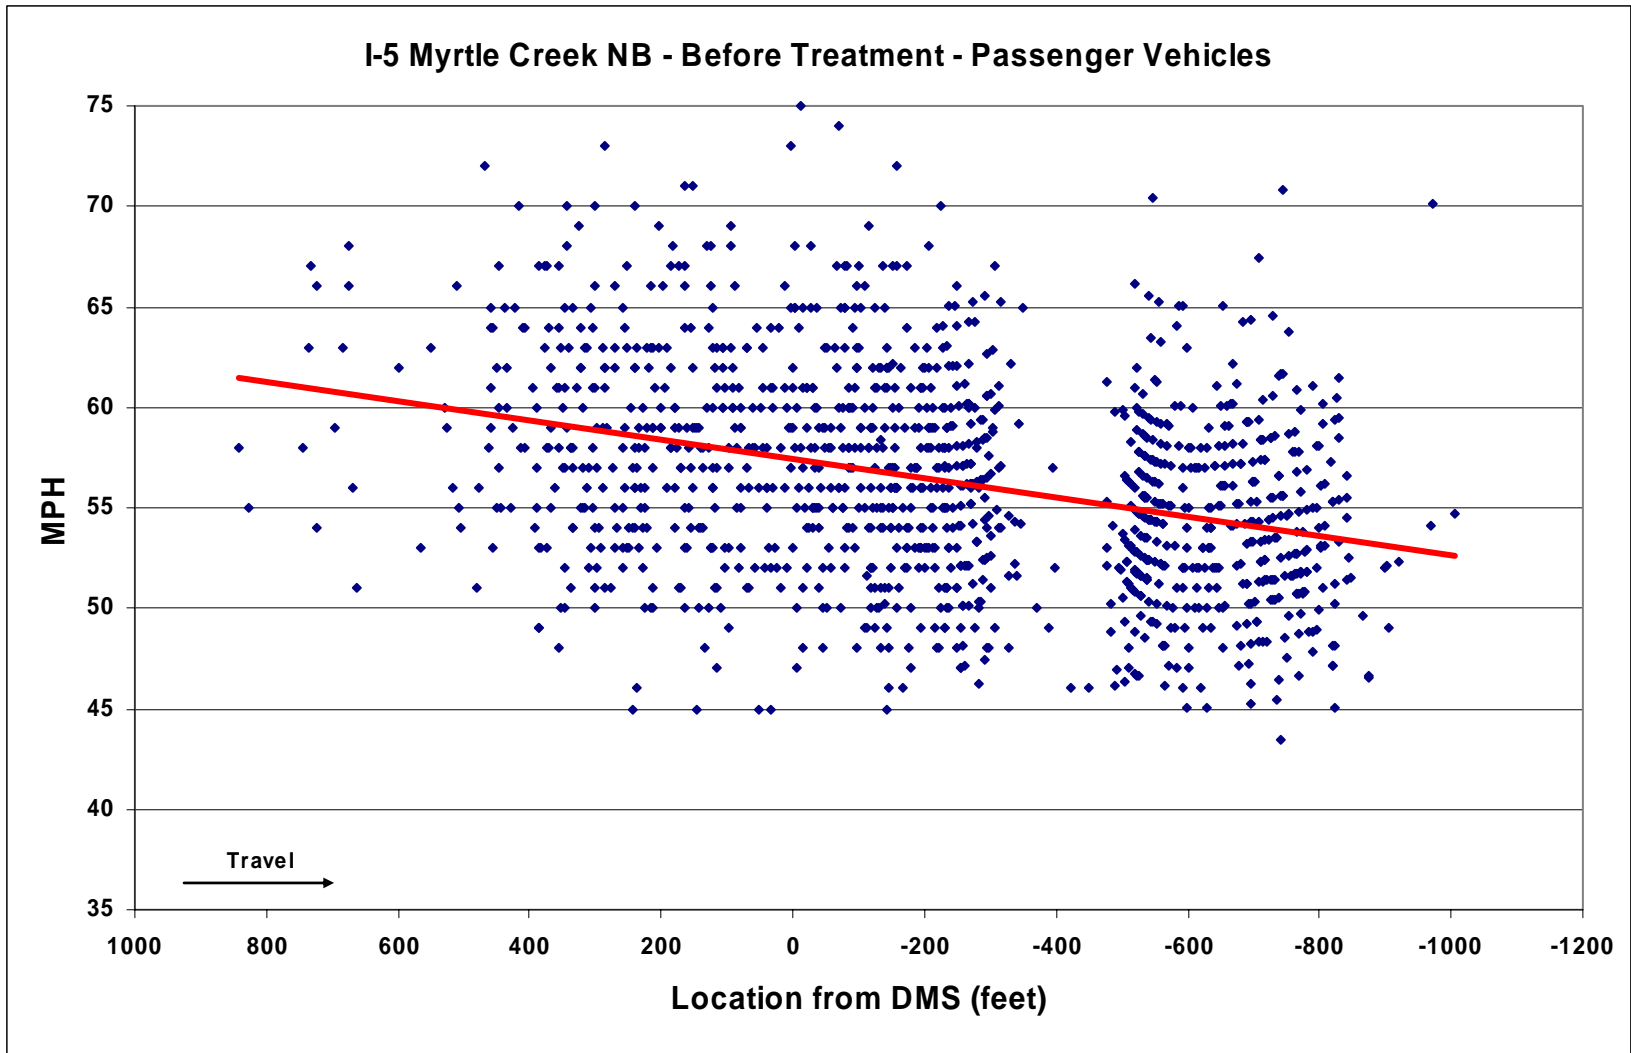
Figure A1: Before data – northbound passenger vehicles

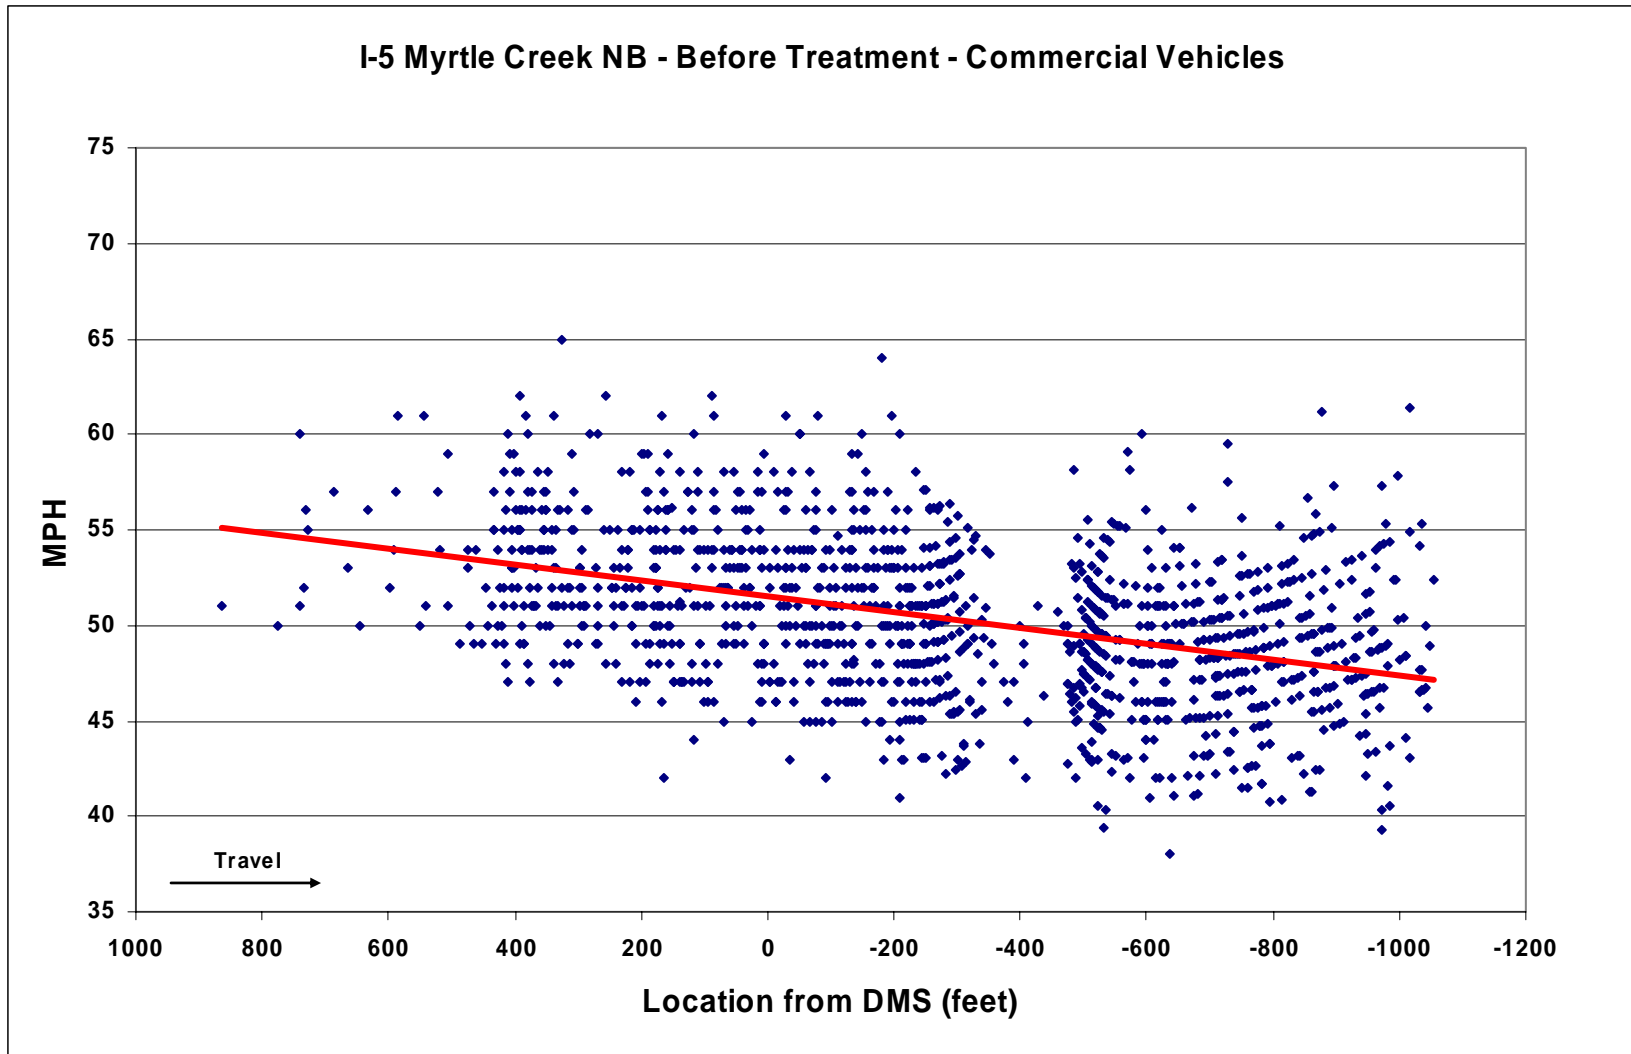
Figure A2: Before data – northbound commercial vehicles

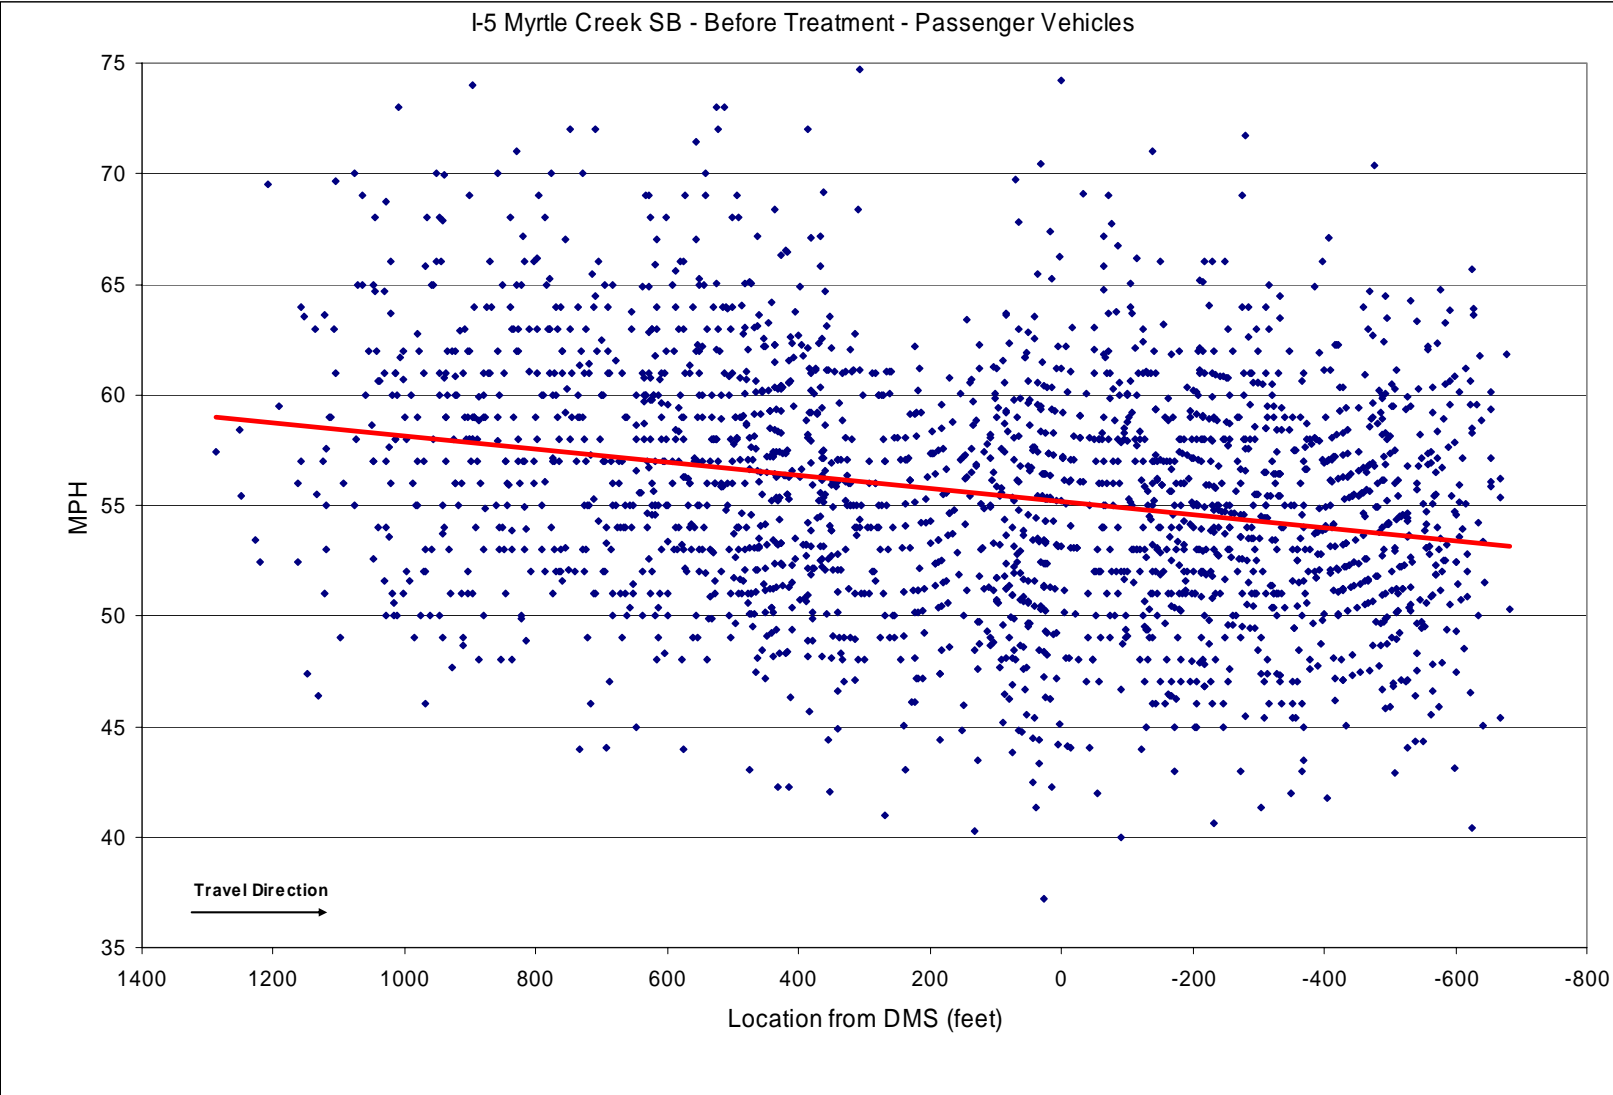
Figure A3: Before data – southbound passenger vehicles

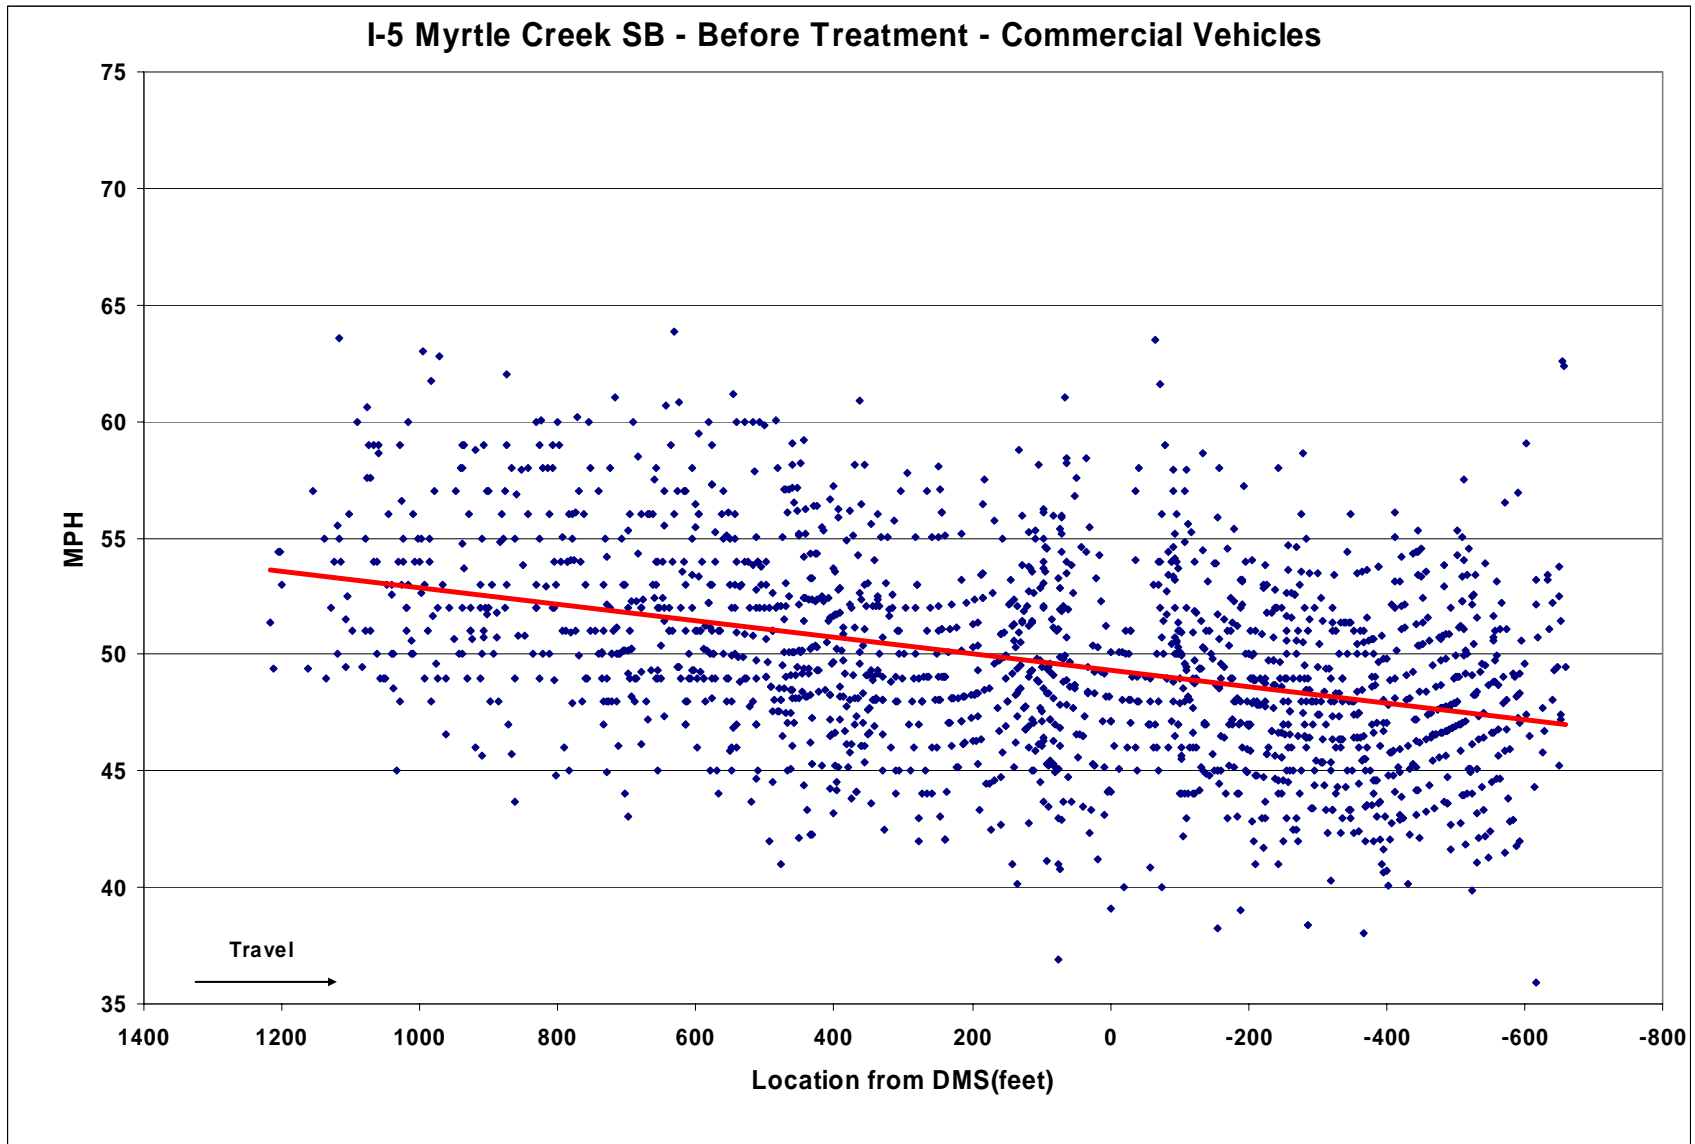
Figure A4: Before data – southbound commercial vehicles

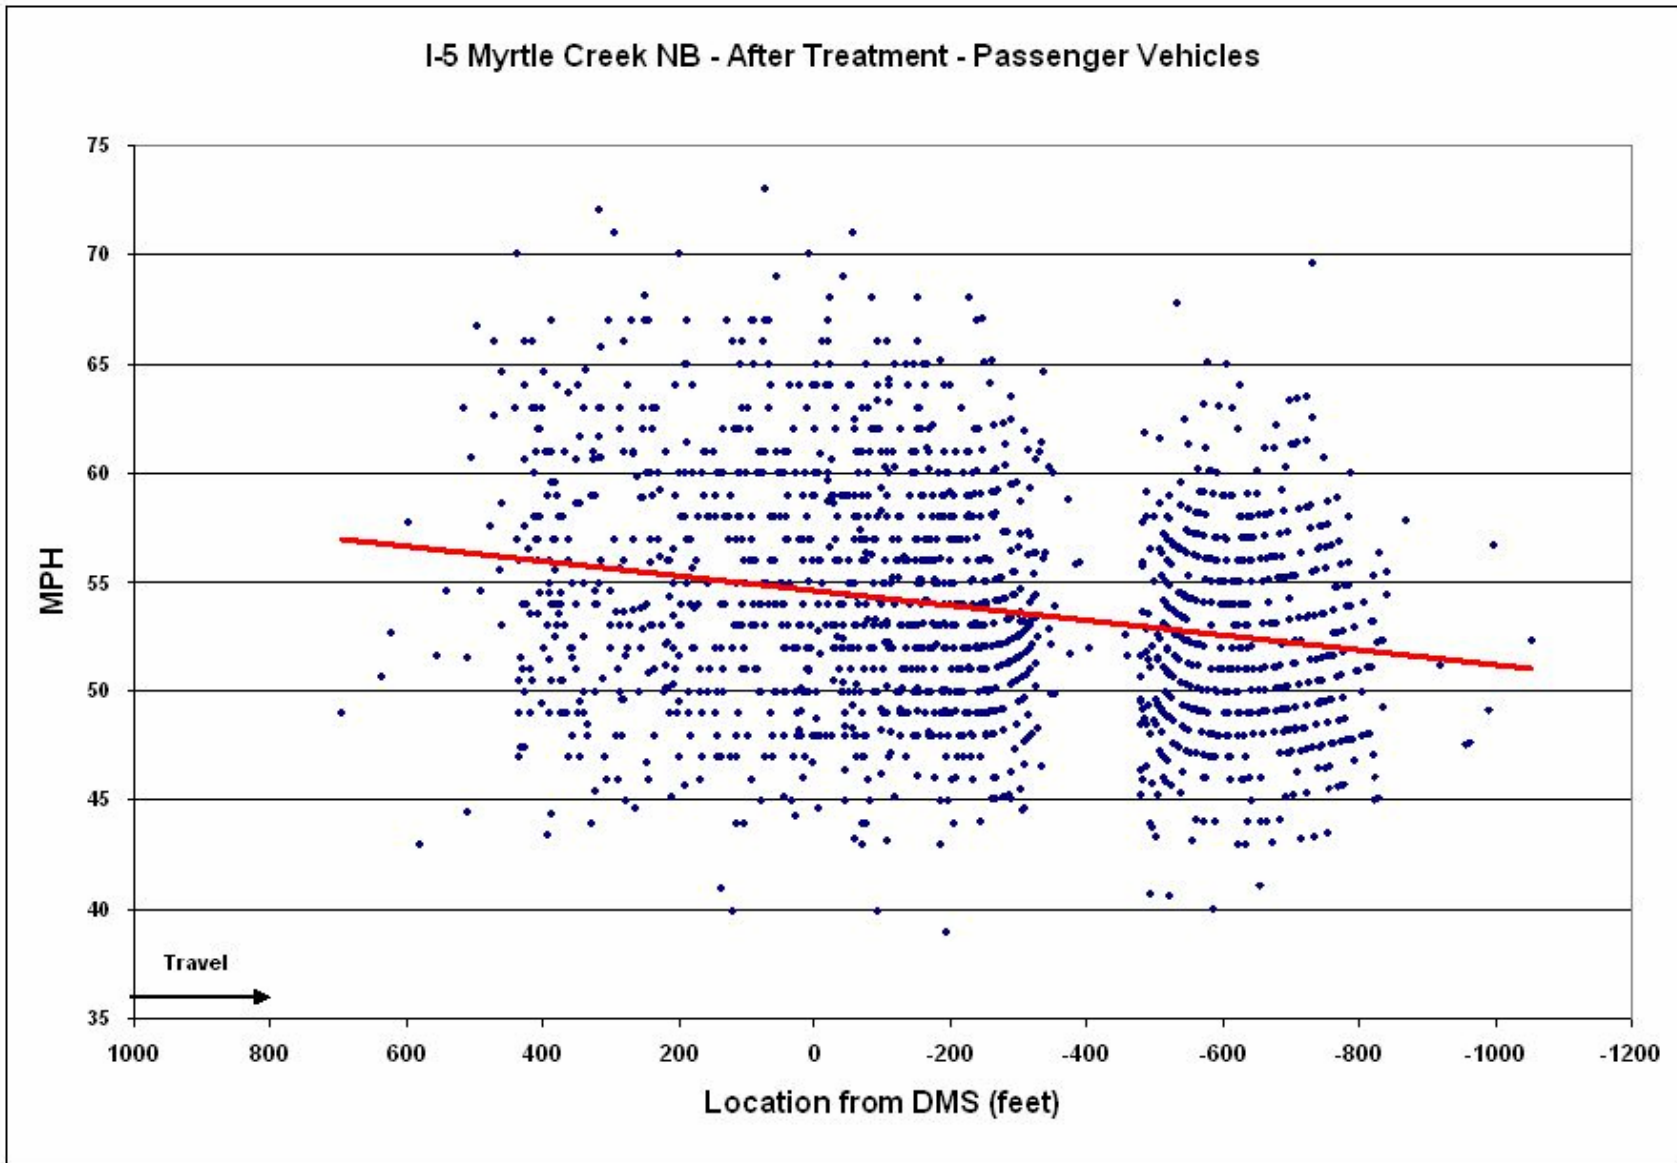
Figure A5: After data – northbound passenger vehicles

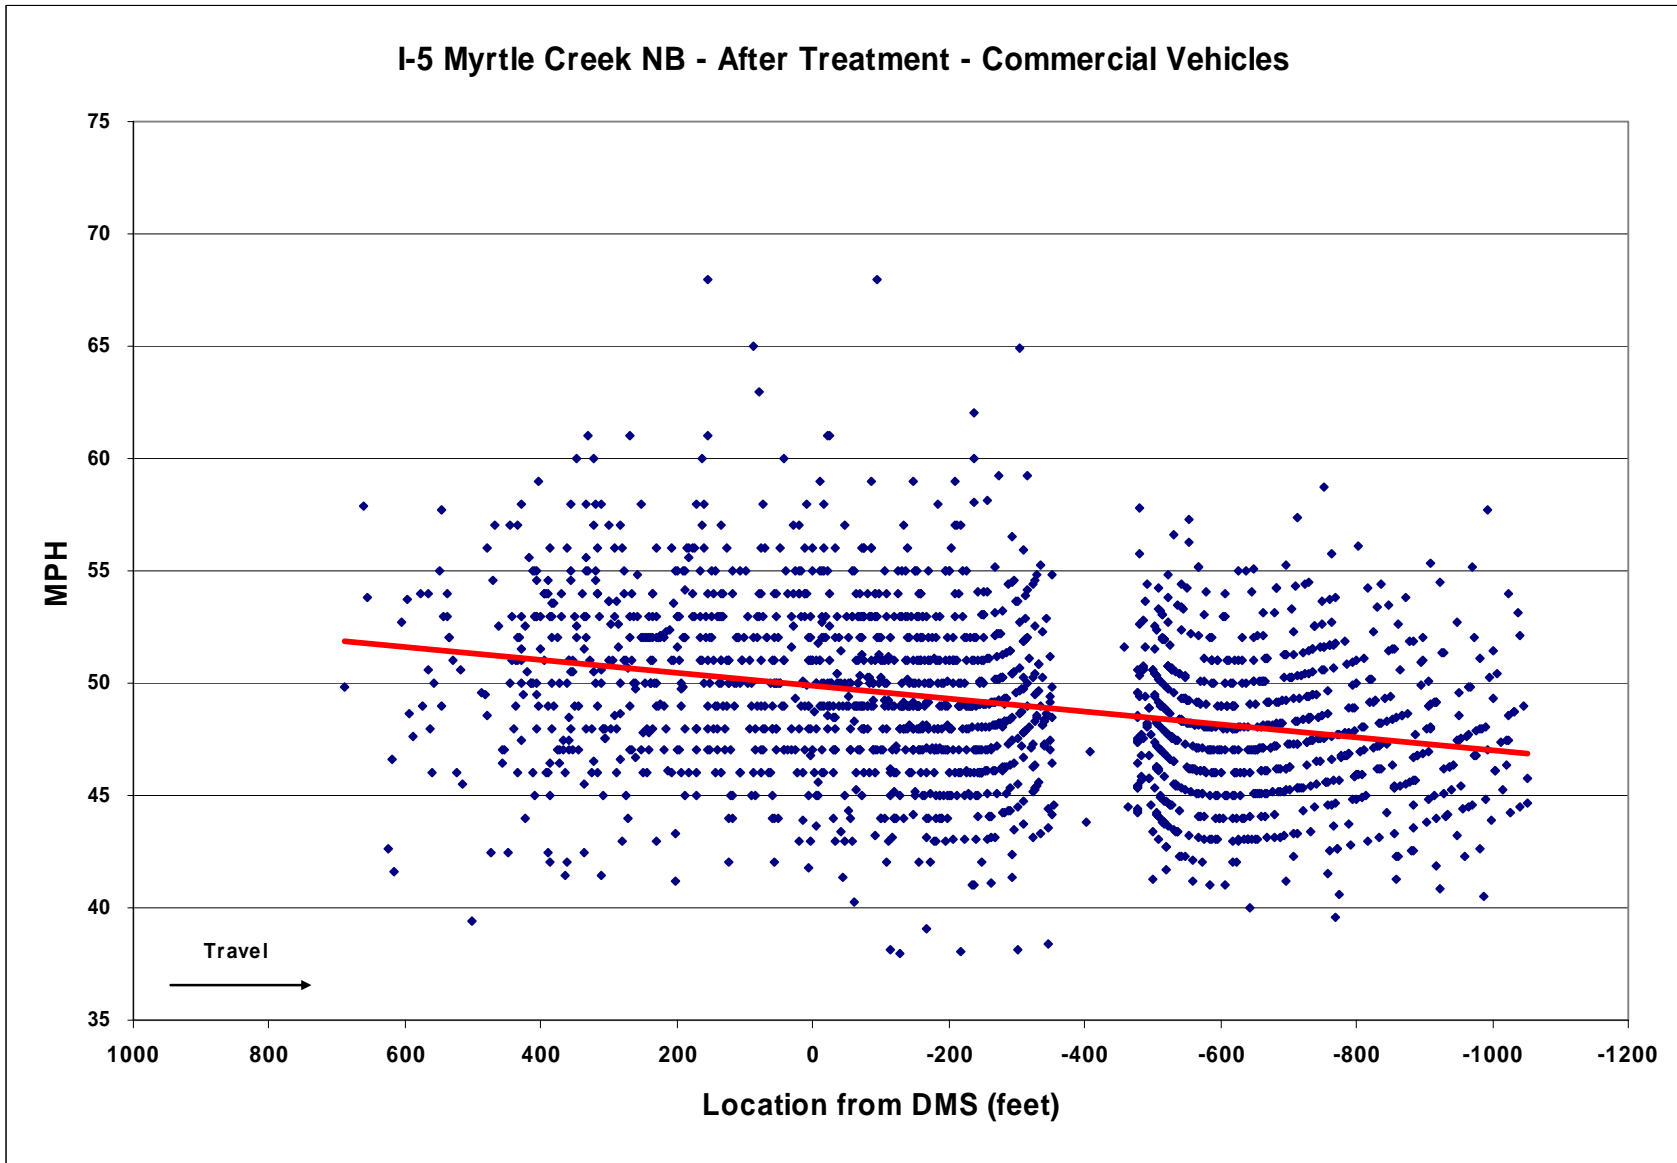
Figure A6: After data – northbound commercial vehicles

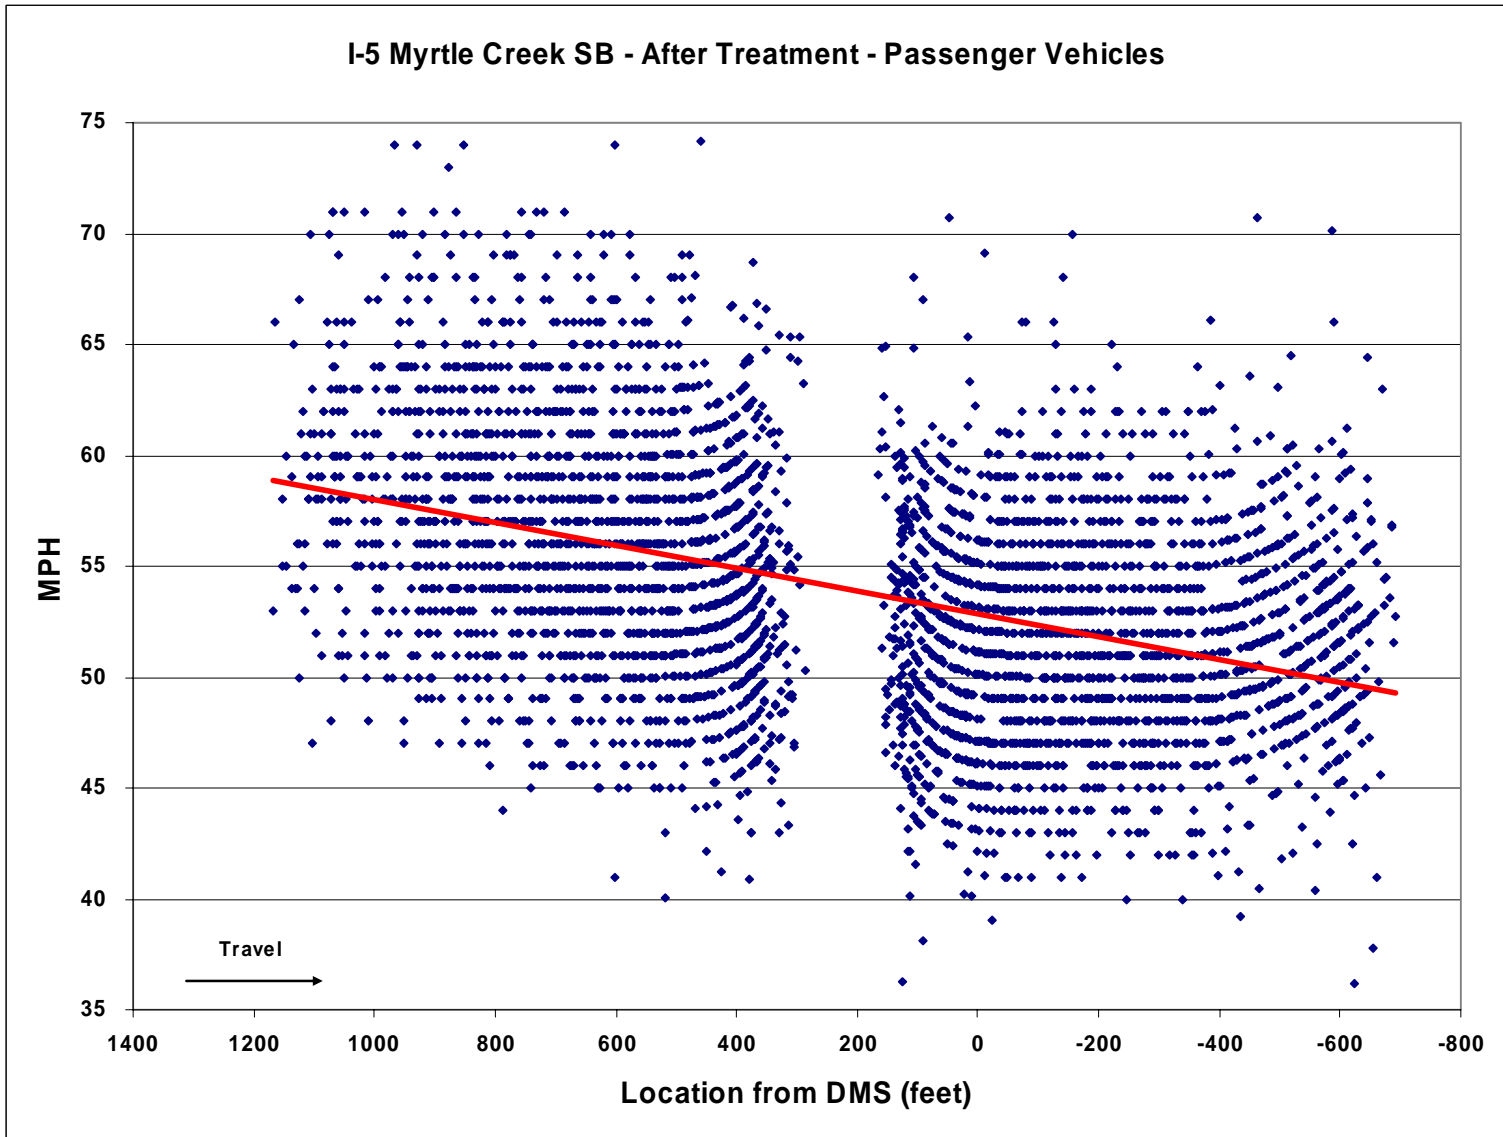
Figure A7: After data – southbound passenger vehicles

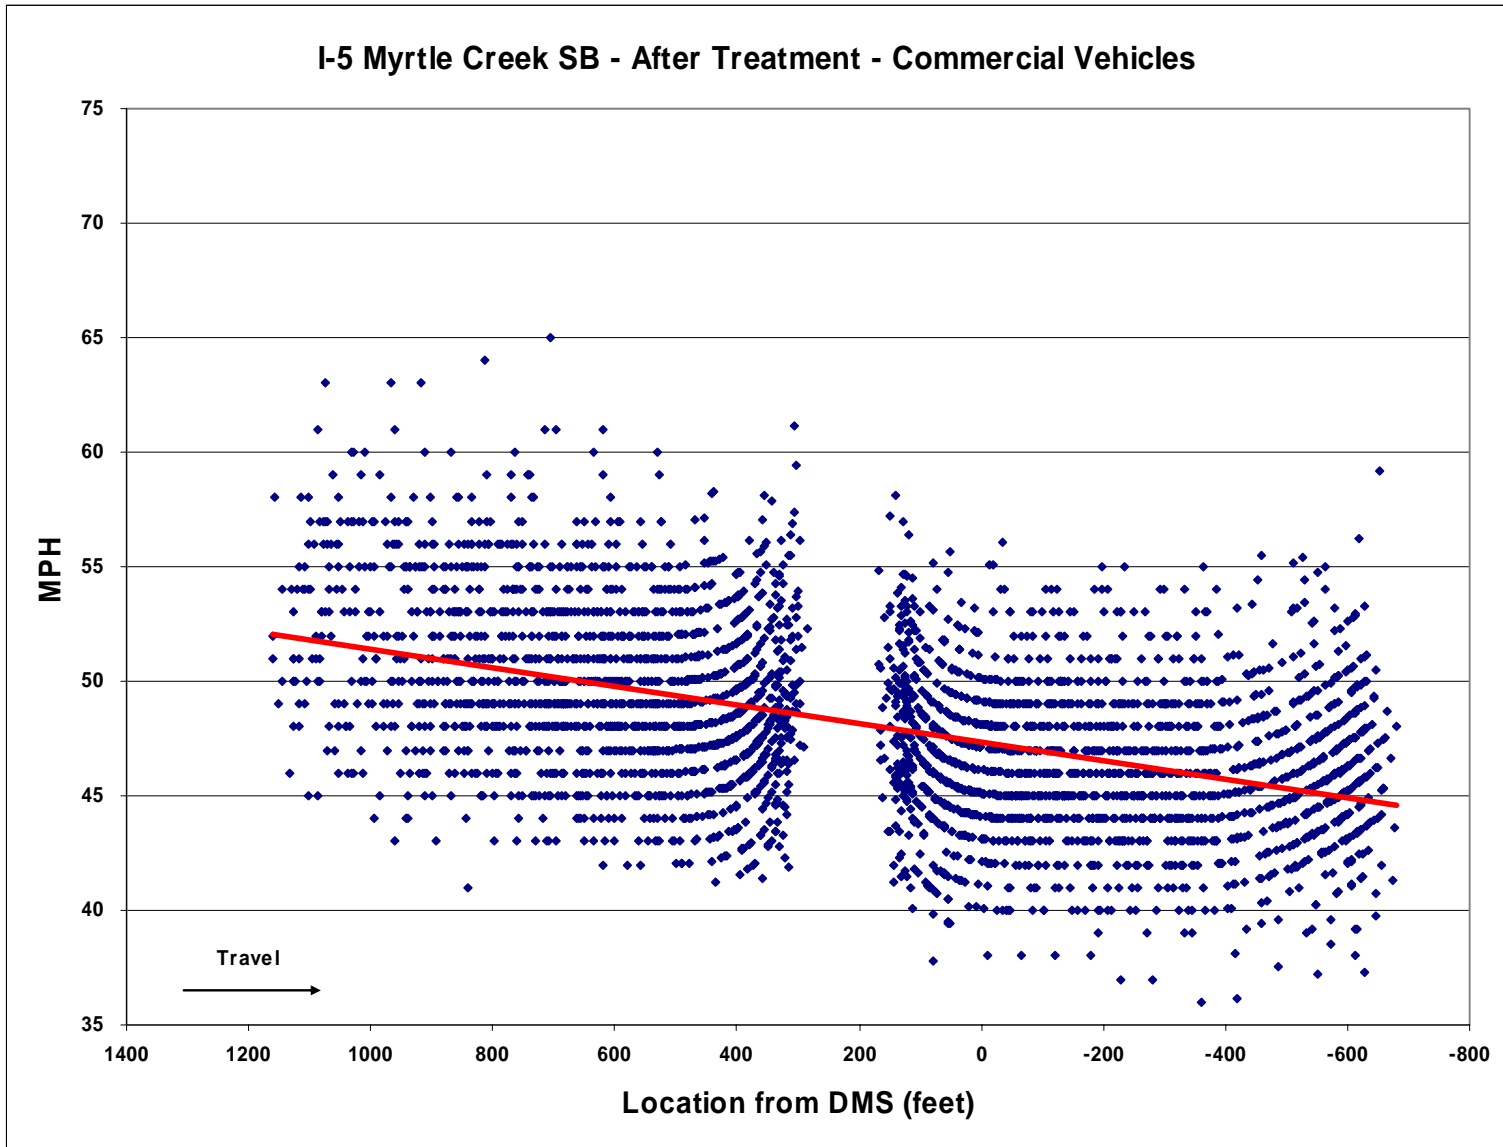
Figure A8: After data – southbound commercial vehicles
