**PRECAST CONCRETE  
BARRIER CRASH TESTING**

**Final Report**

**SPR 330**

**December 2001**

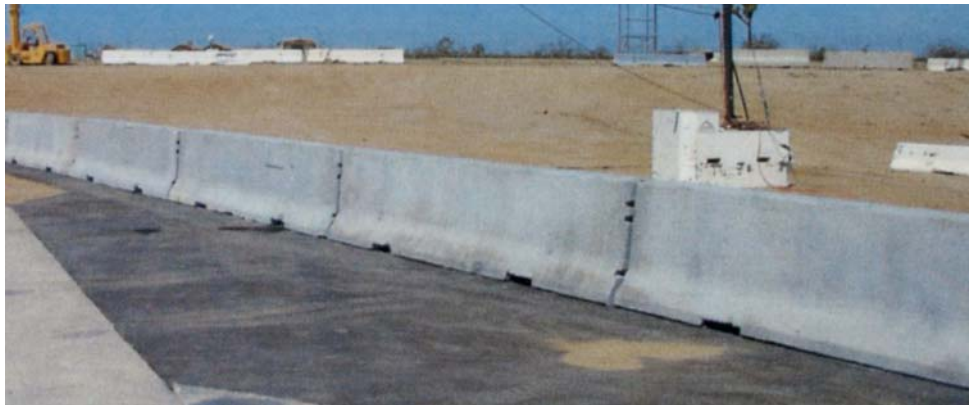
Figure 1.1: Standard F-shape precast concrete barrier

The Oregon Department of Transportation (ODOT) has been using a “Standard F-shape” precast concrete barrier – 810 mm (32 in) in height – along its highways for many years. Approximately 322 km (200 mi) of the current design of barrier are in use. Each barrier section is 3.81 m (12.5 ft) in length. The barrier sections are held together with a pin and steel bar loop assembly. Figure 1.1 shows the Standard F-shape barrier. The specifications for this barrier are included in Appendix A.

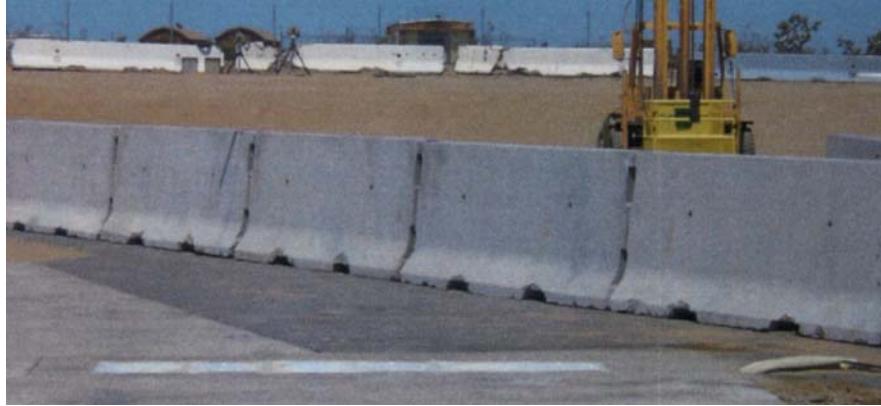
Figure 1.2: Tall F-shape precast concrete barrier

In addition, ODOT recently adopted a “Tall F-shape” precast concrete barrier for use on highways which carry large volumes of trucks. The higher barrier – 1065 mm (42 in) in height – is intended to provide more safety on the roadway, by better managing the impact of larger vehicles than the smaller barrier. Each barrier section is 3.0 m (10 ft) in length. The barrier sections are held together with a 25 x 760 mm (1 x 30 in) bolt and perforated C-shape assembly. Figure 1.2 shows the Tall F-shape barrier. The specifications for this barrier are included in Appendix B.

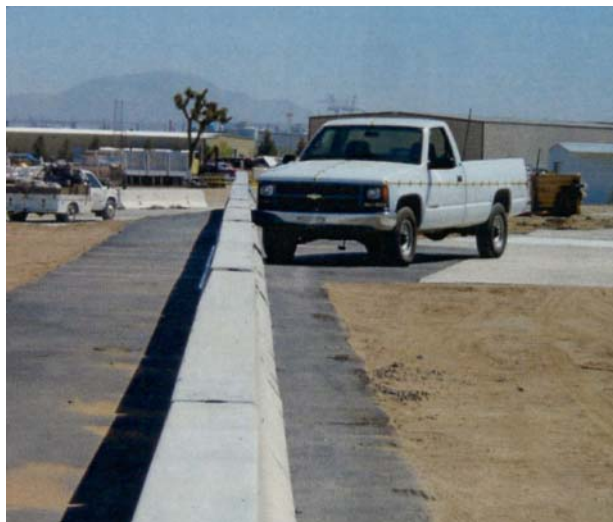
Figure 3.1: Test vehicle prior to Crash Test 1, showing angle of impact

The test vehicle provided by KARCO Engineering was a 1995 Chevrolet Cheyenne  $\frac{3}{4}$  ton pickup (Figure 3.1) with a gross static weight of 2,041 kg (4,500 lb). This weight was within the allowable range of  $\pm 45$  kg, as specified in NCHRP Report 350 (Ross, *et al.* 1993). The pickup was connected by nylon line to a tow cable, which was embedded in a track. The pickup was towed toward the barrier by a tow vehicle. At the point of impact the test vehicle had achieved a speed of 100.74 km/h (62.6 mph).

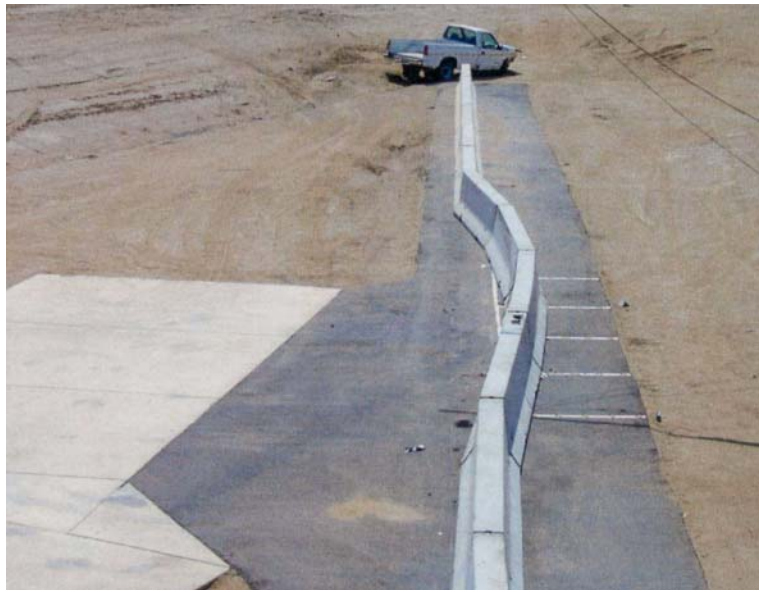
Figure 3.2: Standard F-shape barrier following Crash Test 1

The point of impact occurred on barrier segment #8, approximately 800 mm (2.6 ft) downstream from the joint between segments #7 and #8. As shown in Figure 3.2, the barrier segments were deflected from the impact; the maximum deflection was 760 mm (30 inches), with no perceptible rebound. The Principal Investigator noted after the impact that there were some minor hairline cracks visible on the backside of the barrier segment #8, which received the initial impact. None of the connection pins failed or were bent. No barrier segment tipped. The test results, as provided by KARCO Engineering, are included in Appendix C and summarized in Table 3.1. As shown in the table, the Standard F-shape barrier passed all of the NCHRP requirements. The terrace was judged not to have had a material effect on the outcome of the test. Thus the crash test of the Standard F-shape barrier was judged to be successful.

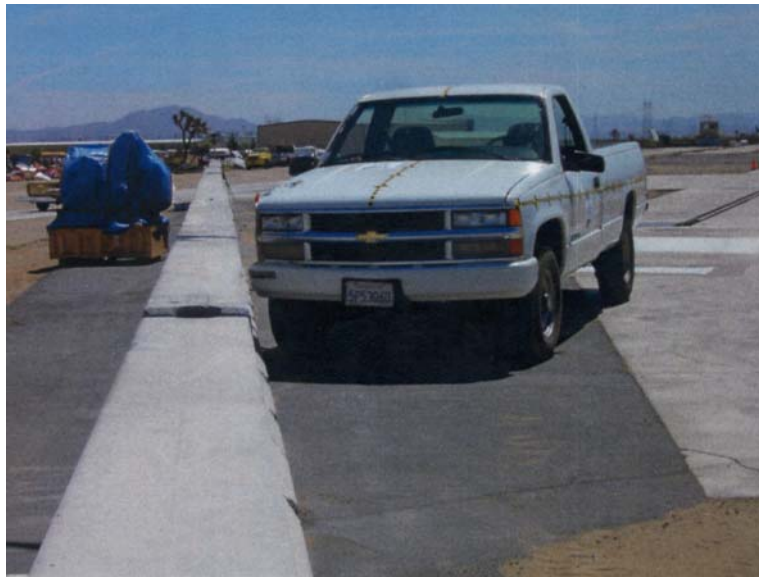
Figure 3.3: Test vehicle prior to Crash Test 2, showing angle of impact

The test vehicle was a 1995 Chevrolet Cheyenne ¾ ton pickup (Figure 3.3) with a gross static weight of 2,024 kg (4,462 lb). This weight was within the allowable range of  $\pm 45$  kg, as specified in NCHRP Report 350 (Ross, *et al.* 1993). The pickup was connected by nylon line to a tow cable, which was embedded in a track. The pickup was towed toward the barrier by a tow vehicle. At the point of impact the test vehicle had achieved a speed of 102.38 km/h (63.6 mph). This velocity was within the allowable range of  $\pm 4$  km/h, as specified in NCHRP Report 350 (Ross, *et al.* 1993).

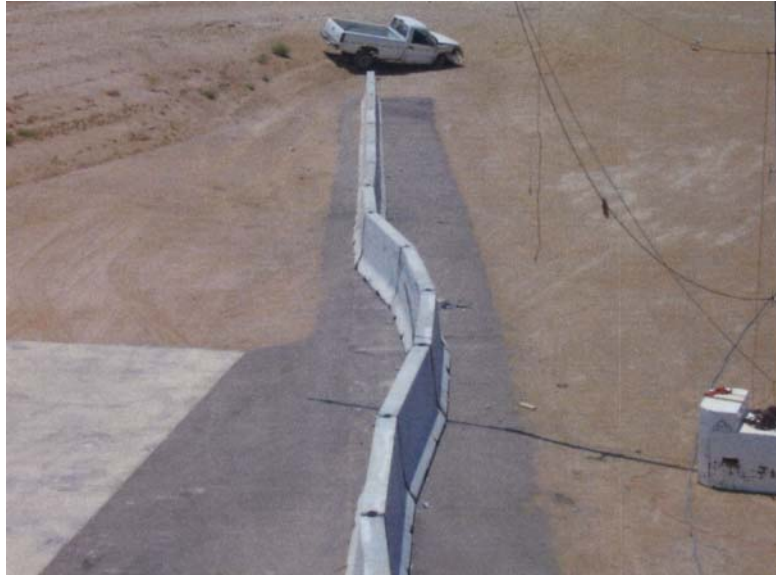
Figure 3.4: Tall F-shape barrier following Crash Test 2

The point of impact occurred on barrier segment #10, approximately 150 mm (6 in) upstream of the joint between segments #10 and #11. As shown in Figure 3.4, the barrier segments were deflected from the impact; the maximum deflection was 813 mm (32 inches), with no perceptible rebound.

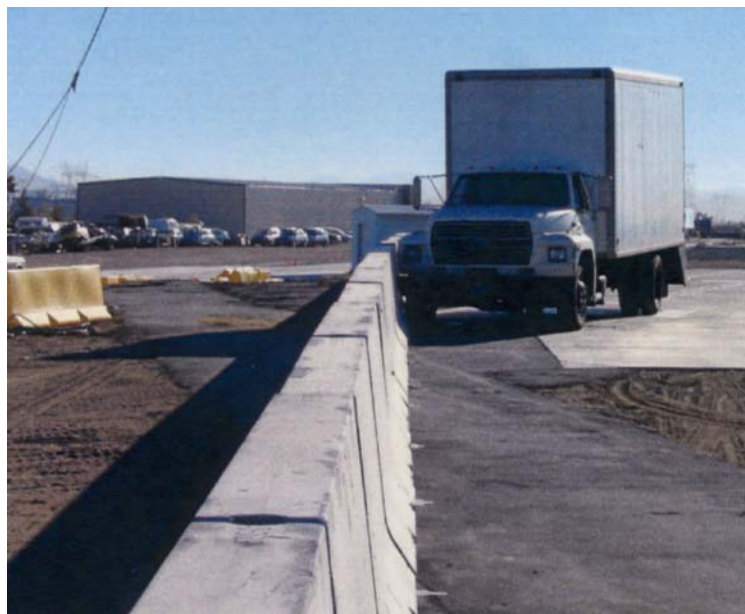
Figure 3.5: Test vehicle prior to Crash Test 3, showing angle of impact

The test vehicle provided by KARCO Engineering was a 1995 Ford F 600 box truck (Figure 3.5) with a curb weight of 4,312 kg (9,506 lb), with added ballast bringing it to a gross static weight of 7,917 kg (17,454 lb). This weight was within the allowable range of  $\pm 200$  kg, as specified in NCHRP Report 350 (Ross, *et al.* 1993). The truck was connected by nylon line to a tow cable, which was embedded in a track. The truck was towed toward the barrier, and at the point of impact it had achieved a speed of 76.06 km/h (47.3 mph). This velocity was within the allowable range of  $\pm 5$  km/h, as specified in NCHRP Report 350 (Ross, *et al.* 1993).

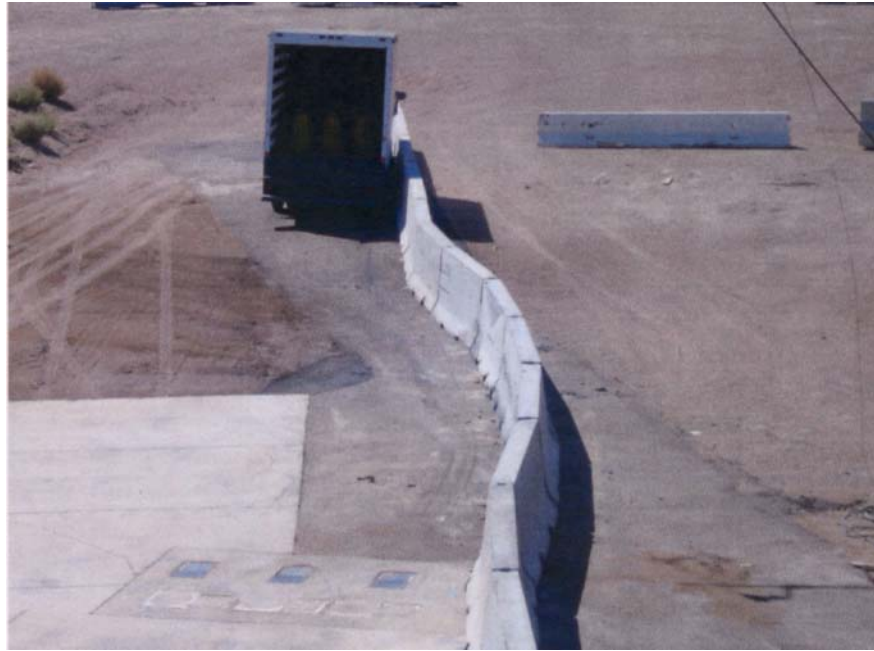
Figure 3.6: Tall F-shape barrier following Crash Test 3

The point of impact occurred on barrier segment #8, approximately 800 mm (2.6 ft) upstream of the joint between segments #8 and #9. As shown in Figure 3.6, the barrier segments were deflected from the impact; the maximum deflection was 826 mm (32.5 inches), with no perceptible rebound.

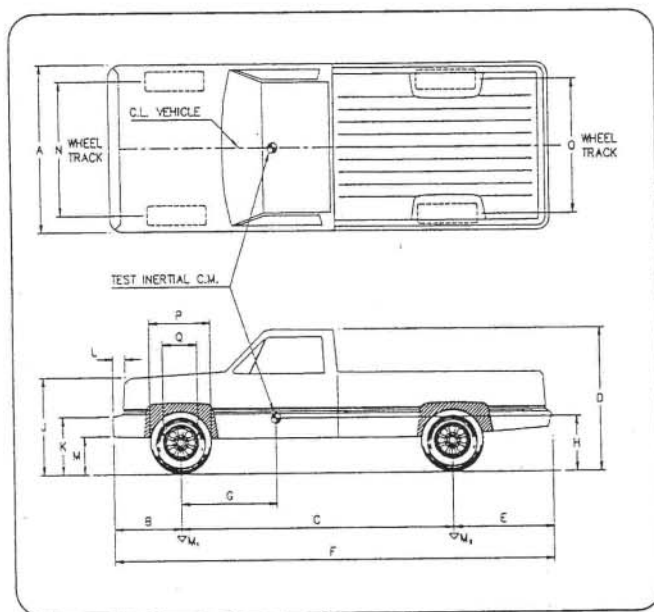
TEST VEHICLE GEOMETRY (mm)							
A	<b>1890</b>	E	<b>1323</b>	J	<b>1032</b>	N	<b>1597</b>
B	<b>914</b>	F	<b>5577</b>	K	<b>671</b>	O	<b>1620</b>
C	<b>3344</b>	G	<b>n/a</b>	L	<b>86</b>	P	<b>775</b>
D	<b>1838</b>	H	<b>n/a</b>	M	<b>451</b>	Q	<b>444</b>

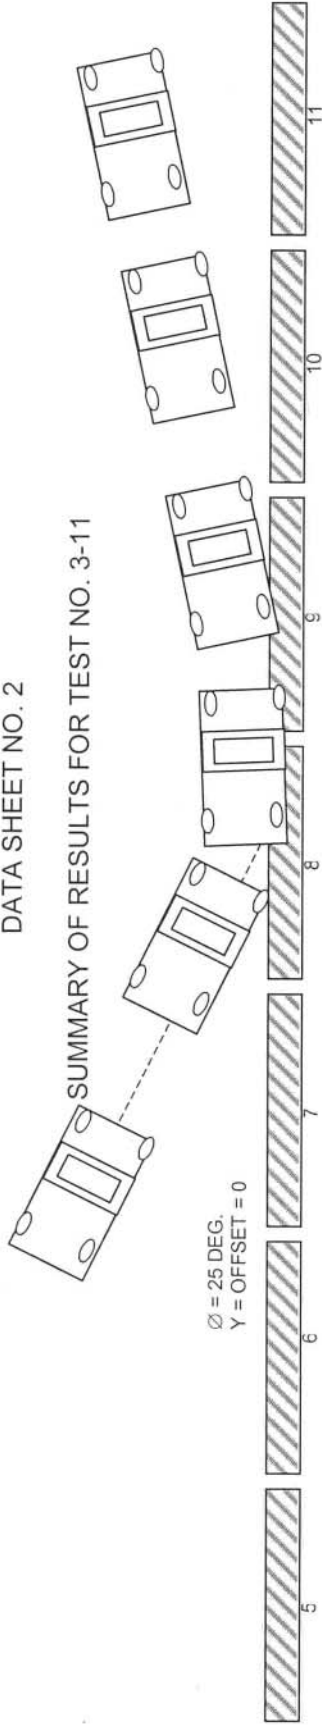
SUMMARY OF RESULTS FOR TEST NO. 3-11

GENERAL INFORMATION		OCCUPANT RISK VALUES	
TEST AGENCY	KARCO ENGINEERING	IMPACT VELOCITY (m/sec)	-5.85
TEST NO.	3-11	X-DIRECTION	0
DATE	04/17/01	Y-DIRECTION	N/A
TEST ARTICLE		THIV (optional)	N/A
TYPE	LONGITUDINAL BARRIERS	RIDEDOWN ACCELERATION (g's)	
INSTALLATION LENGTH (m)	61.37 m (201.3 ft.) precast concrete	X-DIRECTION	+ 11.17 to -12.52
SIZE AND/OR DIMENSION OF KEY ELEMENTS	3.84 m (12 ft 7 in.)	Y-DIRECTION	+ 15.96 to -18.23
SOIL TYPE AND CONDITION	N/A	PHD (optional)	N/A
TEST VEHICLE		ASI (optional)	1.614
TYPE	PRODUCTION	TEST ARTICLE DEFLECTIONS (m)	
DESIGNATION	2000P	DYNAMIC	30 in.
MODEL	1995 CHEVROLET PICKUP TRUCK	PERMANENT	30 in.
MASS (CURB)	2165 kg	VEHICLE DAMAGE	
MASS (TEST INERTIAL)	2041 kg	EXTERIOR	
DUMMY(S) MASS	N/A	VDS	n/a
GROSS STATIC WEIGHT	2041 kg	GDC	n/a
IMPACT CONDITIONS		INTERIOR	
SPEED (km/h)	100.74 k/h (62.6 mph)	OCDI	n/a
ANGLE (Deg.)	25		
IMPACT SEVERITY (kJ)	N/A		
EXIT CONDITIONS		POST IMPACT VEHICULAR BEHAVIOR

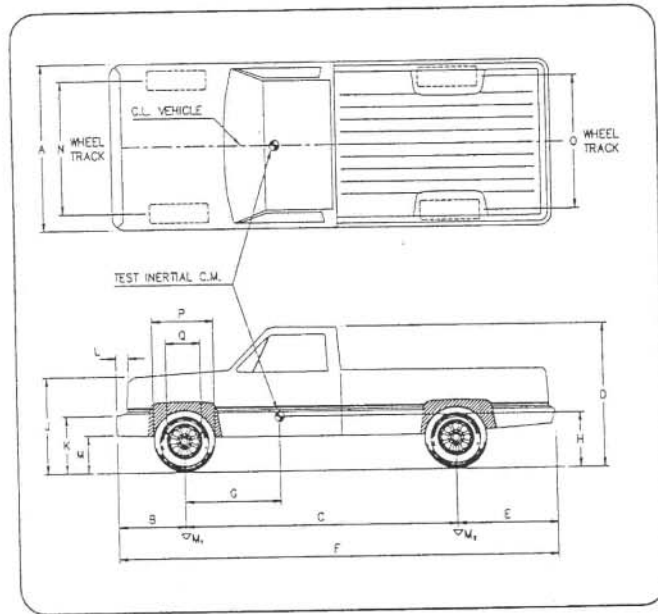
TEST VEHICLE GEOMETRY (mm)							
A	880	E	1330	J	1075	N	620
B	860	F	5518	K	650	O	620
C	3328	G	1963	L	98	P	760
D	1830	H	760	M	500	Q	445

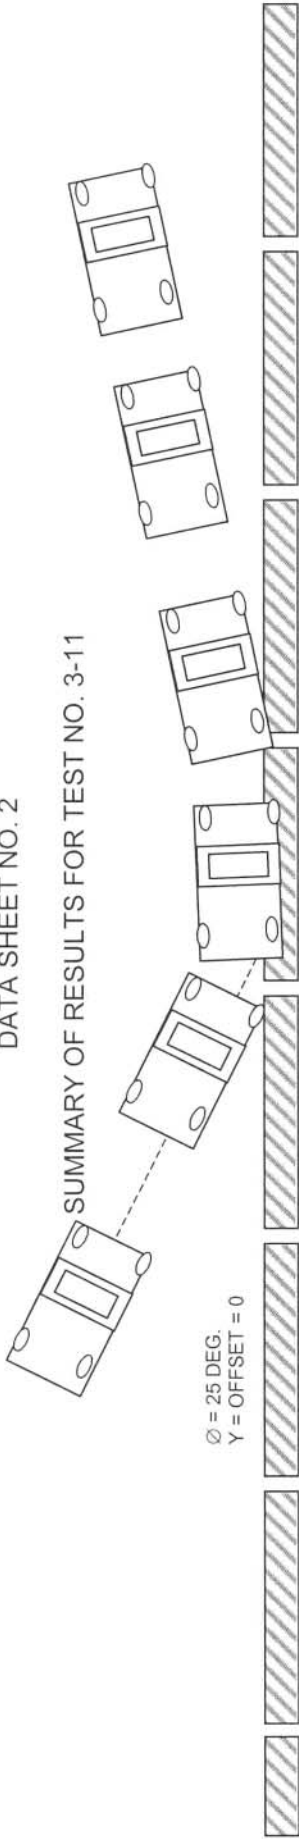
SUMMARY OF RESULTS FOR TEST NO. 3-11

7	8	9	10	11	12	13	14
<b>GENERAL INFORMATION</b>								
TEST AGENCY	KARCO ENGINEERING							
TEST NO.	3-11							
DATE	06/19/01							
TEST ARTICLE								
TYPE	LONGITUDINAL BARRIERS							
INSTALLATION LENGTH (m)	60.96 m (200 ft.) precast concrete							
SIZE AND/OR DIMENSION OF KEY ELEMENTS	3.023 m (9 ft 11 in.)							
SOIL TYPE AND CONDITION	N/A							
TEST VEHICLE								
TYPE	PRODUCTION							
DESIGNATION	2000P							
MODEL	1995 CHEVROLET PICKUP TRUCK							
MASS (CURB)	2165 kg							
MASS (TEST INERTIAL)	2024 kg							
DUMMY(S) MASS	N/A							
GROSS STATIC WEIGHT	2024 kg							
<b>IMPACT CONDITIONS</b>								
SPEED (km/h)	102.38 km/h (63.62 mph)							
ANGLE (Deg.)	25°							
IMPACT SEVERITY (kJ)	N/A							
<b>EXIT CONDITIONS</b>								
SPEED (km/h)	81.00 km/h (50.34 mph)							
ANGLE (Deg.)	12°							
<b>OCCUPANT RISK VALUES</b>								
IMPACT VELOCITY (m/sec)								
X-DIRECTION	-6.22 m/sec							
Y-DIRECTION	5.08 m/sec

THIV (optional)	N/A							
<b>RIDEDOWN ACCELERATION (g's)</b>								
X-DIRECTION	+ 10.10 to -19.36							
Y-DIRECTION	+ 12.25 to -8.58							
PHD (optional)	N/A							
ASI (optional)	1.405							
<b>TEST ARTICLE DEFLECTIONS (m)</b>								
DYNAMIC	32 in.							
PERMANENT	32 in.							
<b>VEHICLE DAMAGE</b>								
EXTERIOR	n/a							
VDS	n/a							
CDC	n/a							
INTERIOR	n/a							
OCDI	n/a							
<b>POST IMPACT VEHICULAR BEHAVIOR</b>								
MAXIMUM ROLL ANGLE (Deg.)	+ 16.04 to -11.49							
MAXIMUM PITCH ANGLE (Deg.)	+ 23.07 to -1.12							
MAXIMUM YAW ANGLE (Deg.)	+ 0.41 to -32.54

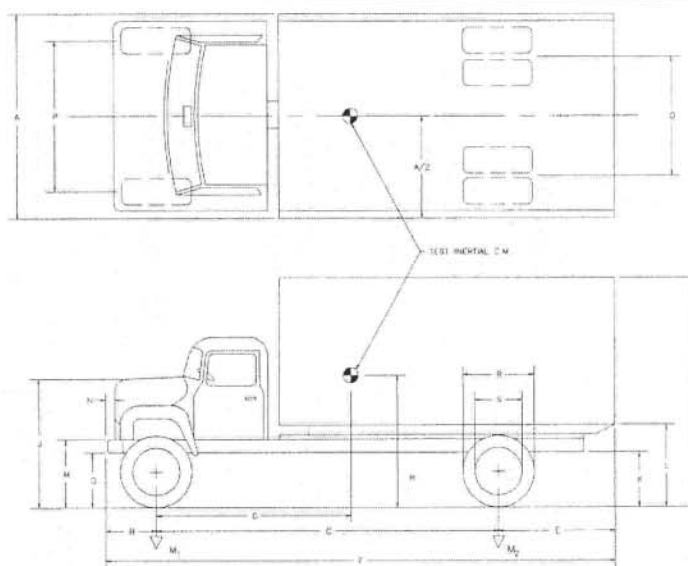
TEST VEHICLE GEOMETRY (mm)							
A	<b>2650</b>	F	<b>8750</b>	L	<b>940</b>	Q	<b>2050</b>
B	<b>860</b>	G	<b>3068</b>	M	<b>730</b>	R	<b>970</b>
C	<b>5290</b>	H	<b>N/A</b>	N	<b>50</b>	S	<b>580</b>
D	<b>3530</b>	J	<b>1530</b>	O	<b>420</b>	-	<b>-</b>
E	<b>2600</b>	K	<b>620</b>	P	<b>2050</b>	-	<b>-</b>

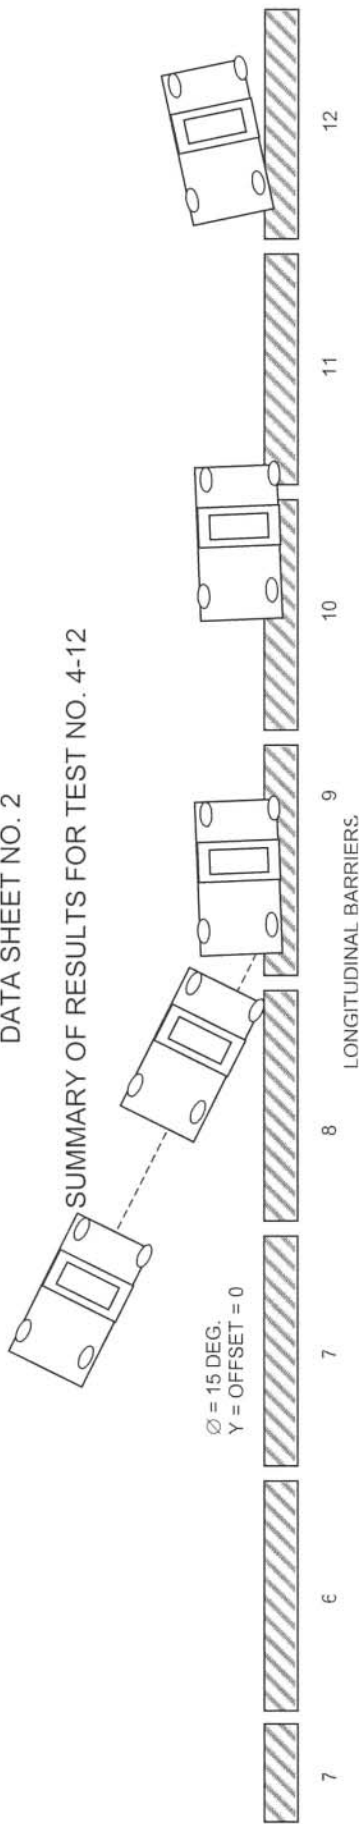
SUMMARY OF RESULTS FOR TEST NO. 4-12

GENERAL INFORMATION		OCCUPANT RISK VALUES	
TEST AGENCY	KARCO ENGINEERING	IMPACT VELOCITY (m/sec)	
TEST NO.	4-12	X-DIRECTION	1.87 m/sec
DATE	09/20/01	Y-DIRECTION	2.74 m/sec
TEST ARTICLE		THIV (optional)	N/A
TYPE	LONGITUDINAL BARRIERS	RIEDOWN ACCELERATION (g's)	
INSTALLATION LENGTH (m)	60.96 m (200 ft.) precast concrete	X-DIRECTION	+ 4.67 to -5.29
SIZE AND/OR DIMENSION OF KEY ELEMENTS	3.023 m (9 ft 11 in.)	Y-DIRECTION	+ 4.47 to -6.78
SOIL TYPE AND CONDITION	N/A	PHD (optional)	N/A
TEST VEHICLE		ASI (optional)	0.514
TYPE	PRODUCTION	TEST ARTICLE DEFLECTIONS (m)	
DESIGNATION	8000S	DYNAMIC	32.5 in.
MODEL	1995 FORD F-600 BOX TRUCK	PERMANENT	32.5 in.
MASS (CURB)	4312 kg	VEHICLE DAMAGE	
MASS (TEST INERTIAL)	7917 kg	EXTERIOR	
DUMMY(S) MASS	N/A	VDS	n/a
GROSS STATIC WEIGHT	7917 kg	CDC	n/a
IMPACT CONDITIONS		INTERIOR	
SPEED (km/h)	76.06 km/h (47.27 mph)	OCDI	n/a
ANGLE (Deg.)	15°		
IMPACT SEVERITY (k-j)	N/A	POST IMPACT VEHICULAR BEHAVIOR

EXIT CONDITIONS		MAXIMUM ROLL ANGLE (Deg.)	+ 0.24 to -9.50
SPEED (km/h)	N/A	MAXIMUM PITCH ANGLE (Deg.)	+ 8.44 to -1.06
ANGLE (Deg.)	7.3°	MAXIMUM YAW ANGLE (Deg.)	+ 0.00 to -25.79
