**WORK ZONE INTRUSION  
ALERT TECHNOLOGIES:  
ASSESSMENT AND  
PRACTICAL GUIDANCE**

**Final Report**

**SPR 790**

Oregon Department of Transportation

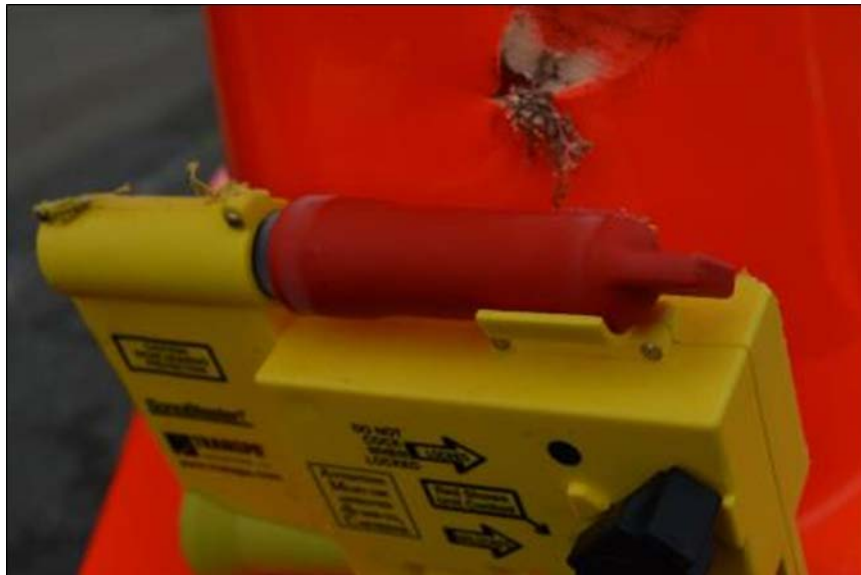
Alarms were triggered by the research team one at a time to record any possible false negatives. Results from this test showed that after more than 20 triggers, none of the technologies had a false negative alarm. That is, each intrusion alert system produced the expected alarm once triggered; in no cases was the alert triggered but the alarm not produced. Notwithstanding the success rate of the technologies, six false negatives were recorded when a SonoBlaster® device was used more than once (following changing of cartridge). The research team believes that the SonoBlaster® is not designed for reuse after impact. In fact, in real operations, it is anticipated that once a SonoBlaster® unit has been triggered by an intrusion, it will likely be discarded due to severe damage occurring to the unit (see Figure 5.2), thereby making the false negatives recorded during the testing more or less understandable and likely not present in practice.

Figure 5.2: SonoBlaster® Damaged after Simulated Intrusion (Vehicle Striking Cone)

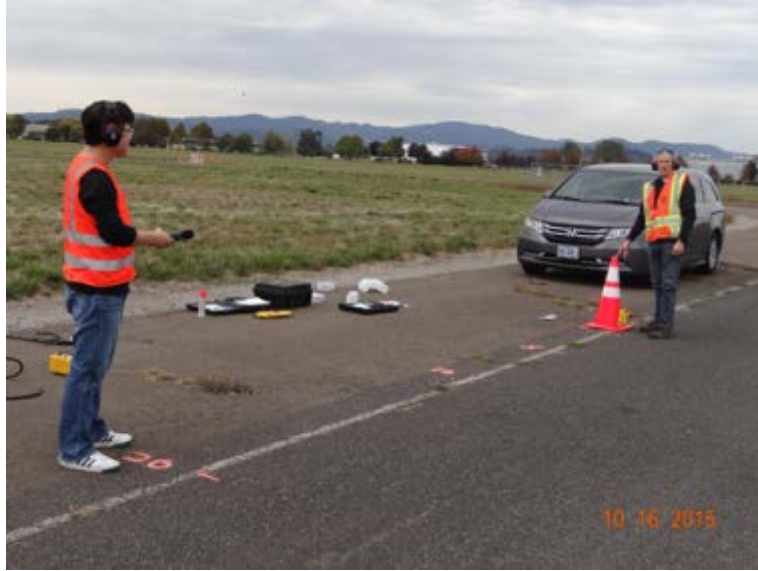
Figure 5.4: Sound Measurement at 20 feet

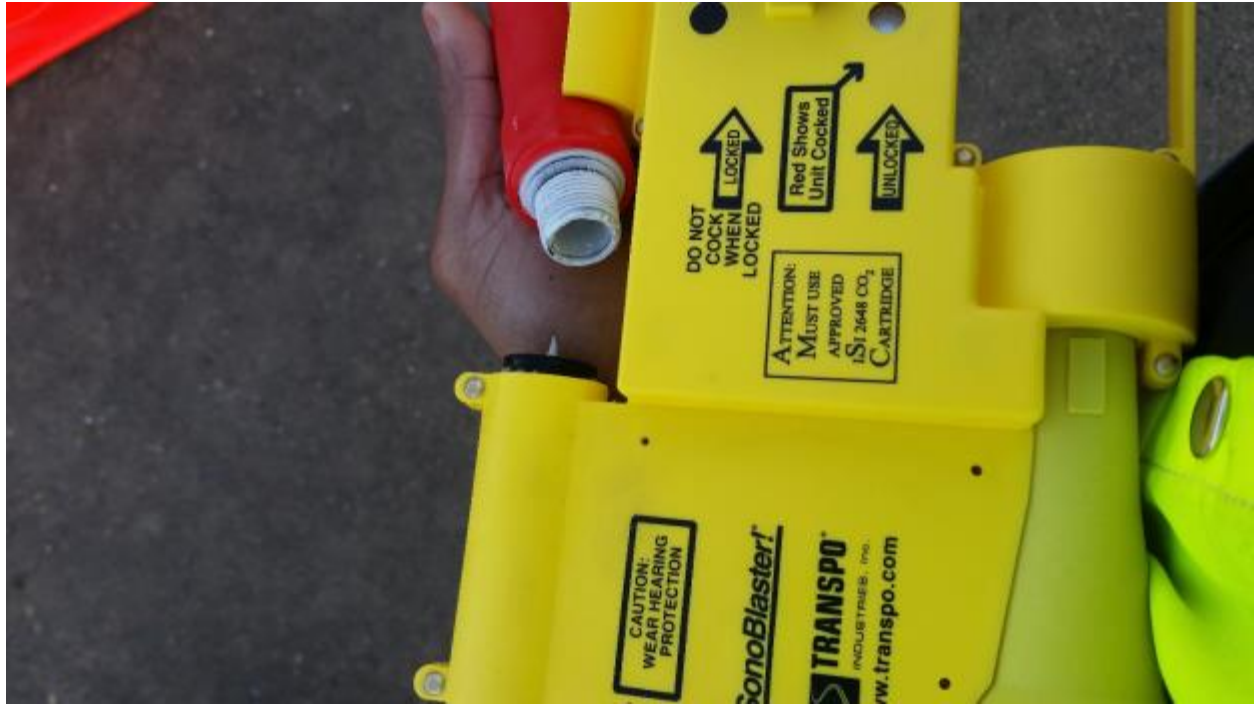
The inconsistency in the duration of sound produced by the SonoBlaster® appears to be largely due to its use of CO2 cartridges as an alarm-creating mechanism. The CO2 cartridge is required to be changed after every use. It was observed that after the SonoBlaster® was triggered once, subsequent uses of the SonoBlaster® with new cartridges produced shorter bursts of sound. Novosel (2015) pointed out that cold or wet weather could be a possible cause for this phenomenon (note that the pilot testing was conducted during the winter season). Also, accumulated ice was noticed on the nozzle after triggering the SonoBlaster®, especially in cold weather. The ice was caused by a reaction of the metallic nozzle to the pressurized CO2 being pushed through it. The accumulated ice made the cartridge changing process challenging because the ice made the cartridge stick to the nozzle, and replacing the cartridge was delayed until the ice melted (see Figure 5.5).

Figure 5.5: Ice Accumulation on Nozzle of SonoBlaster®

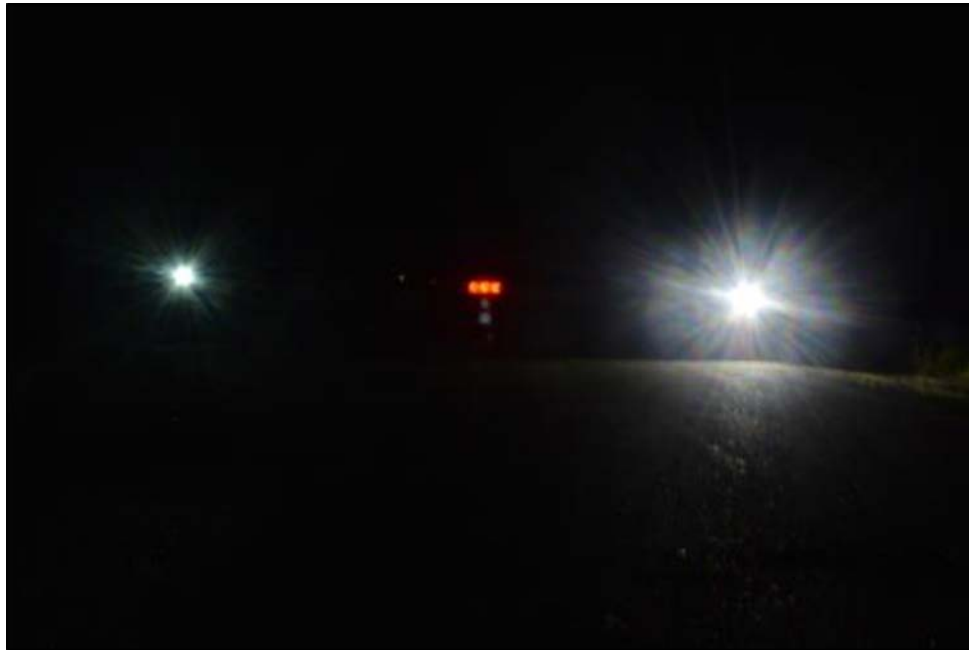
reference lights on the Intellicone® and WAS, respectively. The pictures were taken at 50 feet away from the technologies using 14, 5, and 100 as the settings for the aperture, shutter speed, and ISO, respectively. Both figures show that the visual alarms of both technologies may not be visually outstanding compared to the work lights. Pictures taken 500 feet away from the alert systems indicate that the visual alert produced by the systems could be detected, meeting Oregon visibility law (see Figure 5.33). The researchers assume that the use of red strobe lights as emergency warning lights in work zones is acceptable in Oregon since Oregon Law does not prohibit the use of red strobe lights on safety equipment (OregonLaws 2015b).

Figure 5.31: Reference Lights at 50 feet away from Intellicone®

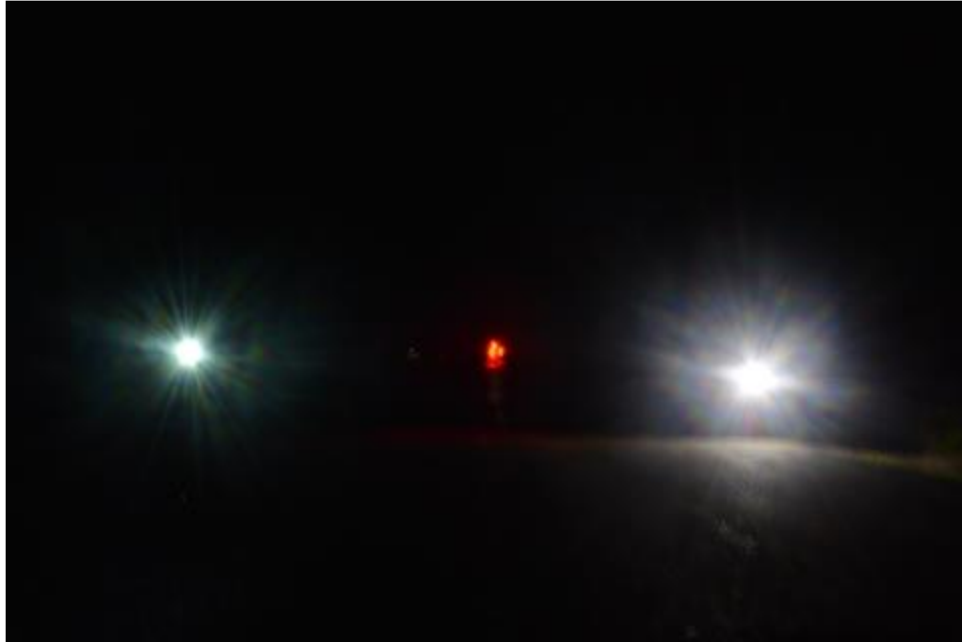
Figure 5.32: Reference Lights at 50 feet away from WAS

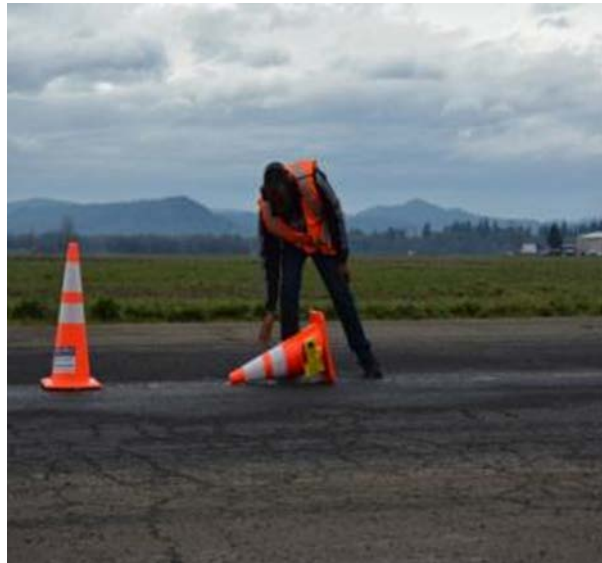
tilting the safety cone (see Figure 6.2). The alarm triggered successfully and lasted for approximately 13 seconds. The researchers also showed the participants how the CO2 cartridge is changed and armed for subsequent use. The second demonstration was designed to mimic the collision between a vehicle and a SonoBlaster®-mounted cone and how the impact may possibly alert construction workers. A sedan, moving at approximately 20 mph struck and successfully triggered the SonoBlaster® intrusion alarm (see Figure 6.3 showing the cone and SonoBlaster® underneath the vehicle and workers trying to free it).

Figure 6.2: SonoBlaster® Activated Manually

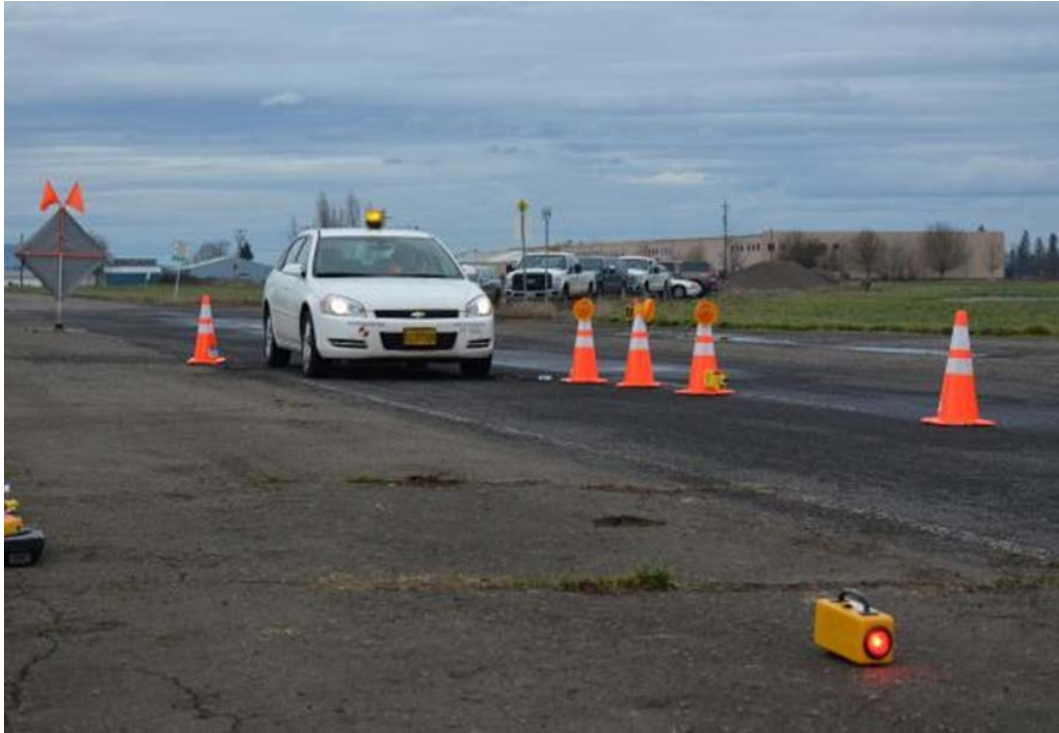
Similar to the previous two work zone intrusion technologies, the WAS technology was deployed and activated multiple times. The participants observed how to activate the WAS and how it could be installed along a work zone. The WAS was triggered manually by stepping on the pneumatic tube. For the first round of testing, the WAS was placed 50 feet away from the equipment, and then triggered by a moving vehicle. Next, the WAS alarm unit was attached to a wheel loader (using the base magnet). Furthermore, varying approach speeds of the sedan were tested to mimic the impact of different levels of speed on the WAS pneumatic unit. Changing the vehicle speed created the opportunity to evaluate how the relationship between triggered alarm and vehicle speed impacts a worker. Figures 6.8 and 6.9 show the different locations where the WAS alarm unit was placed.

Figure 6.8: WAS Located 50ft from Equipment while Activated by Intruding Vehicle

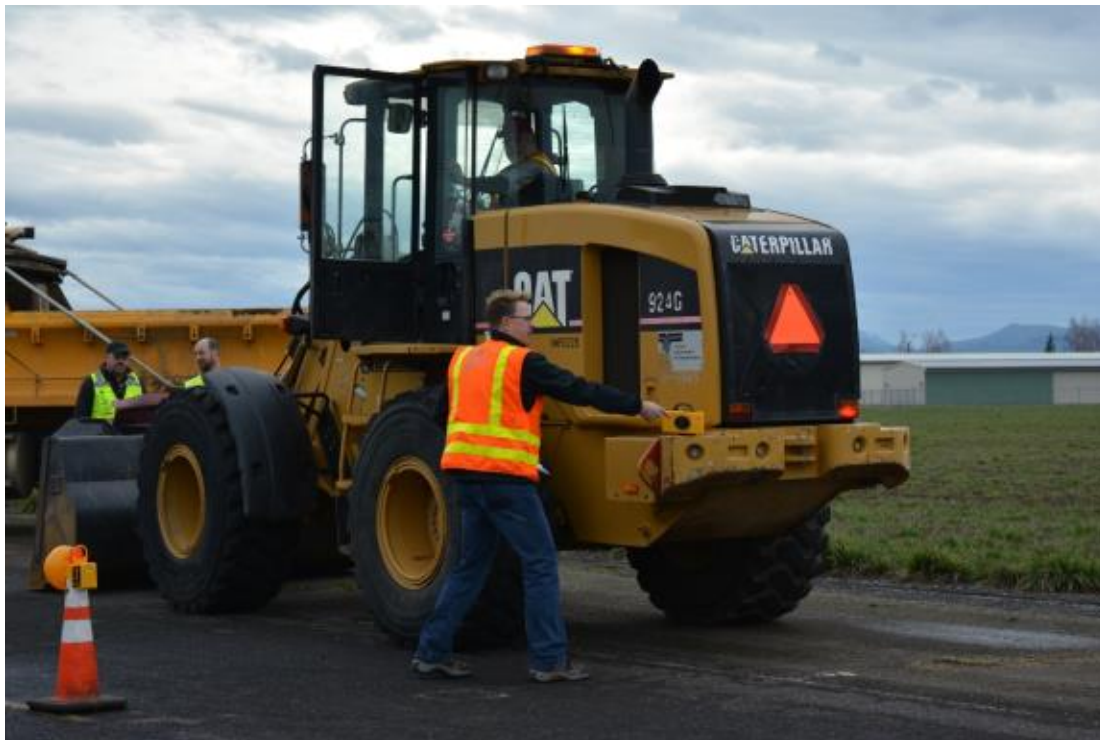
Figure 6.9: WAS Located on Wheel Loader

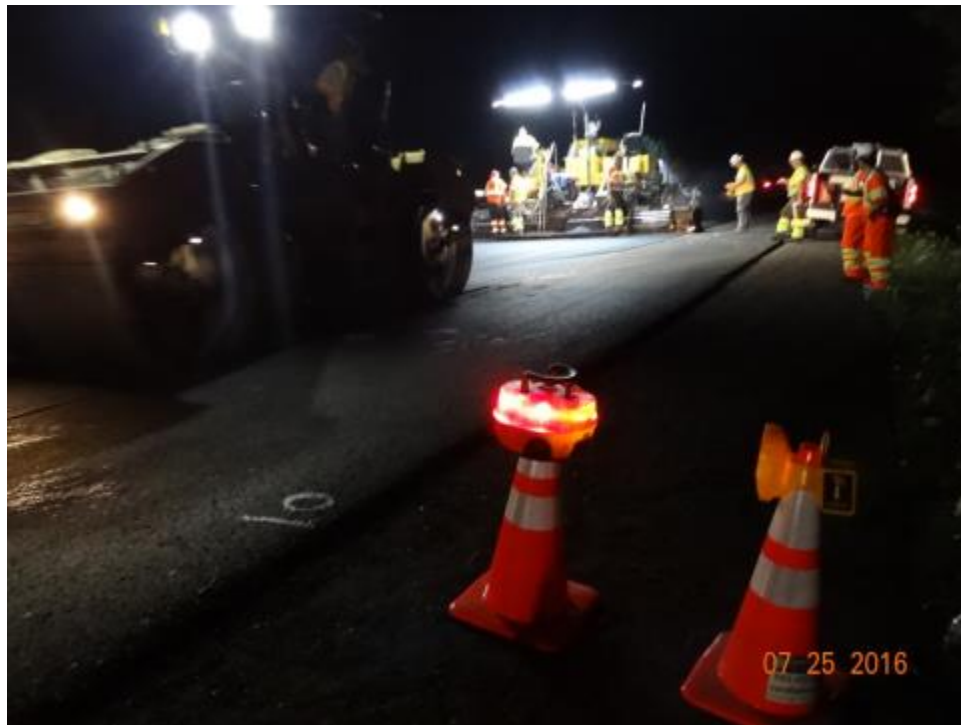
Figure 7.14: Intellicone® triggered 100 feet away from Paver

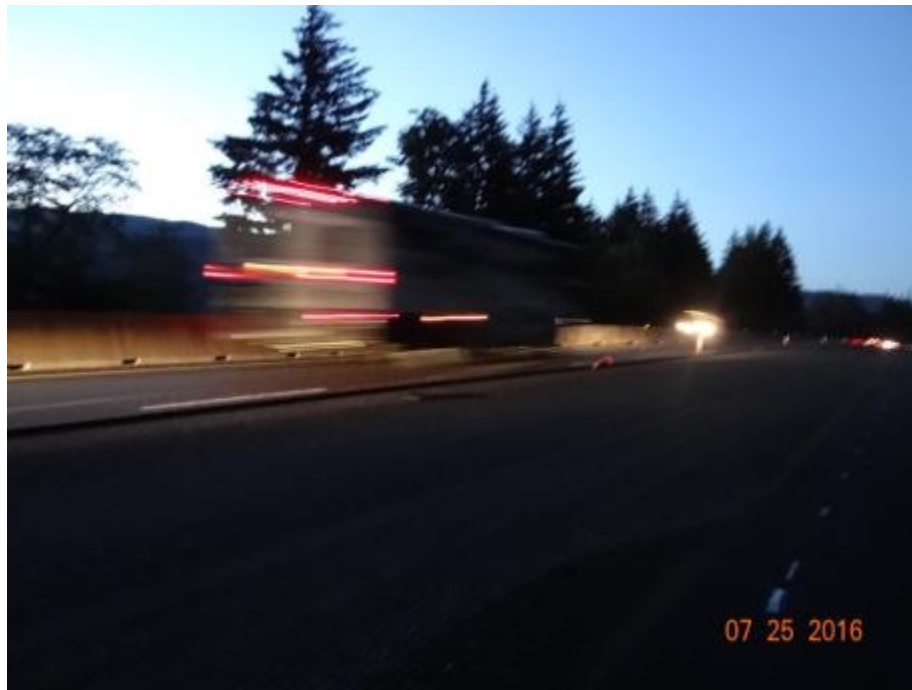
Intellicone® considering their design is dependent on the reliability and orientation of work zone cones.

Figure 7.15: Cone in Work Zone Knocked Over
