# OWEB-SRFB Coordinated Monitoring Program for Livestock Exclusion Projects

## 2012 Annual Progress Report

November 2012

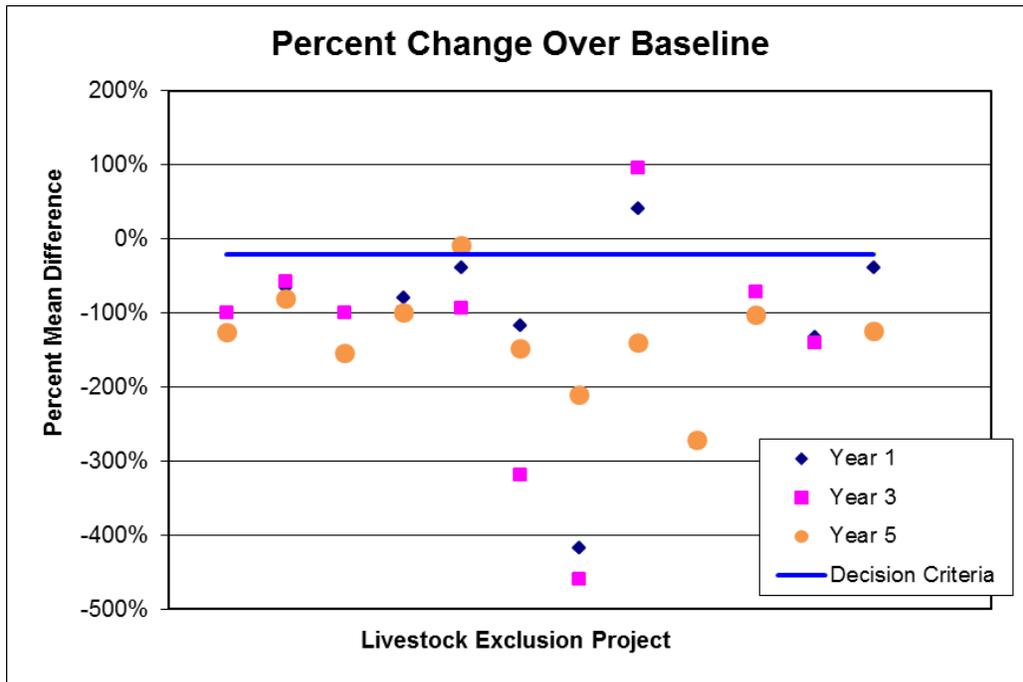
**Figure 2.** Percent Change Over Baseline

All but one project monitored showed reduced bank erosion by at least 20 percent in Year 5 (Figure 2). In Years 1 and 3, several projects had a percent difference of 100

because there was no difference between the impact and control reach in Year 0, Year 1, or Year 3, and 100 percent is used as the default value.

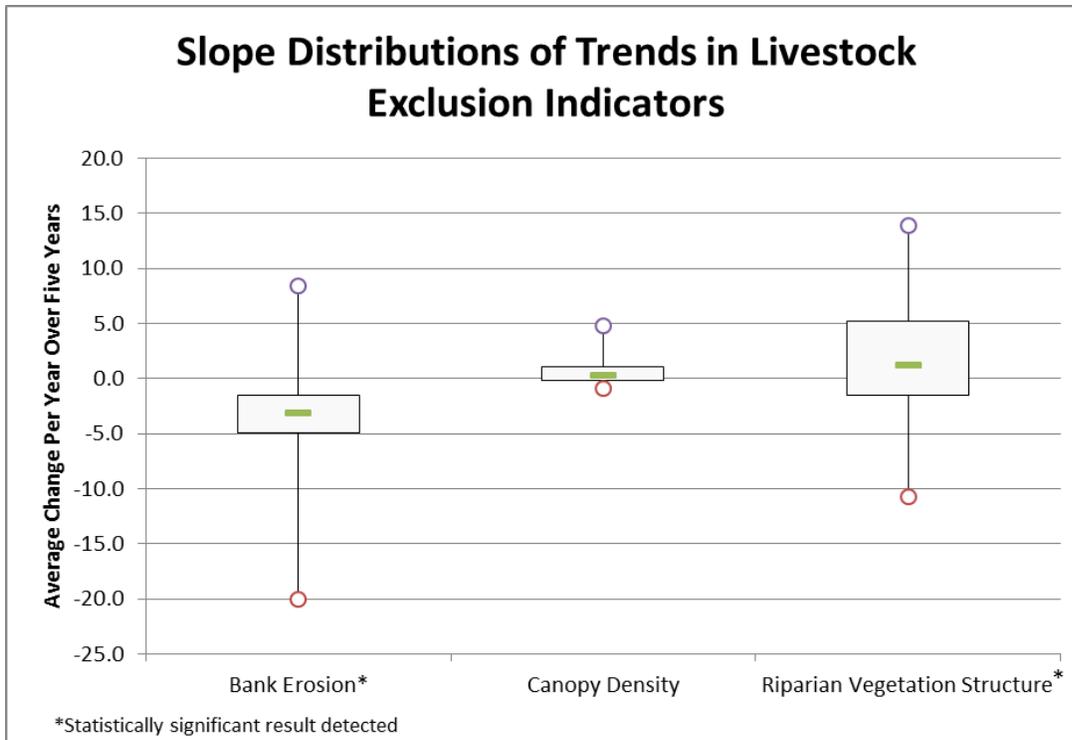
**Figure 3.** Slope Box Plot Showing Trends for Each Indicator Tested

The slope box plot graph for livestock exclusion indicators (Figure 2) shows the average of the trend line slopes for the difference in each indicator between the impact and the control across all projects. Bank erosion and riparian vegetation structure are all showing improving trends toward change, with some variability. For bank erosion, improvement is shown as a decreasing trend through time (negative slope), while for canopy density and riparian vegetation structure improvement is shown as an increasing trend (positive slope). Mean canopy density, however, has shown little indication of change and much lower variability (Figure 3).

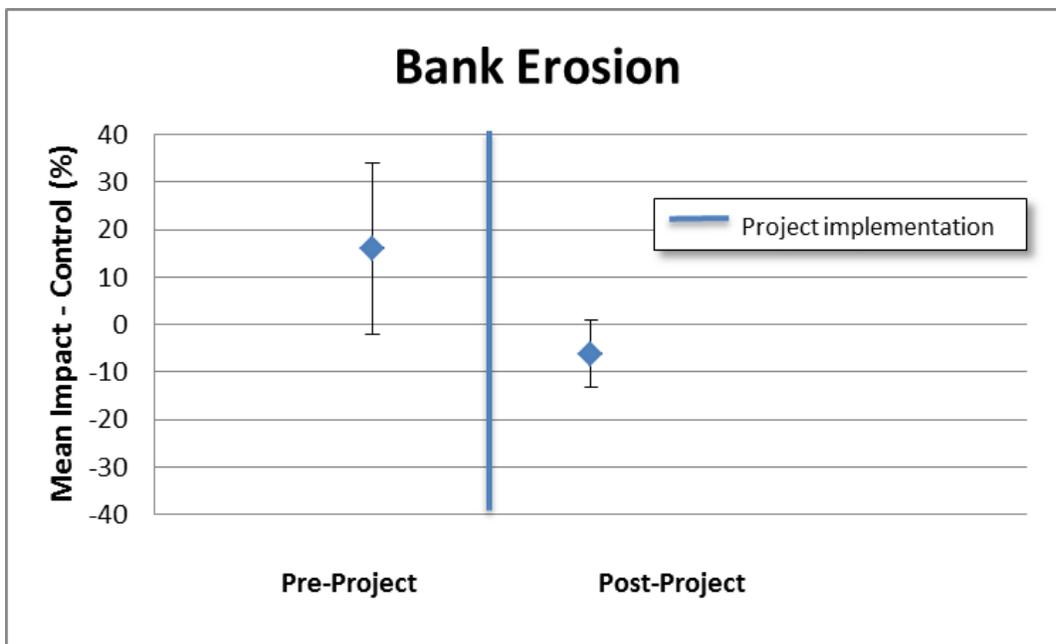
**Figure 4.** Mean Plot of Pre-Project versus Post-Project Conditions for Bank Erosion

When comparing average pre-project and post-project conditions across all Livestock Exclusion sites, a significant decrease in bank erosion was seen following project implementation (Figure 4). This is an improvement in habitat condition, as the goal for this project category is to decrease the linear proportion of actively eroding banks over time.

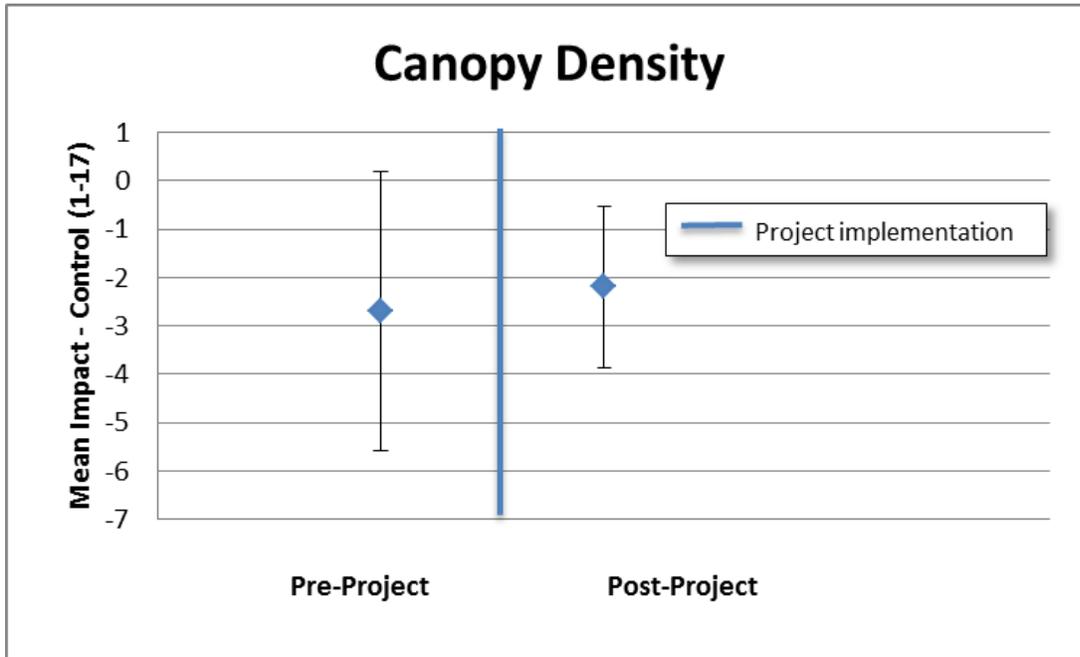
**Figure 5.** Mean Plot of Pre-Project versus Post-Project Conditions for Canopy Density

There has been little variability in the response of canopy density structure through time and statistically significant results were not found for this indicator in Year 5 (Table 4 and Figure 3). However, a slight average increase in canopy density following project implementation was apparent when comparing average pre-project and post-project conditions (Figure 5).

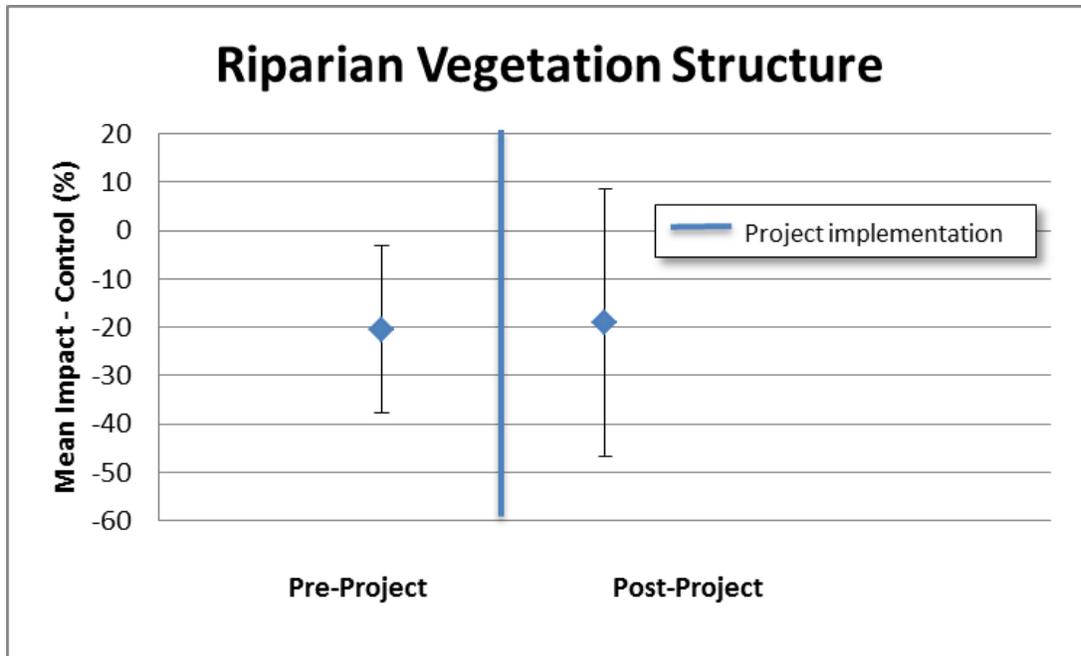
**Figure 6.** Mean Plot of Pre-Project versus Post-Project Conditions for Riparian Vegetation Structure

Although statistically significant results were not found for riparian vegetation structure, it has shown an improving trend toward change, as shown in the slope box plot (Figure 3). However, very little difference between pre- and post-project means has been found for this indicator (Figure 6).

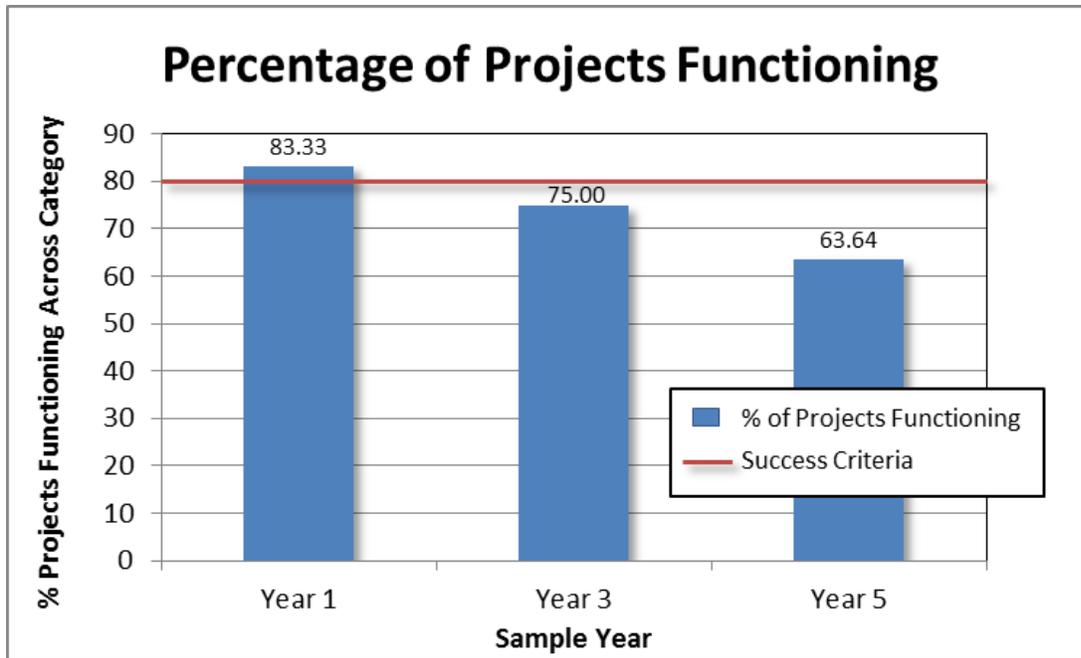
**Figure 7.** Percentage of Projects Monitored that Meet Success Criteria for Livestock Exclusion Category

Evaluation of livestock projects includes an assessment of exclusion function. This assessment evaluates whether the fencing structure is fully intact and is successfully excluding livestock from the fenced area. Observations of animal droppings, wildlife grazing or browsing, and other indicators are documented as well. Of the projects included in the analysis for Year 1, 83.3 percent of them were evaluated as functional. For Year 3, 75 percent of the projects included in the analysis were considered functioning. In Year 5, eleven livestock exclusion projects were monitored and seven of them, or approximately 64 percent, were found to be functional (Figure 7). Therefore, in Year 3 and Year 5, the livestock exclusion projects, as a category, did not meet the success criteria of 80 percent of projects in the category being intact by Year 10.

At least one project was deemed non-functional in every year of monitoring. In one case, funding for fencing was obtained and the fencing was partially installed, but never completed because the landowner decided not to graze cattle on the land. As a result, this project has been non-functional during each monitoring event. Another project was deemed not functional was due to a large tree falling across the exclusion fencing and subsequently allowing livestock to access the stream. This project has consistently met the success criteria in the past and is expected to meet them again once the fence is repaired. In other cases, gates installed in the fencing structure or poorly maintained fences allowed livestock access and resulted in a non-functional determination. Improvements in the implementation and maintenance of projects are needed to improve the success of the restoration project category as a whole.

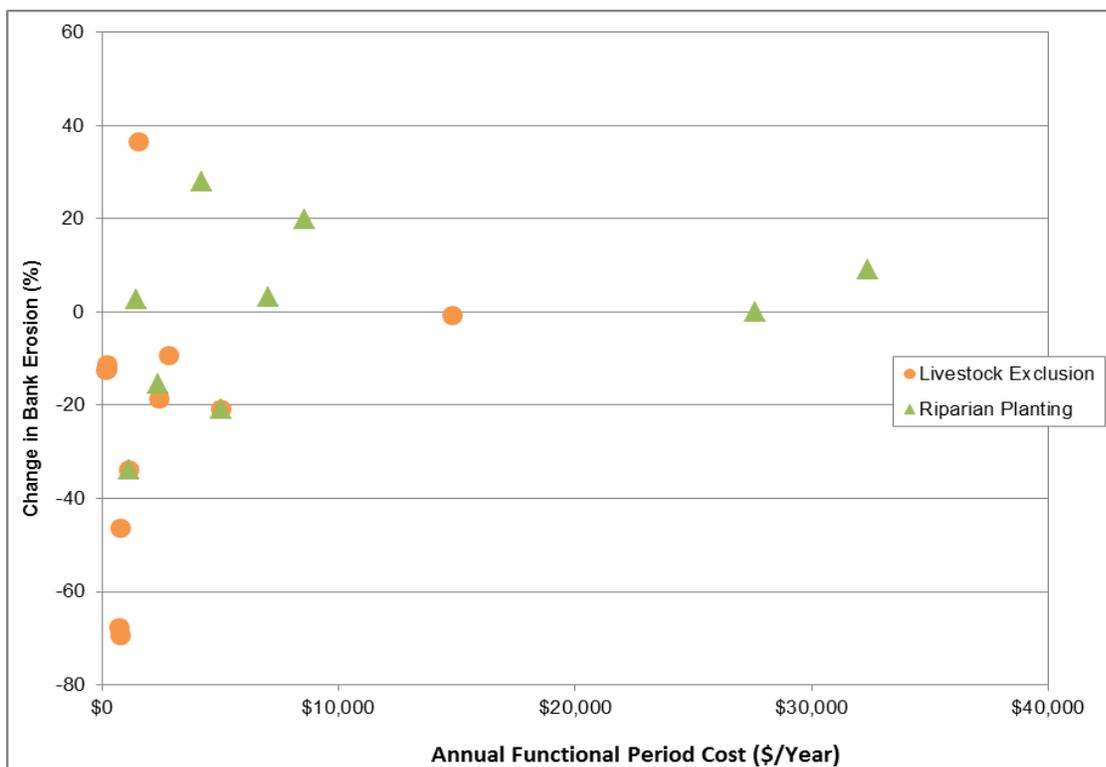
**Figure 8.** Change in Bank Erosion versus Annual Functional Period Cost

Results of the analysis indicated that livestock exclusion projects were the most cost-effective at improving riparian vegetation structure, mean canopy density, and decreasing bank erosion (Figure 8), as compared to other project types tested. This may suggest that in areas where livestock graze along streams, there is more severe damage than in areas where livestock are not present. The removal of livestock via fencing may have more dramatic effects on increasing vegetation metrics in the short-term, such that the relative increase for these projects is much more notable as compared to a control reach. In contrast, areas where riparian planting projects are installed may already have vegetation, but the goal may be to improve the quality of that vegetation. Hence, the differences seen in canopy density, riparian vegetation structure, and bank erosion may be less noticeable.

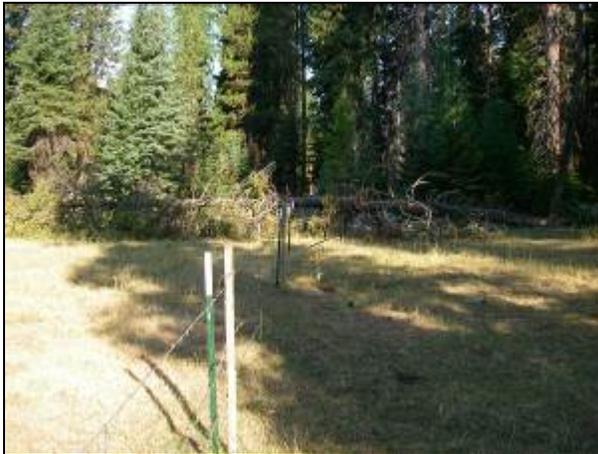
In 2011, field personnel observed a large tree that recently had fallen across the exclusion fencing at Bottle Creek. This tree caused the fence to fail and, as a result, cattle were observed grazing inside the exclusion area. Photos below show the tree lying across the fence, cattle within the impact reach, an eroded area of streambank where cattle had been accessing the stream, and cattle droppings near the stream. It did not appear as though the fallen tree had been down very long, as it still had green branches and leaves; however,

Tree lying across exclusion fencing in 2011

livestock were accessing the exclusion area as a result of the damage. Livestock were observed grazing near the stream in the impact reach and evidence of livestock accessing the stream itself was also documented. Other than the area affected by the fallen tree, the fencing appeared to be intact. Survey personnel notified the project sponsor of the observed damage to the fence.

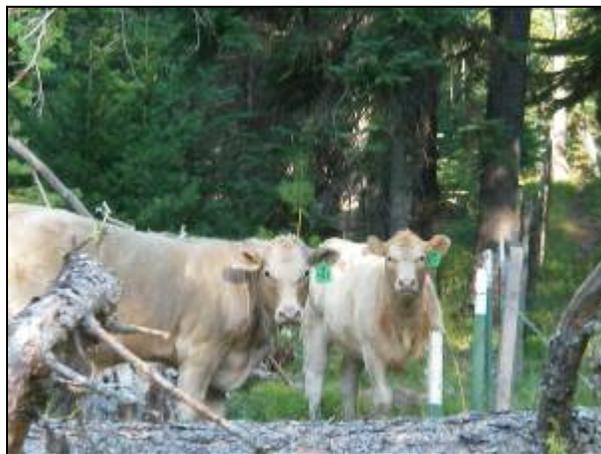
Livestock within fenced area in 2011

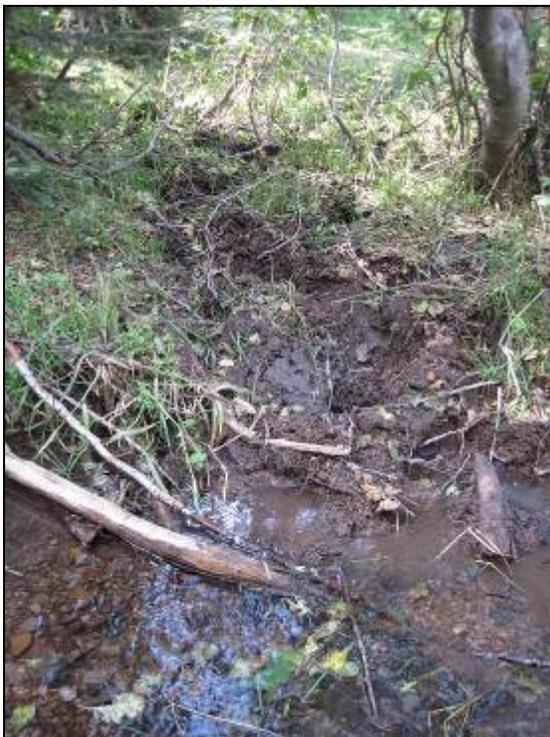
Trail being used by cattle to access creek in 2011

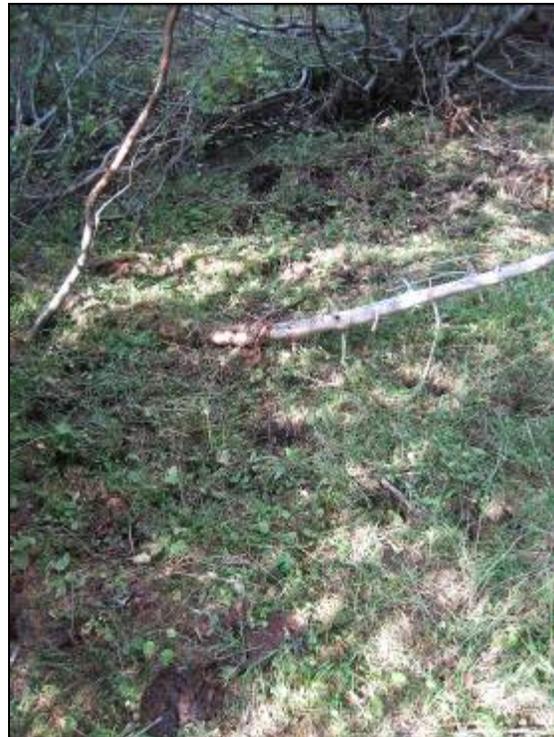
Cattle droppings inside exclusion area in close proximity to stream in 2011

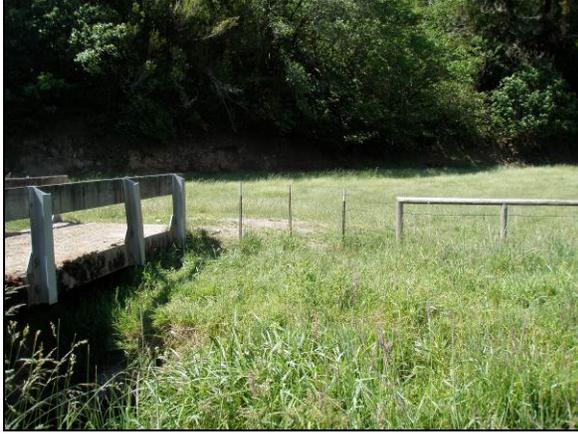
The fence along the control reach on Noble Creek was not intact in the vicinity of Transect F (see photo below), and the gate was left open for livestock to pass through. Evidence of livestock access to Noble Creek is shown in the photo below.

Impaired fence on control reach (Noble Creek 2009)

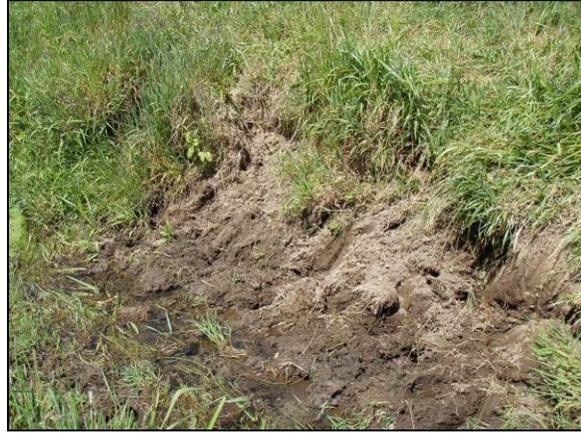
Evidence of livestock in control reach (2009)

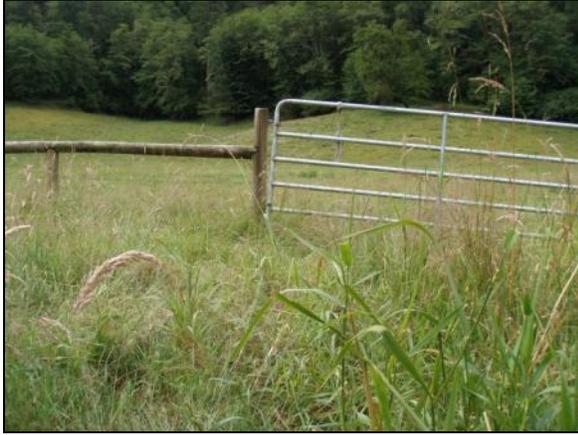
The livestock fencing appeared intact at the time of the survey in 2011; however, there were gates in the fencing, which were open and would have allowed livestock to access the creek. Evidence of livestock near the gate at Transect G was documented in the photos shown below.

Gate located in fencing at Transect G of the impact reach (Year 5)

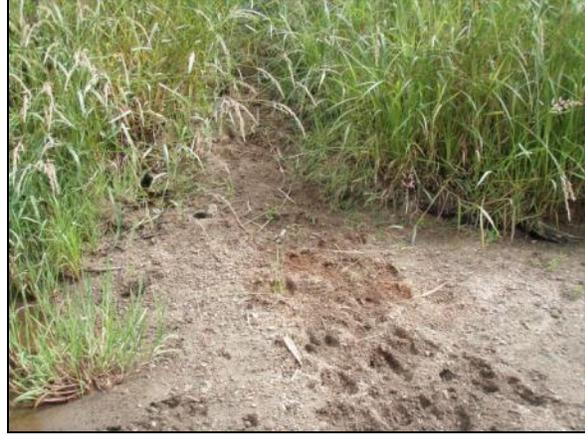
Livestock tracks observed near Transect G of the reach (Year 5)

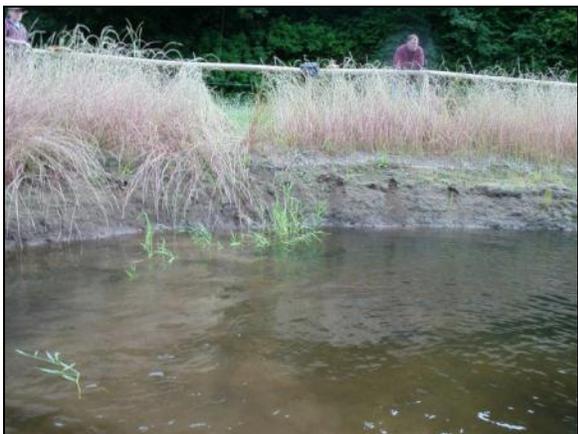
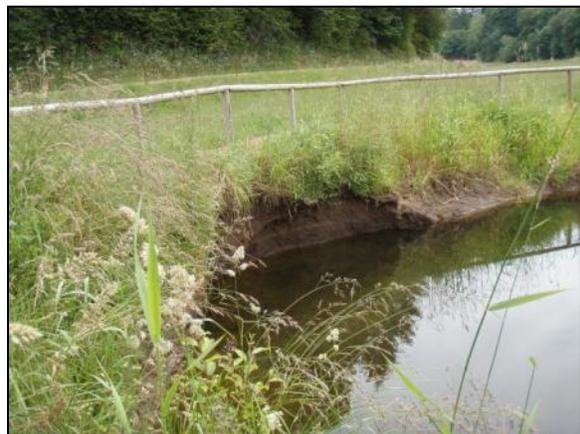
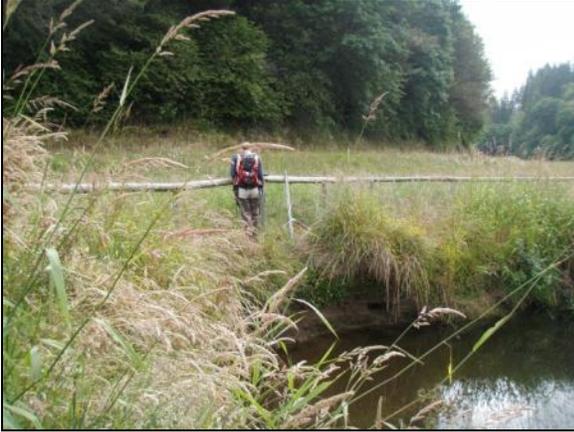
At the project site, Johnson Creek travels through agricultural lands and consists of deep pools, steep banks, and fine sediment. Measured parameters at Johnson Creek continue to show overall positive trends for the site by Year 5. The series of photos below show an exposed right bank at Transect A in the impact reach during Year 1 and the sloughing that occurred before the Year 3 monitoring in the same area where the rebar was placed in Year 1. In Year 5, erosion was observed in the same area in Transect A.

Impact reach at Transect A in 2007 (Year 1)

Impact reach at Transect A in 2009 (Year 3)

Impact reach at Transect A in 2011 (Year 5)

This erosion was not caused by livestock, but was likely due to high water flows, and is expected continue occurring with high flow events in the future. Year 10 monitoring of the Johnson Creek project is scheduled for 2016, which will complete the monitoring cycle for this site.

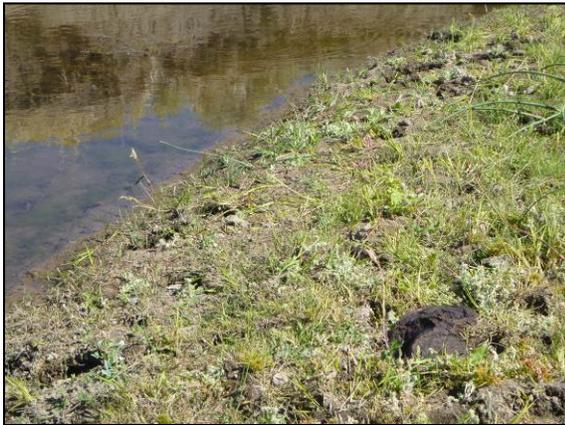
Evidence of recent livestock access to the impact reach was documented during the survey (see photos below). Although evidence of recent access was observed, no cattle were observed in or near the stream within the impact reach at the time of the survey. Since observations made during field surveys only reflect conditions at that time, it was not possible to determine the extent to which cattle were allowed access to the stream, or for what period of time. Despite apparent access by livestock, bank erosion numbers decreased in both the control and impact reaches in Year 5 (Table 1).

Cow feces and tracks near river in impact reach.

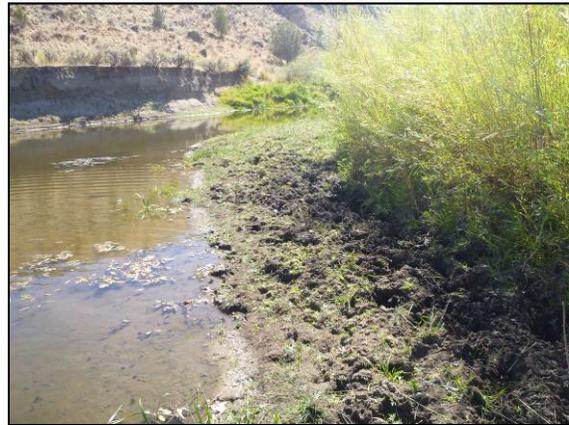
Cattle print along left bank at Transect B in impact reach.

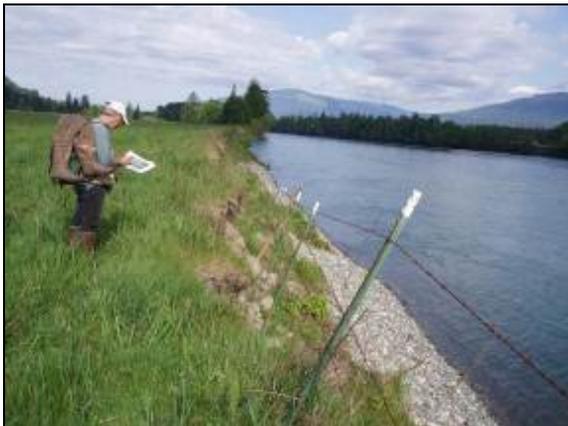
Impact reach before livestock exclusion fencing in 2005 (Year 0). Fence shown here was original fencing and was removed by bank erosion between 2005 and 2006.

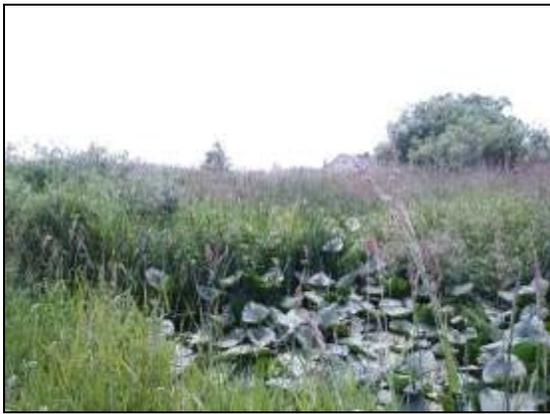
Impact reach – overgrown with reed canary grass (2009).
