PROJECT COMPLETION REPORT

End Creek-Rice Fish Habitat & Wetland Restoration Project

Oregon Watershed Enhancement Board Project No. 204-434

January 2007

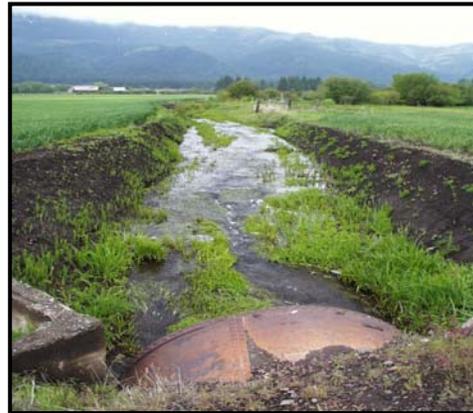
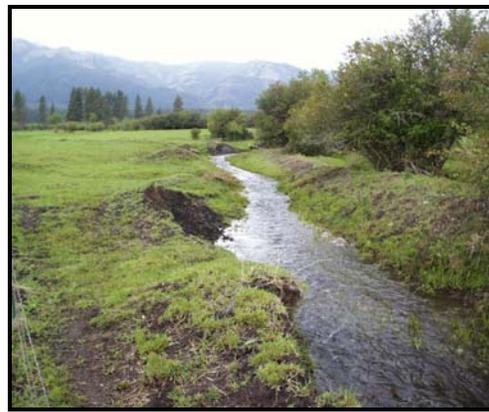
June 2003 Photos illustrate lower channelized End Creek. Extensive channelization in project area created unstable stream channels, excessive erosion, elevated water temperatures, loss of riparian and wetland vegetation, and poor fish habitat.

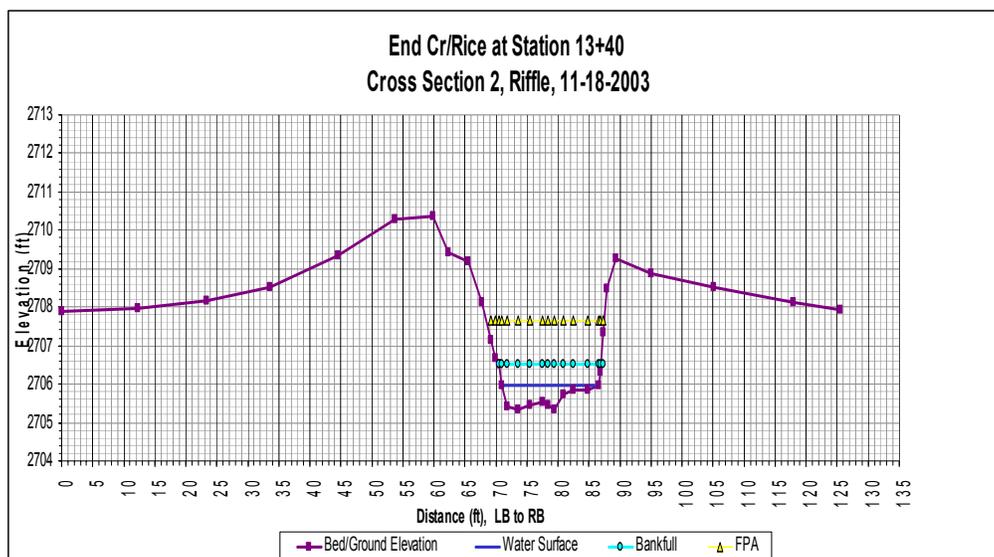
Figure 6 Riffle Cross Section of Existing End Creek Reach

The following figure depicts a typical riffle cross section generated from survey data collected at Station 13+40 along lower End Creek. The cross section clearly illustrates the extent of channel incision and lack of floodplain connectivity. Flood conveyance capacity of the channel is significant which contributes to unstable stream banks shown in the above photos. Note that both the bankfull discharge and floodprone area are contained entirely within the existing channel, limiting connectivity to the floodplain.

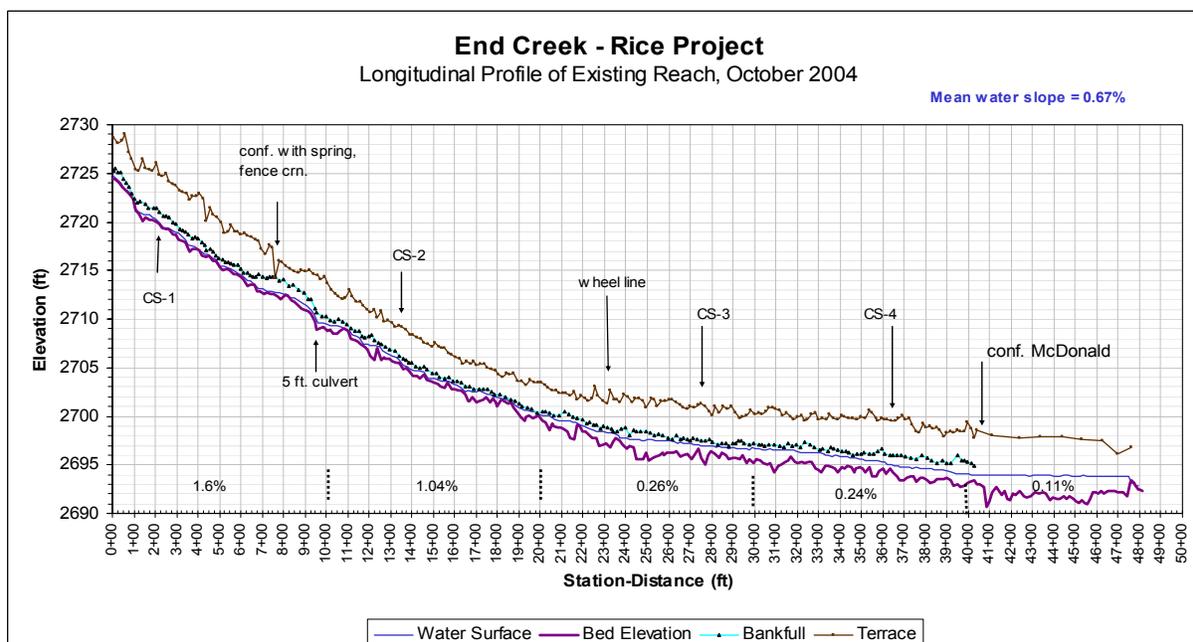
Figure 7 Longitudinal Profile of Lower End Creek

Figure 7 illustrates the profile of lower End Creek. Note the relation of the channel thalweg in comparison to adjacent terraces which illustrates extensive channel entrenchment, confinement, and high water slopes (mean of 0.67%). Also of note in the profile is the lack of large pool habitat. In the current condition, End Creek is severely unstable and lacks stable morphology necessary to develop high quality fish habitat.

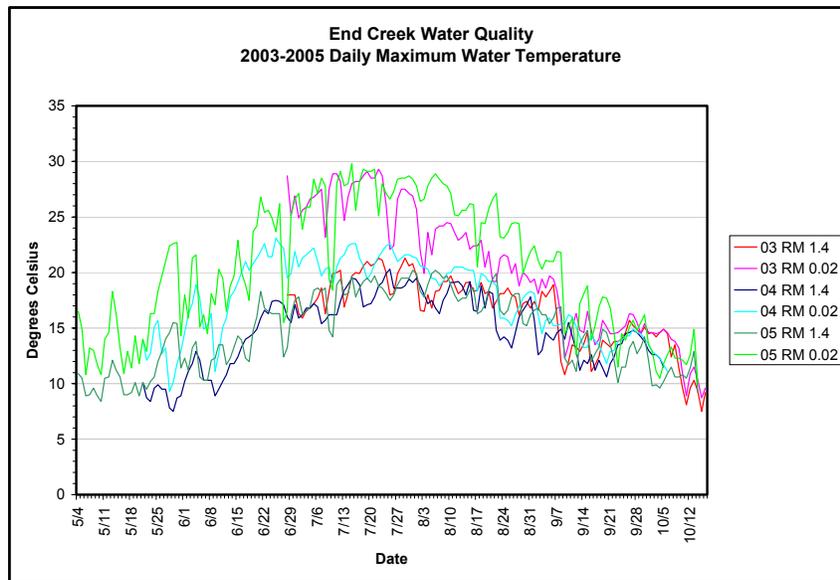
Figure 8 End Creek Daily Maximum Water Temperatures 2003-2005

Water temperatures recorded at the upper monitoring site have been observed to be consistently cooler than the lower site during 2003 through 2005 with a consistent heating trend detected through the lower channelized project reach. Observed maximum temperatures indicate that summer salmonid distribution in lower End Creek is limited by high summer water temperatures. Figure 8 illustrates data collected during 2003 through 2005.

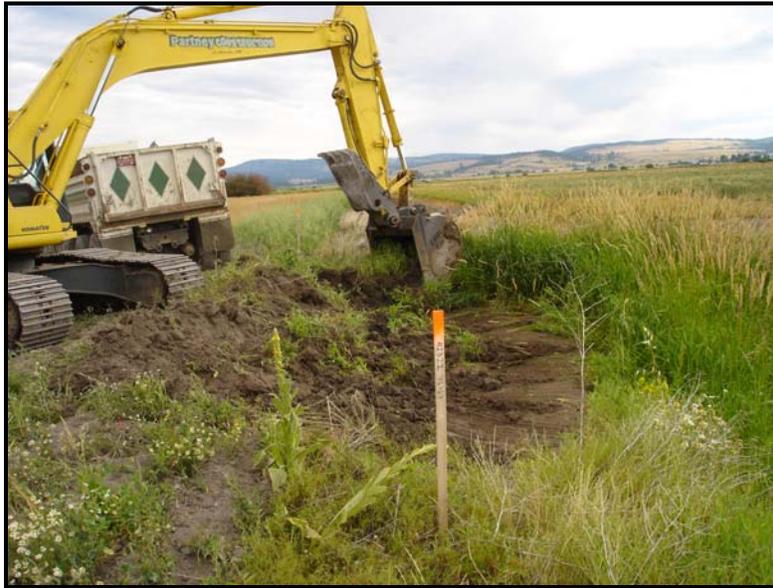
Initiation of End Creek restoration channel construction. July 2006

Channel construction was performed using a 200 series track-mounted excavator, D5 dozer, and dump trucks. In stream channel segments requiring floodplain excavation (areas where the bankfull channel was deeper than existing ground surface), the floodplain was excavated first, followed by the bankfull channel and associated typical cross sections. Floodplain cuts involving extensive earth excavation were generally cut first using a dozer to bulk material which was then loaded by track-hoe onto dump trucks and hauled to designated locations (i.e., earthen terrace locations, backfill for channel reclamation, etc). In other channel segments that did not require floodplain construction, a track-hoe was utilized to sequentially excavate the channel per typical cross sectional dimensions in a downstream to upstream manner.

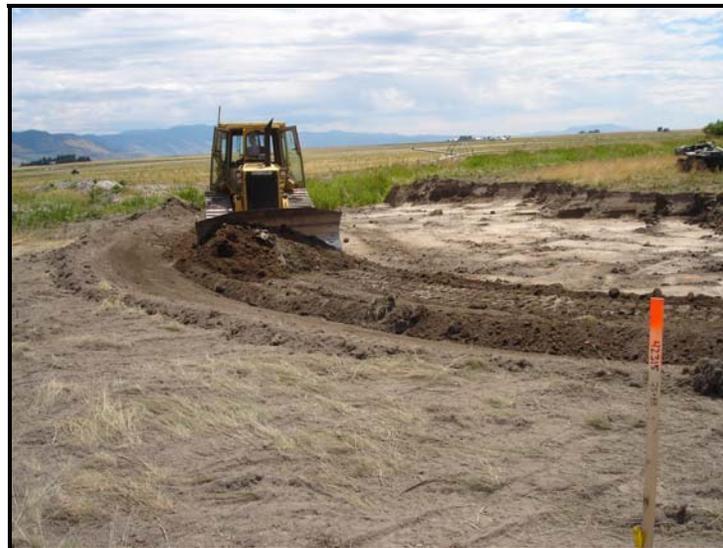
D5 Dozer grading material from floodplain in preparation for bankfull channel excavation by track-hoe. July 2006

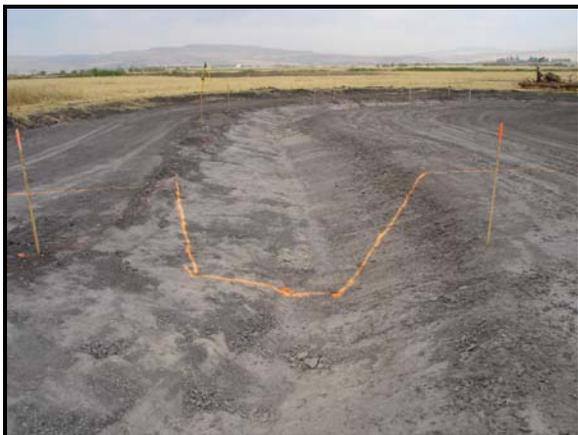
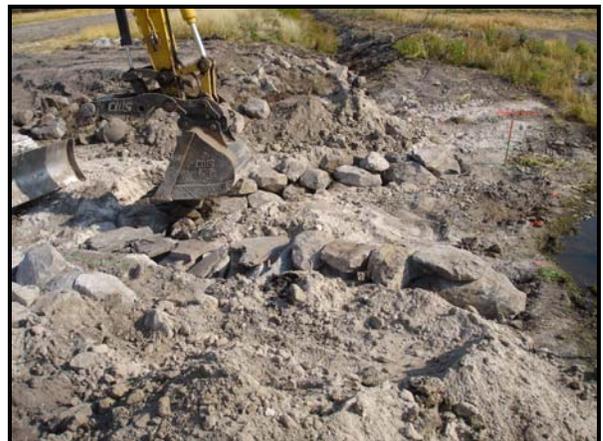
Photos below illustrate structure layout in the constructed restoration channel and an installed structure prior to backfill. Note that the elevation (invert) of the structure is the same as the bottom (thalweg) of the channel. August 2006.

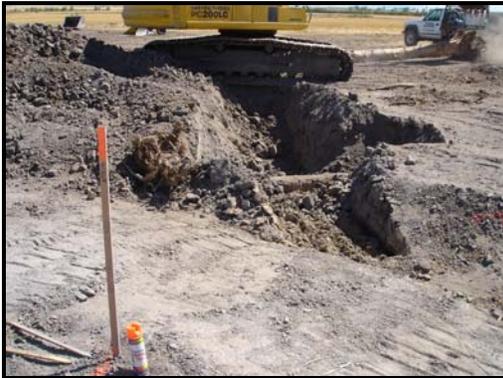
Rootwad revetment installation. Photo illustrates installed footer log and keyway for rootwad and tree bole installation. August 2006

Rootwad revetments were incorporated into the project design to provide streambank stability on outside meander streambanks until vegetation re-colonizes the site. Additionally, the rootwads provide structural diversity and contribute to complex pool habitat. Revetments consist of a tree bole with attached rootwad and a footer log which are keyed (excavated) into the streambed and streambank and backfilled.

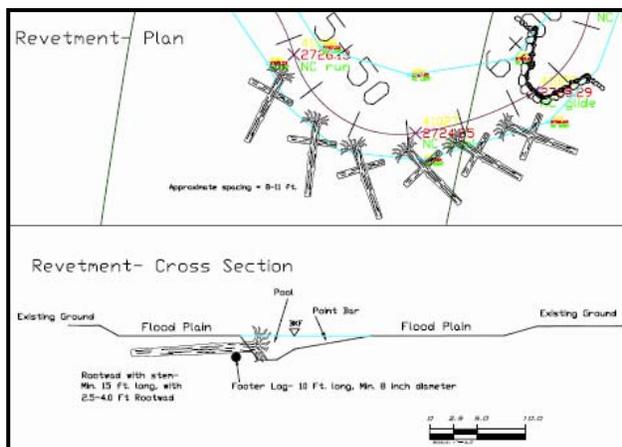
Figure 19 Rootwad Revetment Diagram

Tree boles were generally spaced 8-10 feet apart and the footers were installed at, or below, the

Root wad diameters were 2.5 feet minimum and up to 4.0 feet maximum. Tree bole length minimum was 15 feet and footer logs were 10 feet in length and 8 inches minimum diameter on both ends. Approximately 960 linear feet of restoration channel streambank were stabilized with revetments. A total of 121 revetment logs 20 sites were installed on the Rice portion of the End Creek restoration channel.

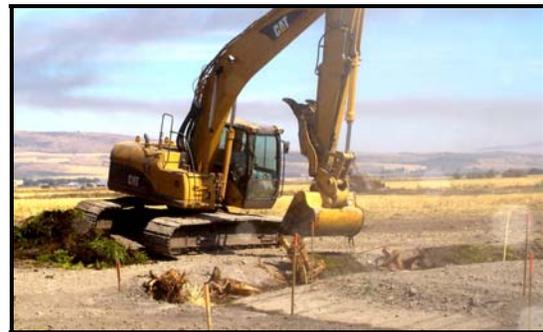
September 2006 photo illustrating rootwad revetment and installation of sedge/rush mats.

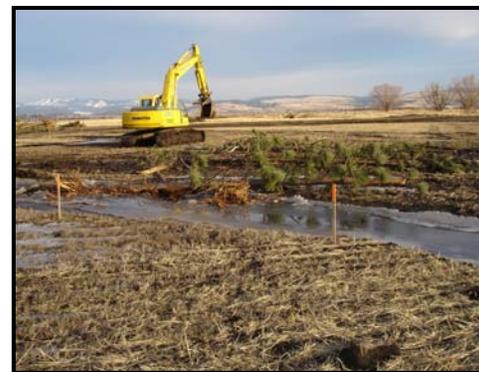
November 2006 photo illustrating wood placement along South Fork Willow restoration channel.

Approximately 200 pieces of large wood was placed along the South Willow Creek channel to enhance floodplain roughness and instream habitat complexity.

Tree boles with intact rootwad and tops were generally placed on log debris jam configurations at strategic locations throughout the new channel reach. Additional wood placement is planned to complete the effort pending improved access conditions.

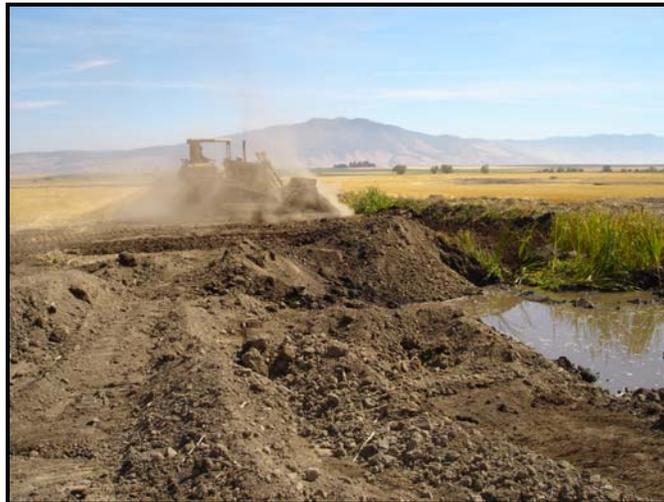
Reclamation of channelized End Creek following activation of restoration channel. August 2006.

Following completion of channel diversion and removal of fish and other organisms from the channelized/abandoned stream reaches, reclamation activities along existing stream channels and ditches were initiated along all channelized stream channels and ditches throughout the project area. The available quantity of excavated material from restoration channels (based on cut/fill calculations, design channel dimensions, and cross sectional measurement of channelized reaches) was found to be sufficient to backfill abandoned channels. Material in excess to that needed for channel reclamation was utilized to construct terraces along the eastern project area boundary and/or blended into floodplain adjacent to restoration channels. Reclamation work consisted of filling in and contouring soil and gravels along approximately 4 miles of existing channel. Fill material was blended into existing ground topography and contoured to provide a “natural” appearance.

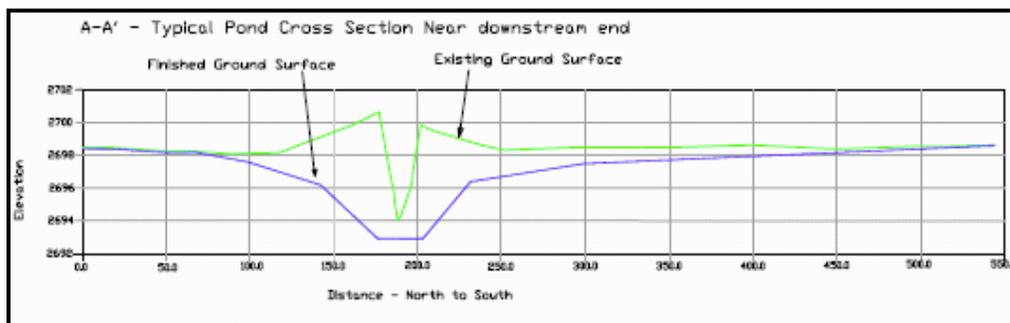
Figure 20 Typical Floodplain Pond Cross Section

Ponds were shaped into various patterns (oxbow, meander) and contoured to develop diversity of macro topographic basins with both shallow and deep water habitat. Nearly all of the ponds filled with groundwater upon completion. Within two months of construction, all ponds were overflowing and activating spillways constructed to maintain connection between the pond and adjacent floodplain and/or spring channel. Waterfowl and shorebird use was observed shortly following construction, including long-necked stilts, avocets, mallard, American wigeon, blue winged teal, Canada goose, and Tundra swan.

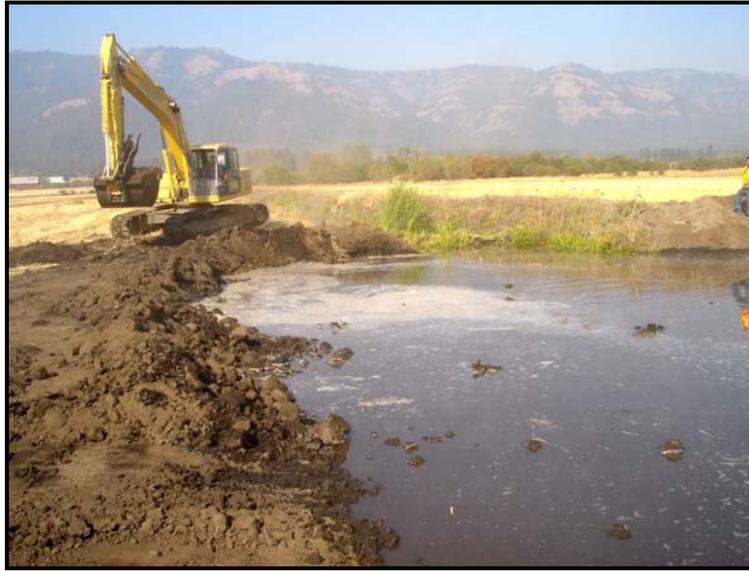
Floodplain pond construction. August 2006.

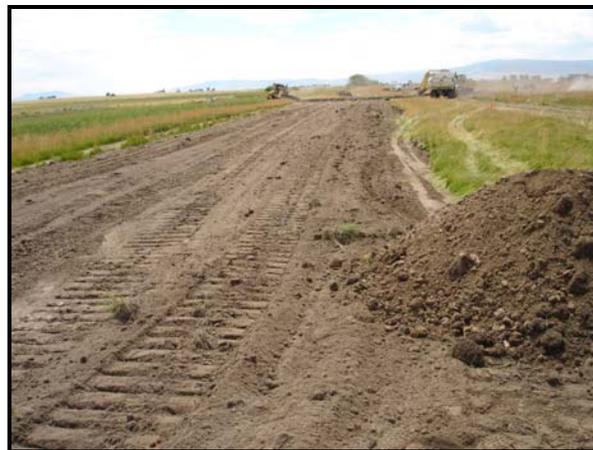
Earthen terrace constructed along eastern project boundary to minimize potential for flooding on adjacent private land. July 2006

Earthen terraces were incorporated into project designs as floodplain features to minimize potential adverse effects from floodflow on adjacent private lands and/or to direct overland flow within the project area. Construction activities associated with these structures included hauling and spreading excess topsoil material generated from channel or pond construction activities. Blended terraces were constructed to a maximum height of 1.0 foot, with a 25-30 foot top width and 10:1 side slopes. Four blended terraces, totaling approximately 3,600 feet, were constructed on the Rice portion of the project area.

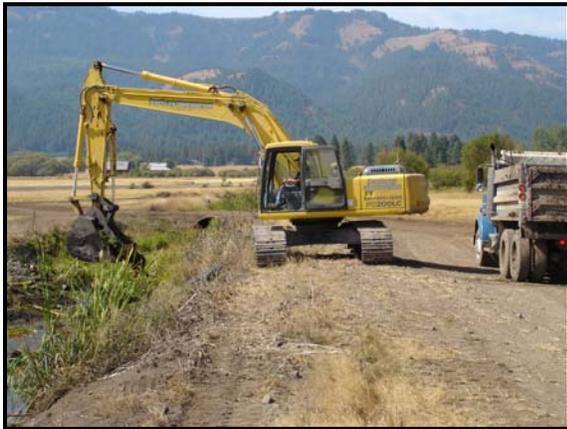
*Excavator prepares excavate and load sedge matt from the channelized End Creek alignment prior to reclamation (backfilling).
September 2006.*

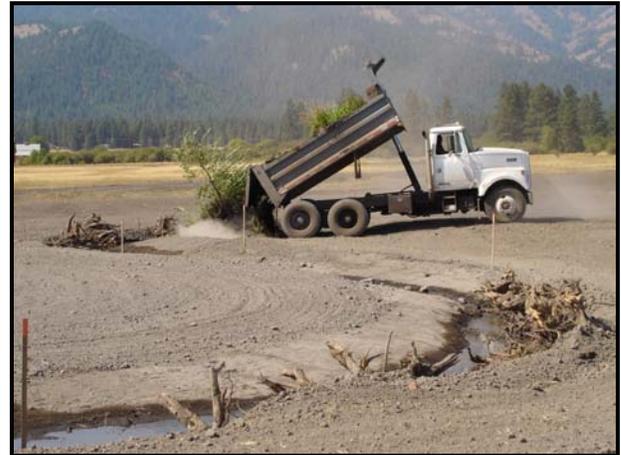
Dump truck hauling and stockpiling plant materials at selected locations along End Creek restoration channel. September 2006.

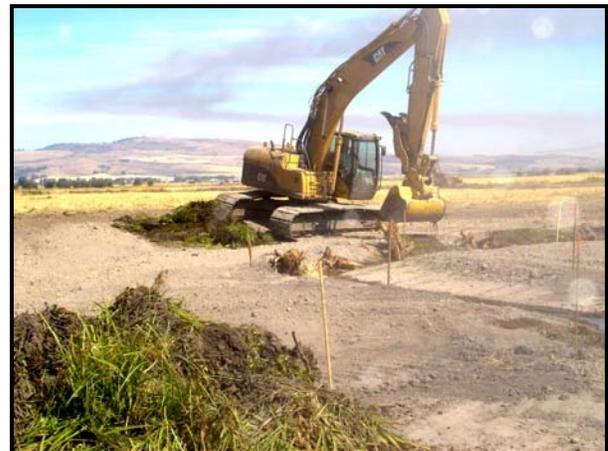
*Excavator installing sedge/rush mats along outside stream meander on rootwad revetment.
September 2006*

Approximately 60 shrubs and 5,180 square feet of sedge/rush mats were salvage and reinstalled along the End Creek restoration channel. Shrubs were generally installed in small groups on point bars while sedge/rush mats were planted on streambanks along outside channel meanders in order to facilitate development of stable banks.

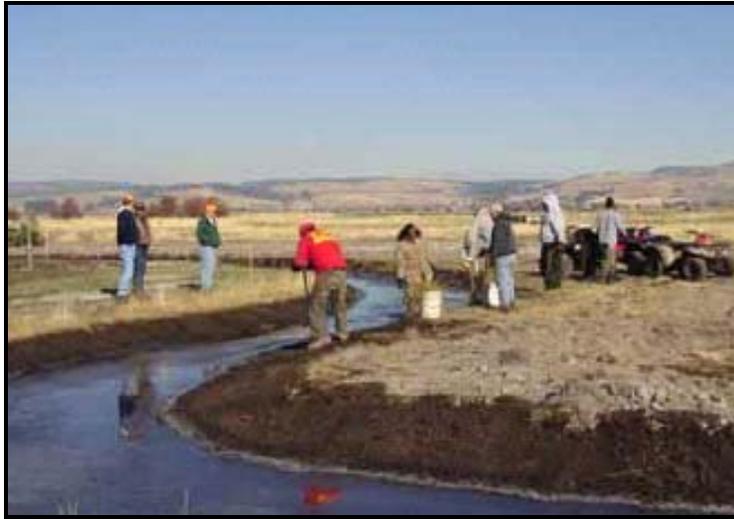
CTUIR habitat crew installing sedge/rush plugs along South Fork Willow Creek. October 2006

Sedge/Rush Plug Planting – Fall planting activities were focused on native sedge/rush plug installation along the End Creek and lower South Fork Willow Creek restoration channels. Local source sites were utilized to cut 3 inch diameter plugs using a simple plug cutting tool which were then hauled to planting locations and installed using a 4 inch power augur. Planting specifications required installation at one foot centers along entire length of channel, generally within the bankfull channel elevation in order to maximize access to moist soil conditions and improve survival. Between late September through mid-November, approximately 12,650 plugs were installed along approximately 10,708 feet of restoration channel. Additional sedge/rush planting is scheduled to get underway during spring 07' and encompass the remainder of the South Willow channel, spring channels, and floodplain ponds.

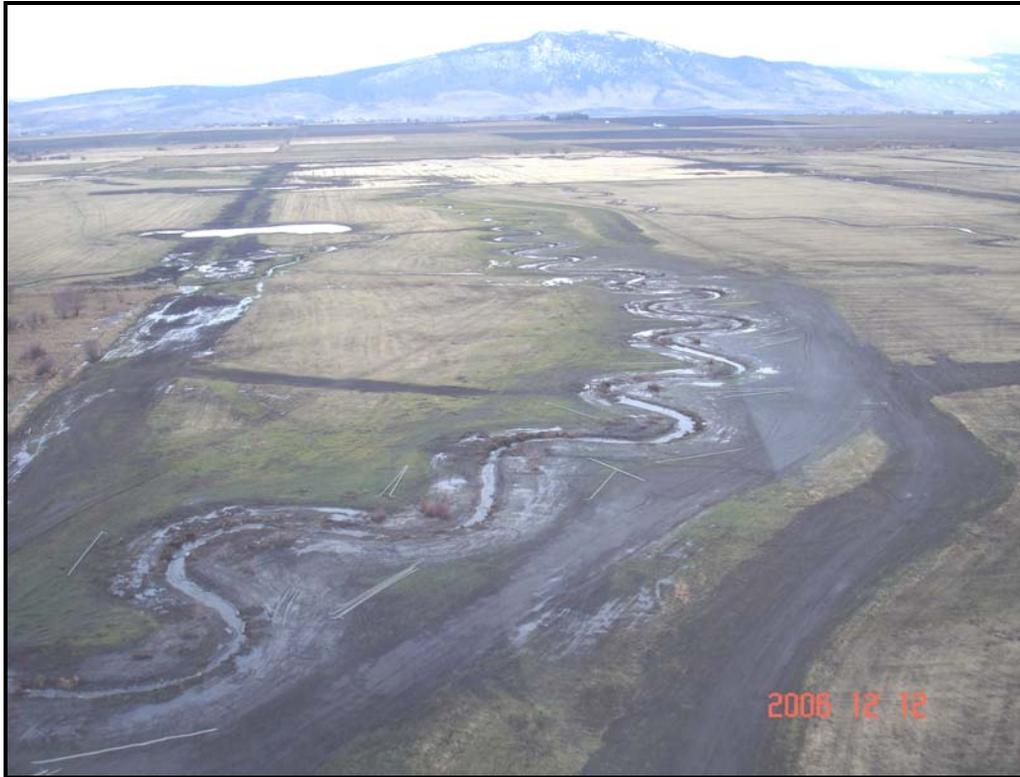
Upstream reach of End Creek (Rice) Restoration Channel, viewing east (downstream) towards South Fork Willow Creek confluence. Note reclaimed channelized reach in left corner of photo and floodplain ponds incorporated into reclamation plan. December 2006

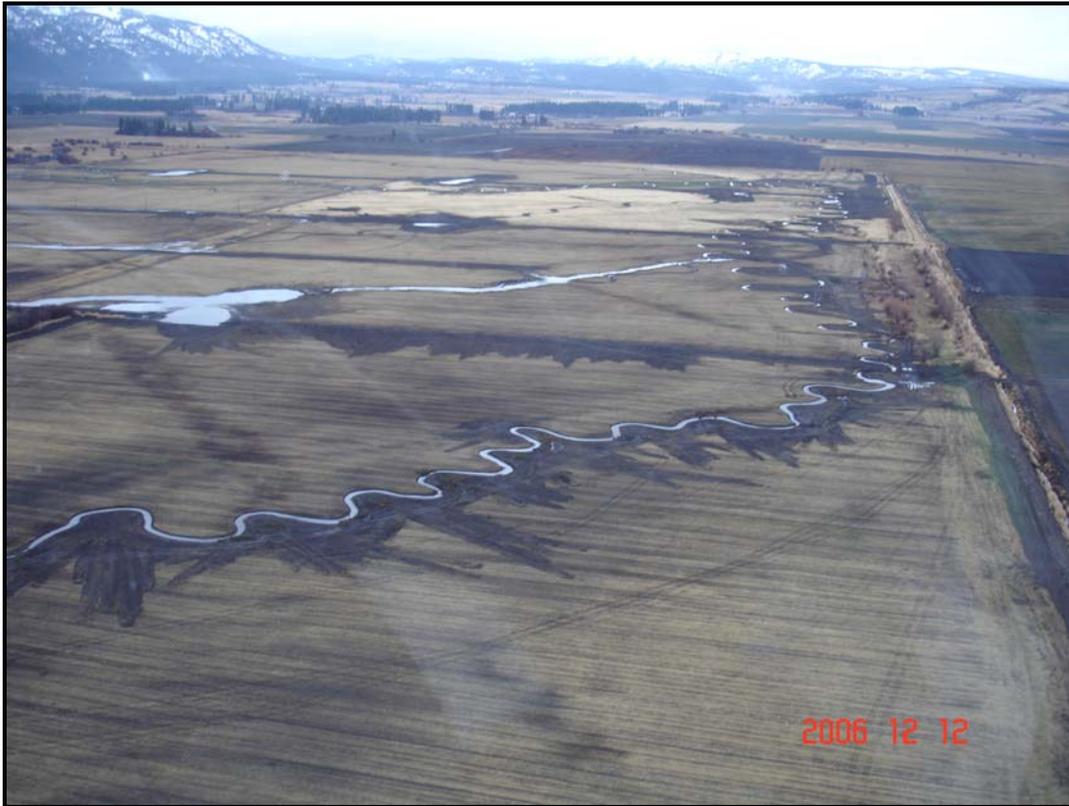
Upper reach of South Fork Willow Creek restoration channel viewing downstream towards confluence with End Creek restoration channel. Note large woody debris placement in channel and floodplain. December 2006

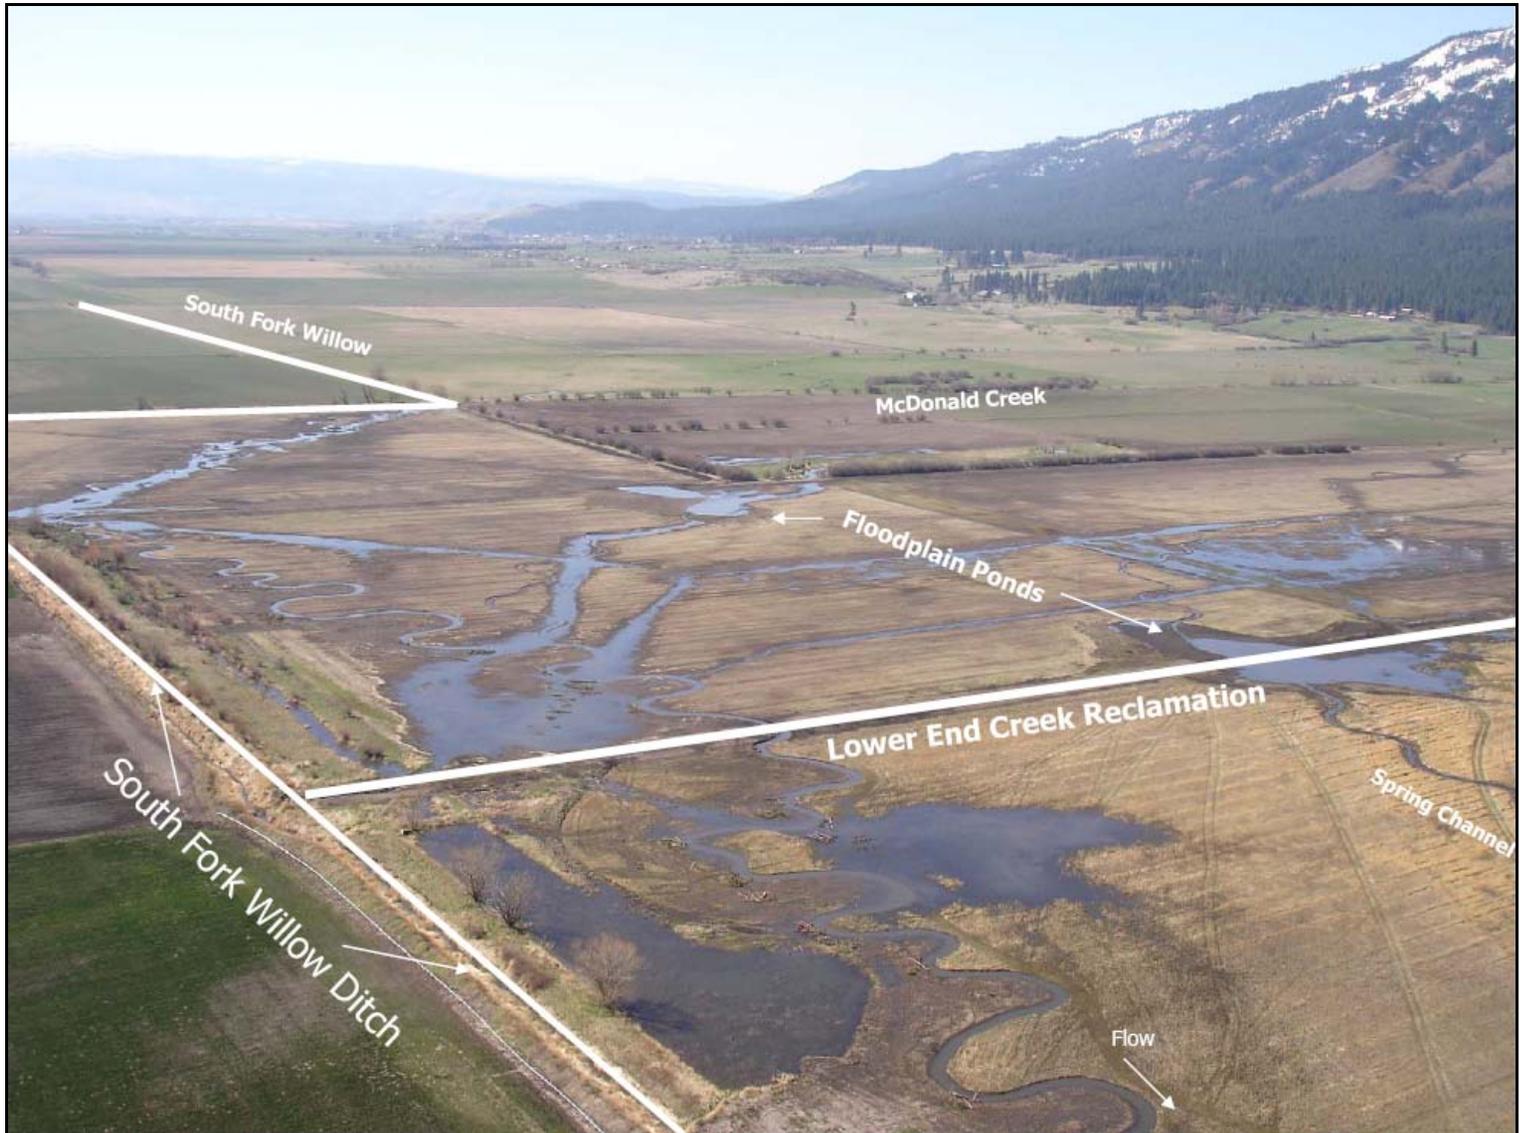
Lower End Creek Restoration Project, March 2007. Note floodplain activation and development of wetland habitat in central and lower portions of project

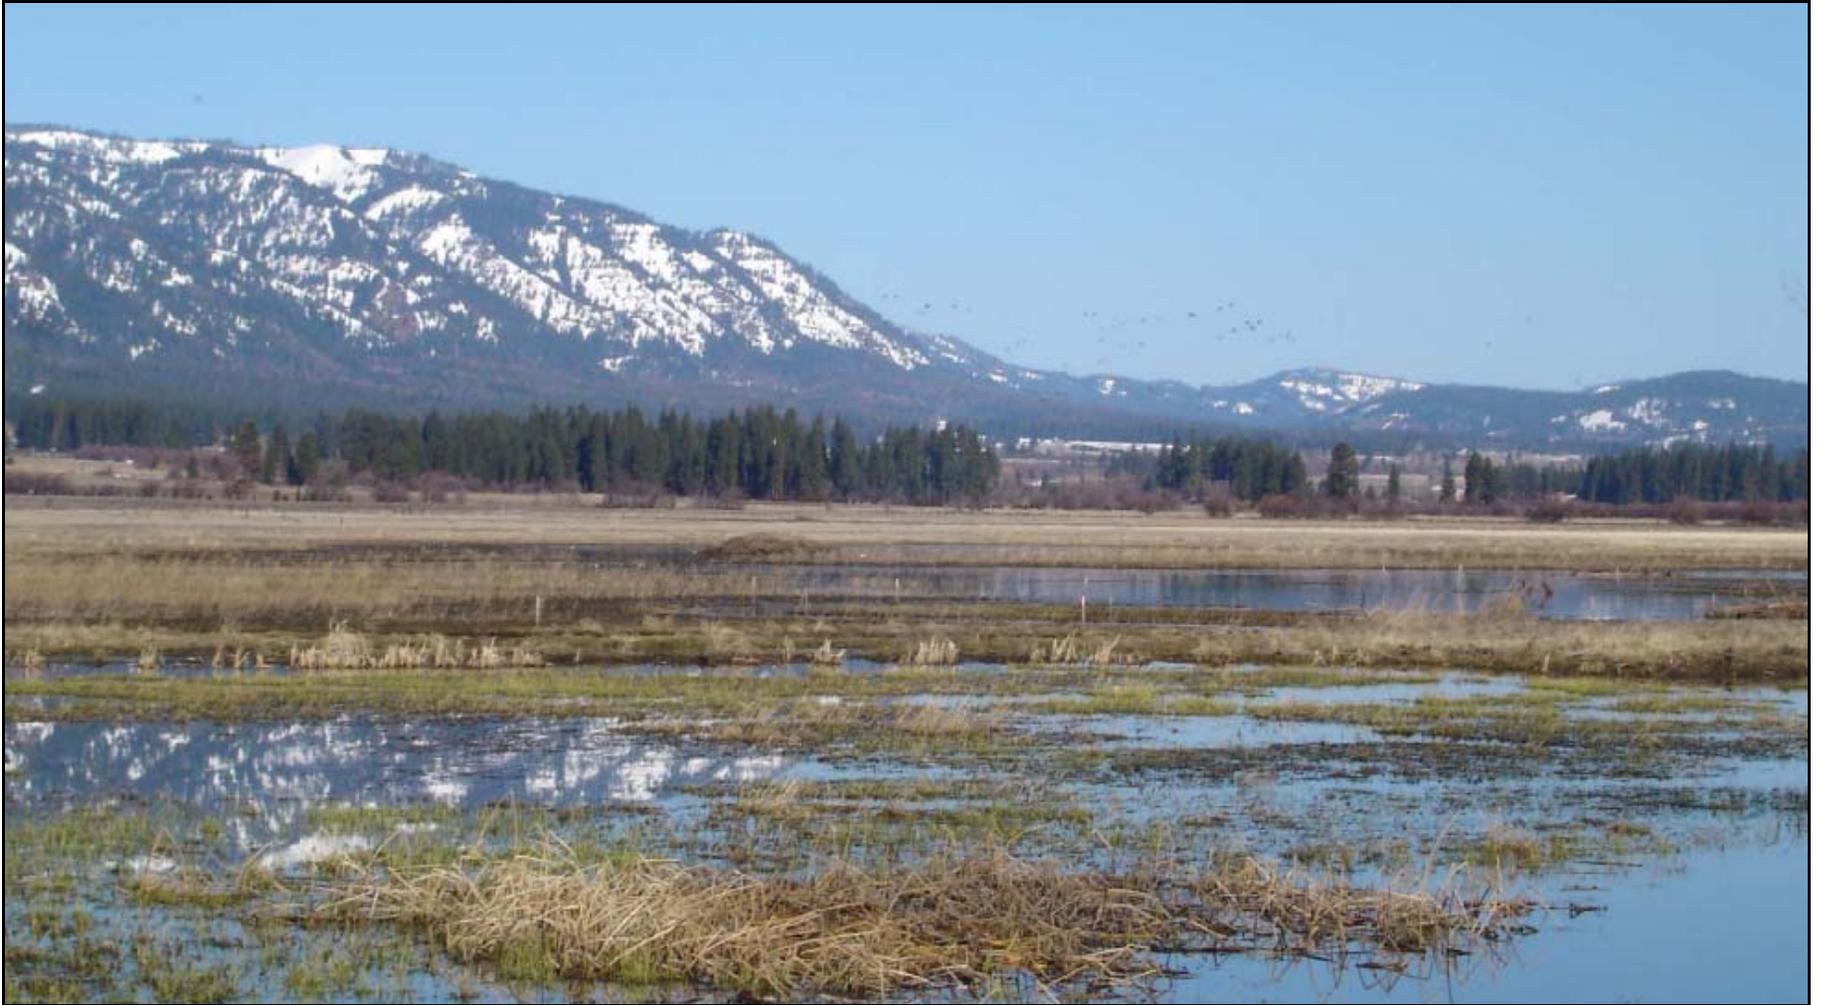
Lower End Creek, Spring 2008. Note extensive wetland and riparian habitat development and waterfowl use.
