**CULTURAL RESOURCE SURVEY OF THE  
MULINO STATE AIRPORT ENVIRONMENTAL ASSESSMENT,  
CLACKAMAS COUNTY, OREGON**

Prepared For  
Century West Engineering Corporation

**Figure 1: Study Areas**  
Mulino State Airport Wetland Reconnaissance  
Clackamas County, OR

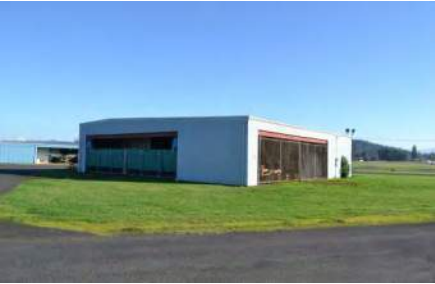
Name	Description	Integrity	NRHP Recommendation	Photograph
Hangar	This circa 1949 hangar building has an internal wood frame that has been supplemented with steel I-beams at oversized openings. The building is capped with a slight gable roof, and is clad with modern corrugated metal siding.	Modifications to the structural system and cladding of the building, in addition to changes to the Mulino State Airport, diminish its integrity of design, setting, materials, workmanship, feeling, and association.	Recommended Not Eligible/ Non-Contributing

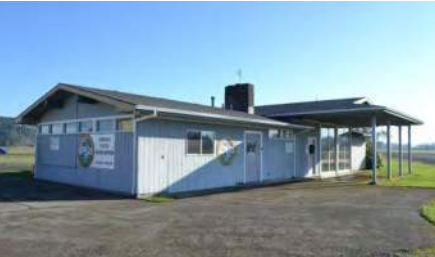
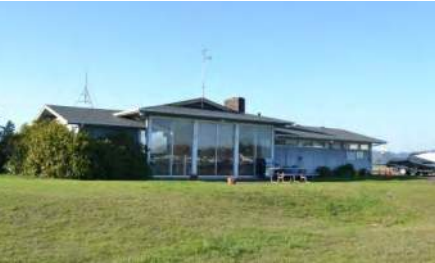
Pilot Lounge/ Airport Management Office	This circa 1968 Ranch-style building is clad with T1-11 siding, has a mixture of vinyl and wood windows, and is capped with a cross gable roof with exposed beams and eave returns. The central crossing gable has been modified to allow for floor to ceiling windows, and the garage has been converted and infilled.	Modifications to the plan, fenestration, and siding of the building, in addition to changes to the Mulino State Airport, diminish its integrity of design, setting, materials, workmanship, feeling, and association.	Recommended Not Eligible/ Non-Contributing

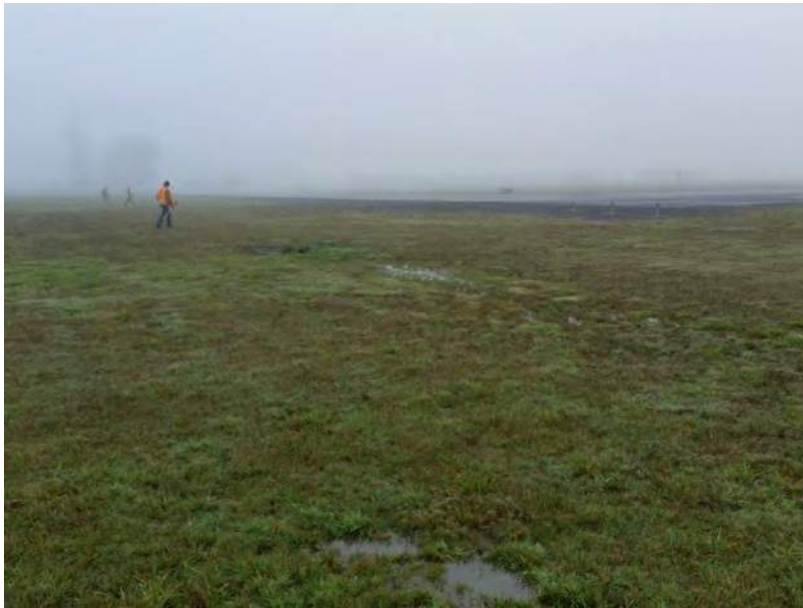
Photo 1. Pedestrian survey adjacent to the north end of the airport runways at the location of the proposed runway safety area improvements. The view is towards the east.

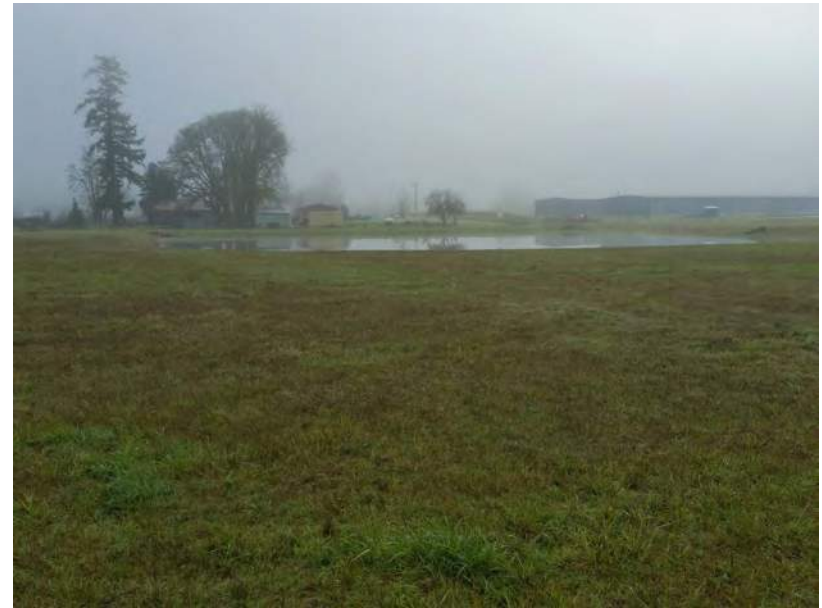
Photo 2. Pedestrian survey conditions northeast of the airport runways encompassing the airport stormwater detention pond and obstruction removal area. The view is towards the east.

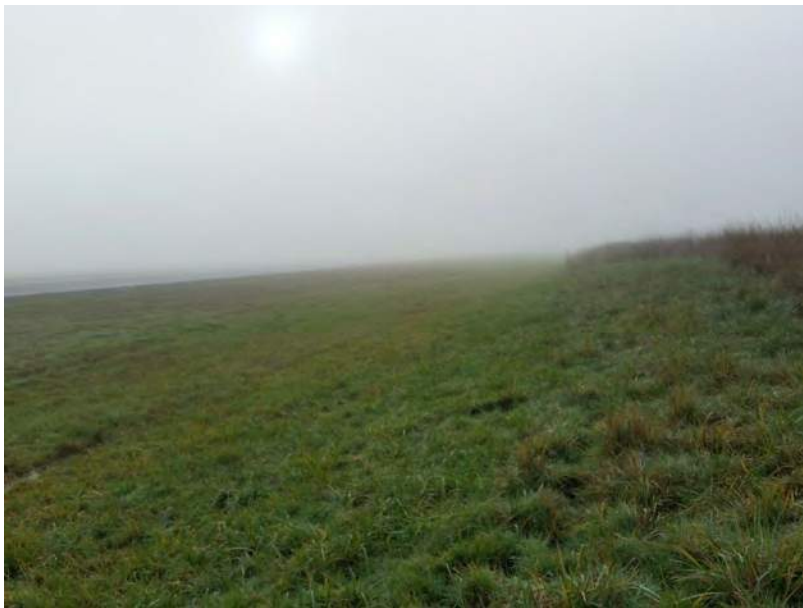
Photo 3. View showing the elevation difference between the runway area at left and natural grade at right. The view is towards the southeast.

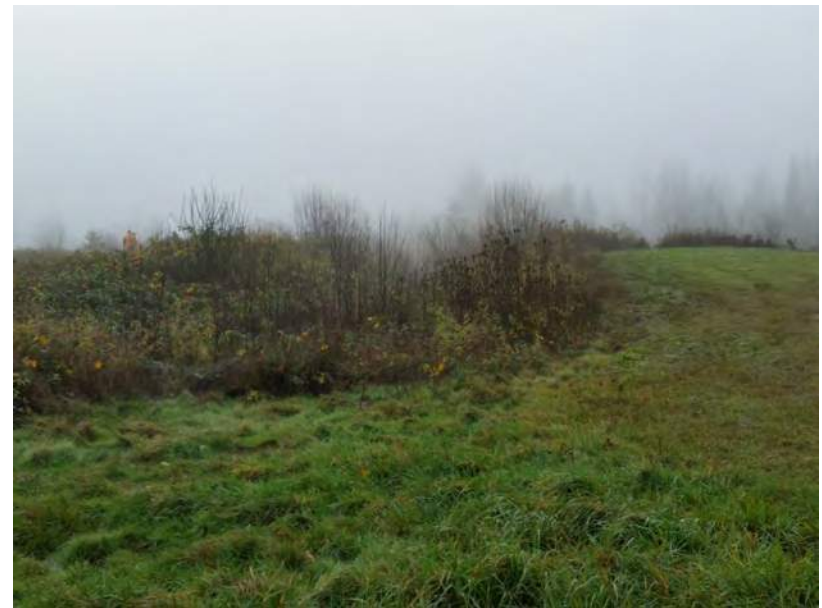
Photo 4. Tall grasses and patches of Himalayan blackberries on the north side of the Molalla River. The view is towards the south.

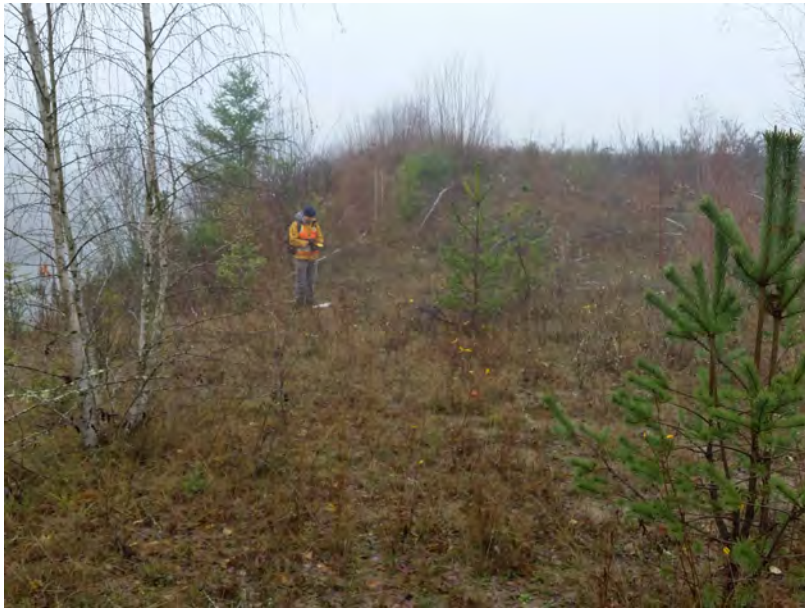
Photo 5. Pedestrian survey near the north bank of the Molalla River. The view is towards the northwest.

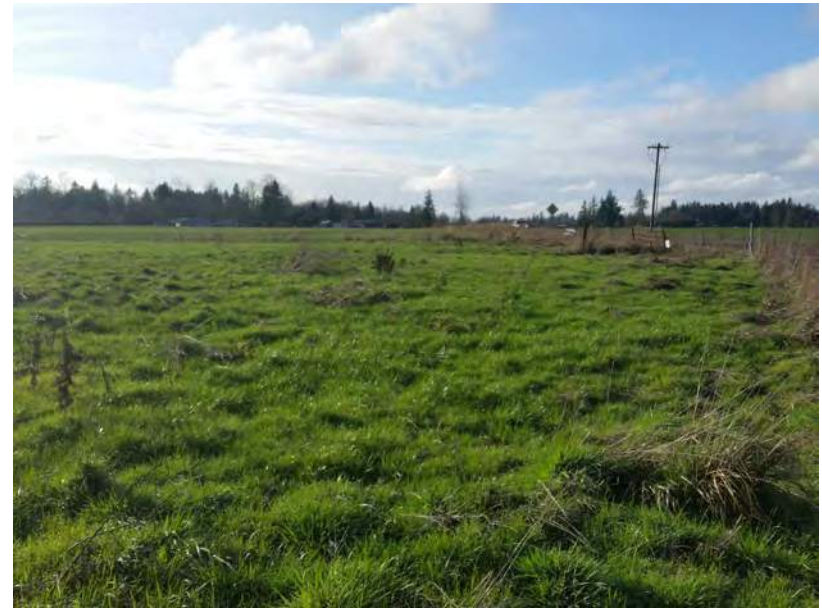
Photo 6. Pedestrian survey conditions at the northern end of the APE within the cow pasture. The view is towards the west.

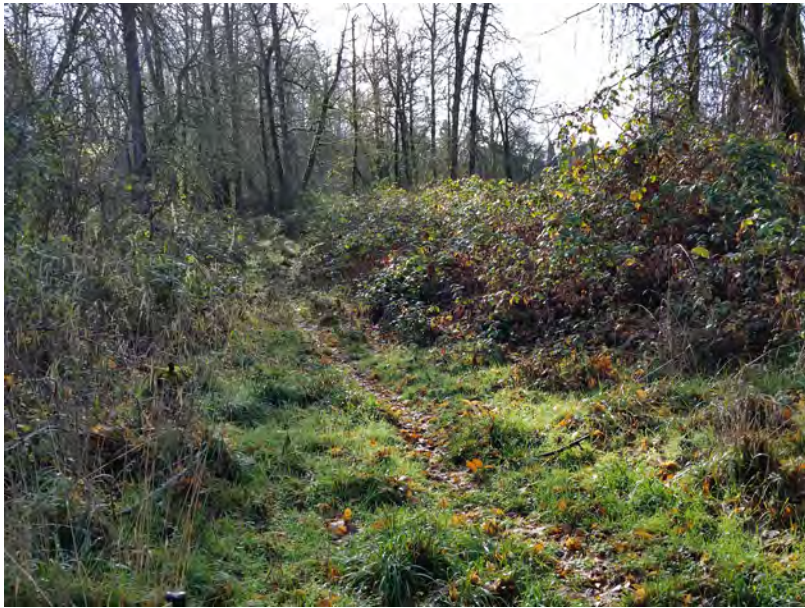
Photo 7. Typical pedestrian survey conditions on the south side of the Molalla River. The view is towards the south.

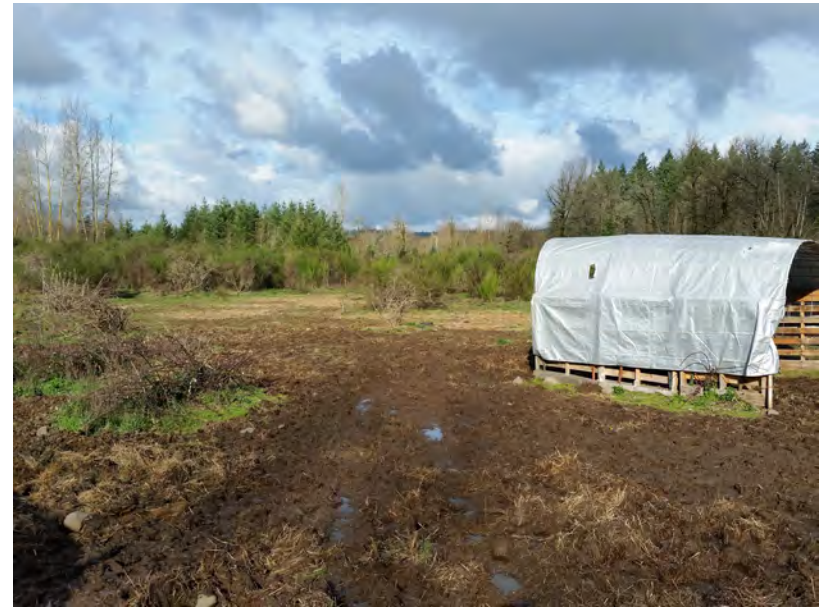
Photo 8. Pedestrian survey conditions in the horse pasture on the south side of the Molalla River. The view is towards the north.

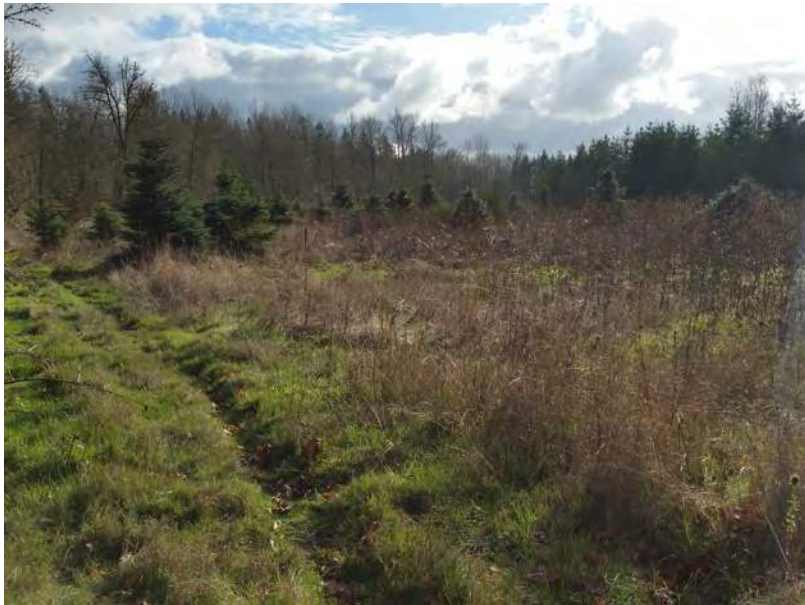
Photo 9. Open area with scattered noble fir trees (in background) on the south side of the Molalla River. The view is towards the south.

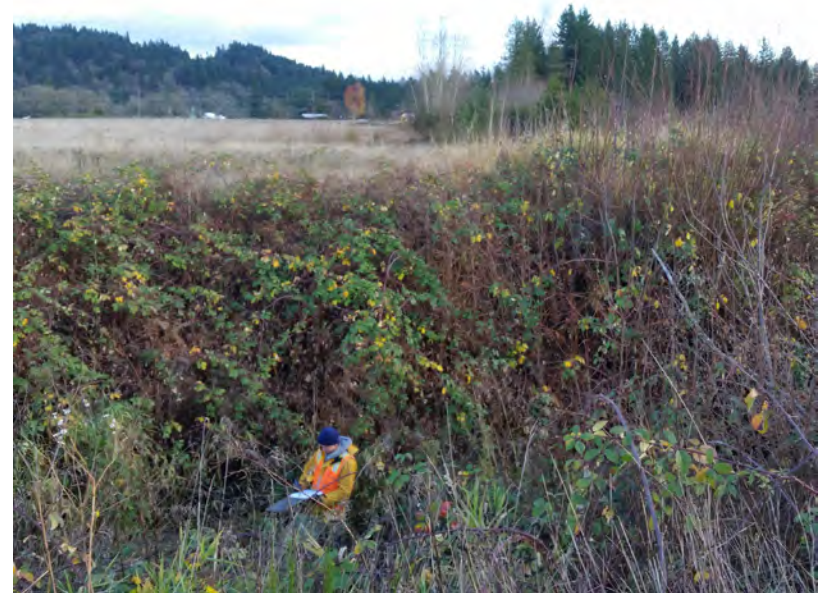
Photo 10. Downgrading trench feature on the north side of the Molalla River along the alignment of the former Willamette Valley Southern Railway (site 17/2634-1). The view is towards the east-southeast.

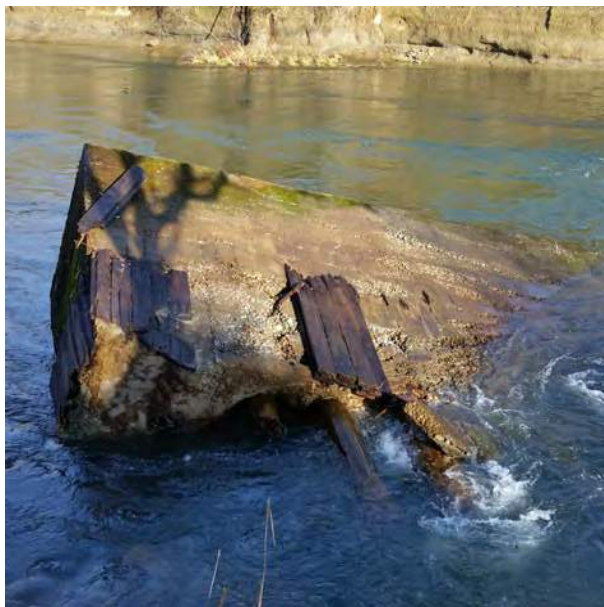
Photo 11. Concrete and wood remnant of the former Willamette Valley Southern Railway trestle crossing the Molalla River (site 17/2634-1). The view is towards the north.

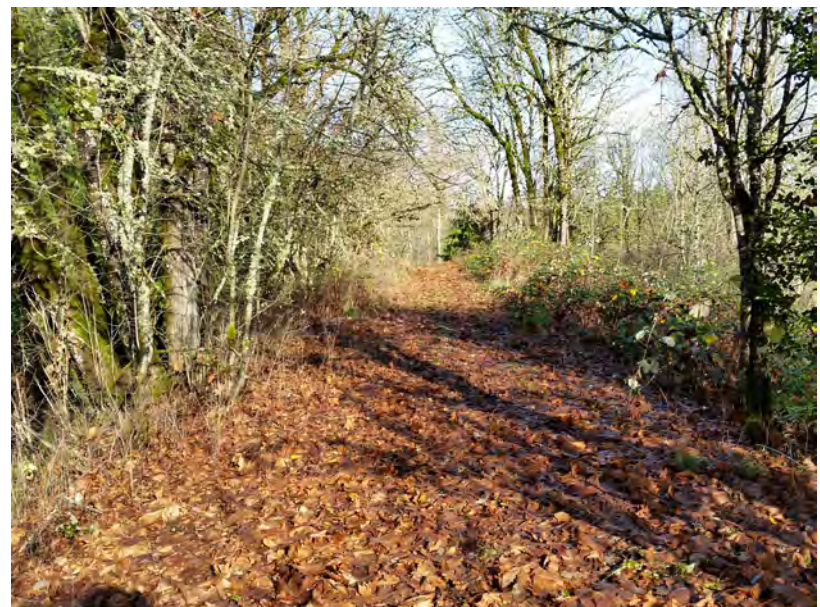
Photo 12. Remnant grade of the former Willamette Valley Southern Railway (site 17/2634-1) extending through the southwestern portion of the APE. The view is towards the north.

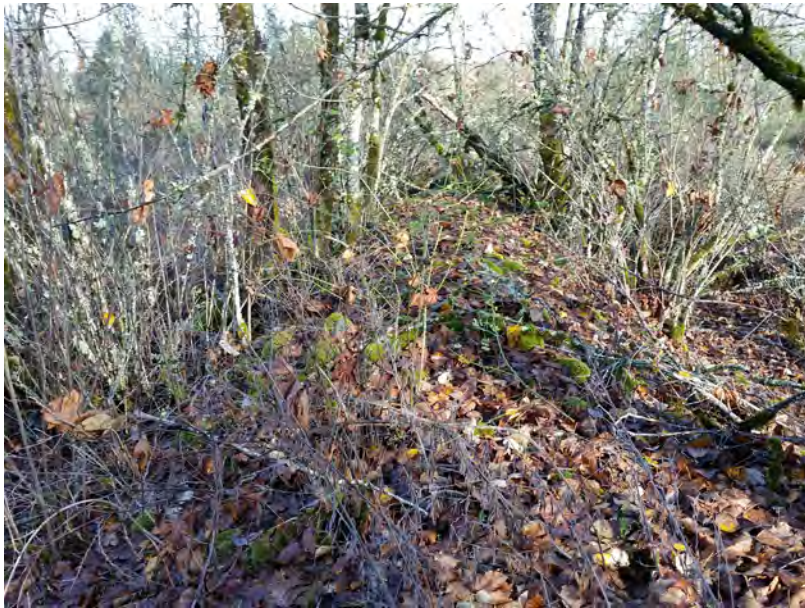
Photo 13. Cobble-covered levee remnant near the alignment of the former Willamette Valley Southern Railway (site 17/2634-1). The view is towards the northeast.

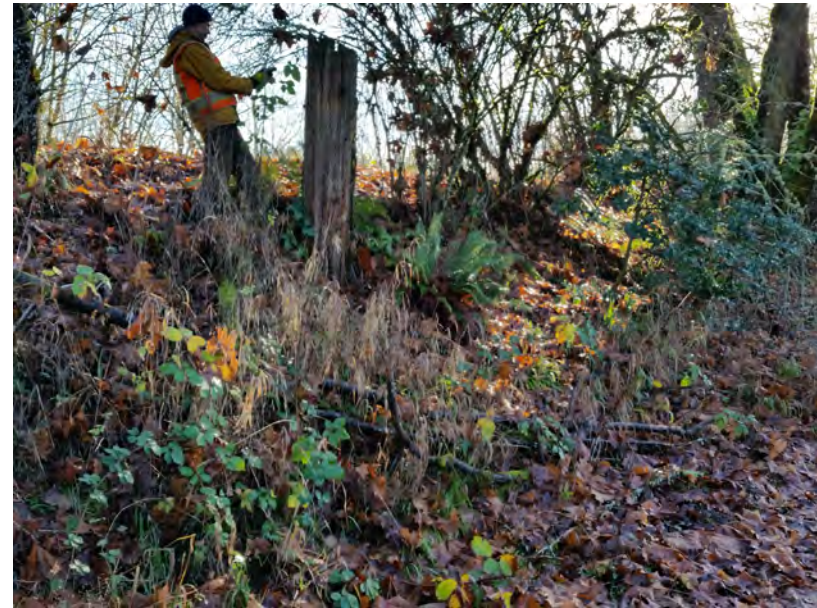
Photo 14. Remnant pole adjacent to the remnant grade of the former Willamette Valley Southern Railway (site 17/2634-1). The view is towards the southeast.

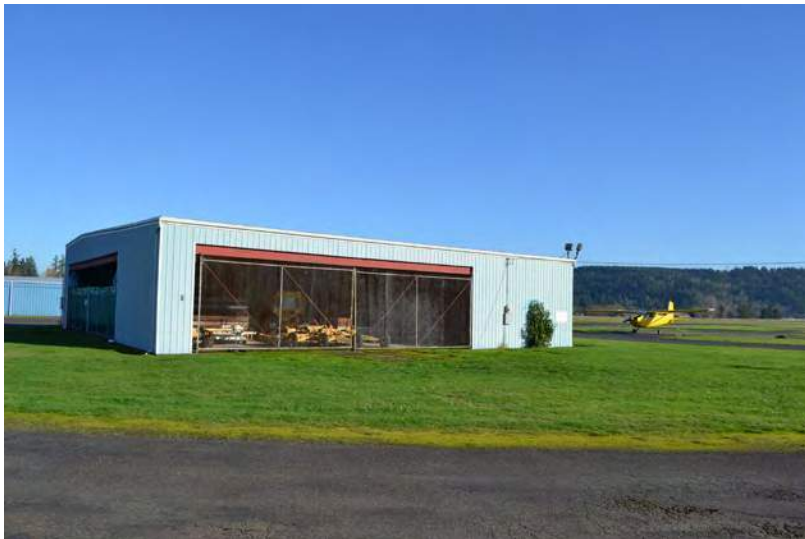
Photo 15. A hangar constructed in 1949 is located near the airport entrance. The view is facing east.

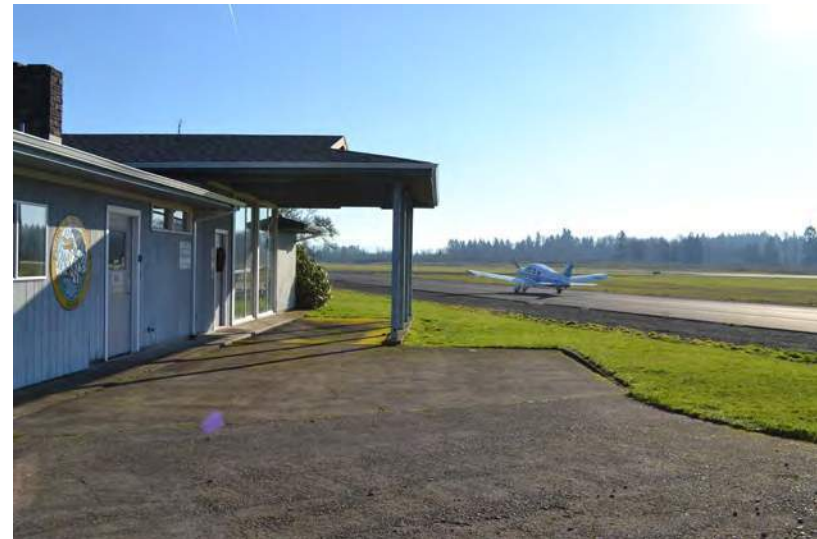
Photo 16. A Pilot Lounge/Airport Office constructed circa 1968 is located adjacent to a modern taxiway used in association with Runway 14-32. The view is facing south.

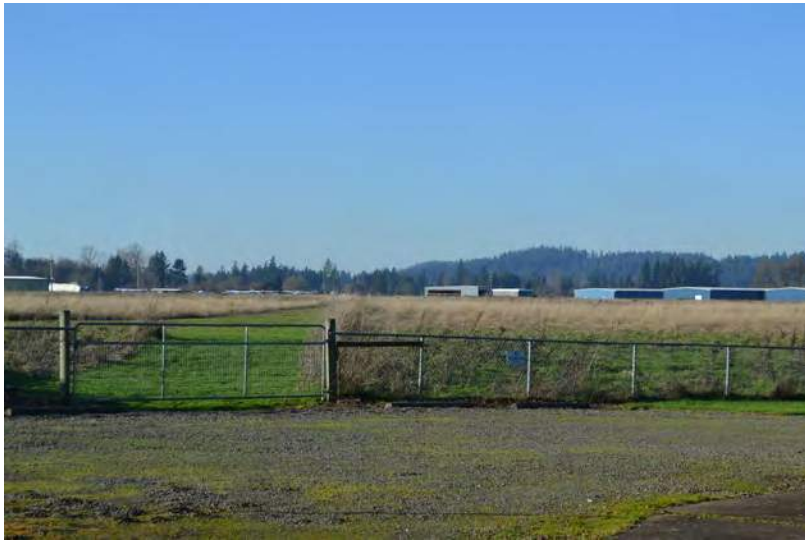
Photo 17. Turf taxiways now cross through the former location of turf runways at the Mulino State Airport. The view is facing northwest from the Mulino EAA Chapter Building at South Darnell Road.

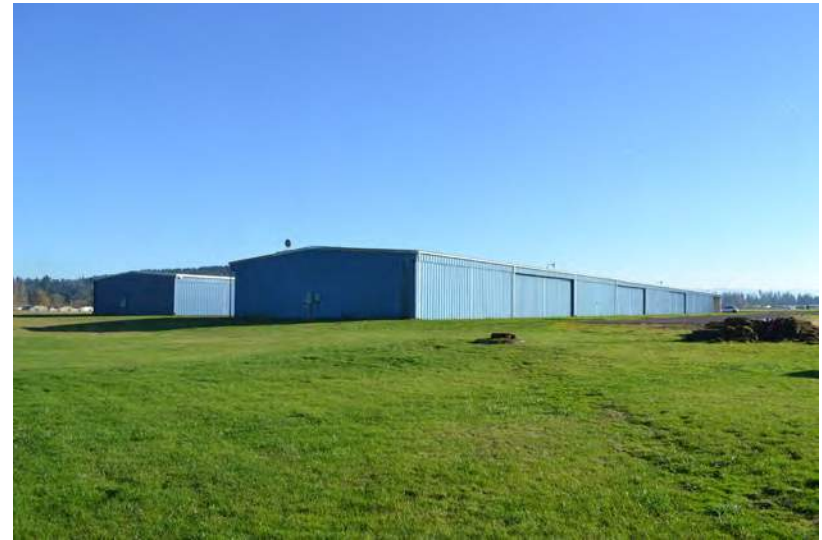
Photo 18. Modern T-hangers located southeast of the intersection of South Airport Road and South Mulino Road. The view is facing southeast.

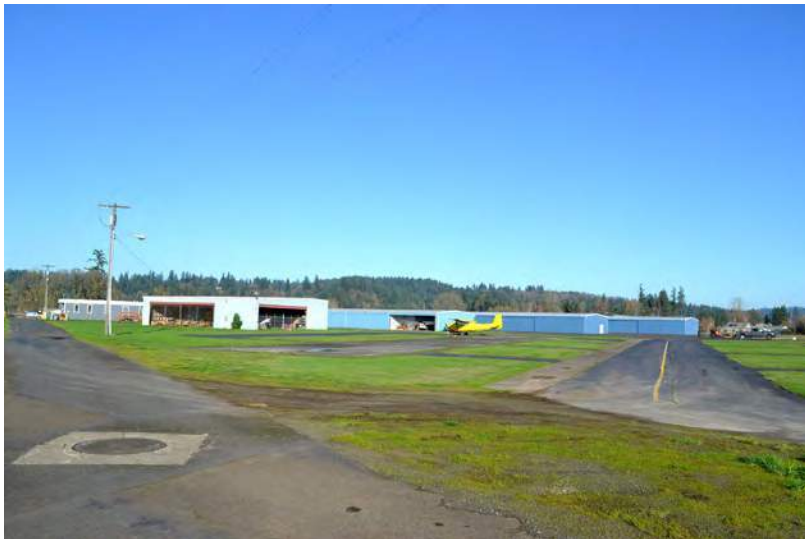
Photo 19. Historic-period T-hangers were once located at the concrete pads where the plane at center is parked. The view is facing northeast from South Airport Road.

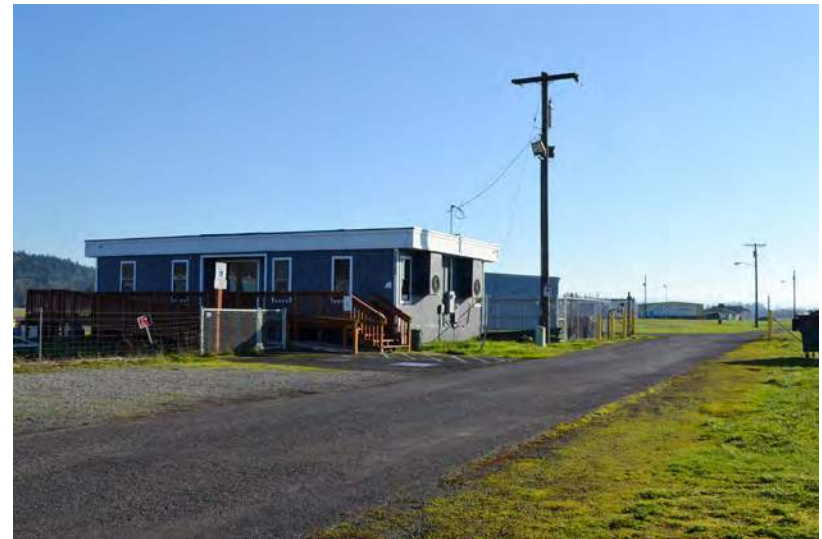
Photo 20. The current Oregon Pilot's Association building (at left) recently replaced a historic-period building at the Mulino State Airport. The view is facing south-southeast.

The construction of Runway 14-32 corresponds with the airport's transition from private ownership to public ownership under the Port of Portland in 1988 (Oregon Department of Aviation 2013). Between 1988 and 1992, the Port oversaw the completion of a parallel taxiway to Runway 14-32, aircraft parking ramps, and utility and lighting updates (Century West Engineering 2015). Private facility developments were also completed under the Port's tenure of ownership, including the first of three T-hangars that are located near the intersection of South Airport Road and South Mulino Road. The other two T-hangars were constructed after ownership of the airport was transferred from the Port of Portland to the Oregon Department of Aviation in 2007 (Photo 18). Also since this change in ownership, two historic-period T-hangars were removed from their location adjacent to South Airport Road (Photo 19), and a historic building to the north was removed and replaced with the current Oregon Pilot's Association building (Photo 20).

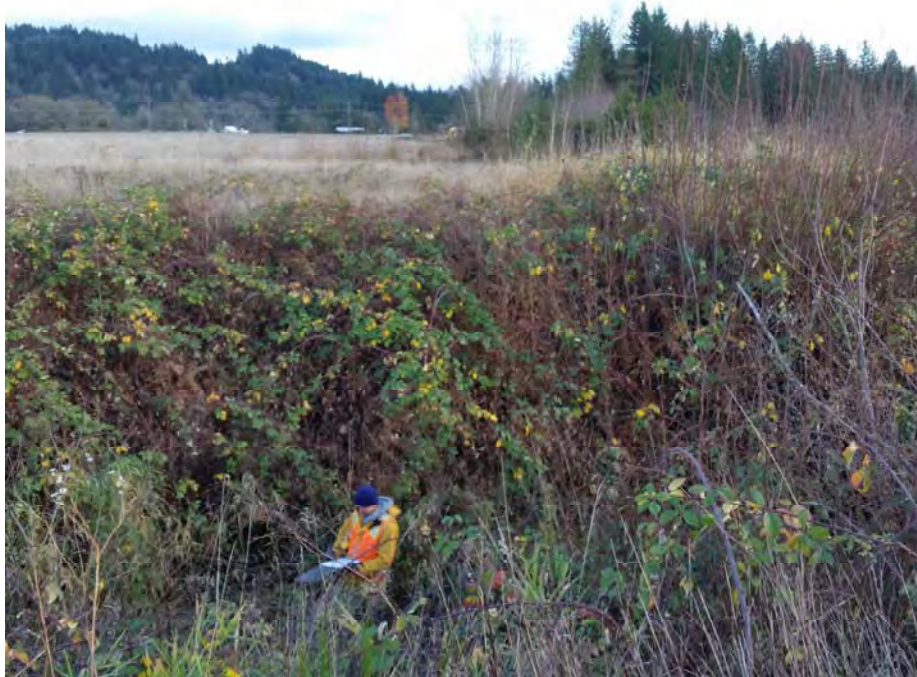
Downgrading trench feature on the north side of the Molalla River at 17/2634-1. The view is towards the east-southeast.

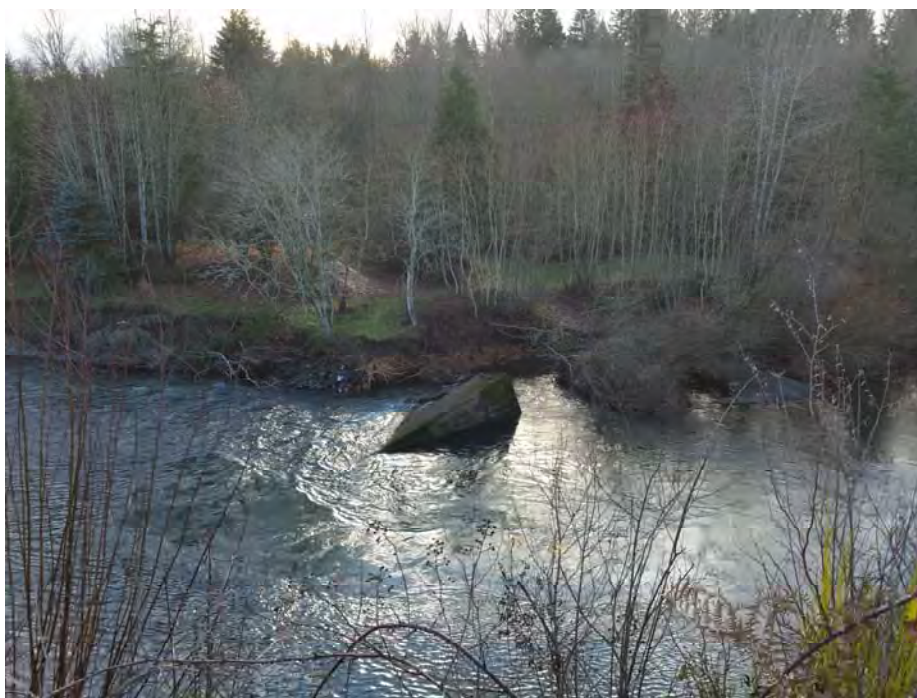
View from area of former trestle approach looking south across the Molalla River along the former alignment of the Willamette Valley Southern Railway. A large remnant of the former concrete railroad trestle is visible near the south bank of the river.

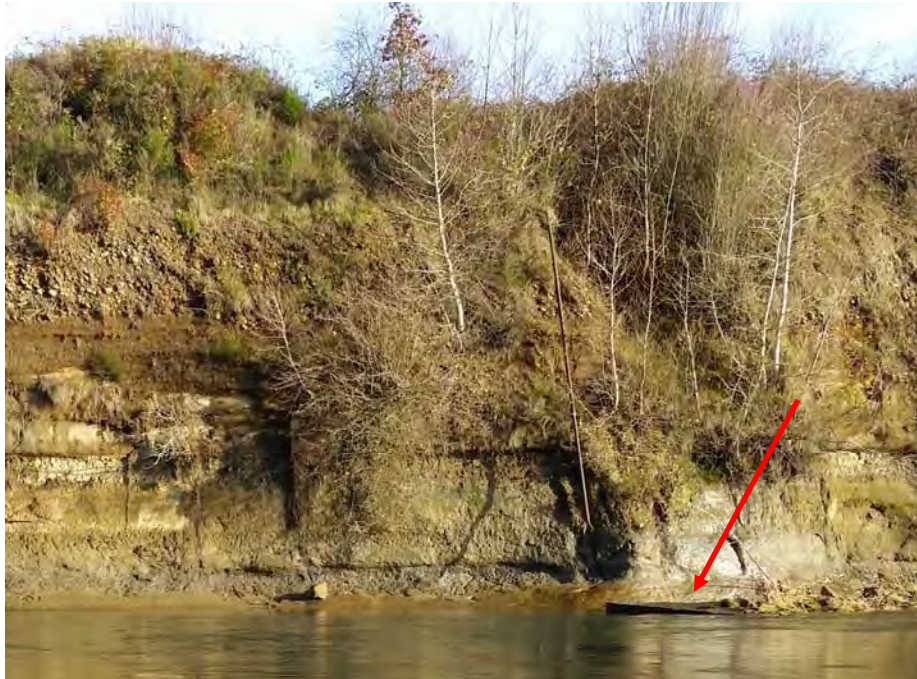
View of concrete railroad trestle remnant (denoted by red arrow) near the north bank of the Molalla River and the downgrading trench opening to the former bridge approach at 17/2634-1. The view is towards the northeast.

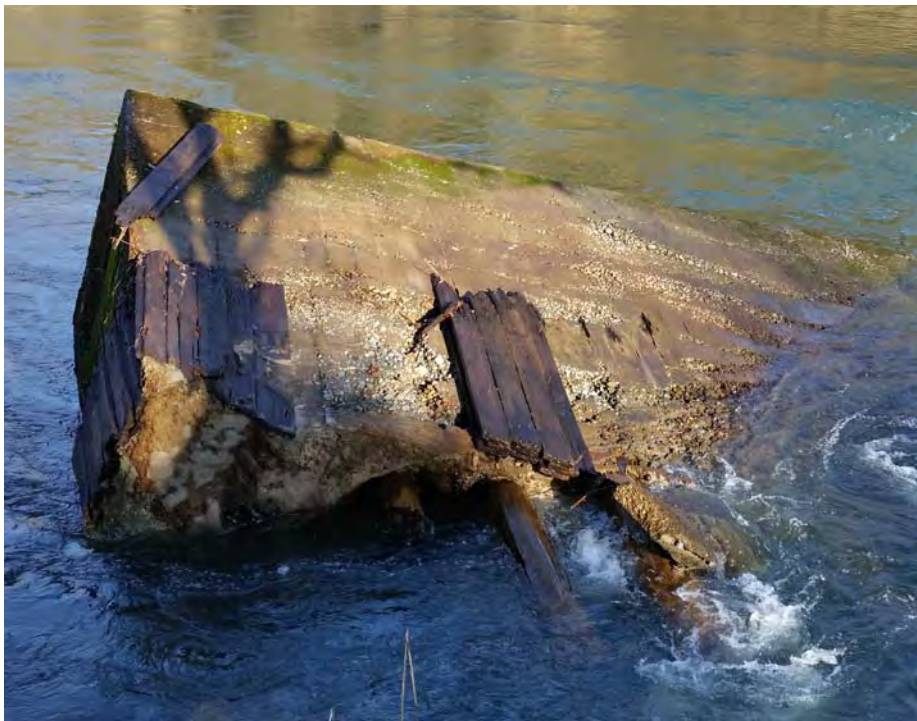
View of concrete railroad trestle remnant at 17/2634-1 near the south bank of the Molalla River. The view is towards the north.

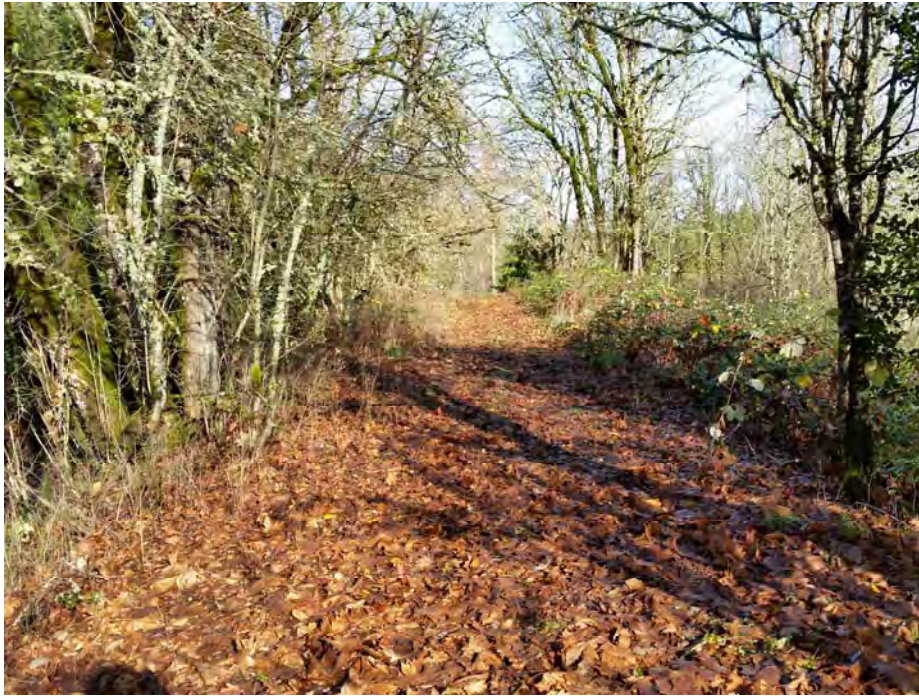
Remnant railroad grade on raised berm on the south side of the Molalla River at 17/2634-1. The view is towards the north.

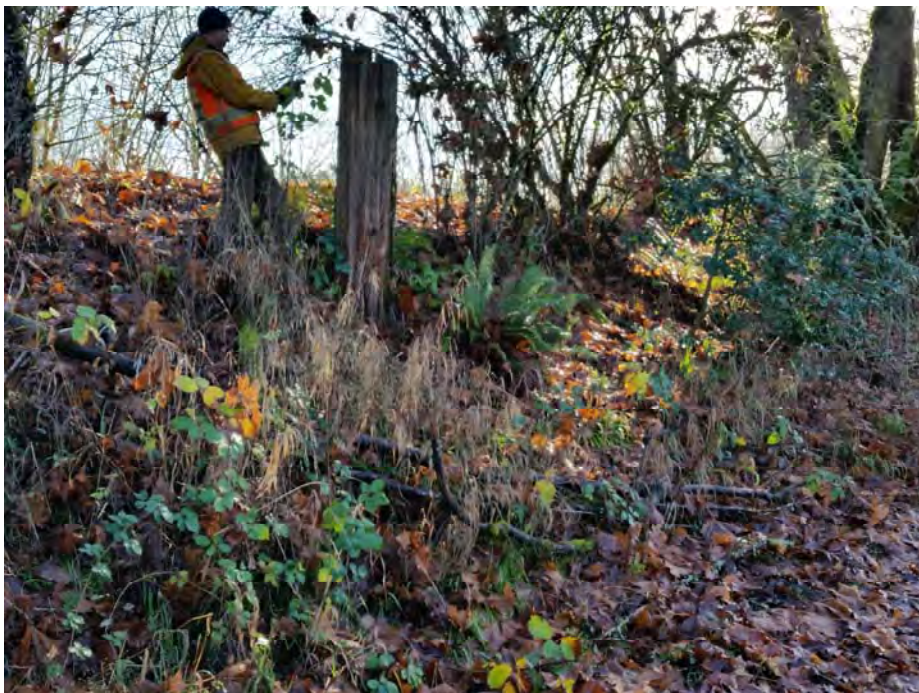
Remnant wooden pole adjacent to remnant railroad grade on the south side of the Molalla River at 17/2634-1. The view is towards the southeast.

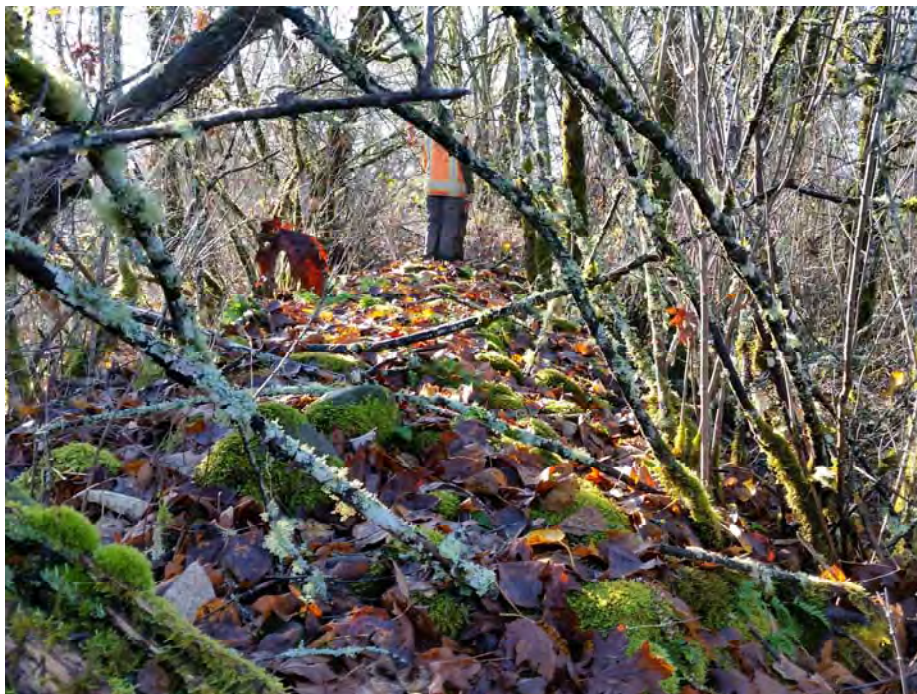
Cobble-covered levee adjacent to the former railroad alignment at 17/2634-1. The view is towards the southwest.

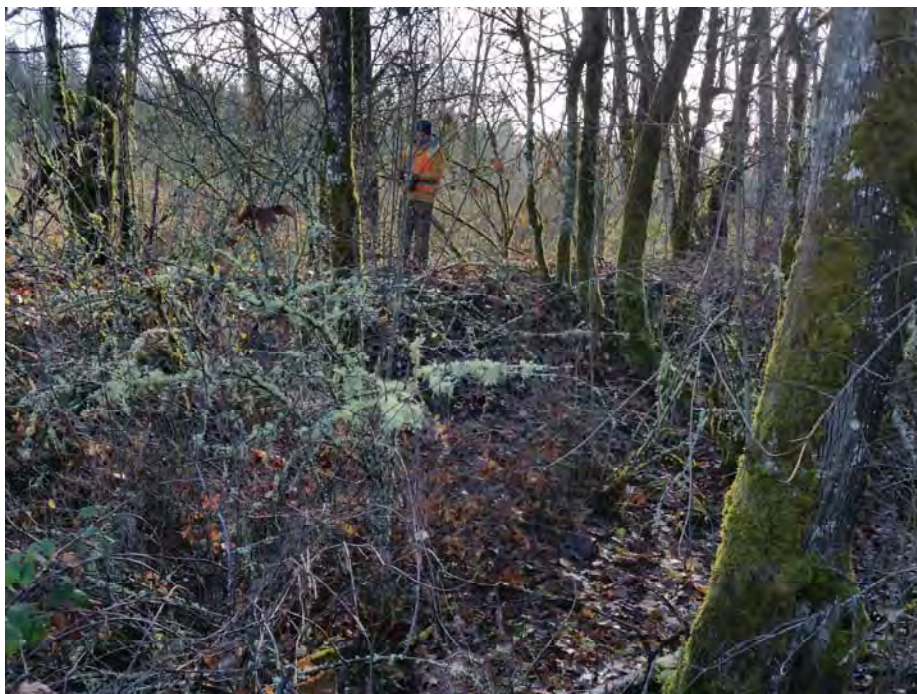
Cobble-covered levee adjacent to the former railroad alignment at 17/2634-1. The view is towards the southeast.

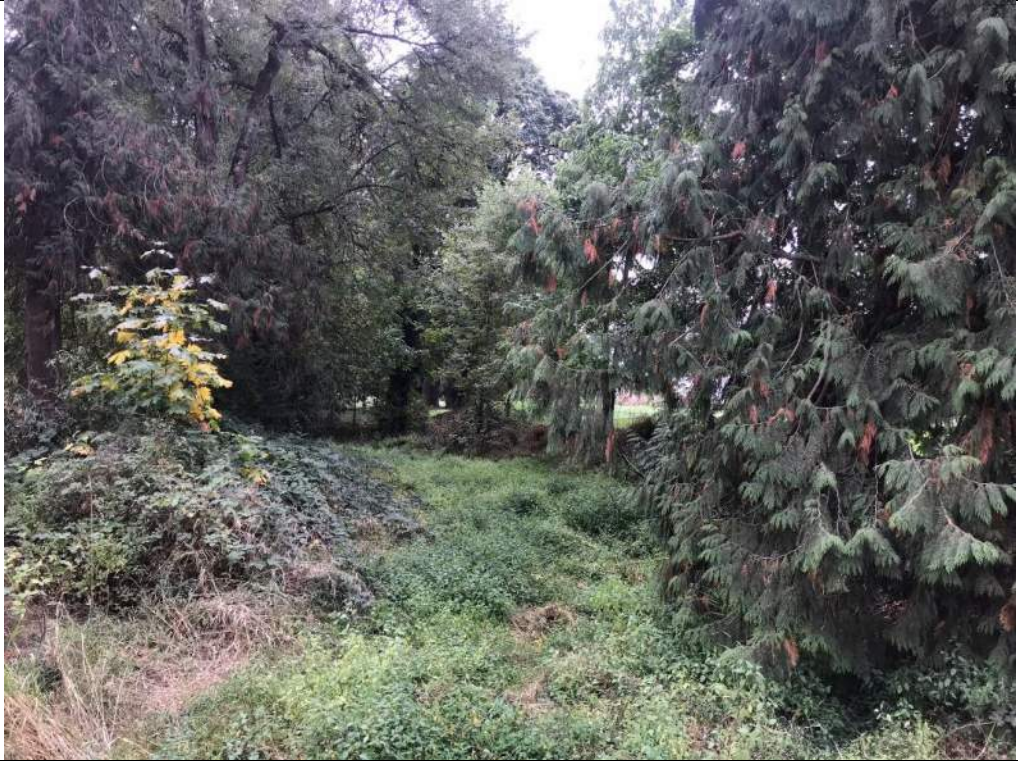
<b>Photo: 1</b>	<b>Looking: South</b>	<b>Notes: South of culvert inlet at north end of Wetland S1 looking south on Right Creek within Arrowhead golf course.</b>
-----------------	-----------------------	--

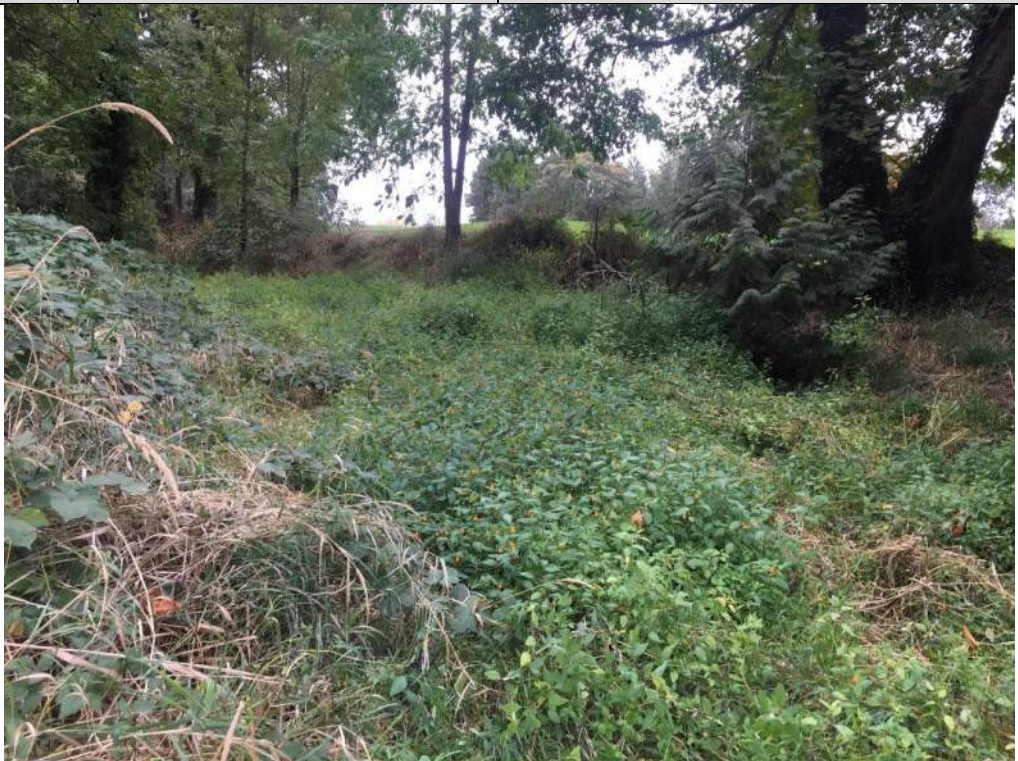
<b>Photo: 2</b>	<b>Looking: South</b>	<b>Notes: Within swale and north of culvert inlet at south end of Wetland S1 looking north on Right Creek within Arrowhead golf course.</b>
-----------------	-----------------------	---

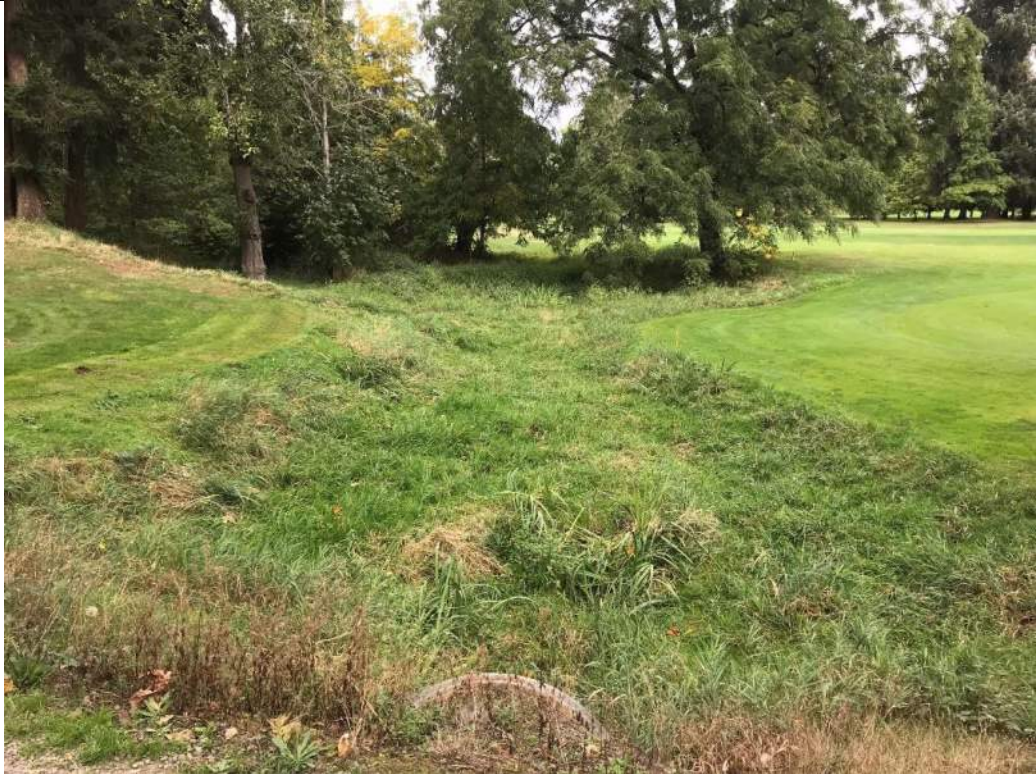
<b>Photo: 3</b>	<b>Looking: North</b>	<b>Notes: South of culvert outlet at south end of Wetland S2 looking north on Right Creek of Arrowhead golf course.</b>
-----------------	-----------------------	---

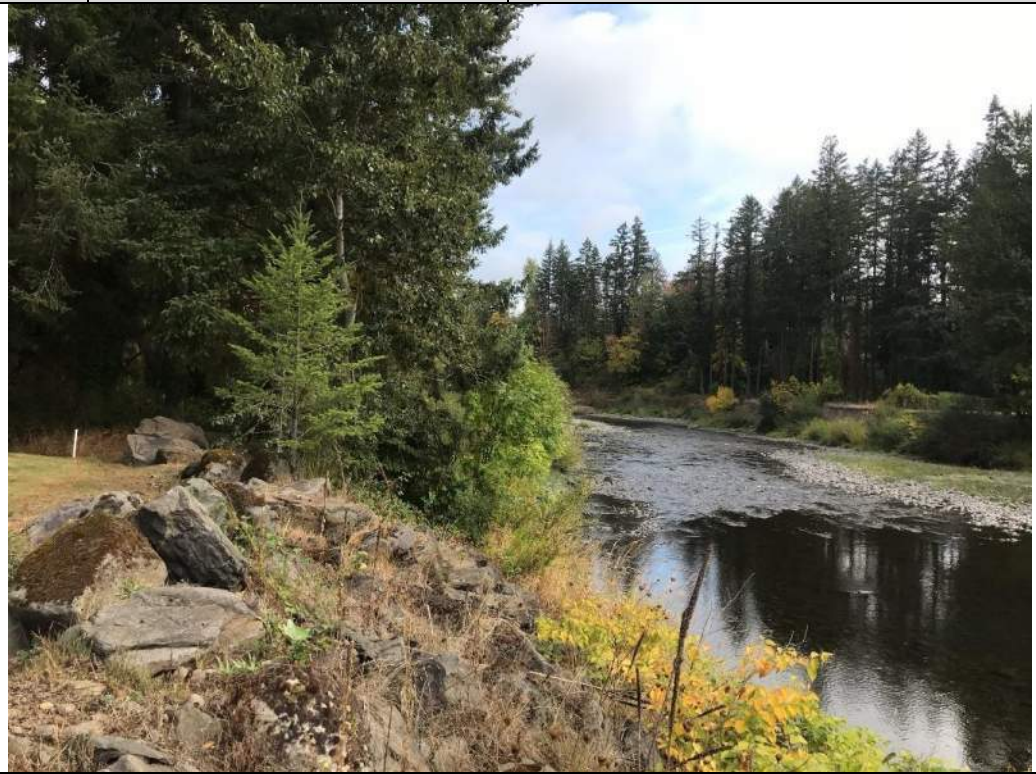
<b>Photo: 4</b>	<b>Looking: Northeast</b>	<b>Notes: Within study area R2 on river left (west) bank of Molalla River</b>
-----------------	---------------------------	---

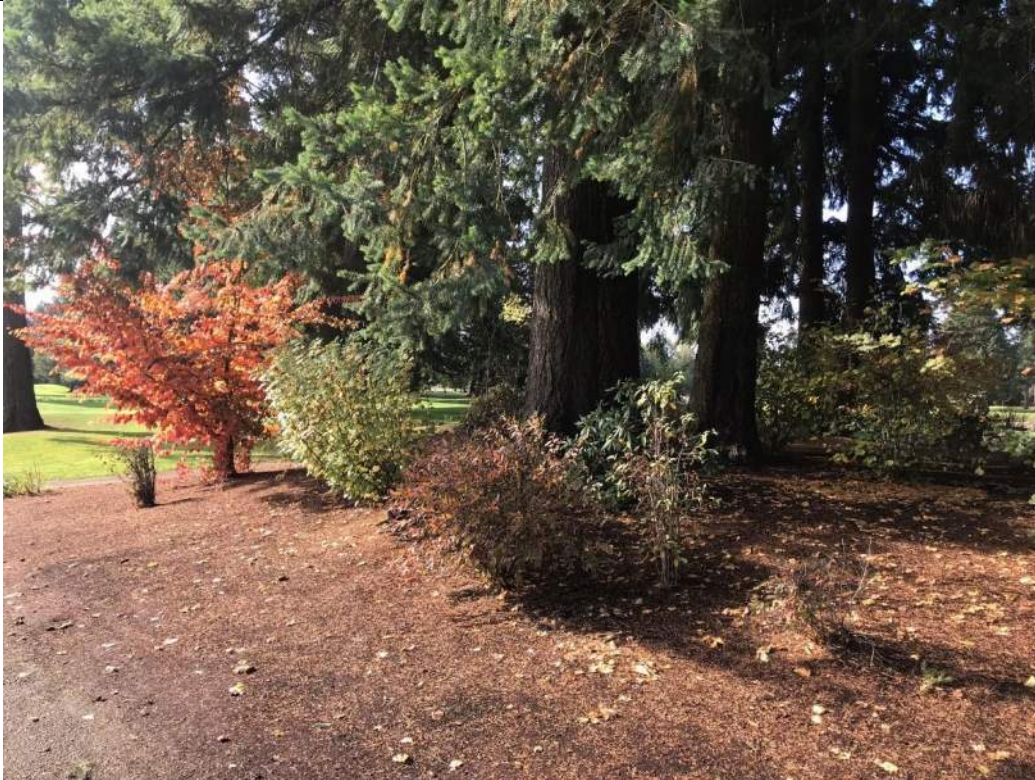
**Photo: 5**

**Notes: Near northern edge of study area R5**

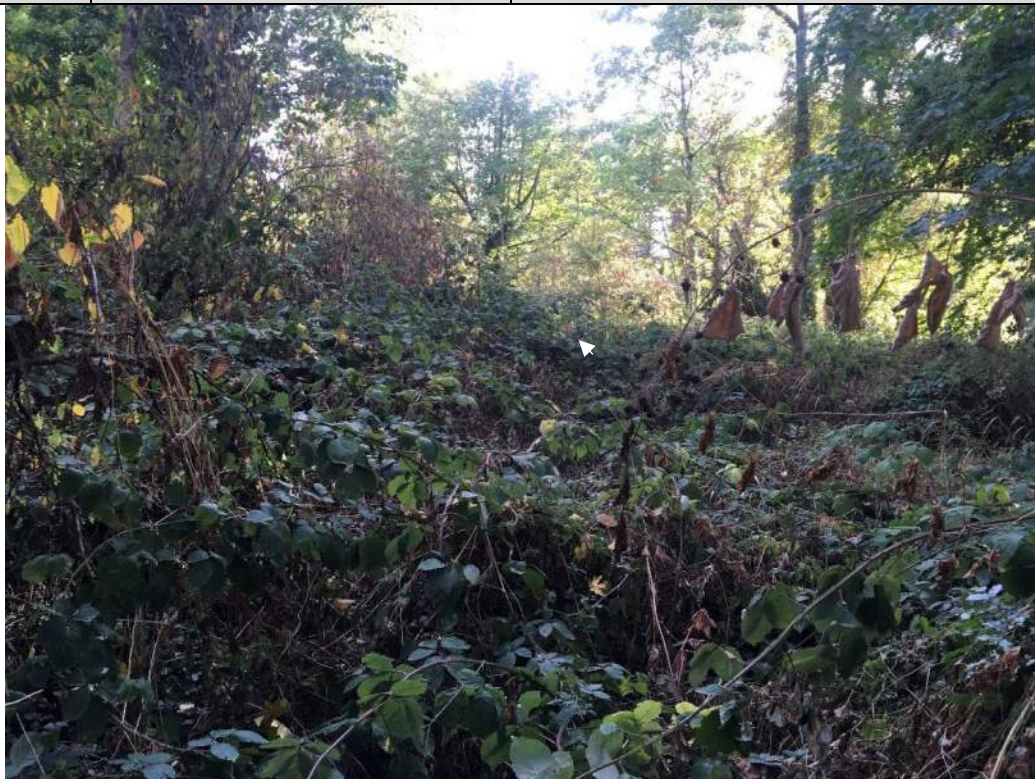
**Photo: 6**

**Notes: Near Sp219 and near edge of golf course**

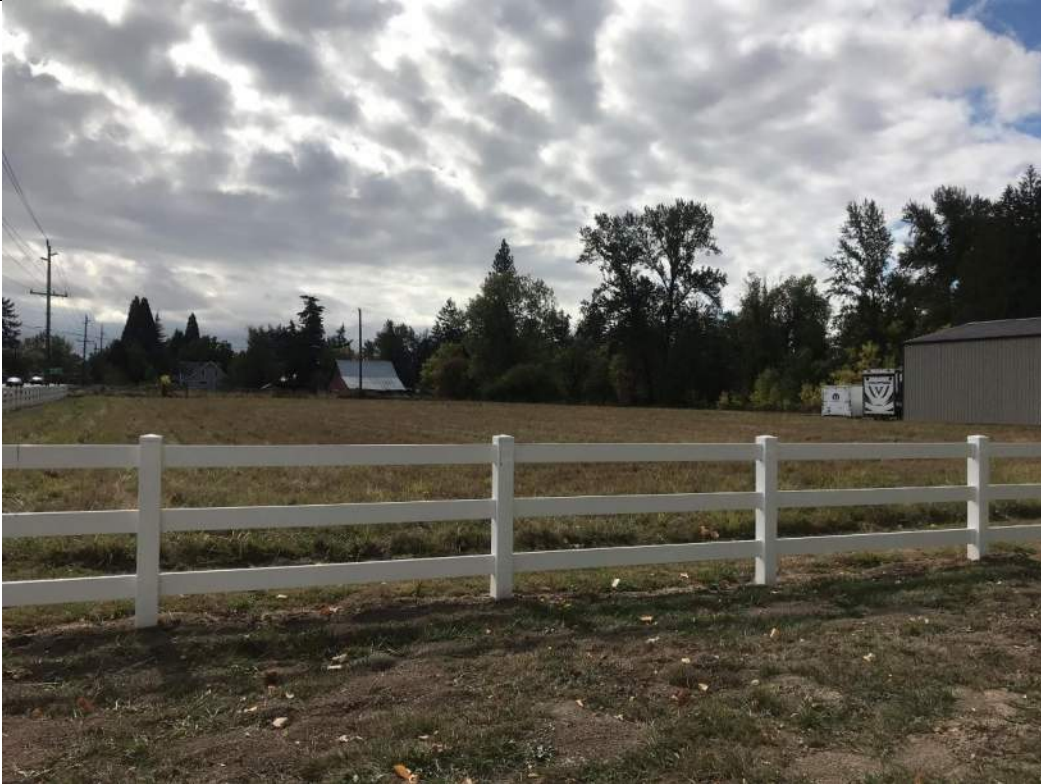
**Photo: 7**

**Notes: On driveway near edge of property access**
