**CULTURAL RESOURCE SURVEY OF THE  
MULINO STATE AIRPORT ENVIRONMENTAL ASSESSMENT,  
CLACKAMAS COUNTY, OREGON**

Prepared For  
Century West Engineering Corporation

**Figure 1: Study Areas**  
Mulino State Airport Wetland Reconnaissance  
Clackamas County, OR

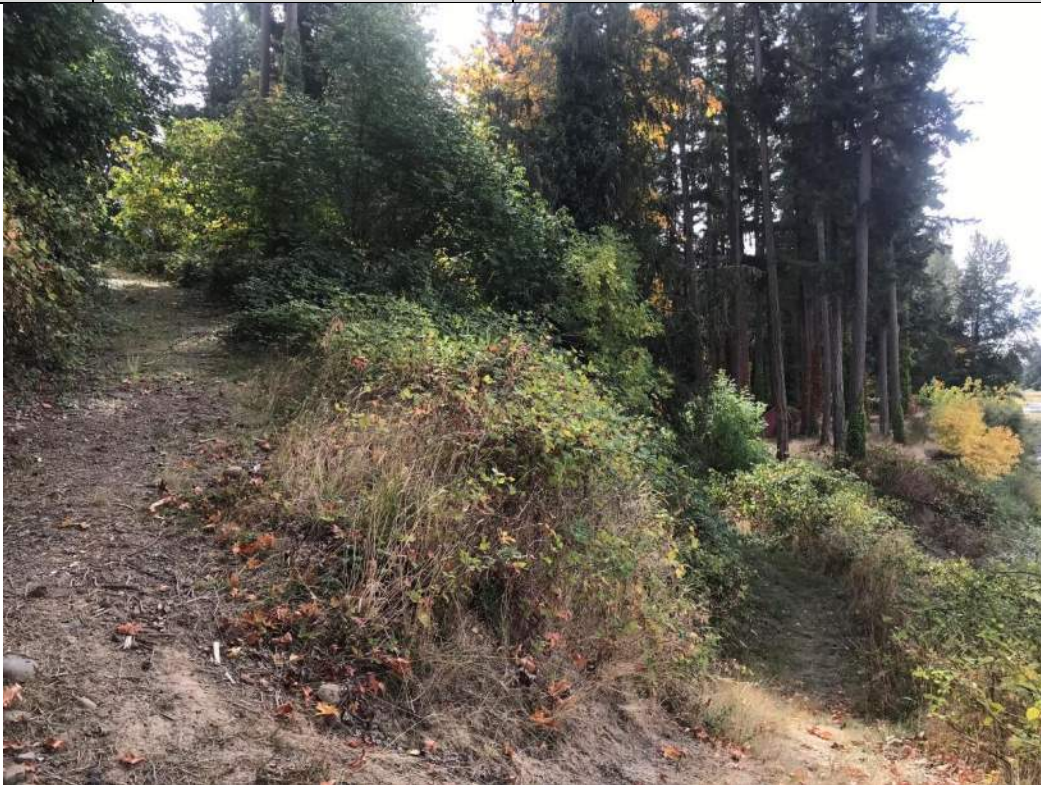
**Photo: 8**

**Notes: On accessed property near Sp222 and at toe of secondary river bluff**
