2024 ODAV Pavement Evaluation Program Myrtle Creek Municipal Airport

Myrtle Creek, Oregon

February 12, 2025

Prepared for
State of Oregon Department of Aviation
3040 25th Street SE
Salem, OR 97303-1125

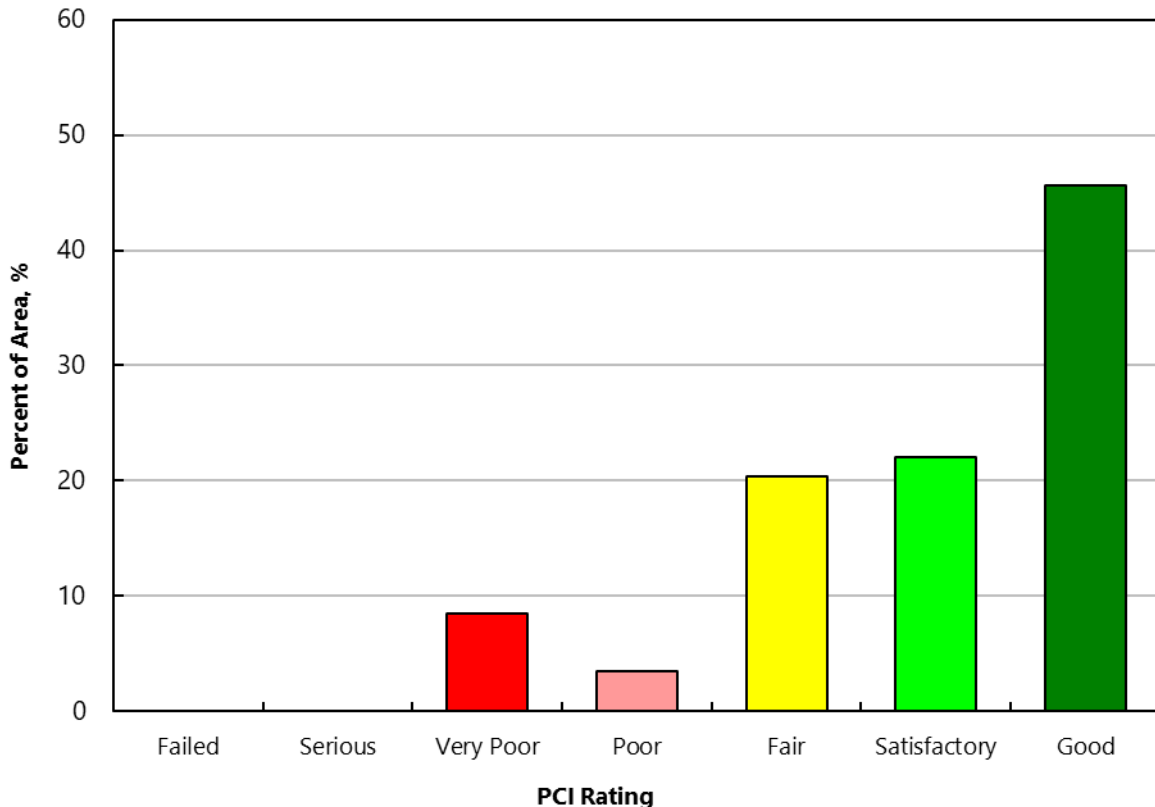
Figure 3.2: MYRTLE CREEK MUNICIPAL AIRPORT PAVEMENT CONDITION RATING BY PERCENT OF AREA

The condition distribution of the network by percent of total pavement area is provided on the Myrtle Creek Municipal Airport Pavement Condition Rating by Percent of Area, Figure 3.2. A summary of the pavement condition results by branch and section is included in Tables 2B and 3B of Appendix B, respectively. A comparison between the previous inspection and the 2024 inspection is provided in Table 4B in Appendix B. The reinspection report that includes inspection details for individual sample units is presented in Appendix E.
