2022 ODA Pavement Evaluation Program Malin Airport

Malin, Oregon

**December 30, 2022
(REVISED: 01/24/2023)**

Prepared for
State of Oregon Department of Aviation
3040 25th Street SE
Salem, OR 97303-1125

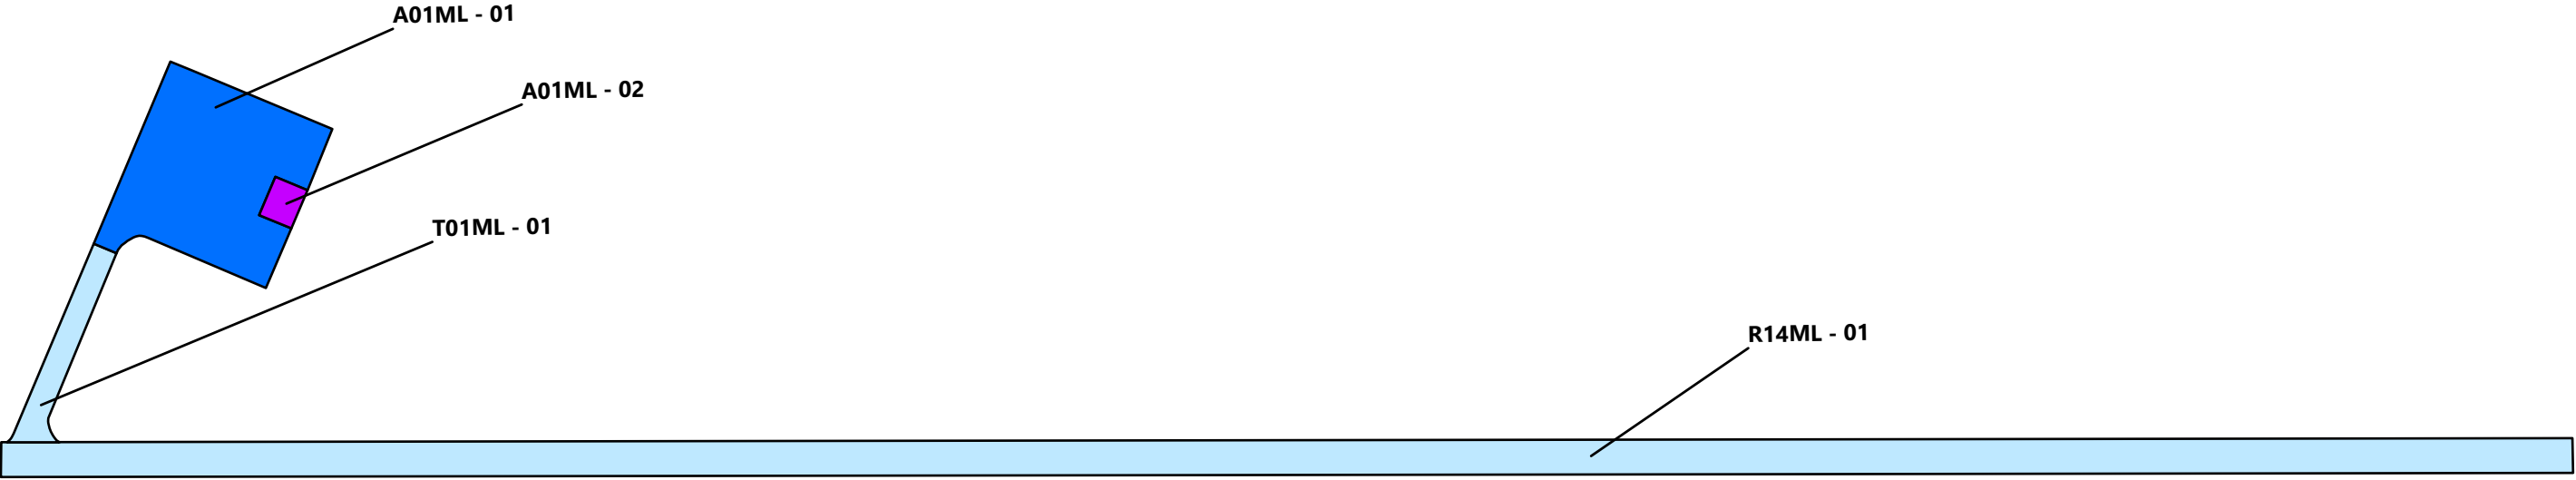
2022 PCI SURVEY RESULTS
MALIN AIRPORT

The area-weighted average PCI for all airport pavements at Malin Airport is approximately 71. The section PCIs ranged from a low of 66 to a high of 88. The primary distresses observed during the inspection were weathering and longitudinal and transverse cracking for flexible pavements, and spalling and shrinkage cracking on rigid pavements. Section PCIs following our pavement survey are displayed below spatially on the 2022 PCI Survey Results, Figure 3.1.
