2022 ODA Pavement Evaluation Program Joseph State Airport

Joseph, Oregon

May 8, 2023

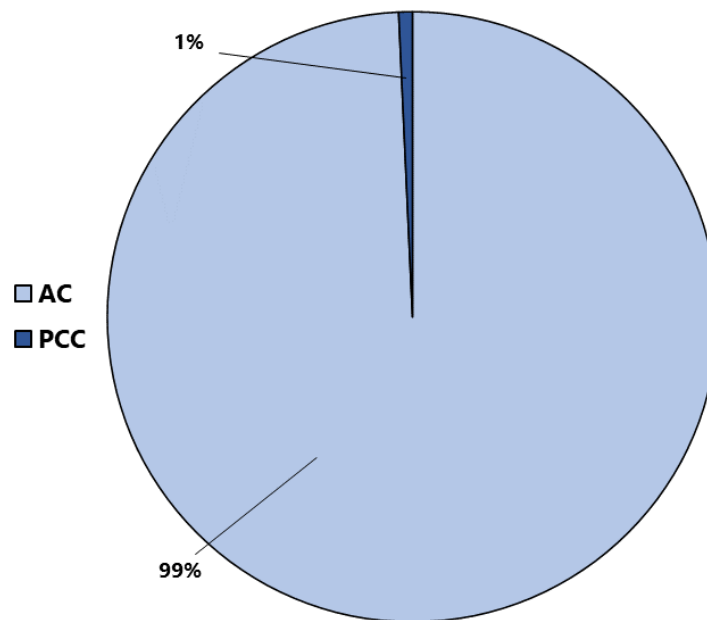
Figure 2.2 - JOSEPH STATE AIRPORT PERCENT OF PAVEMENT AREA BY SURFACE TYPE

Joseph State Airport contains one runway, one primary parallel taxiway, and multiple connector taxiways, taxilanes, and aprons. Types of airside pavements include asphalt concrete (AC) and portland cement concrete (PCC). The airport pavements, delineated by surface type and branch use, are shown on the Joseph State Airport Percent of Pavement Area by Surface Type, Figure 2.2 and on the Joseph State Pavement Area by Branch Use, Figure 2.3. The pavement inventory, including work history for each pavement section, is displayed spatially on the Joseph State Airport Pavement Inventory, Figure 2.4. The pavement facilities summarized by branch and section are listed in Tables 1A and 2A, respectively, in Appendix A. The sample unit layout for each section is shown on Figure 1A in Appendix A. We used the sampling rates outlined in Table 3A of Appendix A in our survey. The pavement inventory, including work history for individual airport pavement sections, is provided in the work history report, Table 1F.

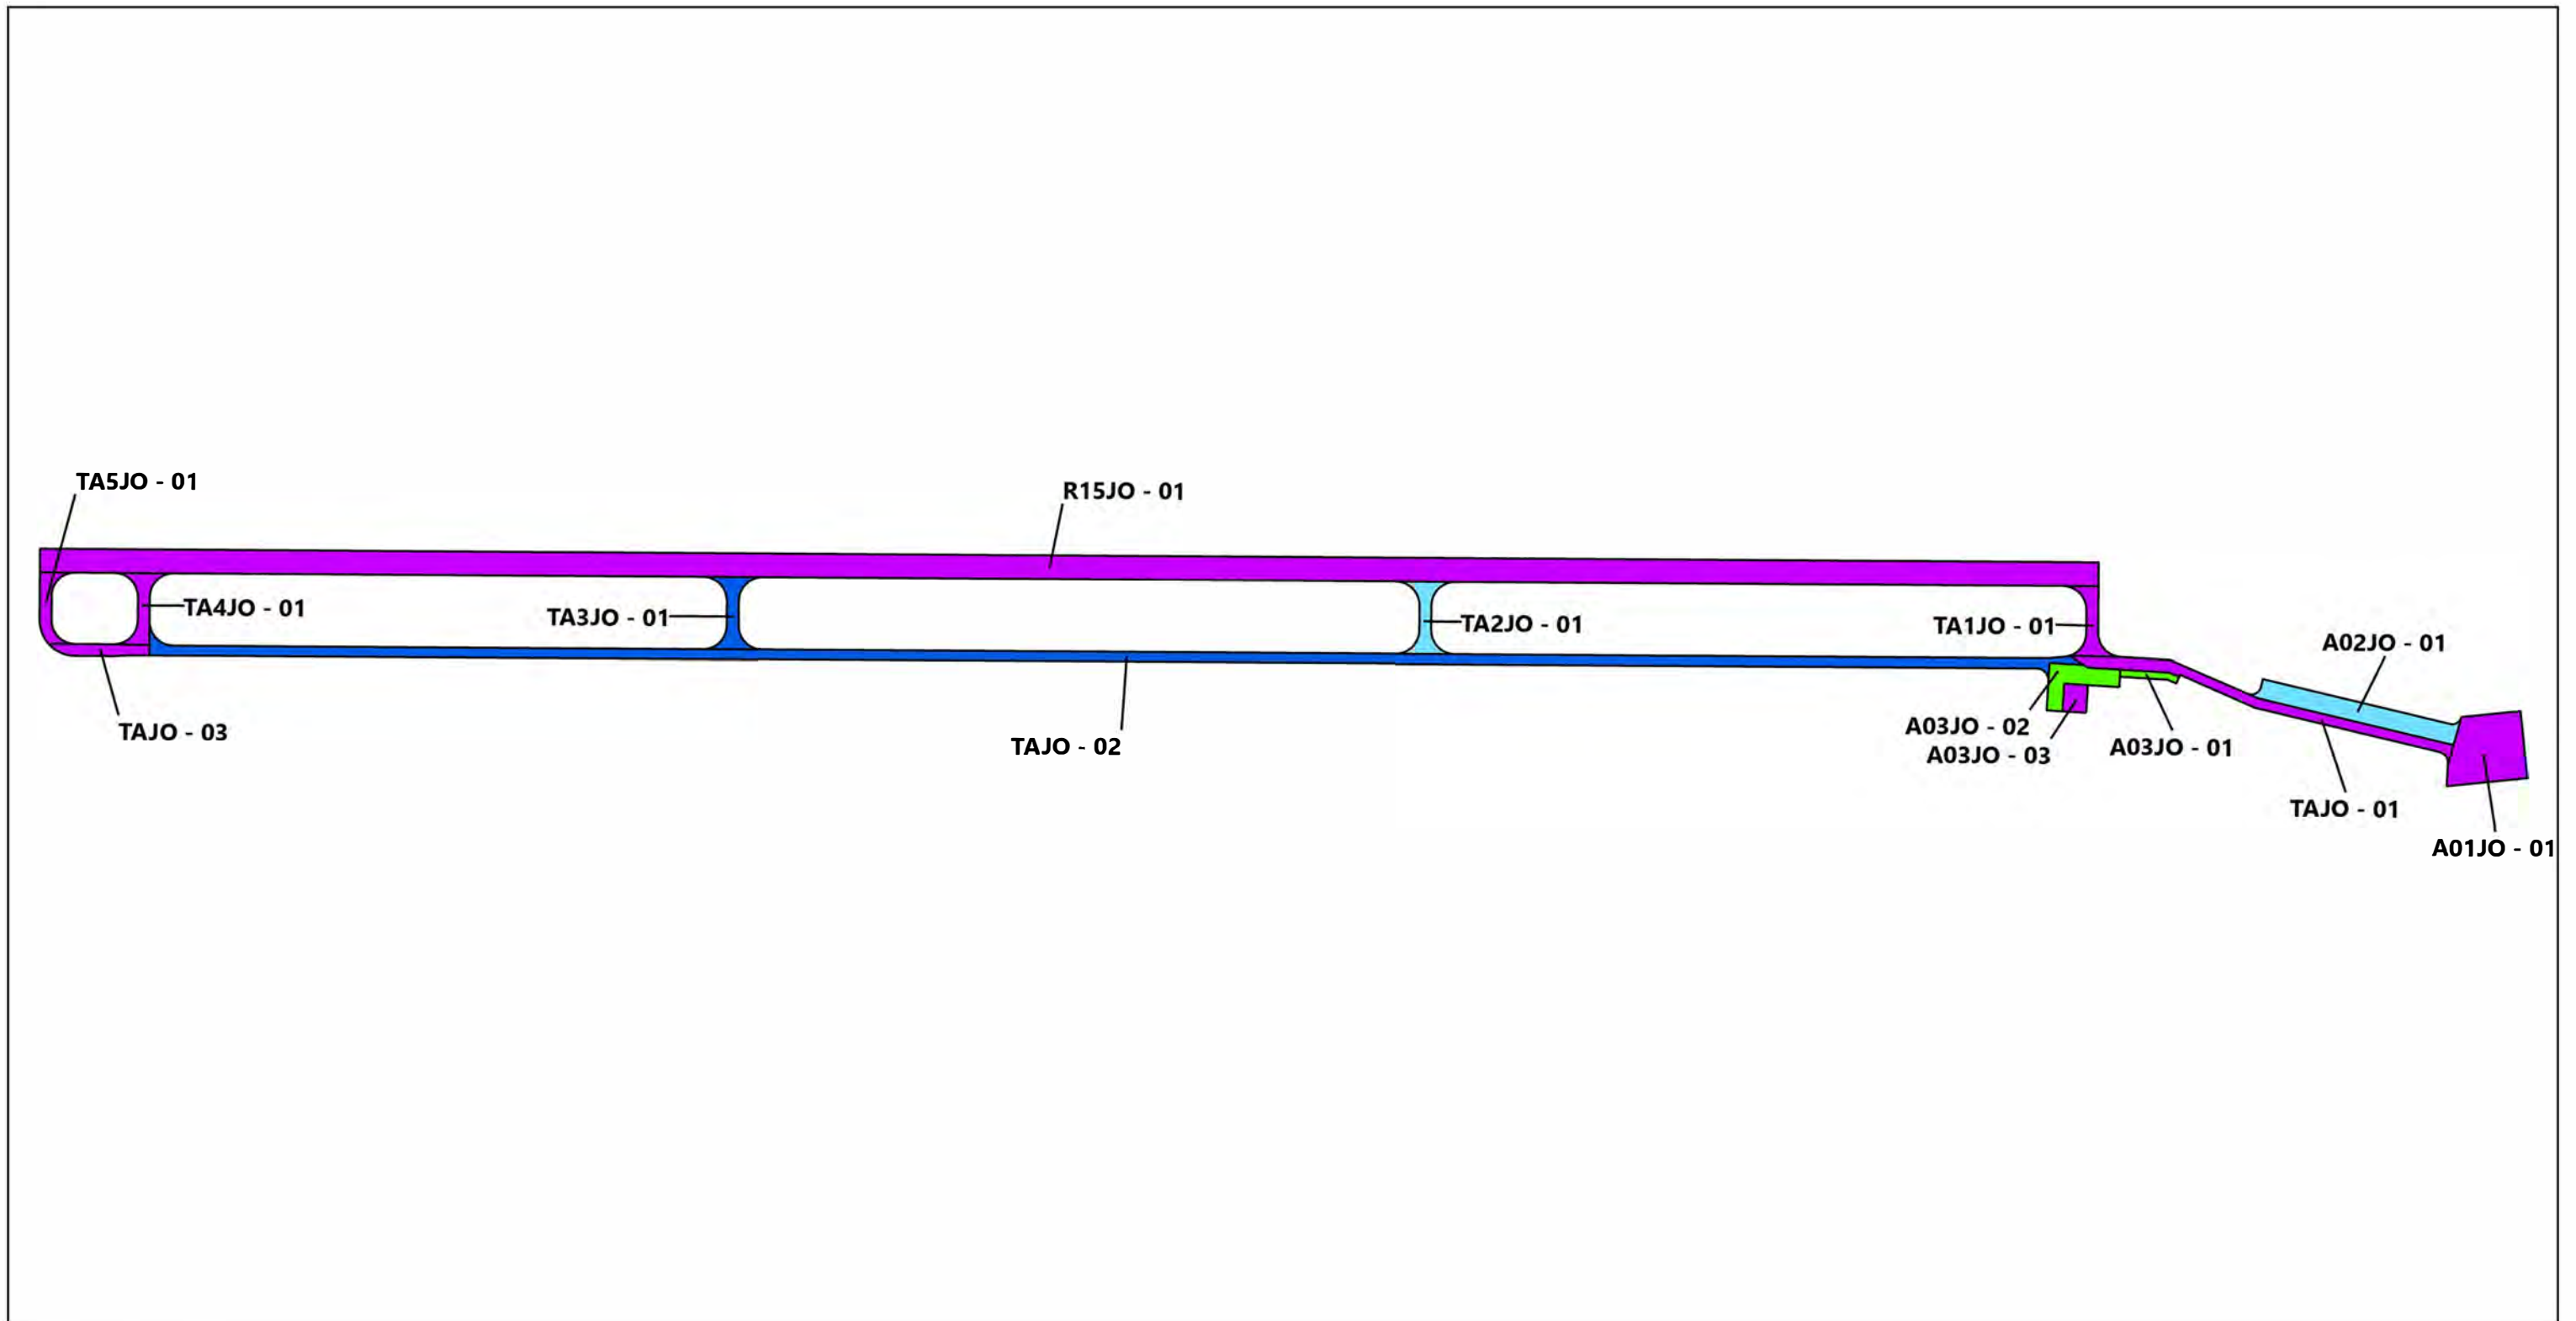
The area-weighted average PCI for all airport pavements at Joseph State Airport is approximately 82. The section PCIs ranged from a low of 45 to a high of 96. The primary distresses observed during the inspection were weathering, longitudinal and transverse cracking, fatigue (alligator) cracking, and patching on AC-surfaced pavements, and spalling on PCC pavements. Section PCIs following our pavement survey are displayed below spatially on the 2022 PCI Survey Results Joseph State Airport, Figure 3.1.

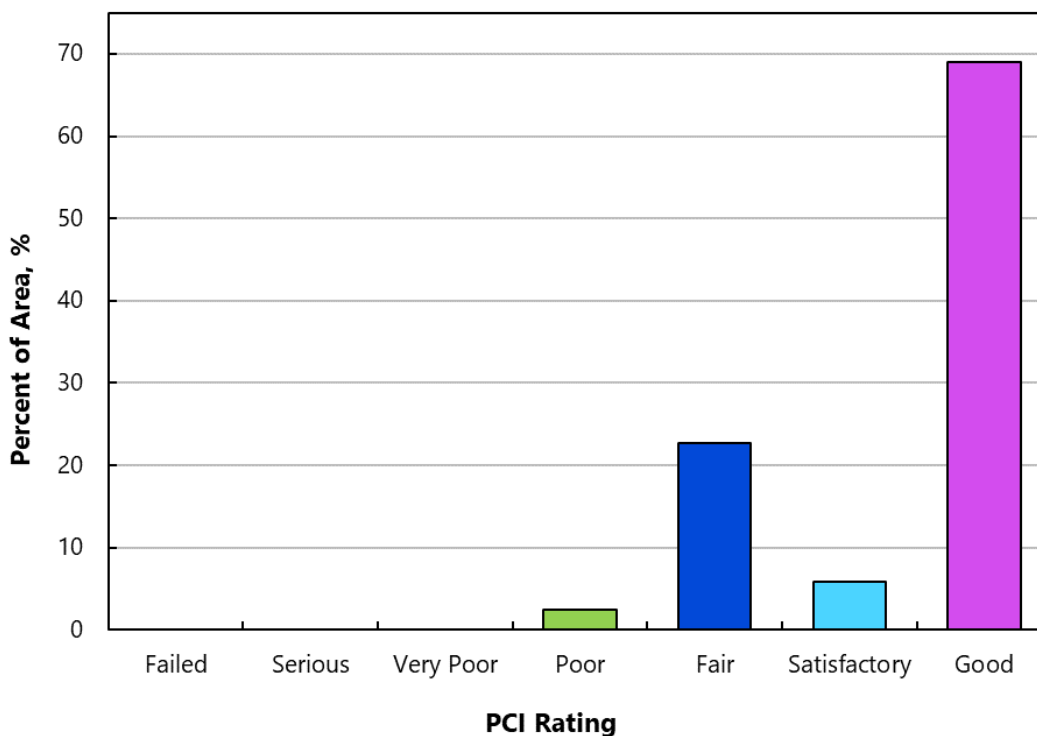
Figure 3.2 - JOSEPH STATE AIRPORT PAVEMENT CONDITION RATING BY PERCENT OF AREA

The condition distribution of the network by percent of total pavement area is provided on the Joseph State Airport Pavement Condition Rating by Percent of Area, Figure 3.2. A summary of the pavement condition results by branch and section are included in Tables 2B and 3B of Appendix B, respectively. A comparison between the previous inspection and the 2022 inspection is provided in Table 4B in Appendix B. The re-inspection report that includes inspection details for individual sample units is provided in Table 1E in Appendix E.

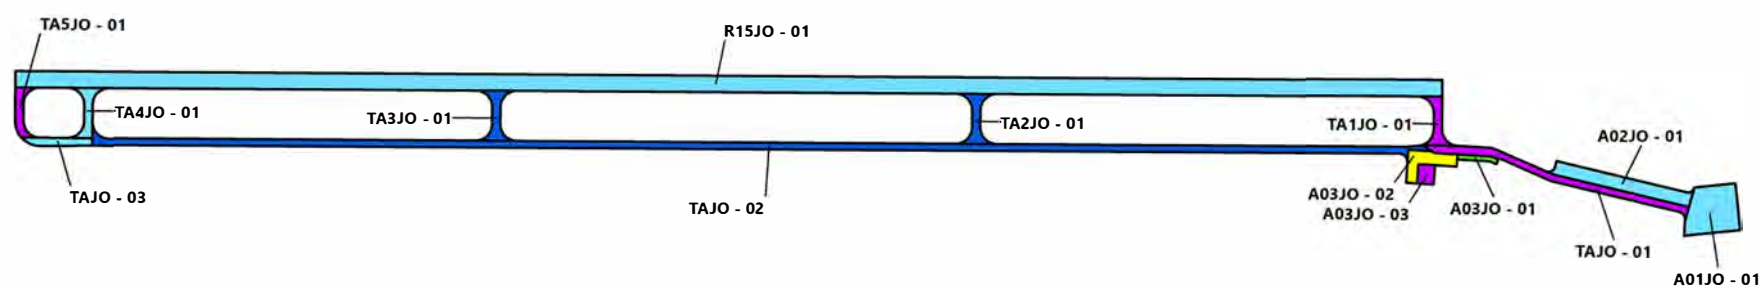
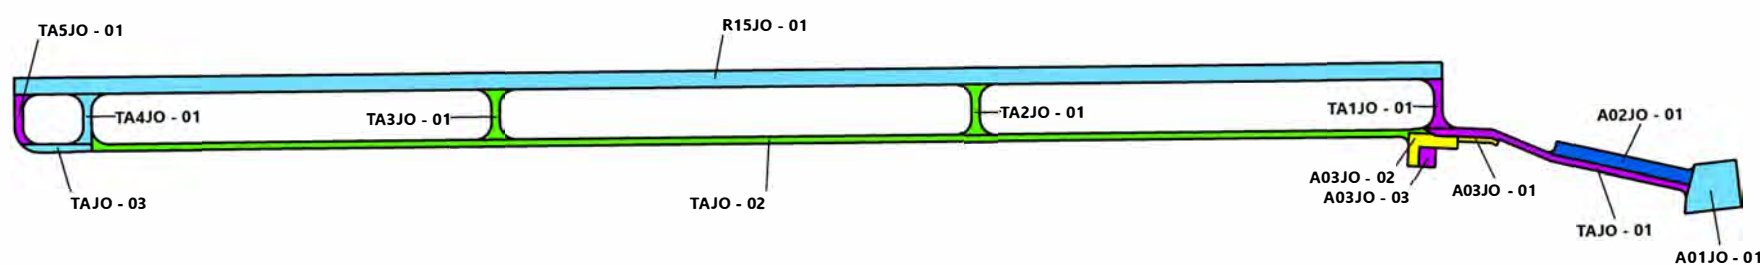
FUTURE PAVEMENT CONDITION
JOSEPH STATE AIRPORT

project the PCI to decrease from a current value of 82 to a value of 74 in 2027 and 67 in 2032 if no maintenance or rehabilitation work is performed. The projected pavement condition in 5 years and 10 years for each pavement section at Joseph State Airport is displayed spatially on the Future Pavement Condition Joseph State Airport, Figure 4.1, and listed in Table 1C in Appendix C, along with the past and present PCI values for the pavement network.

PREDICTED CONDITION IN 2027

PREDICTED CONDITION IN 2032

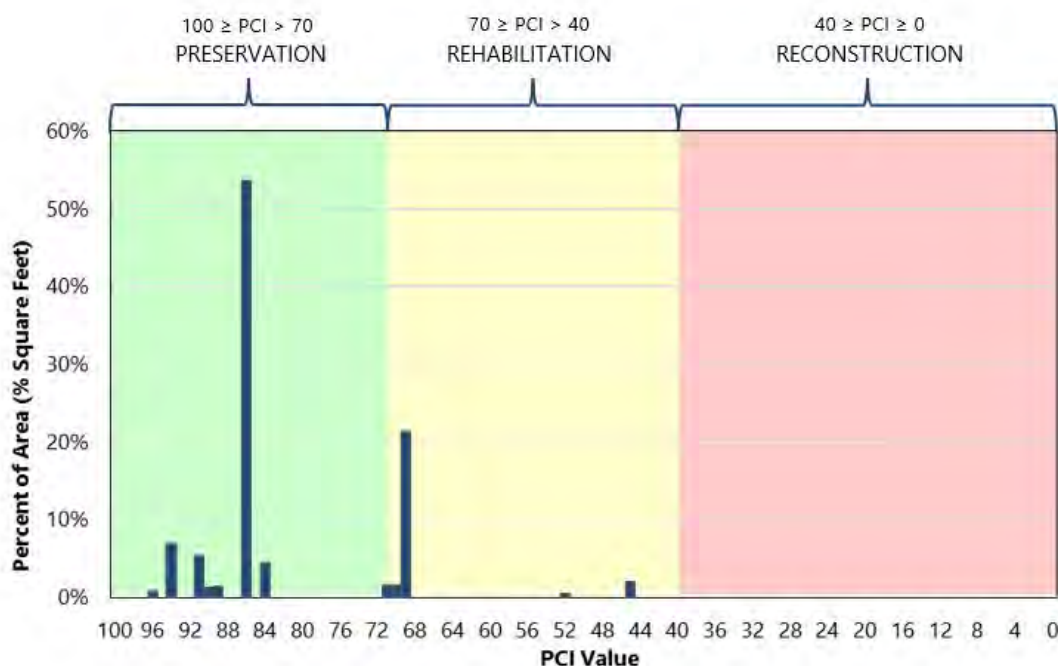
Figure 5.1 - JOSEPH STATE AIRPORT PAVEMENT NETWORK GENERAL TREATMENT TYPE DISTRIBUTION BASED ON PCI

Based on the 2022 PCI-survey results shown on the Joseph State Airport Pavement Network General Treatment Type Distribution Based on PCI, Figure 5.1 displays a breakdown of the Joseph State Airport network pavement condition by percent of area and general M&R treatment categories. Approximately 75% and 25% of the area require preservation treatments and rehabilitation, respectively.

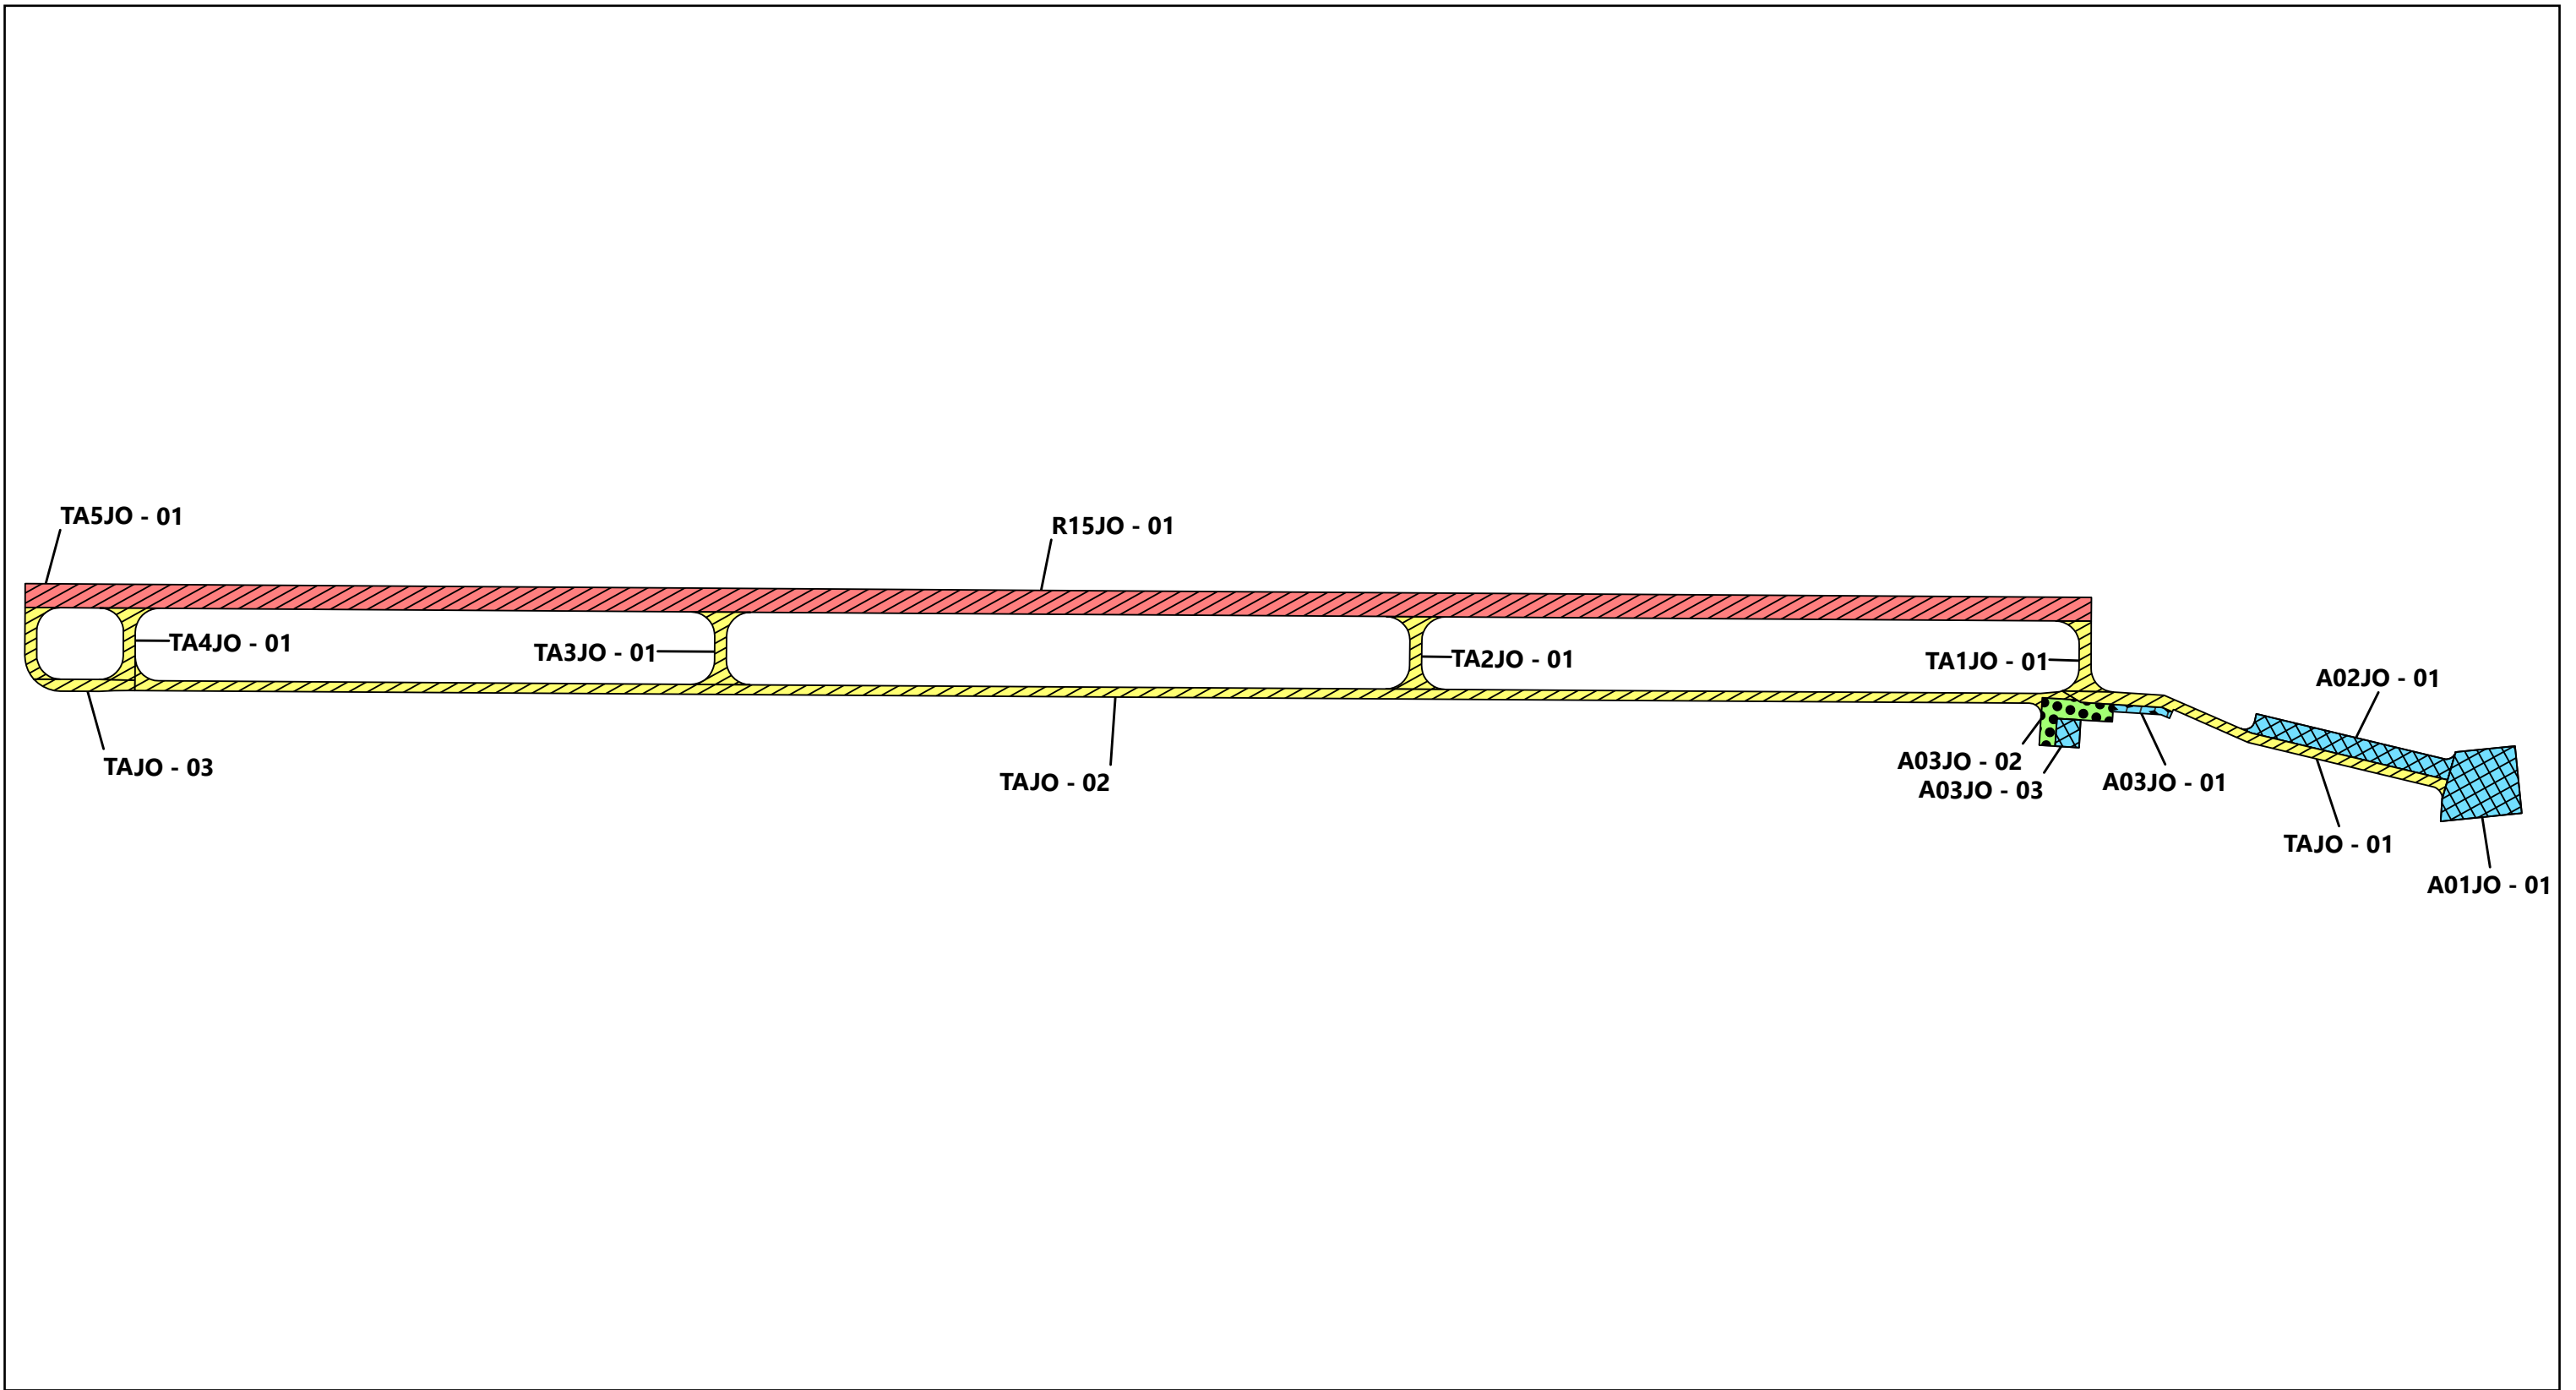
To develop the five-year work plan, we first ran the eliminate backlog scenario with the PAVER M&R Work Planning Module in order to generate a list, organized by year, of global and M&R projects. We then reviewed the project list and refined it into practical construction projects for each year. A summary of global and M&R quantities is provided in Table 5-2 below, and maps of the project locations by year are shown on the 5-Year Pavement Management Plan Joseph State Airport, Figure 5.2. The complete list of recommended global and M&R projects is presented in Table 4D in Appendix D.

Global Maintenance or Rehabilitation Operation	Quantity, square feet
Reconstruction	11,259
Overlay	2,661
Fog Seal	60,825
Slurry Seal	507,249

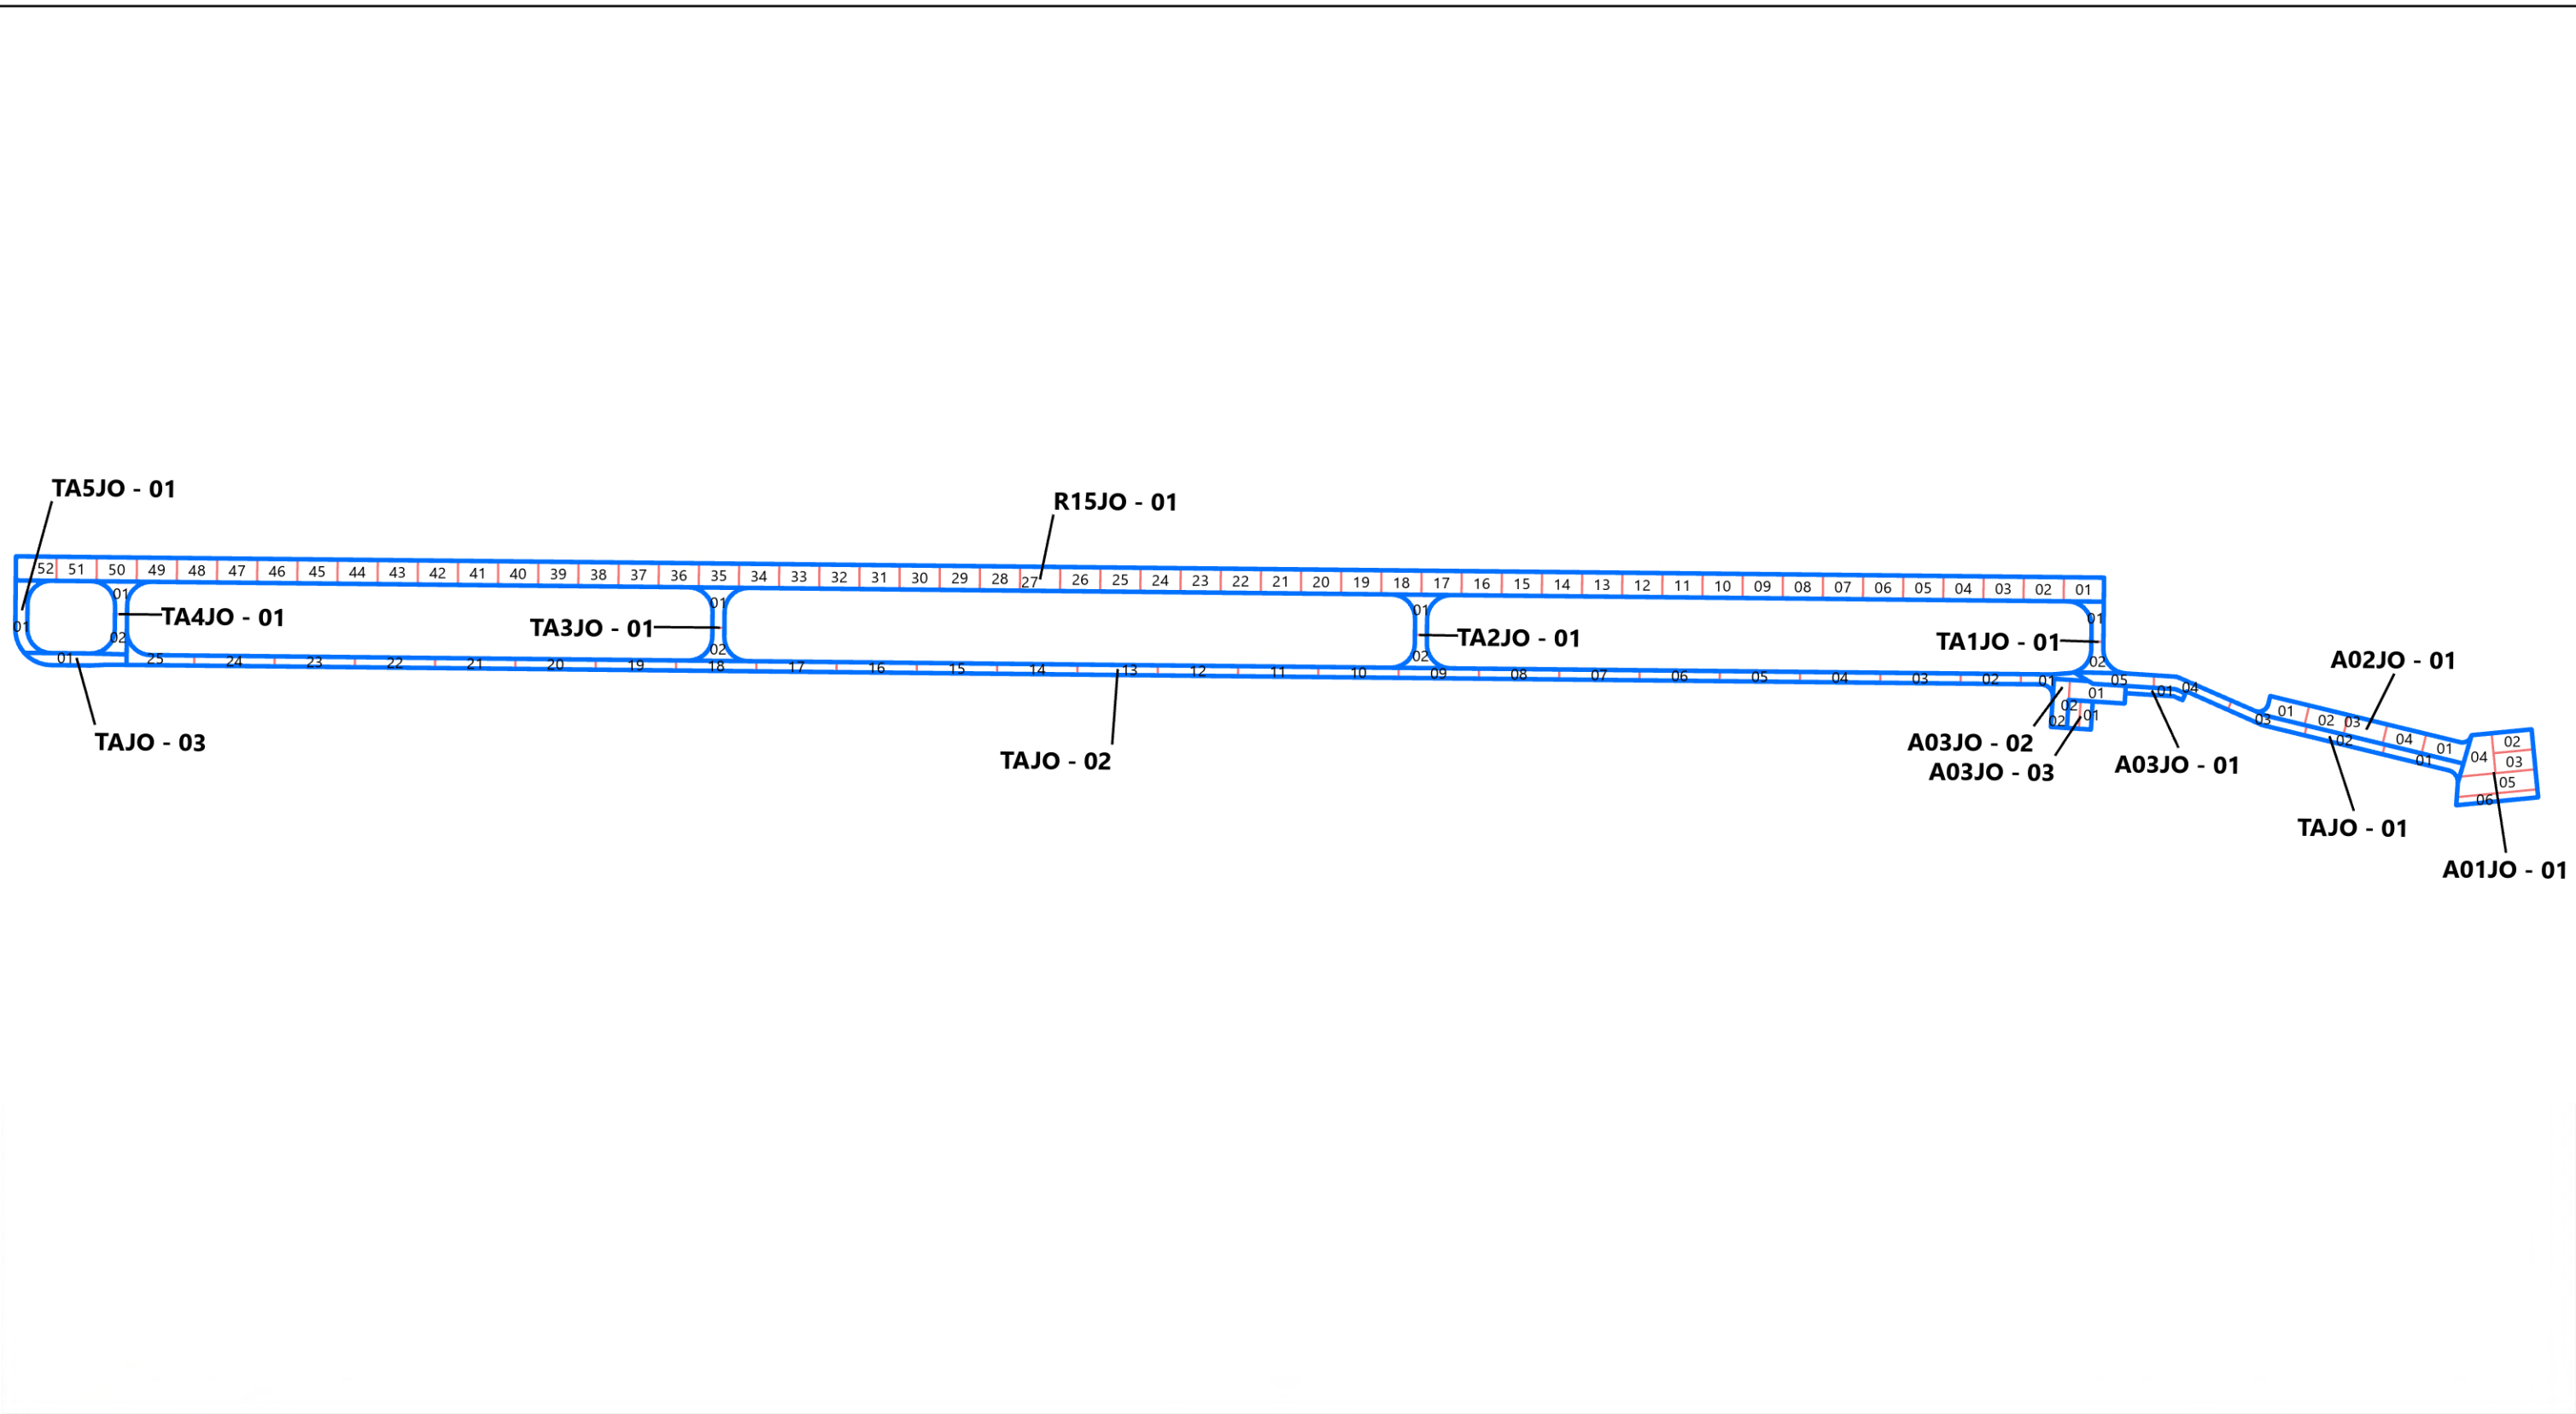
SAMPLE UNIT LAYOUT
JOSEPH STATE AIRPORT

To facilitate the visual survey of the airport pavement, each section is further subdivided into smaller areas called sample units. Similar sizing of these units is critical, and studies have found that maintaining the size of the sample units to within 40% of the established normal distribution reduces the standard error of the average pavement condition index (PCI) values. To meet this criterion, the ASTM method recommends sample units for flexible pavements be $5,000 \pm 2,000$ square feet and $20 \text{ slabs} \pm 8 \text{ slabs}$ for rigid pavements. The delineation of sample units for each section is displayed on Figure 1A.

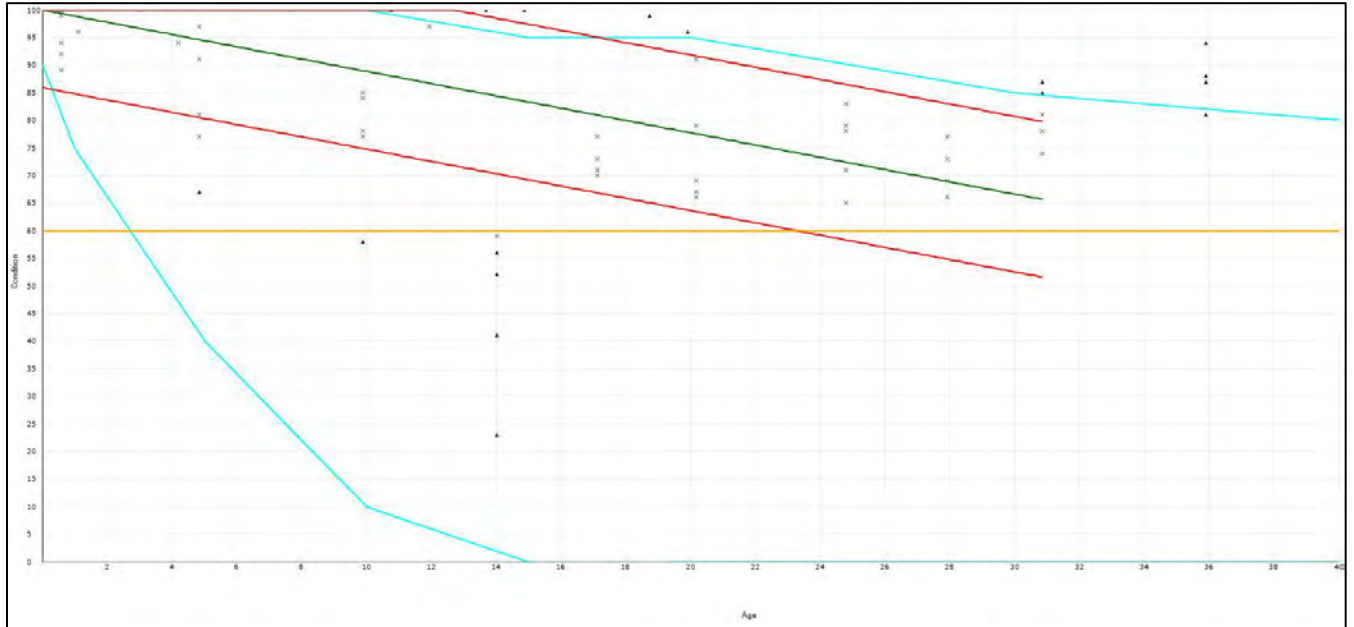
Figure 1C - CONDITION PREDICTION MODEL FOR EASTERN CATEGORY 4 PCC RUNWAYS, TAXIWAYS, AND APRONS

We developed separate condition prediction models for each pavement “family” at Joseph State Airport. The delineation is based on branch use, surface type, section rank, and structural design life. We use four distinct models for the following “families” of pavements at Joseph State Airport. For each model, we reviewed the data in order to filter out any inconsistent or inaccurate data or any data that fall outside boundary values set by PAVER. After outliers are removed and the data are checked for accuracy and reasonableness, the PAVER program calculates a best-fit curve using a polynomial-constrained, least-squares analysis procedure. This best-fit curve for each family is used in the analysis to predict the average behavior of all sections within each “family.” Our condition prediction models for each “family” are provided on Figures 1C through 4C below.
