# **2022 ODA Pavement Evaluation Program Lexington Airport**

Lexington, Oregon

**May 8, 2023**

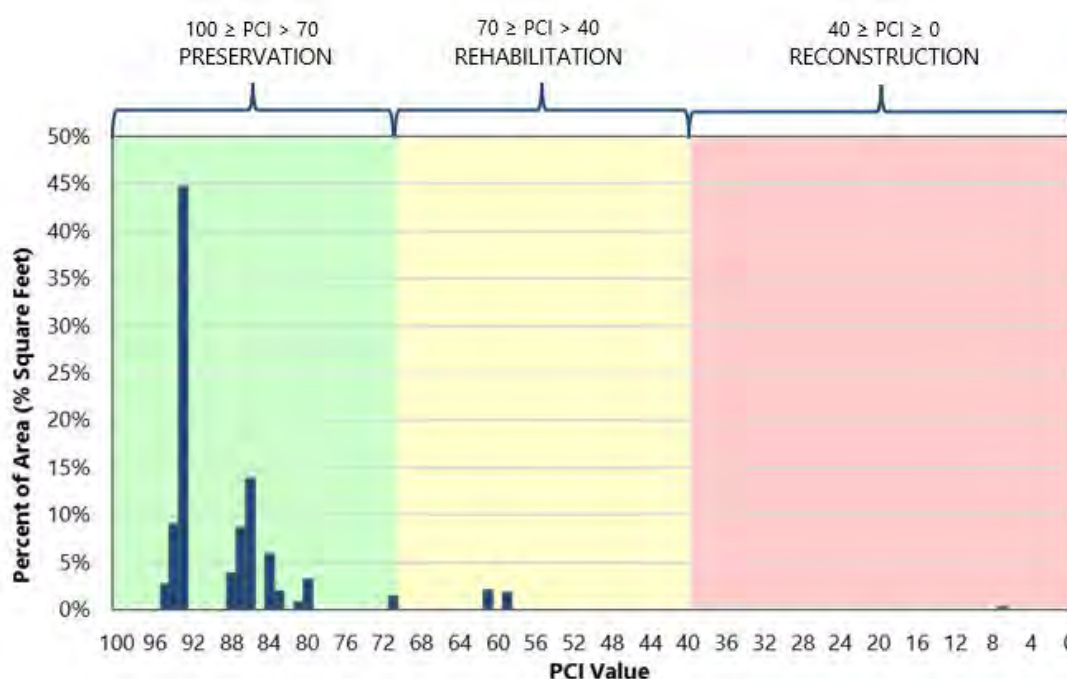
**Figure 5.1 - LEXINGTON AIRPORT PAVEMENT NETWORK GENERAL TREATMENT TYPE DISTRIBUTION BASED ON PCI**

Based on the 2022 PCI-survey results shown on the Lexington Airport Pavement Network General Treatment Type Distribution Based on PCI, Figure 5.1 displays a breakdown of the Lexington Airport network pavement condition by percent of area and general M&R treatment categories. Approximately 95.9%, 3.8%, and 0.3% of the area require preservation treatments, rehabilitation, and reconstruction, respectively.
