2022 ODA Pavement Evaluation Program McDermitt State Airport

McDermitt, Oregon

May 8, 2023

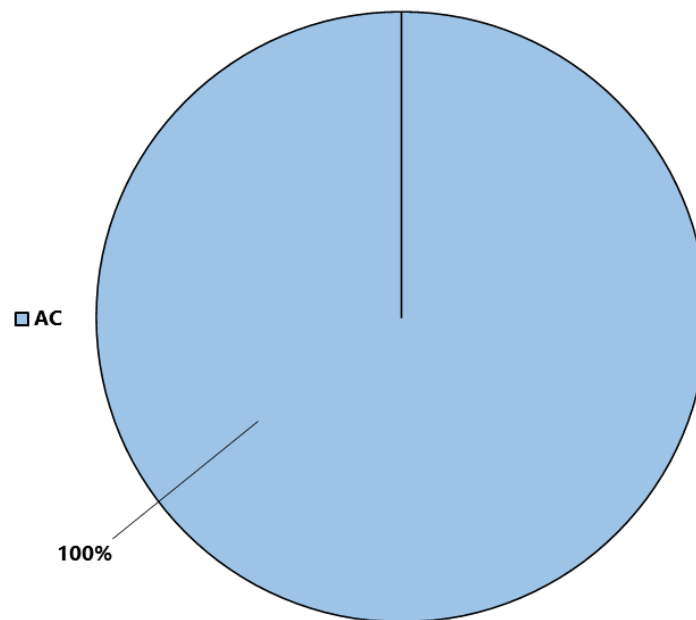
Figure 2.2 - MCDERMITT STATE AIRPORT PERCENT OF PAVEMENT AREA BY SURFACE TYPE

McDermitt State Airport contains one runway, connector taxiways, taxilanes, and one apron. Types of airside pavements include asphalt concrete (AC). The airport pavements, delineated by surface type and branch use, are shown on the McDermitt State Airport Percent of Pavement Area by Surface Type, Figure 2.2 and on the McDermitt State Pavement Area by Branch Use, Figure 2.3. The pavement inventory, including work history for each pavement section, is displayed spatially on the McDermitt State Airport Pavement Inventory, Figure 2.4. The pavement facilities summarized by branch and section are listed in Tables 1A and 2A, respectively, in Appendix A. The sample unit layout for each section is shown on Figure 1A in Appendix A. We used the sampling rates outlined in Table 3A of Appendix A in our survey. The pavement inventory, including work history for individual airport pavement sections, is provided in the work history report, Table 1F.

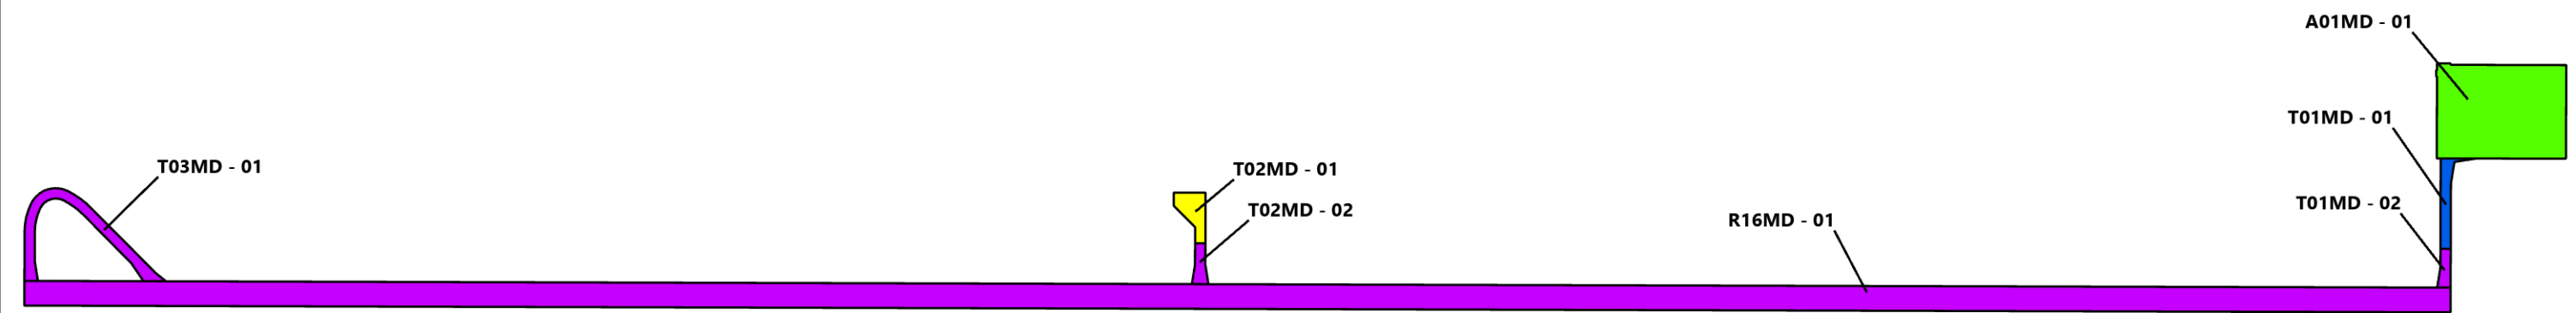
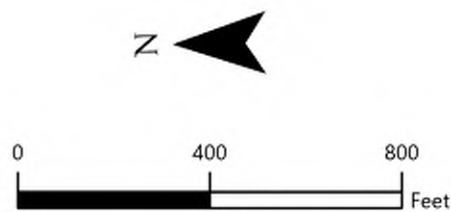
2022 PCI SURVEY RESULTS
MCDERMITT STATE AIRPORT

The area-weighted average PCI for all airport pavements at McDermitt State Airport is approximately 80. The section PCIs ranged from a low of 39 to a high of 92. The primary distresses observed during the inspection were weathering, longitudinal and transverse cracking, fatigue (alligator) cracking, block cracking, and slippage cracking on AC-surfaced pavements. Section PCIs following our pavement survey are displayed below spatially on the 2022 PCI Survey Results McDermitt State Airport, Figure 3.1.

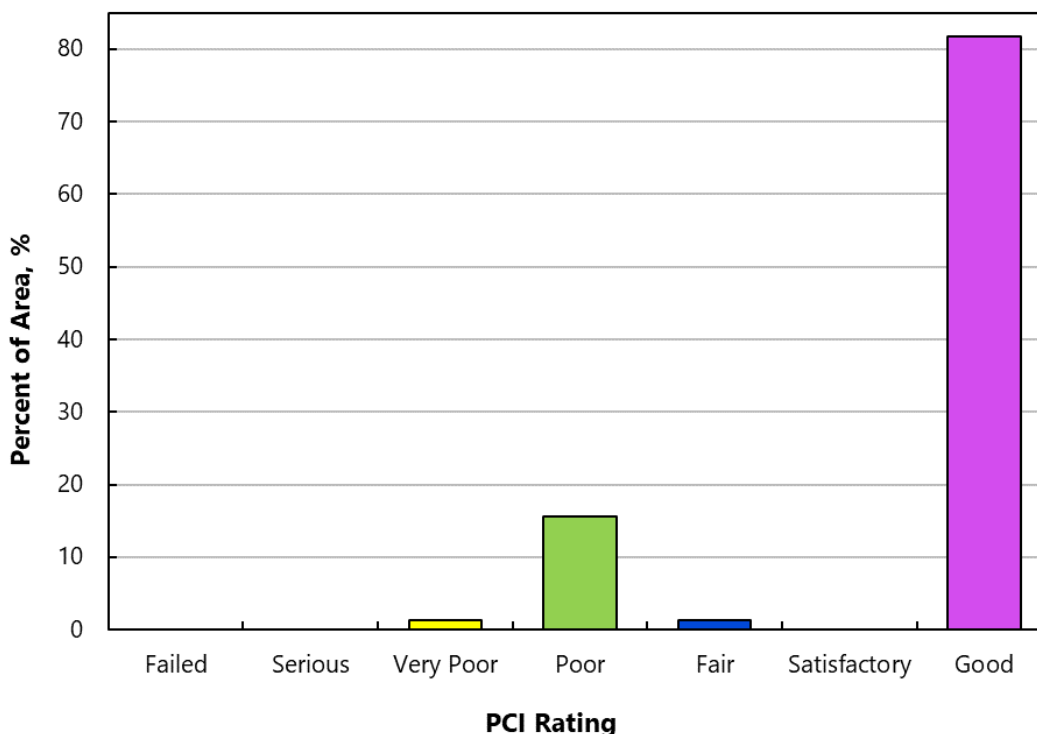
Figure 3.2 - MCDERMITT STATE AIRPORT PAVEMENT CONDITION RATING BY PERCENT OF AREA

The condition distribution of the network by percent of total pavement area is provided on the McDermitt State Airport Pavement Condition Rating by Percent of Area, Figure 3.2. A summary of the pavement condition results by branch and section are included in Tables 2B and 3B of Appendix B, respectively. A comparison between the previous inspection and the 2022 inspection is provided in Table 4B in Appendix B. The re-inspection report that includes inspection details for individual sample units is provided in Table 1E in Appendix E.

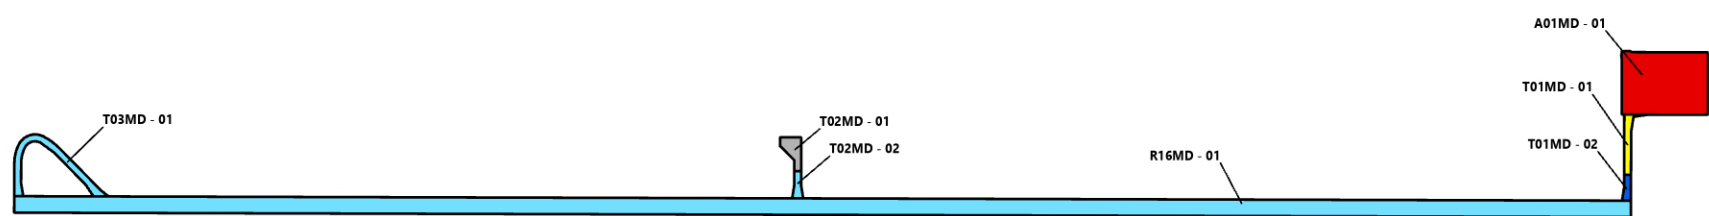
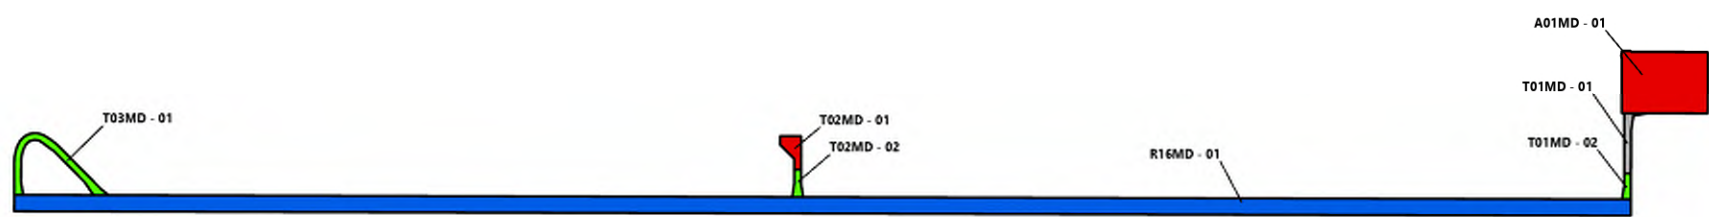
FUTURE PAVEMENT CONDITION
MCDERMITT STATE AIRPORT

project the PCI to decrease from a current value of 80 to a value of 66 in 2027 and 56 in 2032 if no maintenance or rehabilitation work is performed. The projected pavement condition in 5 years and 10 years for each pavement section at McDermitt State Airport is displayed spatially on the Future Pavement Condition McDermitt State Airport, Figure 4.1, and listed in Table 1C in Appendix C, along with the past and present PCI values for the pavement network.

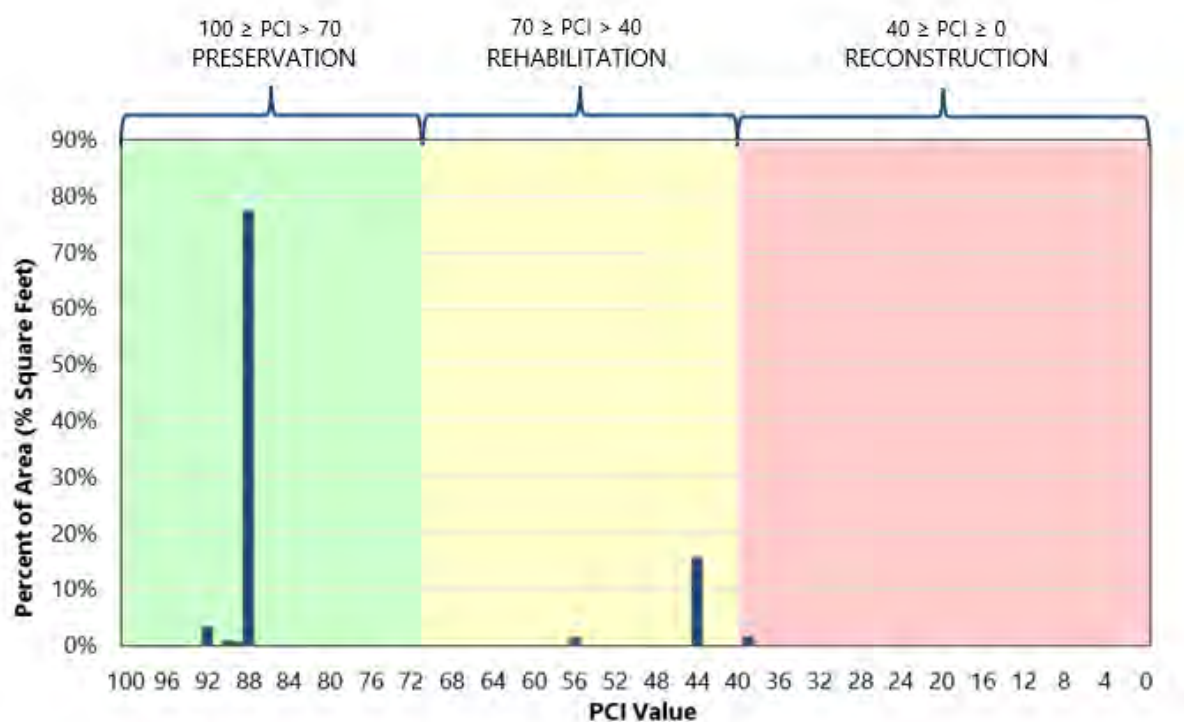
Figure 5.1 - MCDERMITT STATE AIRPORT PAVEMENT NETWORK GENERAL TREATMENT TYPE DISTRIBUTION BASED ON PCI

Based on the 2022 PCI-survey results shown on the McDermitt State Airport Pavement Network General Treatment Type Distribution Based on PCI, Figure 5.1 displays a breakdown of the McDermitt State Airport network pavement condition by percent of area and general M&R treatment categories. Approximately 82%, 17%, and 1% of the area require preservation treatments, rehabilitation, and reconstruction, respectively.

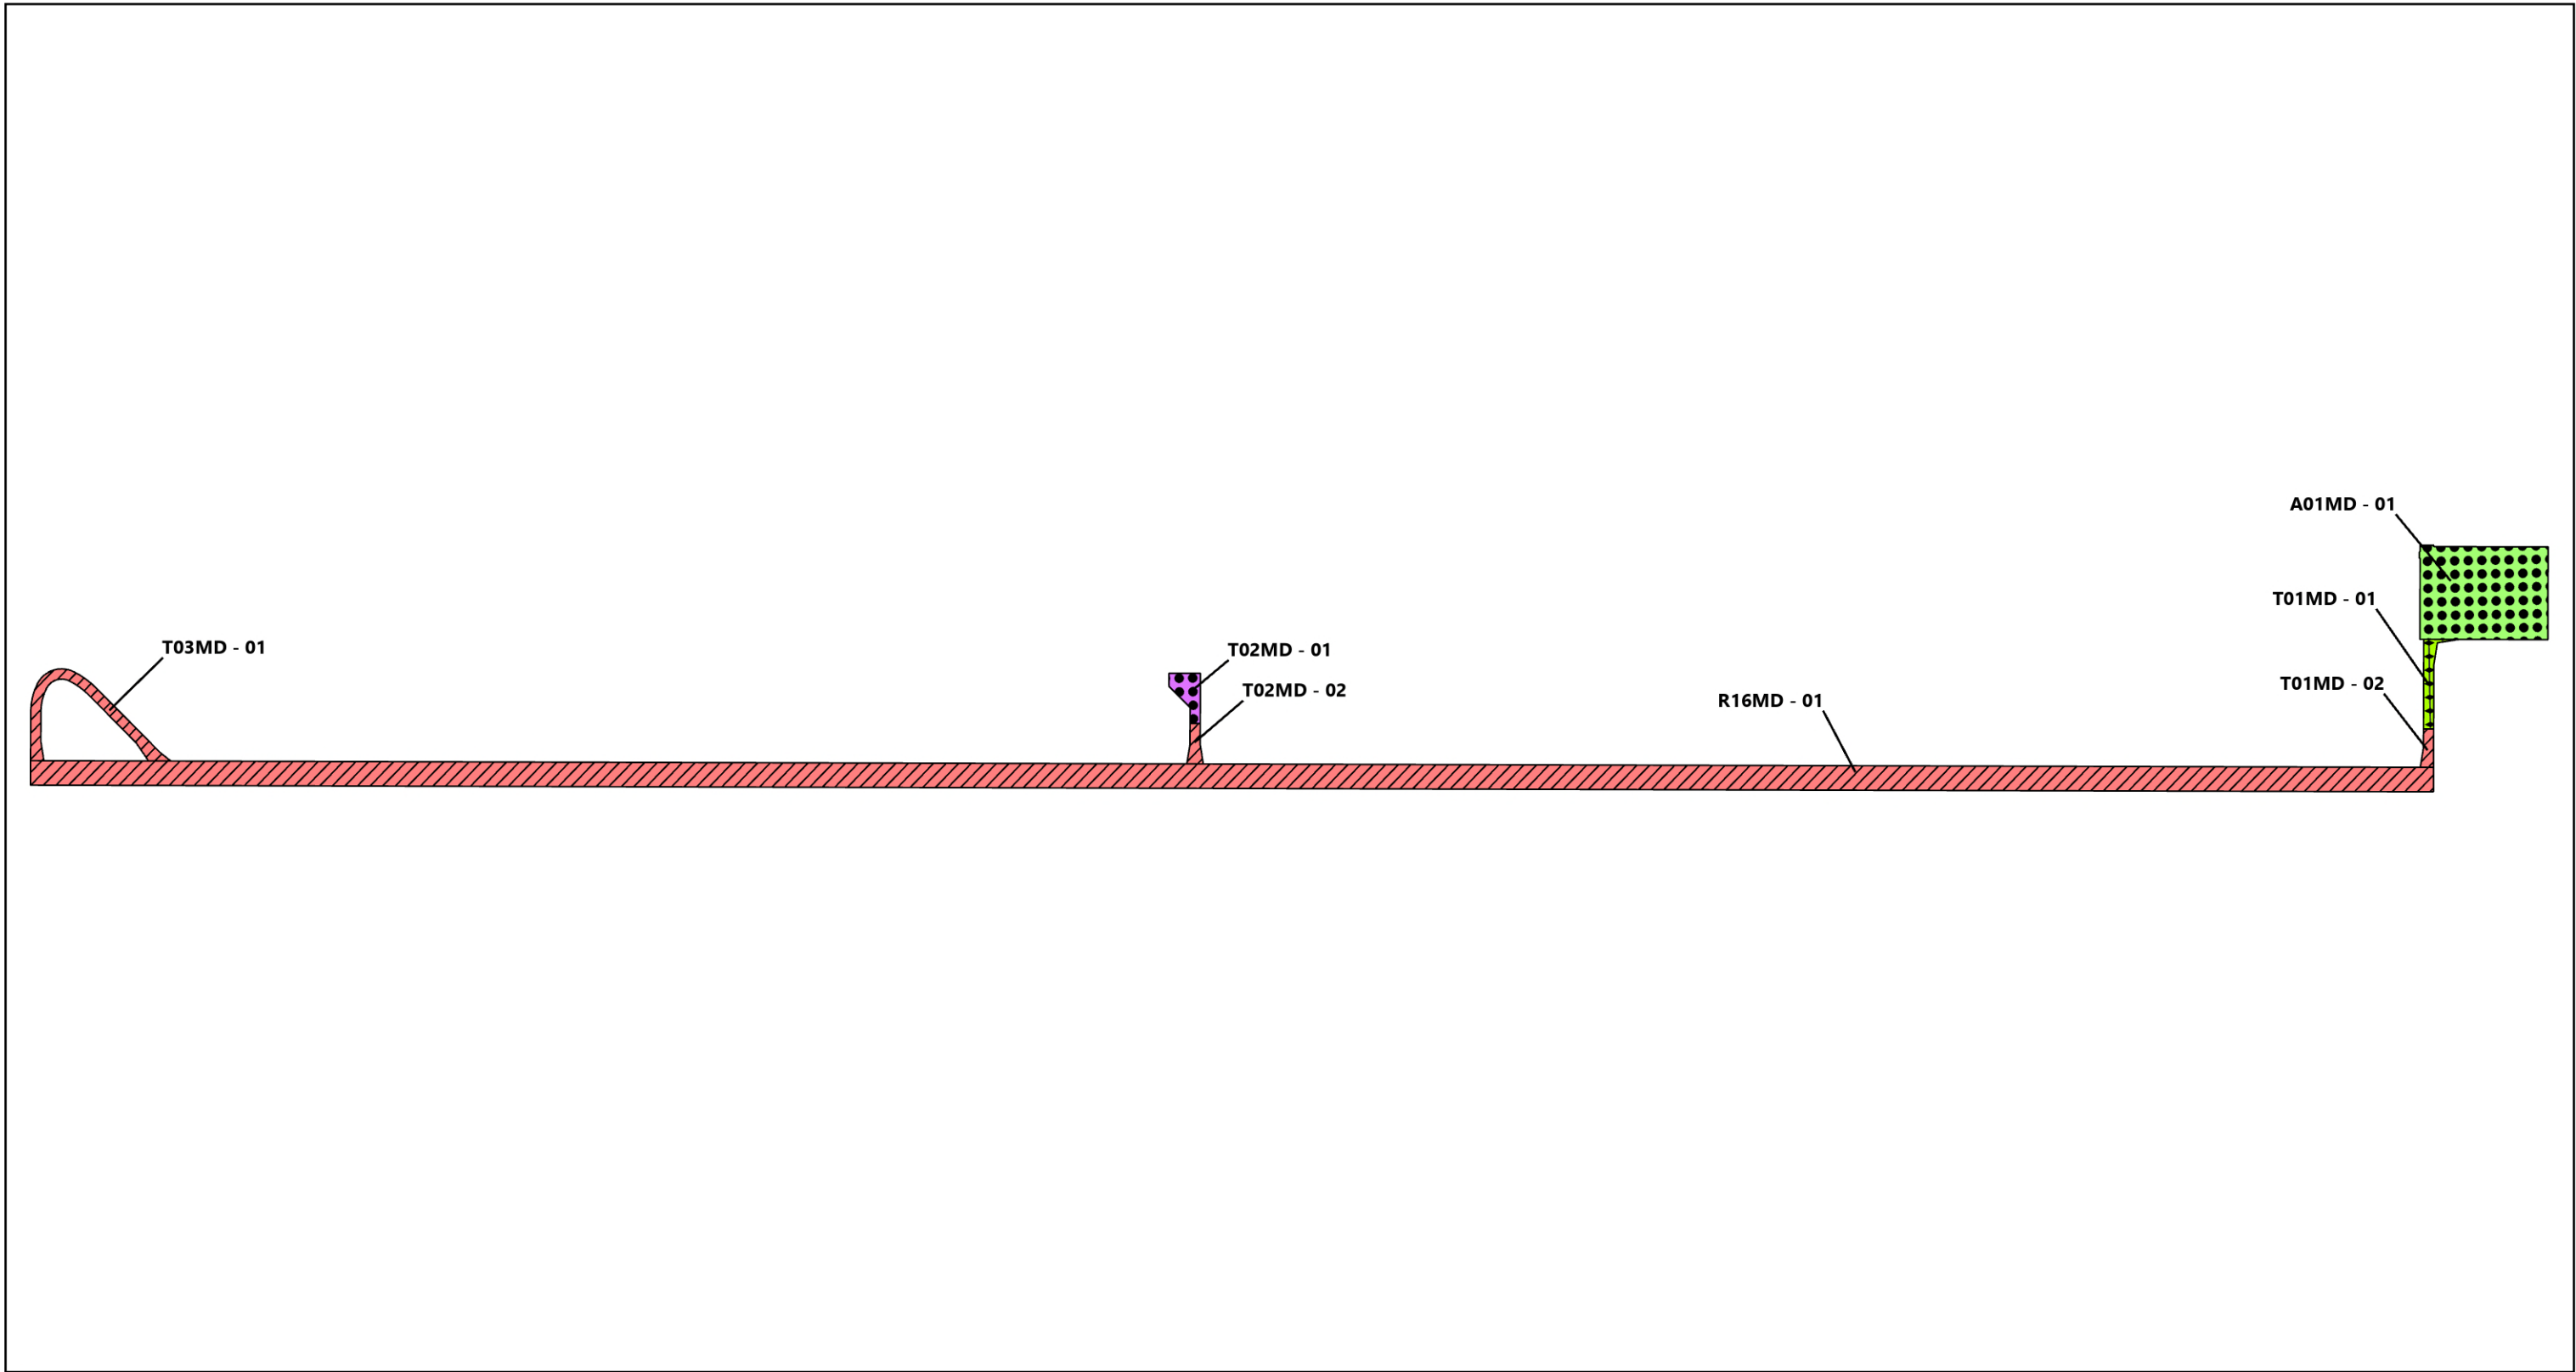
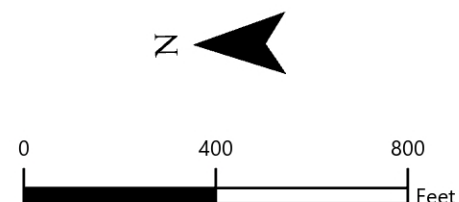
**5-YEAR PAVEMENT MANAGEMENT PLAN
MCDERMITT STATE AIRPORT**

ACTION TIMING		ACTION	
	2024		FOG SEAL
	2025		SLURRY SEAL
	2026		OVERLAY
	2027		RECONSTRUCTION
	2028		ROUTINE MAINTENANCE

To develop the five-year work plan, we first ran the eliminate backlog scenario with the PAVER M&R Work Planning Module in order to generate a list, organized by year, of global and M&R projects. We then reviewed the project list and refined it into practical construction projects for each year. A summary of global and M&R quantities is provided in Table 5-2 below, and maps of the project locations by year are shown on the 5-Year Pavement Management Plan McDermitt State Airport, Figure 5.2. The complete list of recommended global and M&R projects is presented in Table 4D in Appendix D.

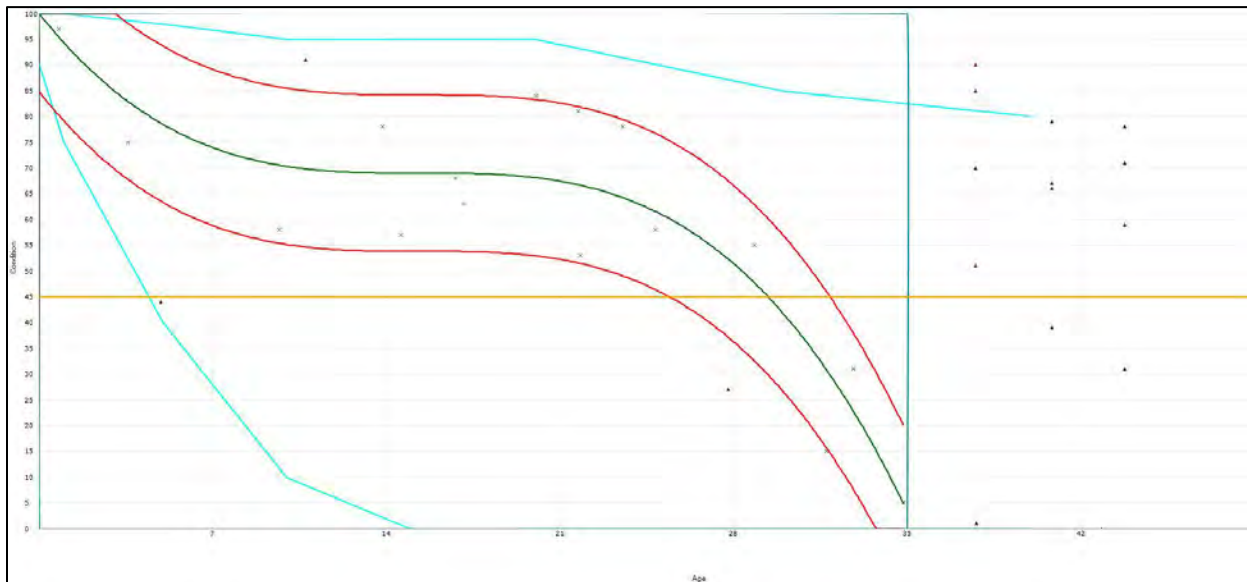
Figure 1C - CONDITION PREDICTION MODEL FOR EASTERN CATEGORY 5 AC AND AAC APRONS

We developed separate condition prediction models for each pavement “family” at McDermitt State Airport. The delineation is based on branch use, surface type, section rank, and structural design life. We use five distinct models for the following “families” of pavements at McDermitt State Airport. For each model, we reviewed the data in order to filter out any inconsistent or inaccurate data or any data that fall outside boundary values set by PAVER. After outliers are removed and the data are checked for accuracy and reasonableness, the PAVER program calculates a best-fit curve using a polynomial-constrained, least-squares analysis procedure. This best-fit curve for each family is used in the analysis to predict the average behavior of all sections within each “family.” Our condition prediction models for each “family” are provided on Figures 1C through 3C below.
