Pavement
Evaluation/
Maintenance
Management Program
2015

Albany Municipal
Airport

**2015 Pavement Evaluation / Maintenance
Management Program**

**Final Report – Individual Airports
Functional Category 4, Central Climatic Zone**

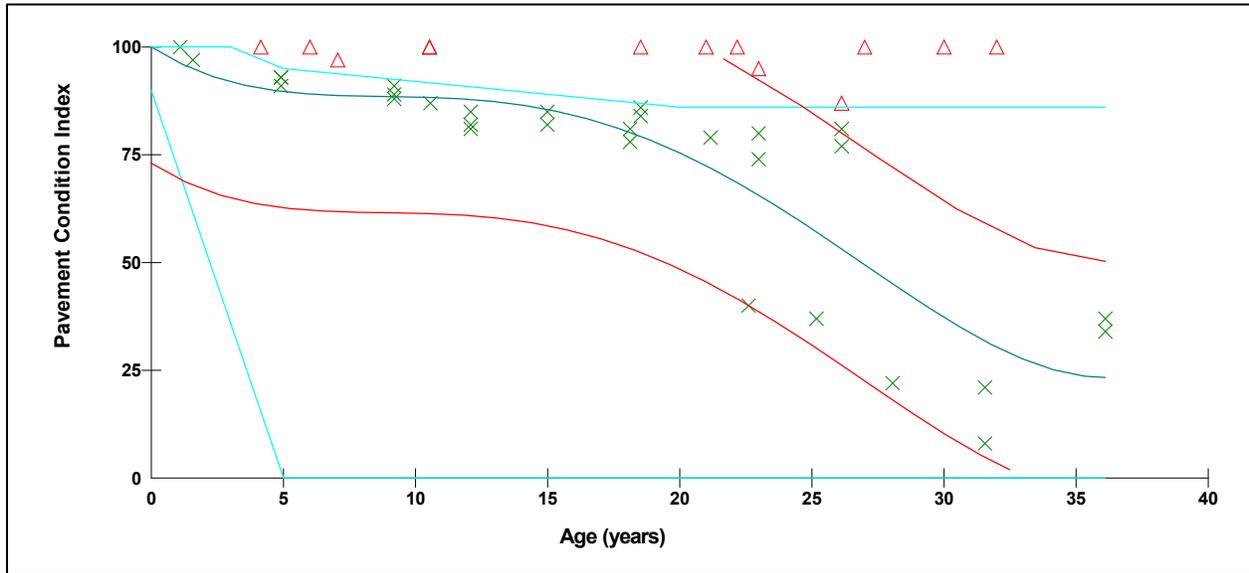
Figure 2. Performance Curve for Category 4 AAC Aprons – Central Oregon.

To allow future pavement condition to be predicted, data collected throughout the State were used to generate "performance curves". The curves were developed based on surface type, use, airport functional category and climatic region. These curves (models) are used to predict future pavement condition by assuming the behavior of an individual pavement section is similar to the behavior of the pavement sections used to generate the "performance curve". Figures 2 through 9 show the "performance curves" used to model pavements in your airport's functional category and climatic region.

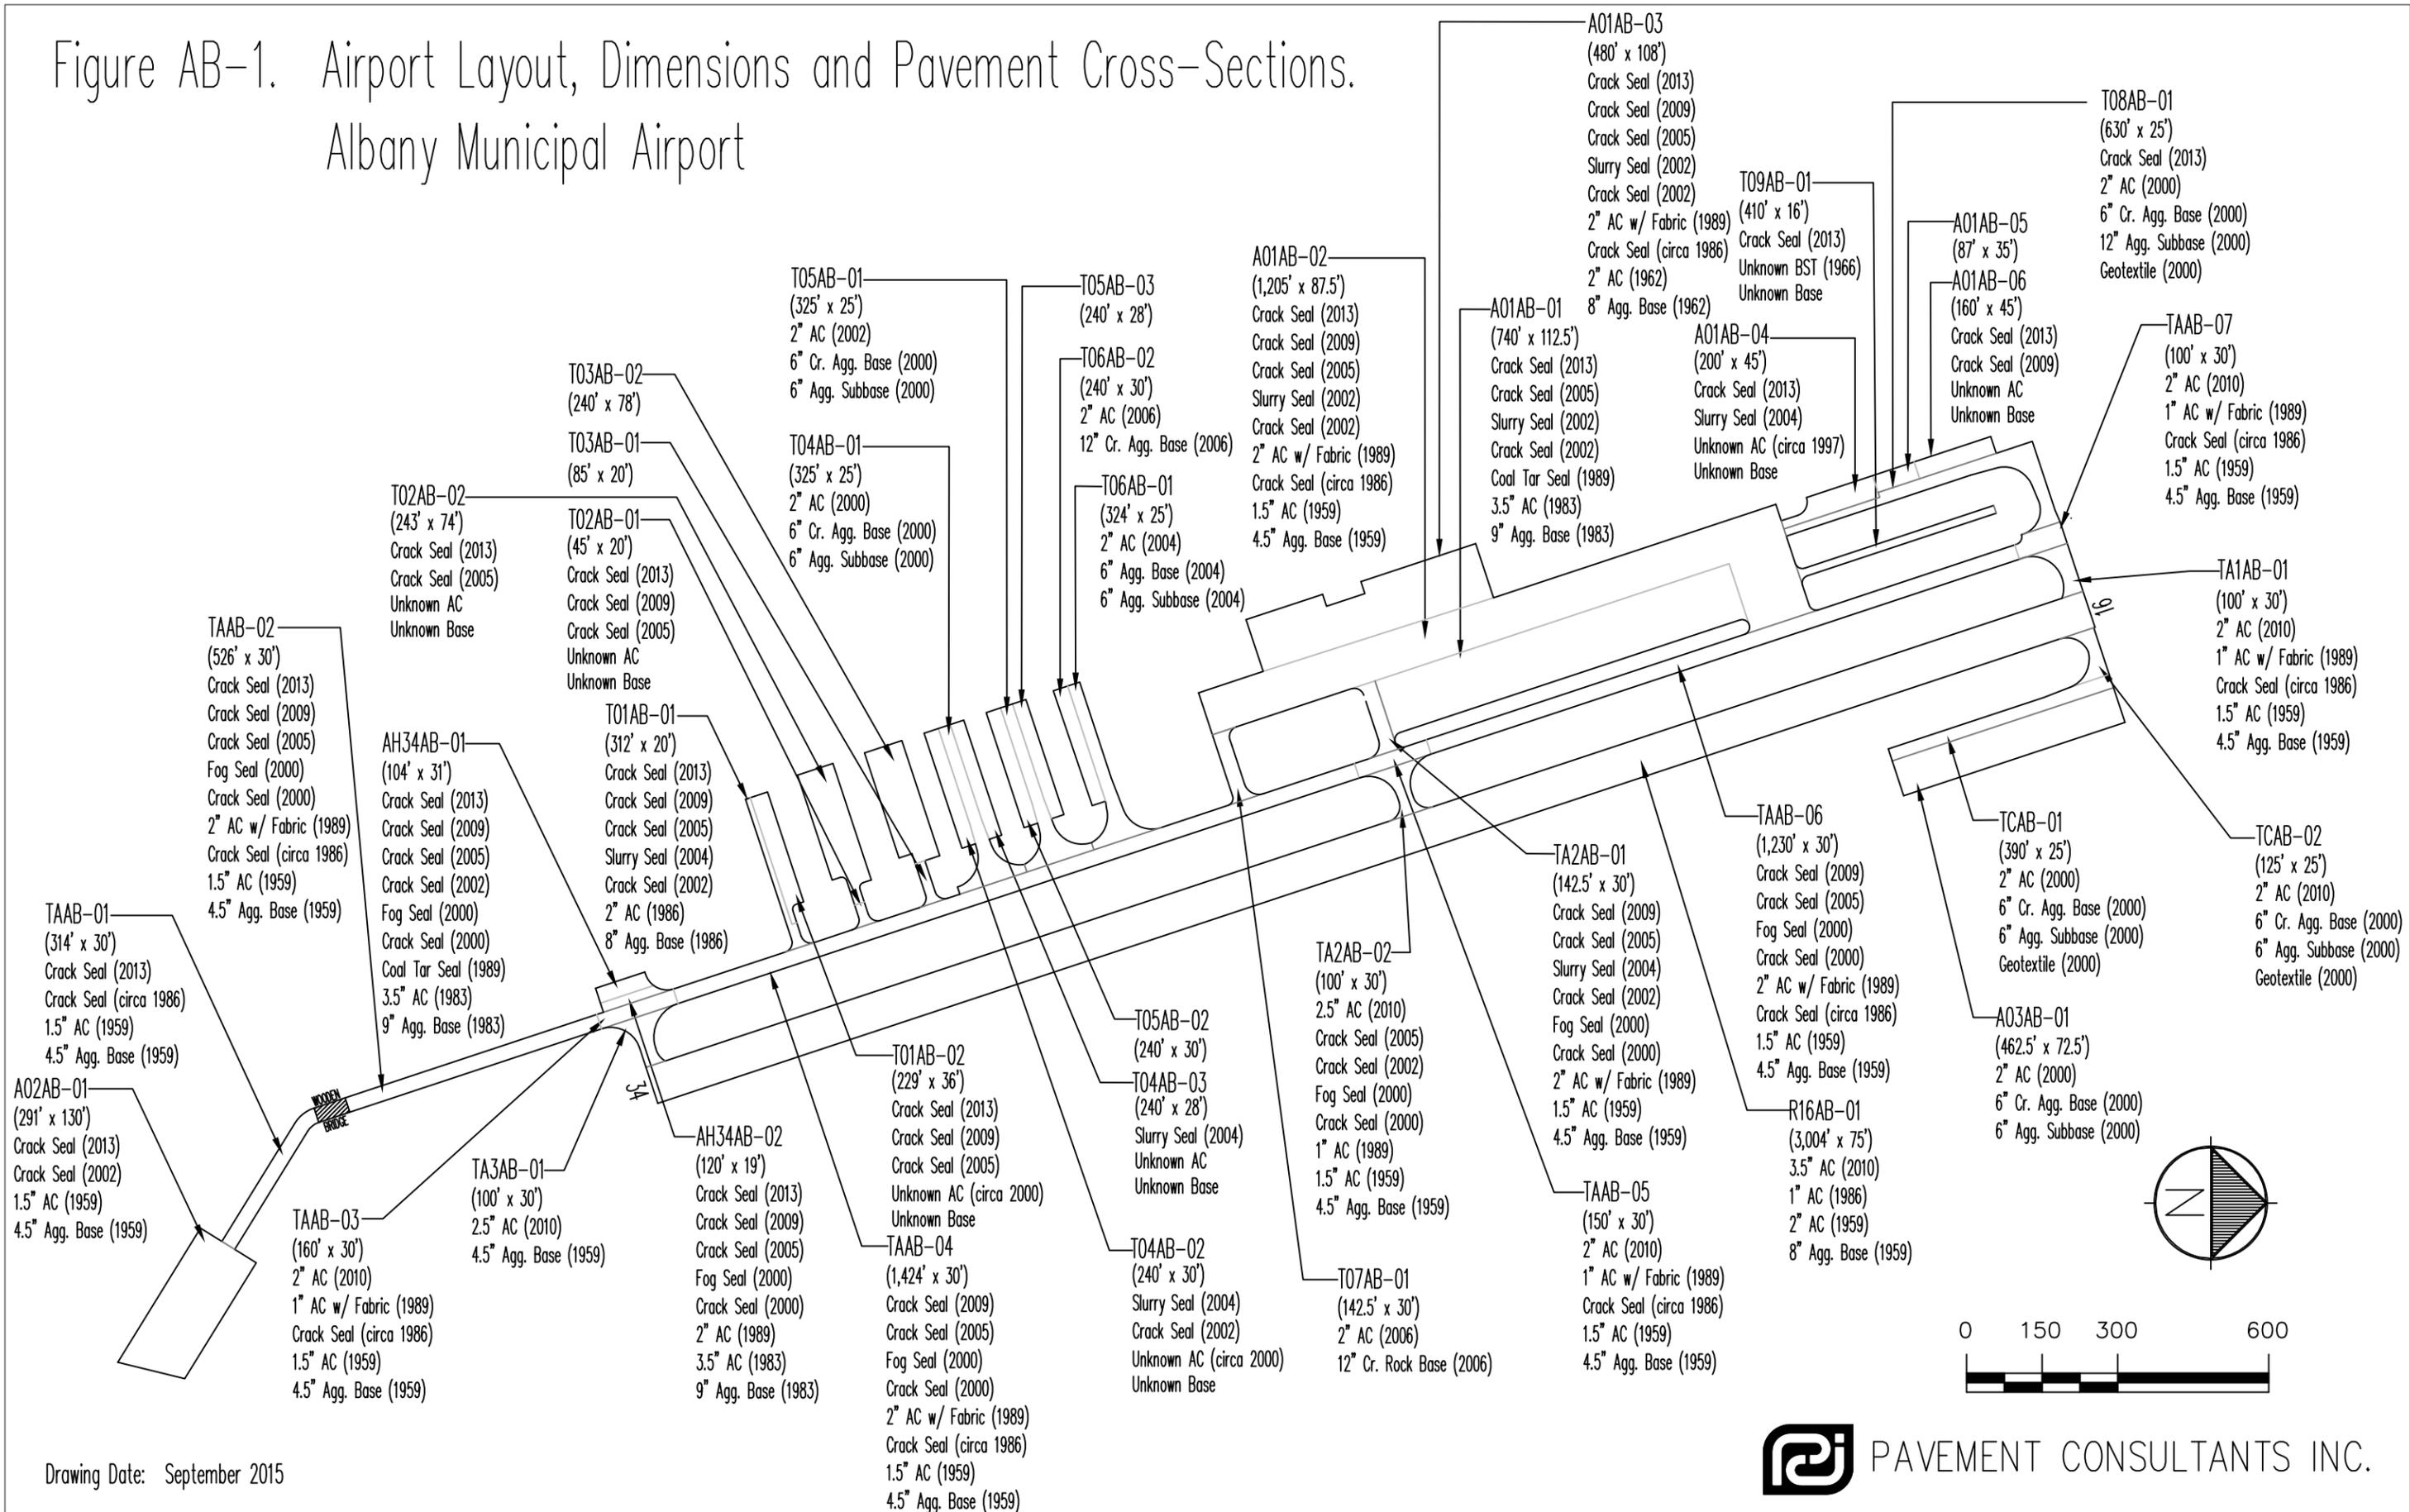
Figure AB-1. Airport Layout, Dimensions and Pavement Cross-Sections.
Albany Municipal Airport

To determine how your pavements were constructed and their age, a records review was conducted. Figure AB-1 shows the records review results. This figure identifies pavement boundaries, dimensions, pavement layer types, thicknesses and dates of construction. The most recent construction date for each pavement can also be found in the Section Condition Report in Appendix 2. Figure AB-1 and the information contained in Appendices 1, 2 and 4 ensure that your airport complies with the “pavement inventory” requirement of FAA’s PMMP guidelines.

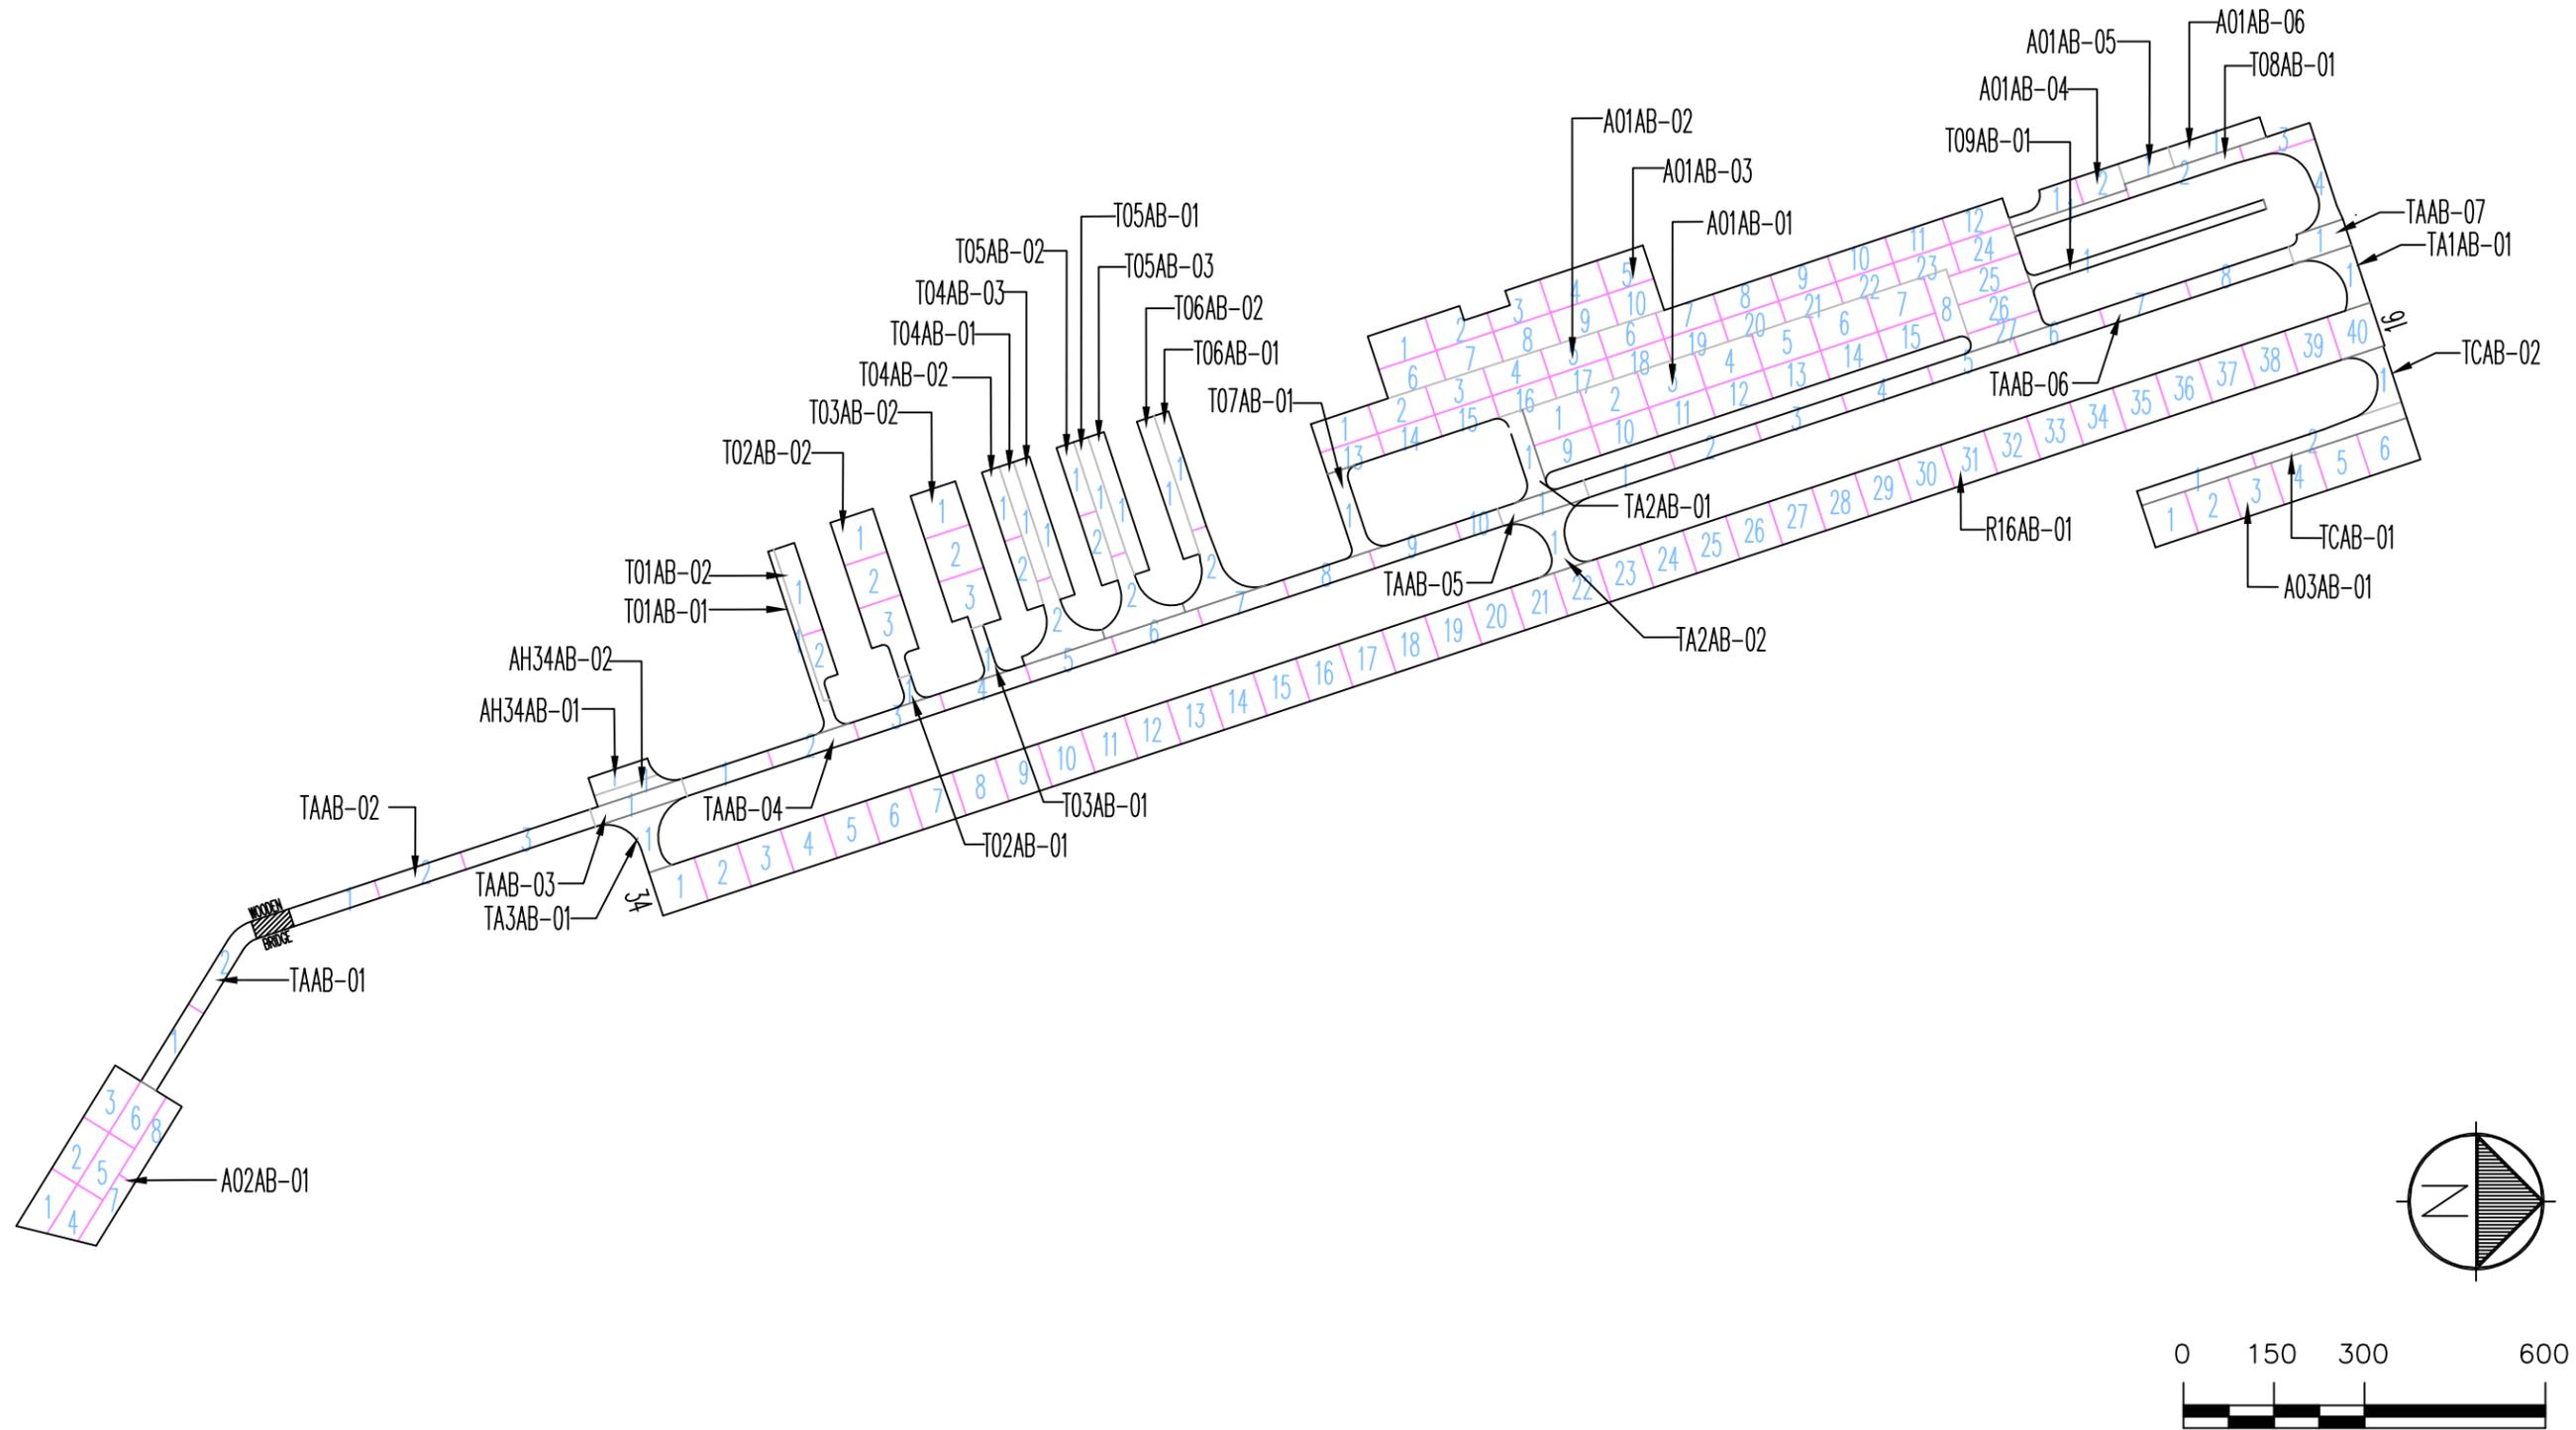
Figure AB-2. Pavement Branch, Section and Sample Unit Layout.
Albany Municipal Airport

The pavements at your airport were divided into branches, sections and sample units in accordance with the methodology outlined in the current edition of ASTM D5430, *Standard Test Method for Airport Condition Index Surveys*. The branches, sections and sample units established at your airport are shown in Figure AB-2. A Branch Condition Report showing all branches, their associated areas, and their area-weighted average condition is provided in Appendix 1. Additionally, the Appendix 2 Section Condition Report provides information used to define each branch and section in the Micro PAVER database.

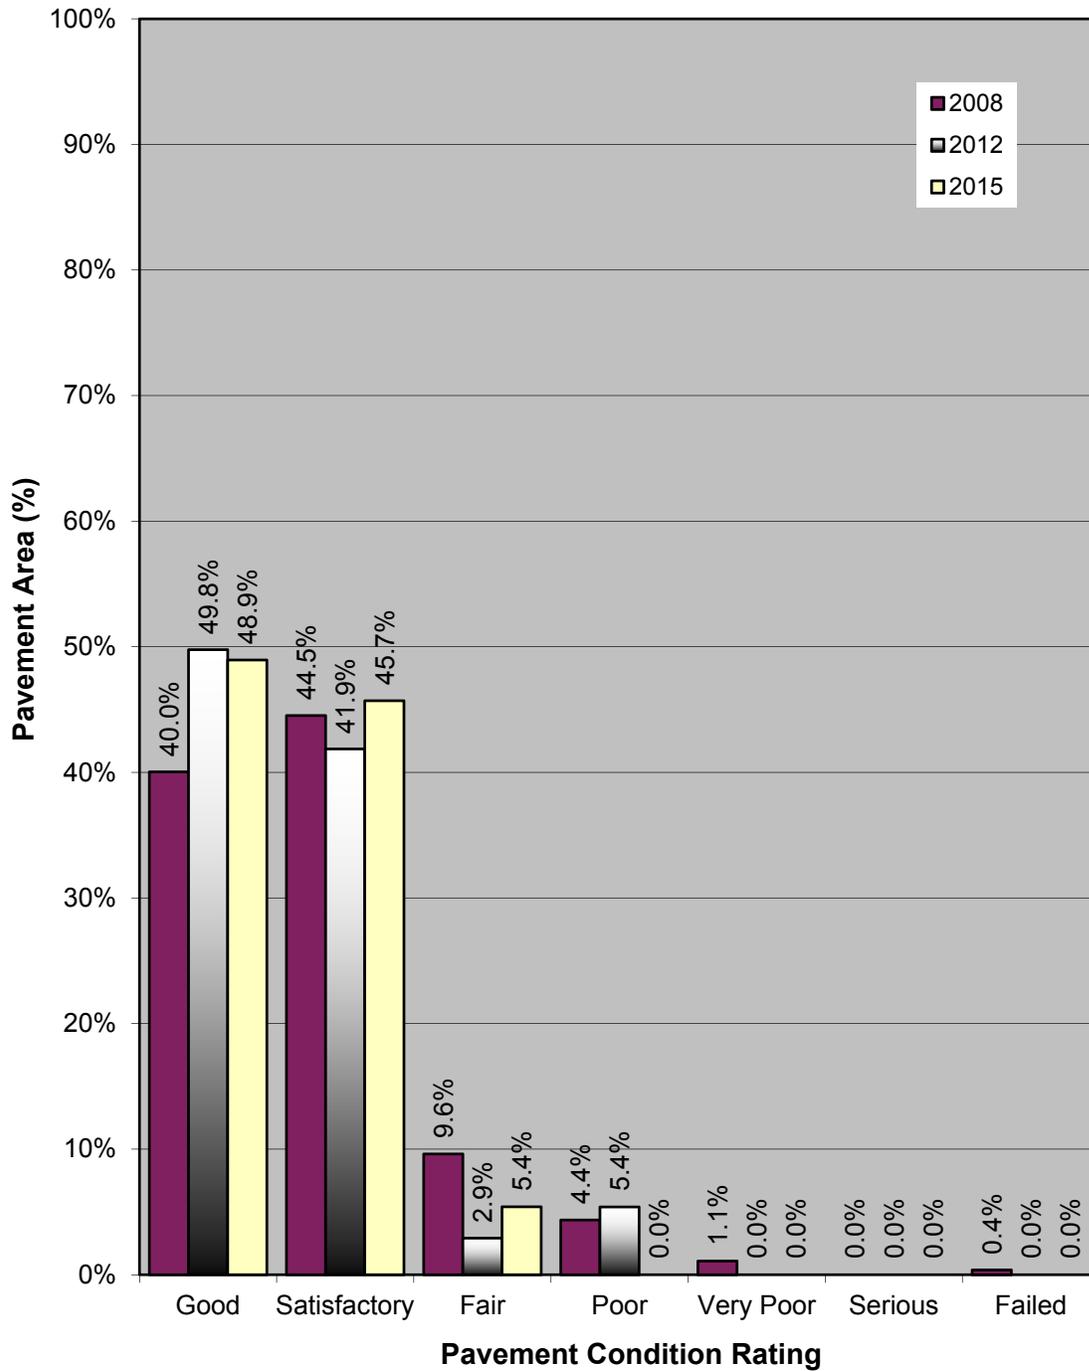
**Figure AB-4. Pavement Condition Distribution
Albany Municipal Airport**

Section PCIs at Albany Municipal Airport range from a low of 64 (a PCR of “Fair”) to a high of 100 (a PCR of “Good”). The area-weighted average PCI for all airport pavements is 86, corresponding to an overall PCR of “Good”. Figure AB-4 shows how much pavement area is associated with each Pavement Condition Rating category and also shows pavement condition distribution from the inspections conducted in 2008 and 2012.

The primary distresses observed during the inspection were: longitudinal and transverse cracking, depressions, weathering, block cracking, alligator cracking, and patching cracking.

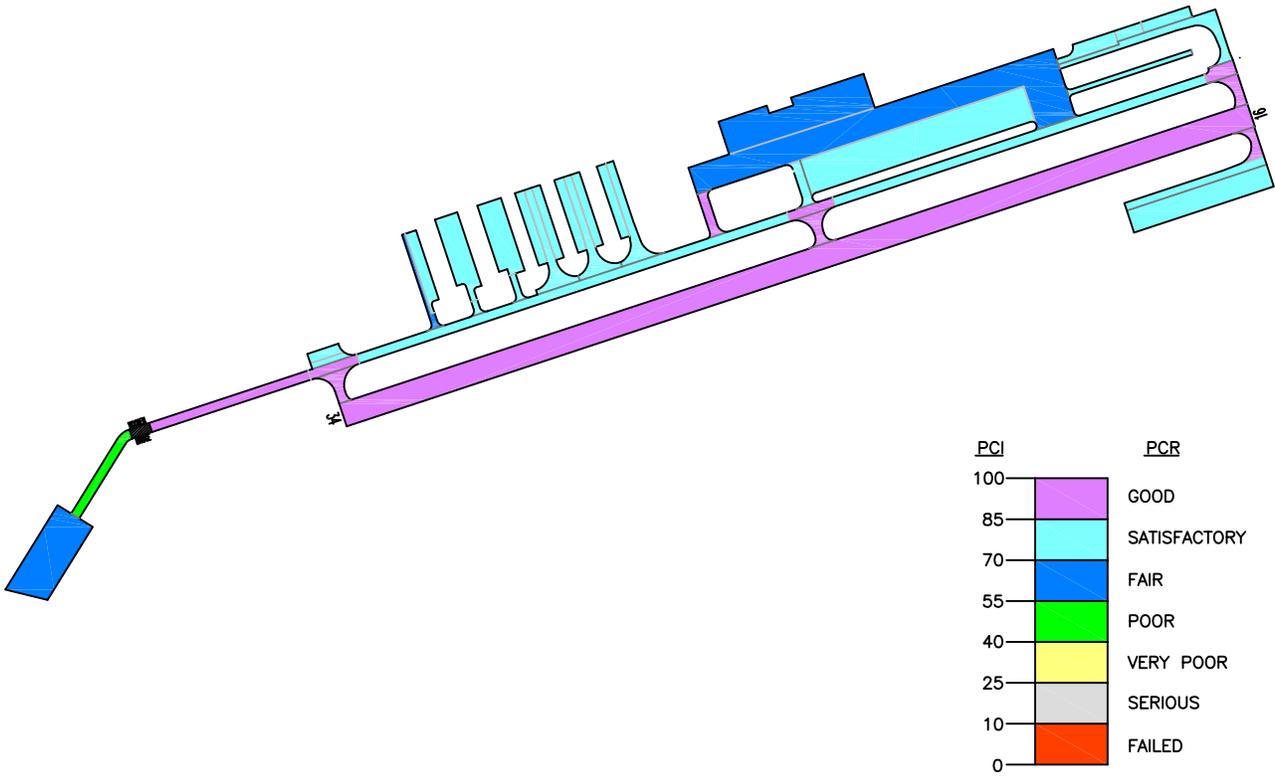
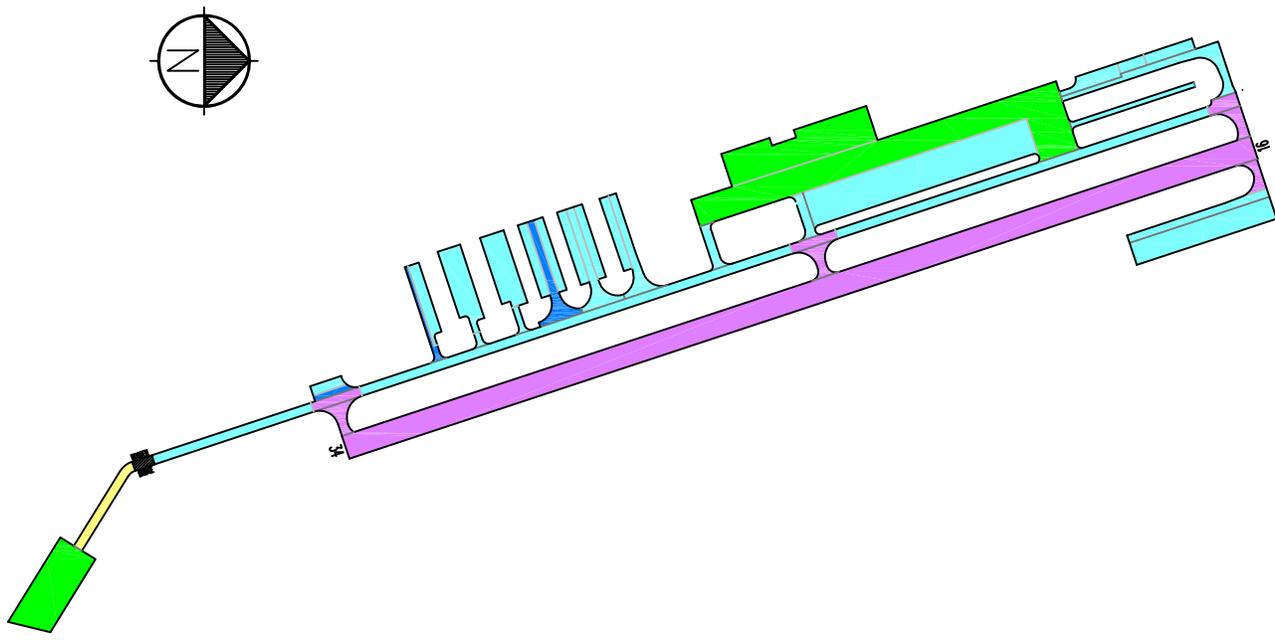
Figure AB-5. Future Pavement Condition.

A graphical representation of the projected PCIs listed in Table 1 is shown in Figure AB-5.

Predicted Condition in 2020.

Predicted Condition in 2025.

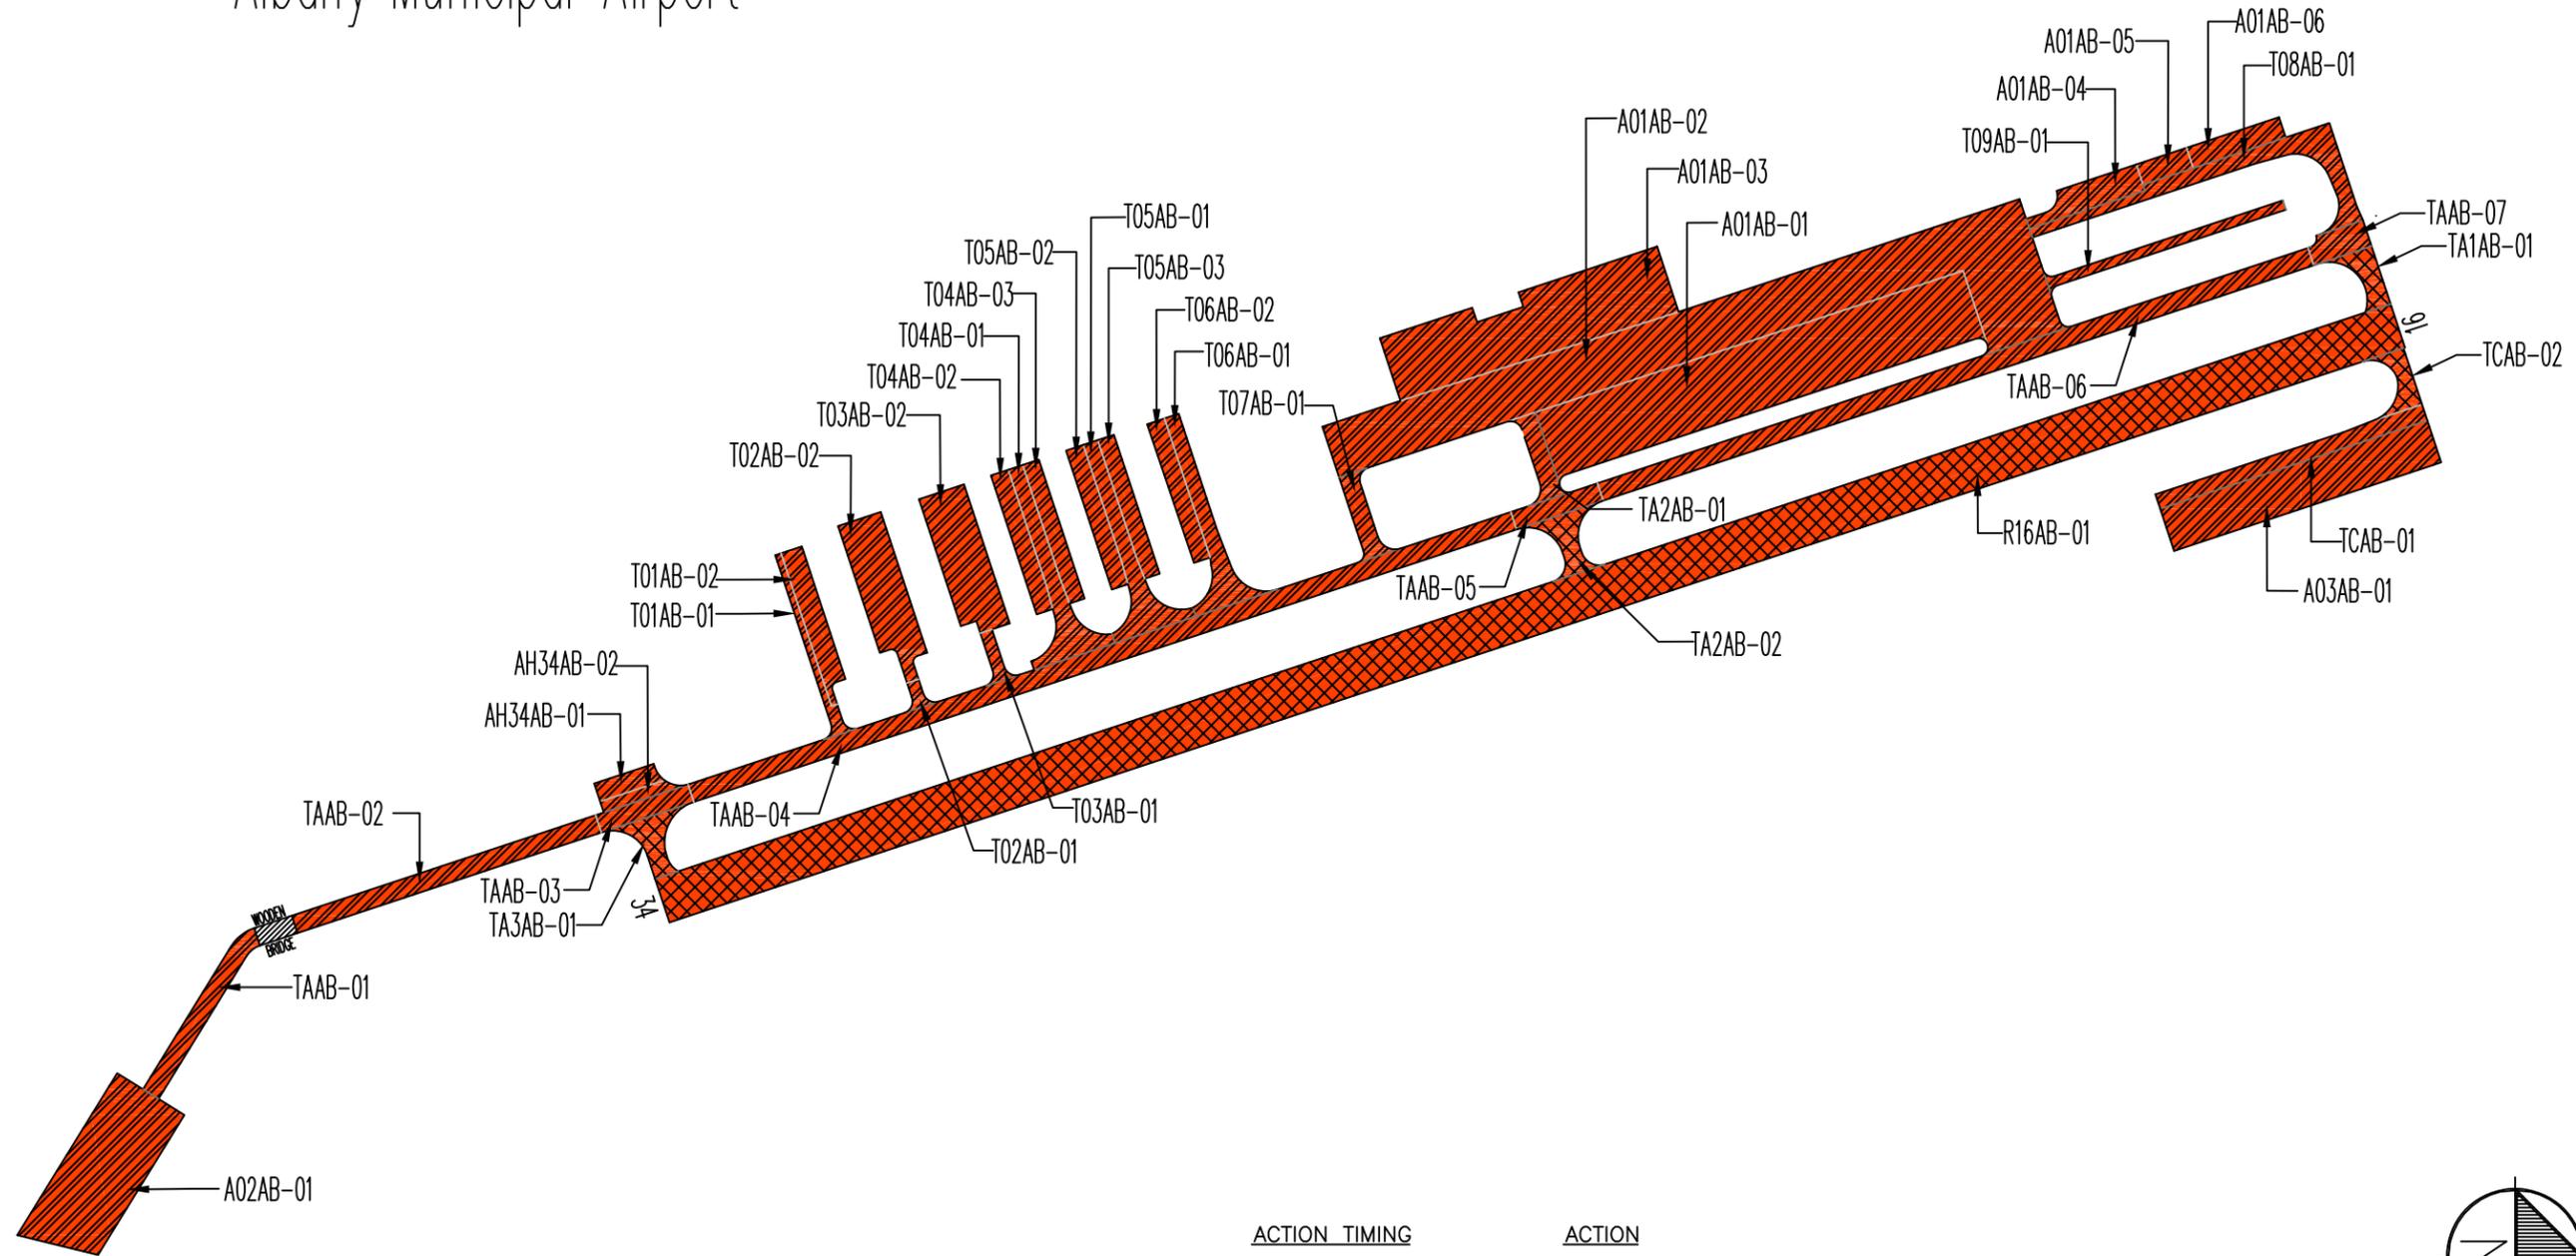
Figure AB-6. Five-Year Pavement Management Plan.
Albany Municipal Airport

During this project a 5-year program outlining recommended global maintenance and rehabilitation was developed. The program begins in the year 2016 to allow time for project development. These recommendations are presented in Table 2, which identifies the pavement section requiring rehabilitation, the year the action should be completed, the type of action, and an associated cost. This information is also presented graphically in Figure AB-6.

If the global maintenance and/or rehabilitation activities recommended in Table 2 are not completed, the localized maintenance activities identified in the Network Maintenance Report (Appendix 3) for that section should be done. Additionally, for those sections not listed in Table 2 as requiring global maintenance or rehabilitation, the localized maintenance activities outlined in the Network Maintenance Report should be completed. By completing the localized maintenance activities, pavement condition is improved, life is extended, deterioration is slowed and the length of time until major repair or rehabilitation is required is increased.
