Pavement  
Evaluation/  
Maintenance  
Management Program  
2013

Brookings Airport

**2013 Pavement Evaluation / Maintenance  
Management Program**

**Final Report – Individual Airports  
Functional Category 4, Coastal Climatic Zone**

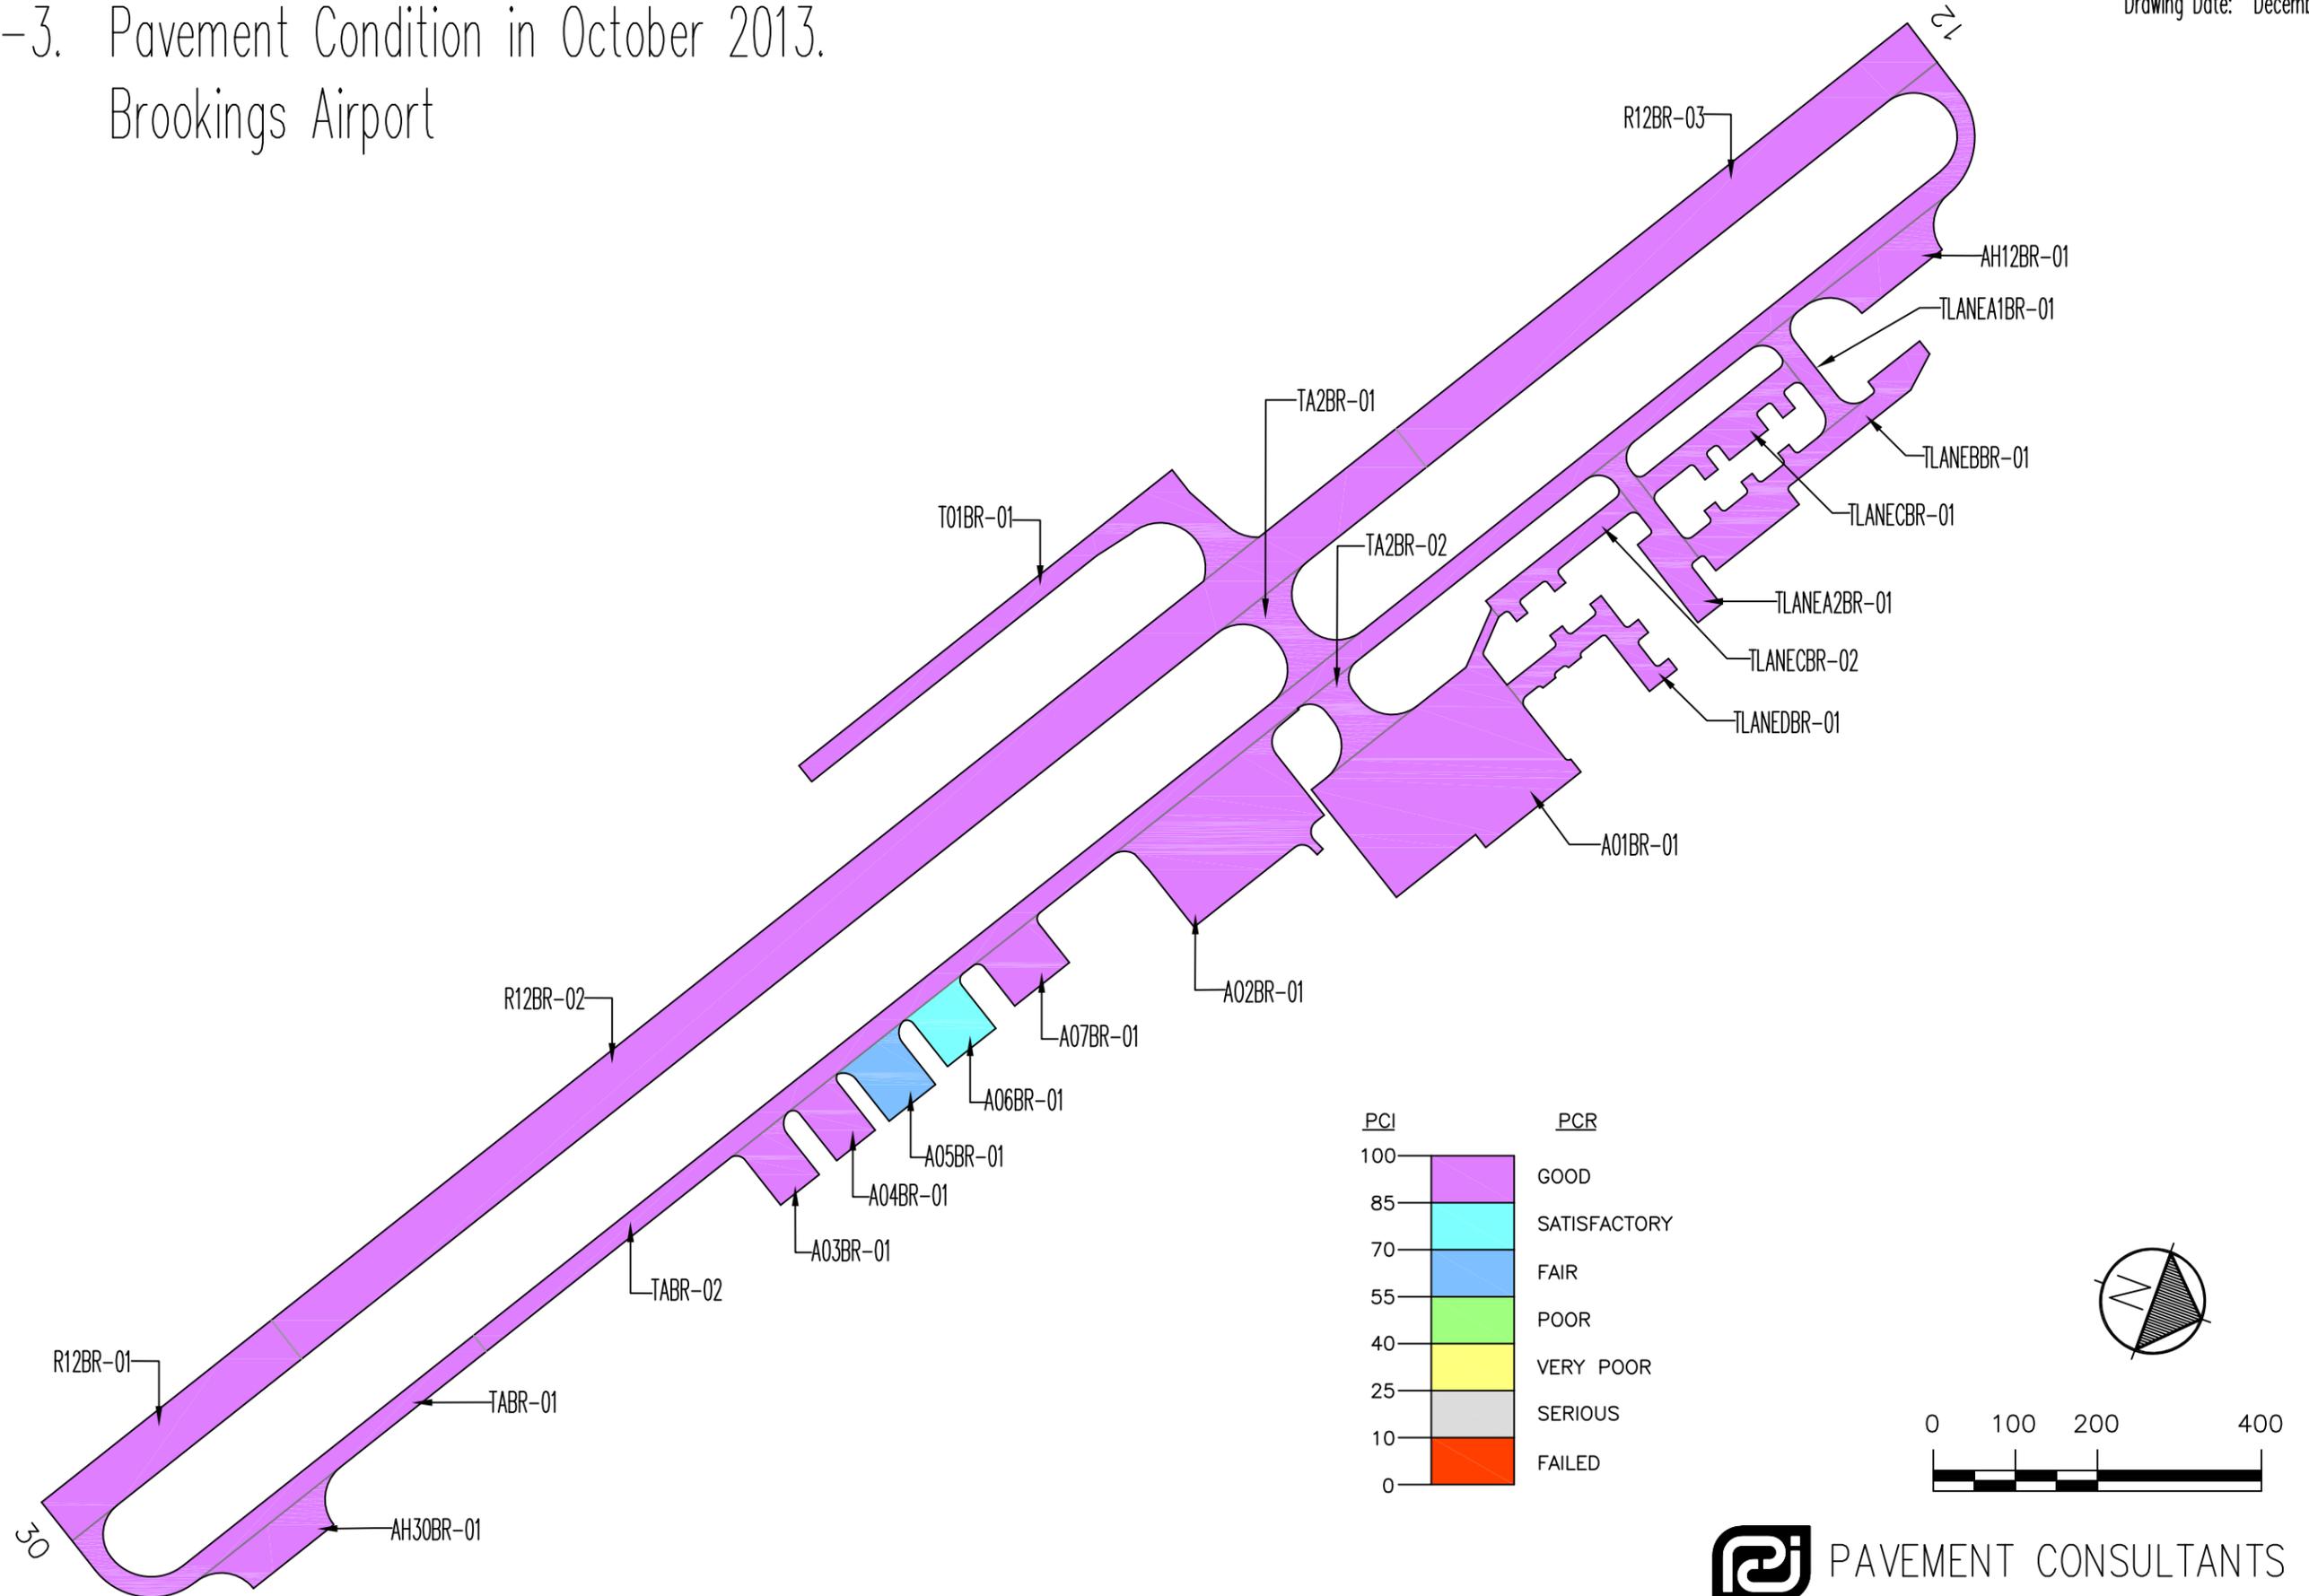
Figure BR-3. Pavement Condition in October 2013.  
Brookings Airport

The Branch Condition Report in Appendix 1 summarizes current pavement condition by branch while the Section Condition Report in Appendix 2 lists pavement condition by section. The current PCR is shown graphically in Figure BR-3.

Section PCIs at Brookings Airport range from a low of 64 (a PCR of “Fair”) to a high of 100 (a PCR of “Good”). The area-weighted average PCI for all airport pavements is 96, corresponding to an overall PCR of “Good”. Figure BR-4 shows how much pavement area is associated with each Pavement Condition Rating category and also shows pavement condition distribution from the inspections conducted in 2005 and 2009.
