PAISLEY AIRPORT

This report describes how your Pavement Maintenance Management Program (PMMP) was developed. Your Program was developed as part of the Oregon Continuous Aviation System Plan sponsored in part by the Oregon Department of Aviation and the Federal Aviation Administration (FAA). The information and data contained in this report ensures you are in compliance with the requirements of FAA Grant Assurance Number 11 which states that any airport requesting federal funds for pavement improvement projects must have implemented a pavement maintenance management program.

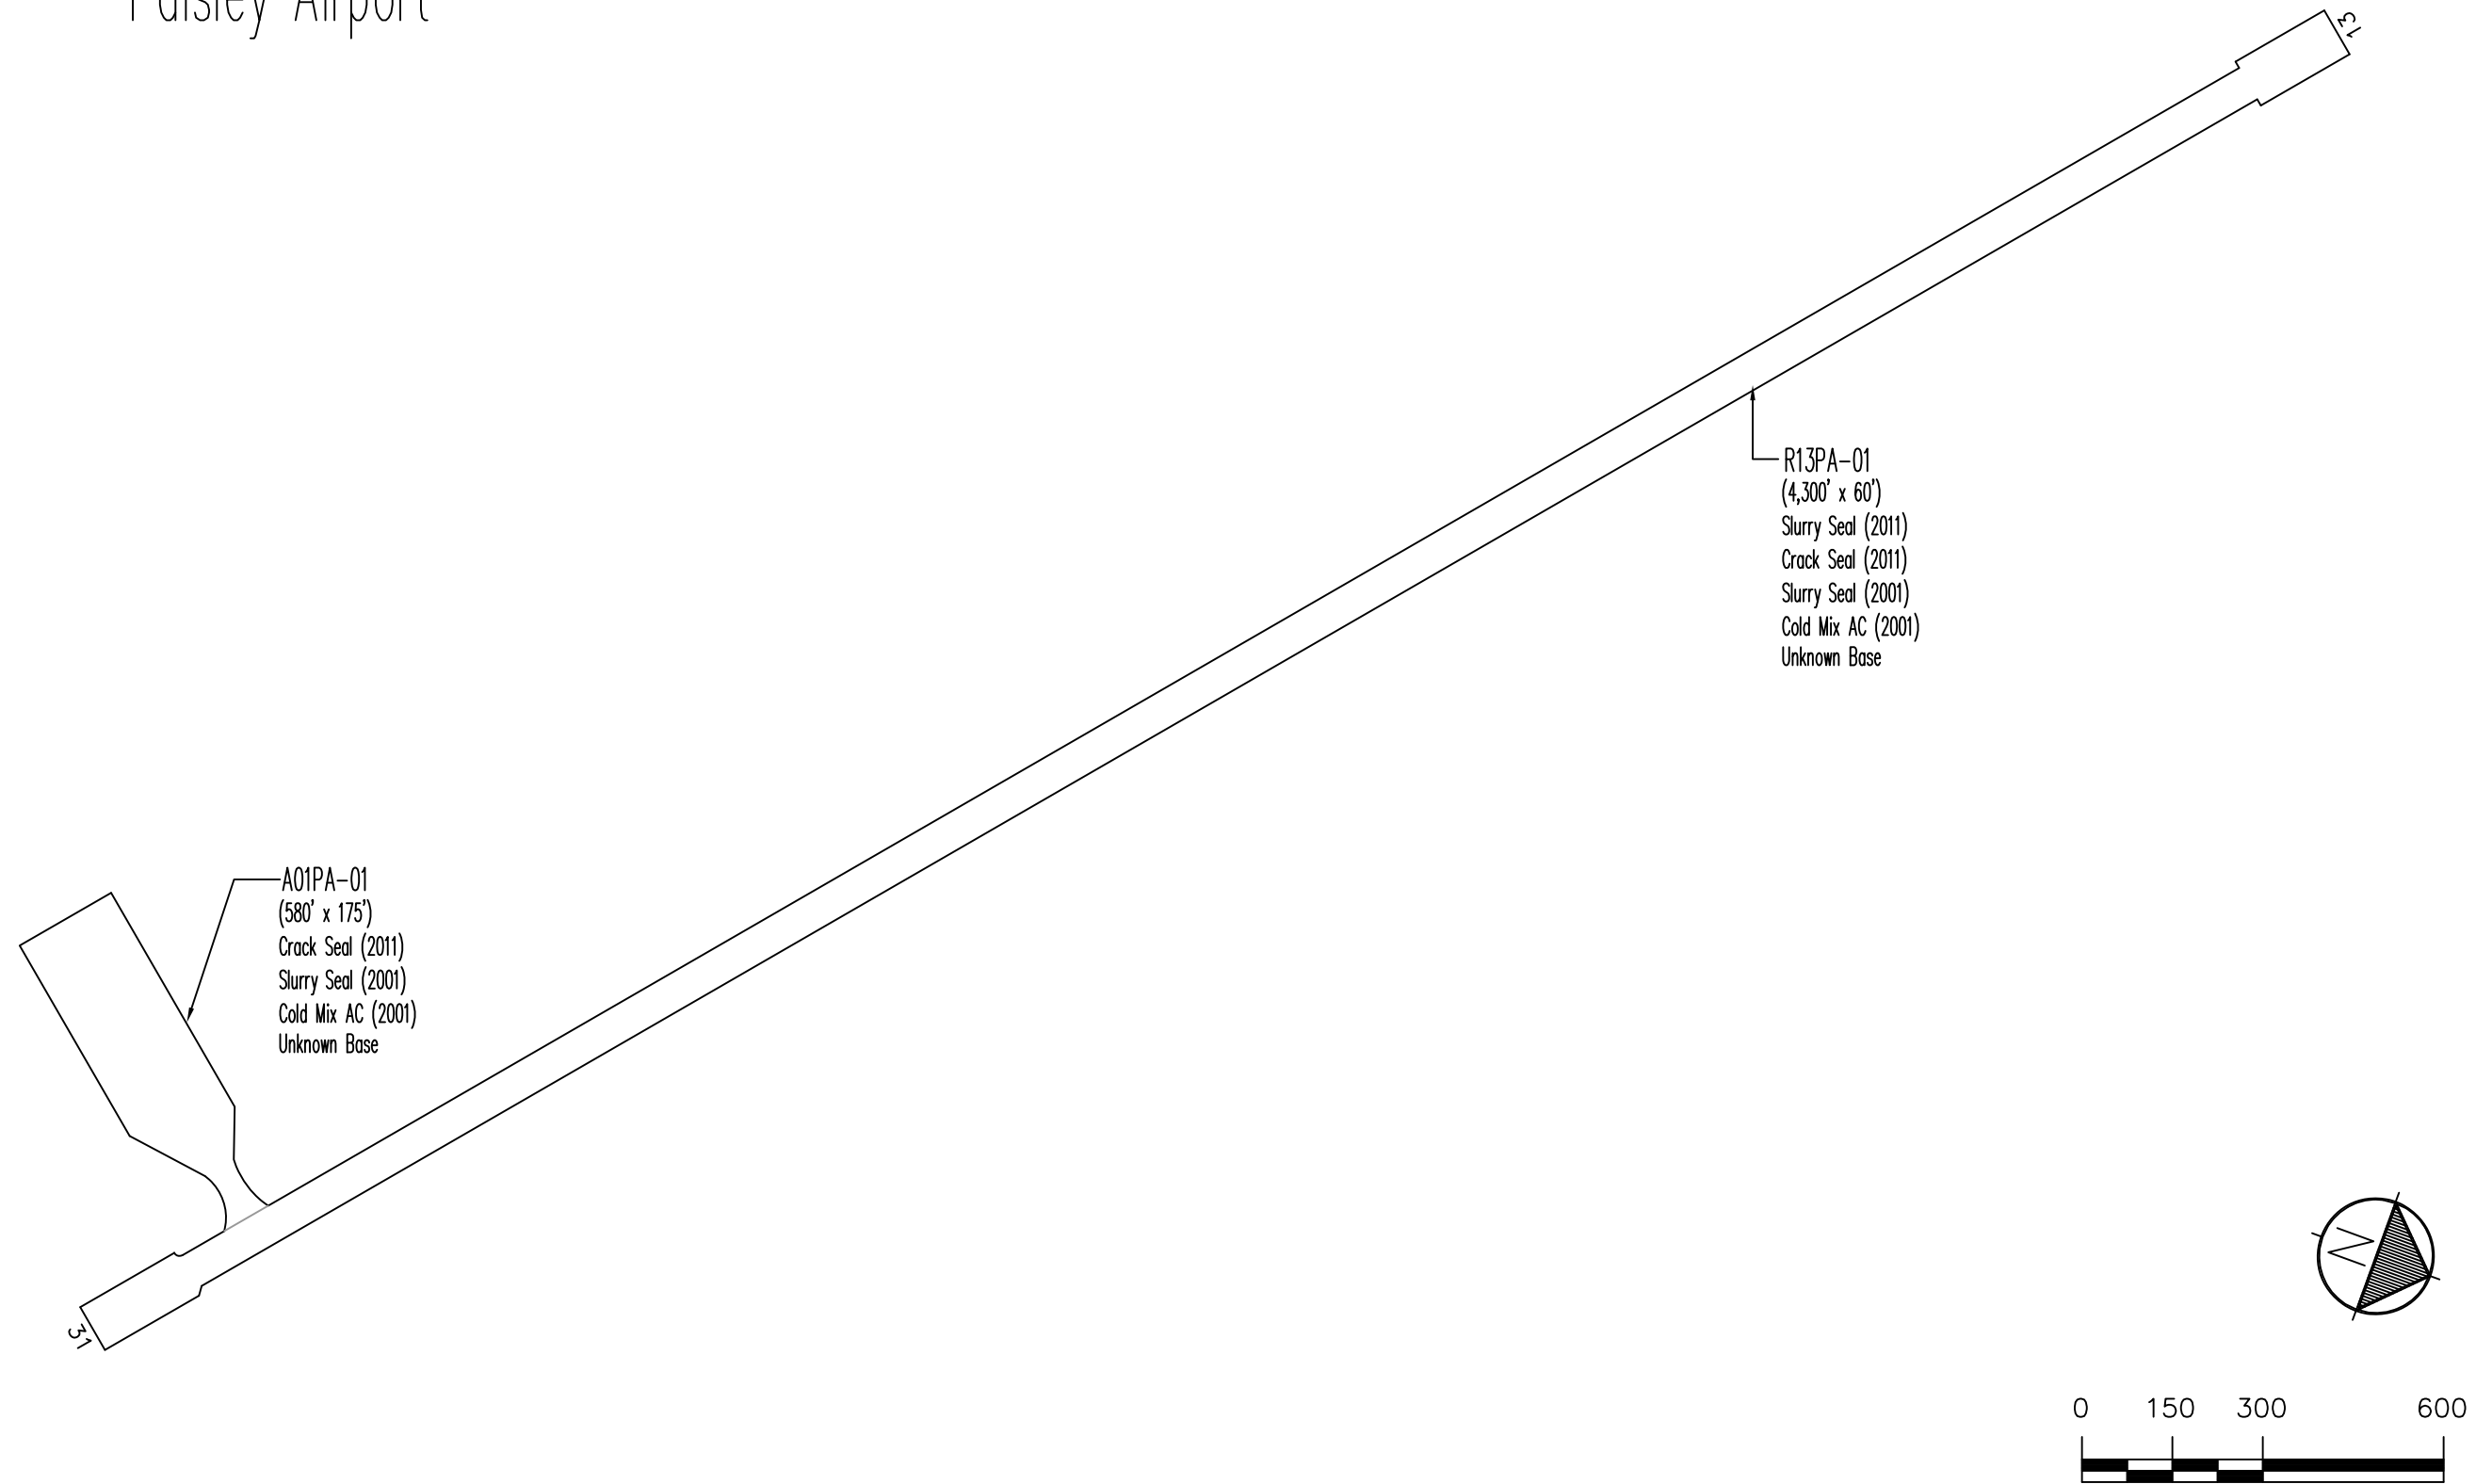
Figure PA-1. Airport Layout, Dimensions and Pavement Cross-Sections.
Paisley Airport

To determine how your pavements were constructed and their age, a records review was conducted. Figure PA-1 shows the records review results. This figure identifies pavement boundaries, dimensions, pavement layer types, thicknesses and dates of construction. The most recent construction date for each pavement can also be found in the Section Condition Report in Appendix 2. Figure PA-1 and the information contained in Appendices 1, 2 and 4 ensure that your airport complies with the “pavement inventory” requirement of FAA’s PMMP guidelines.

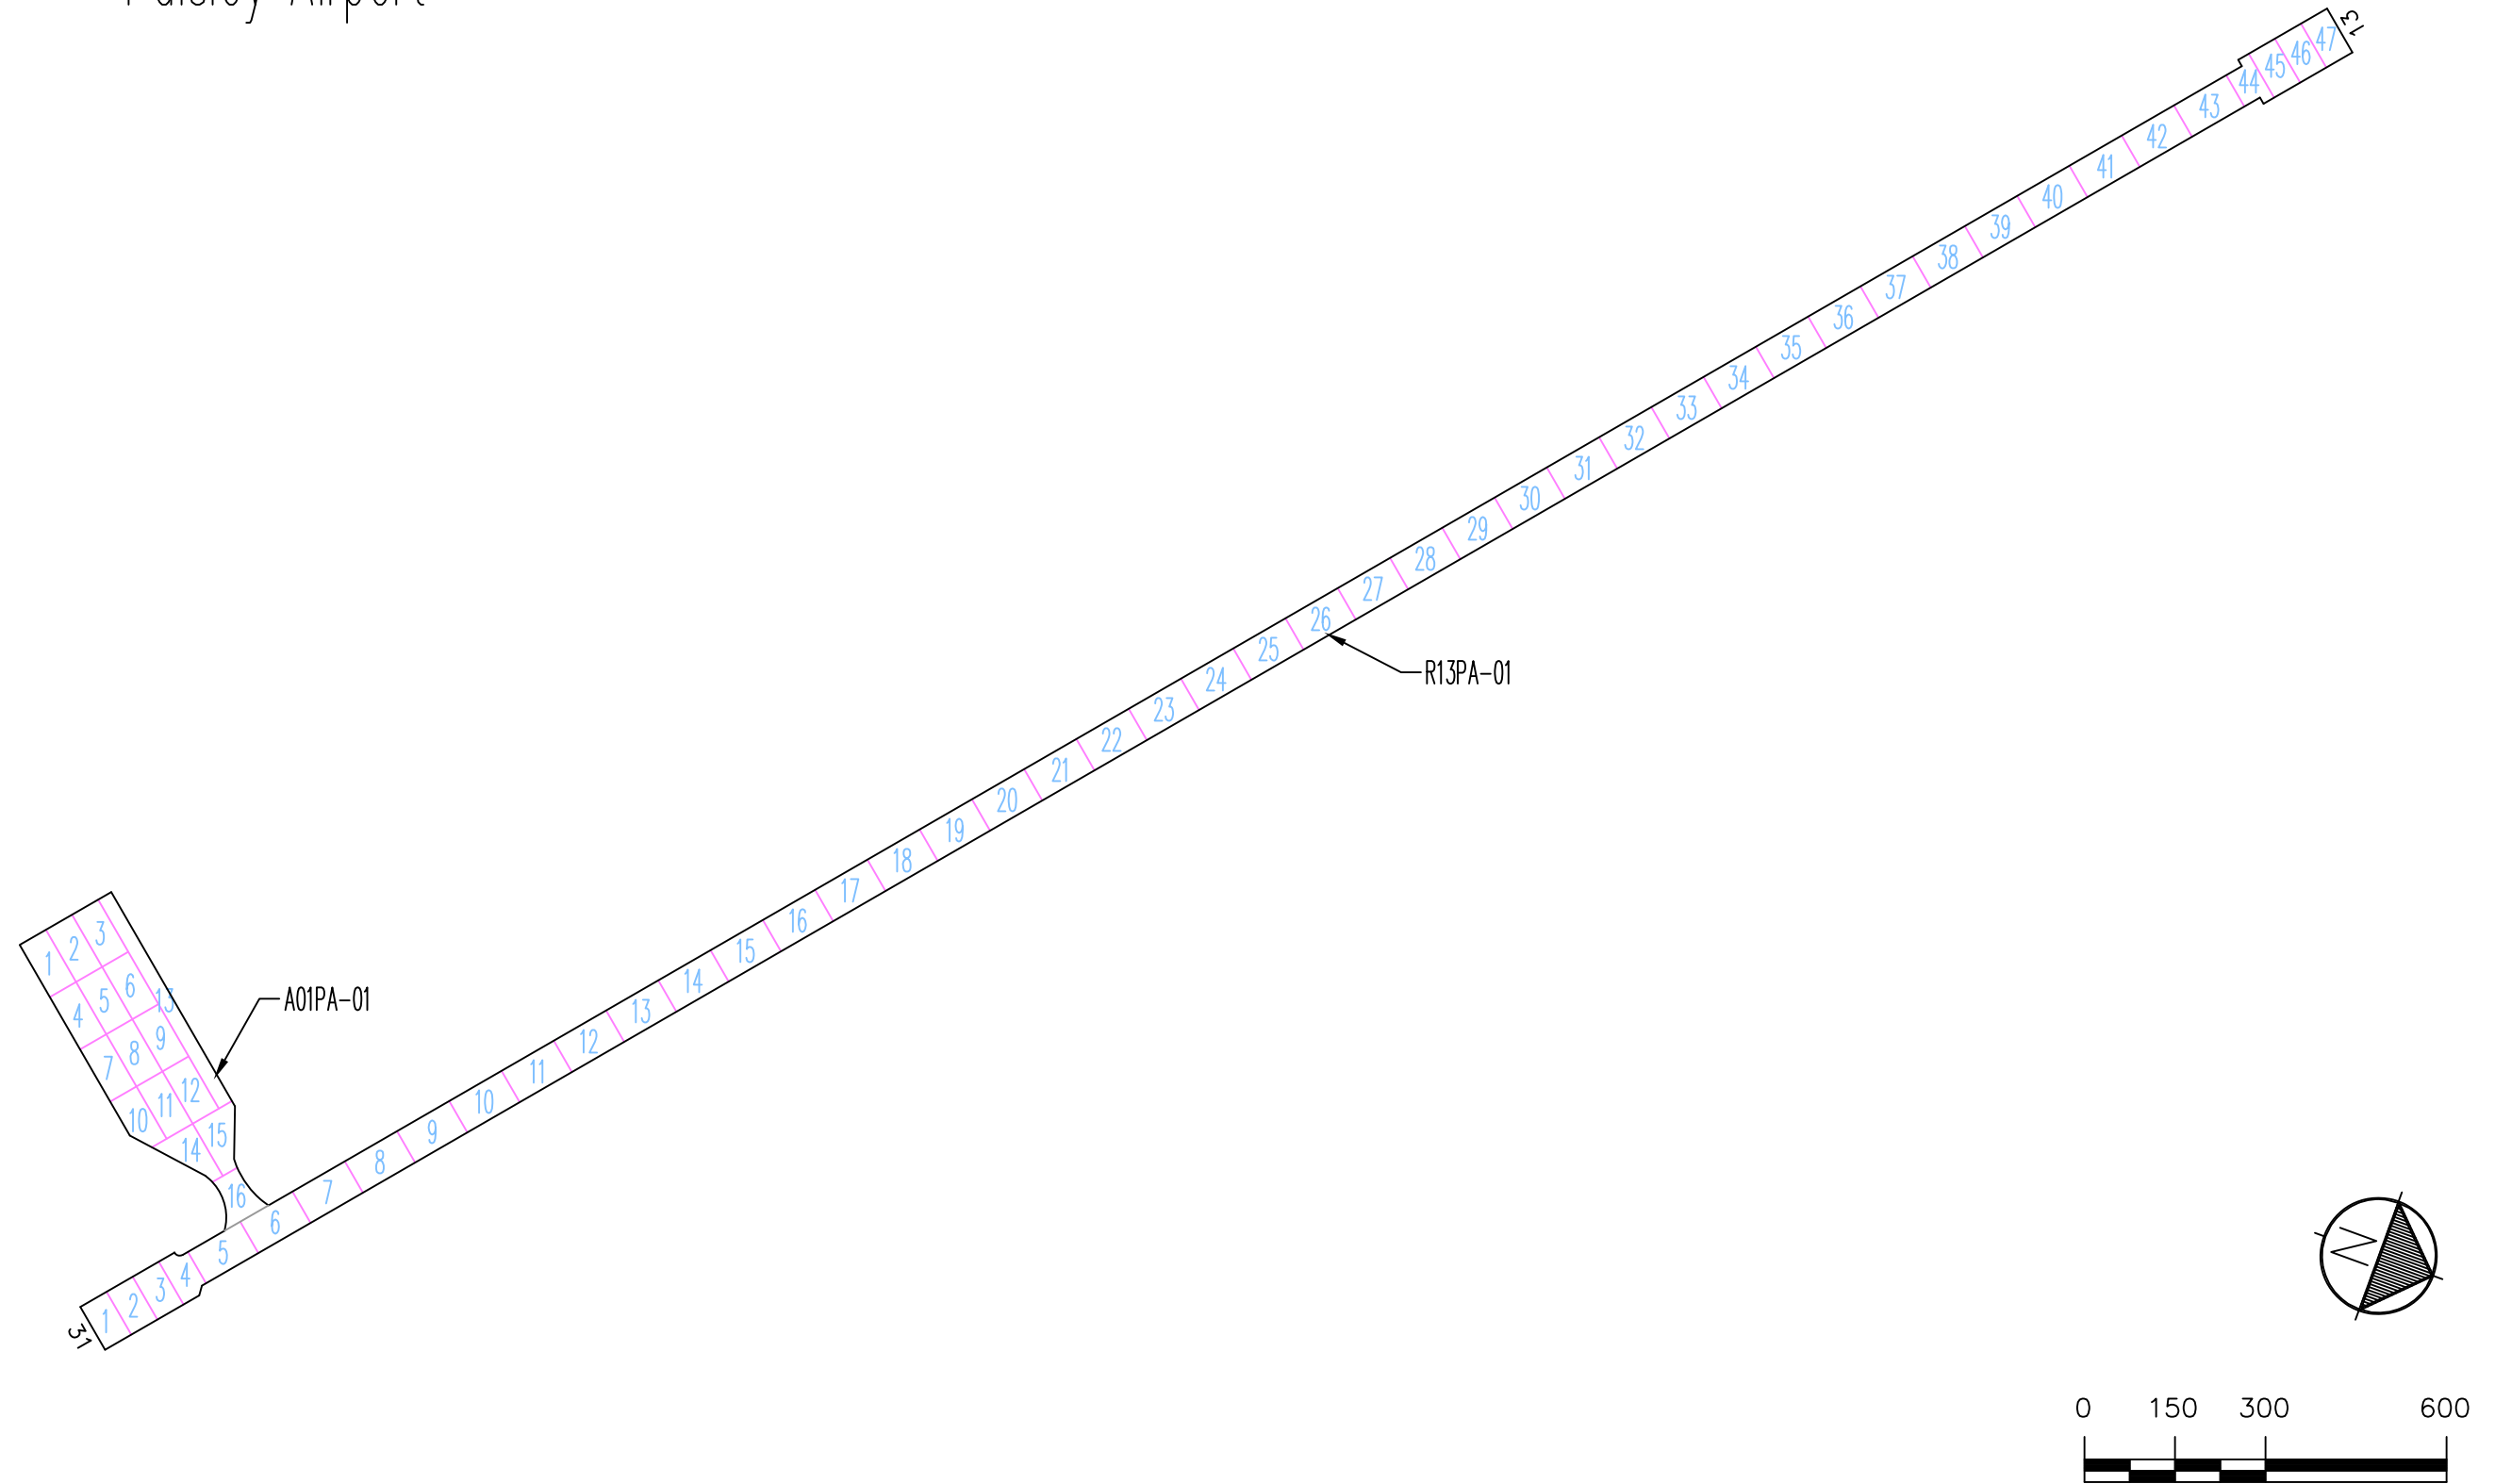
Figure PA-2. Pavement Branch, Section and Sample Unit Layout.
Paisley Airport

The pavements at your airport were divided into branches, sections and sample units in accordance with the methodology outlined in the current edition of ASTM D5430, *Standard Test Method for Airport Condition Index Surveys*. The branches, sections and sample units established at your airport are shown in Figure PA-2. A Branch Condition Report showing all branches, their associated areas, and their area-weighted average condition is provided in Appendix 1. Additionally, the Appendix 2 Section Condition Report provides information used to define each branch and section in the Micro PAVER database.

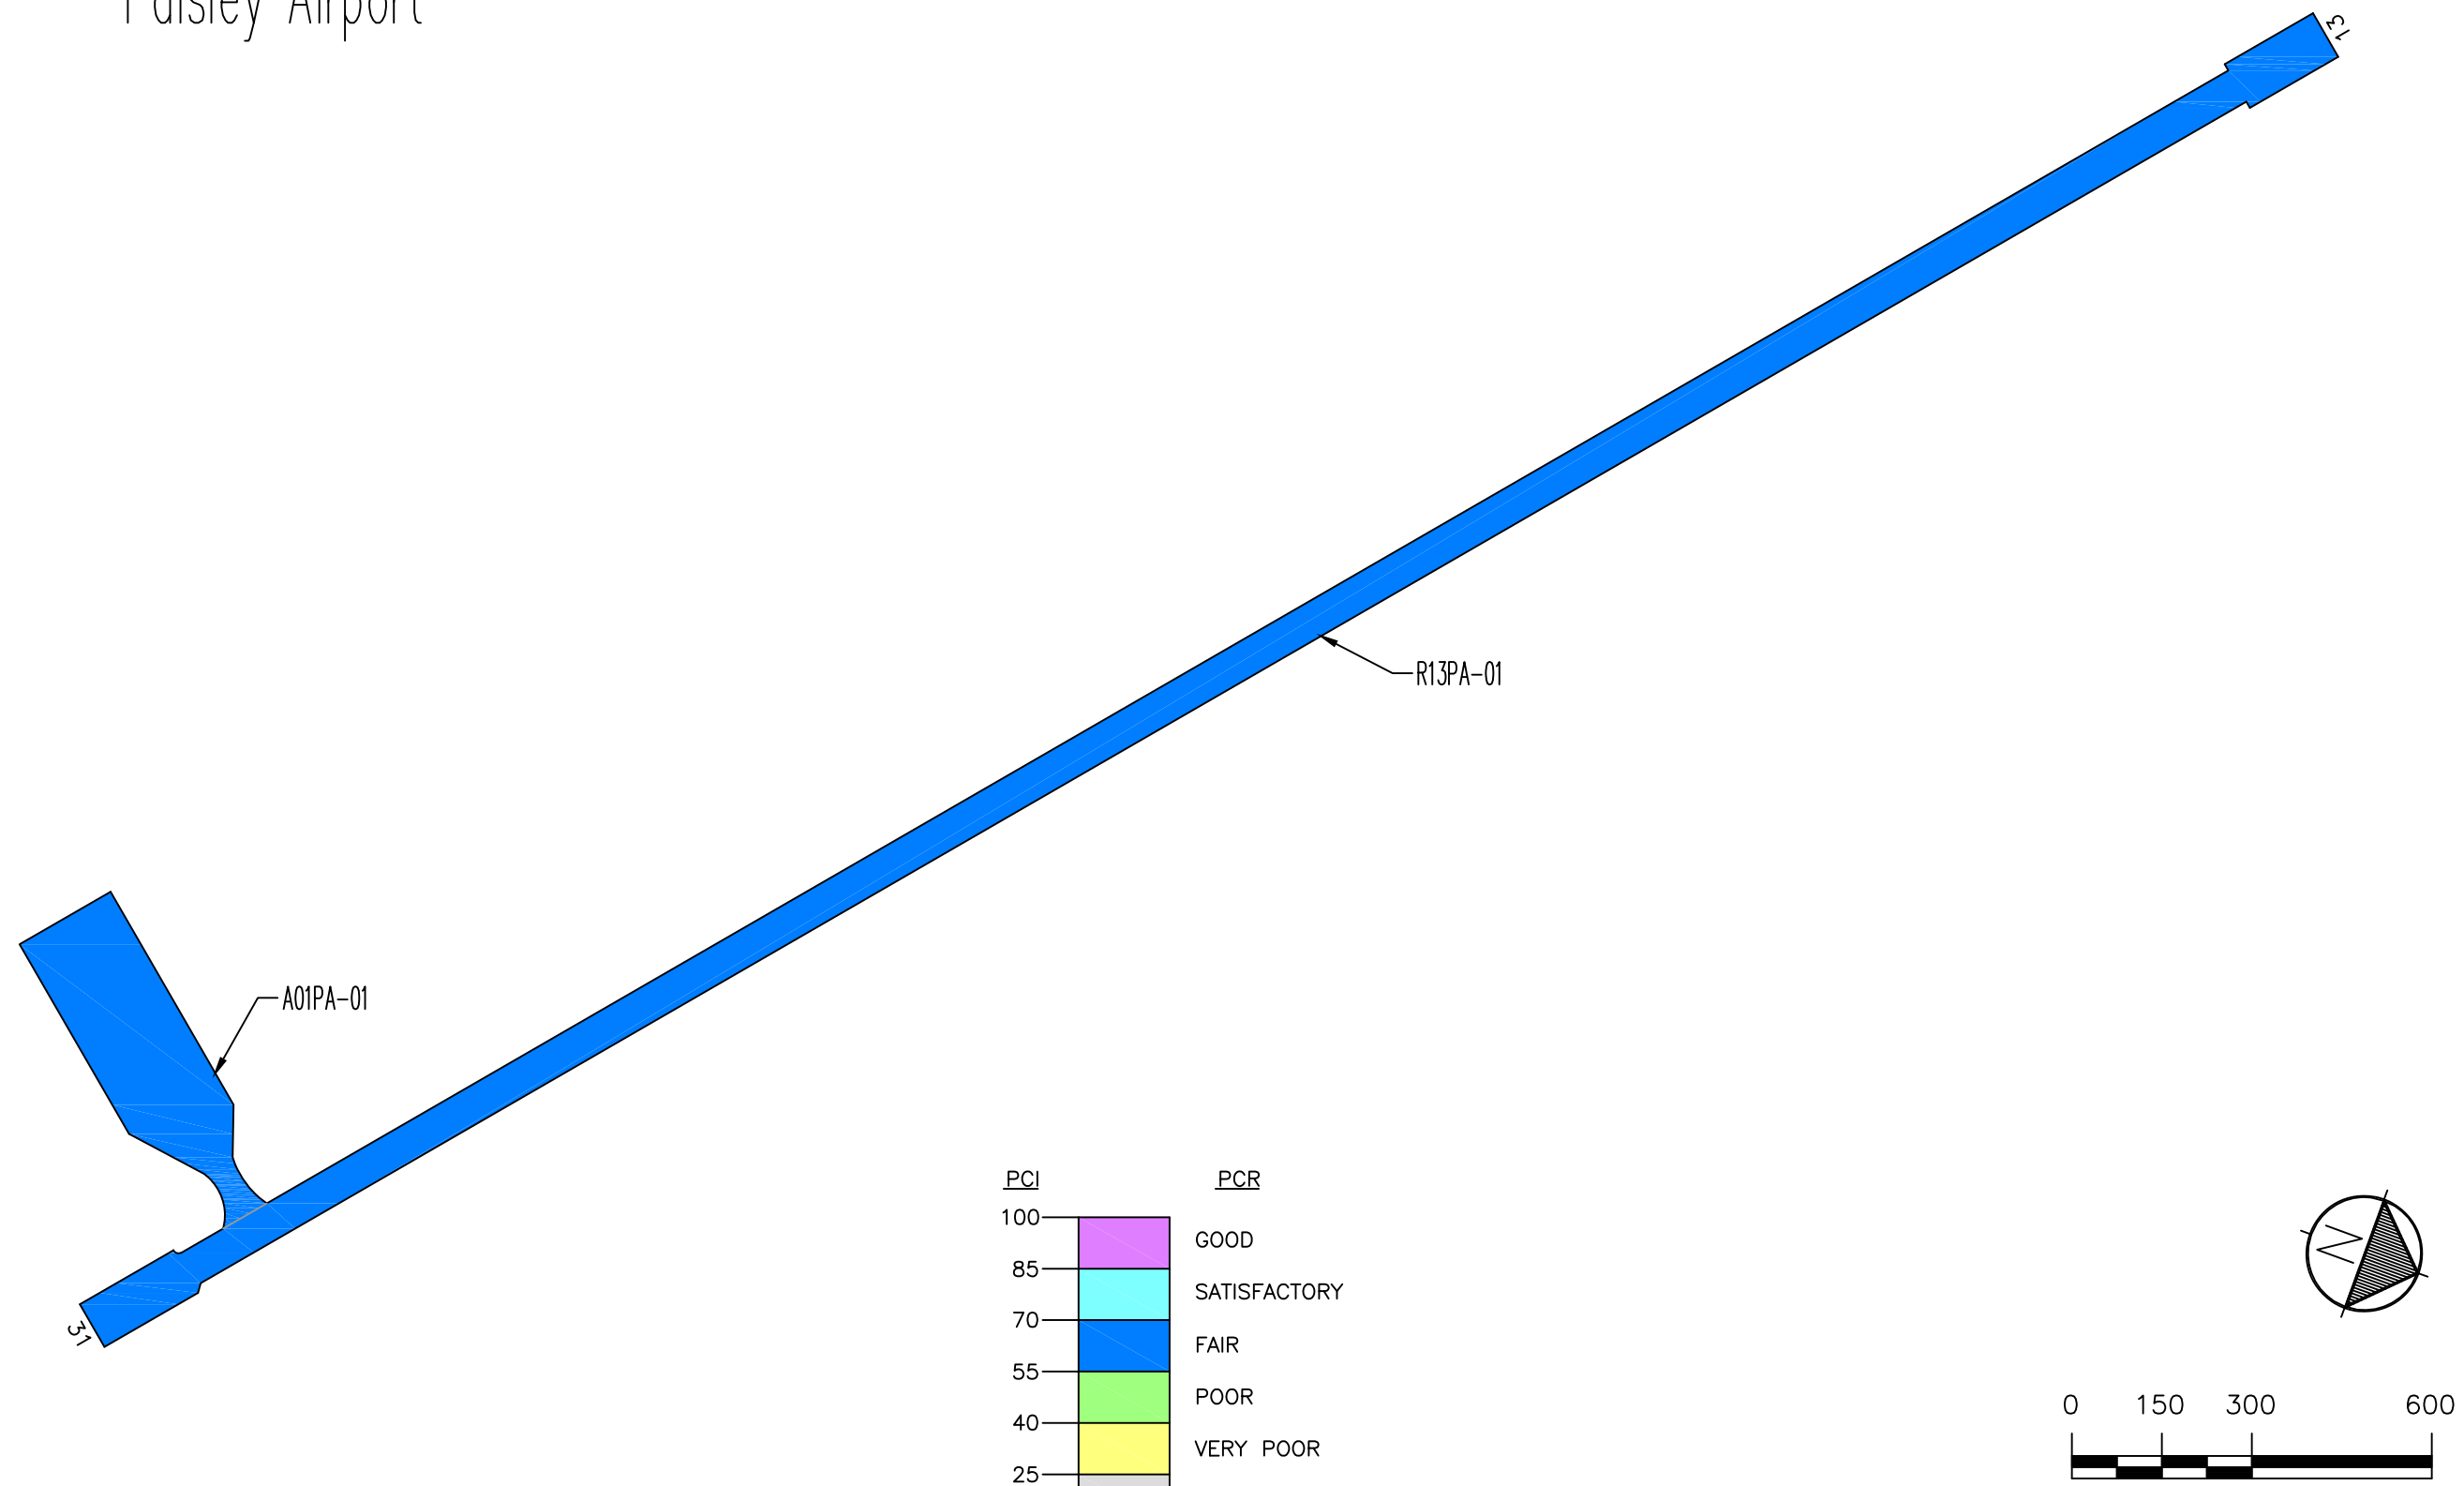
Figure PA-3. Pavement Condition in July 2016.
Paisley Airport

The Branch Condition Report in Appendix 1 summarizes current pavement condition by branch while the Section Condition Report in Appendix 2 lists pavement condition by section. The current Pavement Condition Rating (PCR) is shown graphically in Figure PA-3.

Section PCIs at Paisley Airport range from a low of 59 (a PCR of "Fair") to a high of 64 (a PCR of "Fair"). The area-weighted average PCI for all airport pavements is 63, corresponding to an overall PCR of "Fair". Figure PA-4 shows how much pavement area is associated with each Pavement Condition Rating category and also shows pavement condition distribution from the inspections conducted in 2009 and 2013.

The primary distresses observed during the inspection were: block cracking and raveling.

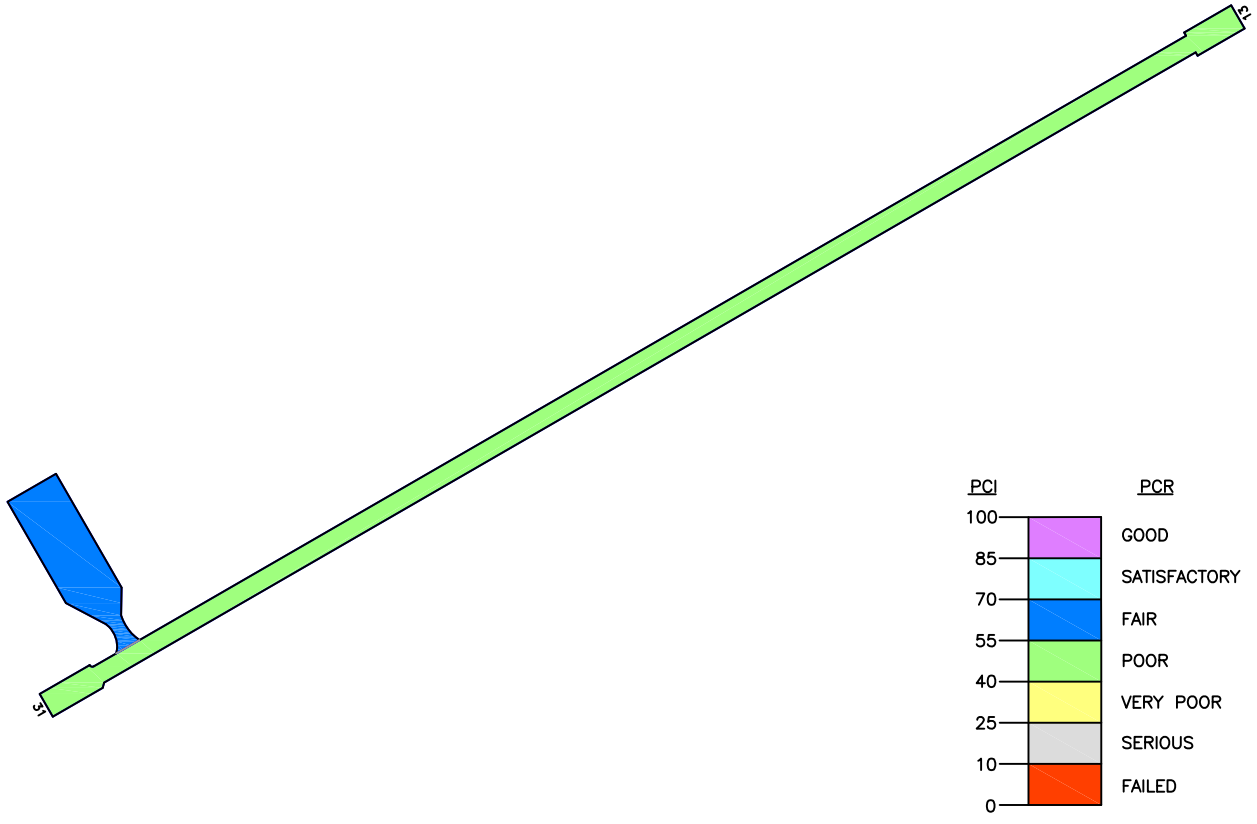
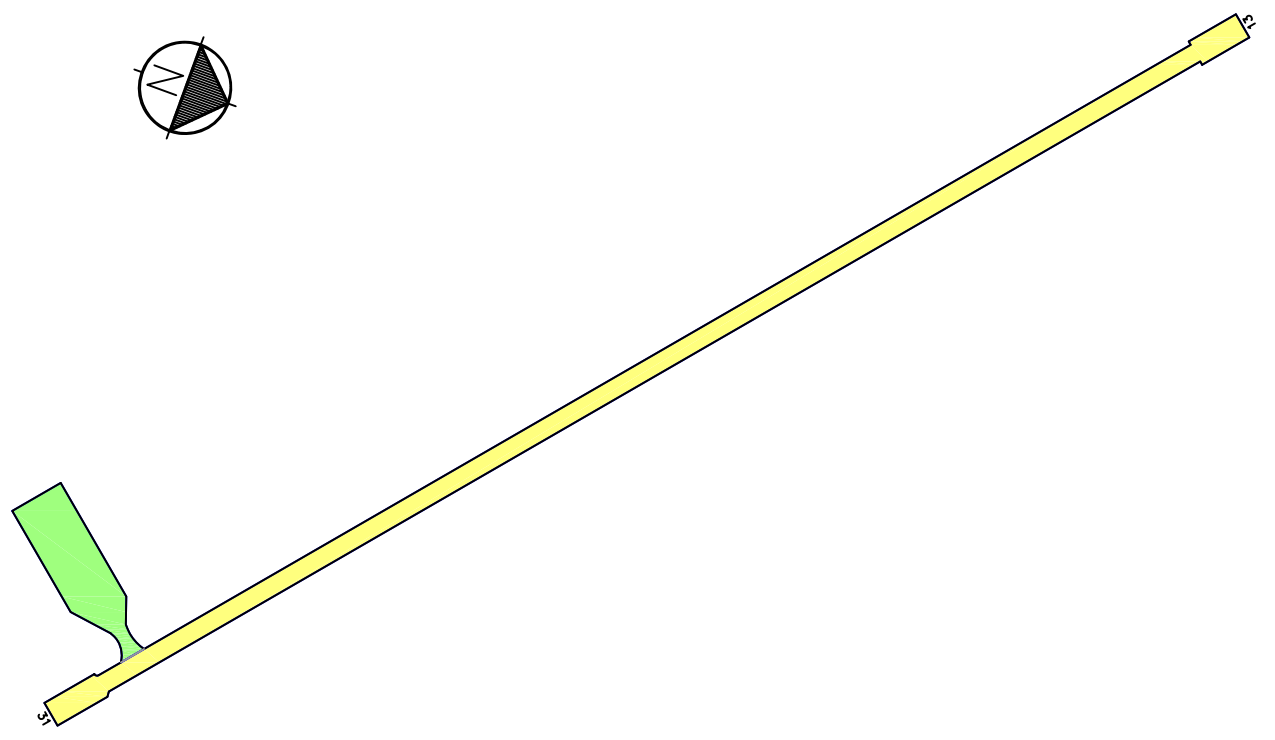
Figure PA-5. Future Pavement Condition.

Branch	Section	Inspections			Forecast	
		2009	2013	2016	2021	2026
A01PA	1	82	64	59	56	53
R13PA	1	81	83	64	50	36

A graphical representation of the projected PCIs listed in Table 1 is shown in Figure PA-5.

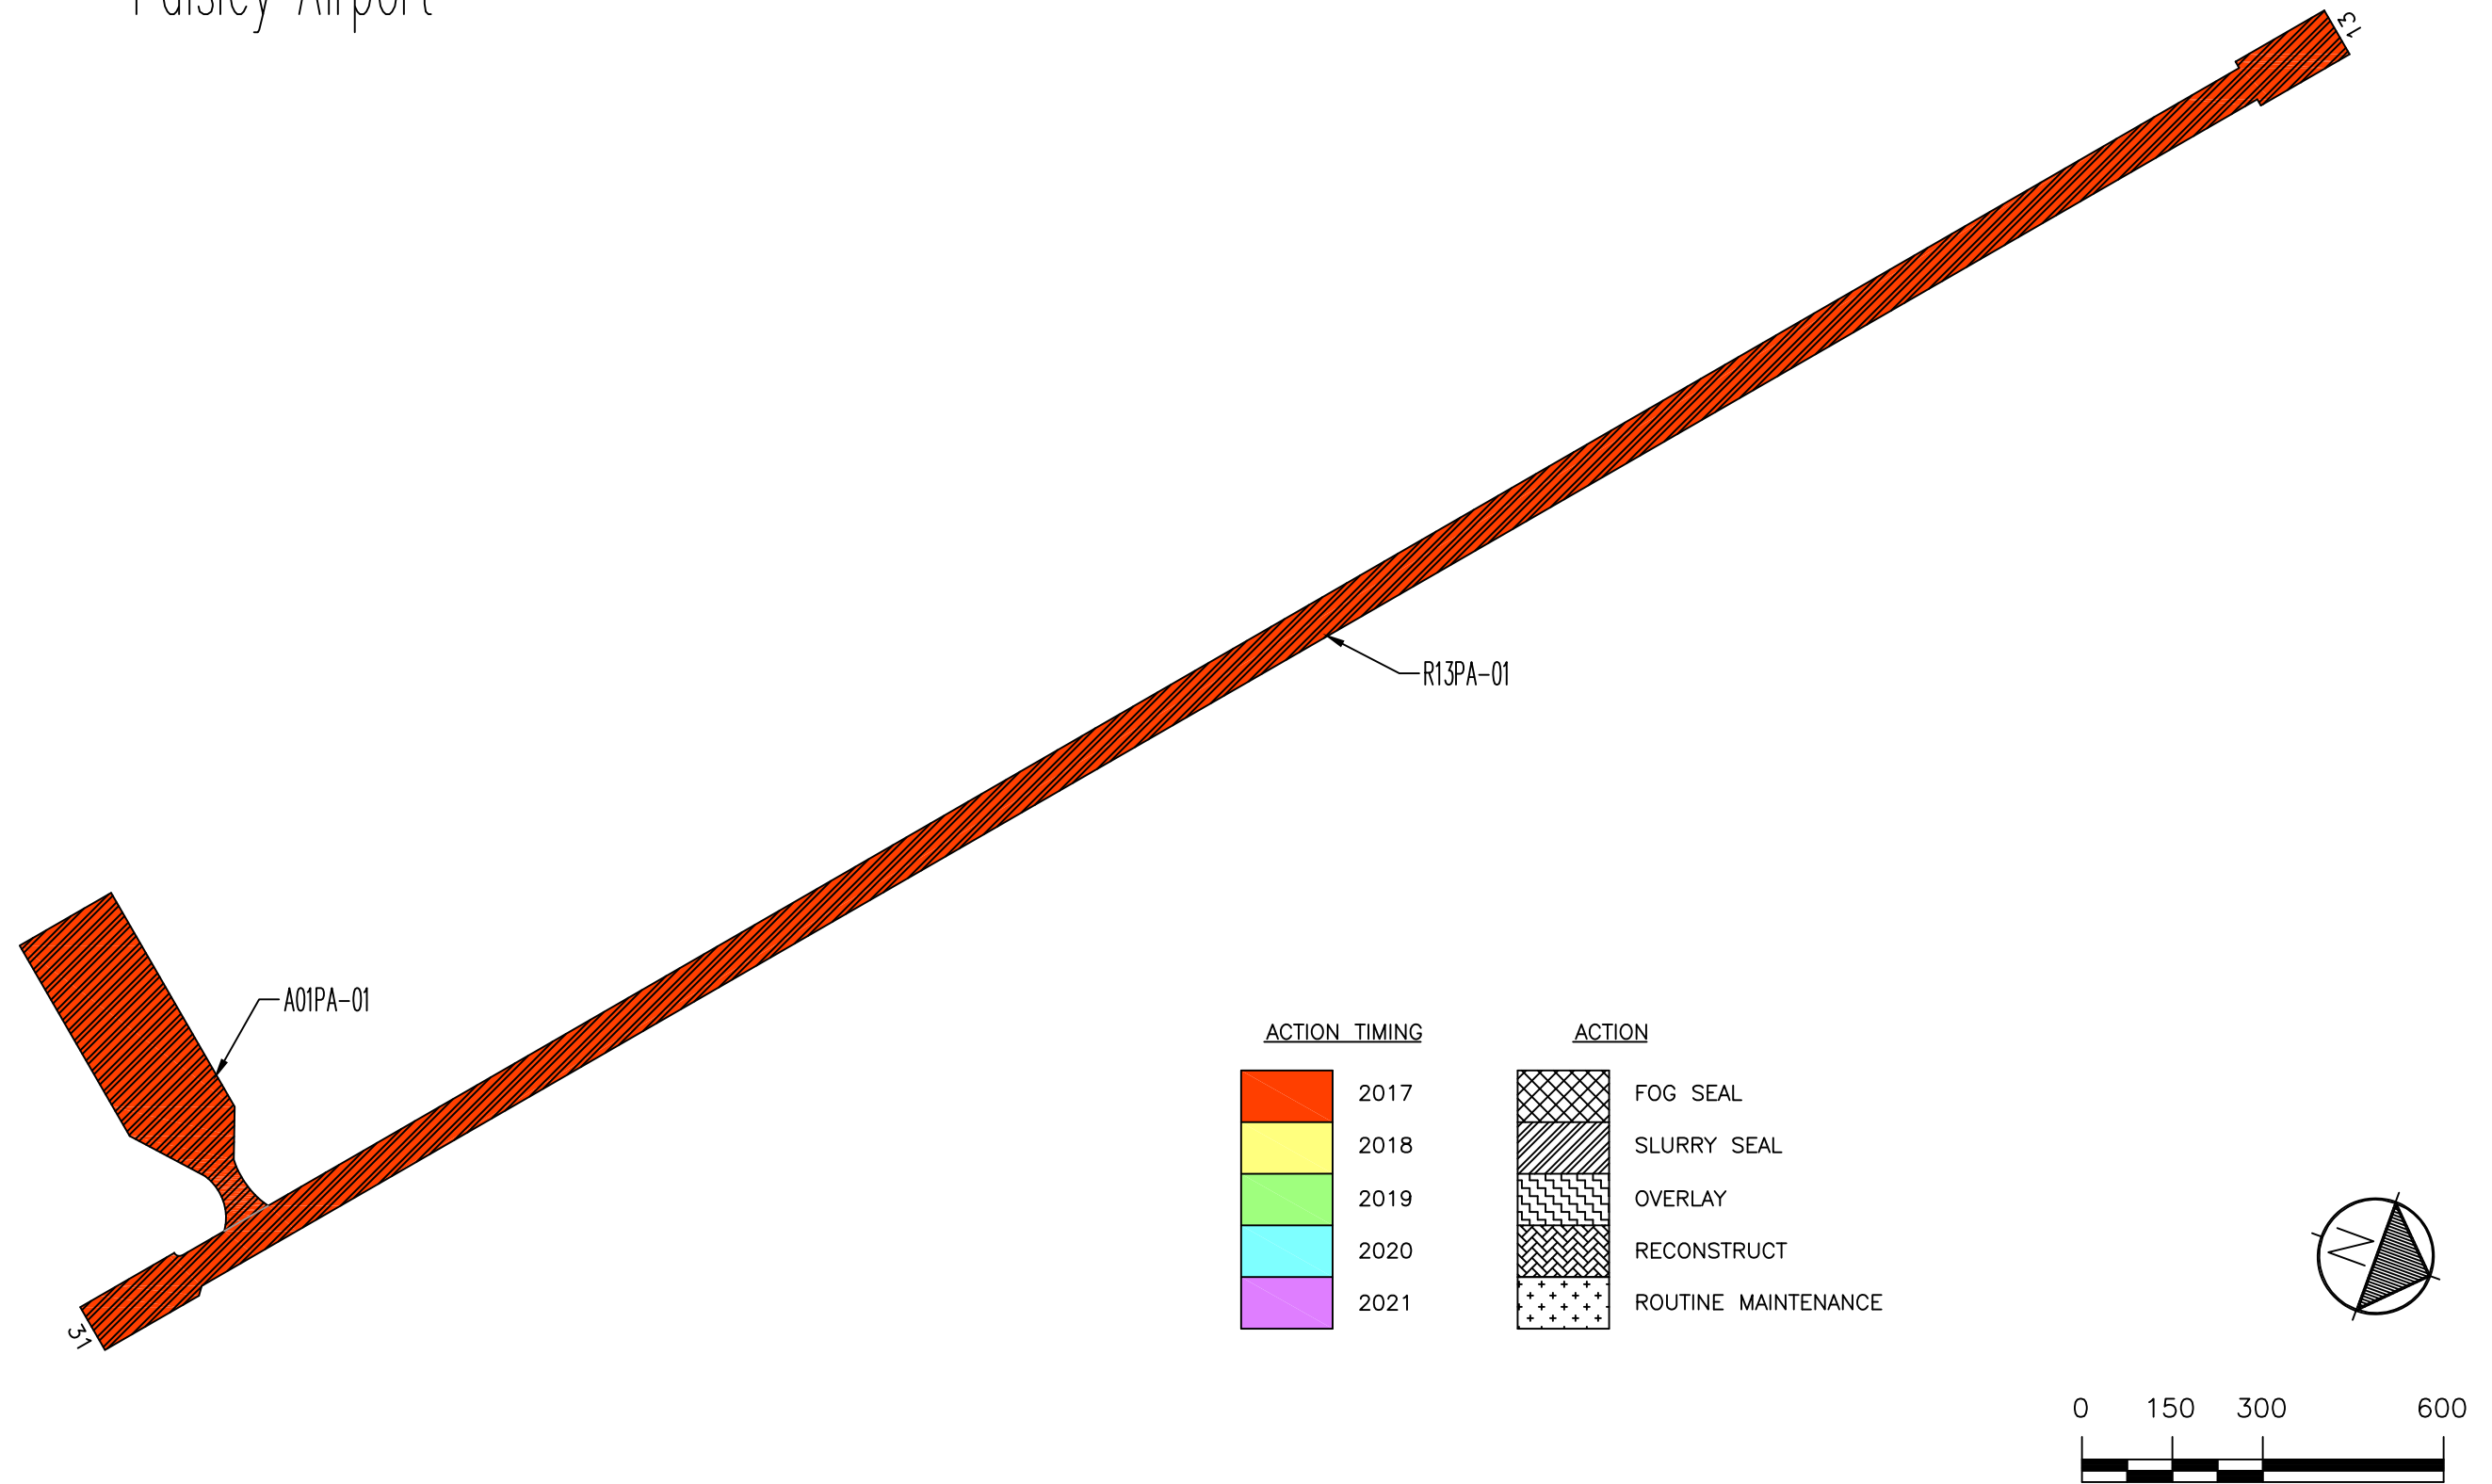
Figure PA-6. Five-Year Pavement Management Plan.
Paisley Airport

During this project a 5-year program outlining recommended global maintenance and rehabilitation was developed. The program begins in the year 2017 to allow time for project development. These recommendations are presented in Table 2, which identifies the pavement section requiring rehabilitation, the year the action should be completed, the type of action, and an associated cost. This information is also presented graphically in Figure PA-6.

Year	Branch	Section	Action	Area (sf)	Unit Cost (\$/sf)	Total Cost (\$)
2017	A01PA	01	Slurry Seal	83,802	\$0.31	\$25,643
2017	R13PA	01	Slurry Seal	266,133	\$0.31	\$81,437
2017 Total						\$107,080
TOTAL						\$107,080
