# OAKRIDGE STATE AIRPORT

This report describes how your Pavement Maintenance Management Program (PMMP) was developed. Your Program was developed as part of the Oregon Continuous Aviation System Plan sponsored in part by the Oregon Department of Aviation and the Federal Aviation Administration (FAA). The information and data contained in this report ensures you comply with the requirements of FAA Grant Assurance Number 11 which states that any airport requesting federal funds for pavement improvement projects must have implemented a pavement maintenance management program.

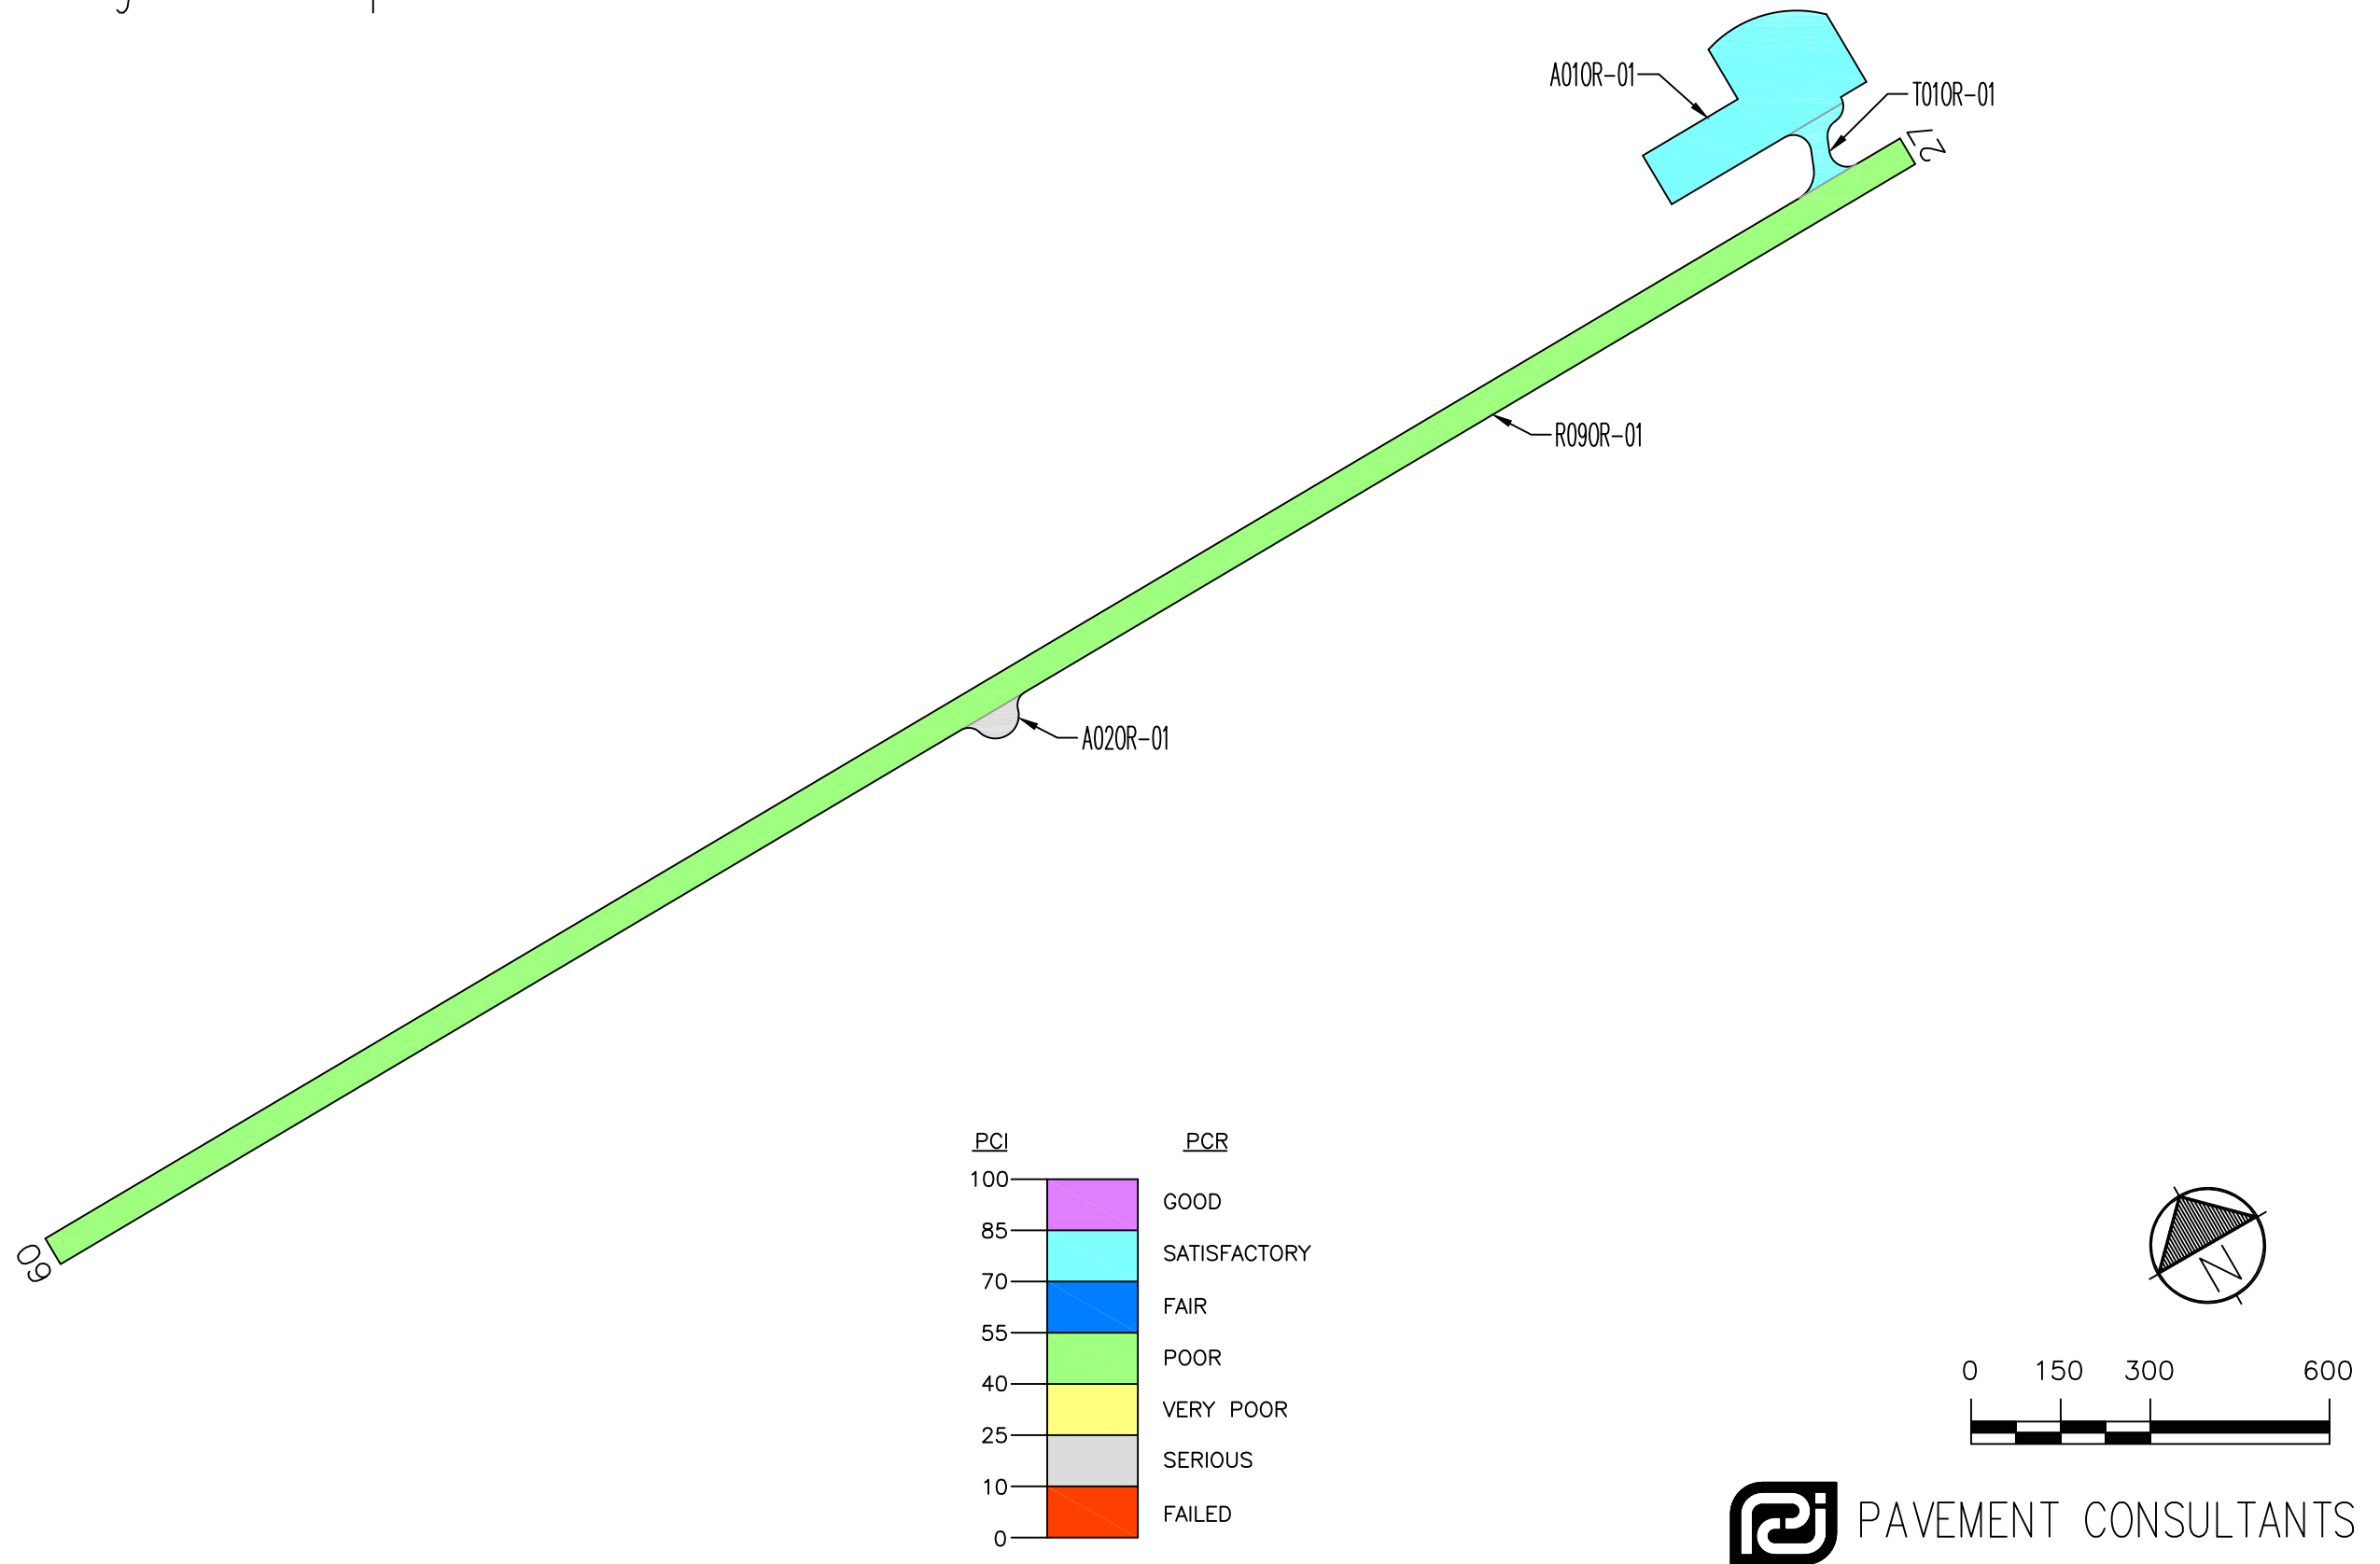
Figure OR-3. Pavement Condition in May 2019.  
Oakridge State Airport

The Branch Condition Report in Appendix 1 summarizes current pavement condition by branch while the Section Condition Report in Appendix 2 lists pavement condition by section. The current Pavement Condition Rating (PCR) is shown graphically in Figure OR-3.

Section PCIs at Oakridge State Airport range from a low of 19 (a PCR of “Serious”) to a high of 74 (a PCR of “Satisfactory”). The area-weighted average PCI for all airport pavements is 55, corresponding to an overall PCR of “Poor”. Figure OR-4 shows how much pavement area is associated with each Pavement Condition Rating category and also shows pavement condition distribution from the inspections conducted in 2013 and 2016.

The primary distresses observed during the inspection were: patching, block cracking and longitudinal and transverse cracking, with isolated occurrences of alligator cracking, and raveling.

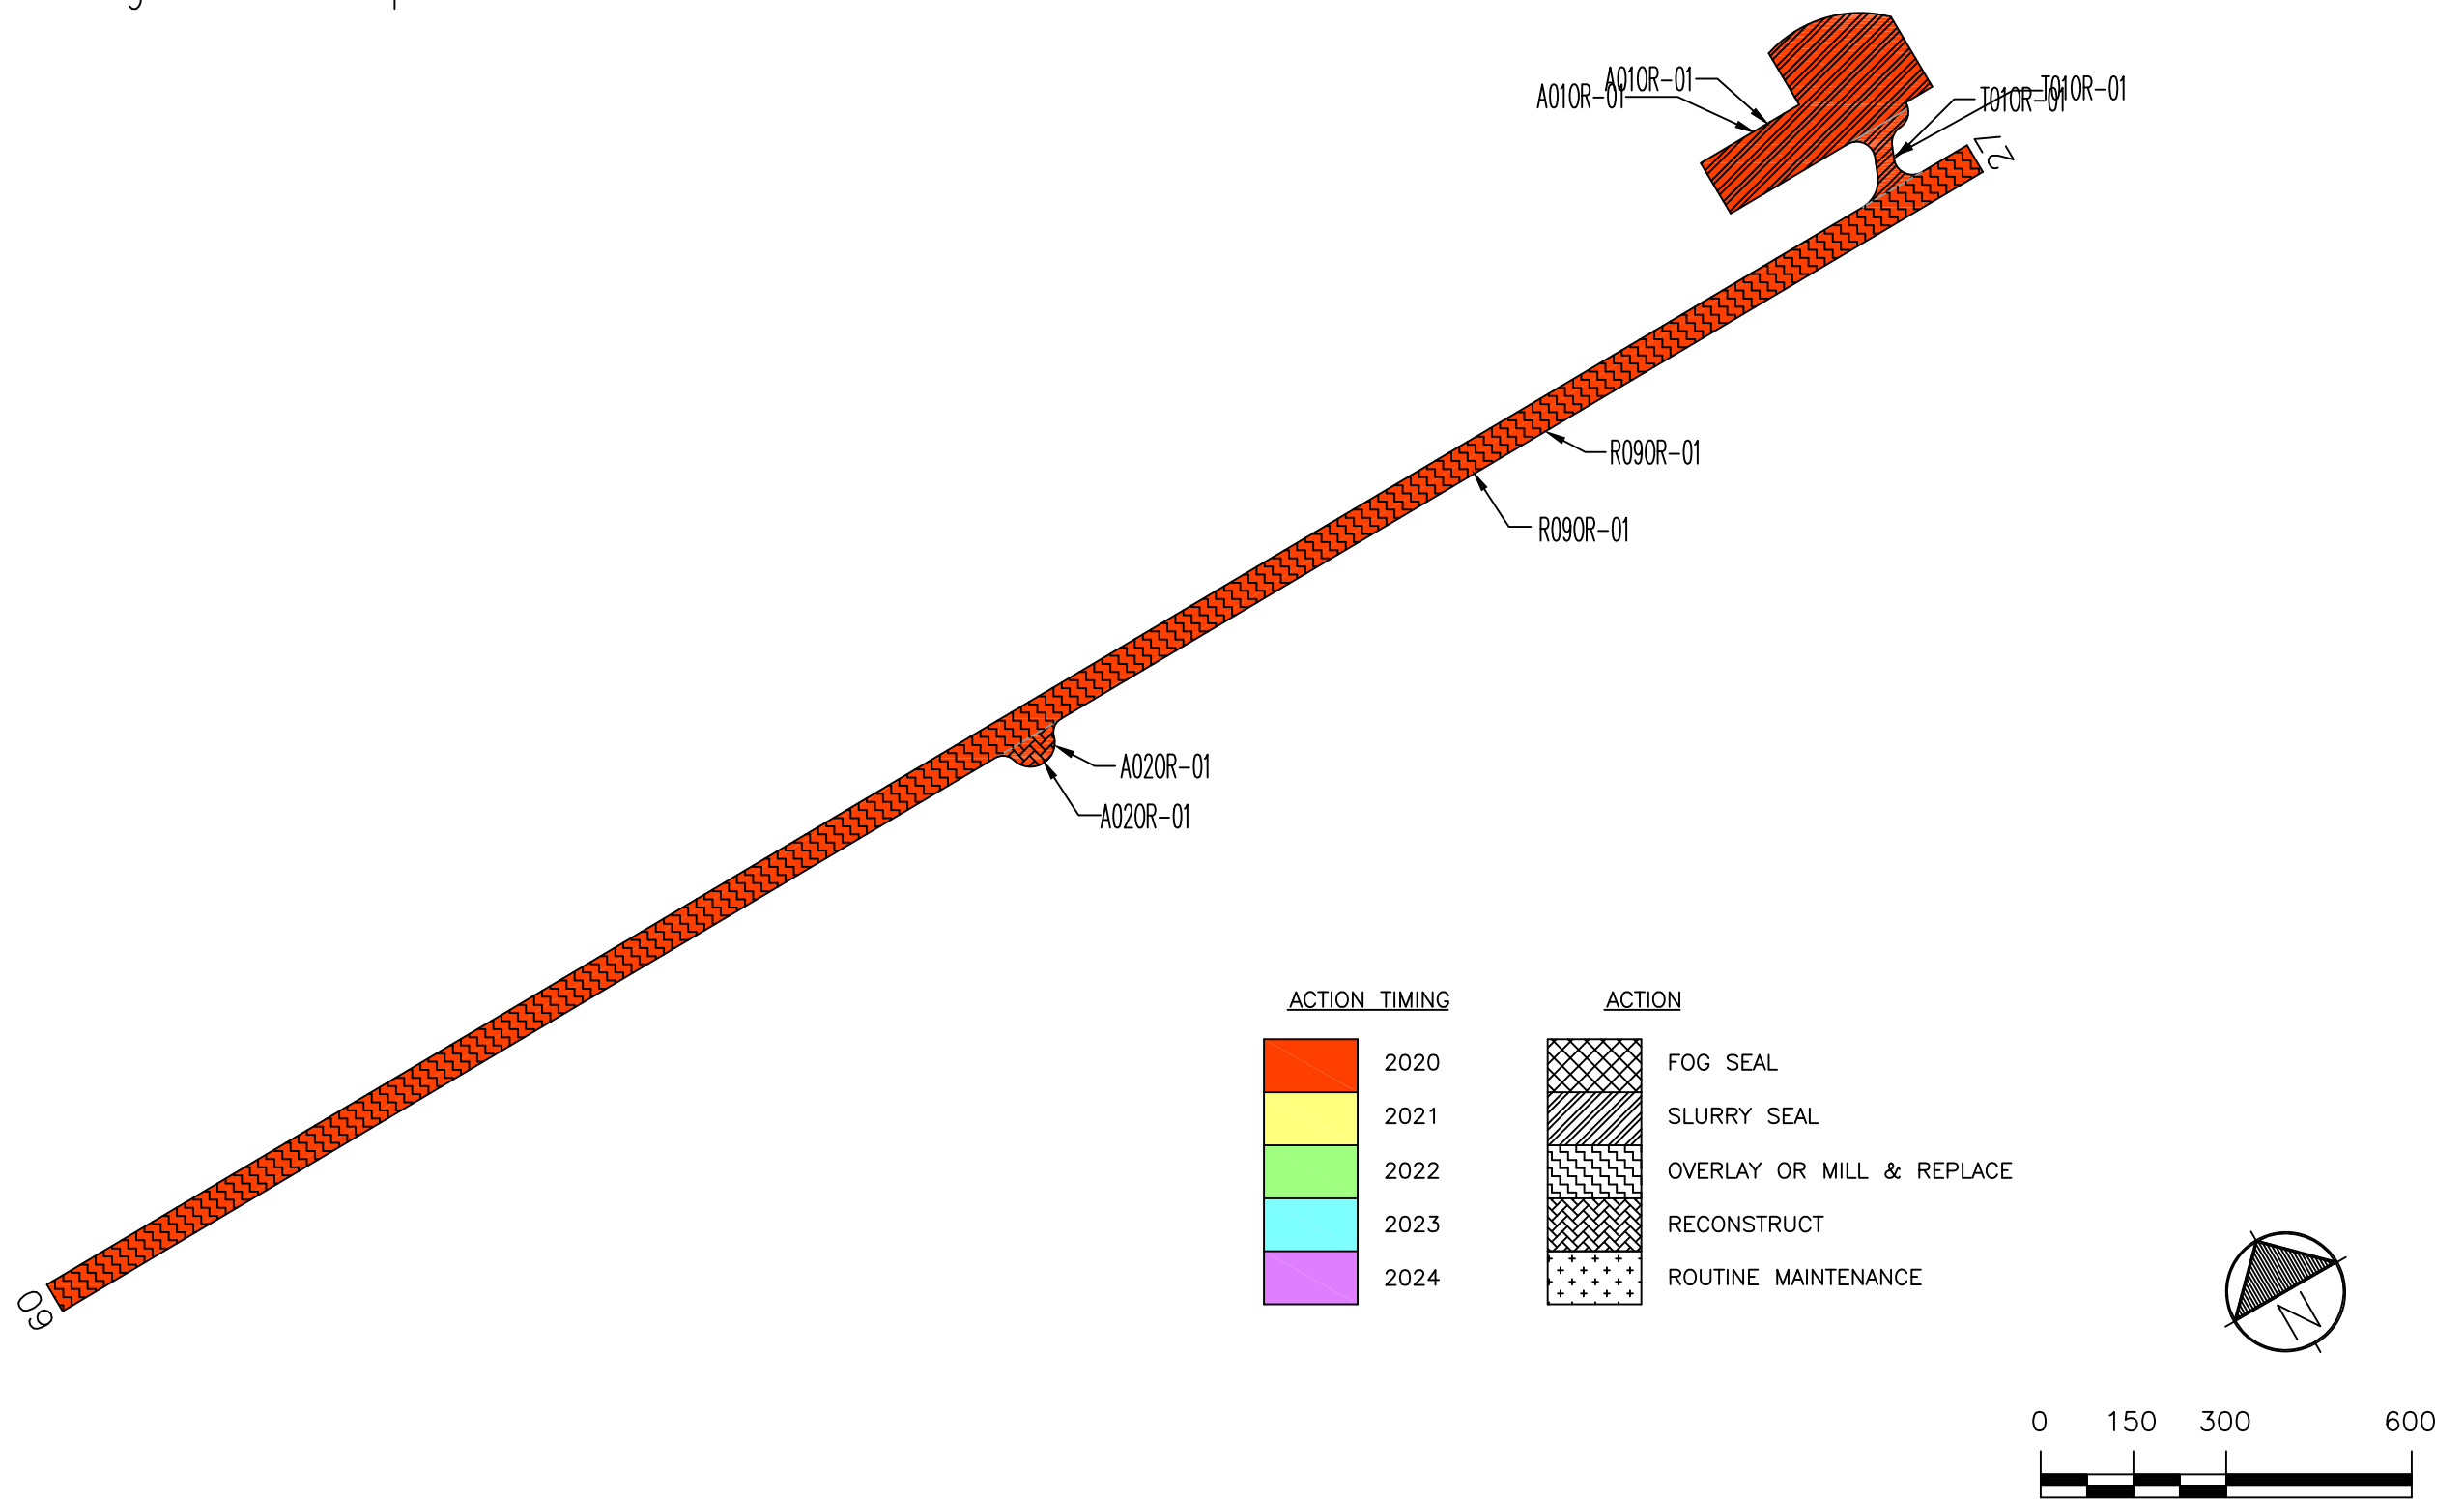
Figure OR-6. Five-Year Pavement Management Plan.  
Oakridge State Airport

During this project a 5-year program outlining recommended global maintenance and rehabilitation was developed. The program begins in the year 2020 to allow time for project development. These recommendations are presented in Table 2, which identifies the pavement section requiring rehabilitation, the year the action should be completed, the type of action, and an associated cost. This information is also presented graphically in Figure OR-6.

Year	Branch	Section	Action	Area (sf)	Unit Cost (\$/sf)	Total Cost (\$)
2020	A01OR	01	Slurry Seal	54,352	\$0.31	\$16,632
2020	A02OR	01	2" AC over 6" Crushed Aggregate Base	3,217	\$4.80	\$15,442
2020	R09OR	01	2" AC Overlay	180,500	\$2.50	\$451,250
2020	T01OR	01	Slurry Seal	5,115	\$0.31	\$1,565
<b>2020 Total</b>						<b>\$484,889</b>
<b>5-Year Total</b>						<b>\$484,889</b>

If the global maintenance and/or rehabilitation activities recommended in Table 2 are not completed, the localized maintenance activities identified in the Network Maintenance Report (Appendix 3) for that section should be done. Additionally, for those sections not listed in Table 2 as requiring global maintenance or rehabilitation, the localized maintenance activities outlined in the Network Maintenance Report should be completed. By completing the localized maintenance activities, pavement condition is improved, life is extended, deterioration is slowed and the length of time until major repair or rehabilitation is required is increased.
