Building Codes Division

Minor Label Inspection Photo Guide

Examples of acceptable submissions are shown below for **Moving or replacing ductwork not involving fire dampers or penetrations of firewalls, fire assemblies, or floors.**

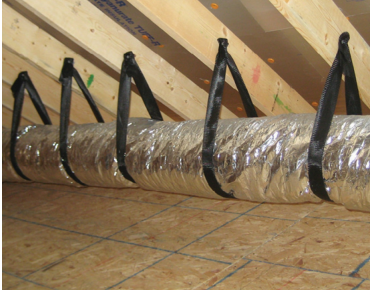
Description	What to provide in photograph	Sample photo (sample photos size is reduced for this document)
Duct work support	<ul style="list-style-type: none"> Provide a picture clearly showing that the duct work is properly supported

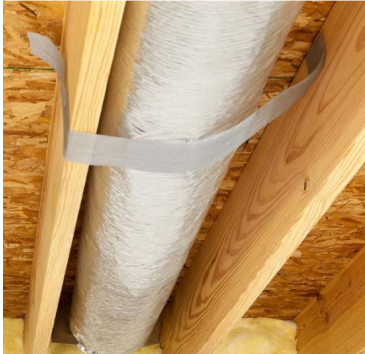
Insulation replaced & upgraded to meet R-19 value per code. Existing insulation can be added to in order to achieve correct R-value	<ul style="list-style-type: none"> Provide a picture clearly showing the insulation is replaced and meets R-19 value for modified sections only
