South Coast Basin Status Report Appendices

South Coast Basin Watershed Approach

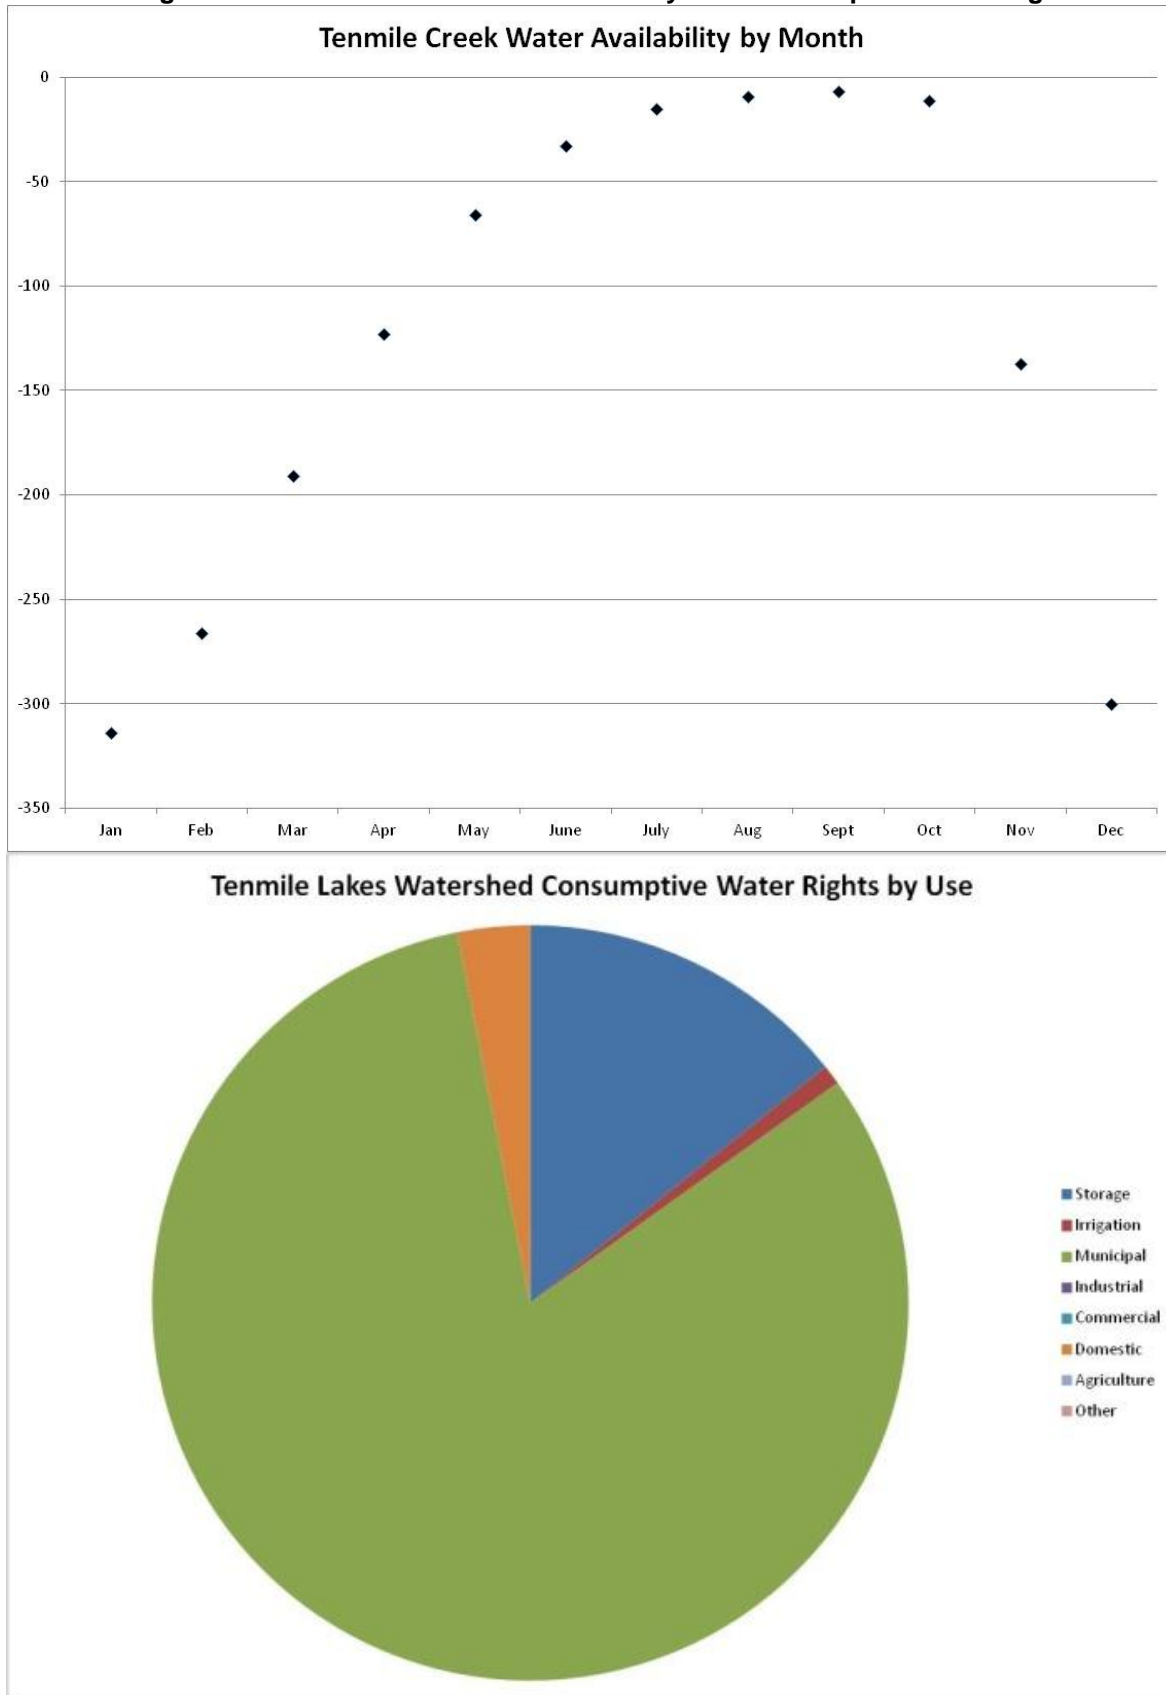
Figure 5 – Tenmile Creek Water Availability and Consumptive Water Right Uses

Water availability in the Tenmile Watershed is limited year around by Tenmile Creek

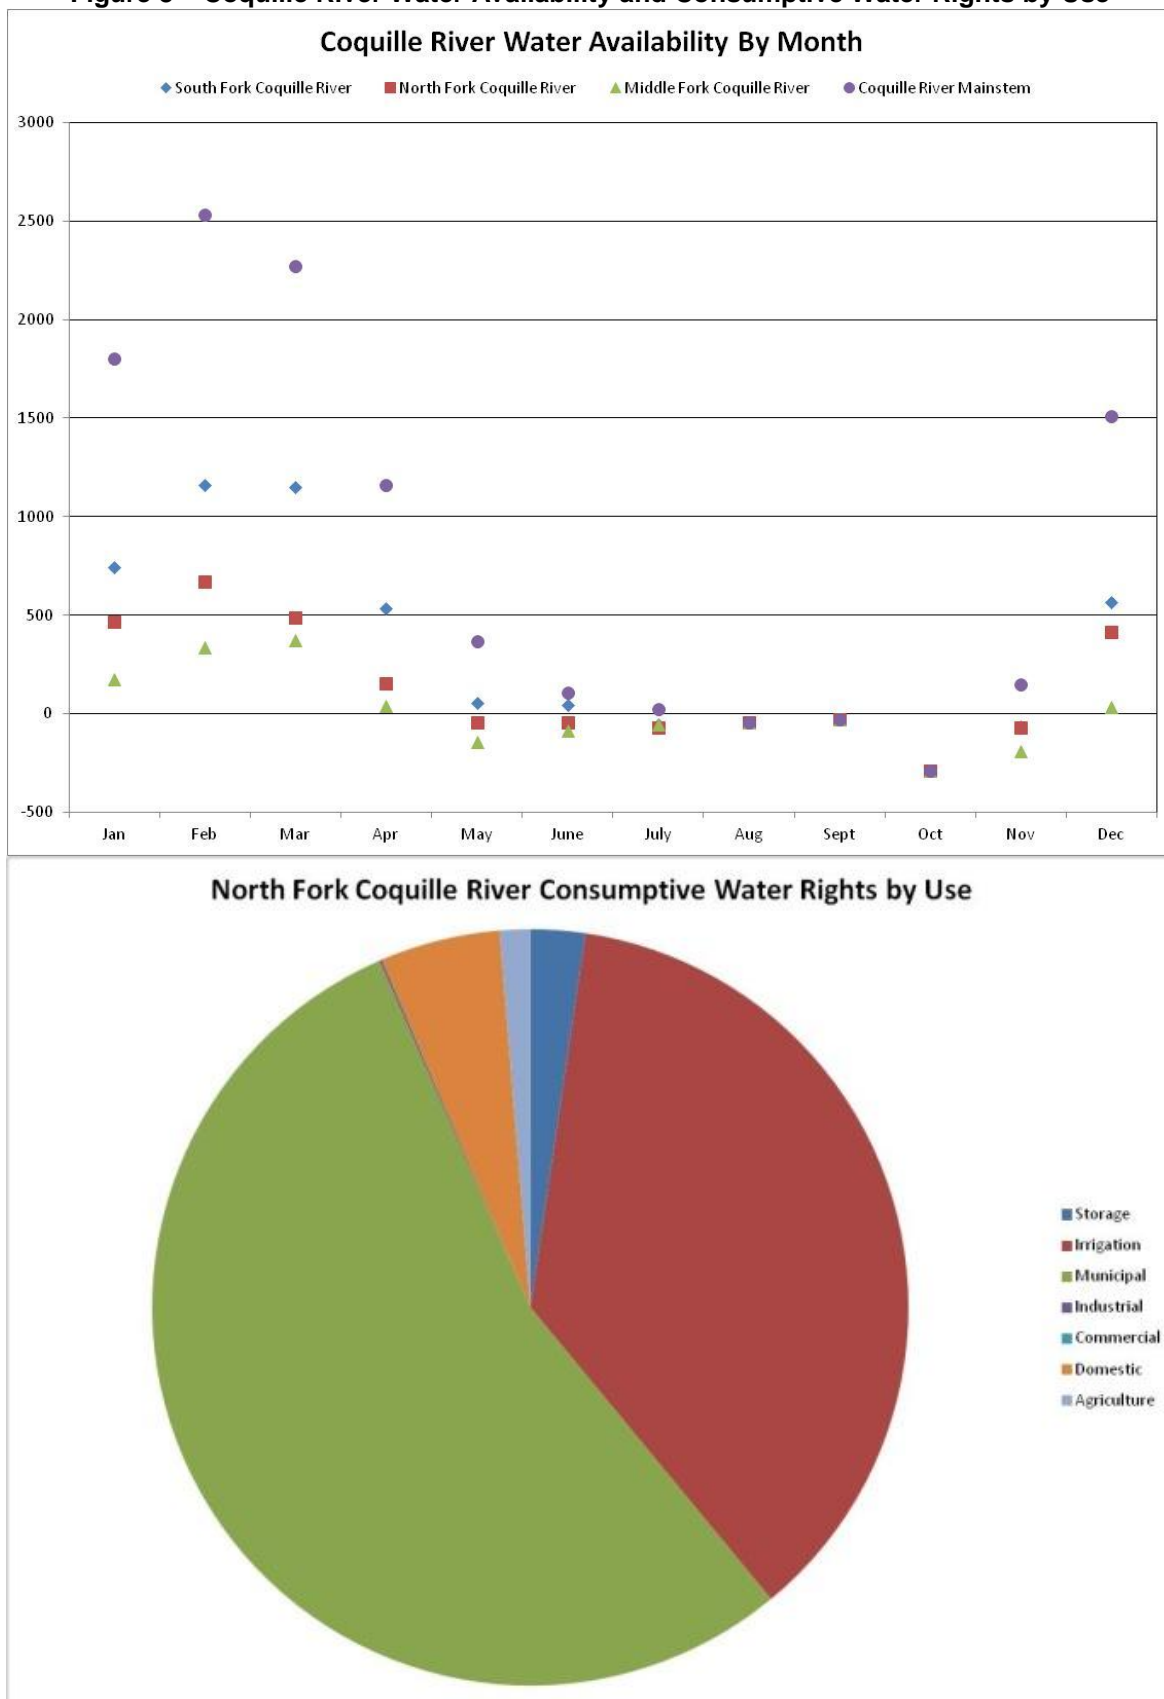
Figure 8 – Coquille River Water Availability and Consumptive Water Rights by Use

Water availability in the Coquille Watershed is limited by mainstem flow volumes May through November

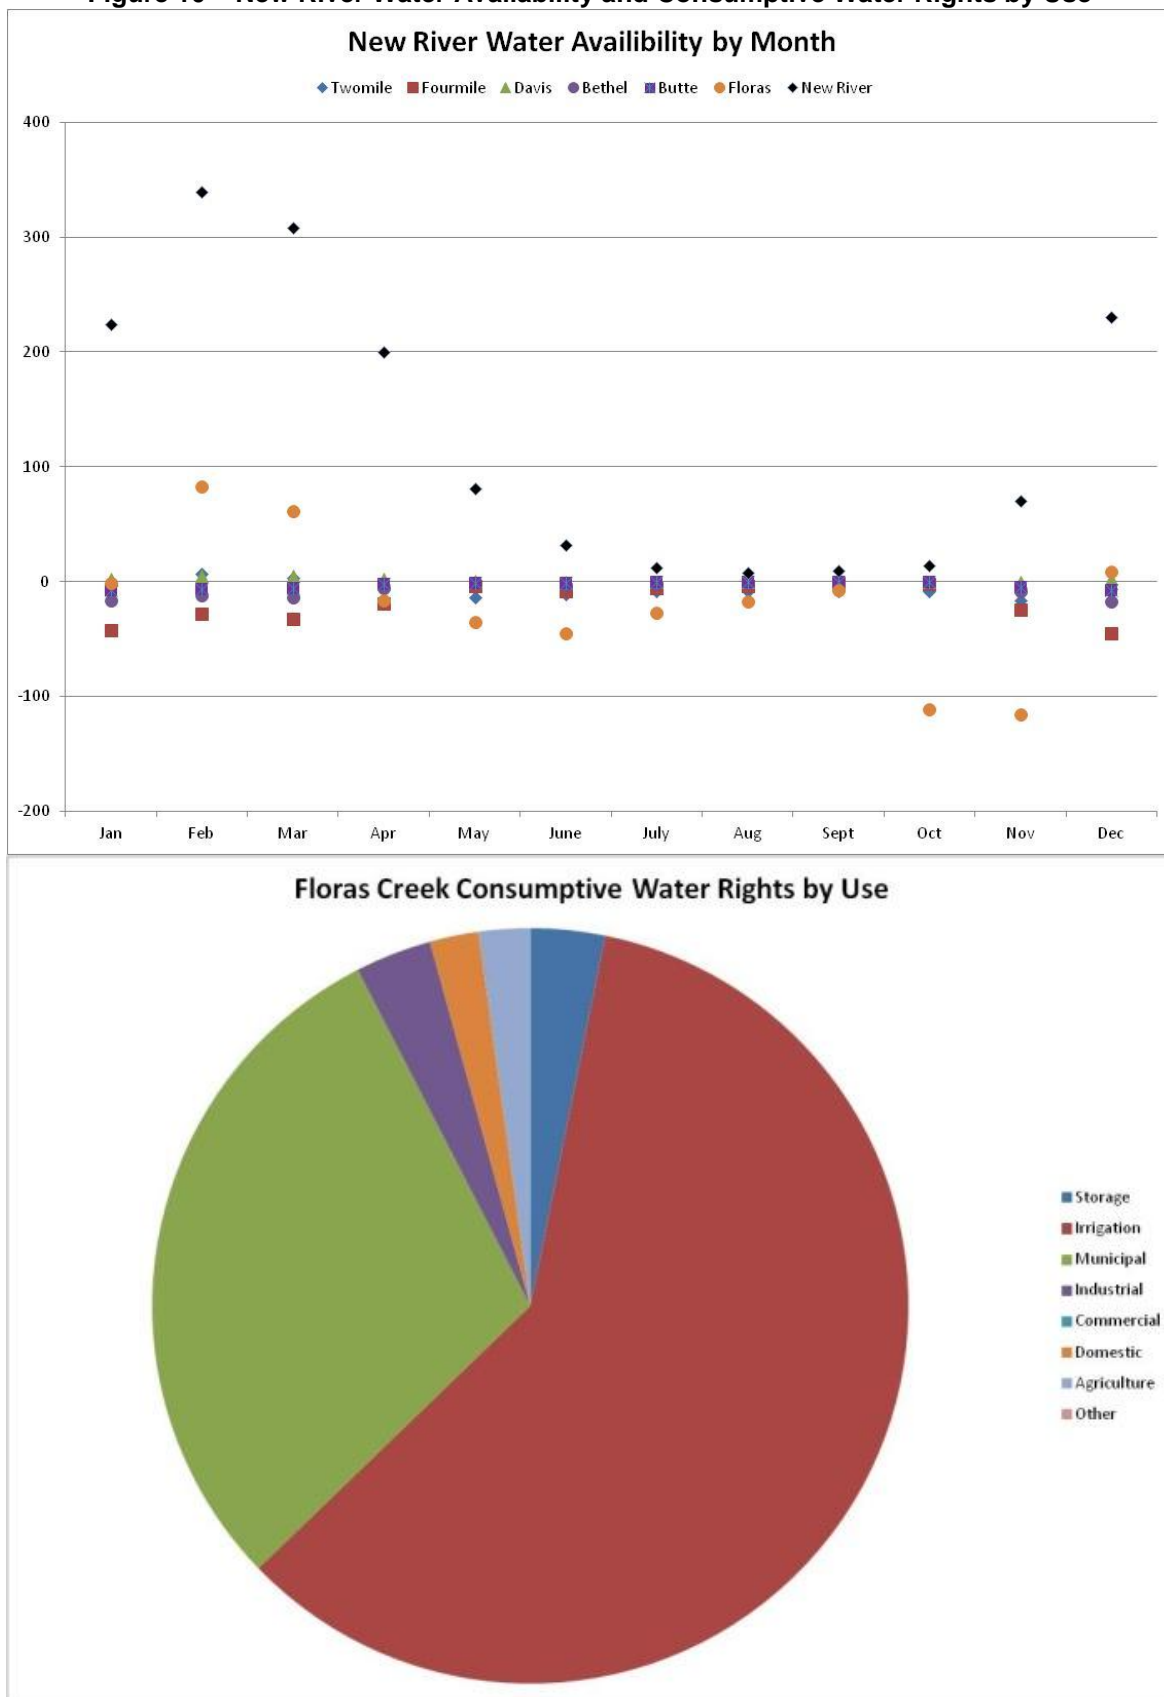
Figure 10 – New River Water Availability and Consumptive Water Rights by Use

Water is currently available year around in New River but not always available in the larger tributaries of New River.
