TECHNICAL MEMORANDUM

Re: Riverbend Landfill Geomorphic Analysis

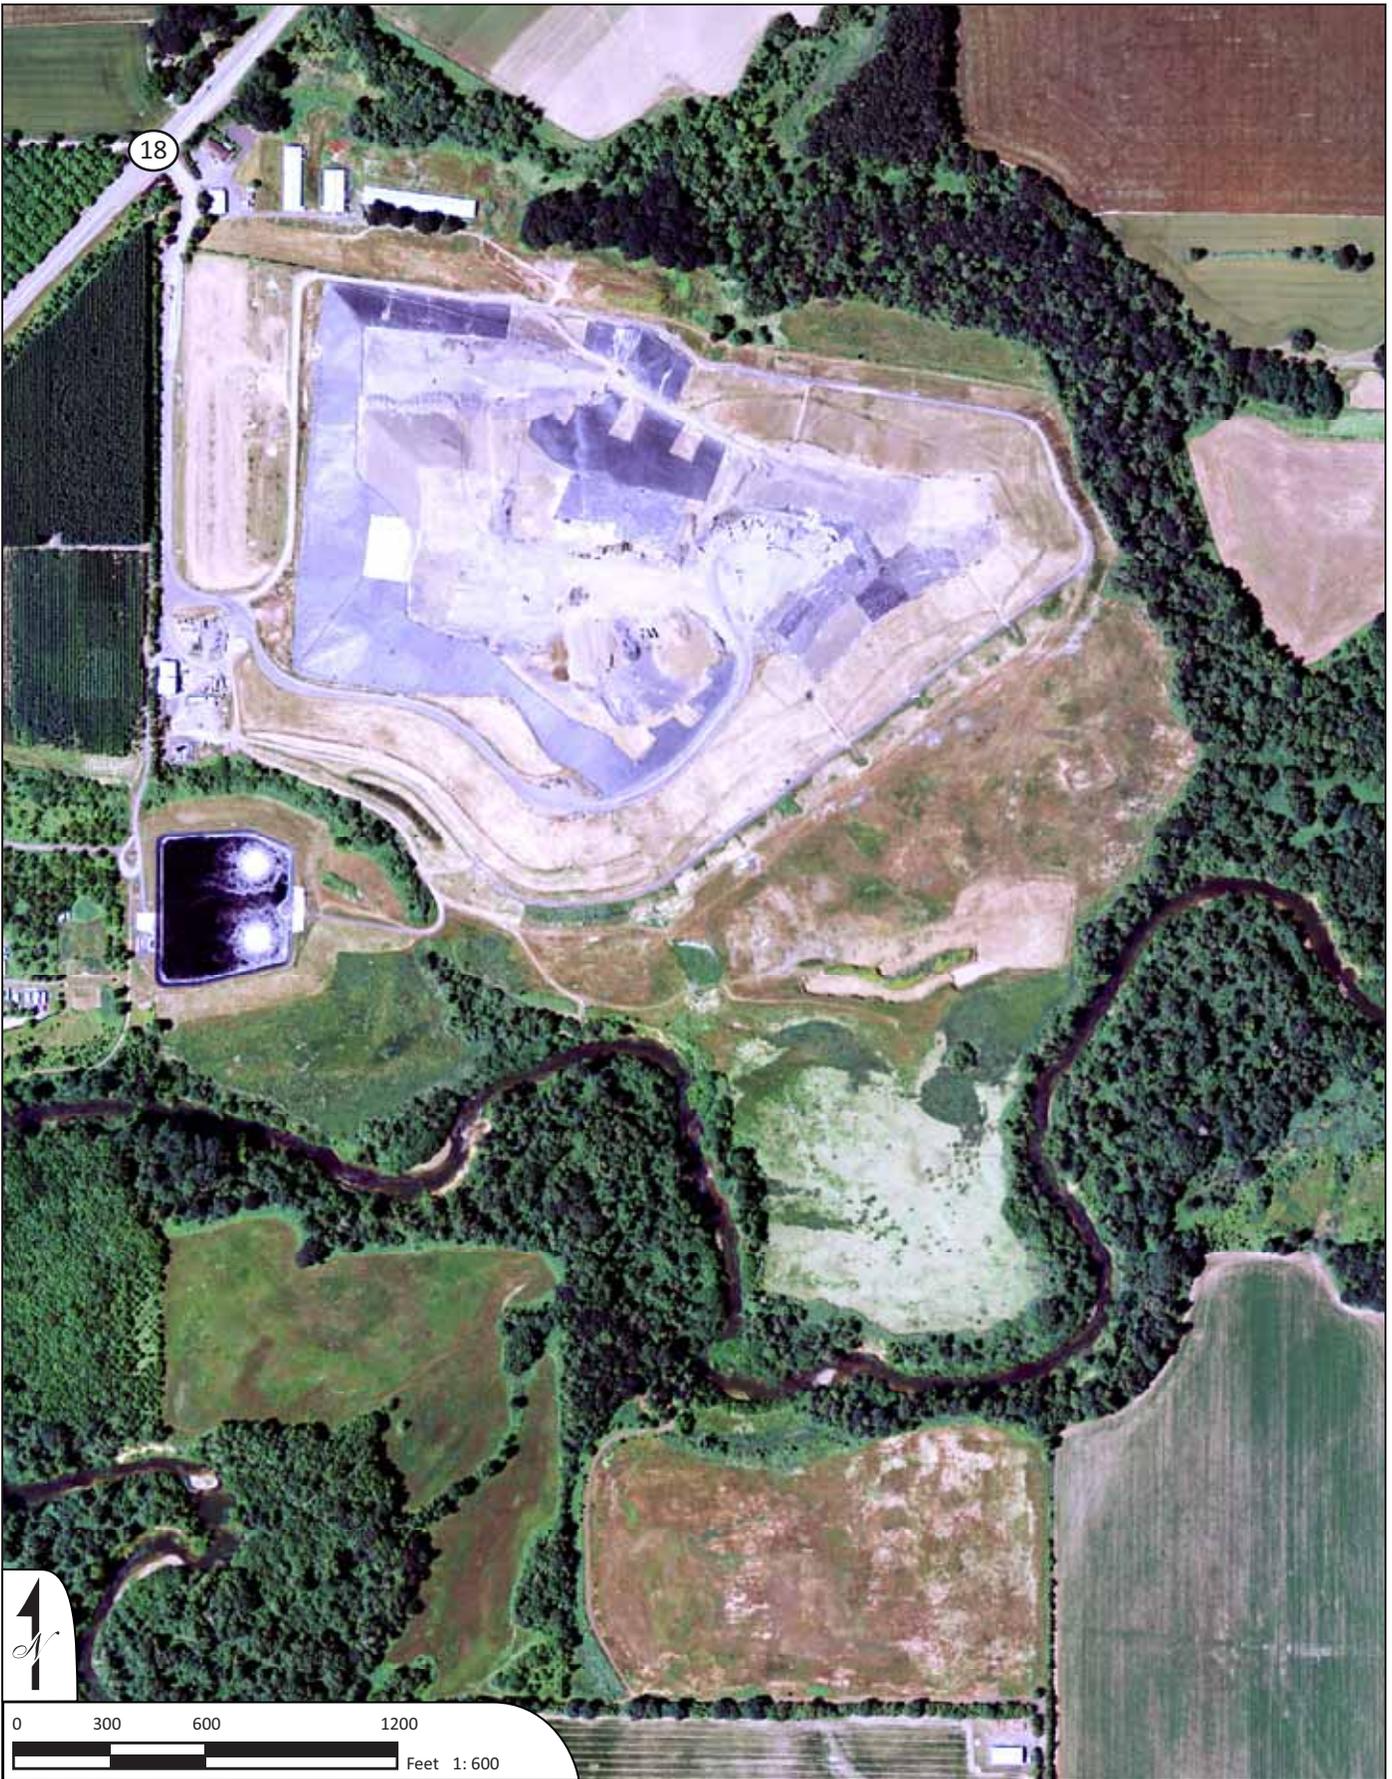
FIGURE 2

Existing project site conditions on the South Yamhill River. The project site is southeast of the existing landfill operation on Salmon River Highway 18.
