Airborne Thermal Infrared Remote Sensing Crooked River, OR

Survey Dates: August 5-8, 2005

Final Report Date: July 31, 2006

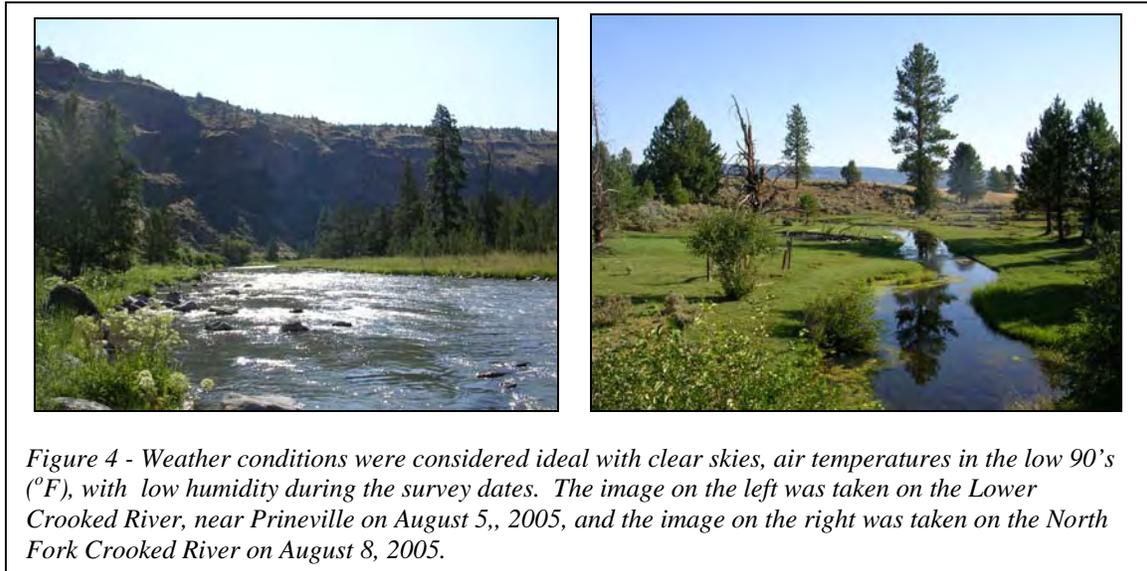
Weather conditions were considered ideal on all four days of the survey with warm air temperatures, low humidity, and clear skies (Figure 4). Table 1 lists the air temperatures and relative humidity recorded during the time frame of the surveys.

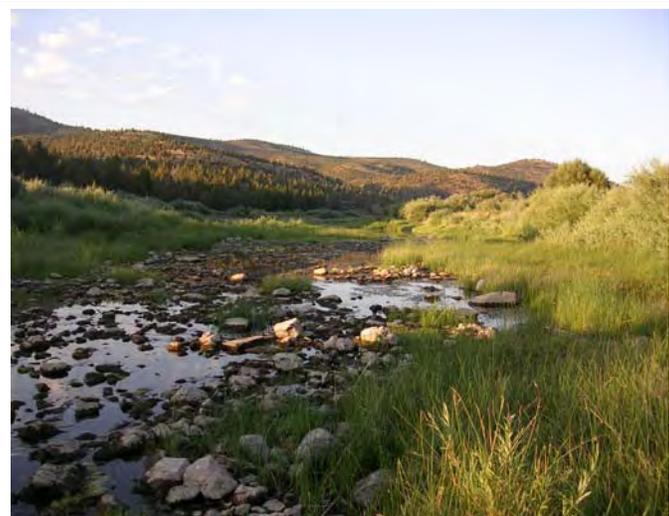
The ground level picture above shows flow conditions in the Crooked River upstream of Prineville Reservoir on 8/6/06.

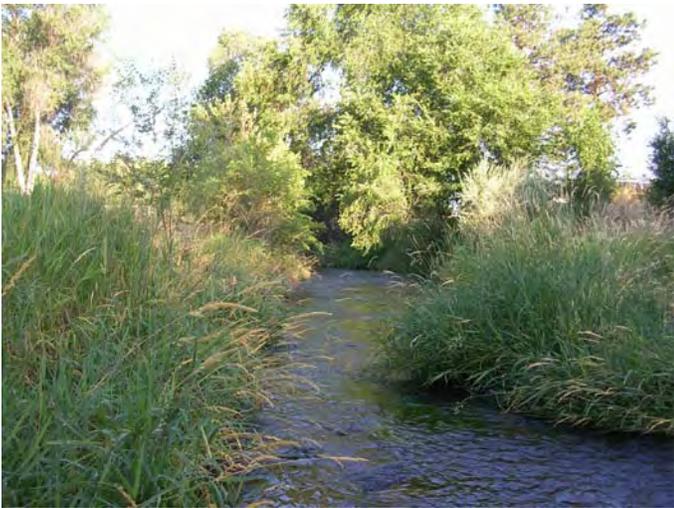
The ground level image above shows Ochoco Creek at mile 4.6. The image illustrates flow and mixing conditions in the creek at this location.
