City of Astoria

Source Water Protection

Benefits & Challenges of a Municipally-
Owned Watershed for Drinking Water

December 12, 2018

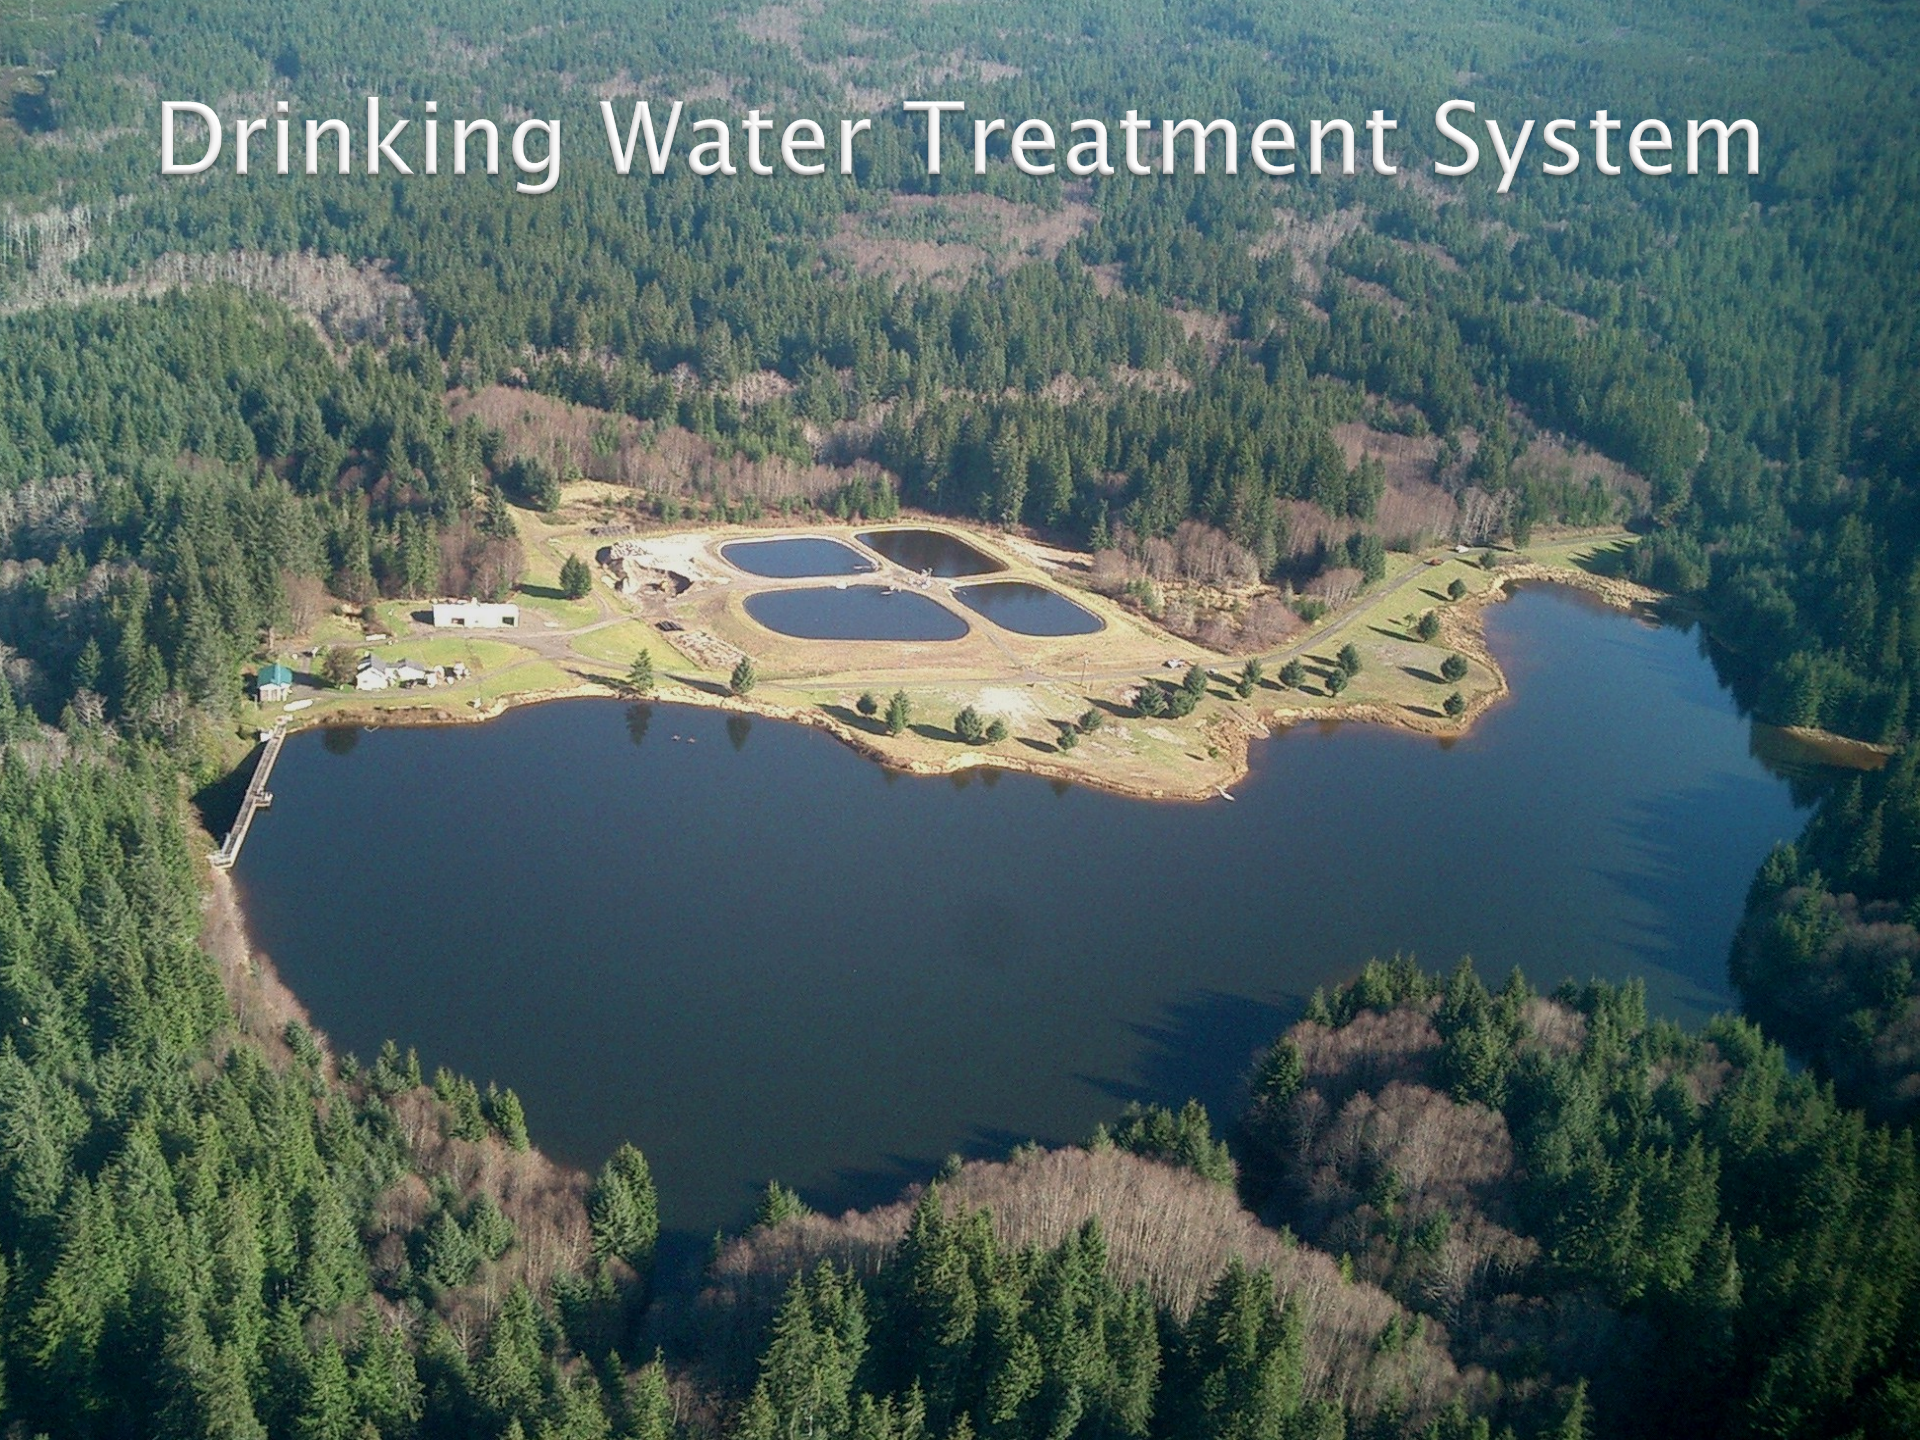
Drinking Water Treatment System

- ▶ Slow Sand Filter System Built in 1993
 - ▶ Economical method to treat drinking water
 - ▶ Must meet state testing standards
 - ▶ Need to re-sand filters every 5–6 years
 - ▶ Currently at capacity of 4 million gallons per day in peak demand season which is summer fish processing season
-

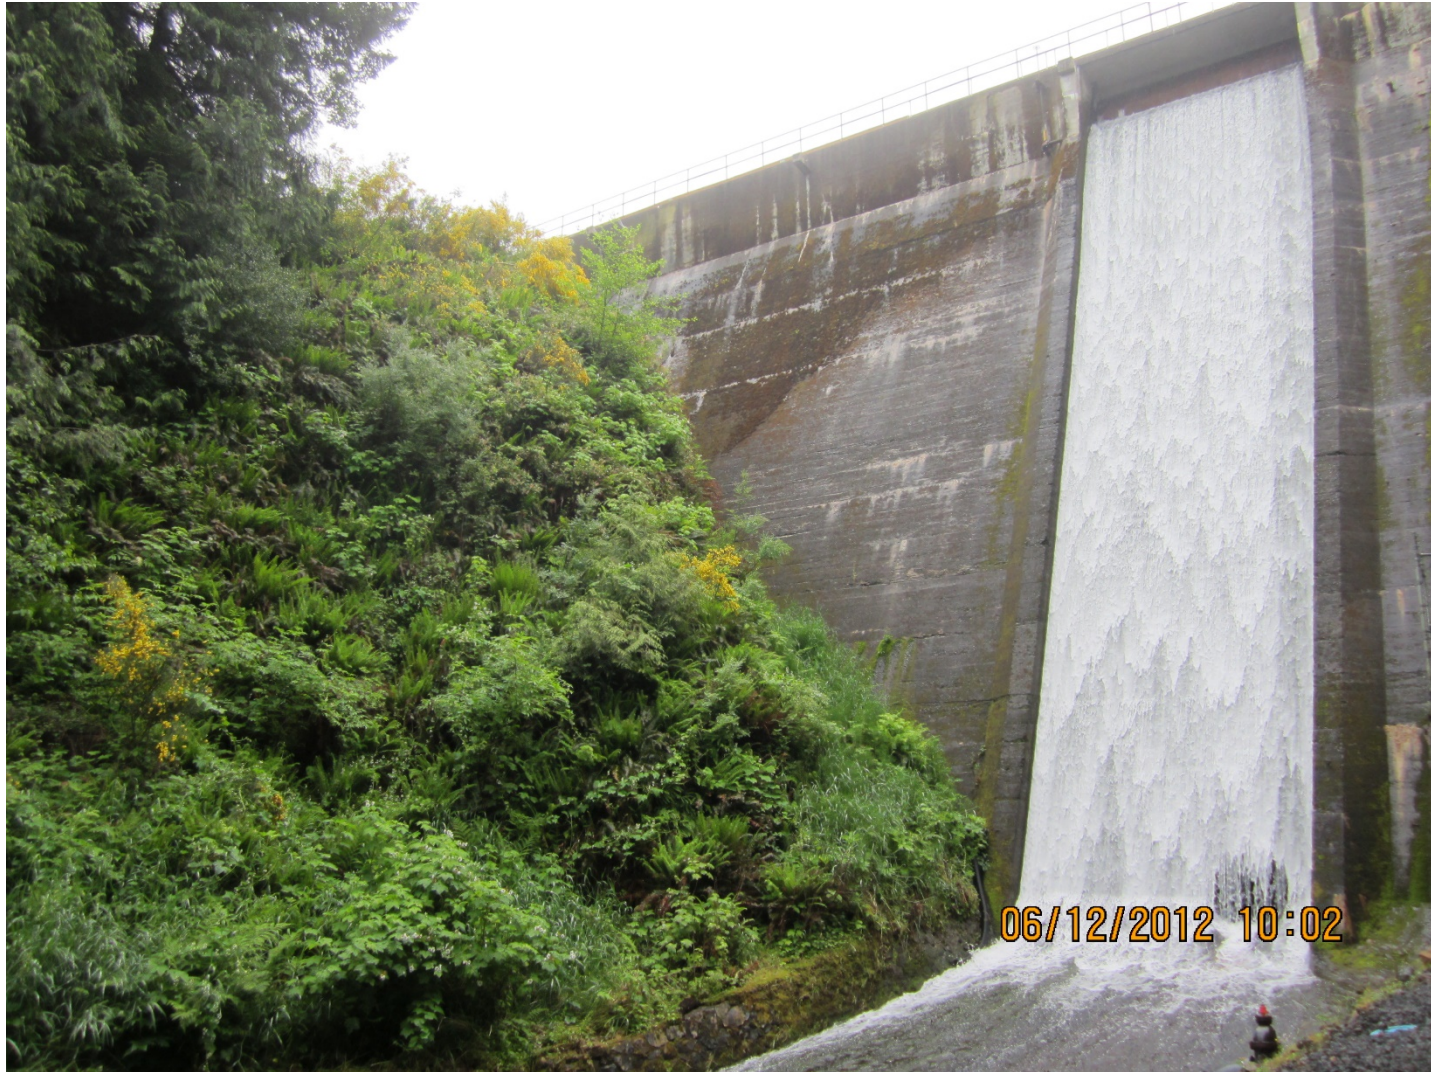
Bear Creek Dam Today

Built in 1911 (75') & raised in 1953 (15')

- ▶ **Bear Creek Dam (Main Lake)**
 - Storage capacity of 200 million gallons
 - Water must be pumped from lake to slow sand filter system
 - Completed seismic stability evaluation in 2016
- ▶ **Middle Lake Dam & Reservoir**
 - Storage capacity of 52 million gallons
 - Gravity feeds to system
- ▶ **Wickiup Lake Dam & Reservoir**
 - Storage capacity of 59 million gallons
 - Gravity feeds to system

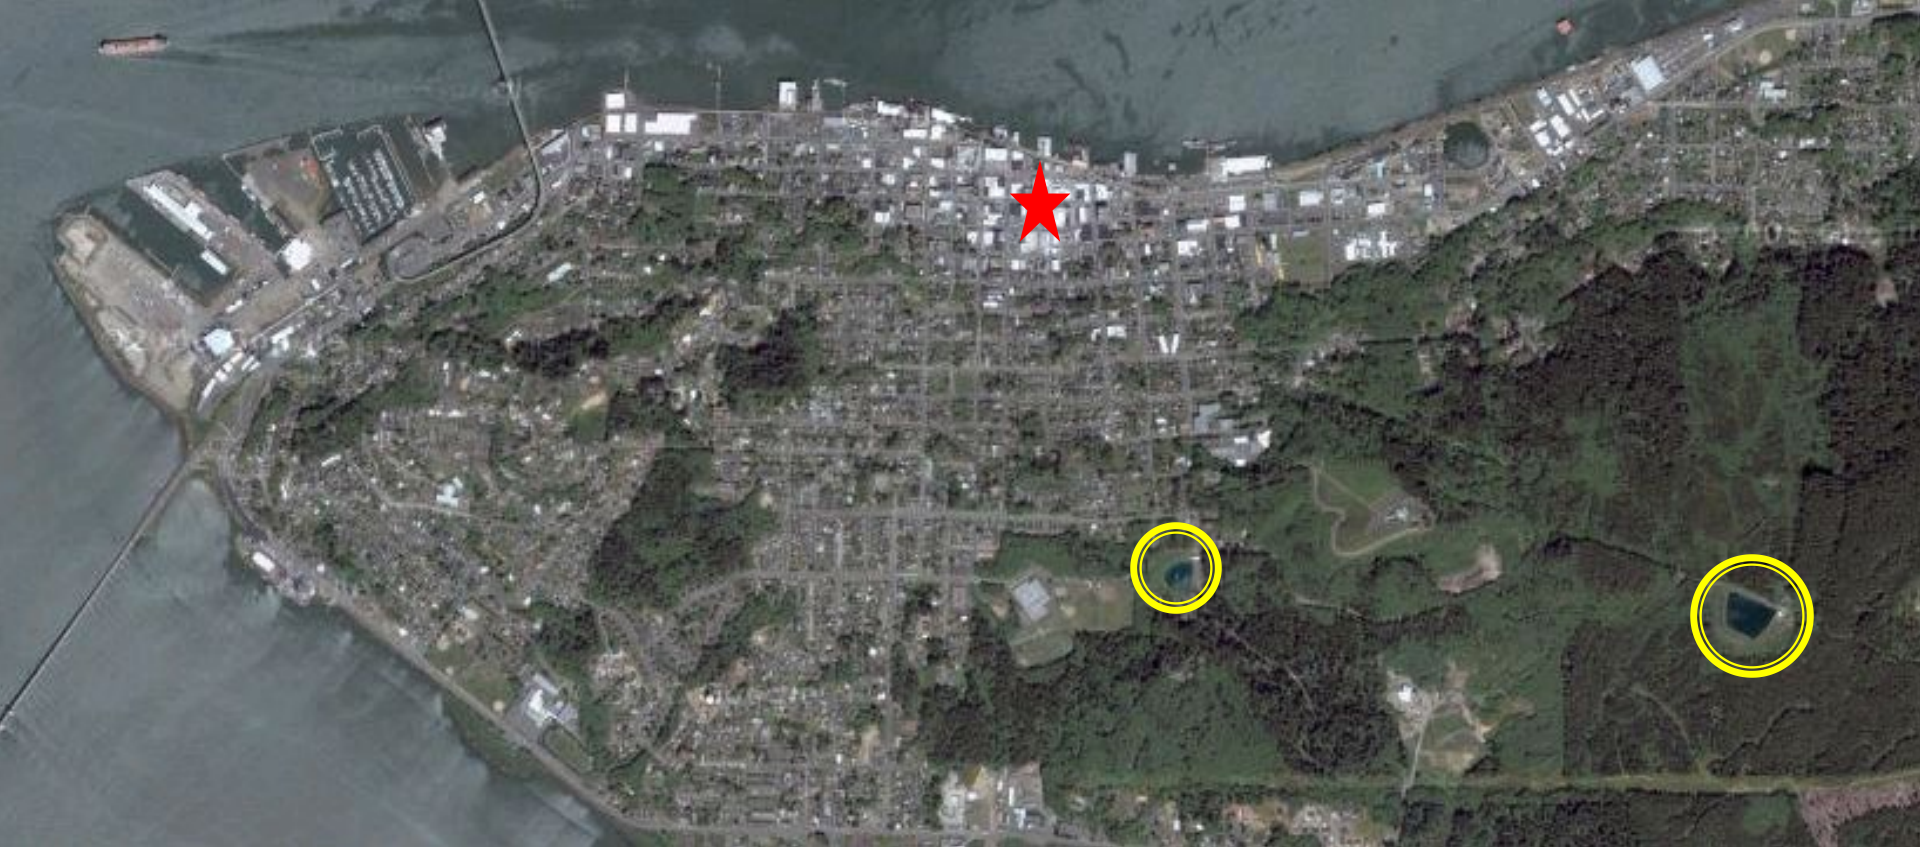
Reservoir No. 2	Reservoir No. 3
Volume (gal)	6 million	20 million
Year Built	1895	1919
Depth (ft)	17.3	25.5
Construction Type	Brick	Concrete
Lining Date	1980's	1970's

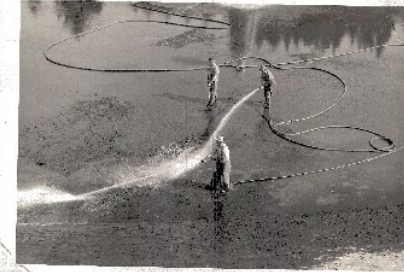
Fred Korki, Art Piddie and Louis Tenny washing down Reservoir #2 floor - side walls have been cleaned and sterilized. May 1959

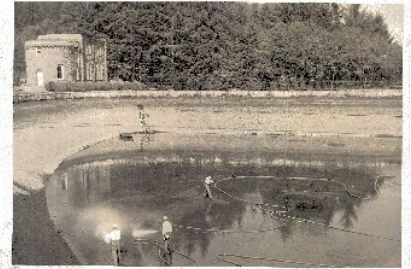
Fred, Art, & Louis washing down two lengths of 3" hose with a yoke to 1 1/2" hose was used 1 length of 3" and 4 lengths of 1 1/2" are needed for job with 1 1/2" nozzles. May 1959-Reservoir #2

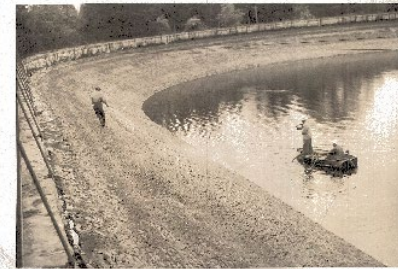
Clearing Res. #2 May 1959
