Aerial Surveys in the Fifteenmile Creek Basin

Thermal Infrared and Color Videography

Final Report
Revised: March 31, 2003

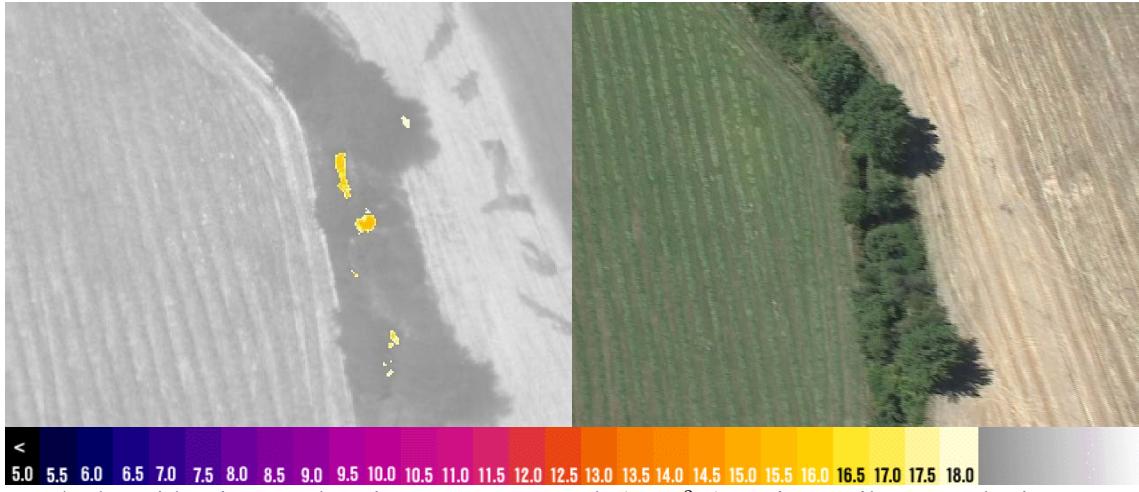
TIR/color video image showing Ramsey Creek (15.4°C) at river mile 0.1. The image pair is an example of how riparian vegetation masked the stream even in the lower reaches and surface water was visible only intermittently (frame: *ram0197*).
