# *Aerial Surveys of the Middle Fork Hood River* Thermal Infrared and Color Videography

February 26, 2003

**Final Report**

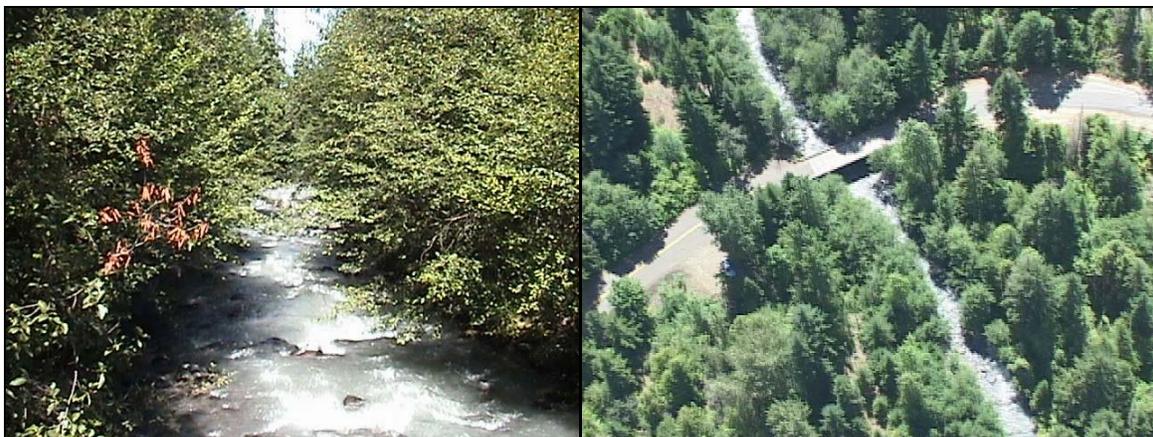
Figure 5 - Ground level image (left) and airborne video image (right) of the MF Hood River at river mile 4.3. The ground level photograph was taken from the bridge looking downstream. (frame: mfh0570).
