CHETCO LAKE CHROMITE DEPOSIT

GARDNER CHROME MINE

Brunton & pace survey, Fourth of July Claim, NW/NE Sec. 10, T.39S., R.1
Curry County, Chetco Mining District, C.I. 10', Datum assumed. Sept. 1954.
By L. Ramp & R.D. Bentley

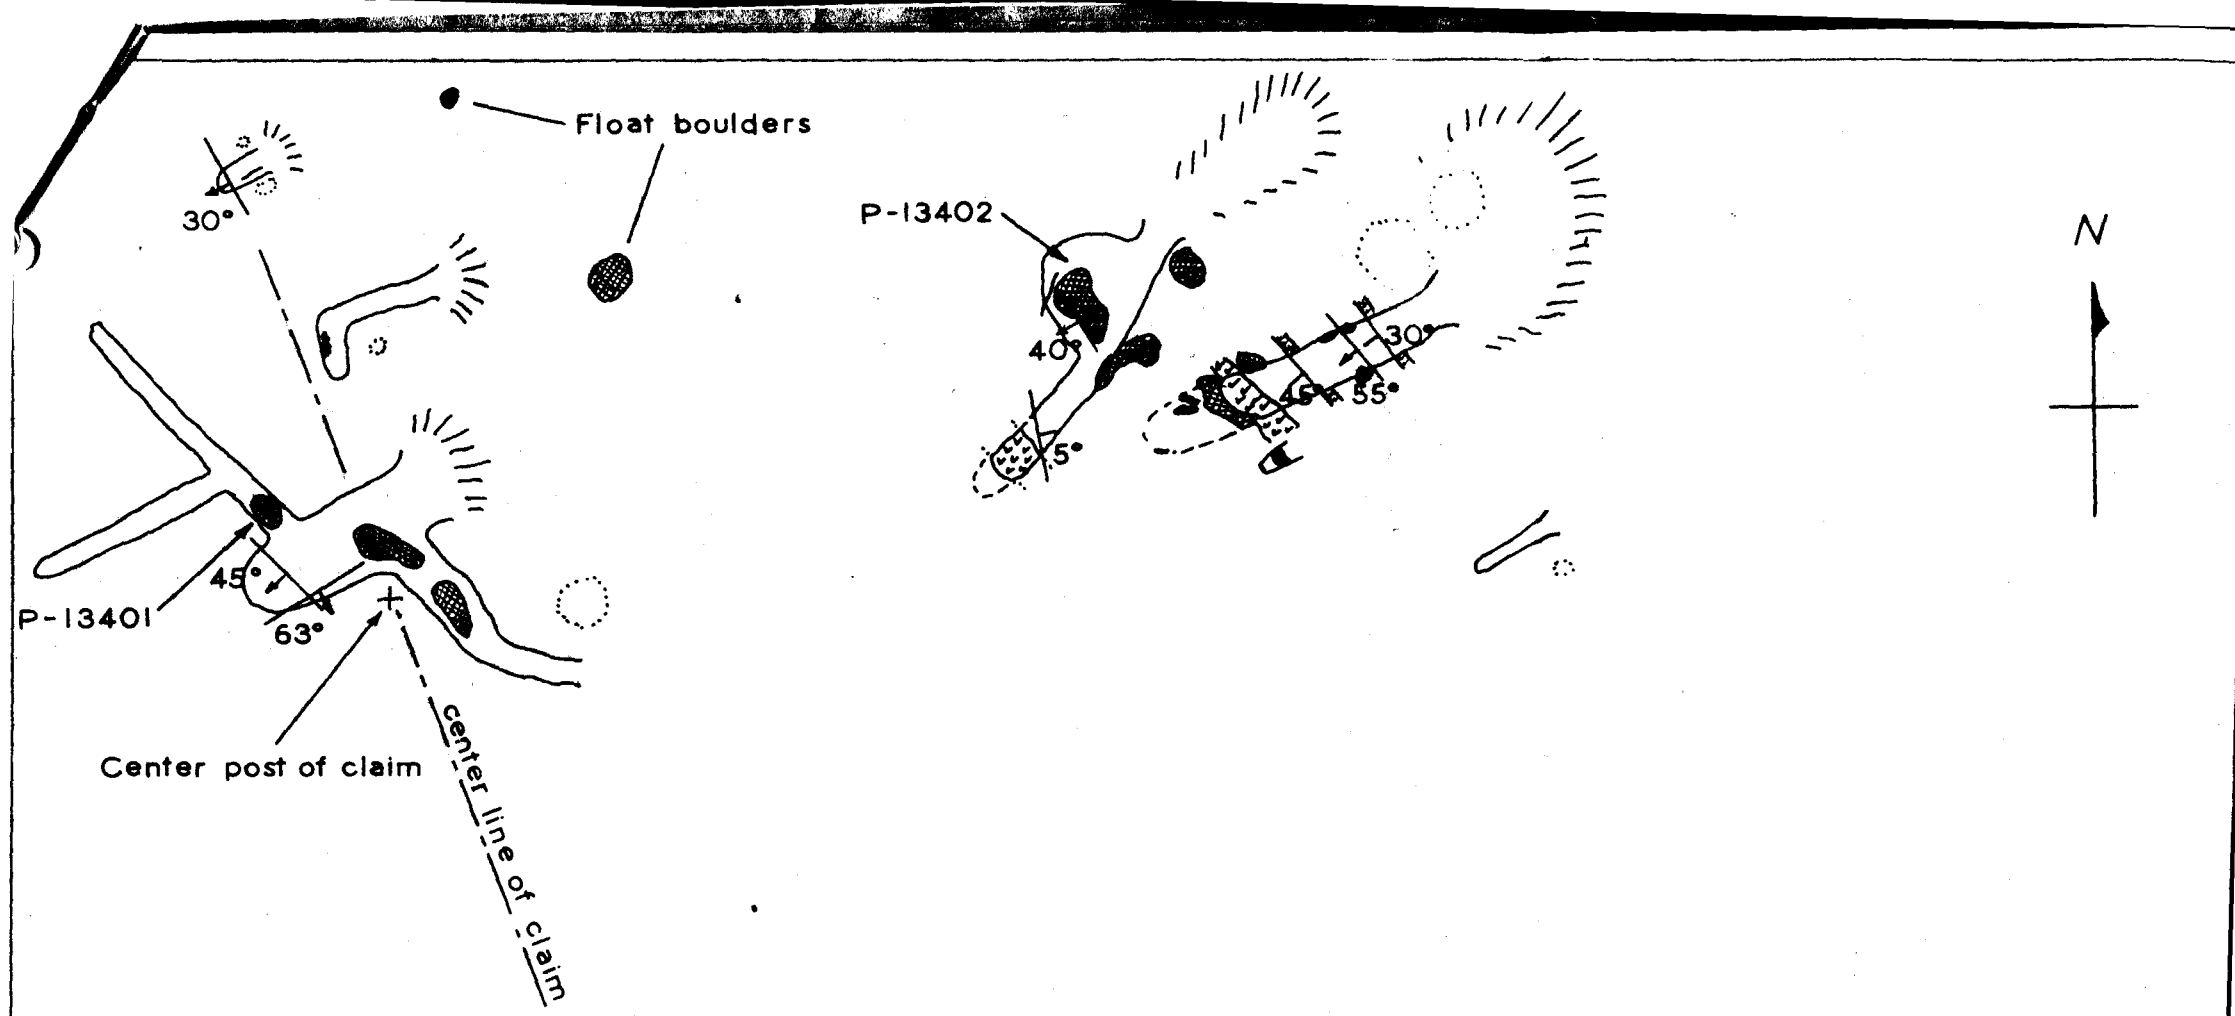
Chromite
-

Serpentine; altered dunite and saxonite
-
