# State Department of Geology and Mineral Industries

PUM-BRICK TILE CO. UNCLASSIFIED DISTRICT DESCHUTES & JEFFERSON  
(Pumice Aggregate & Building Blocks) COUNTIES

PUM-BRICK TILE COMPANY  
(Pumice Aggregate & Building Blocks)

**TUMALO ( <sup>Top</sup> ) PUMICE (Pumice)** UNCLASSIFIED DISTRICT DESCHUTES COUNTY

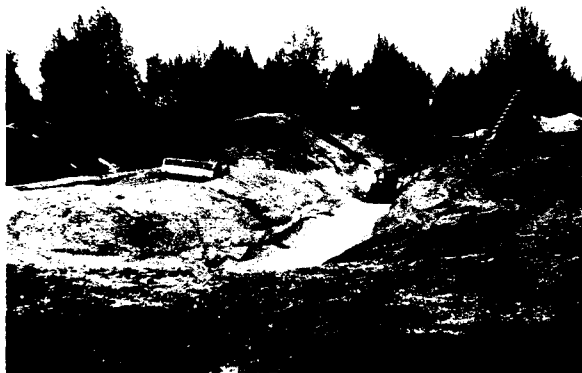
VIEW OF THE TUMALO PUMICE PLANT

Pumice is excavated by a tractor with a blade and is pushed to set of vibrating screens and rolls.

An elevator hoists the crushed product to a bunker, situated in the pit. The mesh of the product is varied to suit the buyer, but is usually about  $\frac{1}{2}$ ".
