# Baker High School

Bake\_sch03A

## FEMA 154 Rapid Visual Screening Score Card

Rapid Visual Screening - Senate Bill #2 - Seismic Needs Assessment  
Oregon Department of Geology and Mineral Industries

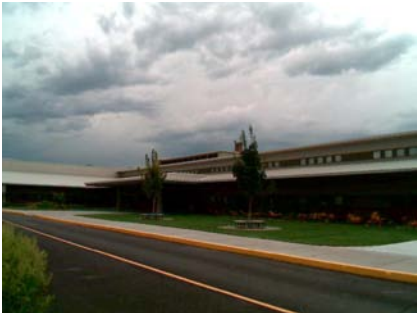
Plan Irregularities	Vertical Irregularities
Reentrant Corners: L Shaped	Steps in Elevation View: Single Change
Reentrant Corners: Other	Steps in Elevation View: 2 to 3 Changes (Adjacent Building/Entity)
None	None

Falling Hazards	Poor Conditions
None	None
None	None
None	None

S Elevation View

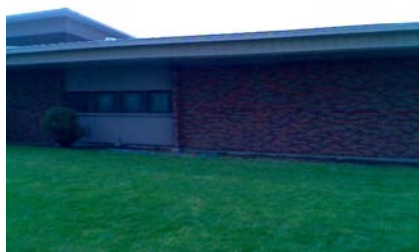
Plan Irregularities	Vertical Irregularities
Reentrant Corners: Other	Steps in Elevation View: 2 to 3 Changes (Adjacent Building/Entity)
Reentrant Corners: Other	None
None	None

Falling Hazards	Poor Conditions
None	None
None	None
None	None

E Elevation View

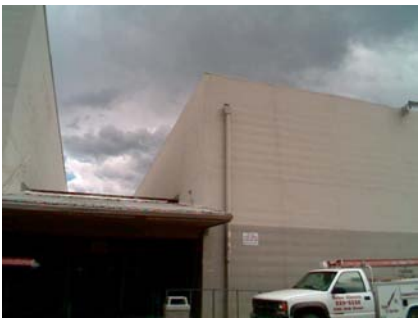
Very High (100%)

Plan Irregularities	Vertical Irregularities
Reentrant Corners:Other (Adjacent Build/Entity)	Steps in Elevation View: 2 to 3 Changes (Adjacent Building/Entity)
None	Steps in Elevation View: Single Change
None	None

W Vertical Irregularity Primary

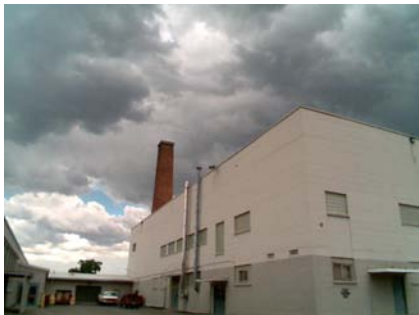
Very High (100%)

Falling Hazards	Poor Conditions
Unreinforced Chimneys	None
None	None
None	None

NW Falling Hazard

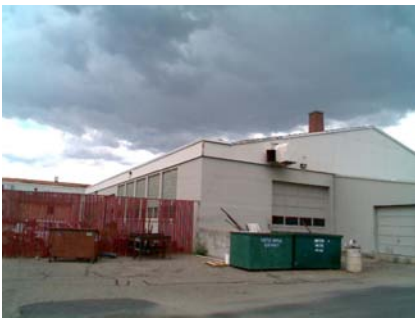
Plan Irregularities	Vertical Irregularities
Reentrant Corners: L Shaped	None
Reentrant Corners: Other	None
None	None

NW Elevation View

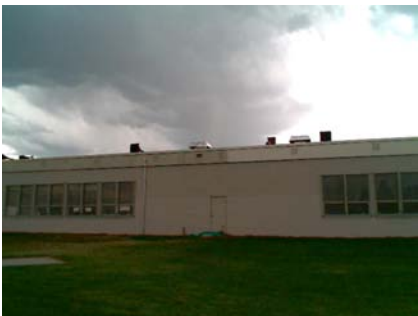
Plan Irregularities	Vertical Irregularities
Reentrant Corners: L Shaped	None
None	None
None	None

N Elevation View
