Corvallis Police Department

FEMA 154 Rapid Visual Screening Score Card

Rapid Visual Screening - Senate Bill #2 - Seismic Needs Assessment
Oregon Department of Geology and Mineral Industries

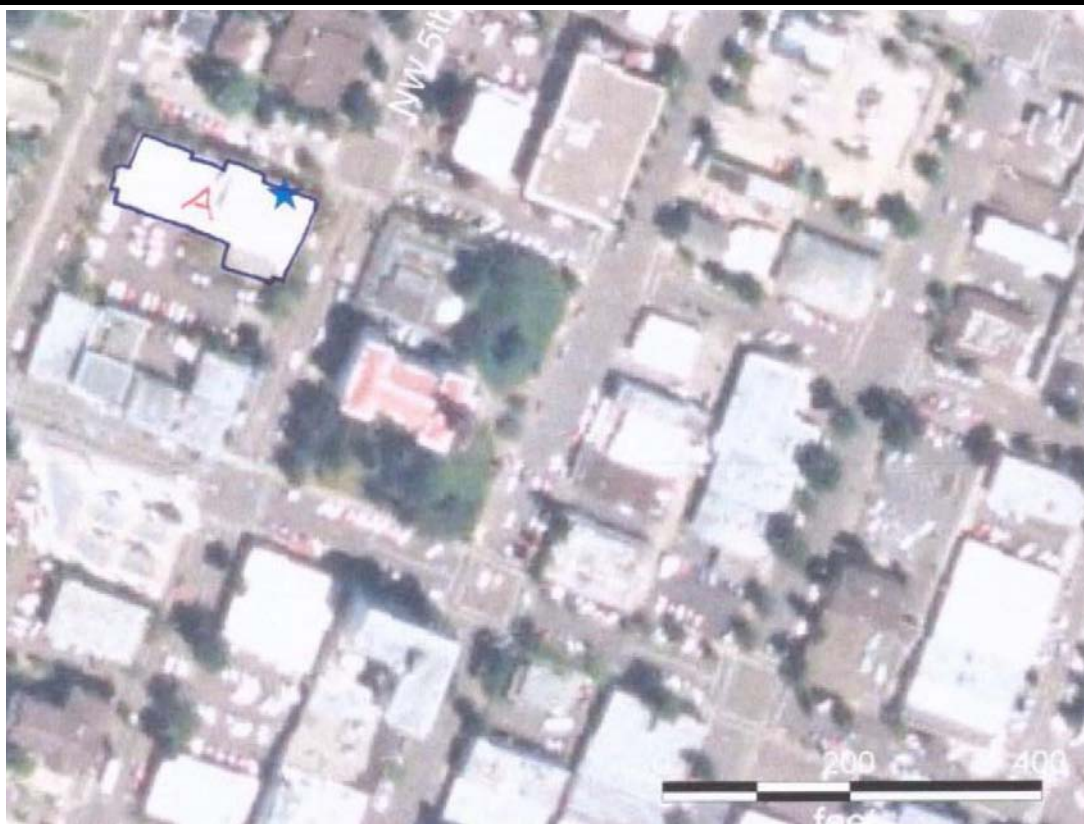
Type	Basic Score	Vert Irreg	Plan Irreg	Pre-Code	Post-Bench	Soil C	Soil D	Soil E	RVS Score
Primary	C2	2.8	-1	-0.5	0	0	0	-0.6	0	0.7
Secondary		0	0	0	0	0	0	0	0	0
Tertiary		0	0	0	0	0	0	0	0	0

High (>10%)

S Primary Structural Type

S Vertical Irregularity Secondary
short column
