Clackamas CC

FEMA 154 Rapid Visual Screening Score Card

Barlow Hall

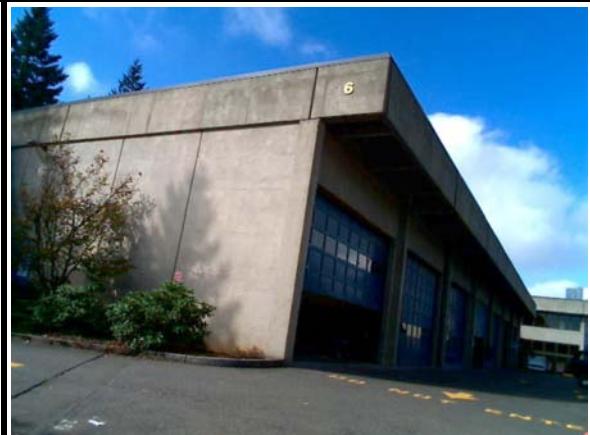
Type	Basic Score	Vert Irreg	Plan Irreg	Pre-Code	Post-Bench	Soil C	Soil D	Soil E	RVS Score
Primary	C2	2.8	-1	-0.5	0	0	-0.4	0	0	0.9
Secondary	C1	2.5	-1.5	-0.5	0	0	-0.4	0	0	0.1
Tertiary	RM1	2.8	-1	-0.5	0	0	-0.4	0	0	0.9

Final Type	Final Score
C2	0.9

High (>10%)
