Clairmont Hall

Clackamas CC

FEMA 154 Rapid Visual Screening Score Card

Rapid Visual Screening - Senate Bill #2 - Seismic Needs Assessment
Oregon Department of Geology and Mineral Industries

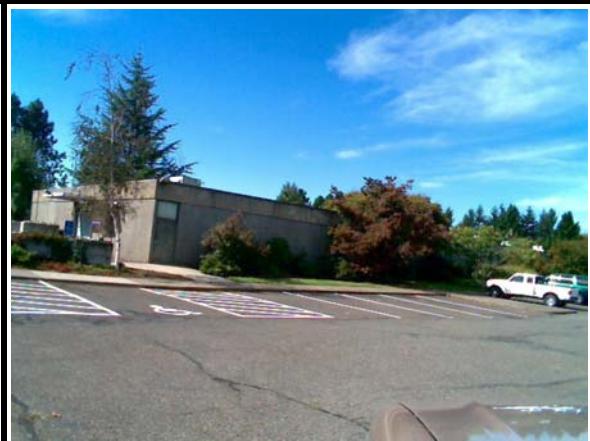
Type	Basic Score	Vert Irreg	Plan Irreg	Pre-Code	Post-Bench	Soil C	Soil D	Soil E	RVS Score
Primary	PC1	2.6	0	0	0	0	-0.4	0	0	2.2
Secondary		0	0	0	0	0	0	0	0	0
Tertiary		0	0	0	0	0	0	0	0	0

Final Type	Final Score
PC1	2.2

Low (<1%)
