# Molalla RFPD 73

## FEMA 154 Rapid Visual Screening Score Card

Rapid Visual Screening - Senate Bill #2 - Seismic Needs Assessment  
Oregon Department of Geology and Mineral Industries

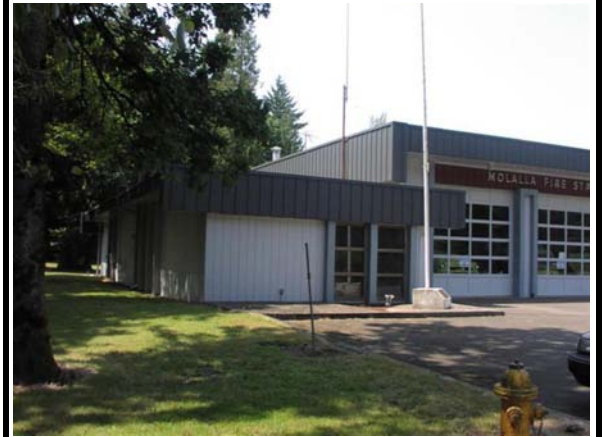
Seismicity Zone: High

| | Type | Basic Score | Vert Irreg | Plan Irreg | Pre-Code | Post-Bench | Soil C | Soil D | Soil E | RVS Score |
| Primary | RM1 | 2.8 | 0 | 0 | 0 | 0 | 0 | -0.6 | 0 | 2.2 |

RM1

2.2

Low (<1%)
