# Molalla RFPD 73

Building Type		County	
Fire - RFPD		Clackamas	
Street			
320 N Molalla Ave			
City	State	Zip	
Molalla	OR	97038	
Latitude		Longitude	
45.15029		122.57699	
Tracking Code		Inspection Date	
Hasenberg 02		9/15/2006

## FEMA 154 Rapid Visual Screening Score Card

Rapid Visual Screening - Senate Bill #2 - Seismic Needs Assessment  
Oregon Department of Geology and Mineral Industries

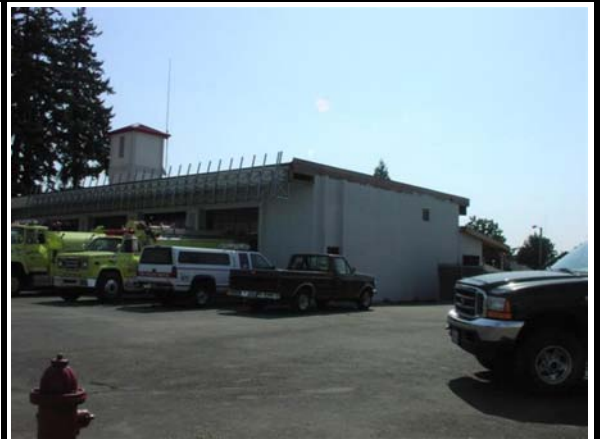
Type	Basic Score	Vert Irreg	Plan Irreg	Pre-Code	Post-Bench	Soil C	Soil D	Soil E	RVS Score
Primary	W2	3.8	0	0	0	0	-0.4	0	0	3.4
Secondary		0	0	0	0	0	0	0	0	0
Tertiary		0	0	0	0	0	0	0	0	0

3.4

Low (<1%)
