Canby Fire District 62

Building Type		County	
Fire - RFPD		Clackamas	
Street			
221 S Pine St.			
City	State	Zip	
Canby	OR	97013	
Latitude		Longitude	
45.26451		122.68271	
Tracking Code		Inspection Date	
New Building		9/15/2006

FEMA 154 Rapid Visual Screening Score Card

Rapid Visual Screening - Senate Bill #2 - Seismic Needs Assessment
Oregon Department of Geology and Mineral Industries

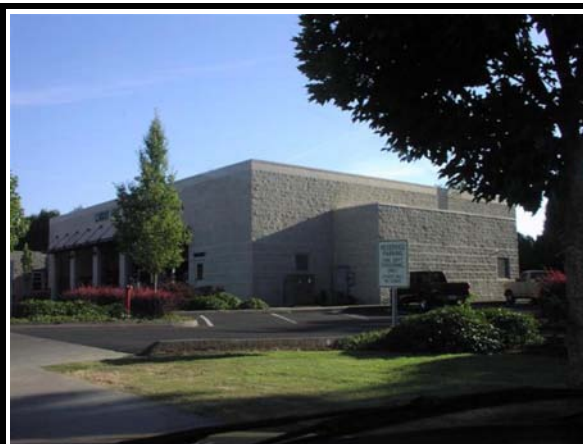
Type	Basic Score	Vert Irreg	Plan Irreg	Pre-Code	Post-Bench	Soil C	Soil D	Soil E	RVS Score
Primary	RM1	2.8	0	0	0	0	-0.4	0	0	2.4
Secondary		0	0	0	0	0	0	0	0	0
Tertiary		0	0	0	0	0	0	0	0	0

Low (<1%)

Enrollment	Year Built (Field Verified)	Year Built (Alt. Source)	Est. Decade Built
		1996	
Total Area (square ft)	Number of Stories	Basement	Pounding Potential
13800	1	No	No
